Daily Activity Report					
	Magnolia Gardens					
	39-03 College Point Boulevard, Queens, NY					
	BCP Site No. C241273					
General Site Information						
Date:	Thursday, May 23, 2024					
Weather:	66-81°F, Cloudy/Rain					
Wind Direction/Speed (towards):	SW @ 6 mph					
AKRF Personnel on Site:	Madelyn Fleming and Isabella Legovich					
AKRF Equipment on Site:	Mini RAE 3000 Photoionization Detectors [(PID) x3] and DustTrak Aerosol Monitors (x3)					
Visitors:	None					
Contractor Information						
Subcontractor						
Archstone Builders LLC				General Contractor (GC)		
Capstone Contracting Corp.				Foundation Contractor		
Description and Location of Work Activities Performed						
Excavation and grading occurred in Grids WC-4, WC-7, and WC-8. As part of the SOE, installed lagging, tiebacks, and worked on underpinning in Grids WC-4, WC-7, and WC-8. No soil stockpiles were generated.						
AKRF collected four post-excavation soil endpoint samples (EP-07 through EP-10), at 15 feet below grade (Track 2 area), and associated QA/QC samples in accordance with the NYSDEC-approved RAWP.

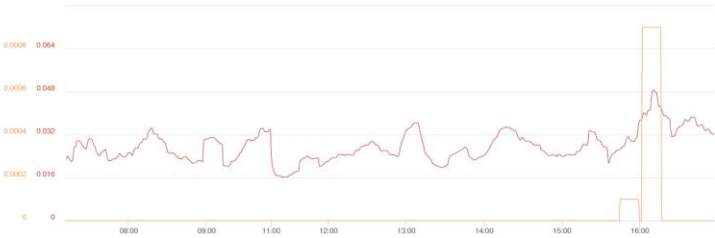
Upwind CAMP Station Data

Mass Conc. Total mg/m³ AVG 15m			
mg/m³			
DustTrak 4530			
R033025			
MIN	AVG	MAX	
0.0163	0.0277	0.0486

VOC ppm AVG 15m			
ppm			
miniRAE 3000			
R033026			
MIN	AVG	MAX	
0	0	0.0009

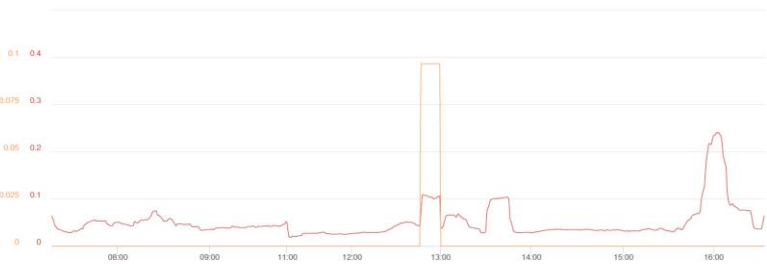
Downwind CAMP Station Data

Particulate Action Level Exceedance(s):	None			Yes		
Maximum VOC Level (ppm) 15-min avg:	0.0009			0.0967		
Maximum Particulate Level (mg/m³) 15-min avg:	0.0486			0.2408		
CAMP Response Actions: CAMP Stations were demobilized between 9:50 and 11:20 AM due to heavy rain. A particulate exceedance occurred at the Downwind station between 3:54 and 4:08 PM due to welding work in the vicinity of the CAMP station. The equipment was relocated approximately 10 feet away, and readings quickly subsided.						
Additional Information						
Planned Work Activity for Next Day/Week:	Continued export of soil offsite for disposal and SOE work.					
Comments:	None.

Mass Conc. Total mg/m³ AVG 15m			
mg/m³			
DustTrak 4530			
R033025			
MIN	AVG	MAX	
0.0185	0.0501	0.2408

VOC ppm AVG 15m			
ppm			
miniRAE 3000			
R033026			
MIN	AVG	MAX	
0	0	0.0967

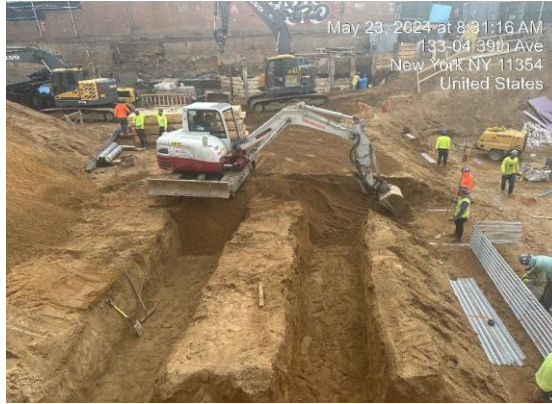
Photograph 1 -
Excavation in Grid WC
4 for the foundation
mat slab.

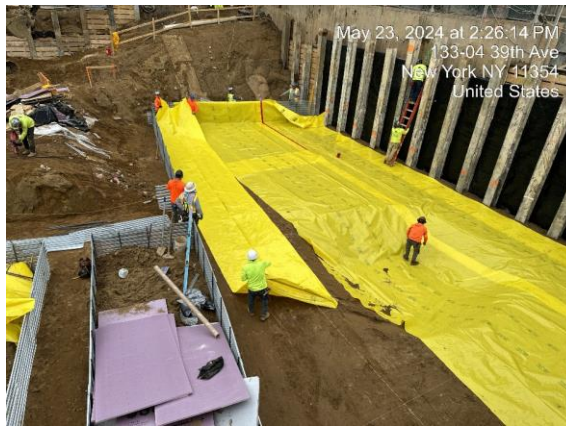
Contractor installed 20-mil Stego wrap vapor barrier membrane in the southwestern portion of the Site.						
Material Disposal Tracking Information						
Destination Facility/Material Type	Daily Trucks	Total Trucks	Daily Approx. Cubic Yds	Total Approx. Cubic Yds	Total Site Loads	Total Approximate Cubic Yards
Clean Earth of North Jersey (CENJ)/(haz lead soil)	0	7	0	140	319	6,380
Clean Earth of North Jersey (CENJ)/(haz TCE soil)	0	6	0	120		
Bayshore Soil Management, LLC (Bayshore)	0	277	0	5,540		
River Front Recycling (C&D)	0	13	0	260		
Clean Earth of Carteret (CEC)	0	16	0	320		
Import Material Tracking Information						
Origin Facility	Daily Trucks	Total Trucks	Daily Tonnage	Total Tonnage	Total Site Loads	Total Quantity (tons)
Vulcan, Wantage or Hamburg Quarry	0	9	0.00	203.07	9	203.07
CAMP Air Monitoring Results						
CAMP Station	UPWIND			DOWNWIND		
Odors:	None			None		
VOC Action Level Exceedance(s):	None			None

Photograph 2 -
Installing 20-mil Stego
Wrap vapor barrier in
the southwestern
portion of Site.

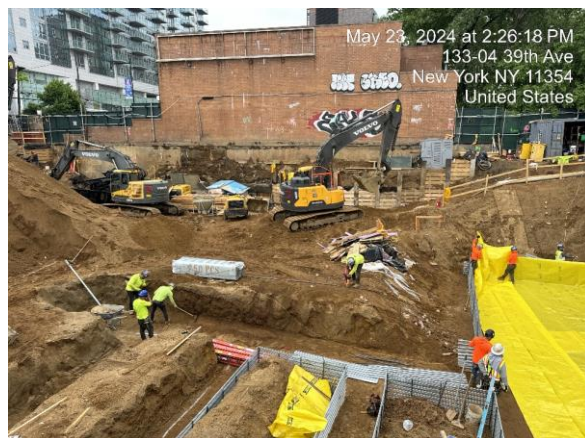
Photograph 3 -
General Site
conditions, view
facing east.
