Daily Activity Report					
	Magnolia Gardens					
	39-03 College Point Boulevard, Queens, NY					
	BCP Site No. C241273					
General Site Information						
Date:	Tuesday, June 11, 2024					
Weather:	60-75°F, Clear					
Wind Direction/Speed (towards):	N @ 3 mph					
AKRF Personnel on Site:	Mackenzie Miller					
AKRF Equipment on Site:	Mini RAE 3000 Photoionization Detectors [(PID) x3] and DustTrak Aerosol Monitors (x3)					
Visitors:	None					
Contractor Information						
Subcontractor						
Archstone Builders LLC				General Contractor (GC)		
Capstone Contracting Corp.				Foundation Contractor		
Description and Location of Work Activities Performed						
Excavation and site grading occurred in Grids WC-1/5/6 for lagging installation (as part of SOE).						
Contractor installed concrete forms and rebar in Grids WC-04, WC-05, and WC-07. Contractor poured concrete for walls in WC-4 and the elevator pit in WC-1.

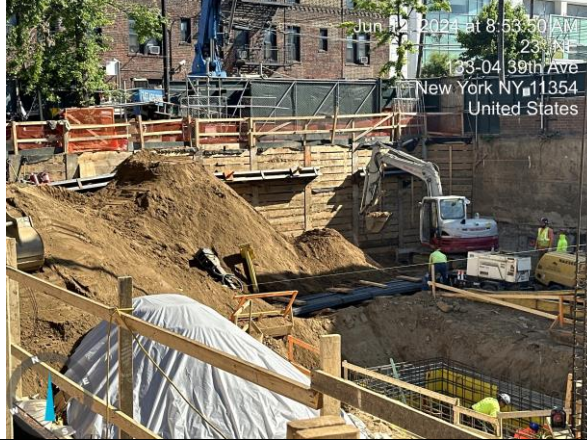
Photograph 1 -
Excavation and
grading in WC-5 for
lagging installation,
view facing northeast.
Soil stockpile remains
covered with poly
sheeting.

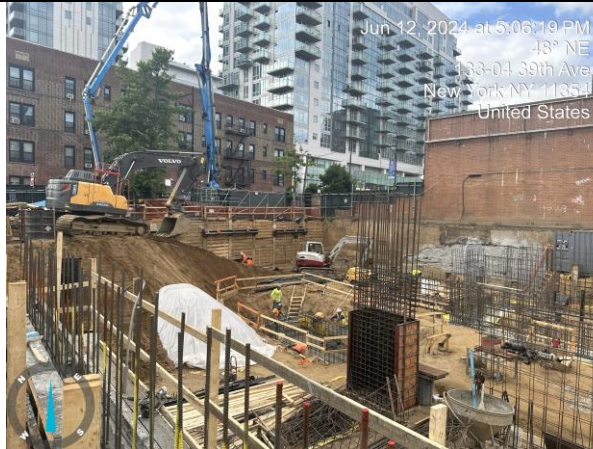
Photograph 2 -
View of Site
conditions, view
facing northeast.

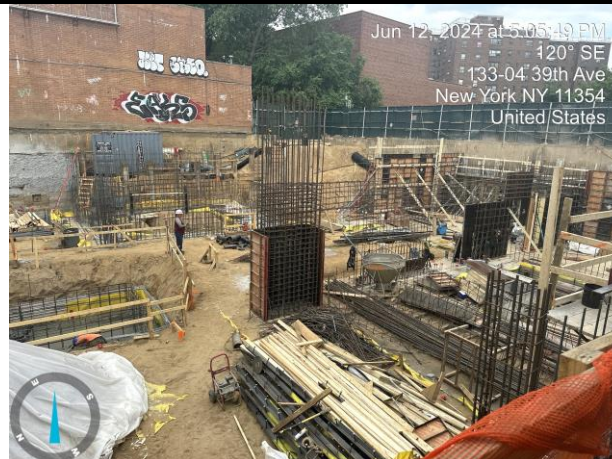
Photograph 3 -
View of Site
conditions, facing
southeast.
