### **Periodic Review Report**

**February 2025 to February 2026**

**32-01 57<sup>th</sup> Street Site**

**NYSDEC Site # 241197**

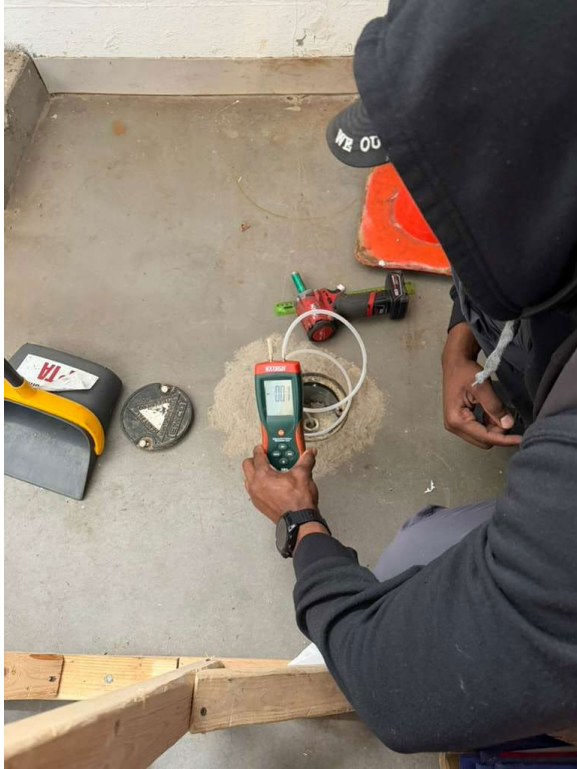
at the sub-slab vacuum monitoring points Probes #1 to Probe #5 ranged between 0.01 WC at Probes #1, Probe #2 and Probe #5, and -0.52 WC at Probe #4. No organic vapors (<0.1 ppm) were measured with the PID the two exhausts from SSDS Pit 1 to SSDS Pit 3 and SSDS-4. Overall, the recent SSDS monitoring data reflects a comparable performance noted during the previous February 2025 SSDS monitoring event.

Vacuum measurement at  
Probe #1

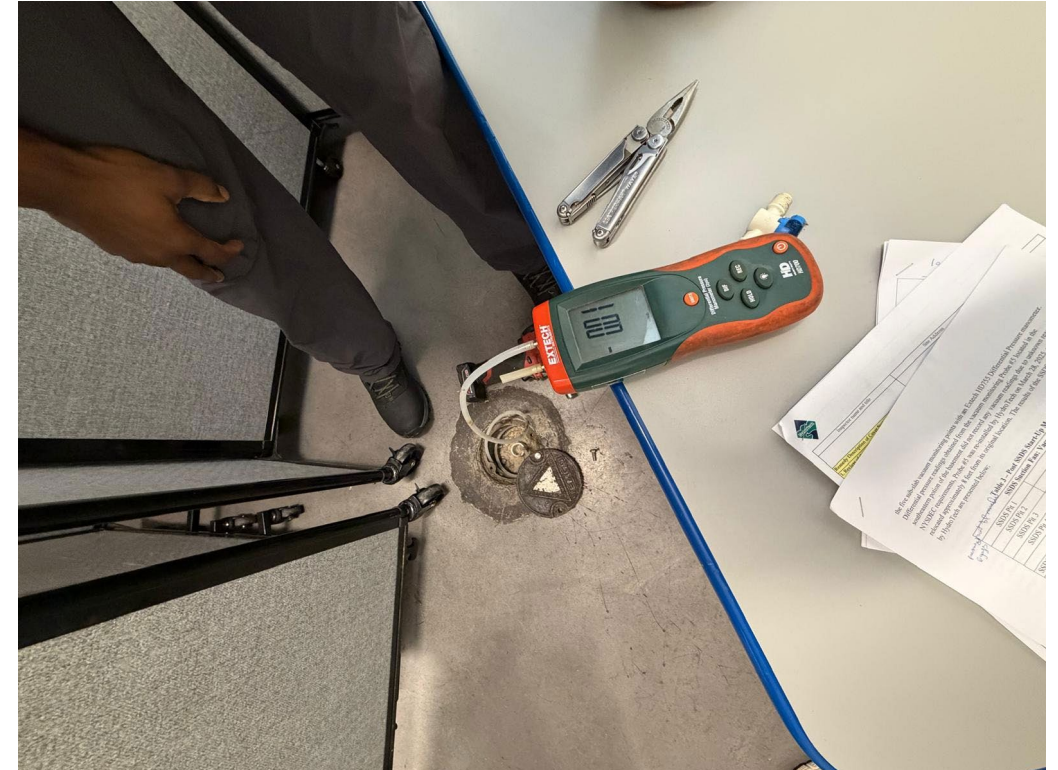
Vacuum measurement at Probe #2

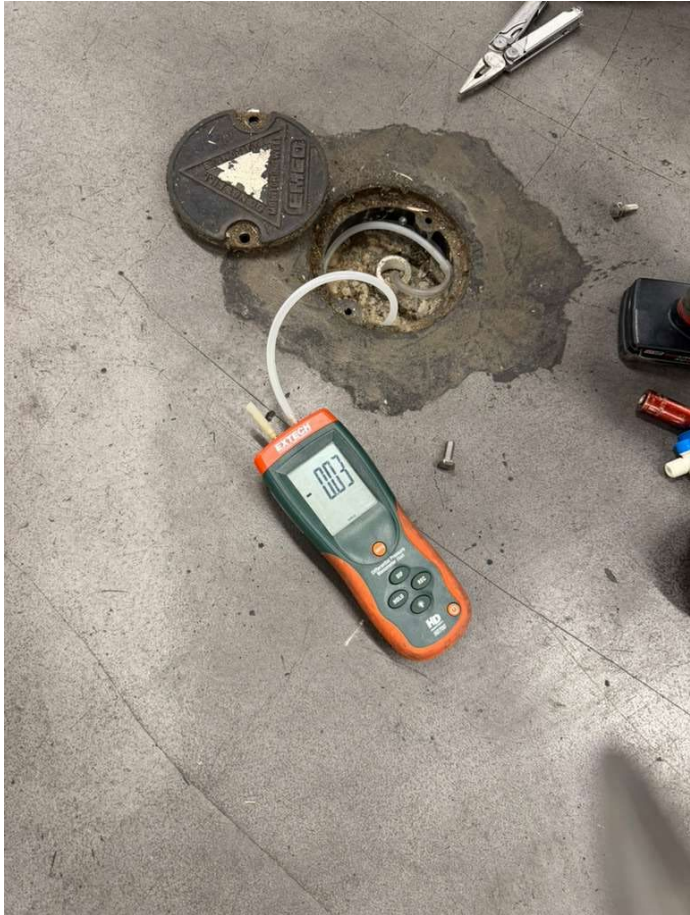
Vacuum measurement at  
Probe #3

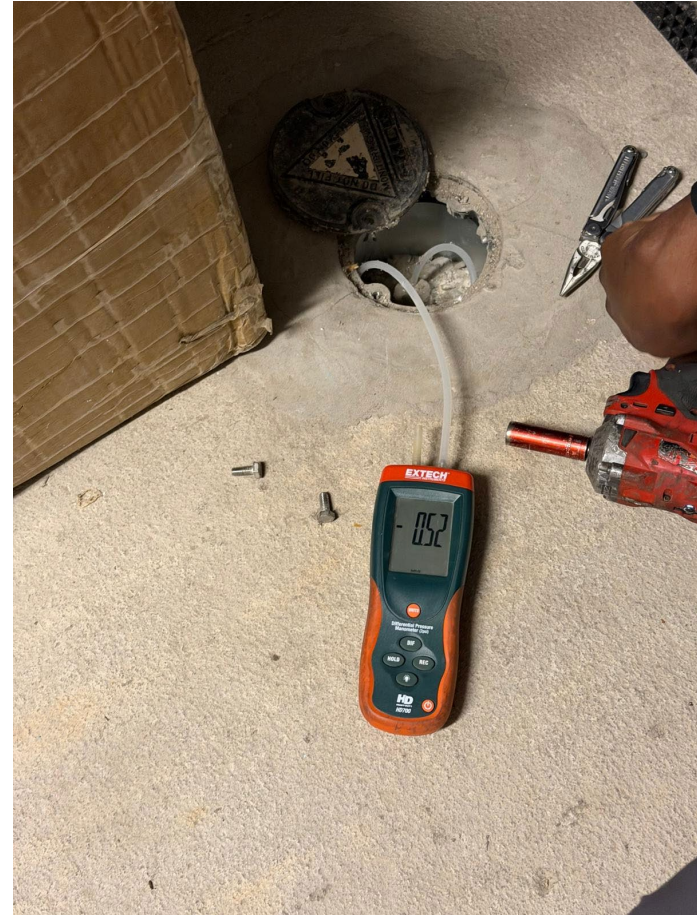
Vacuum measurement at  
Probe #4

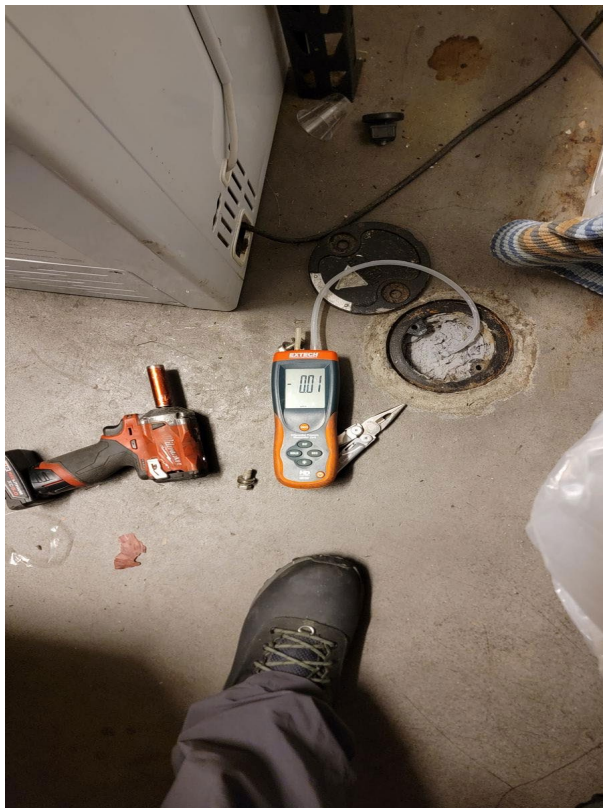
Vacuum measurement at  
Probe #5

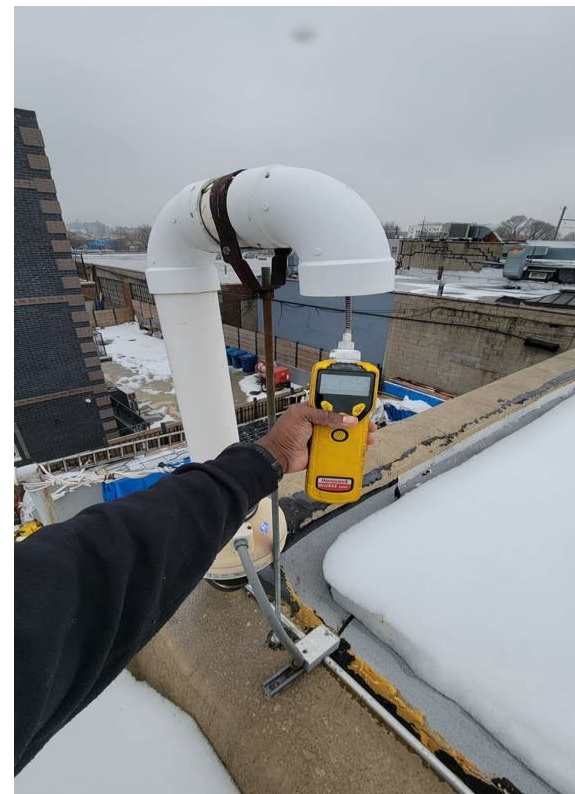
The SVE system inspection and monitoring during this reporting period indicate the system components including the suction fan, the individual Magnehelic gauges and alarm are functioning properly in accordance with the SVE system OM&M in the SMP. The negative pressure dial at the SVE Magnehelic gauge indicated a vacuum of -4 WC. Also, no organic vapors (<0.1 ppm) were measured with the PID the SVE exhaust. The monitoring of the SVE system during this period also reflects a comparable performance noted during the previous February 2025 monitoring event.

Organic vapor measurement at  
SVE effluent

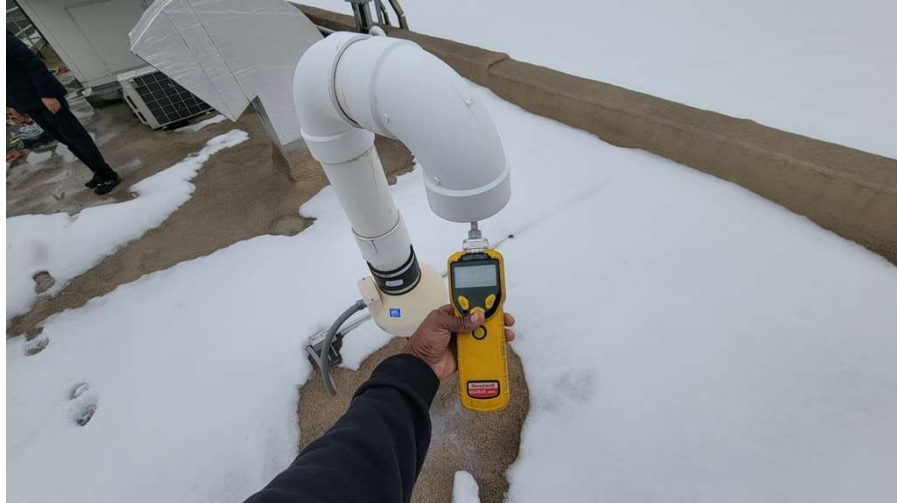
Organic vapor measurement at the effluent from SSDS Pit 1 to SSDS Pit 3

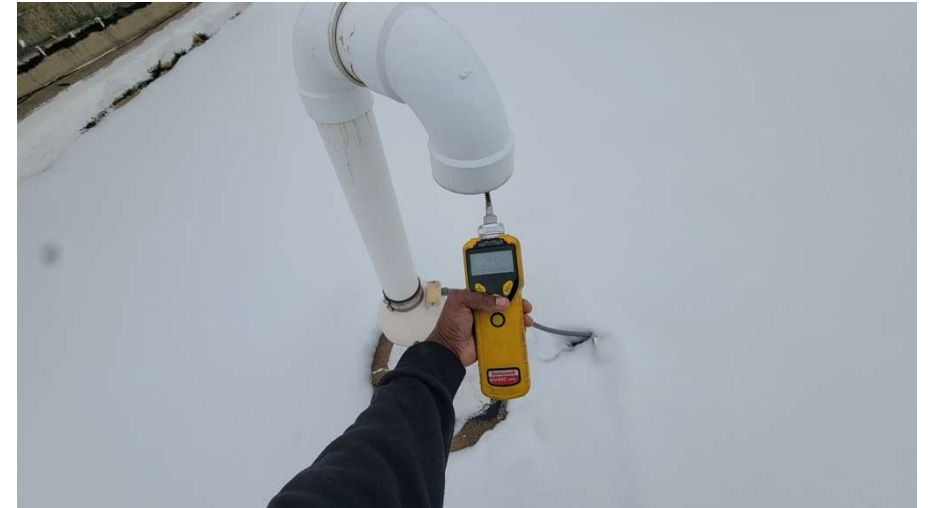
Organic vapor measurement at the effluent from SSDS Pit 4

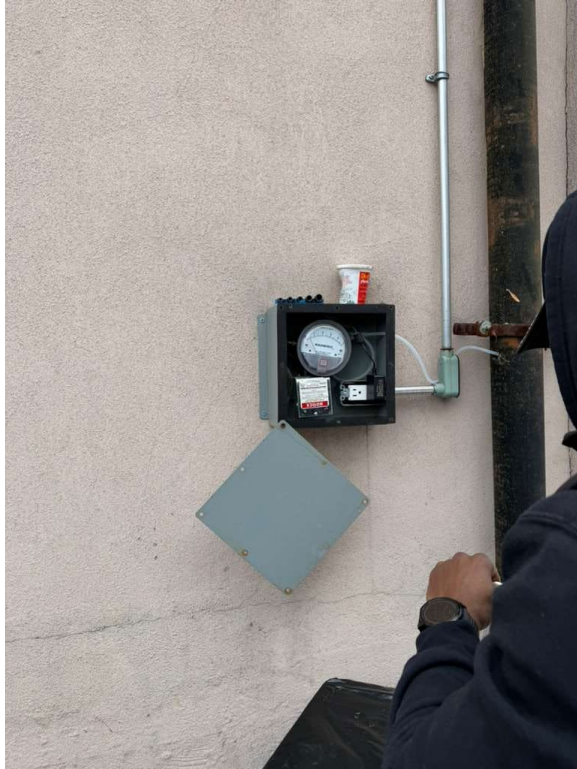
Dwyer magnehelic gauge and alarm at SVE system

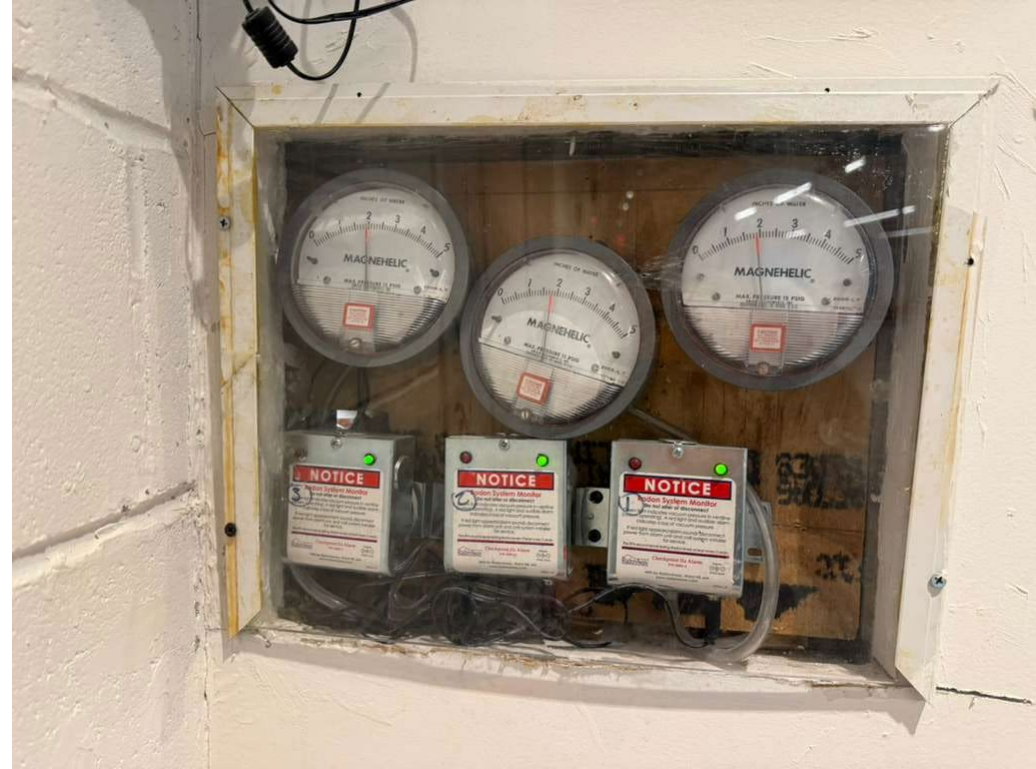
As noted above, the negative pressure (vacuum) at the Magnehelic gauges was recorded between -1 WC at SSDS-4 and -2 WC at SSDS-3. The measured vacuum

Dwyer magnehelic gauges and alarms at SSDS Pit 1 to Pit 3

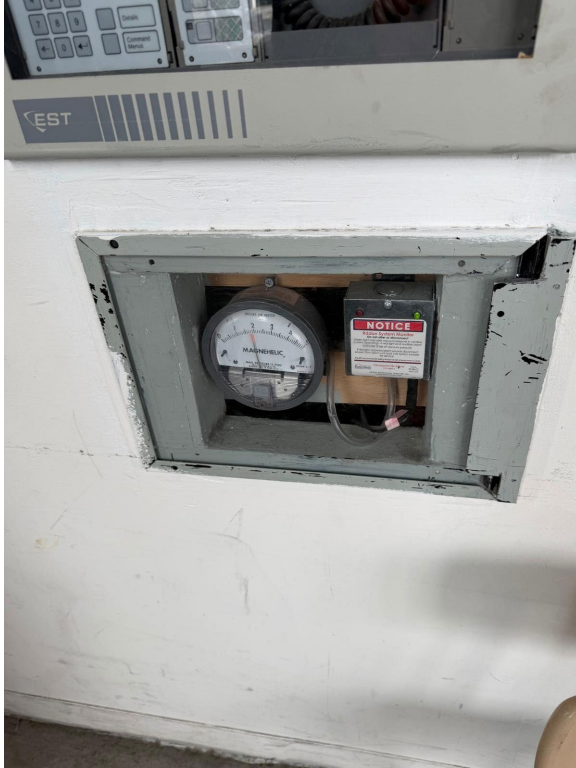
Dwyer magnehelic gauge  
and alarm at SSDS Pit 4

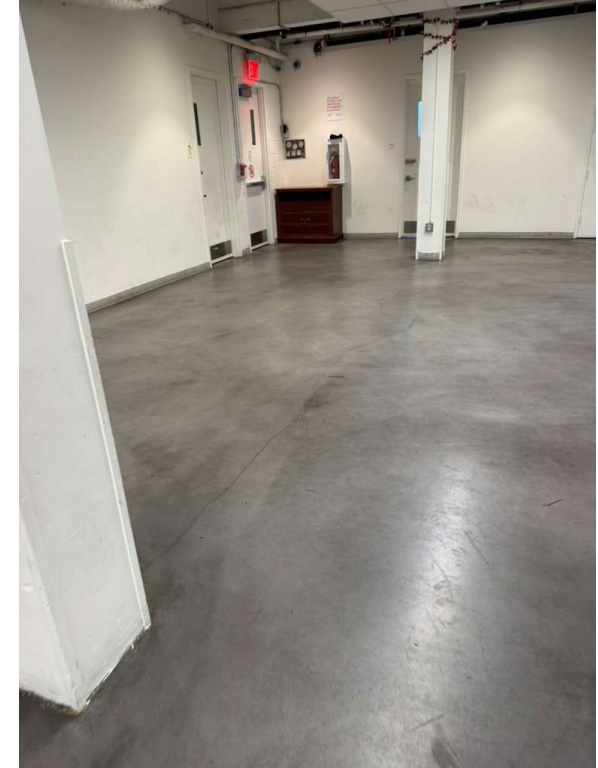
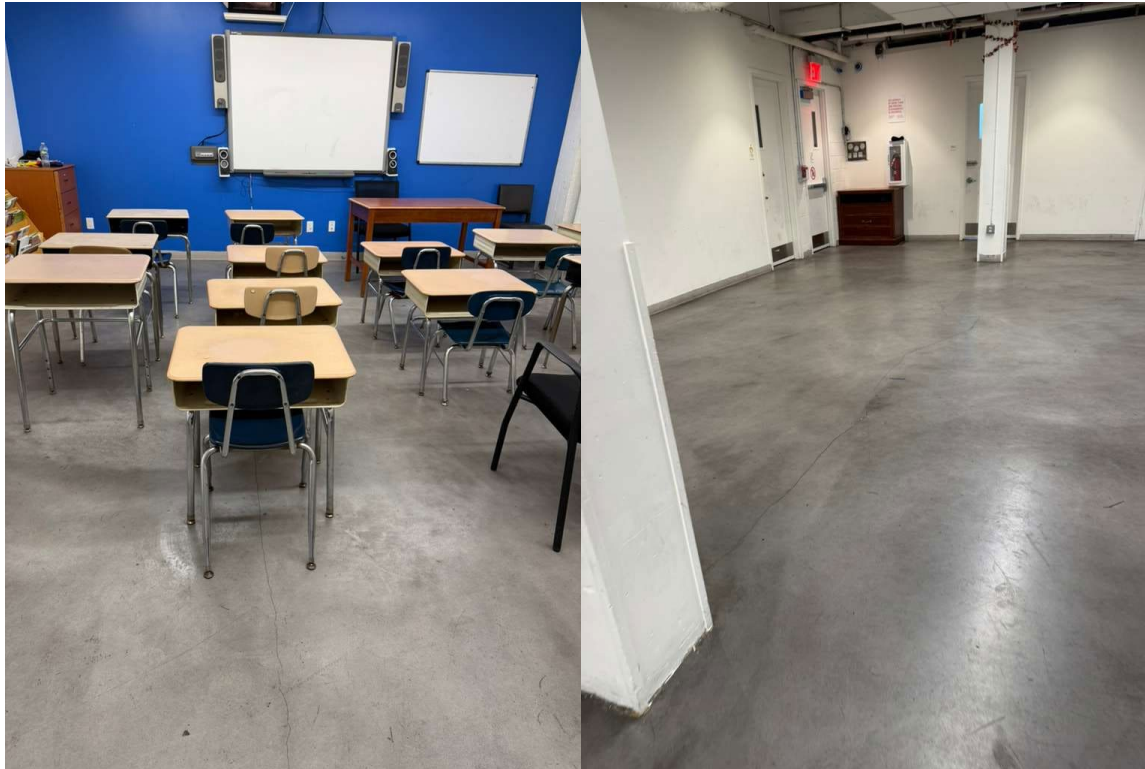
Findings of the inspection observations indicated the cover system was not altered and it continues to show evidence of the same surficial cracks observed in the building slab and around slab joints as during the February 2025 inspection. These surficial cracks range in thickness from 1 to 2 millimeters. These cracks will be closely monitored in subsequent Site-wide inspection events.

The cover system at the Site shows evidence of surficial cracks in the slab that should not short-circuit the negative pressure under the slab by the SSDS as evidenced by the satisfactory vacuum communication measured at the sub-slab vacuum monitoring points. Monitoring at the five vacuum monitoring points (Probe #1 to probe #5) achieved the minimum vacuum of -0.01 WC required for this Site. This sub-slab vacuum is induced by the operation of the two SSDS suction fans at the SSDS Pit 1 to SSDS Pit 3, and SSDS Pit 4.

View of fine cracks in the  
basement slab

| If yes describe the level of alteration needed for repairs and remedies?    Fine cracks were observed in exposed portions of concrete slab in basement | |

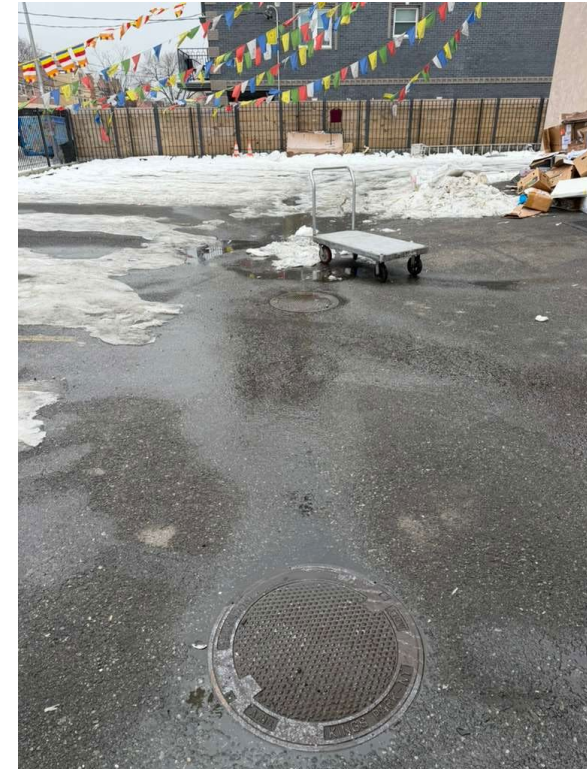
View of manholes of retention tank  
system beneath the open parking  
area
