Date: March 24, 2025
To: Hiralkumar Patel, NYSDEC
From: Rachel Miller, Roux Environmental Engineering and Geology, D.P.C.
cc: Charlie McGuckin, P.E., Roux Environmental Engineering and Geology, D.P.C.
Timothy Dragone, The Durst Organization
Subject: **Annual 2024 Well Gauging Results Summary**
Halletts Point Buildings 40 and 50 BCP #C241192/Spill #2300395 and #2300786
27-02 and 27-50 1st Street, Astoria, New York

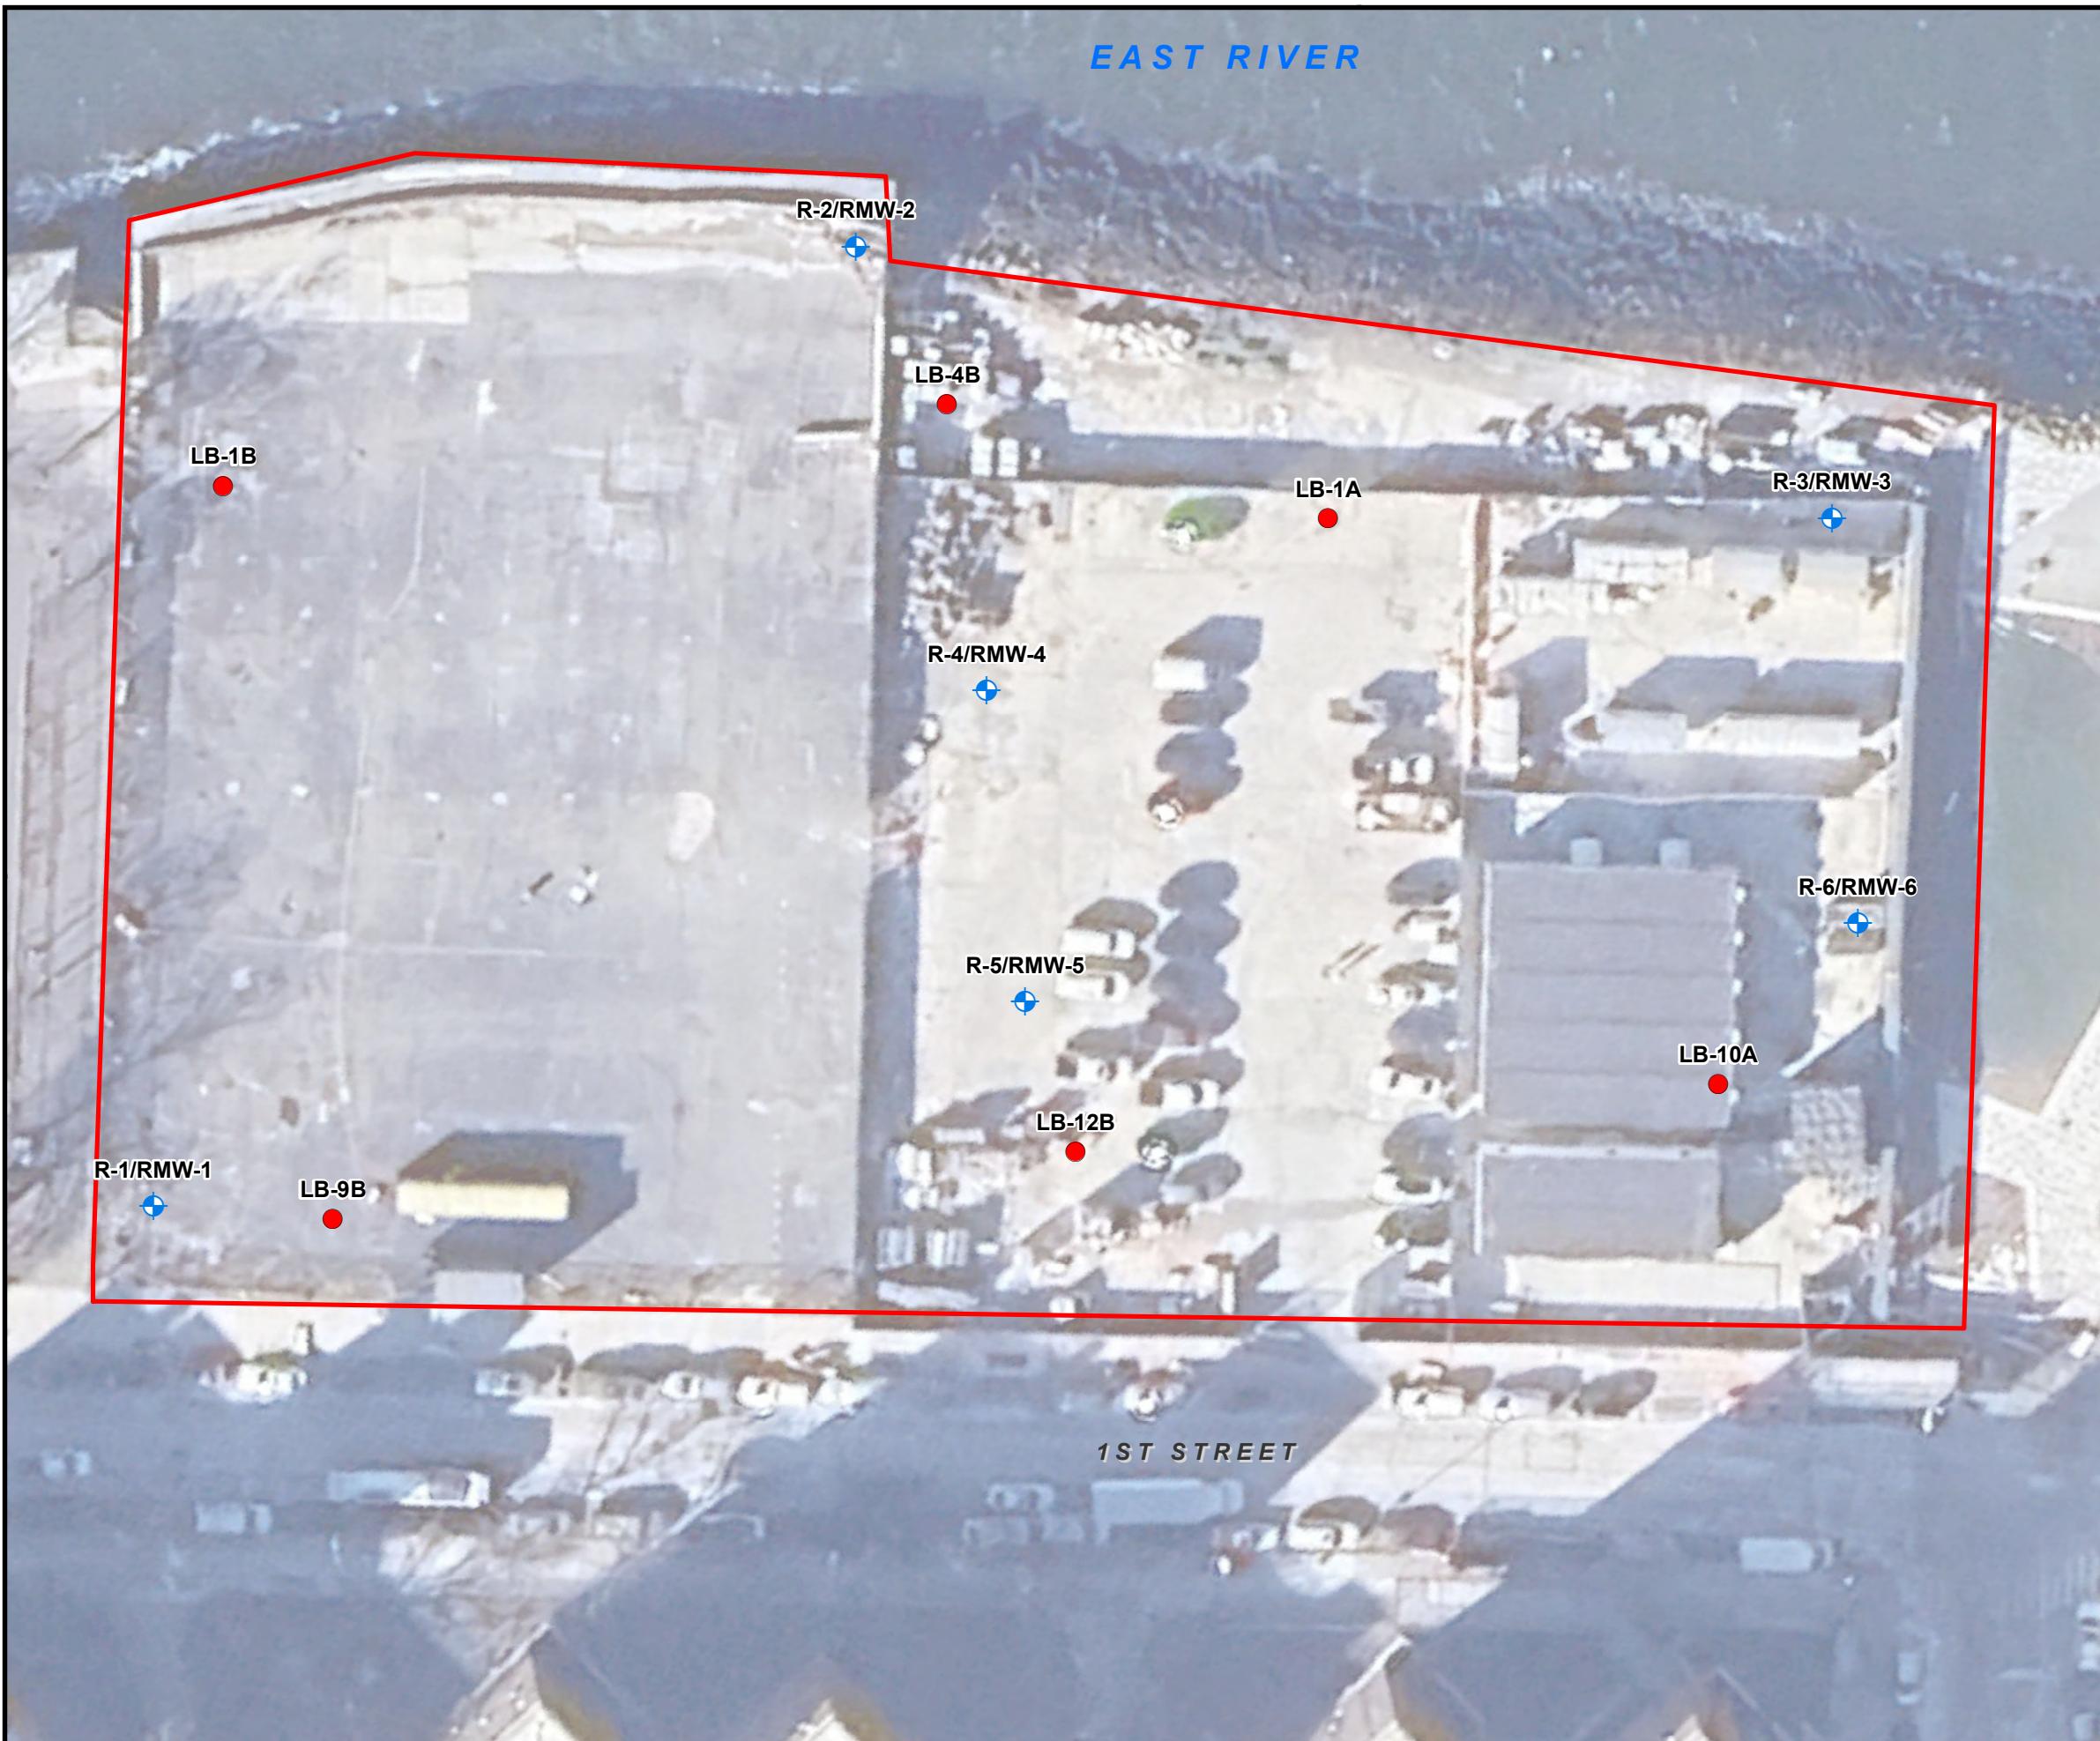
Title: **SITE MONITORING WELL LOCATIONS**

During each quarter of 2024, accessible wells were gauged to monitor groundwater elevations and document the thickness of any light non-aqueous phase liquid (LNAPL) or dense non-aqueous phase liquid (DNAPL), if present. Monitoring well locations are shown in Figure 1 and a summary of the quarterly 2024 monitoring well gauging data is provided in Table 1.
