DAILY STATUS REPORT

Langan Project No:	100849501	Project:	990 Rossville Ave	Date:	03/02/2022
NYSDEC BCP Site No:	C243043			Time:	8:00 – 13:30

Langan Project No:	100849501	Project:	990 Rossville Ave	Date:	03/07/2022
NYSDEC BCP Site No:	C243043			Time:	8:00 – 14:00

Langan Project No:	100849501	Project:	990 Rossville Ave	Date:	03/16/2022
NYSDEC BCP Site No:	C243043			Time:	8:00 – 16:00

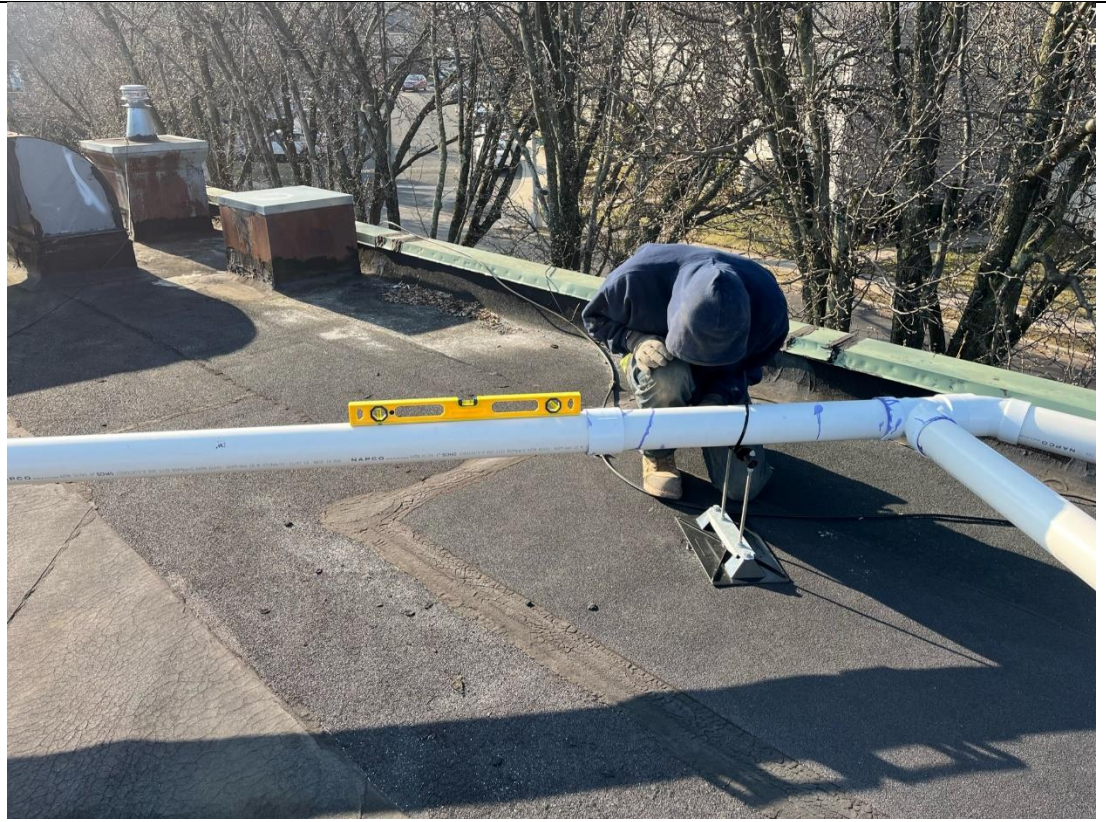
Photo 1 – View of Pennington correcting pipe sloping issues, facing south.

- Langan and Pennington identified locations within the exterior sub-header piping network exhibiting sloping (i.e., low-points/U-traps) issues.
- Pennington corrected sloping issues by adjusting pipe support brackets, as needed.
- Pennington installed Aerocel Stay-Seal with Protape (SSPT) tube insulation to all 2-inch and 4-inch exterior sub-header piping.
- Pennington installed drain plugs on the piping.

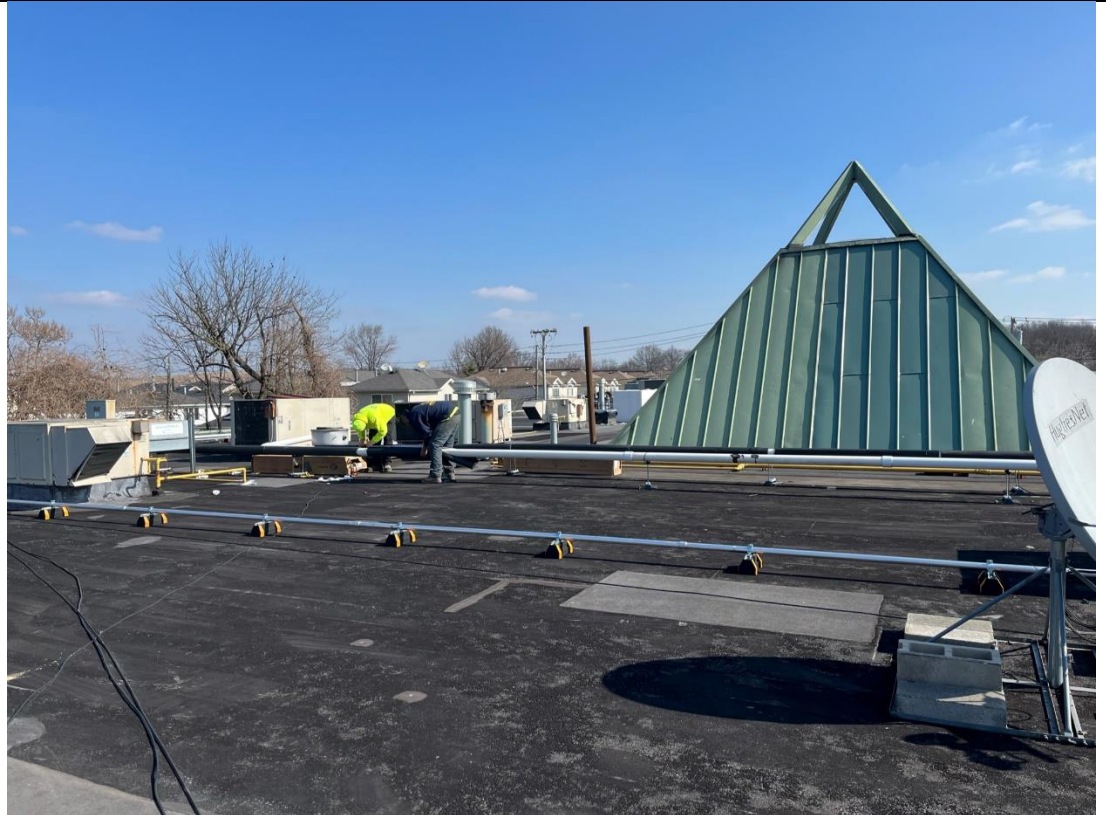
Photo 2 – View of Pennington installing insulation to 4-inch sub-header piping, facing northeast.

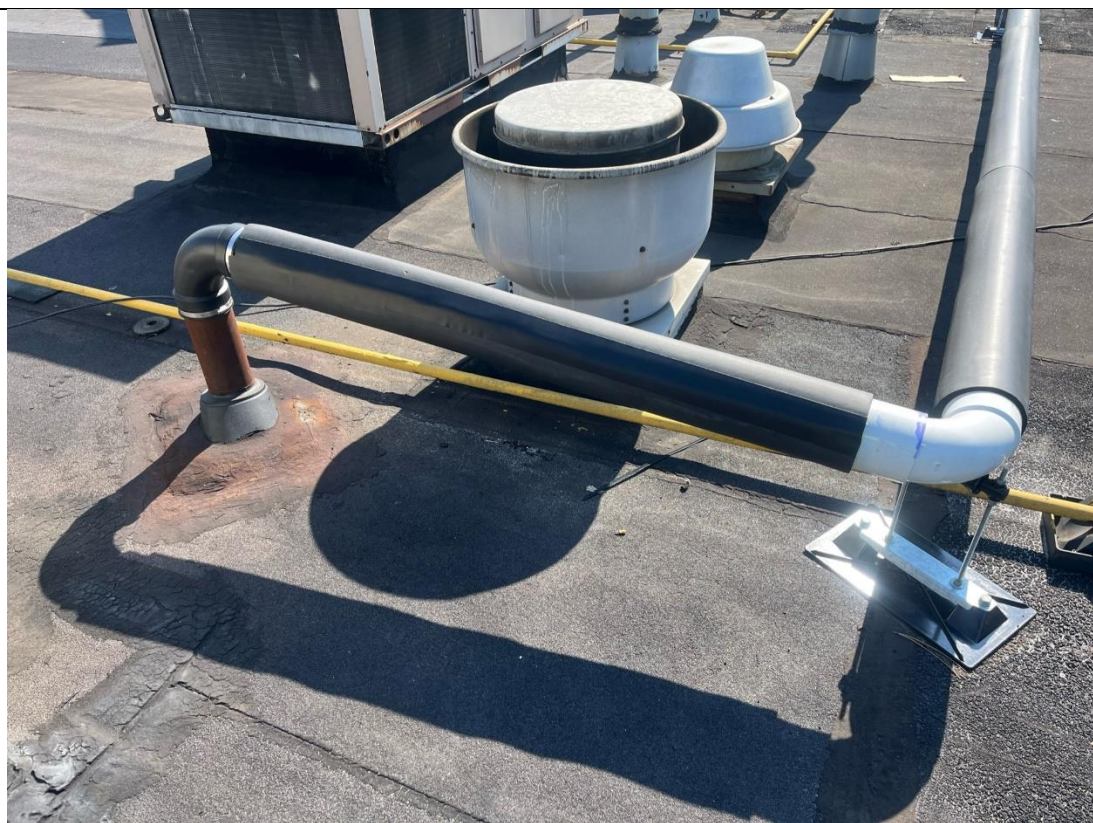
- Two locations exhibiting sloping issues will require the 4-inch black steel sub-header line near the roof penetration points to be cut down and PVC elbow reinstalled in order to achieve the appropriate pitch.
- One run of 4-inch PVC sub-header piping located adjacent to the process equipment was identified as a significant low spot in the system. This run will need to be cut and reinstalled above nearby lines, rather than below them.

Photo 3 – View of one location where 4-inch black steel sub-header line will need to be cut down to achieve the appropriate pitch, facing southeast.

- Pennington will install exterior 6-inch main-header piping insulation and insulate all system elbows and joints.
- Pennington will cut and reinstall piping to correct the remaining slope issues.
- Following installation of piping insulation, Langan will restart the process equipment for long-term use.
- Pennington will continue installation of vacuum gauges and sample ports on interior well-line risers.
- Langan and Pennington will continue SSDS startup and system optimization, including a full round of vacuum gauging at all vapor monitoring points (VMPs) and all vapor extraction point (VEP) risers, following completion of exterior piping insulation and system restart.

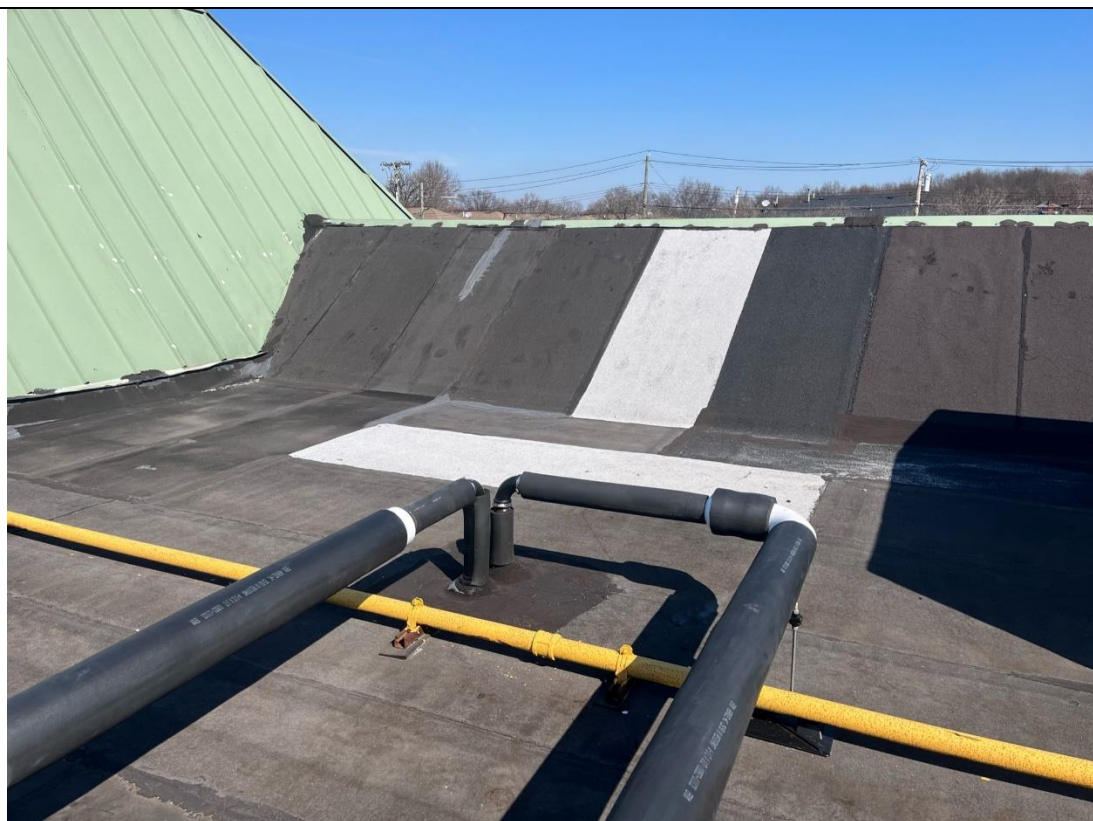
Photo 4 – View of insulated 2-inch and 4-inch sub-header piping, facing north.

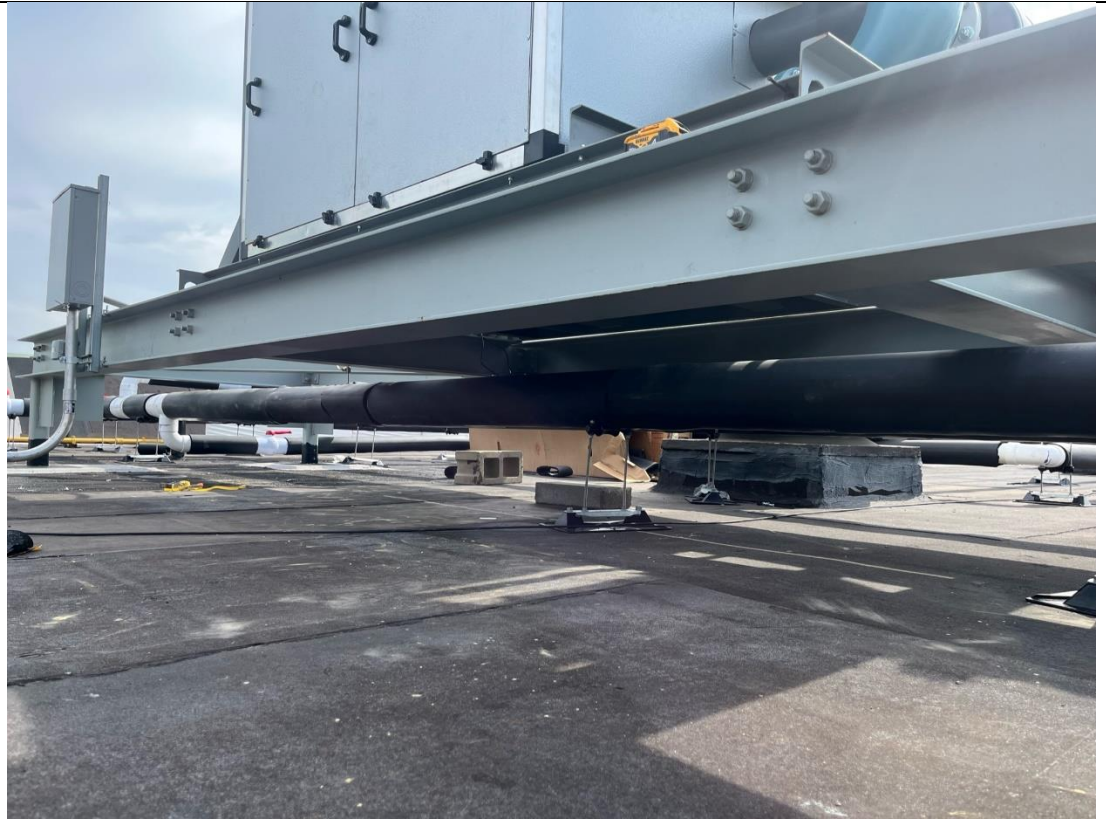
Photo 1 – View of insulated 6-inch header piping, facing southeast.

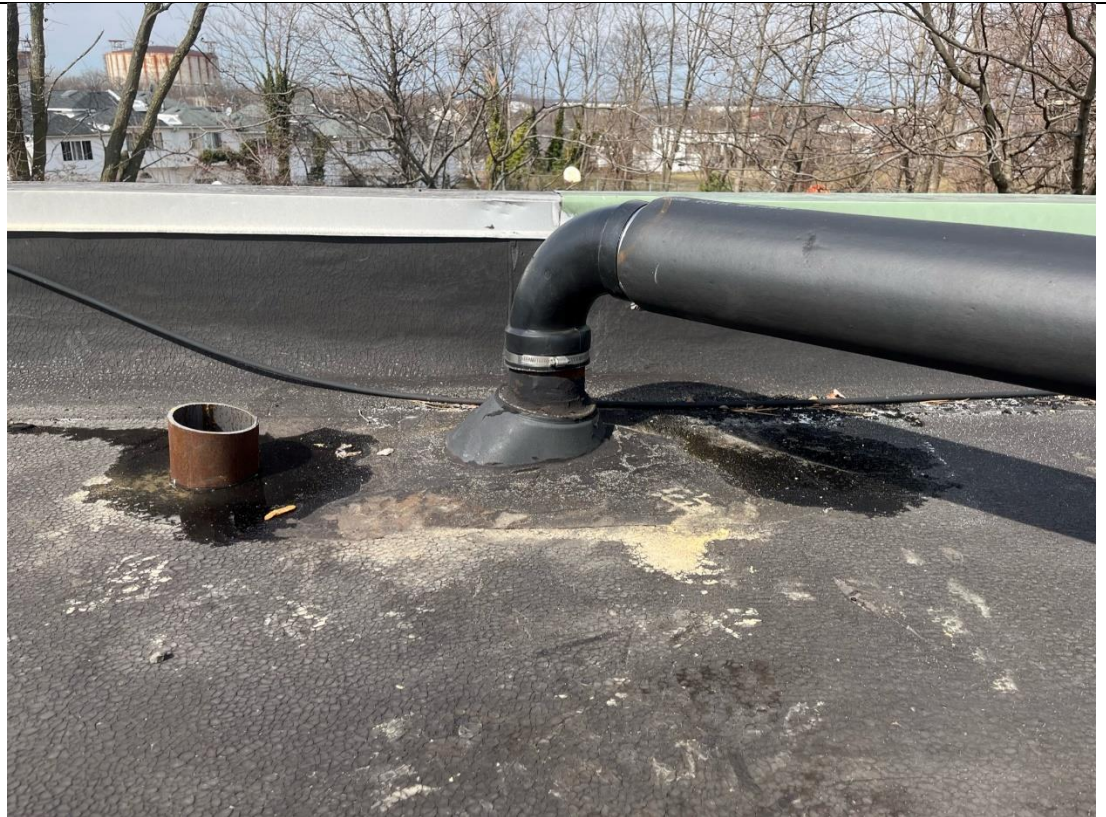
Photo 2 – View of one location where 4-inch black steel sub-header line was cut down to achieve the appropriate pitch, facing northwest.

- Pennington installed Aerocel Stay-Seal with Protape (SSPT) tube insulation to all 6-inch exterior header piping.
- Pennington corrected remaining sloping issues by cutting down and re-installing select 4-inch steel and 2-inch PVC vertical piping penetrating the roof.
- Pennington cut and reinstalled the 4-inch PVC sub-header piping located adjacent to the process equipment to run above nearby lines rather than below them, to eliminate a low spot in the system.
- Pennington continued installation of vacuum gauges and sample ports on interior well-line risers in the grocery basement, dry cleaners, liquor store, and ice cream shop.

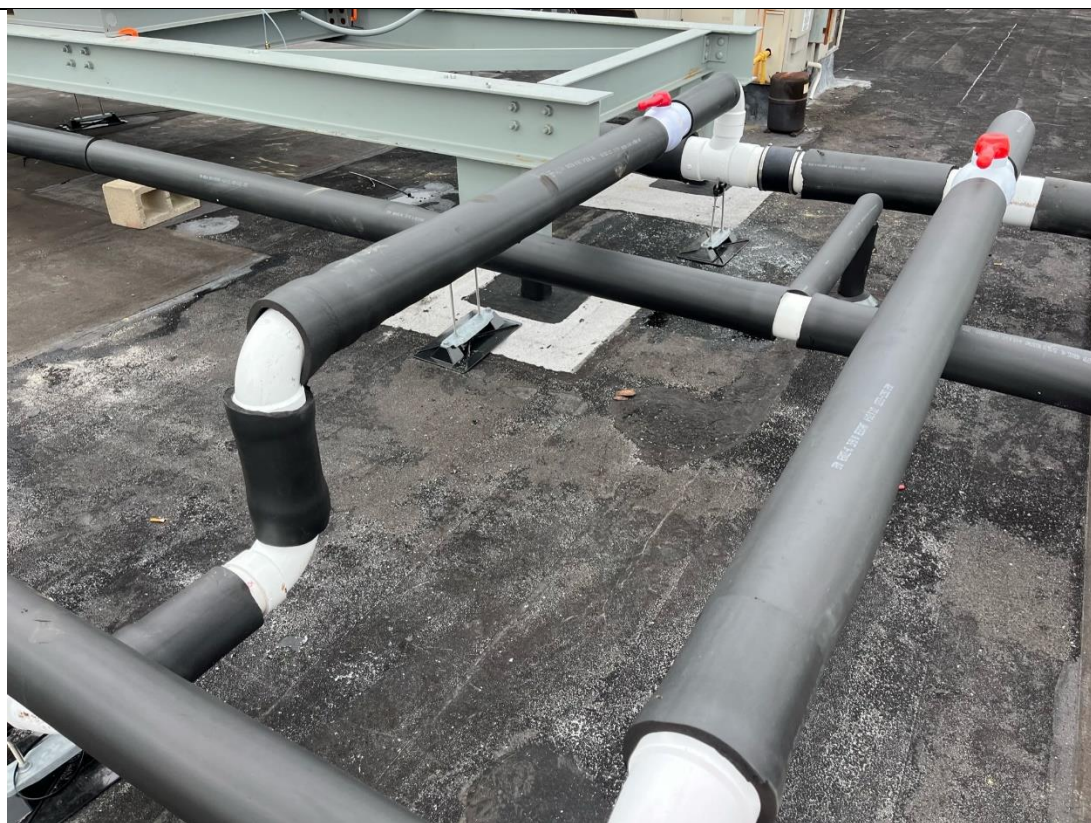
Photo 3 – View of cut and reinstalled 4-inch PVC sub-header piping, now running above nearby lines rather than below them, facing northwest.

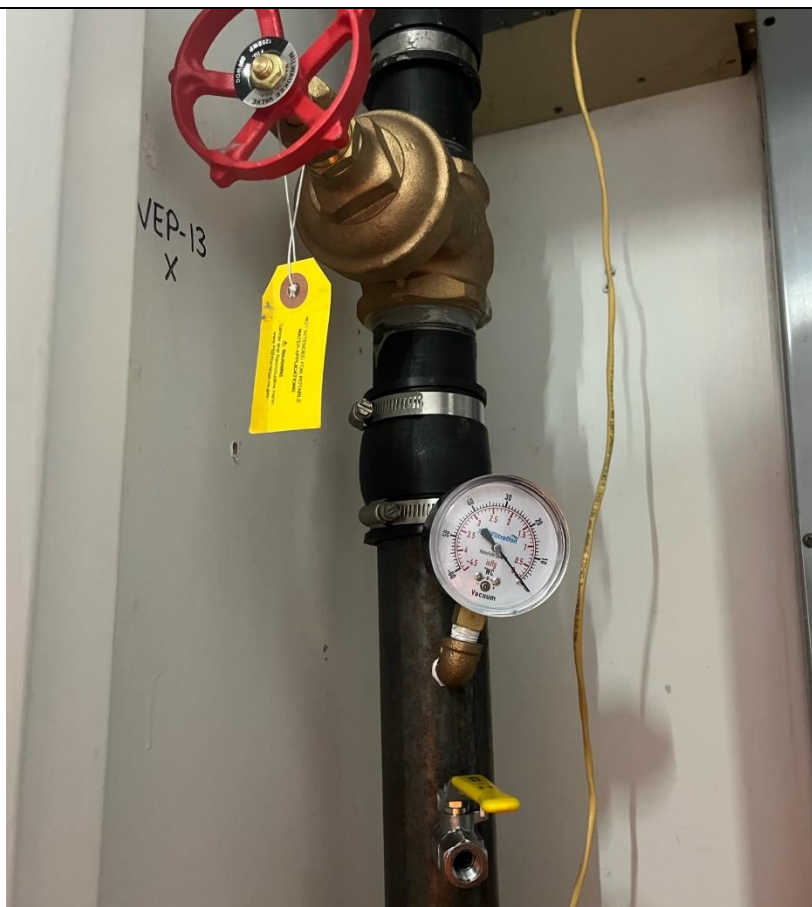
Photo 4 – View of installed vacuum gauge and sample port on interior well-line riser, facing west.

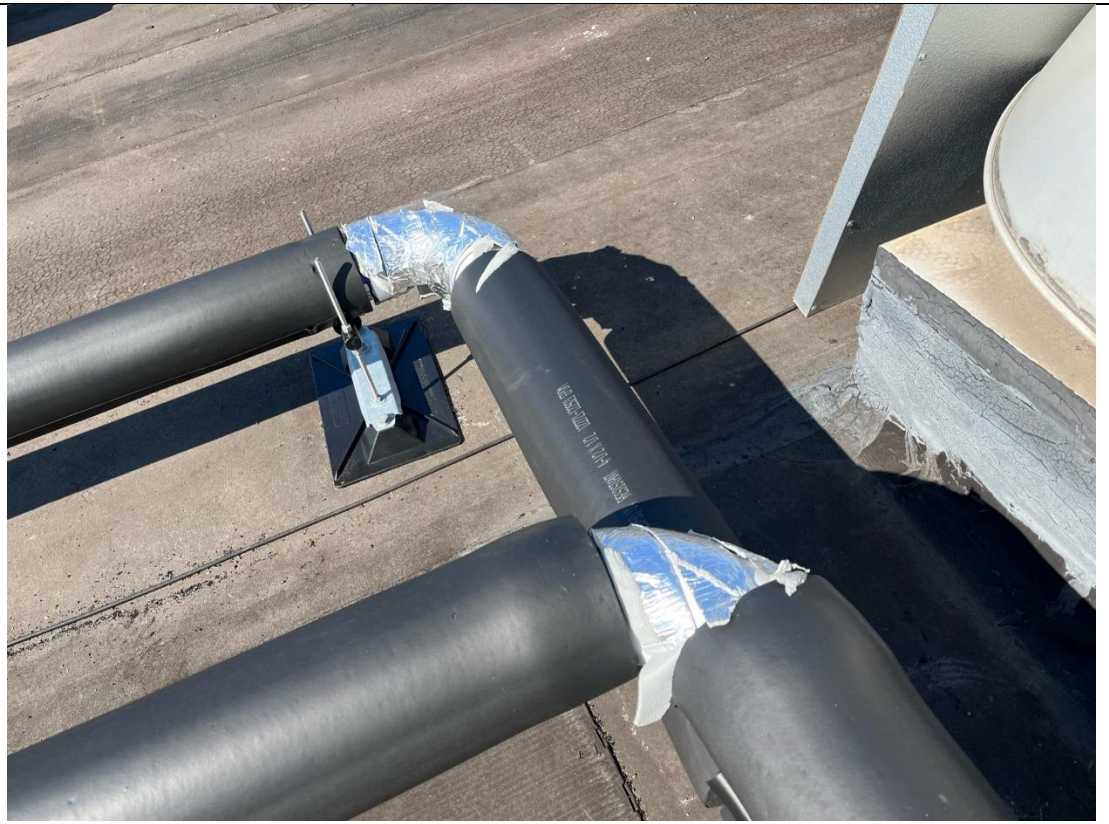
Photo 1 – View of system elbows insulated with tape, facing west.

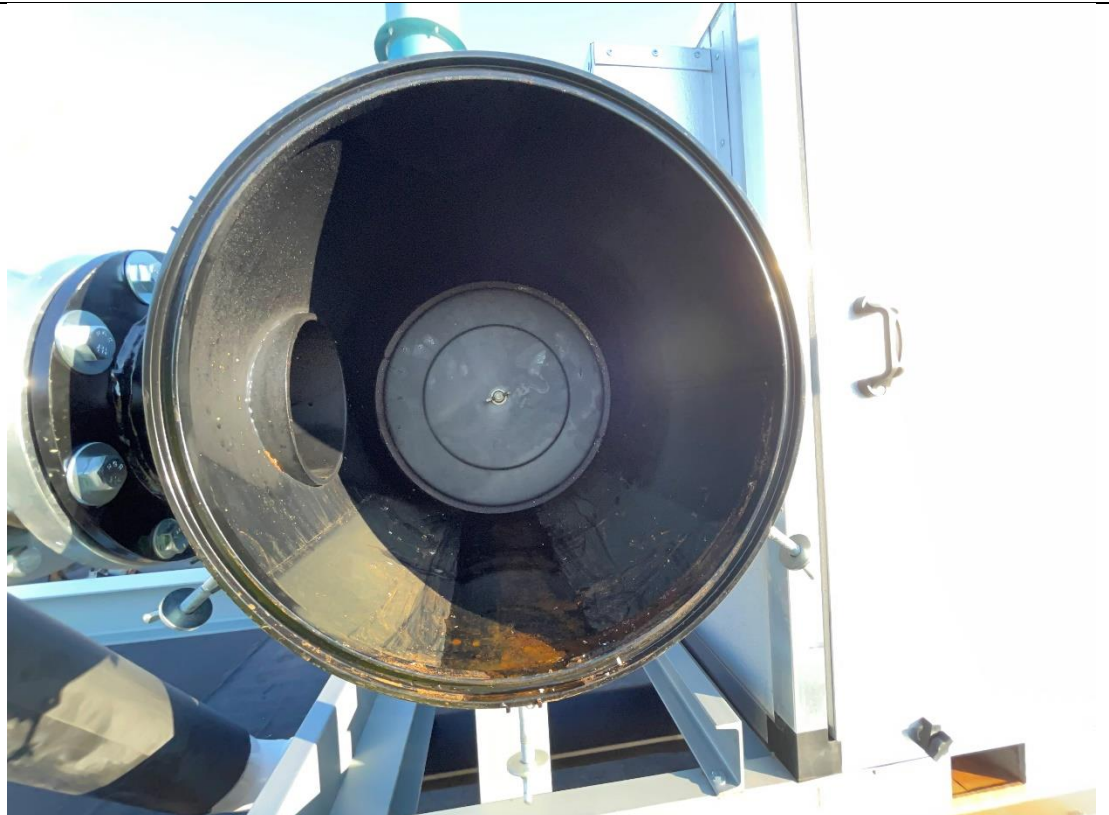
- Water was observed exiting system pipes as certain sections were cut for re-leveling. Pennington opened the in-line filter housing to investigate. A significant volume of water was collected within the in-line filter housing and poured out when opened. After all water was drained the filter housing was re-secured. The source of this collecting water is unknown at this time and is being investigated further.
- The hair salon was closed and inaccessible today; installation of vacuum gauges and sample ports on interior well-line risers was not completed in this tenant space.
- Interior well-line risers in the Taekwondo school require taps be drilled prior to installation of vacuum gauges and sample ports in this tenant space.

Photo 2 – View of air filter housing; no additional water accumulation observed prior to system startup, facing northwest.

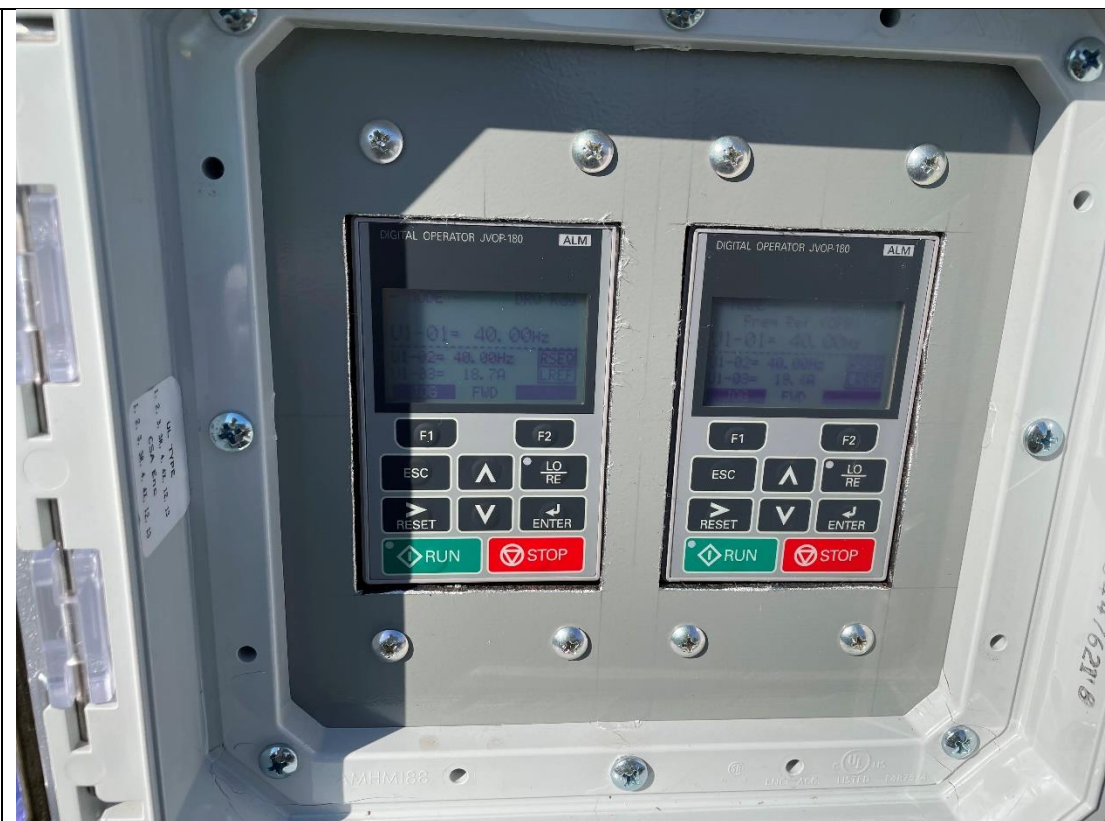
Photo 3 – View of SSDS control panel screens at system startup, facing southwest.

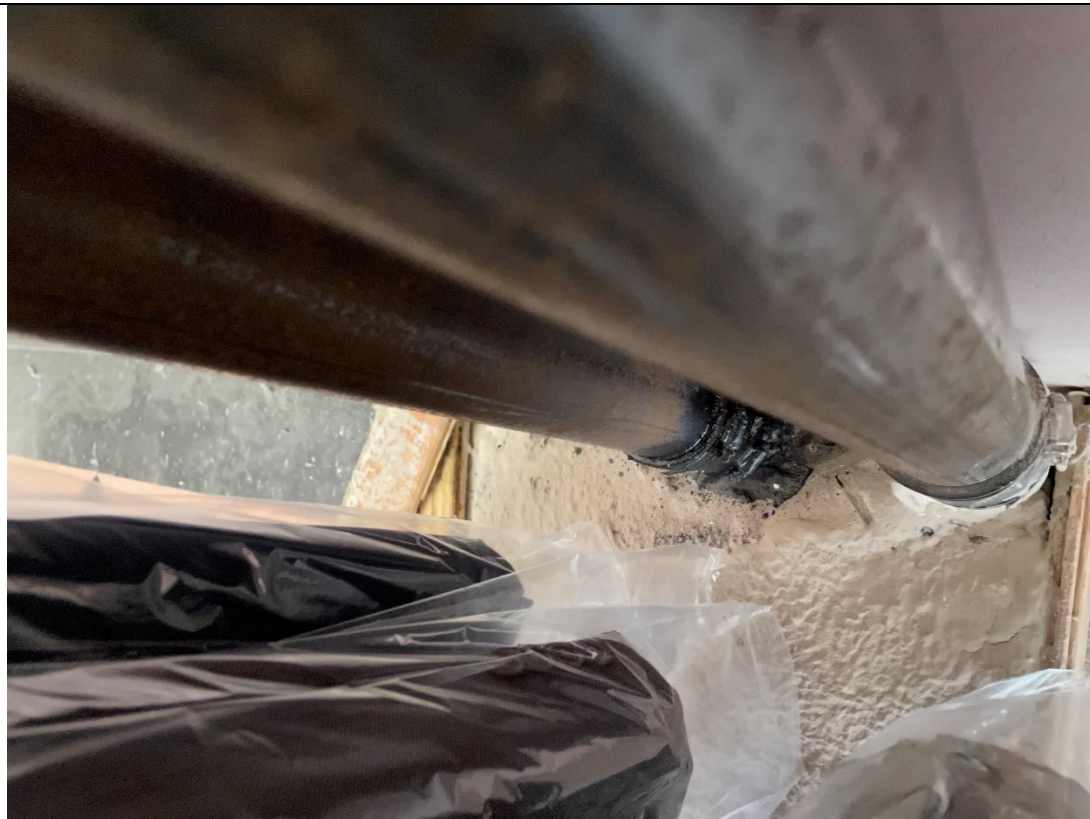
- The following VMPs require re-drilling due to borehole collapse and/or possible concrete blockage:
 - VMP-1, VMP-2, VMP-4, VMP-5, VMP-6, VMP-9, VMP-12
- VMP-10 was not installed or is otherwise unable to be located.
- VEP-2 requires vacuum gauge and sample port to be installed.
- The valve serving the sub-header including VEP-7 through VEP-12 is broken and requires repair/replacement (stuck in closed position). As such, the VEPs on this leg of the system were unable to be tested.
- Air leaks were observed at the following VEPs:
 - VEP-14 (leaking air at base of well)
 - VEP-17 (well appears okay; trench concrete patch seal is leaking, needs additional caulking or similar)
 - VEP-29 (leaking air at base of well; already attempted to seal, but leak persists)

Photo 4 – From left to right, view of VEP-29 (leaking air at base of individual well-line), and VEP-17 (leaking air at trench concrete patch), facing northwest.

- Pennington replaced the valve serving the sub-header including VEP-7 through VEP-12.
- Pennington patched air leaks at VEPs and concrete trench using DRYLOK® Pourable Masonry Crack Filler in the dry cleaner tenant space.
- Pennington re-drilled the VMPs exhibiting borehole collapse in several tenant spaces, and installed VMP-10 in the rear of the dry cleaner tenant space.
- Pennington installed a vacuum gauge and sample port on the VEP-2 interior well-line riser in Carvel.
- Langan performed the SSDS pre-startup inspection and shakedown/startup procedures.
- Langan completed a round of vacuum gauging at all vapor extraction points (VEPs) and vacuum monitoring points (VMPs).
- System was left operational upon departure of the site.

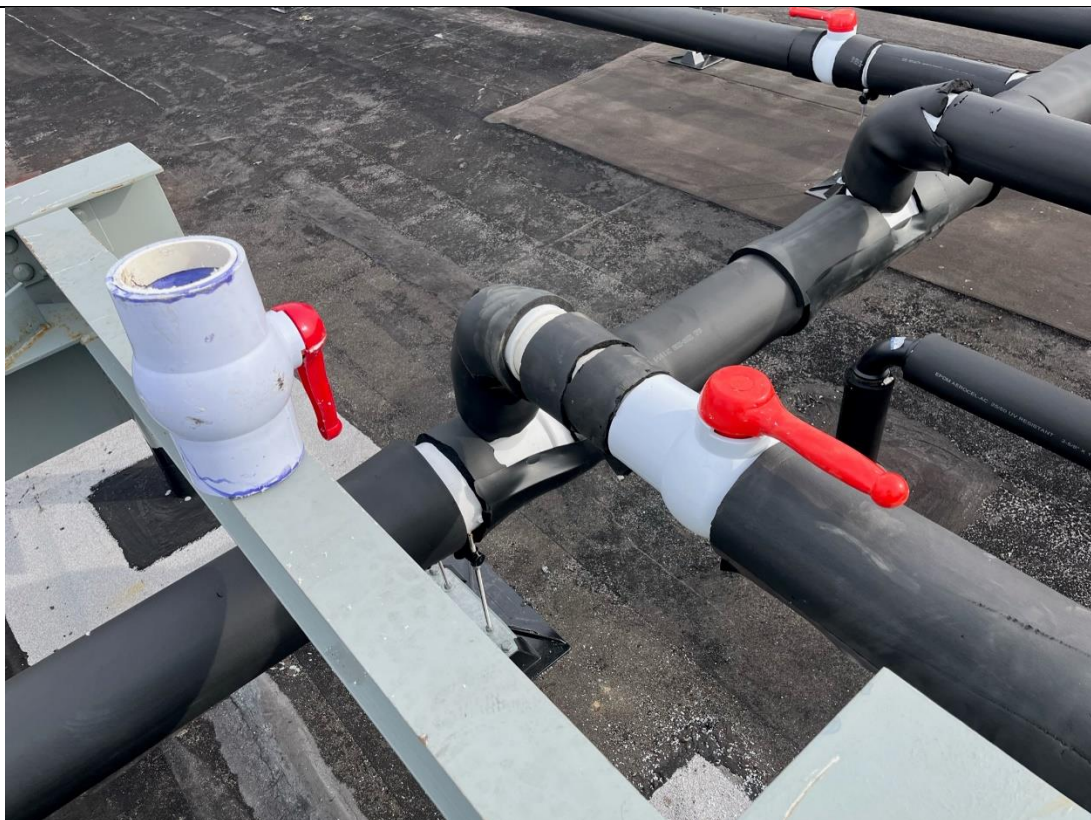
Photo 1 – View of new valve installed on the sub-header line serving VEP-7 through VEP-12, facing north.

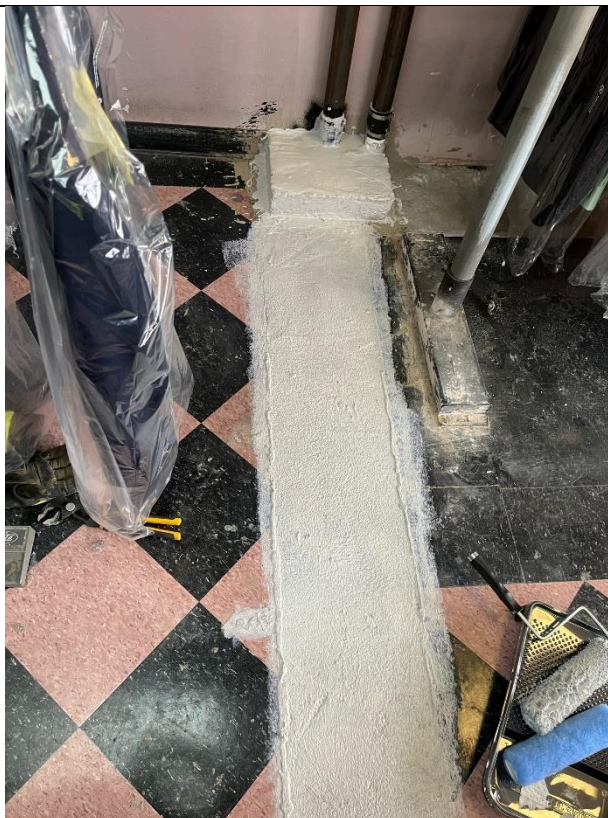
Photo 2 – View of patched air leaks at VEP-29 (left), VEP-17 (right), and concrete trench in the dry cleaner tenant space, facing northwest.

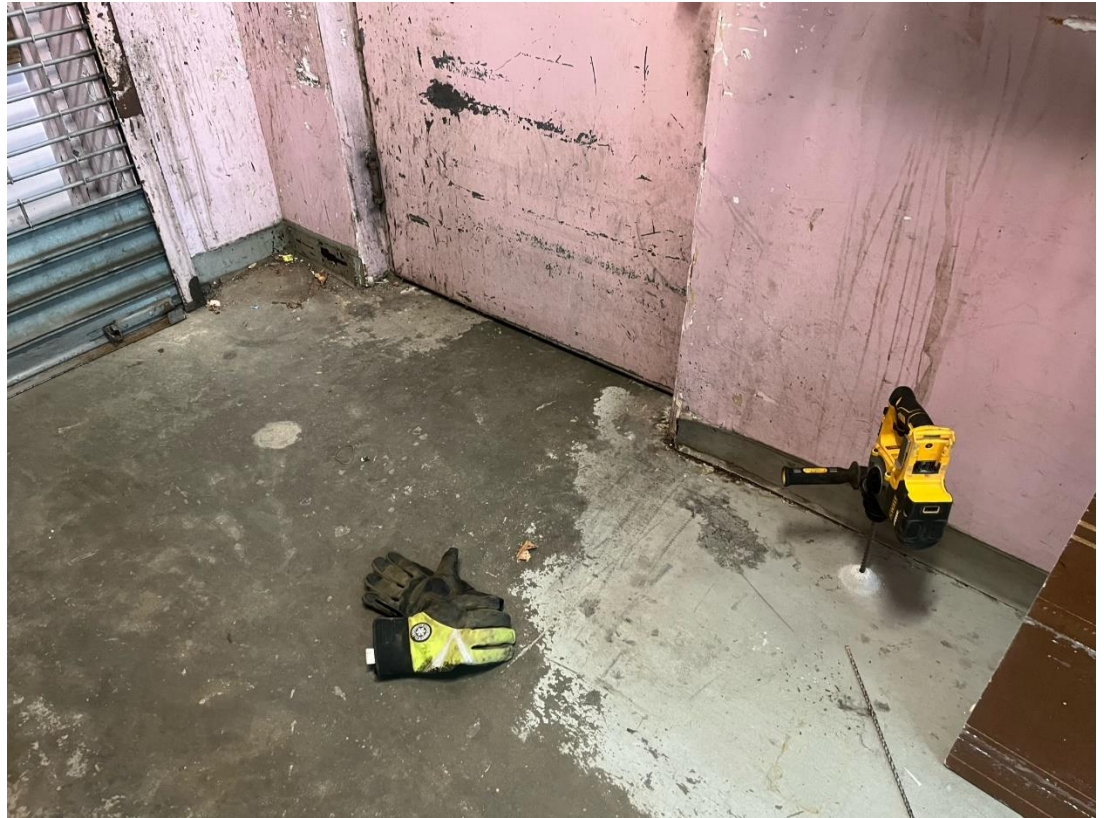
Photo 3 – View of VMP-10 being installed in the rear of the dry cleaner tenant space, facing west.

- Pennington will re-drill the VMPs exhibiting borehole collapse.
- Pennington will install VMP-10 in the rear of the dry cleaner tenant space.
- Pennington will install a vacuum gauge and sample port on the VEP-2 interior well-line riser in Carvel.
- Pennington will repair/replace the valve serving the sub-header including VEP-7 through VEP-12.
- Langan and Pennington will continue SSDS startup and system optimization, including a full round of vacuum gauging at all VMPs and VEPs, following completion of remaining installation items.

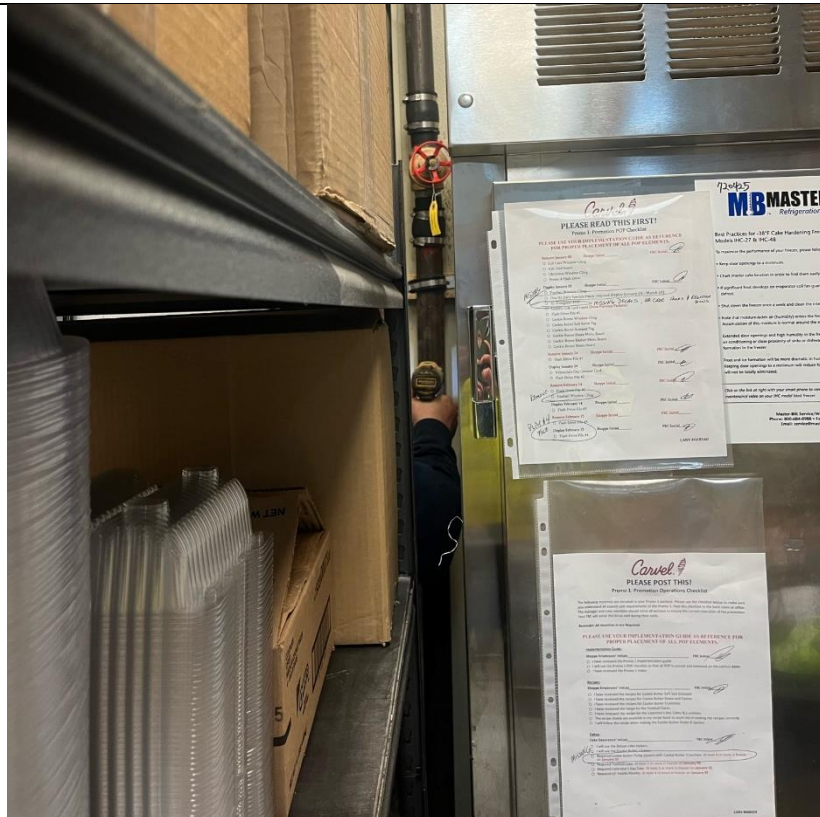
Photo 4 – View of Pennington drilling to install a vacuum gauge and sample port on VEP-2 in Carvel, facing northwest.
