RE: Reiley Building

# Ecosystems Strategies, Inc.

Re: Summary Letter-Report Regarding Environmental Conditions on the Reilly's Garage  
Property Located on Main Street in the Village of Pawling, Dutchess County, New York  
Our File: RP9433.10

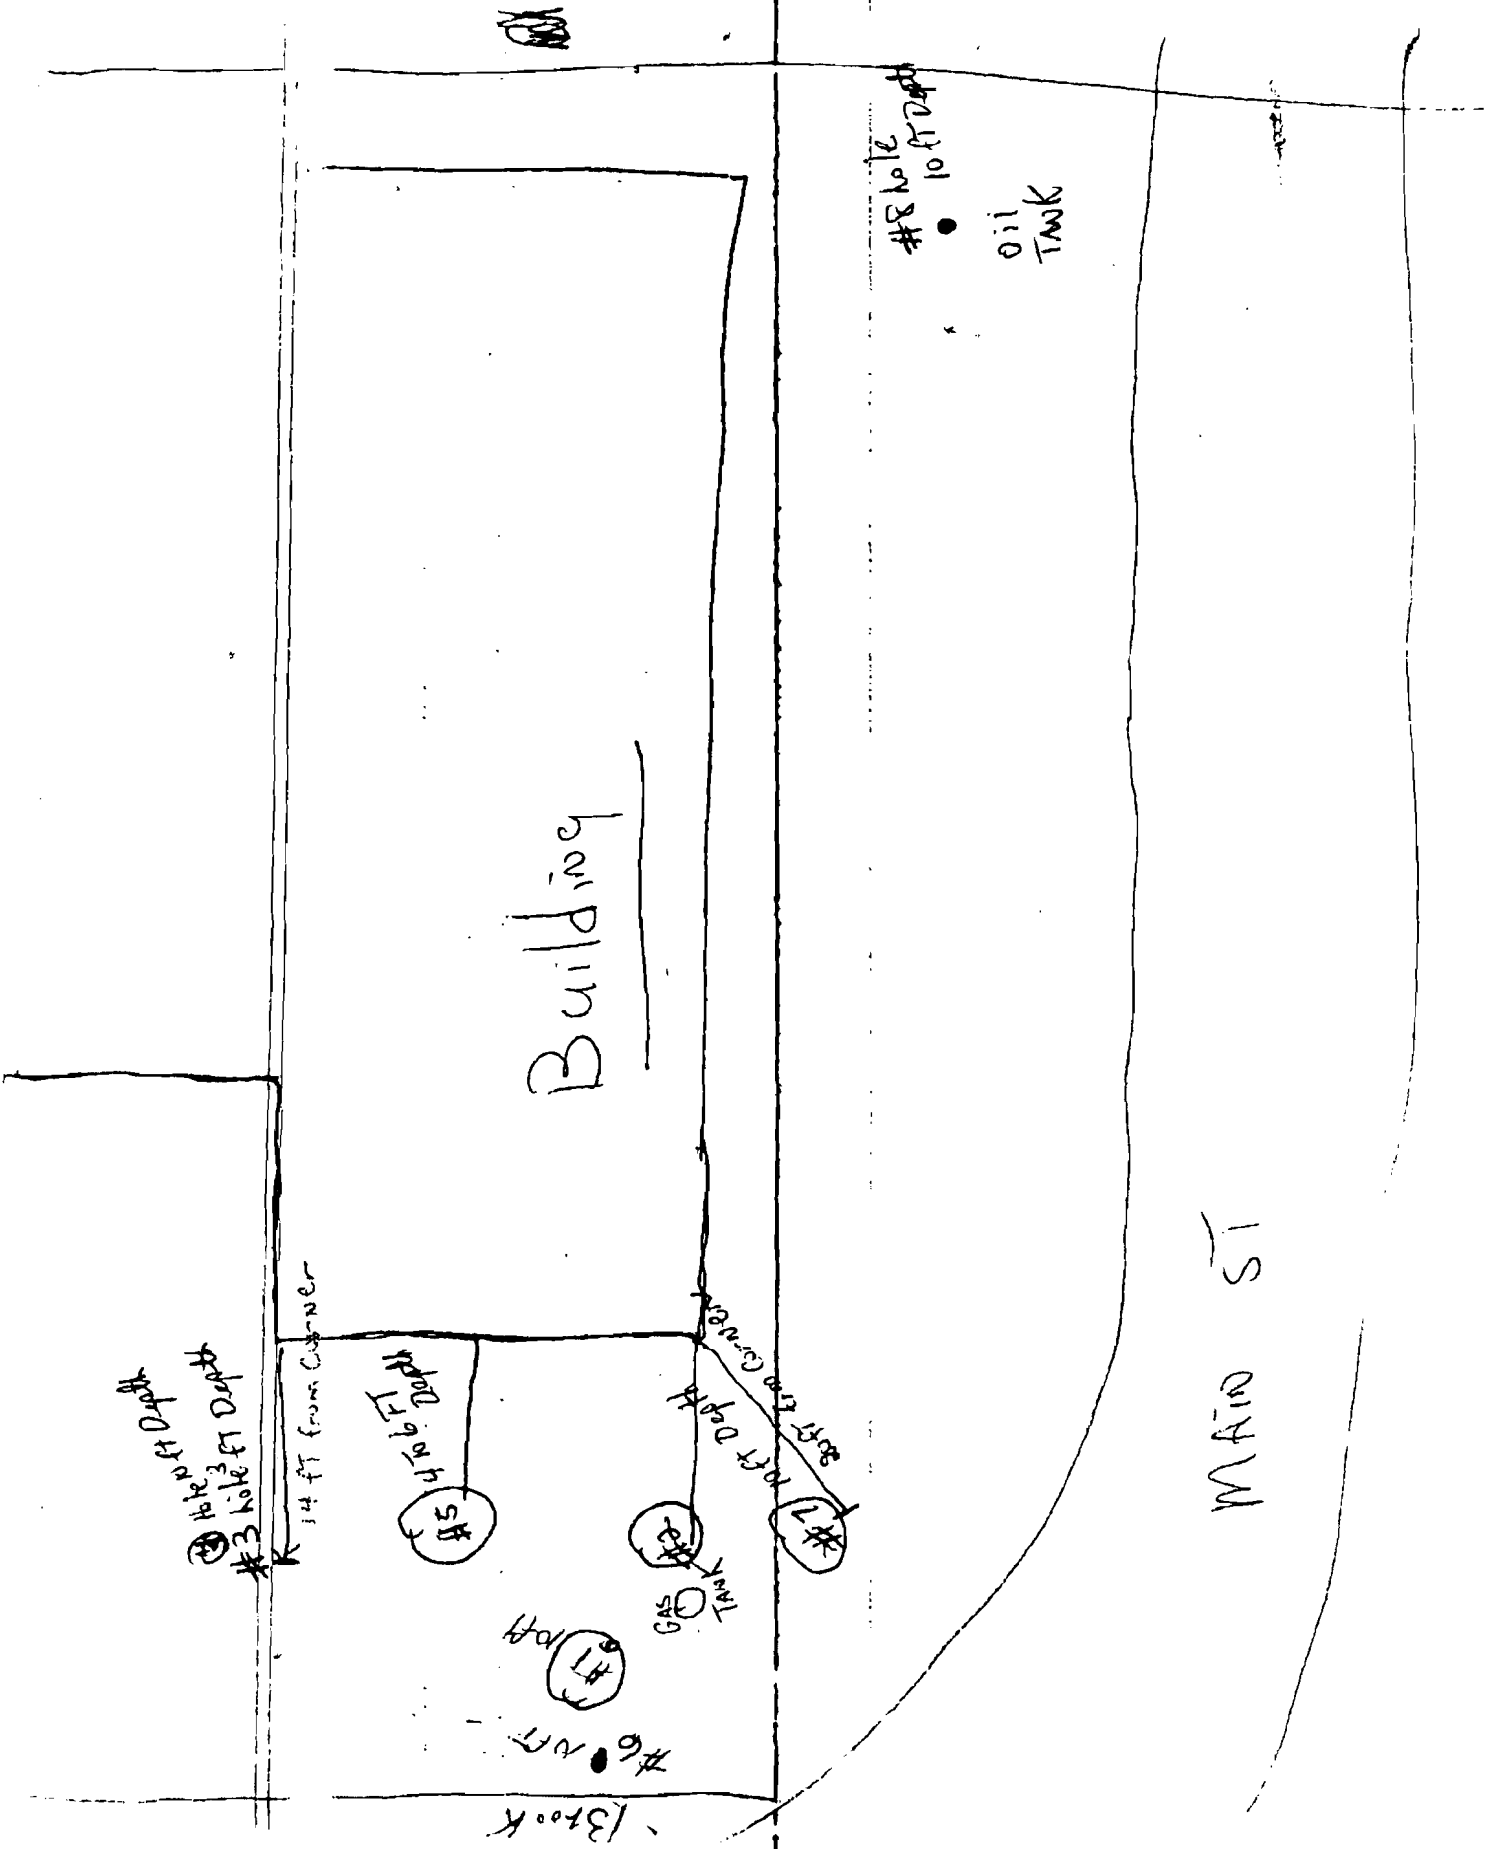
#9 10 FT Depth  
#3 10 FT Depth

#5 4 to 6 FT Depth

#7 10 FT Depth  
28 FT from Corner

#6 10 FT  
1300K

GAS TANK

#8 10 FT Depth

oil TANK
