## MONTHLY STATUS REPORT

BCP No.:	C314121	PVE Project No.:	560909	Date:	2/25/2020
Project Name:	3532 North Road, Dutchess County, Poughkeepsie, New York

Consultant: PVE	Consultant On-Site: Trevor Treglia
General Contractor: Saber Development	General Contractor Contact: Richard DeCola

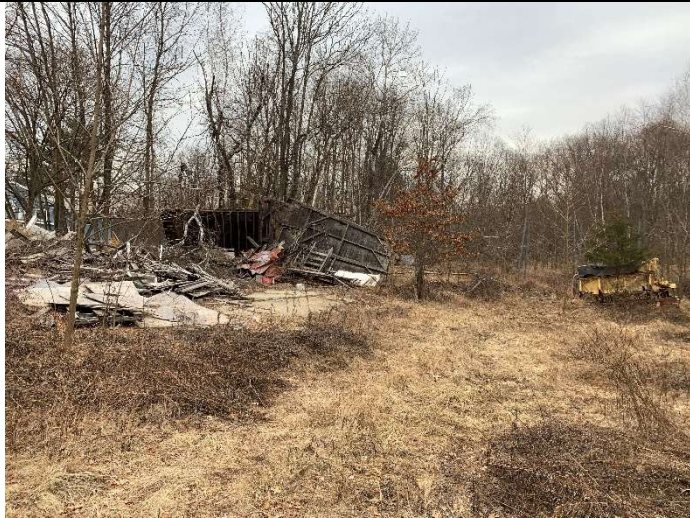
Photo 1 –

Auto Garage East (Collapsed).

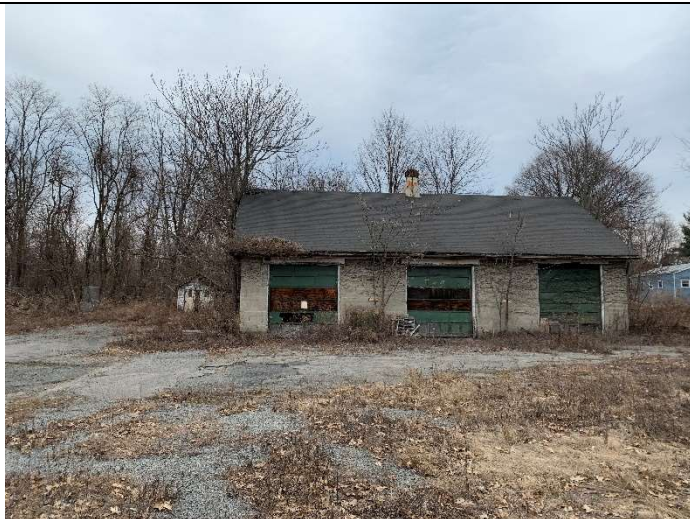
Photo 2 –

Auto Garage West.

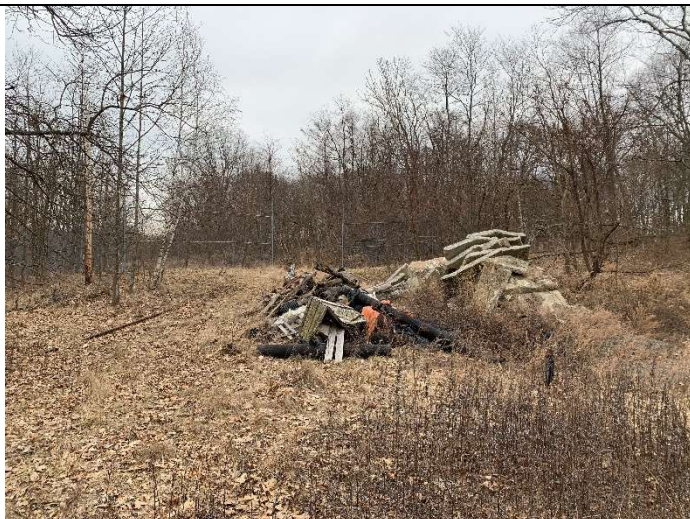
Photo 3 –

Pile of debris outside fenced area.  
Just south of Auto Garage East.

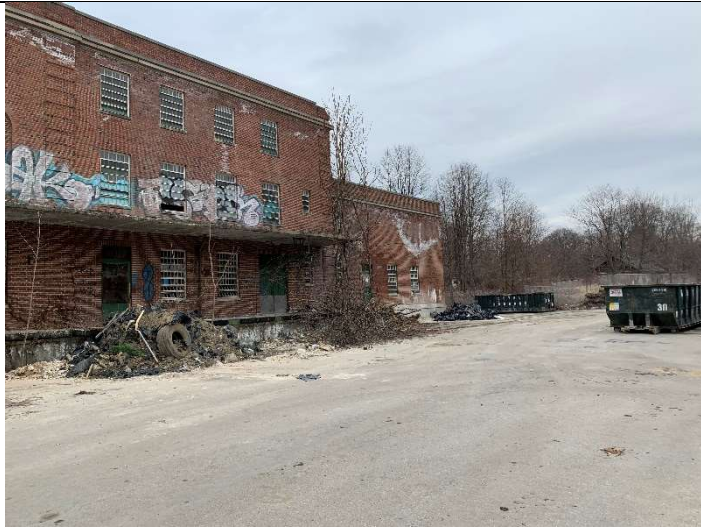
Photo 4 –

Bakery/Storage structure. Piles of debris along southern side of structure.

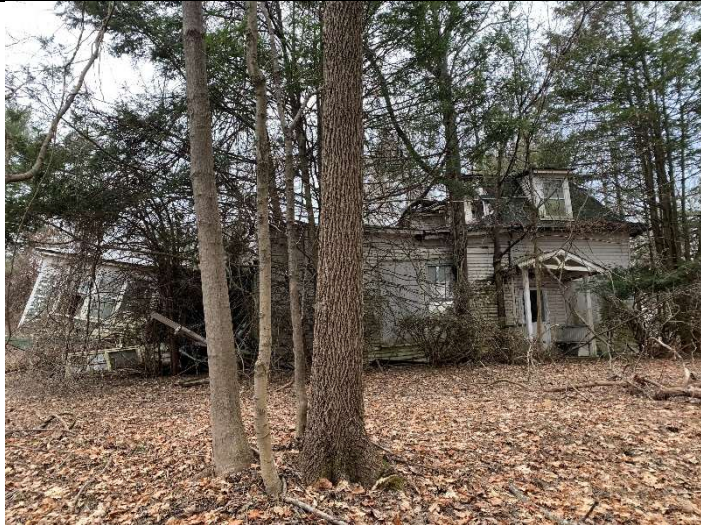
Photo 5 –

Residential structure with shed directly west of the Bakery/Storage structure. Severe deterioration of both structures.

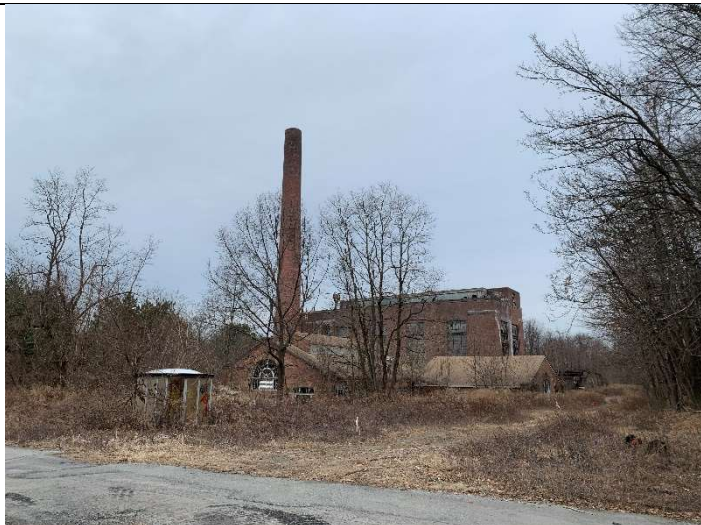
Photo 6 –

Powerhouse.

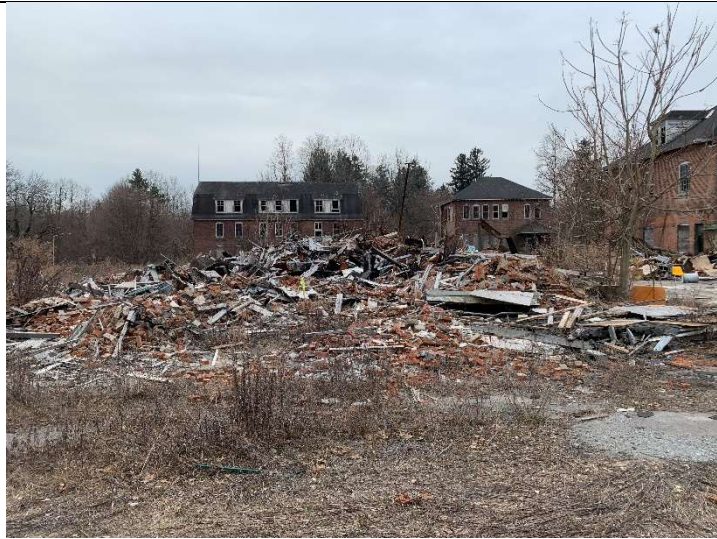
Photo 7 –

Engineer's Office (Demolished).

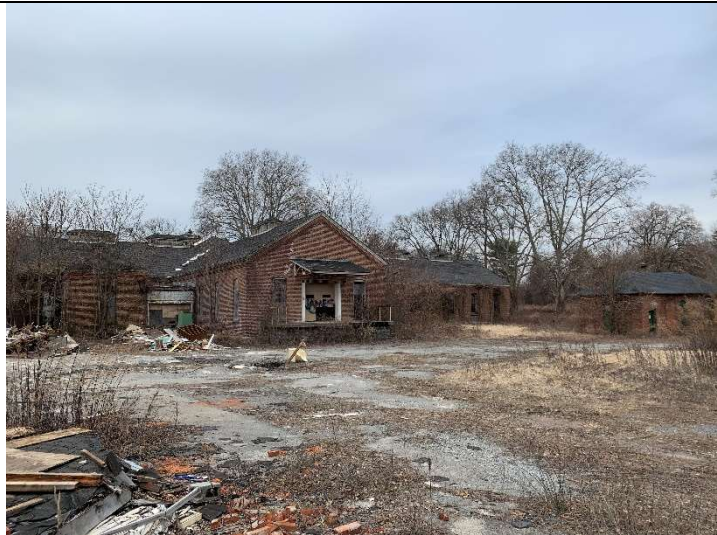
Photo 8 –

Carwash with shed (pictured right).

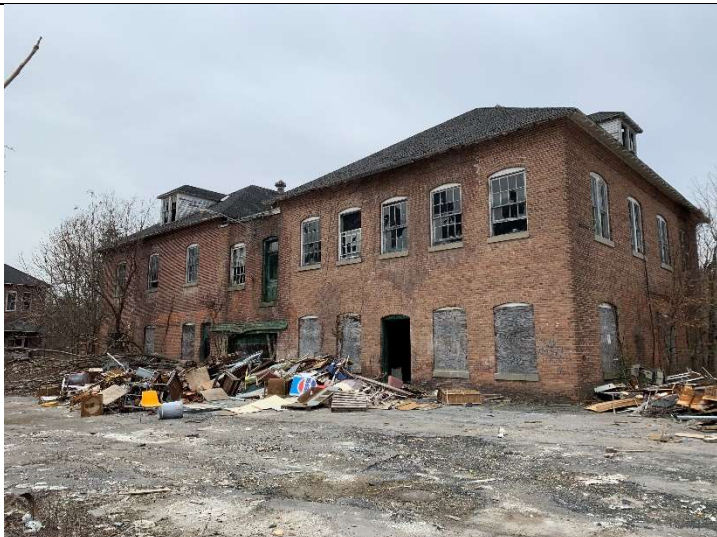
Photo 9 –

Maintenance Building with piles of debris along east side of structure.

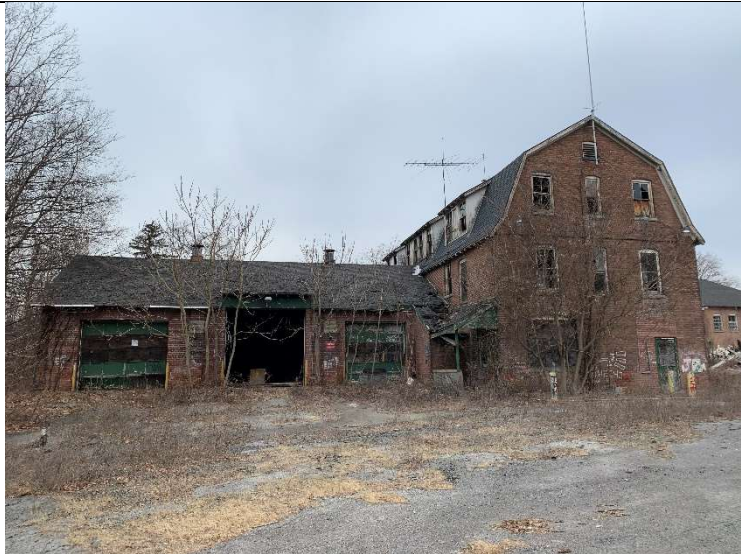
Photo 10 –

Fire House.

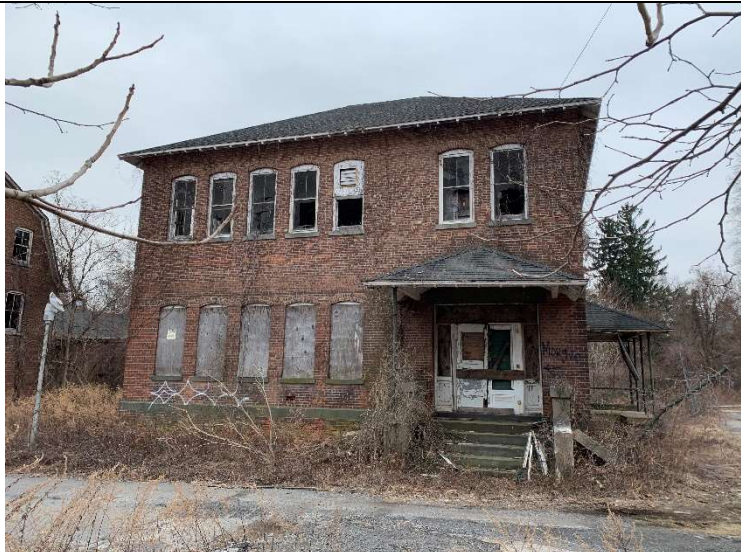
Photo 11 –

Mortuary Building.

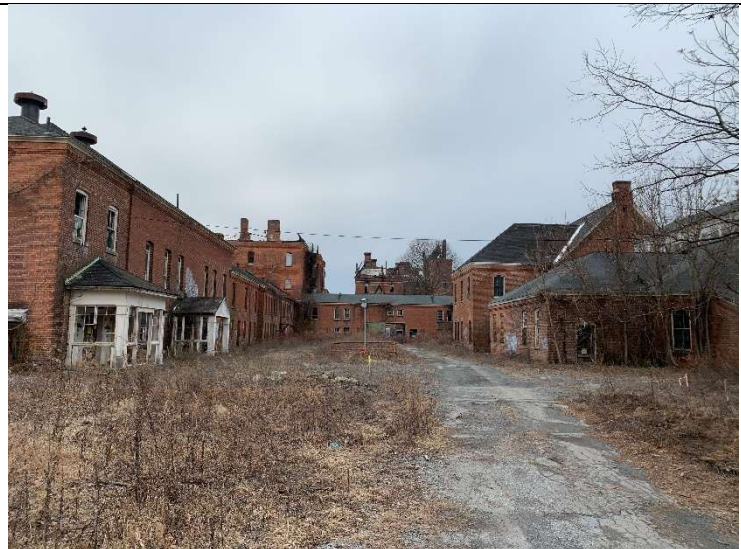
Photo 12 –

Structures west of the Mortuary Building, facing west.

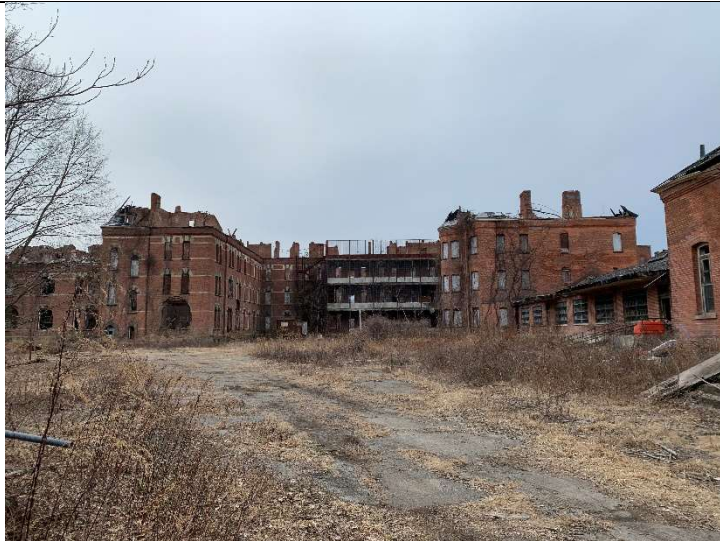
Photo 13 –

Structures in southwest corner of BCP boundary / behind Mortuary Building. North view.

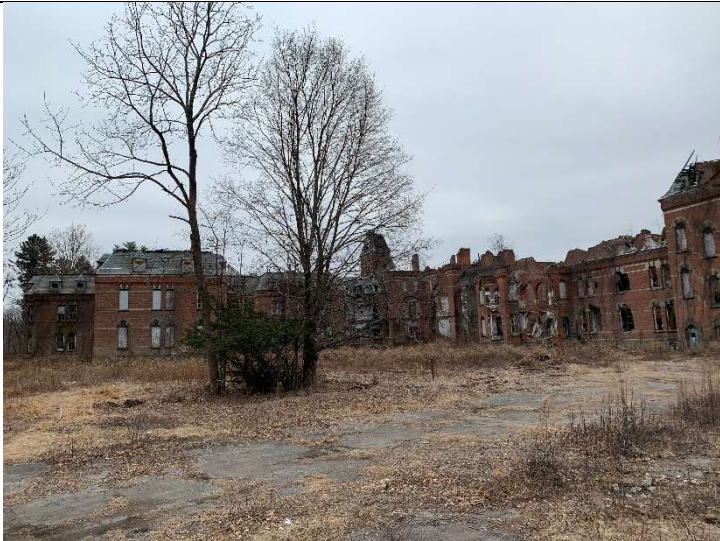
Photo 14 –

Structures in southwest corner of BCP boundary / behind Mortuary Building. South view.

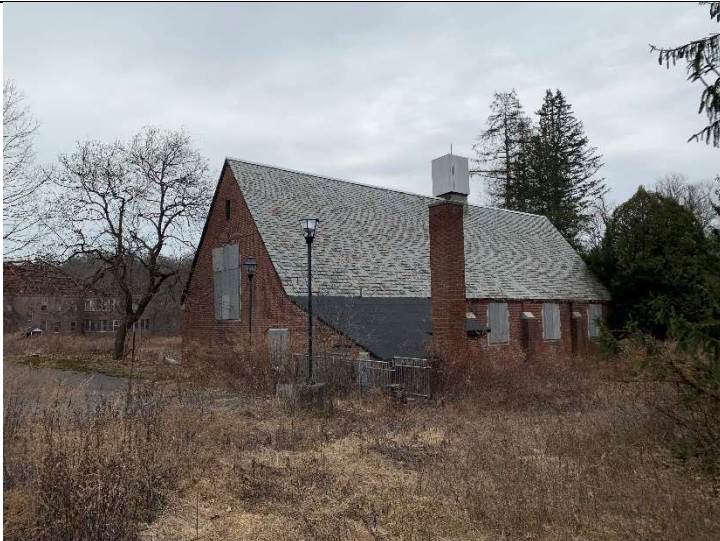
Photo 15 –

Rectory south of the Recreational Hall building.

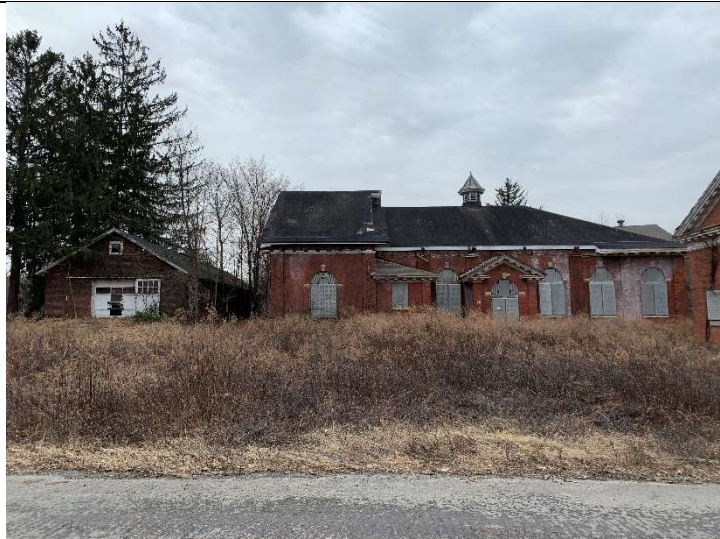
Photo 16 –

Recreational Hall.

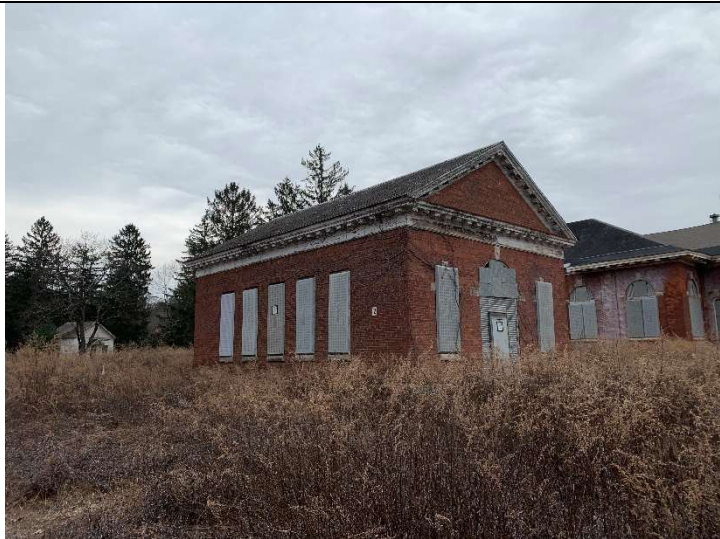
Photo 17 –

Library.

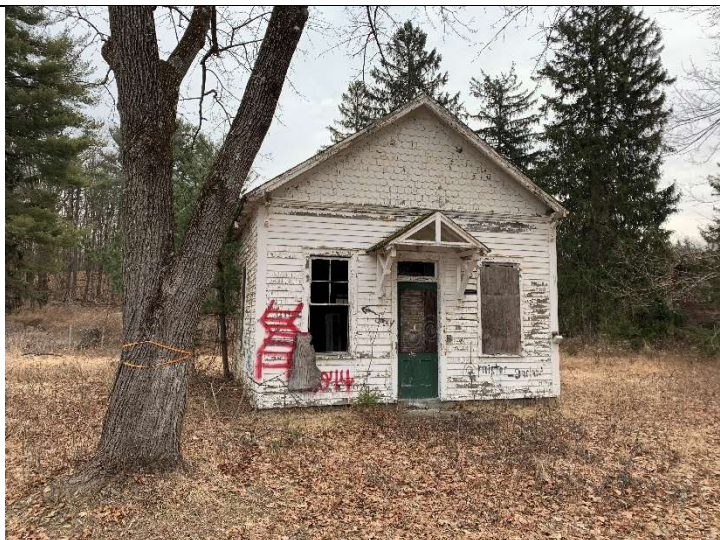
Photo 18 –

Small structure east of the Library.

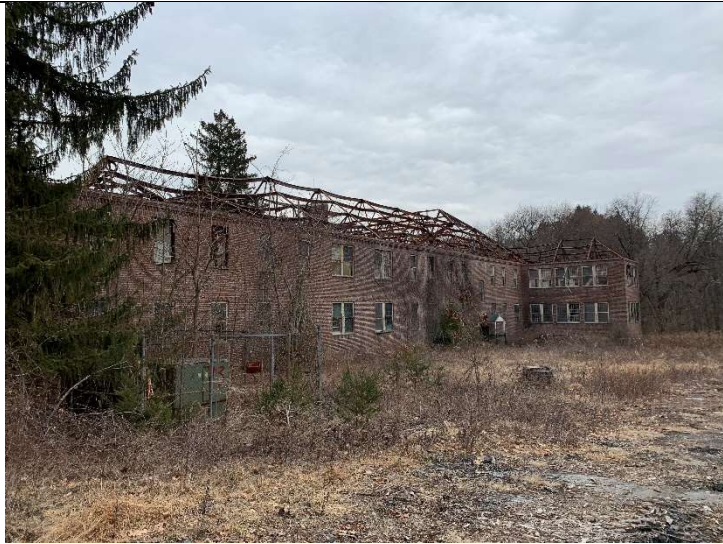
Photo 19 –

Brookside structure, severe deterioration of roof.

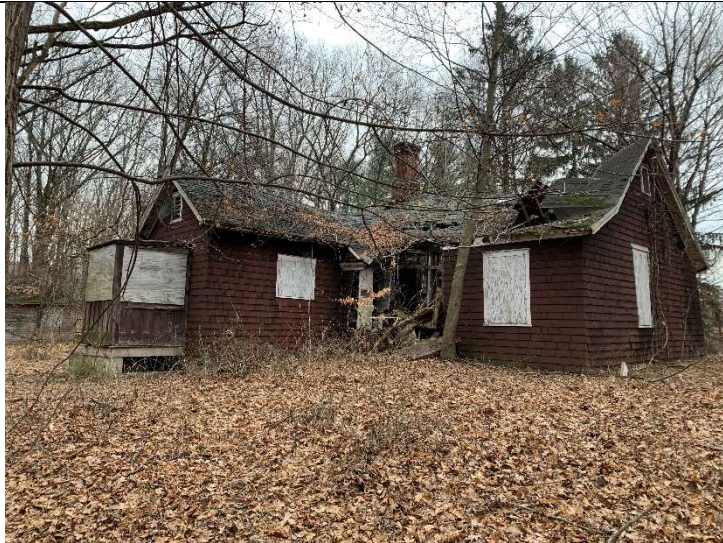
Photo 20 –

Staff House, severe deterioration of roof and interior floor.

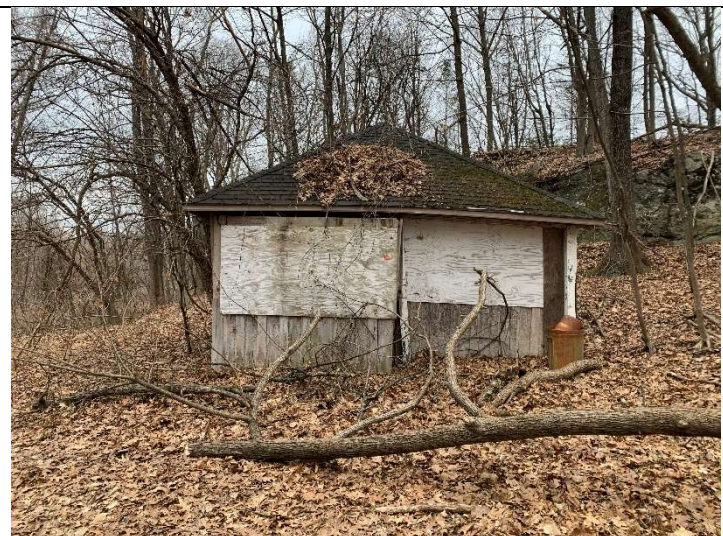
Photo 21 –

Small structure just east of the Staff House.
