## MONTHLY STATUS REPORT

BCP No.:	C314121	PVE Project No.:	560909	Date:	3/26/2020
Project Name:	3532 North Road, Dutchess County, Poughkeepsie, New York

Consultant: PVE	Consultant On-Site: Trevor Treglia
General Contractor: Saber Development	General Contractor Contact: Richard DeCola

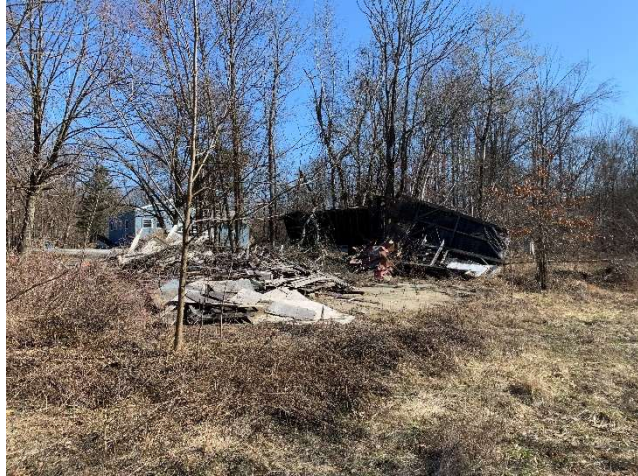
Photo 1 –

Auto Garage East (Collapsed).

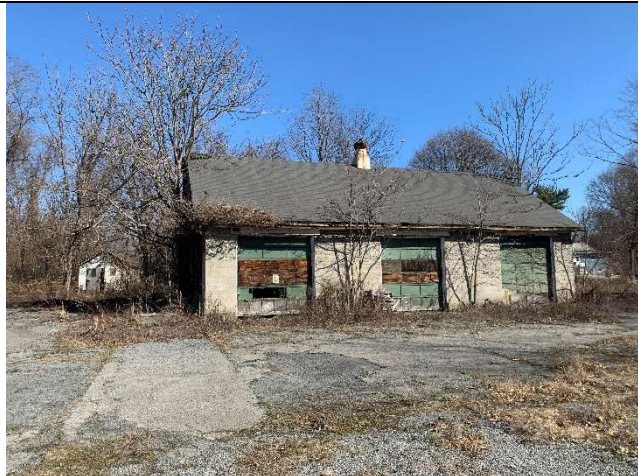
Photo 2 –

Auto Garage West.

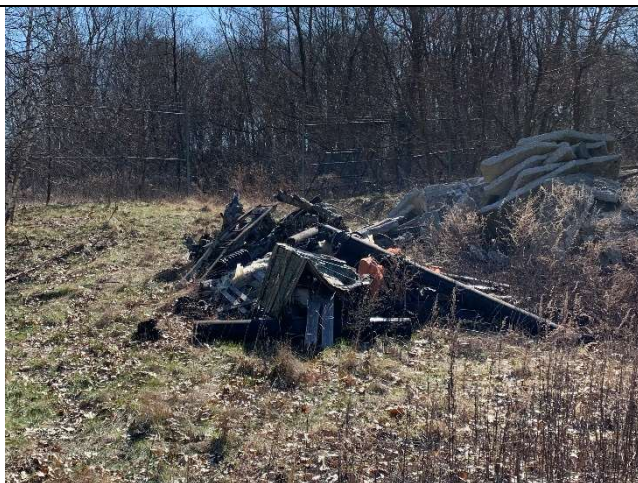
Photo 3 –

Pile of debris outside fenced area.  
Just south of Auto Garage East.

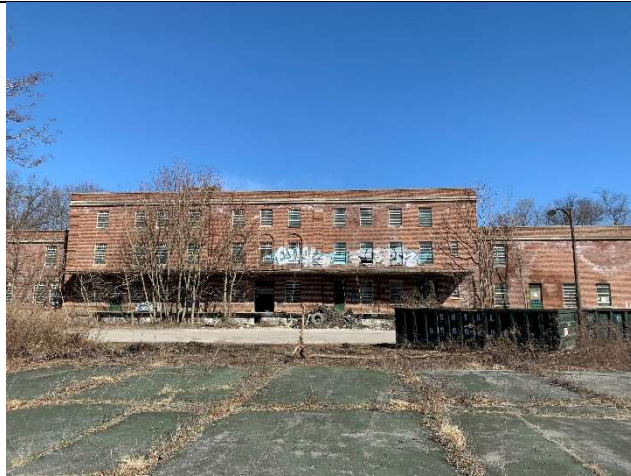
Photo 4 –

Bakery/Storage structure. Piles of debris along southern side of structure.

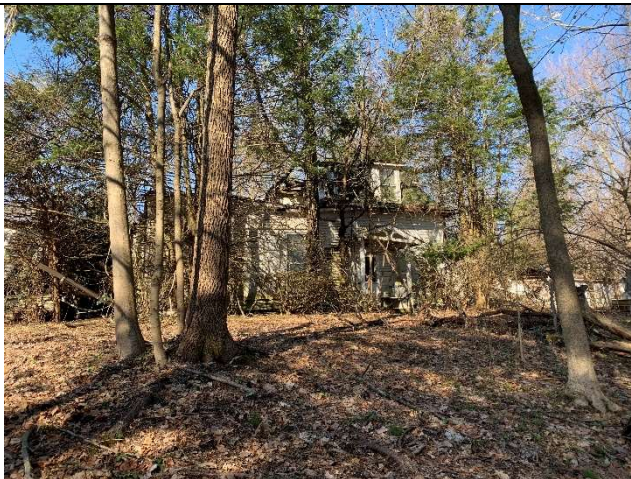
Photo 5 –

Residential structure with shed directly west of the Bakery/Storage structure. Severe deterioration of both structures.

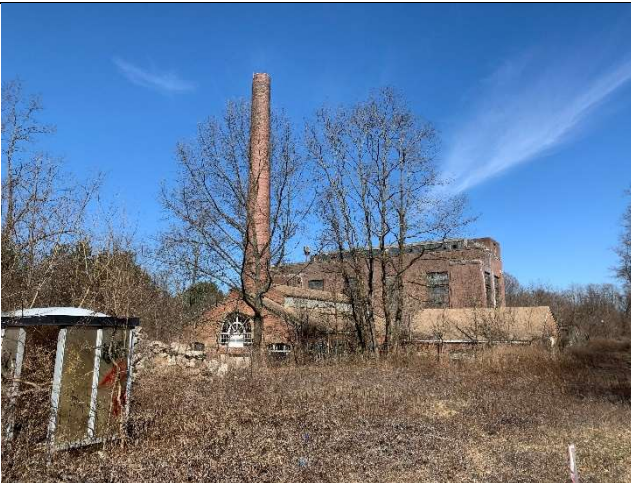
Photo 6 –

Powerhouse.

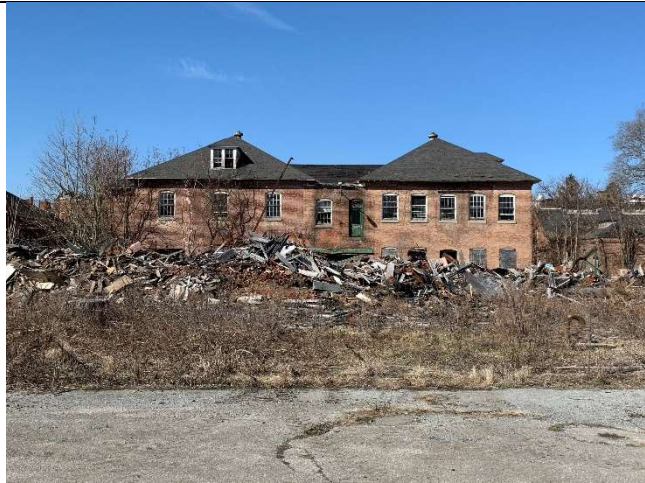
Photo 7 –

Engineer's Office (Demolished).

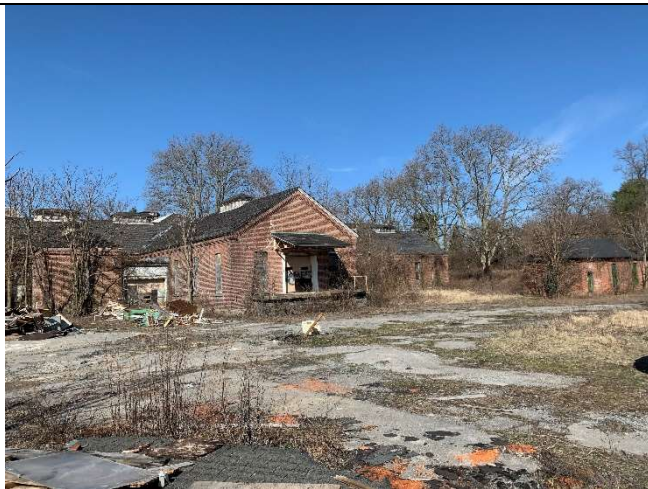
Photo 8 –

Carwash with shed (pictured right).

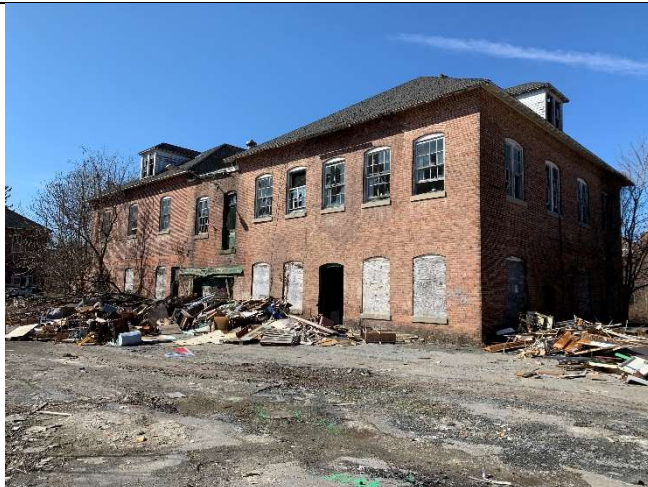
Photo 9 –

Maintenance Building with piles of debris along east side of structure.

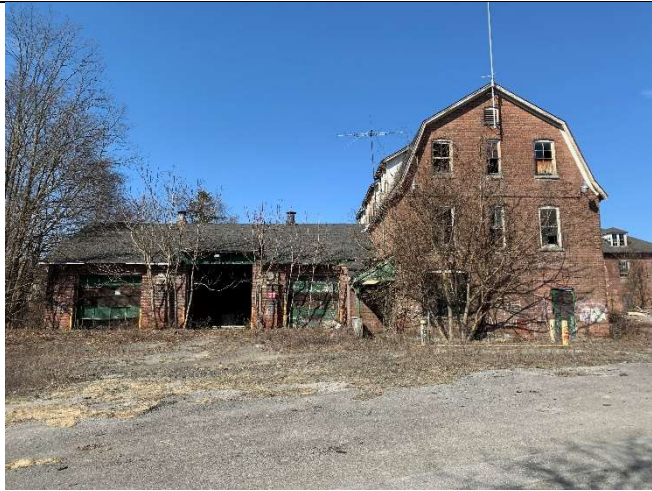
Photo 10 –

Fire House.

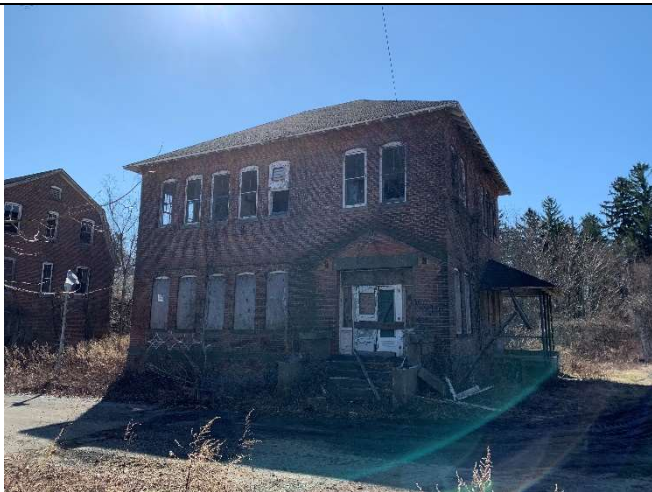
Photo 11 –

Mortuary Building.

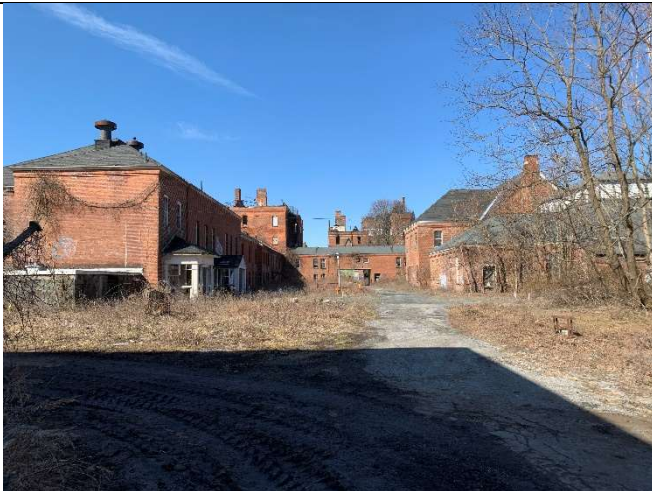
Photo 12 –

Structures west of the Mortuary Building, facing west.

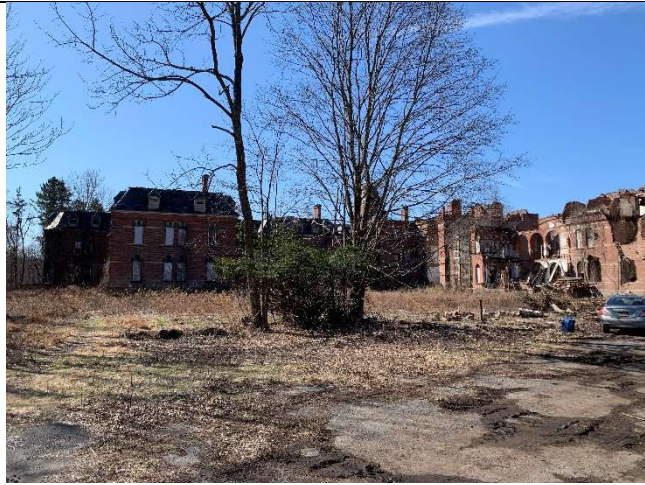
Photo 13 –

Structures in southwest corner of BCP boundary / behind Mortuary Building. South view.

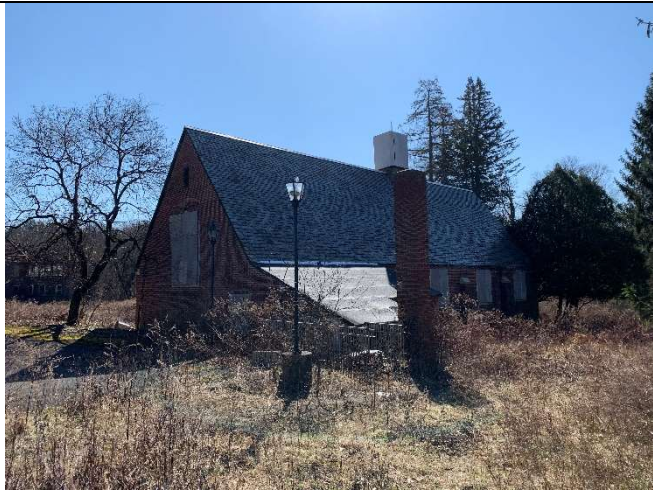
Photo 14 –

Rectory south of the Recreational Hall building.

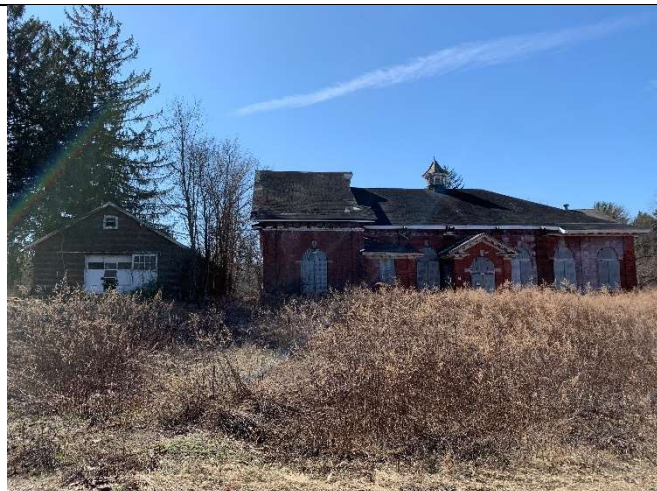
Photo 15 –

Recreational Hall.

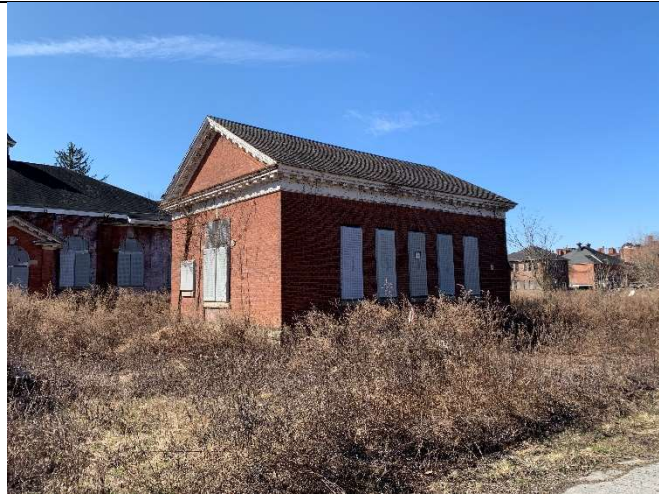
Photo 16 –

Library.

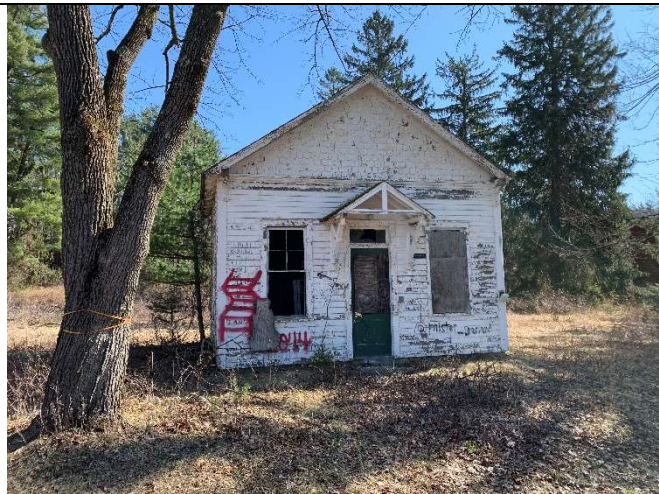
Photo 17 –

Small structure east of the Library.

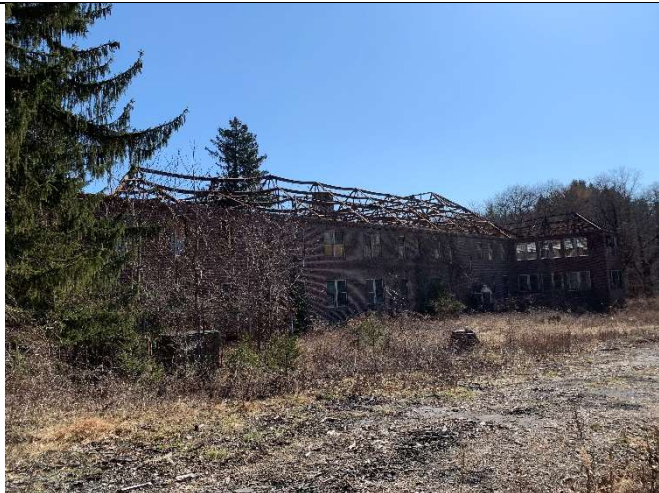
Photo 18 –

Brookside structure, severe deterioration of roof.

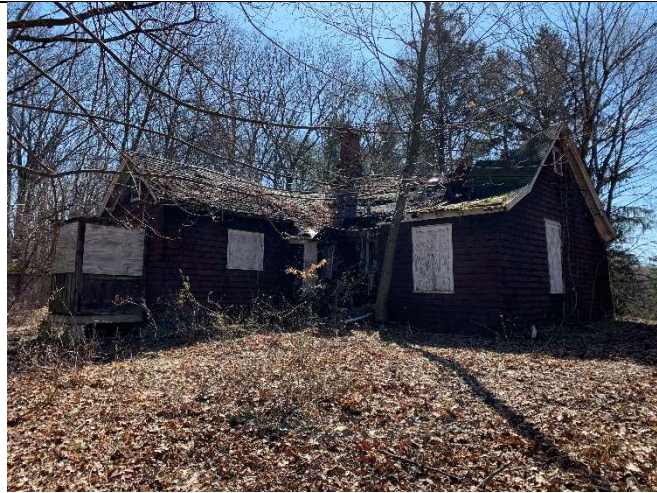
Photo 19 –

Staff House, severe deterioration of roof and interior floor.

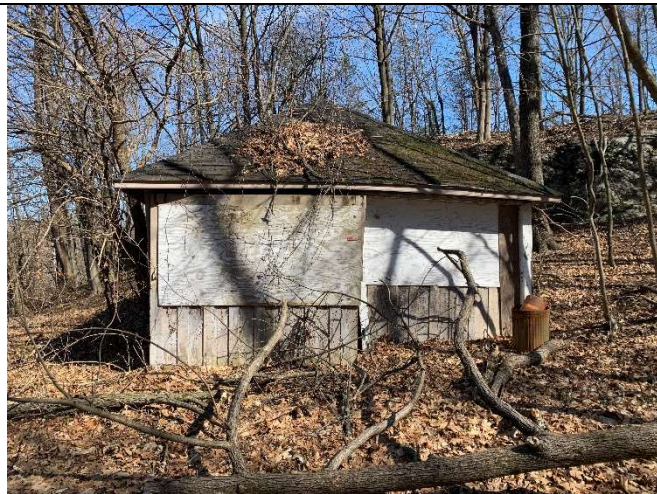
Photo 20 –

Small structure just east of the Staff House.
