MONTHLY STATUS REPORT

BCP No.:	C314121	PVE Project No.:	560909	Date:	1/28/2021
Project Name:	3532 North Road, Dutchess County, Poughkeepsie, New York

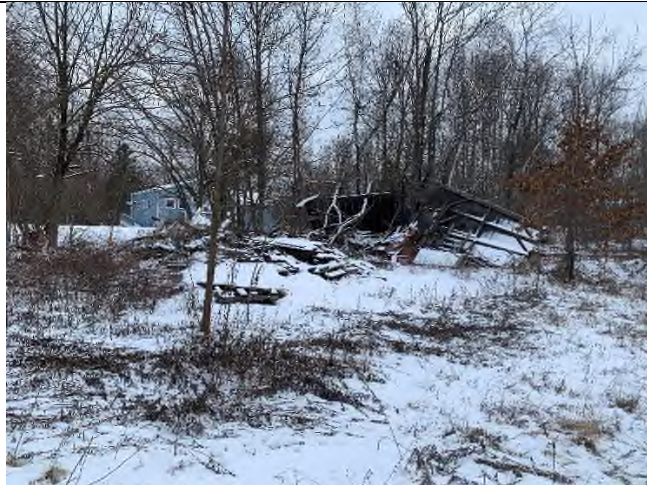
Photo 1 –

Auto Garage East (Collapsed).

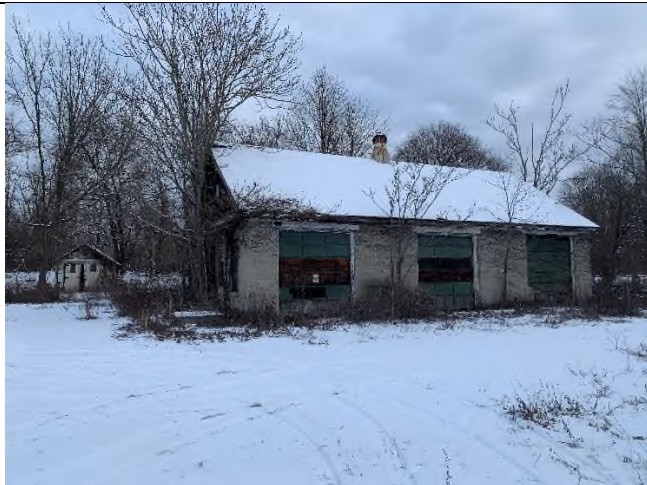
Photo 2 –

Auto Garage West.

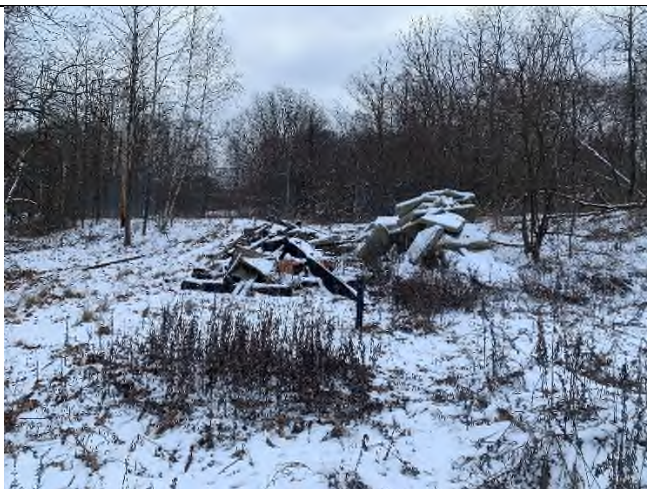
Photo 3 –

Pile of debris located south of Auto Garage East.

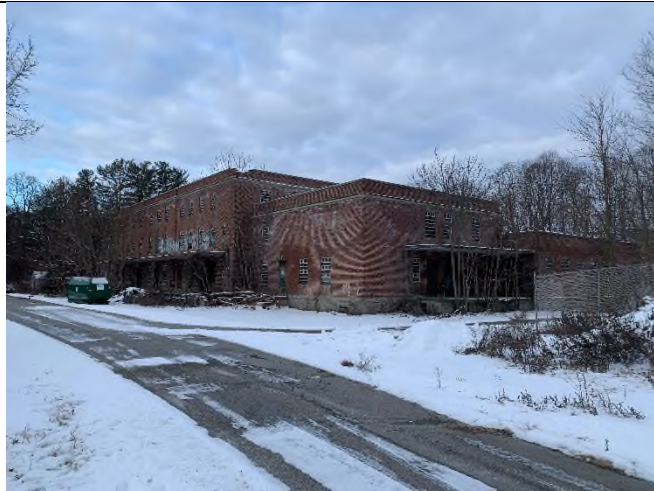
Photo 4 –

Bakery/Storage structure.
Dumpster located south of structure.

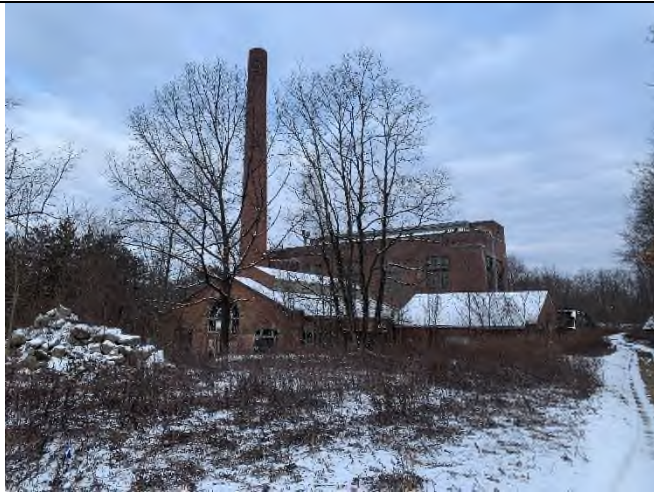
Photo 5 –

Powerhouse.

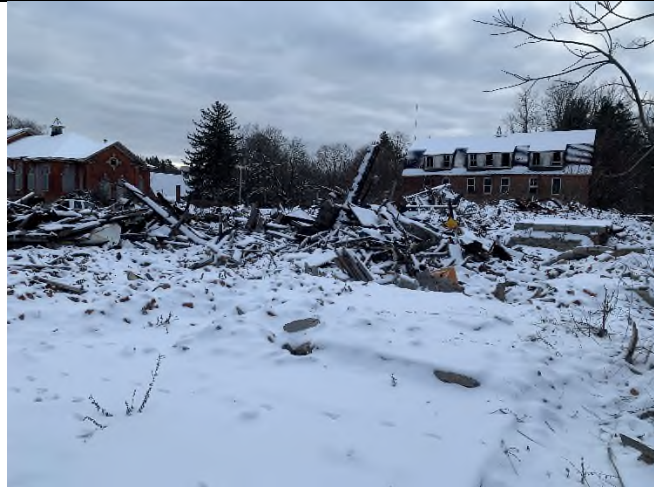
Photo 6 –

Engineer's Office (Demolished).
Dumpsters located south of debris.

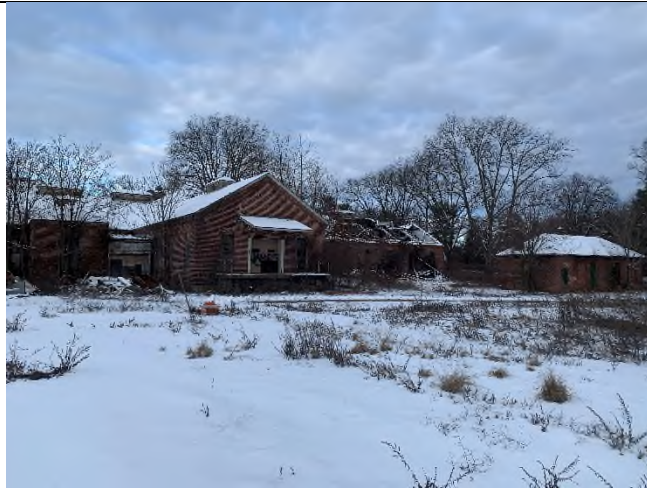
Photo 7 –

Carwash (pictured left) with shed (pictured right).

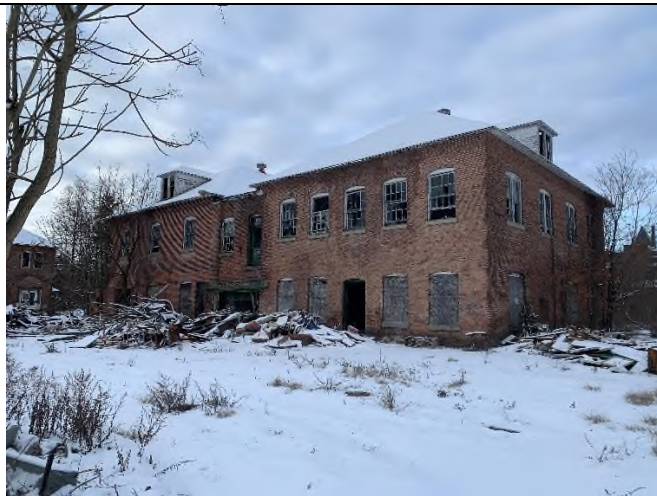
Photo 8 –

Maintenance Building with debris located east side of structure.

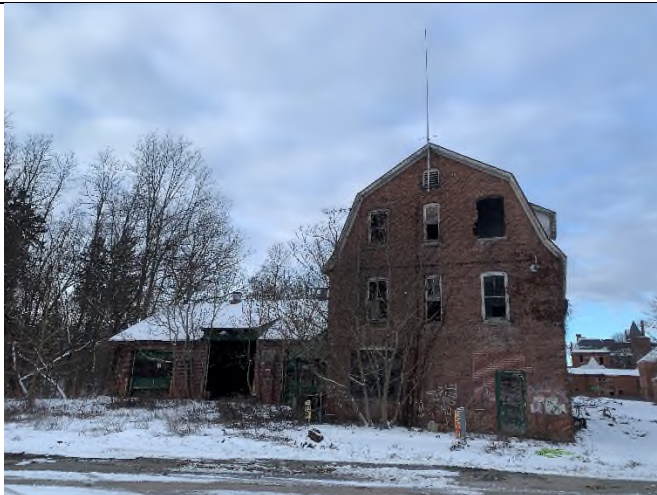
Photo 9 –

Fire House.

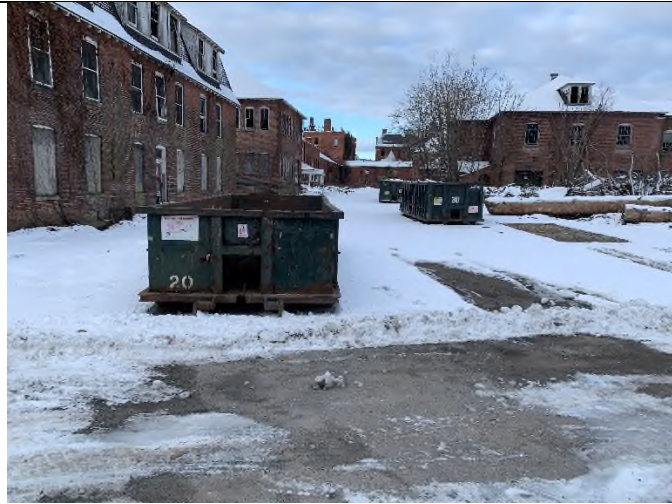
Photo 10 –

Three (3) dumpsters north of the
Fire House building.

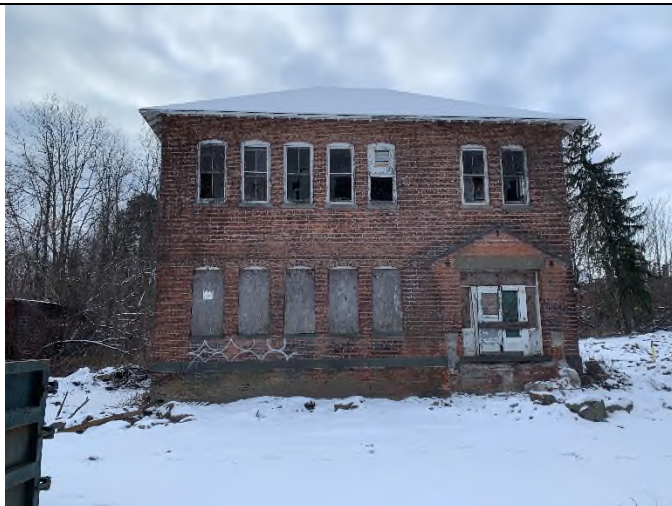
Photo 11 –

Mortuary Building.

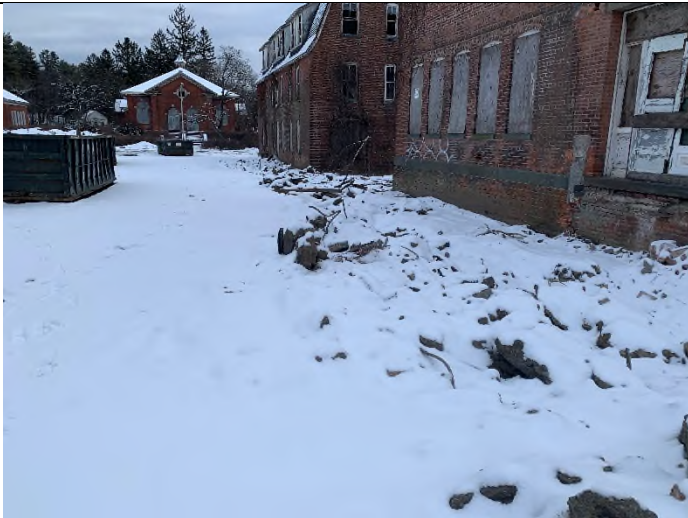
Photo 12 –

Backfilled trench north side of
Mortuary. Trench was backfilled on
January 21, 2021.

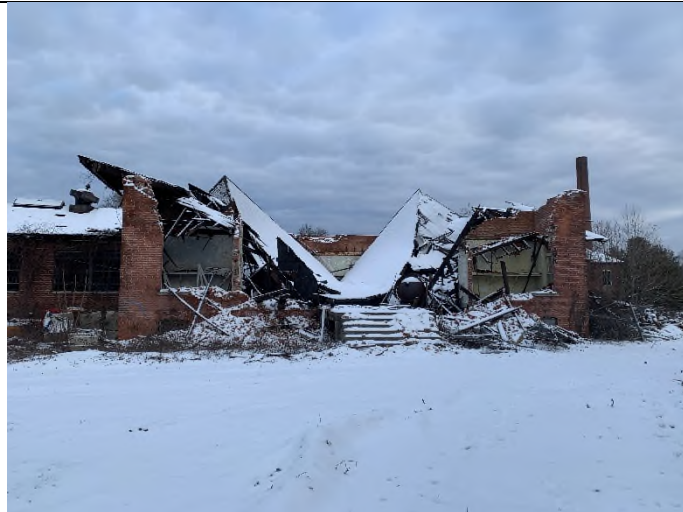
Photo 13 –

Structure west of the Mortuary Building, facing north (collapsed).

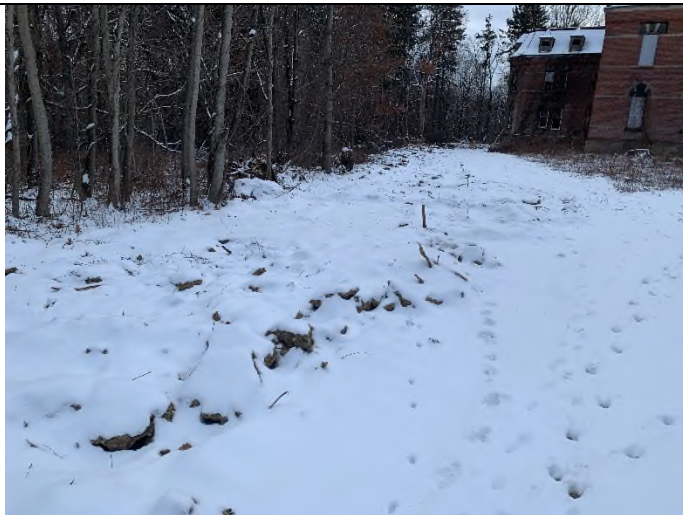
Photo 14 –

Backfilled trench in southern section of BCP area. Trench was backfilled on January 21, 2021.

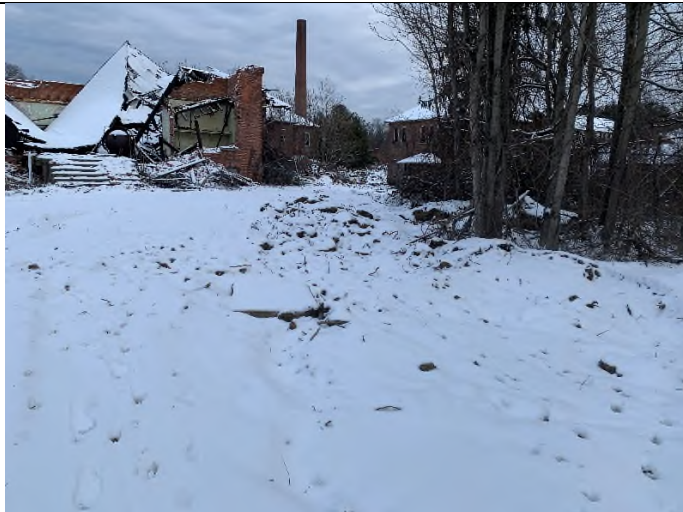
Photo 15 –

Backfilled trench in southern section of BCP area. Trench was backfilled on January 21, 2021.

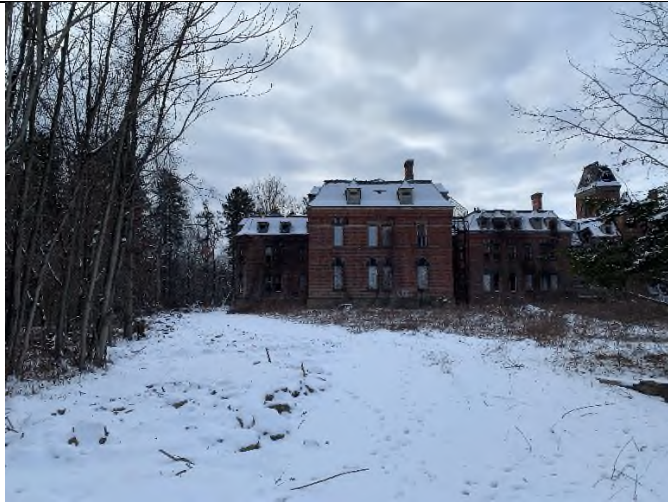
Photo 16 –

Structures in southwest corner of BCP boundary, facing south.

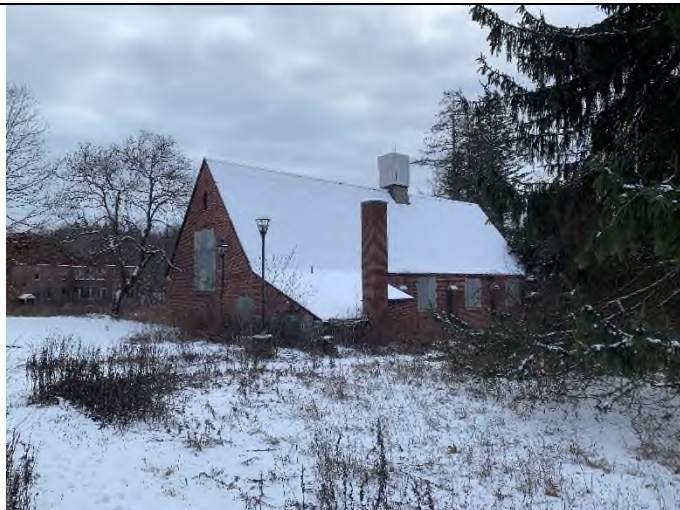
Photo 17 –

Rectory south of the Recreational Hall building.

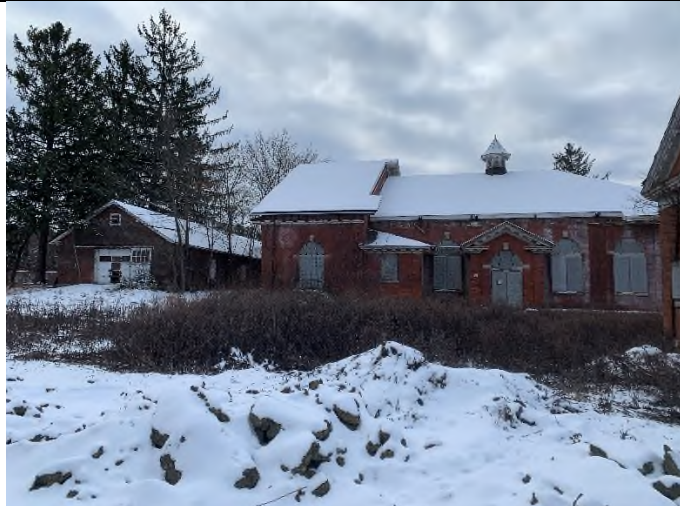
Photo 18 –

Recreational Hall. Backfilled trench observed north of Recreational Hall extending east to west.

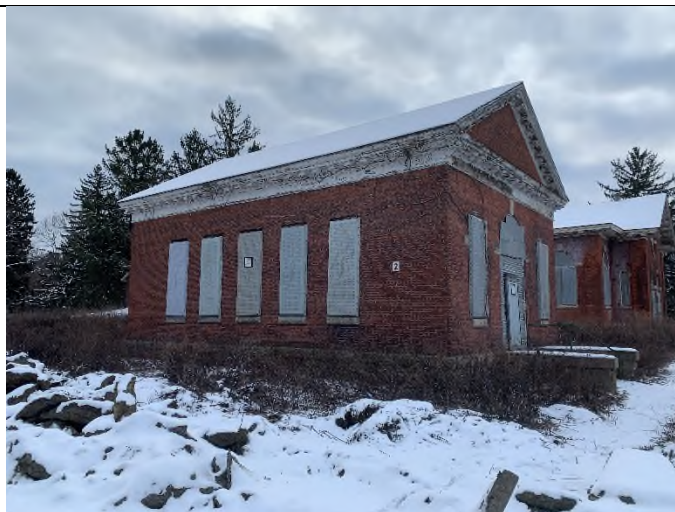
Photo 19 –

Library. Backfilled trench observed north of Library, extending east to west.

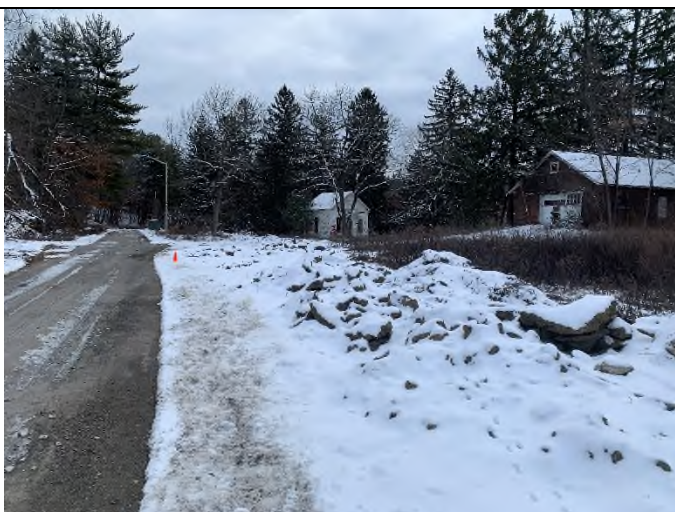
Photo 20 –

Backfilled trench east of Library, heading to fire hydrant. Trench was backfilled on January 21, 2021.

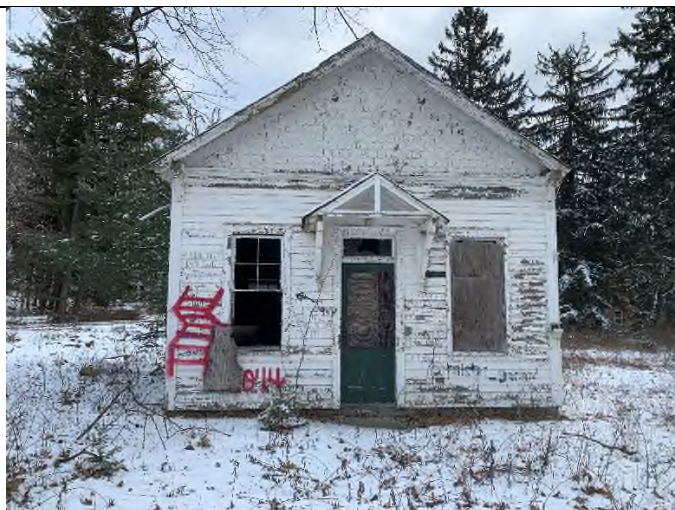
Photo 21 –

Small structure east of the Library.

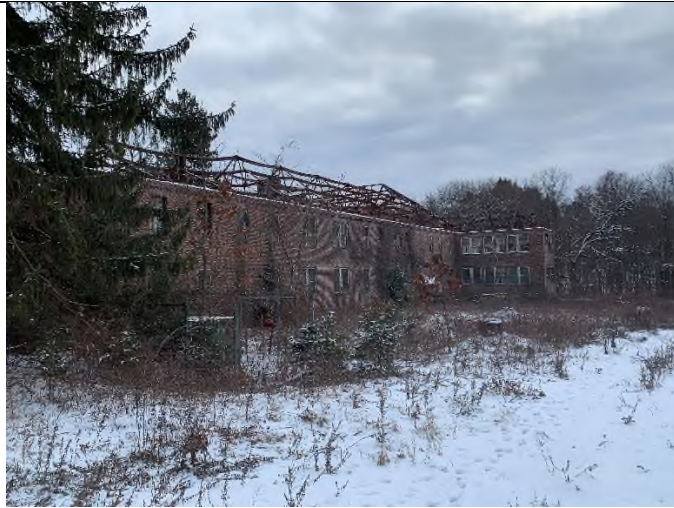
Photo 22 –

Brookside structure, severe deterioration of roof.

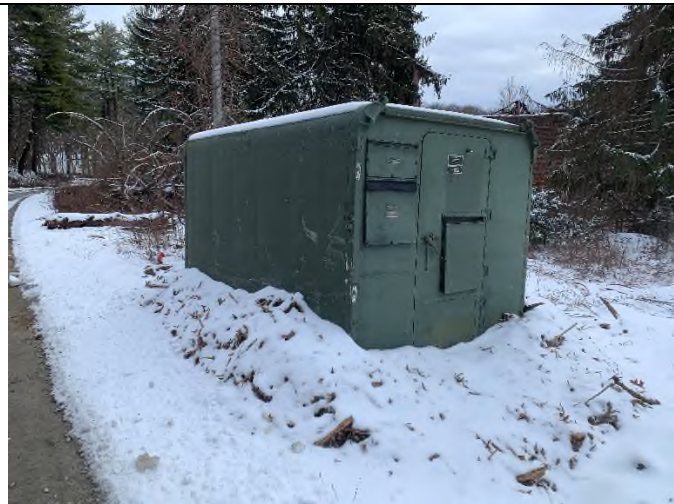
Photo 23 –

Metal container placed over fire hydrant to prevent freezing. Base of container is bordered with wood chips.

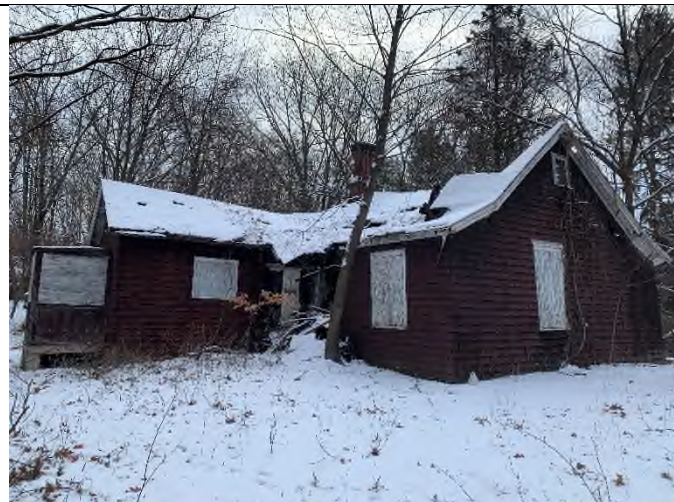
Photo 24 –

Staff House, severe deterioration of roof and interior floor.

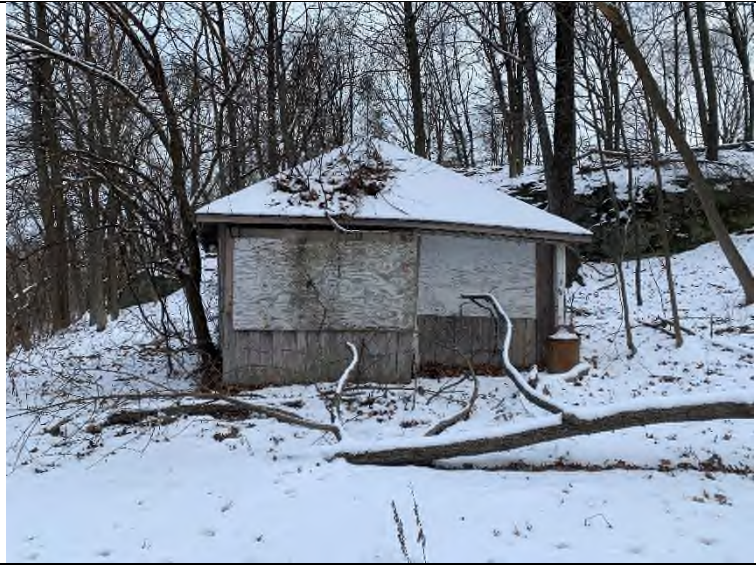
Photo 25 –

Small structure east of the Staff House.
