MONTHLY STATUS REPORT

BCP No.:	C314121	PVE Project No.:	560909	Date:	2/17/2021
Project Name:	3532 North Road, Dutchess County, Poughkeepsie, New York

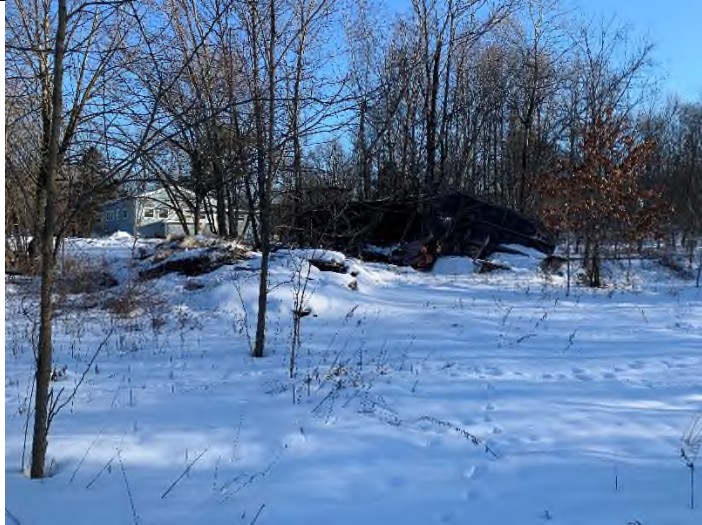
Photo 1 –

Auto Garage East (Collapsed).

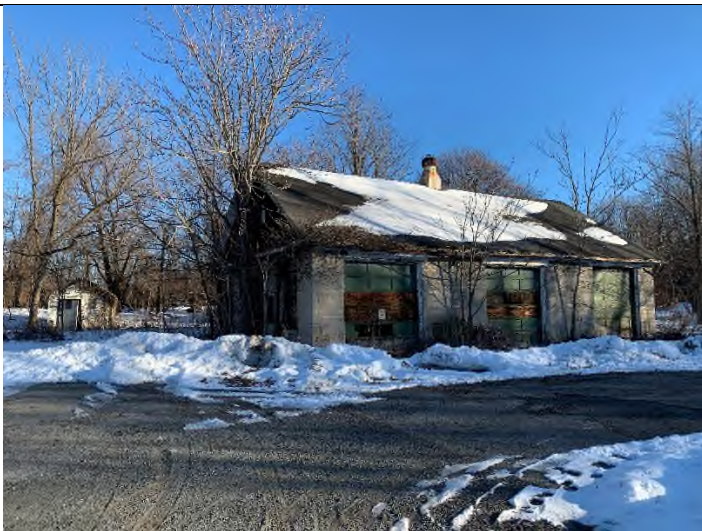
Photo 2 –

Auto Garage West.

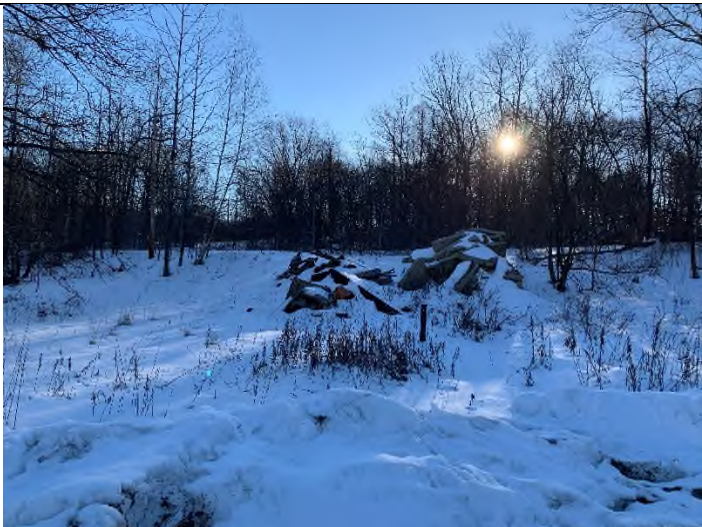
Photo 3 –

Pile of debris located south of Auto Garage East.

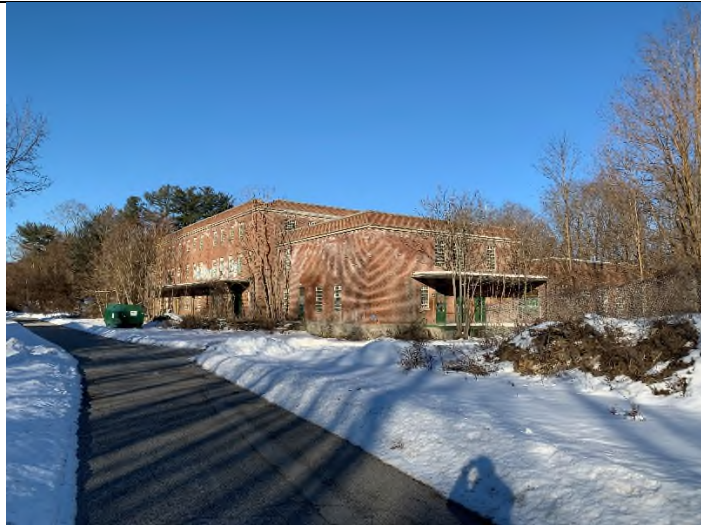
Photo 4 –

Bakery/Storage structure.
Dumpster located south of
structure.

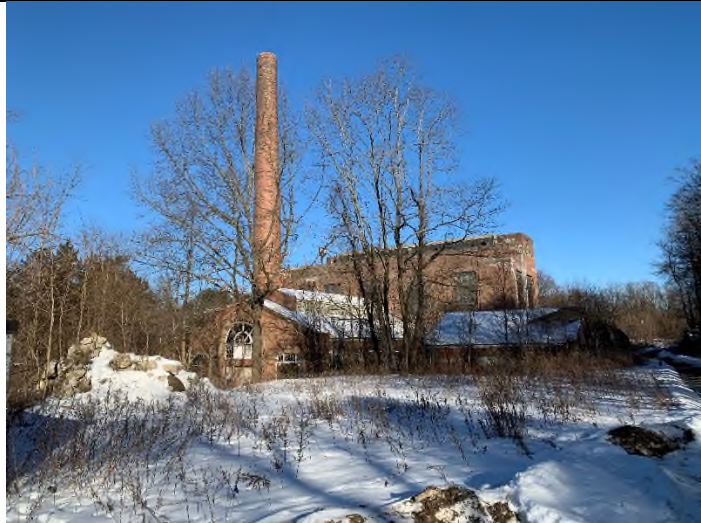
Photo 5 –

Powerhouse.

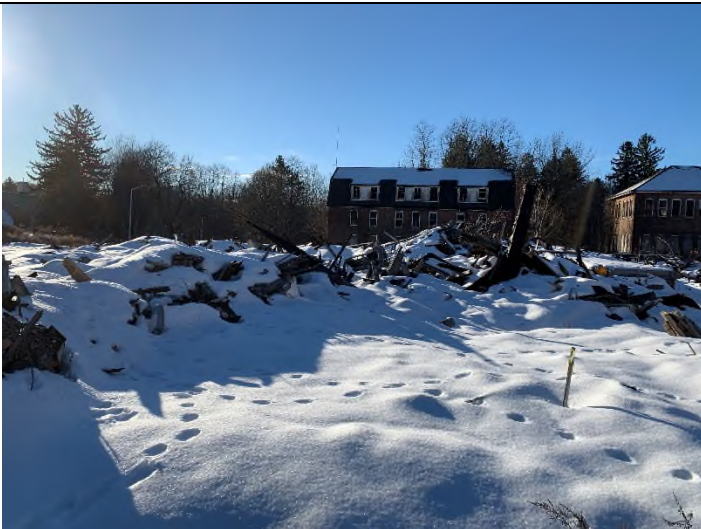
Photo 6 –

Engineer's Office (Demolished).

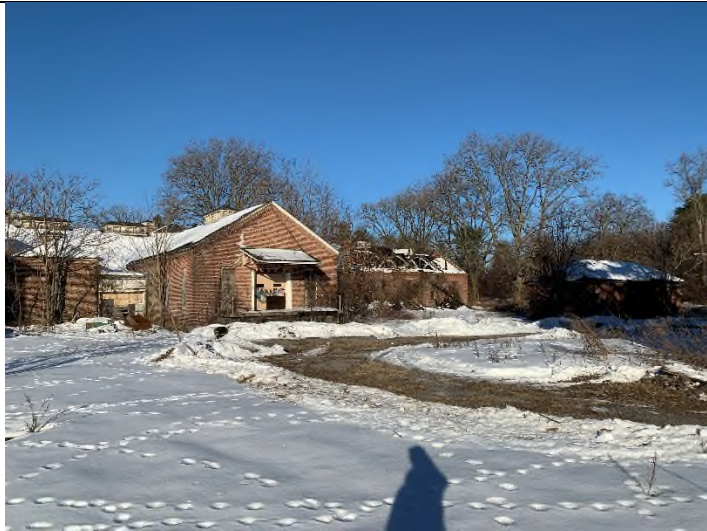
Photo 7 –

Carwash (pictured left) with shed (pictured right).

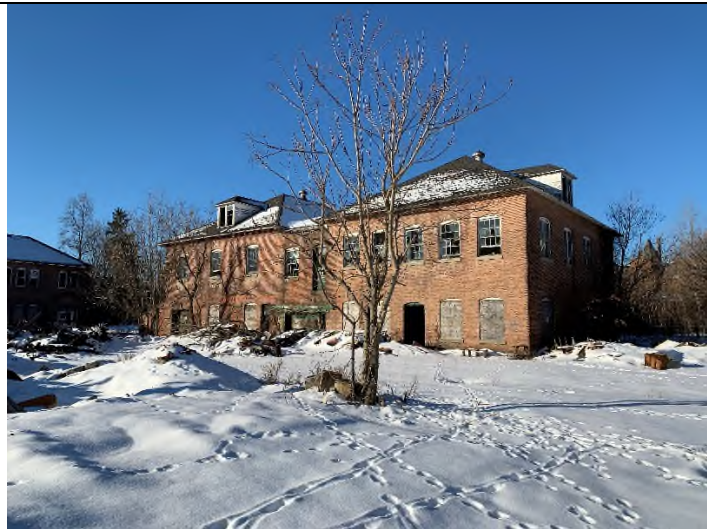
Photo 8 –

Maintenance Building with debris located east side of structure.

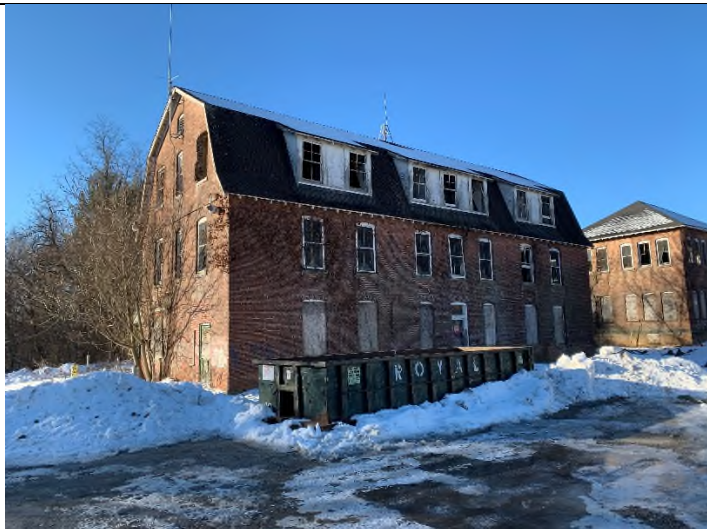
Photo 9 –

Fire House.

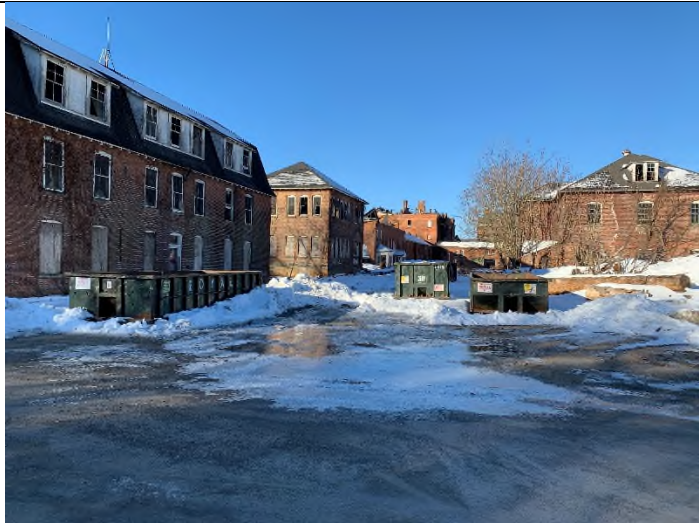
Photo 10 –

Four (4) dumpsters north of the Fire House building.

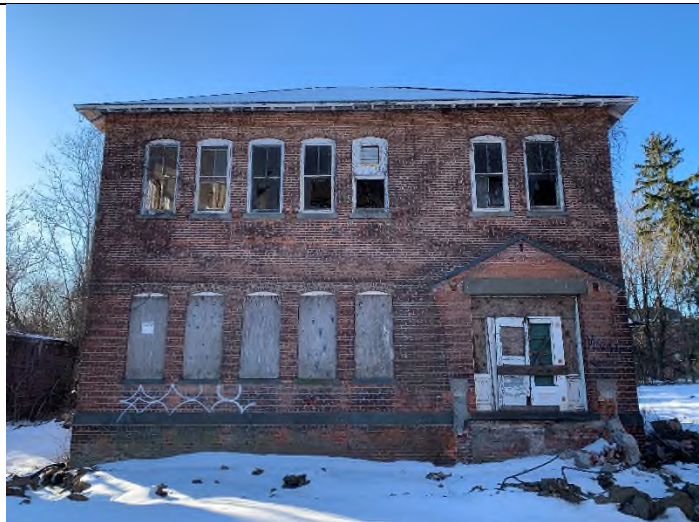
Photo 11 –

Mortuary Building.

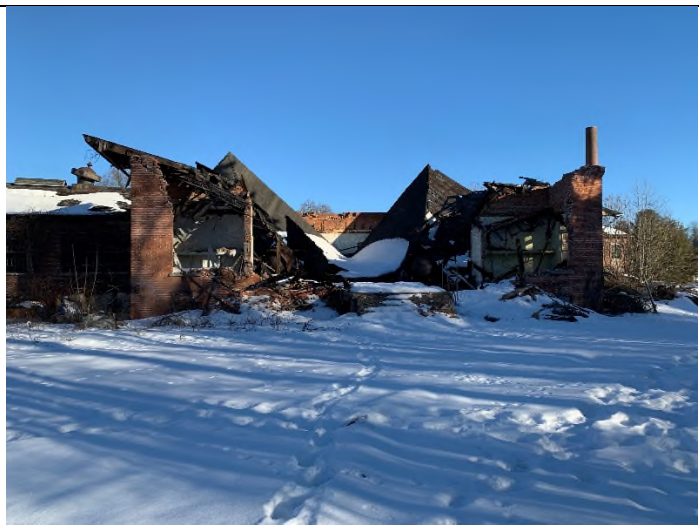
Photo 12 –

Structure west of the Mortuary Building, facing north (collapsed).

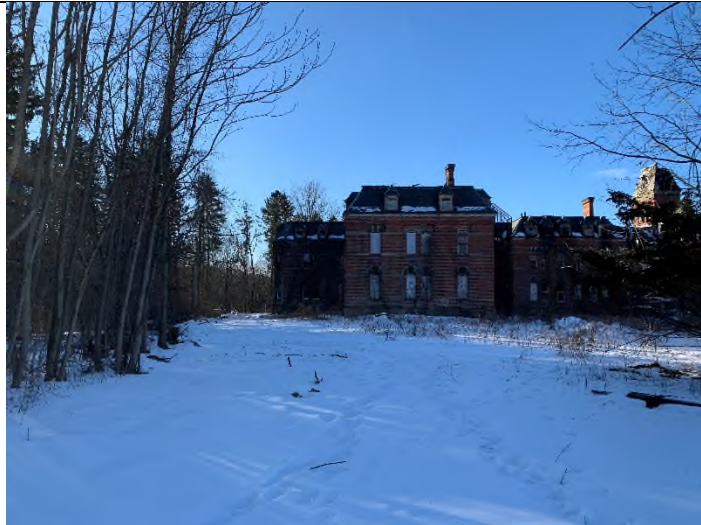
Photo 13 –

Structures in southwest corner of BCP boundary, facing south.

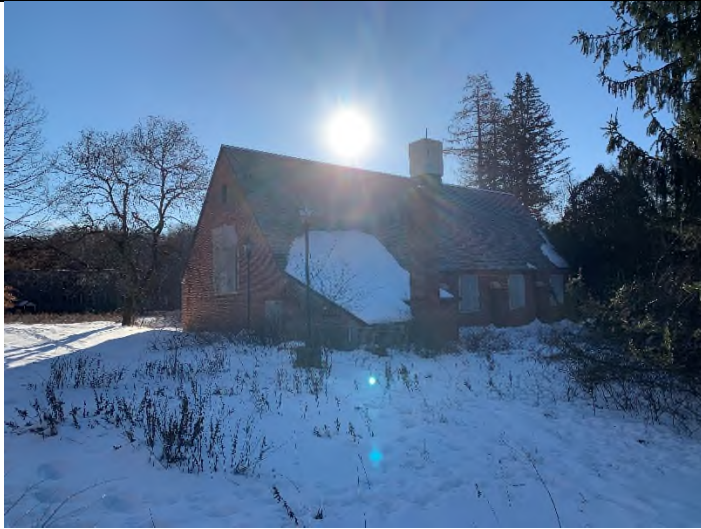
Photo 14 –

Rectory south of the Recreational Hall building.

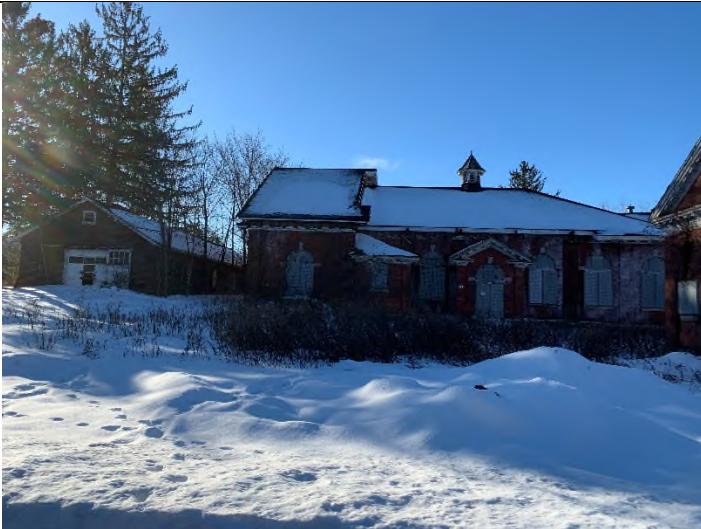
Photo 15 –

Recreational Hall. Backfilled trench observed north of Recreational Hall extending east to west.

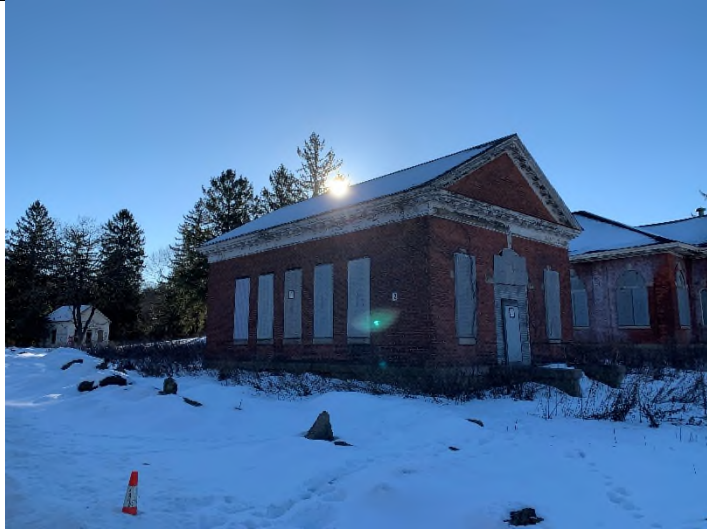
Photo 16 –

Library. Backfilled trench observed north of Library, extending east to west.

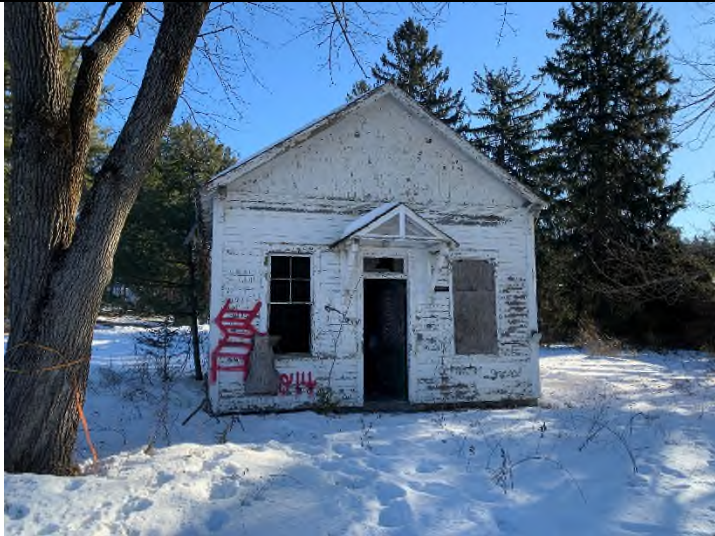
Photo 17 –

Small structure east of the Library.

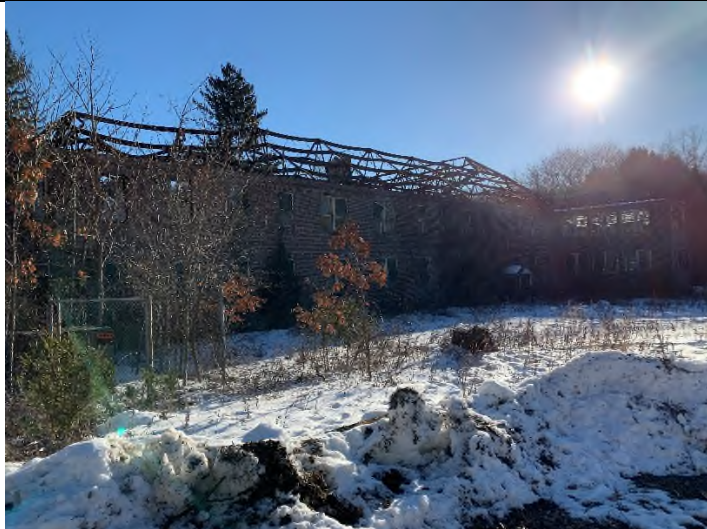
Photo 18 –

Brookside structure, severe deterioration of roof.

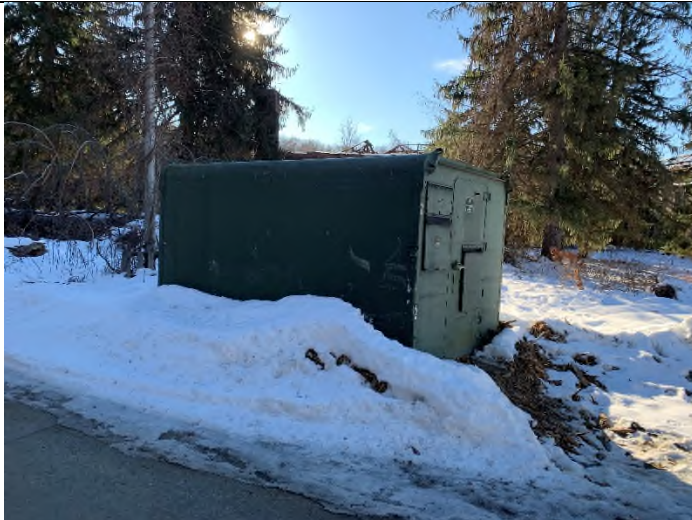
Photo 19 –

Metal container placed over fire hydrant to prevent freezing. Base of container is bordered with wood chips.

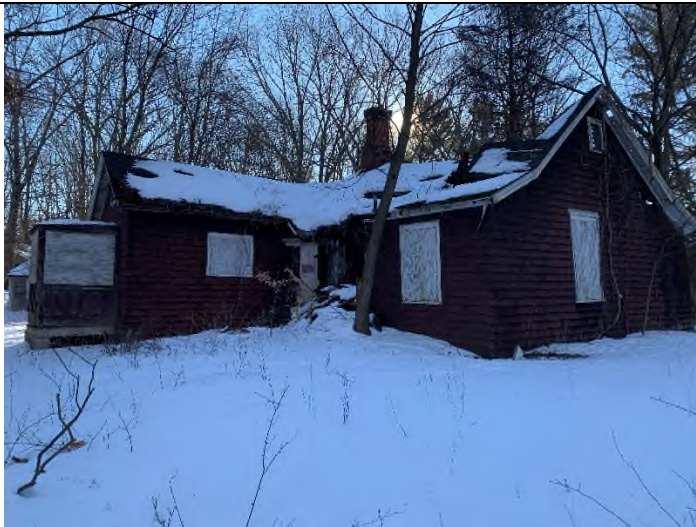
Photo 20 –

Staff House, severe deterioration of roof and interior floor.

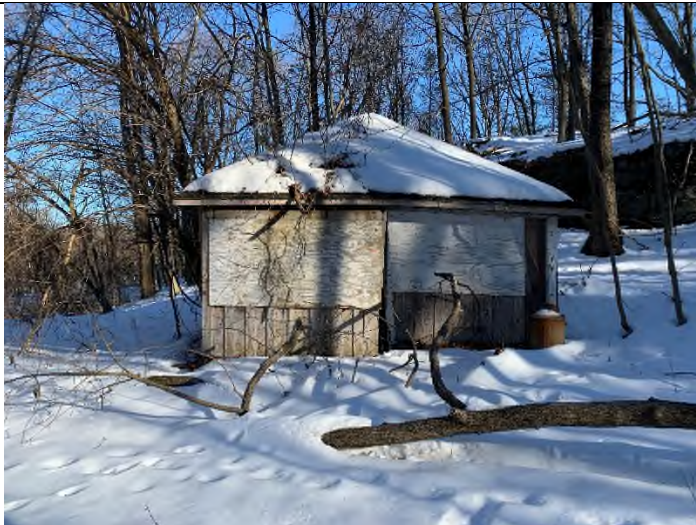
Photo 21 –

Small structure east of the Staff House.
