## MONTHLY STATUS REPORT

| BCP No.: | C314121 | PVE Project No.: | 560909 | Date: | 3/30/2021 |
| Project Name: | 3532 North Road, Dutchess County, Poughkeepsie, New York | | | | |

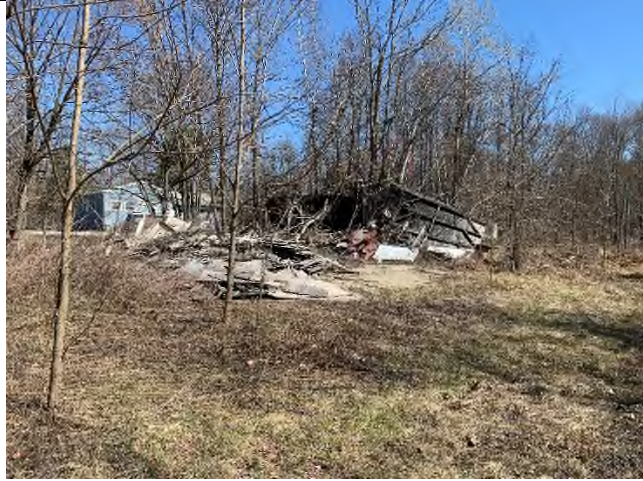
Photo 1 –

Auto Garage East (Collapsed).

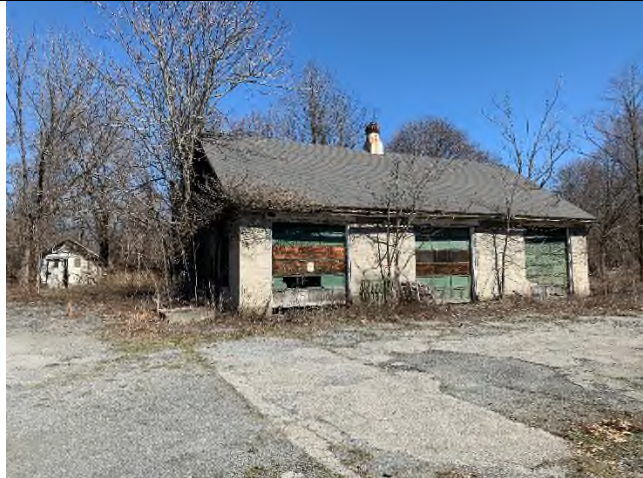
Photo 2 –

Auto Garage West.

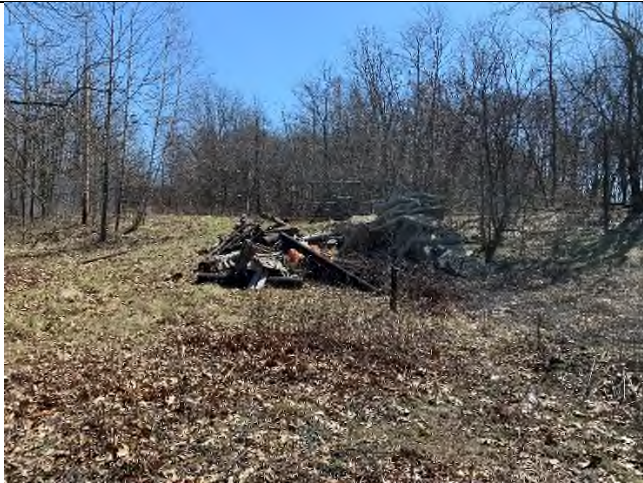
Photo 3 –

Pile of debris located south of Auto Garage East.

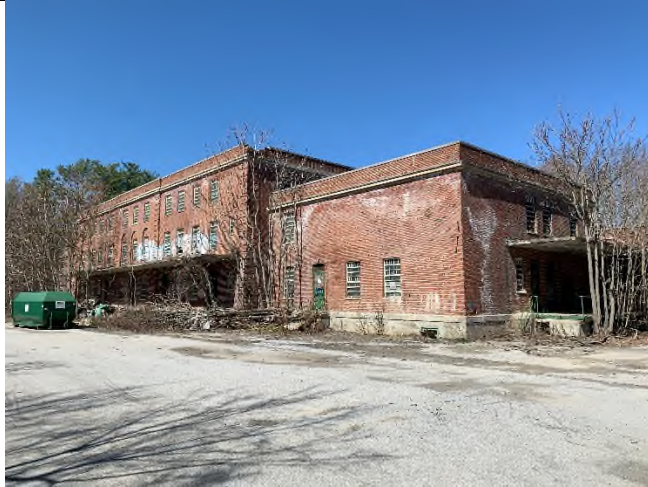
Photo 4 –

Bakery/Storage structure.  
Dumpster located south of  
structure.

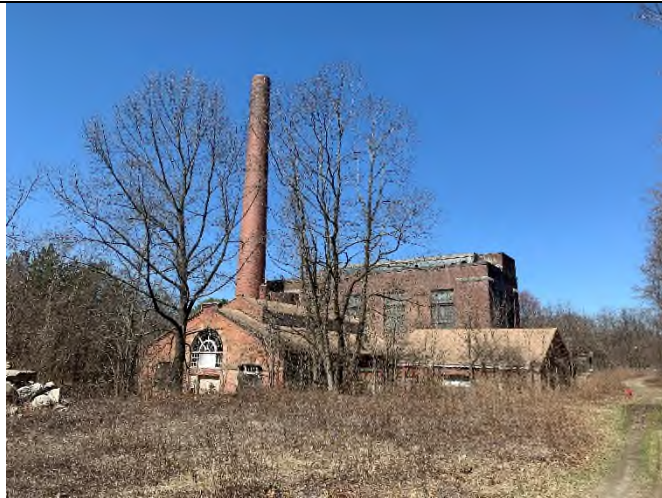
Photo 5 –

Powerhouse.

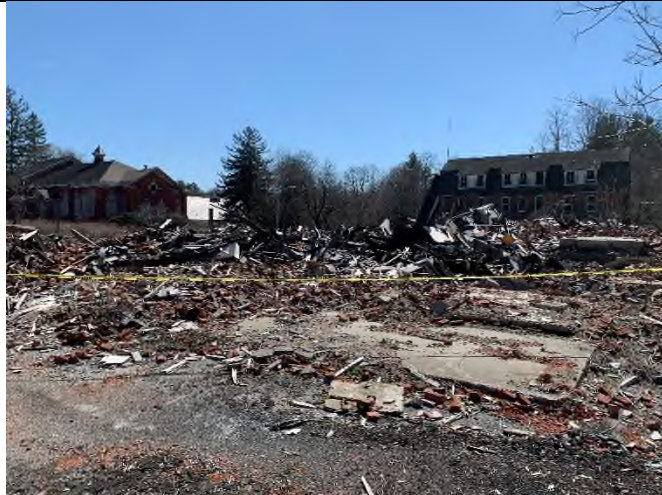
Photo 6 –

Engineer's Office (Demolished).

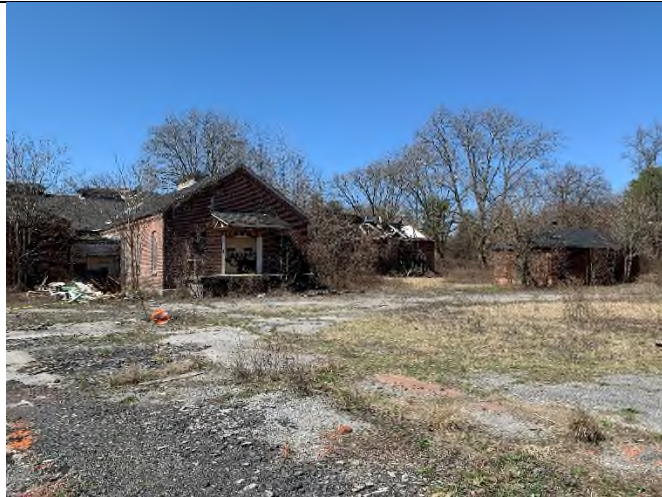
Photo 7 –

Carwash (pictured left) with shed (pictured right).

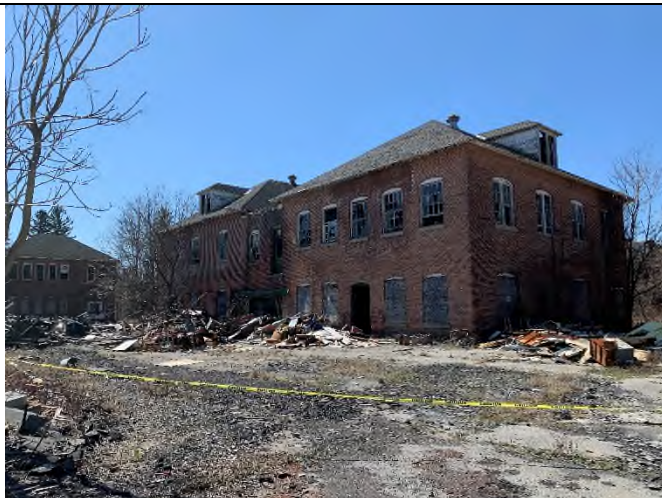
Photo 8 –

Maintenance Building with debris located east side of structure.

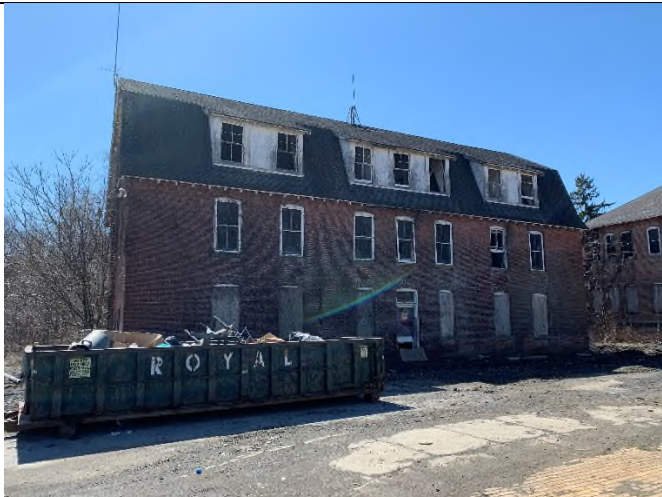
Photo 9 –

Fire House.

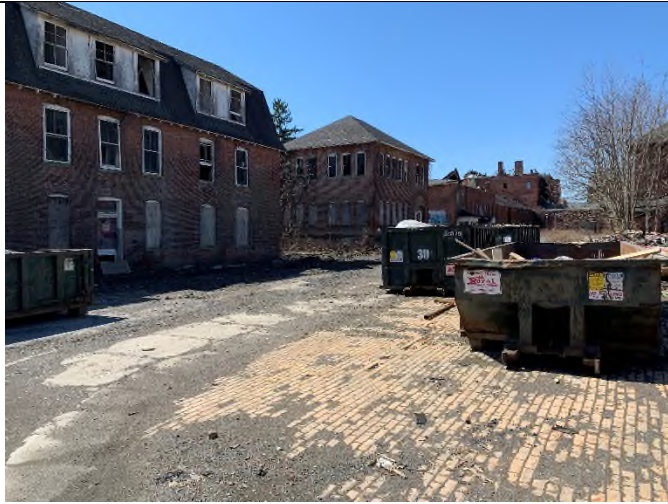
Photo 10 –

Four (4) dumpsters north of the Fire House building.

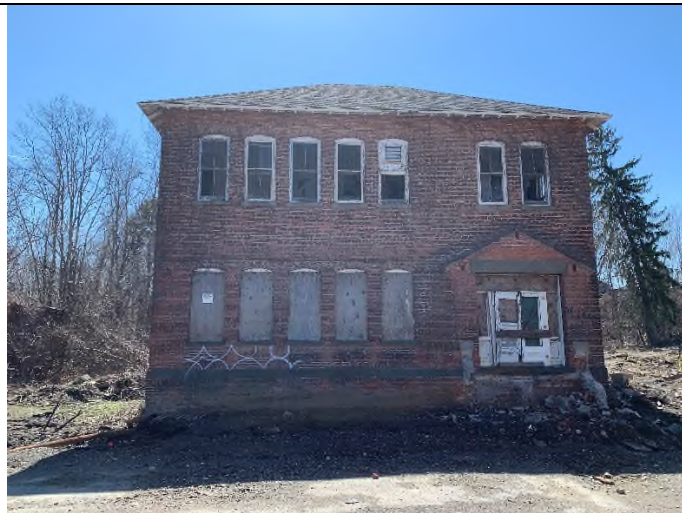
Photo 11 –

Mortuary Building.

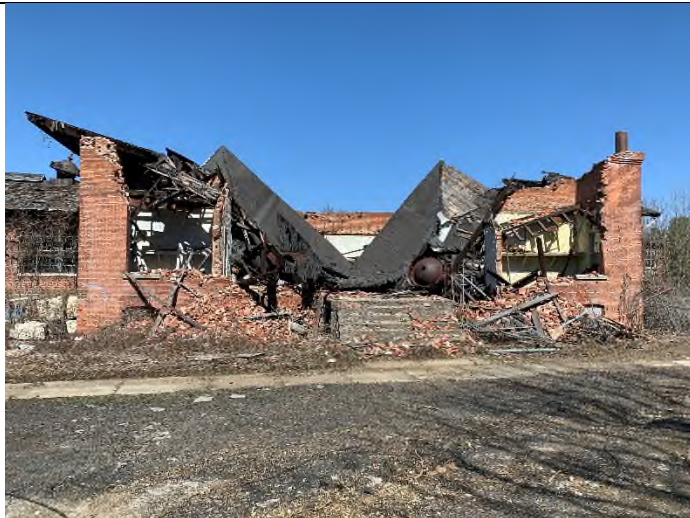
Photo 12 –

Structure west of the Mortuary Building, facing north (collapsed).

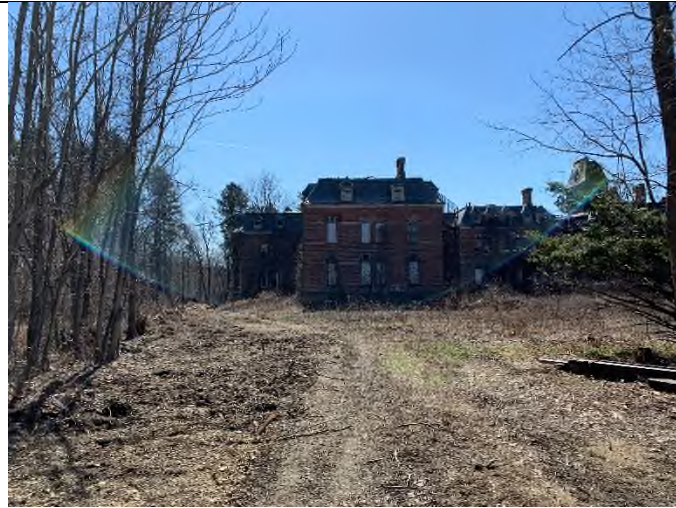
Photo 13 –

Structures in southwest corner of BCP boundary, facing south.

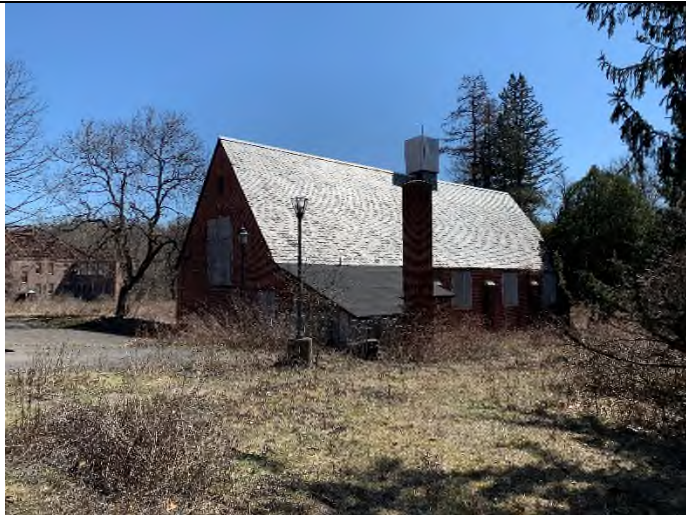
Photo 14 –

Rectory south of the Recreational Hall building.

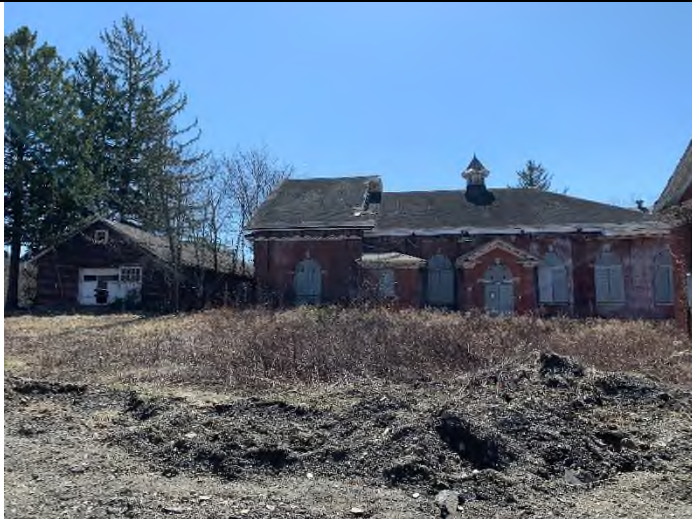
Photo 15 –

Recreational Hall. Backfilled trench observed north of Recreational Hall extending east to west.

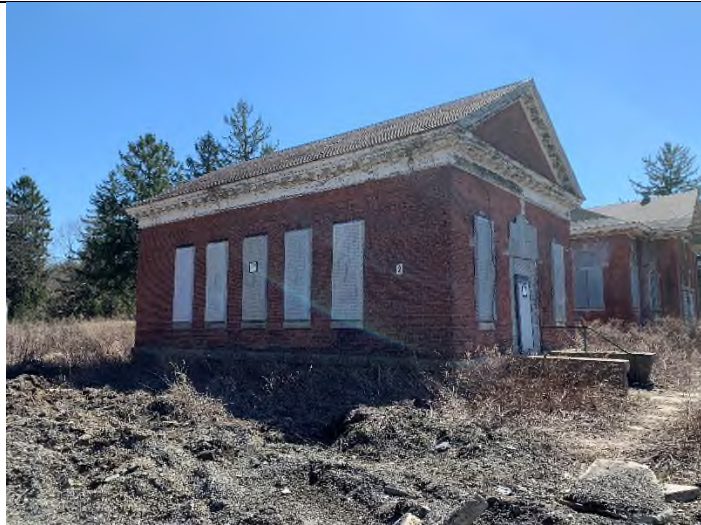
Photo 16 –

Library. Backfilled trench observed north of Library, extending east to west.

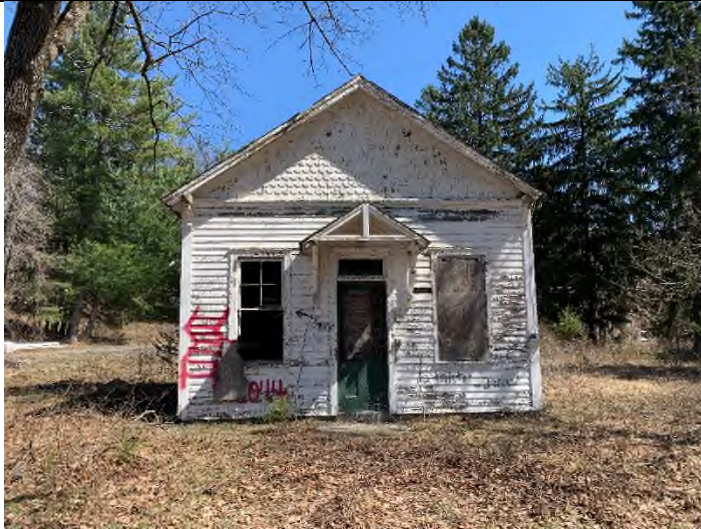
Photo 17 –

Small structure east of the Library.

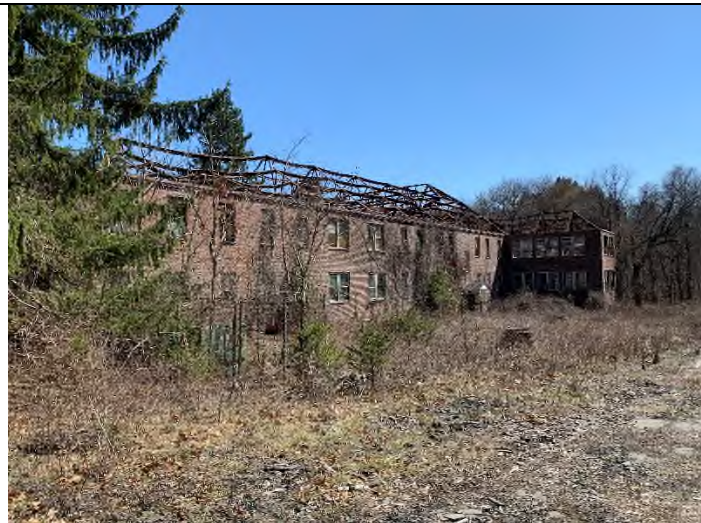
Photo 18 –

Brookside structure, severe deterioration of roof.

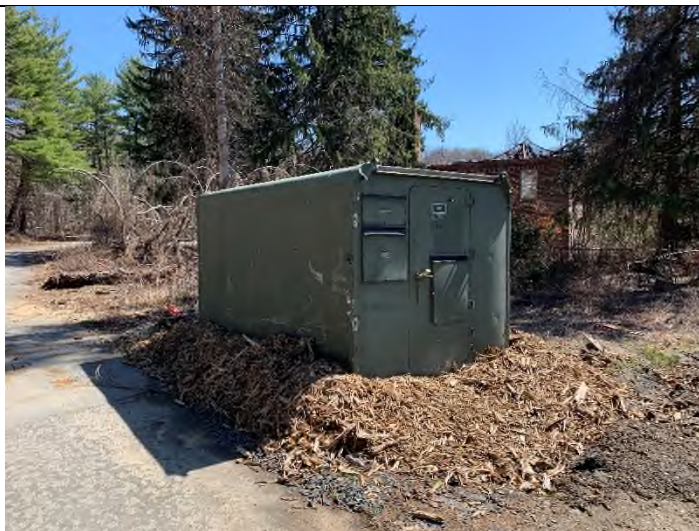
Photo 19 –

Metal container placed over fire hydrant. Base of container is bordered with wood chips.

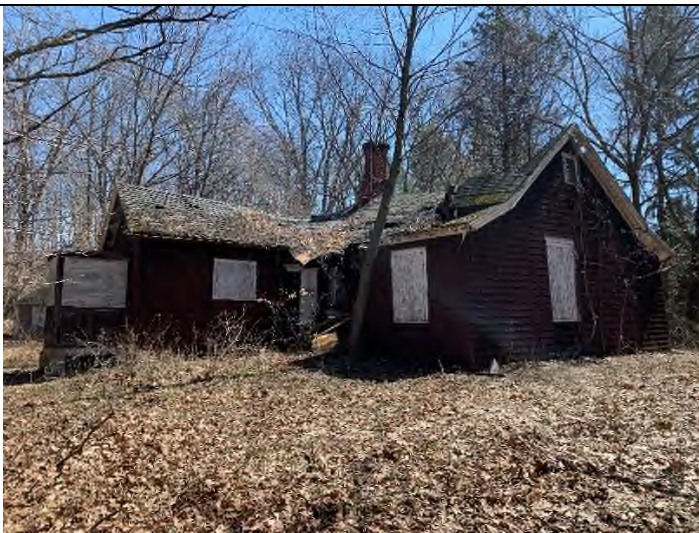
Photo 20 –

Staff House, severe deterioration of roof and interior floor.

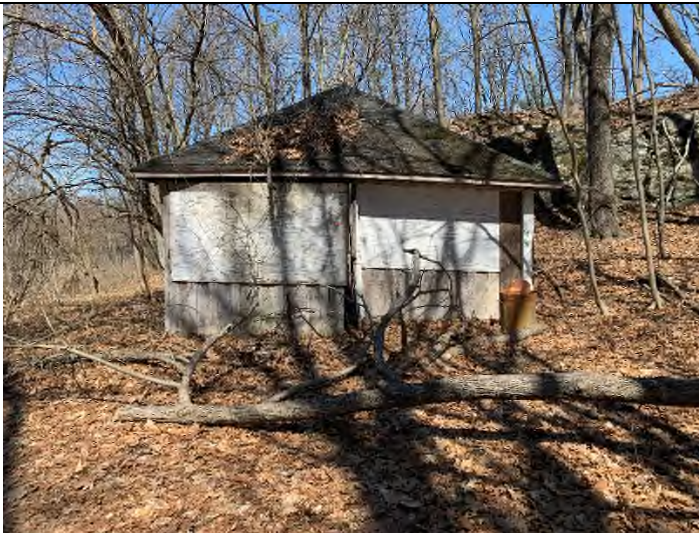
Photo 21 –

Small structure east of the Staff House.
