## MONTHLY STATUS REPORT

| BCP No.: | C314121 | PVE Project No.: | 560909 | Date: | 4/26/2021 |
| Project Name: | 3532 North Road, Dutchess County, Poughkeepsie, New York | | | | |

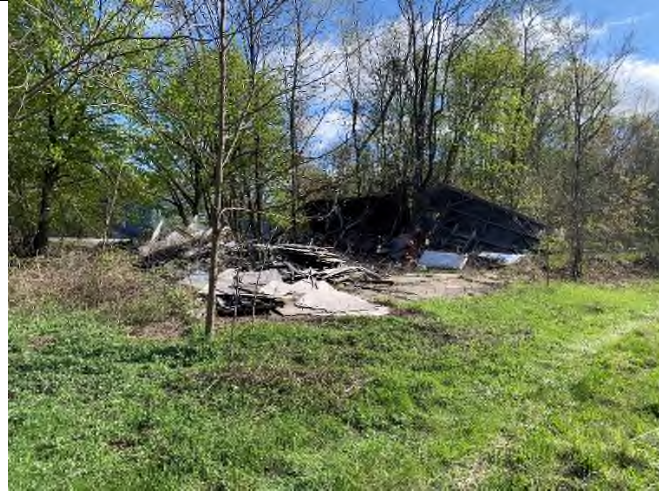
Photo 1 –  
Auto Garage East (Collapsed).

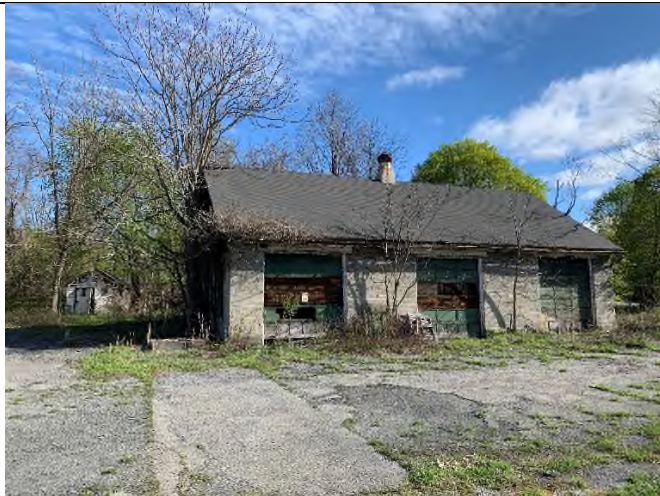
Photo 2 –  
Auto Garage West.

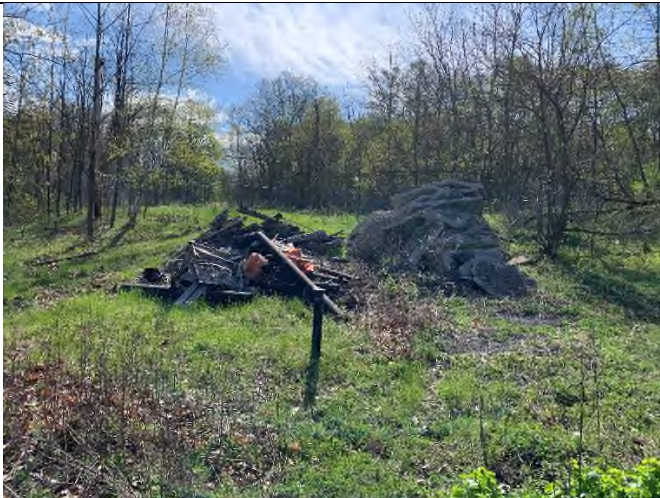
Photo 3 –  
Pile of debris located south of  
Auto Garage East.

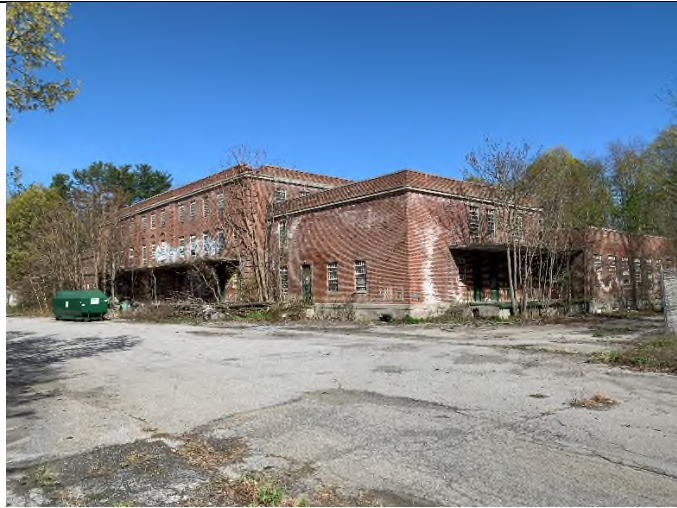
Photo 4 –

Bakery/Storage structure.  
Dumpster located south of  
structure.

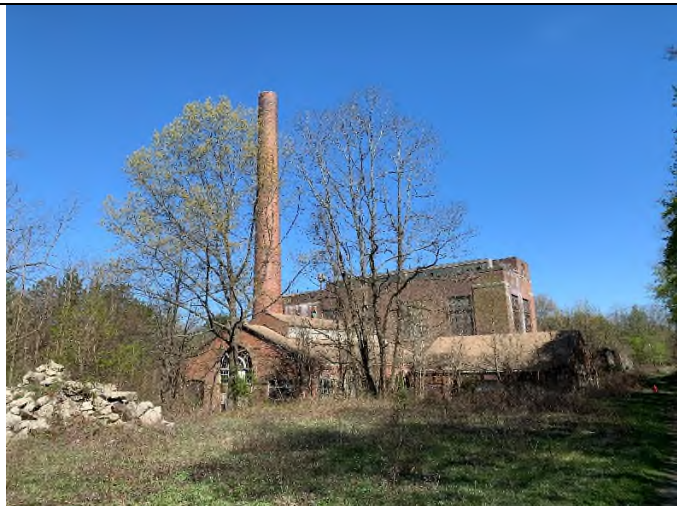
Photo 5 –

Powerhouse.

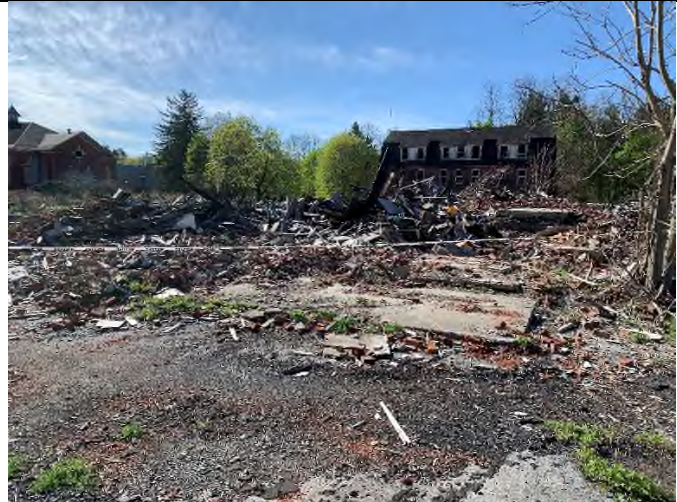
Photo 6 –

Engineer's Office (Demolished).

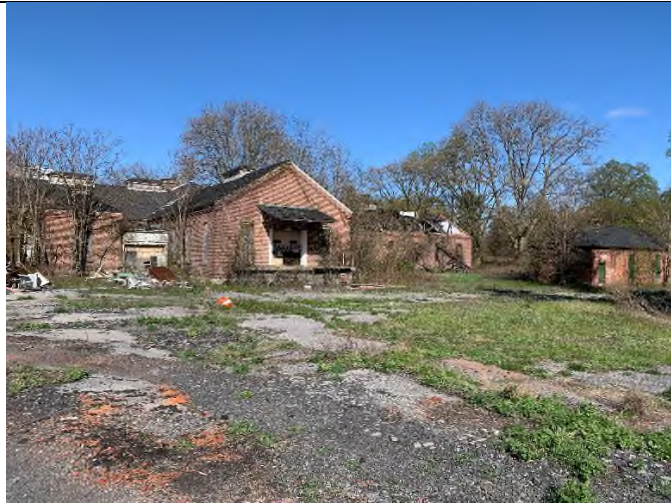
Photo 7 –

Carwash (pictured left) with shed (pictured right).

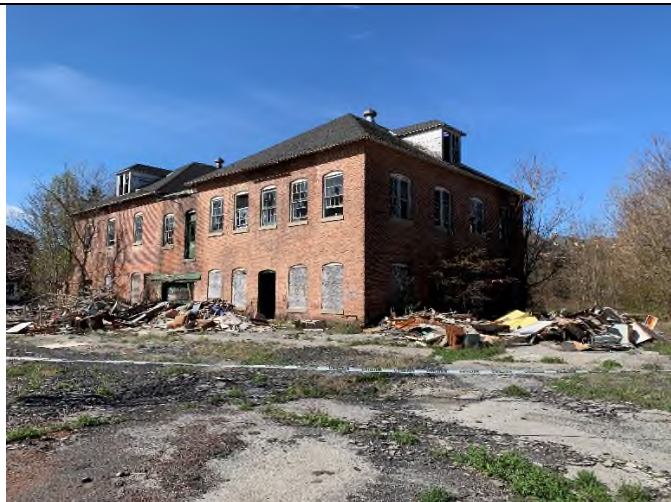
Photo 8 –

Maintenance Building with debris located east side of structure.

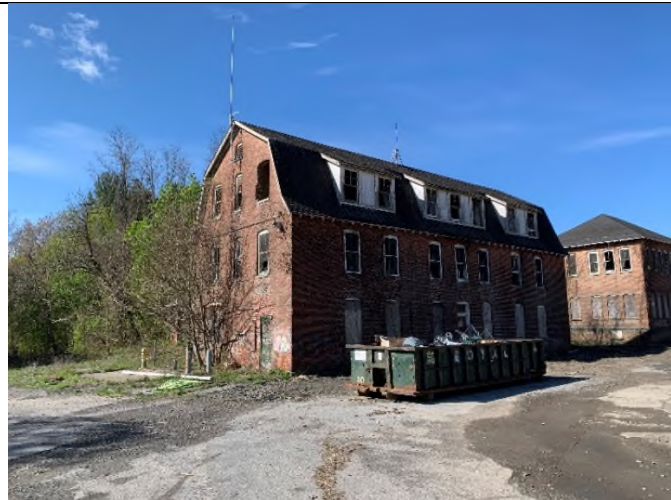
Photo 9 –

Fire House.

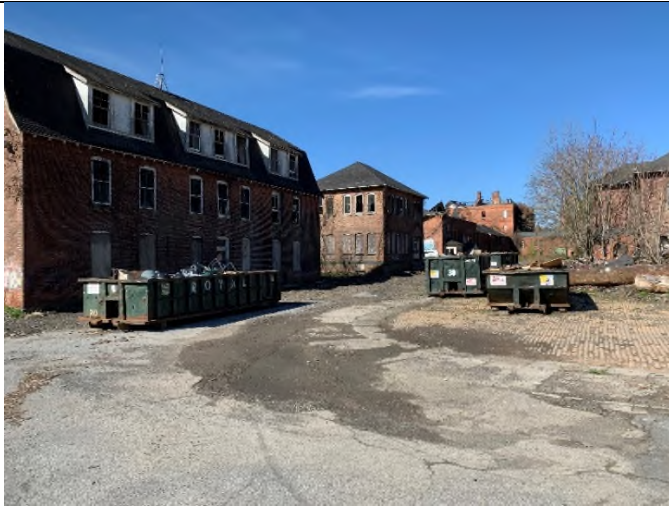
Photo 10 –

Four (4) dumpsters north of the  
Fire House building.

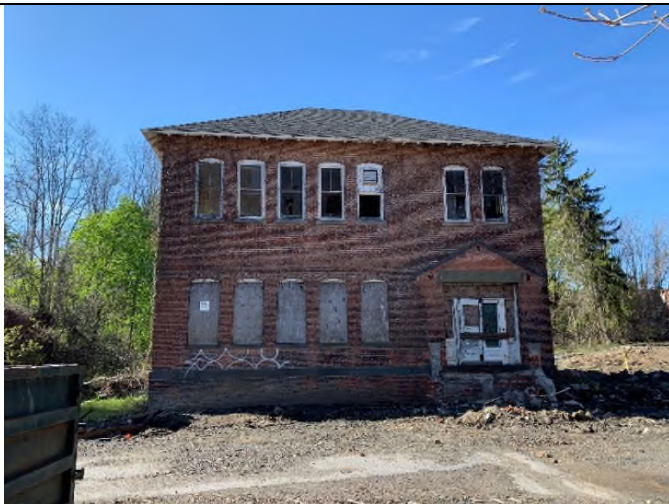
Photo 11 –

Mortuary Building.

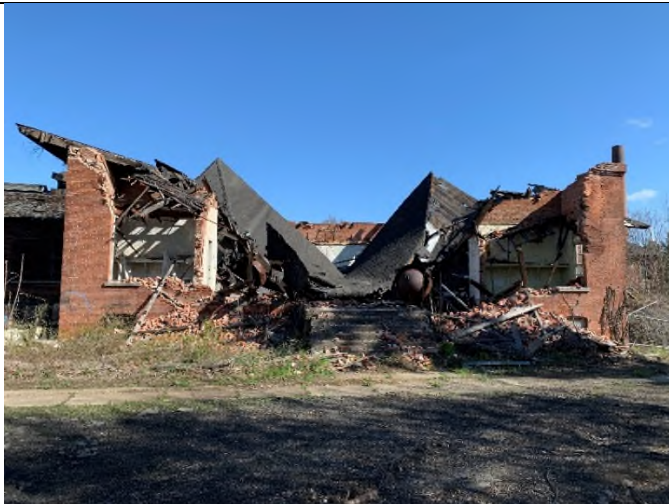
Photo 12 –

Structure west of the Mortuary  
Building, facing north (collapsed).

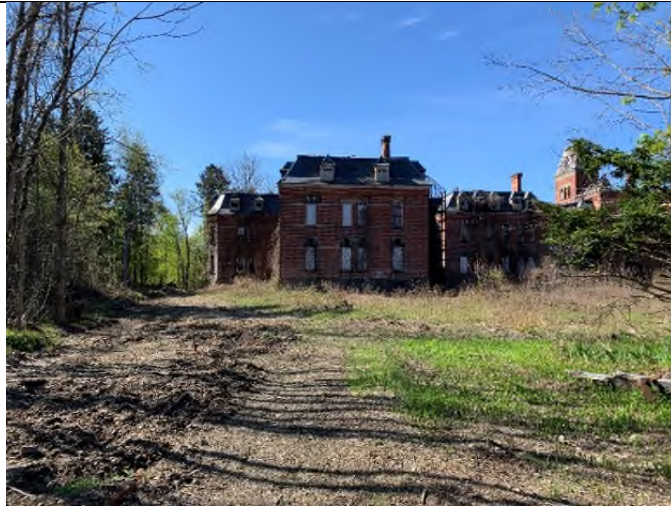
Photo 13 –

Structures in southwest corner of BCP boundary, facing south.

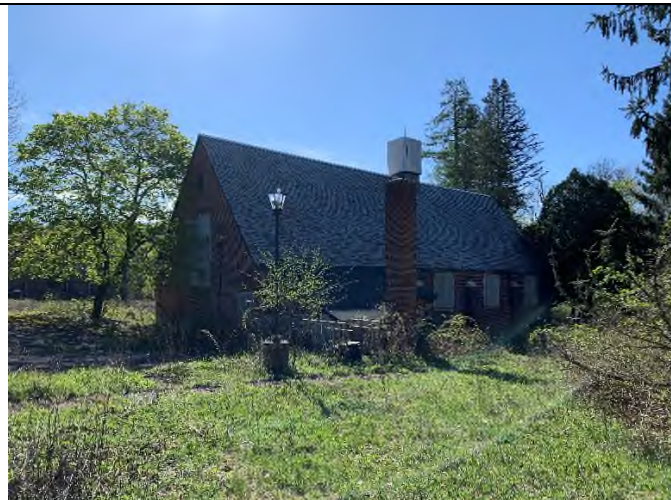
Photo 14 –

Rectory south of the Recreational Hall building.

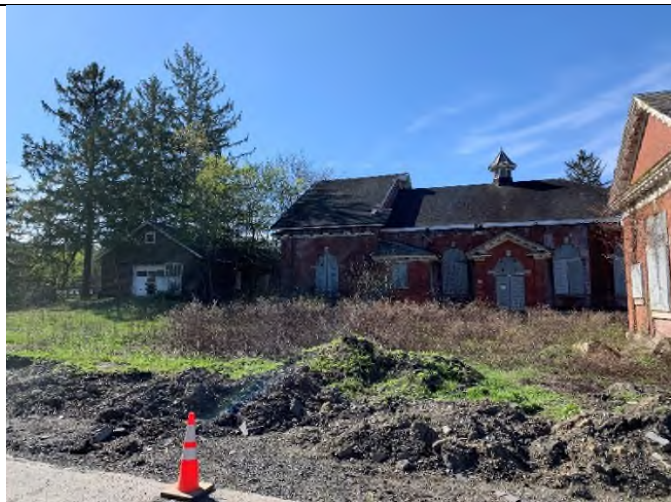
Photo 15 –

Recreational Hall. Backfilled trench observed north of Recreational Hall extending east to west.

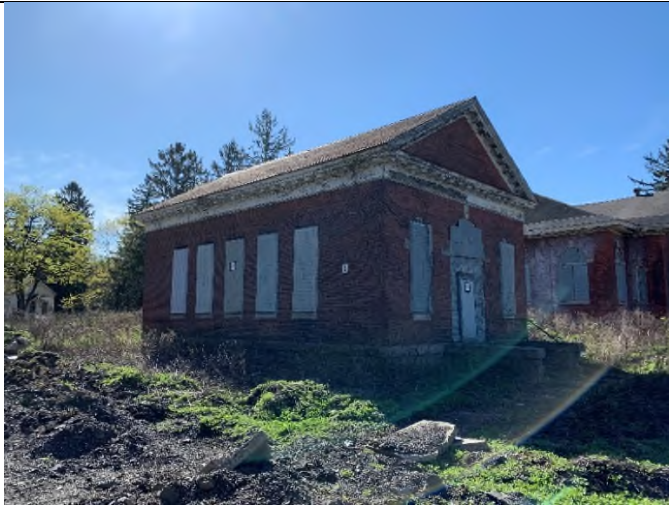
Photo 16 –

Library. Backfilled trench  
observed north of Library,  
extending east to west.

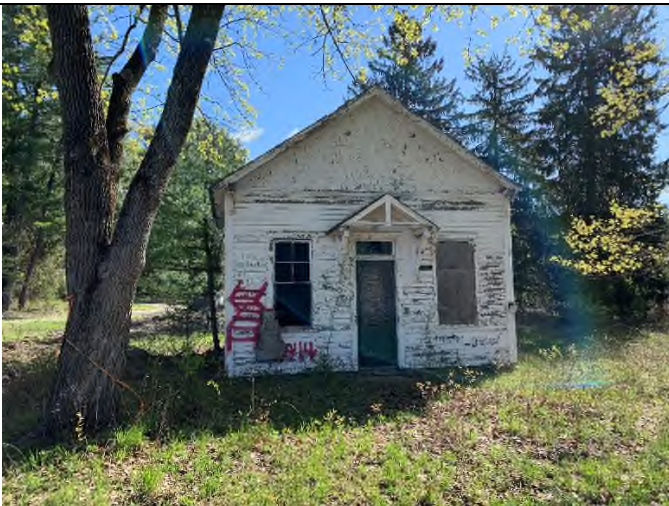
Photo 17 –

Small structure east of the Library.

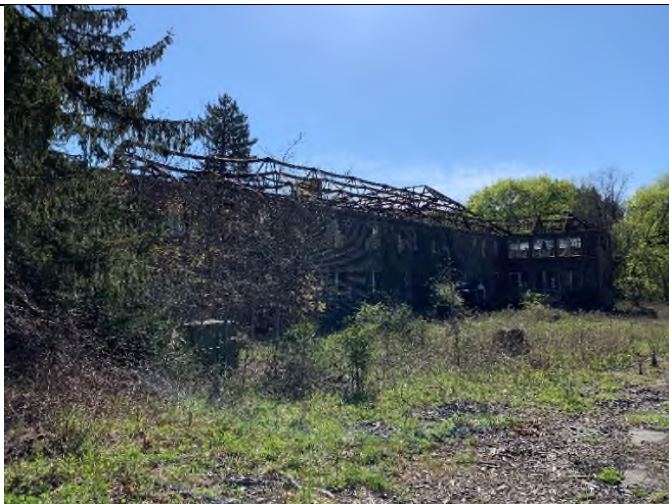
Photo 18 –

Brookside structure, severe  
deterioration of roof.

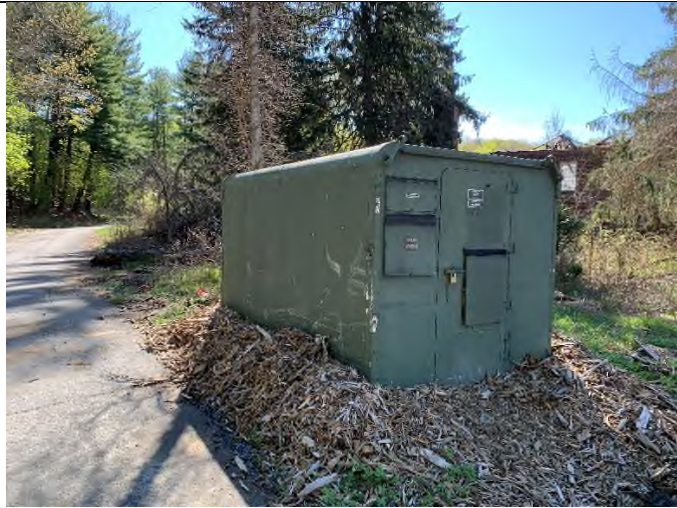
Photo 19 –

Metal container placed over fire hydrant. Base of container is bordered with wood chips.

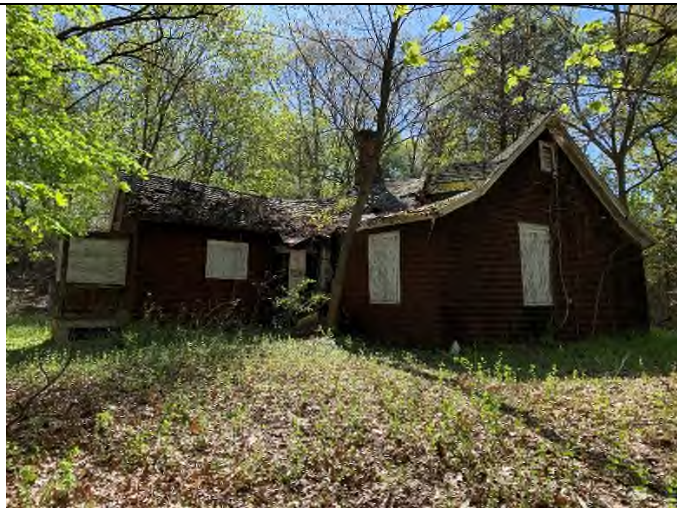
Photo 20 –

Staff House, severe deterioration of roof and interior floor.

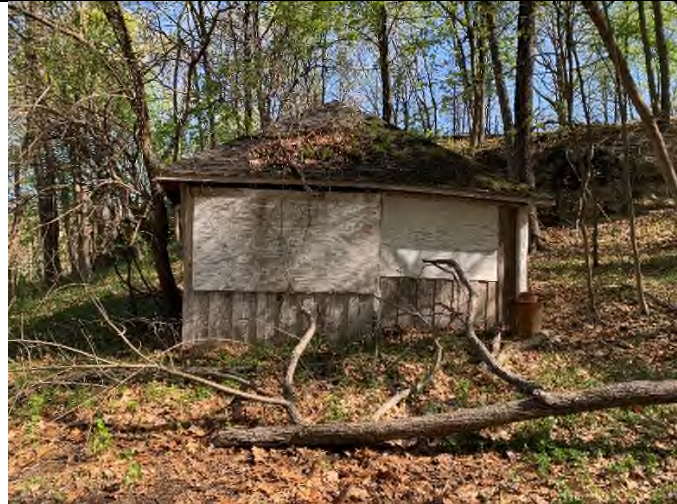
Photo 21 –

Small structure east of the Staff House.
