## MONTHLY STATUS REPORT

BCP No.:	C314121	PVE Project No.:	560909	Date:	5/24/2021
Project Name:	3532 North Road, Dutchess County, Poughkeepsie, New York

Consultant: PVE	Consultant On-Site: Trevor Treglia
General Contractor: Saber Development	General Contractor Contact: Richard DeCola

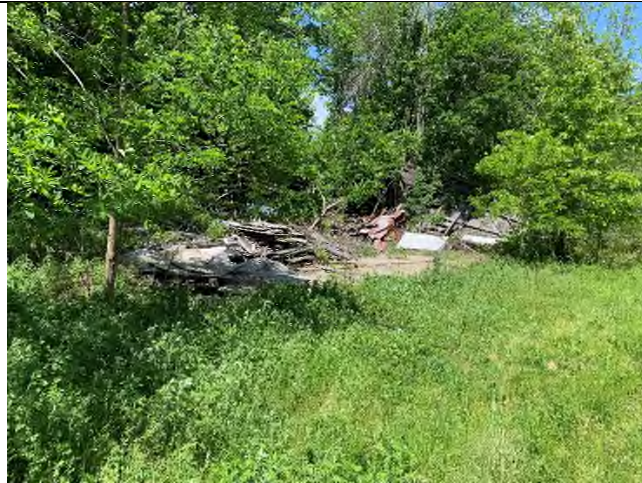
Photo 1 –

Auto Garage East (Collapsed).

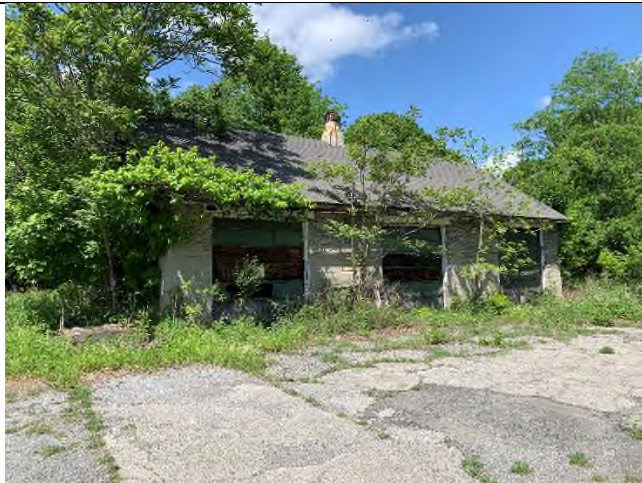
Photo 2 –

Auto Garage West.

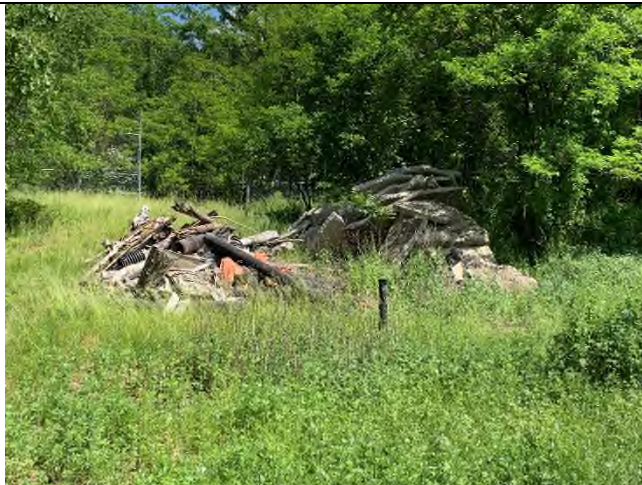
Photo 3 –

Pile of debris located south of  
Auto Garage East.

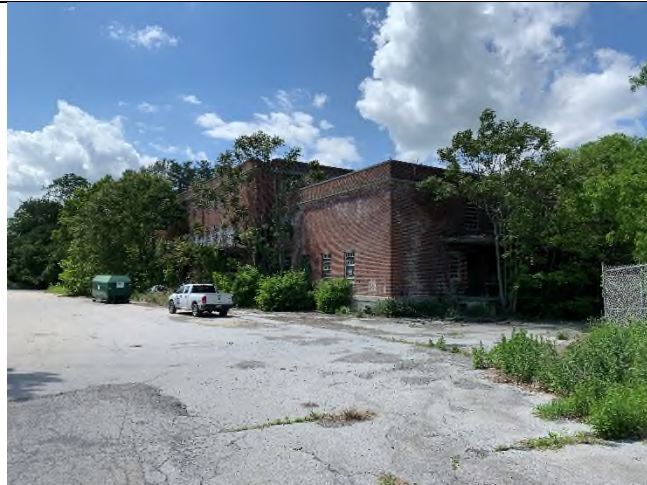
Photo 4 –

Bakery/Storage structure.  
Dumpster located south of  
structure.

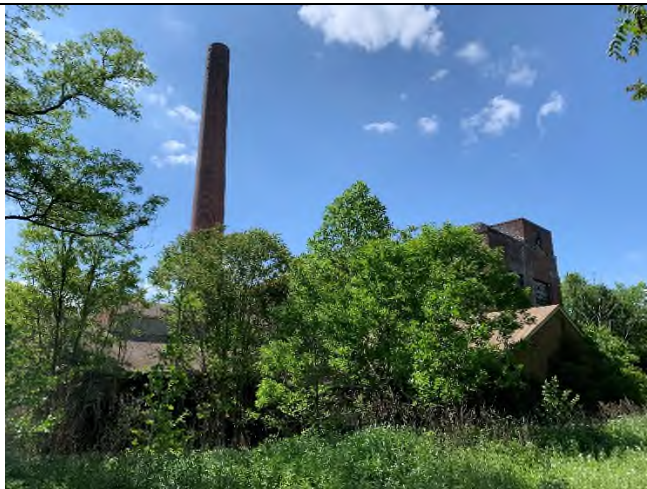
Photo 5 –

Powerhouse.

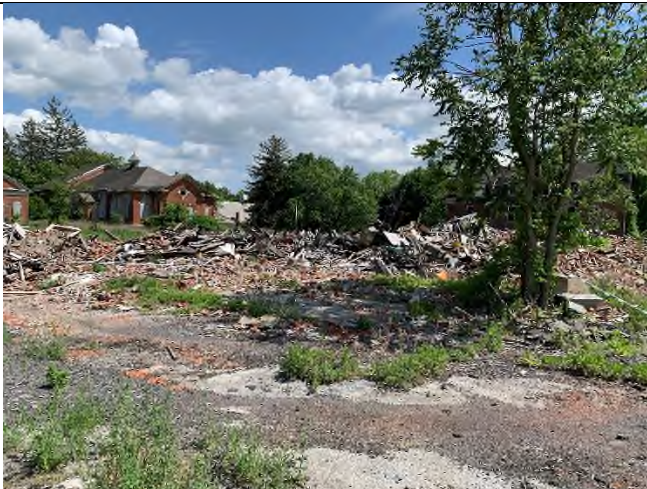
Photo 6 –

Engineer's Office (Demolished).

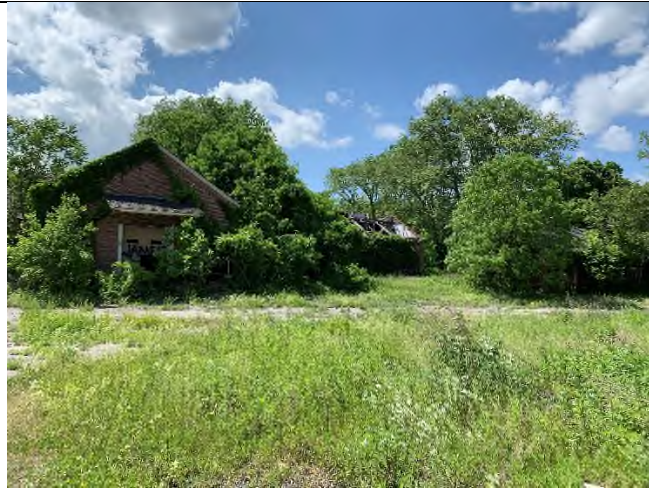
Photo 7 –

Carwash (pictured left) with shed (pictured right).

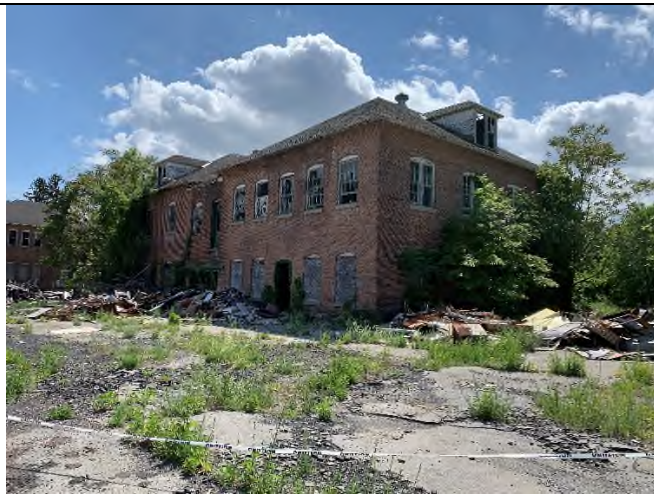
Photo 8 –

Maintenance Building with debris located east side of structure.

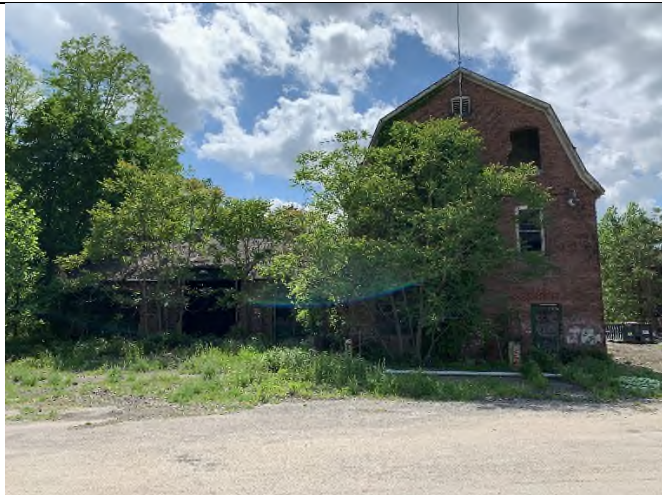
Photo 9 –

Fire House.

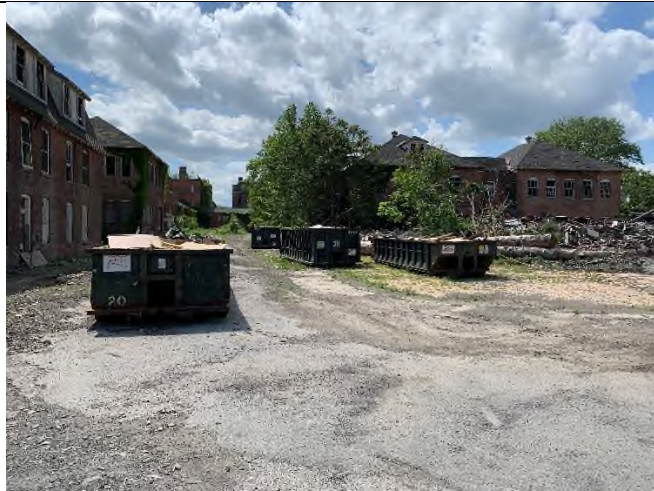
Photo 10 –

Four (4) dumpsters north of the  
Fire House building.

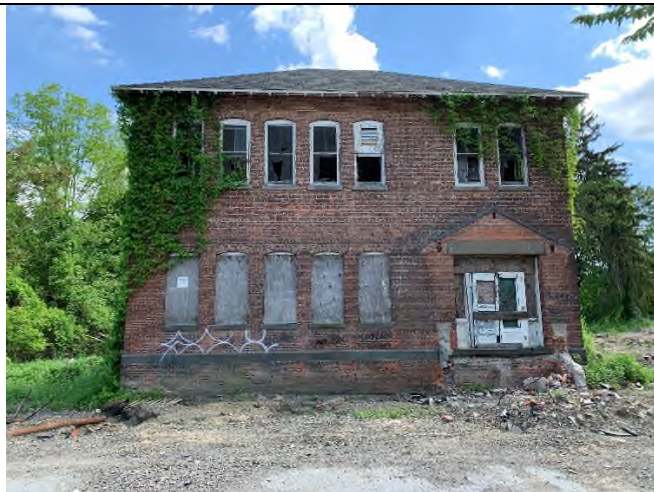
Photo 11 –

Mortuary Building.

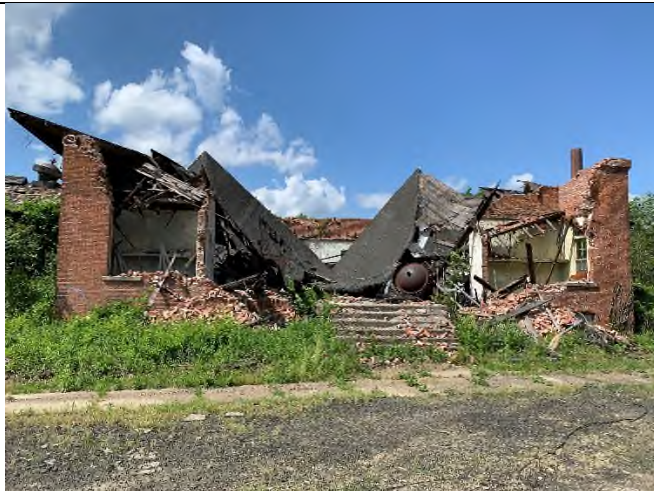
Photo 12 –

Structure west of the Mortuary  
Building, facing north (collapsed).

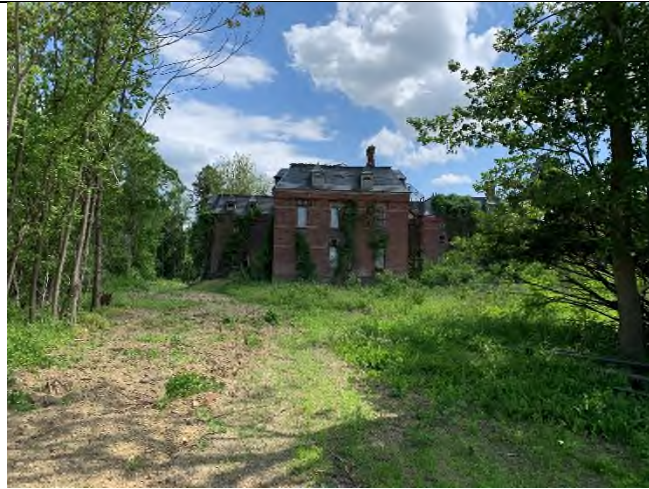
Photo 13 –

Structures in southwest corner of BCP boundary, facing south.

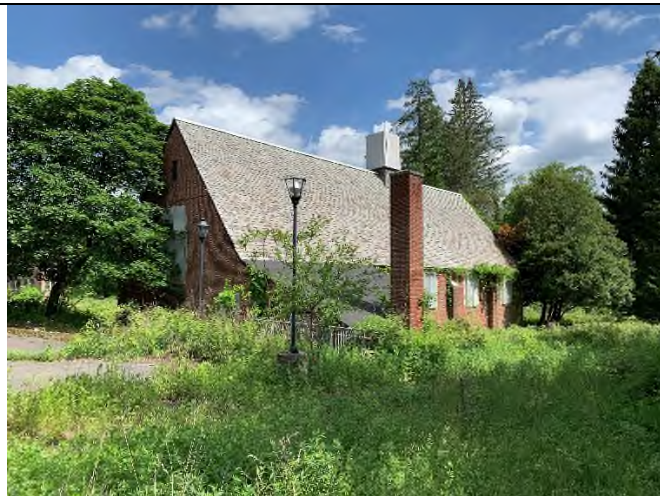
Photo 14 –

Rectory south of the Recreational Hall building.

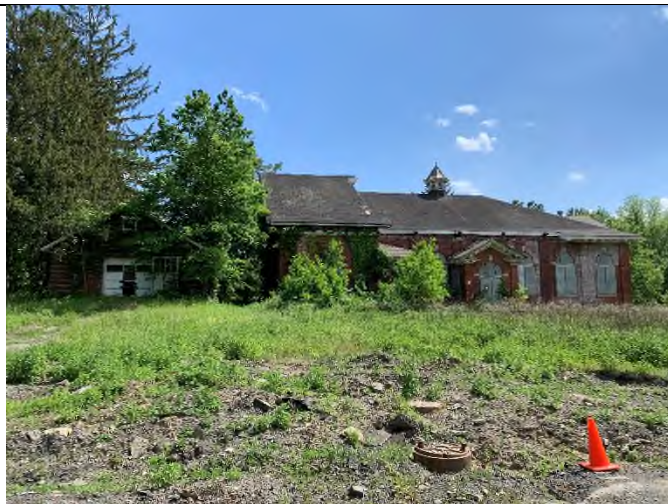
Photo 15 –

Recreational Hall. Backfilled trench observed north of Recreational Hall extending east to west.

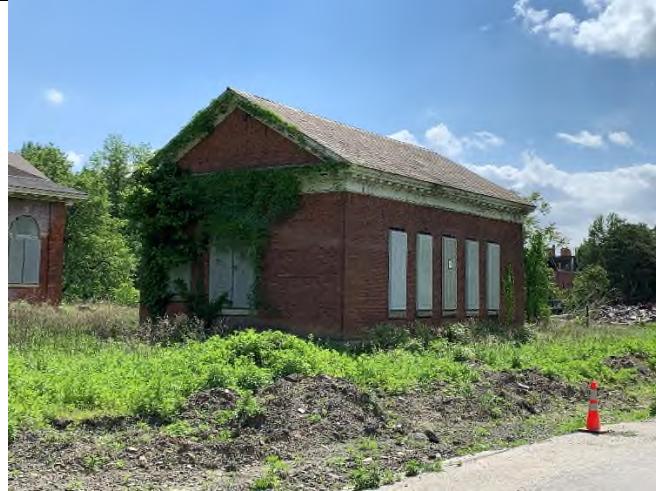
Photo 16 –

Library. Backfilled trench  
observed north of Library,  
extending east to west.

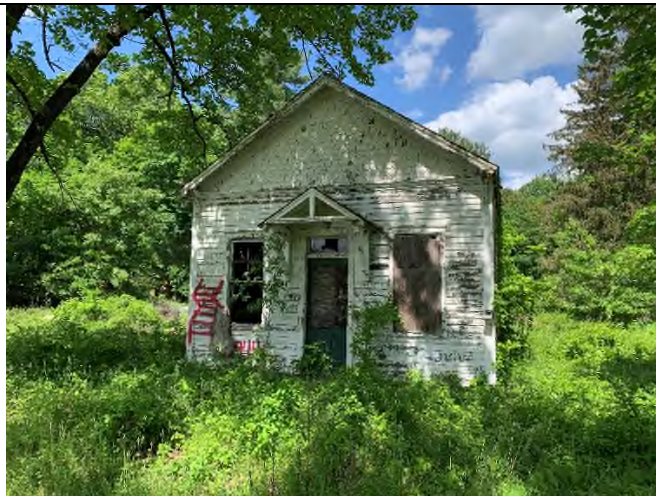
Photo 17 –

Small structure east of the Library.

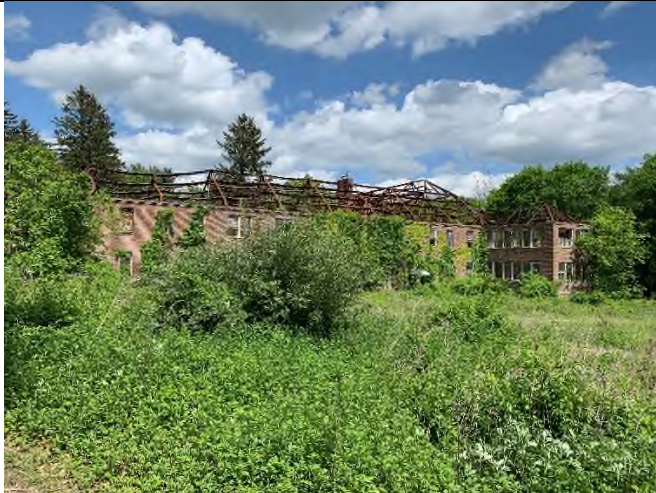
Photo 18 –

Brookside structure, severe  
deterioration of roof.

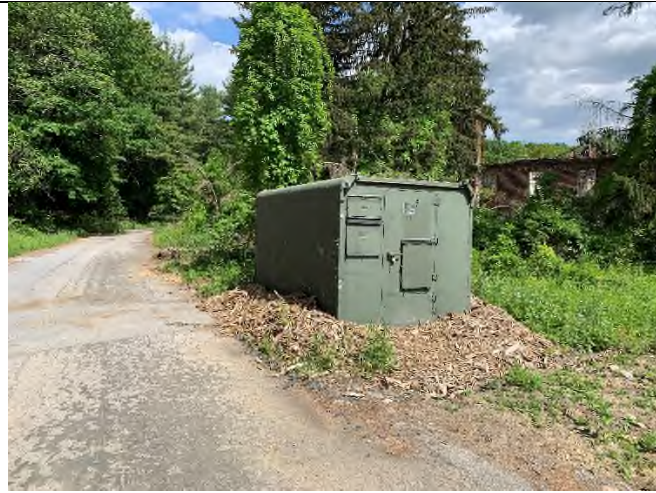
Photo 19 –

Metal container placed over fire hydrant. Base of container is bordered with wood chips.

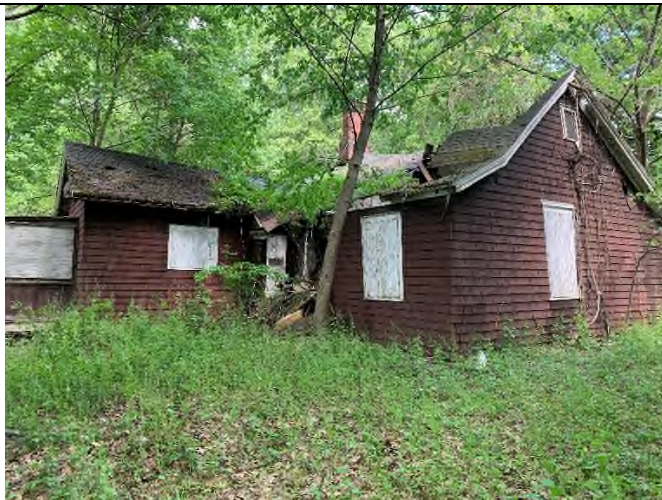
Photo 20 –

Staff House, severe deterioration of roof and interior floor.

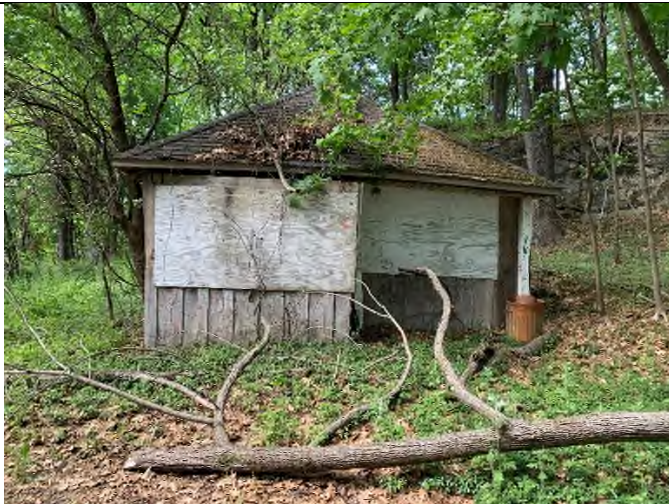
Photo 21 –

Small structure east of the Staff House.
