## MONTHLY STATUS REPORT

| BCP No.: | C314121 | PVE Project No.: | 560909 | Date: | 6/24/2021 |
| Project Name: | 3532 North Road, Dutchess County, Poughkeepsie, New York | | | | |

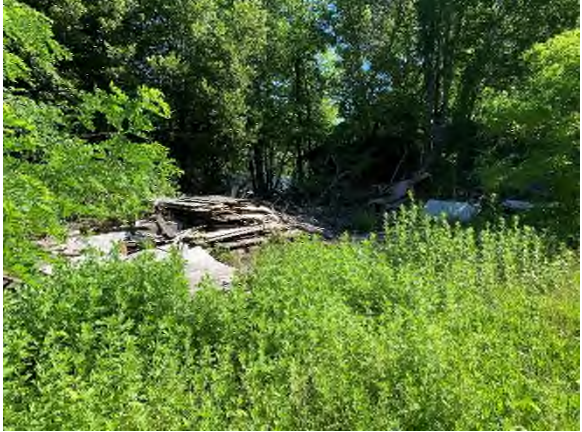
| <p>Photo 1 –<br/>Auto Garage East (Collapsed).</p> | A photograph showing a collapsed structure, likely an auto garage, surrounded by dense green vegetation and trees. The debris is visible through the foliage. |

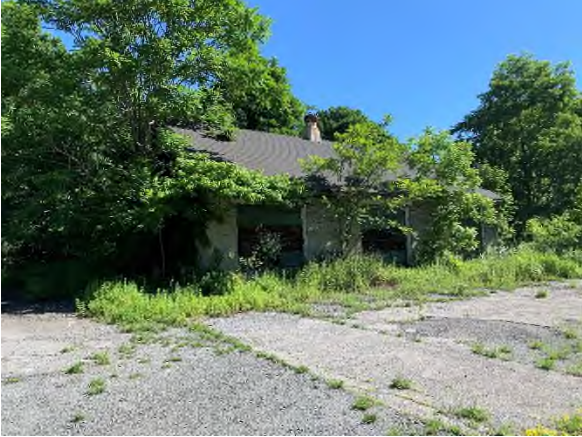
| <p>Photo 2 –<br/>Auto Garage West.</p> | A photograph of a single-story building, identified as the Auto Garage West, with a dark roof and light-colored walls. The building is partially obscured by trees and is situated on a gravel lot. |

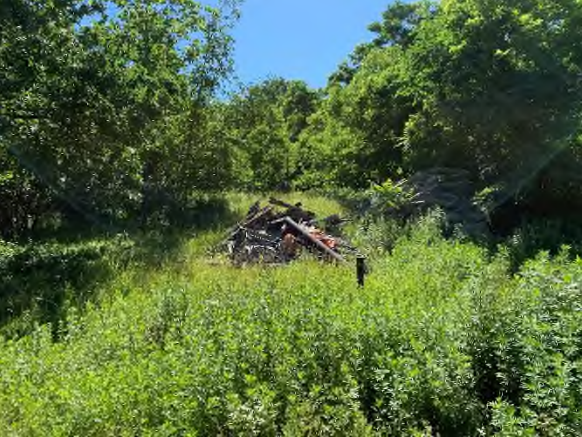
| <p>Photo 3 –<br/>Pile of debris located south of<br/>Auto Garage East.</p> | A photograph showing a pile of debris, including what appears to be a collapsed vehicle or structure, located in a grassy area south of the Auto Garage East. The debris is partially obscured by tall grass and trees. |

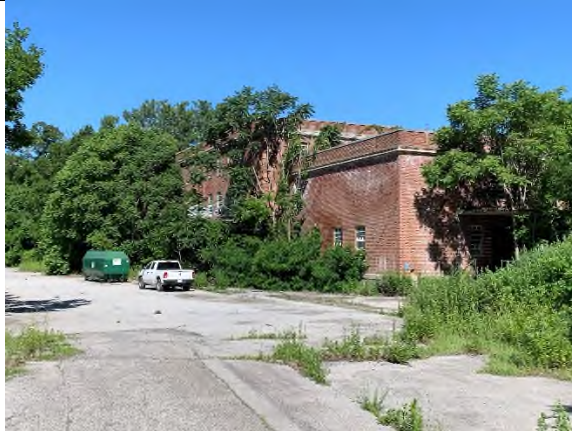
Photo 4 –

Bakery/Storage structure.  
Dumpster located south of  
structure.

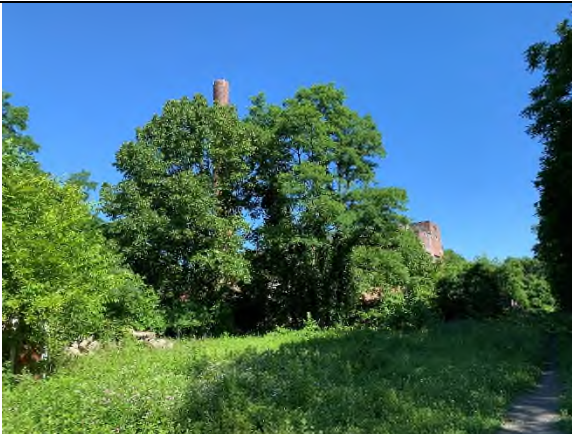
Photo 5 –

Powerhouse.

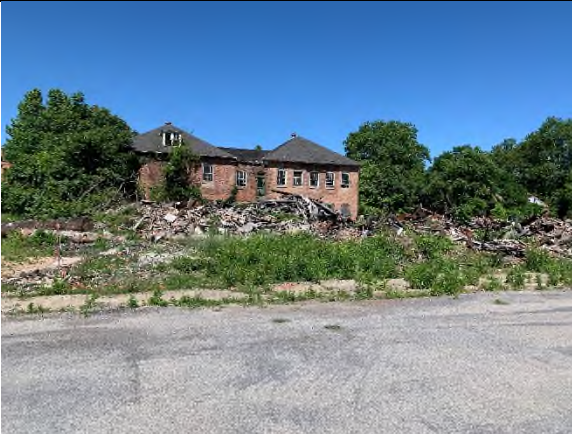
Photo 6 –

Engineer's Office (Demolished).

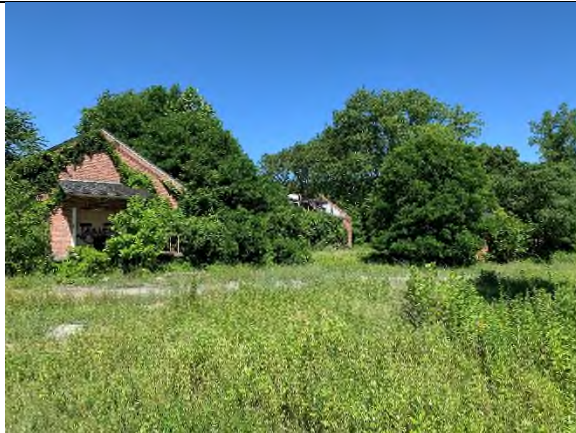
Photo 7 –

Carwash (pictured left) with shed (pictured right).

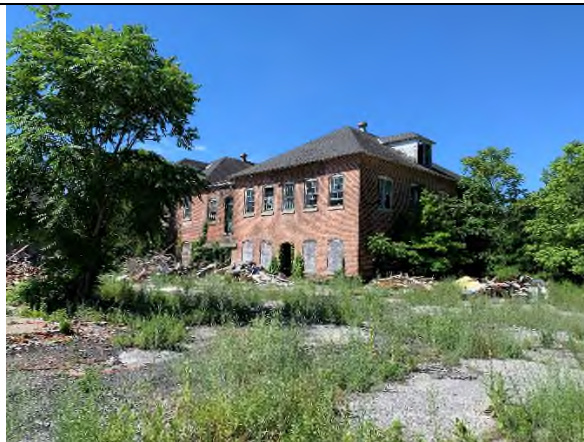
Photo 8 –

Maintenance Building with debris located east side of structure.

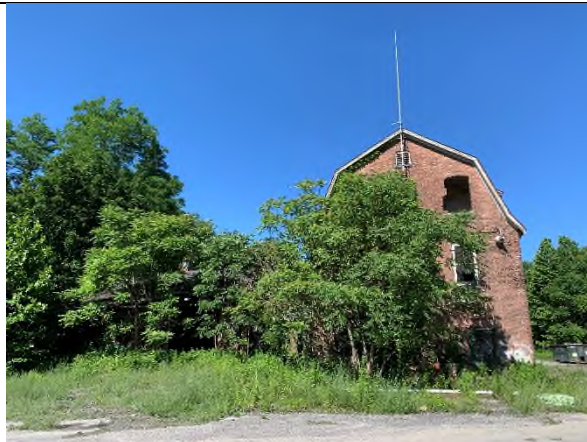
Photo 9 –

Fire House.

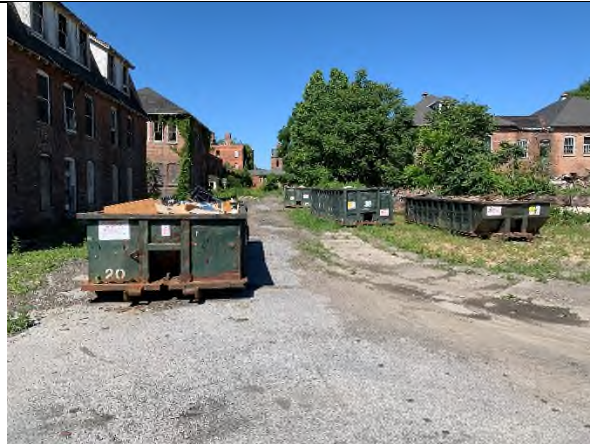
Photo 10 –

Four (4) dumpsters north of the  
Fire House building.

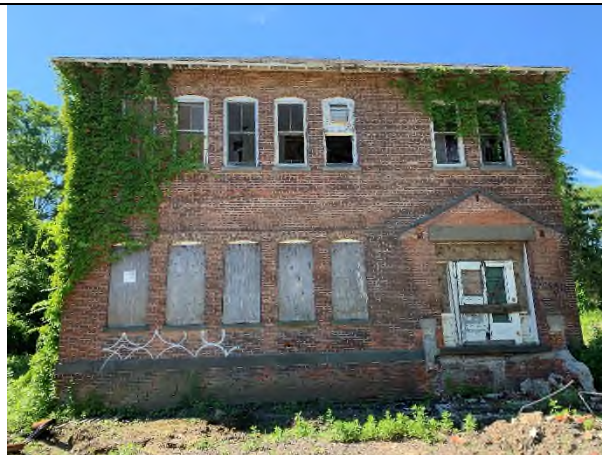
Photo 11 –

Mortuary Building.

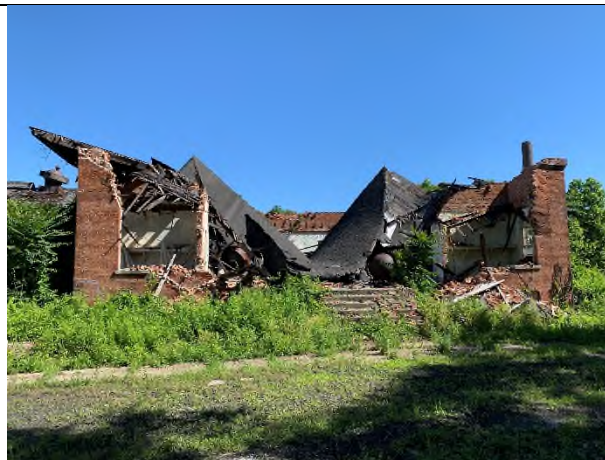
Photo 12 –

Structure west of the Mortuary  
Building, facing north (collapsed).

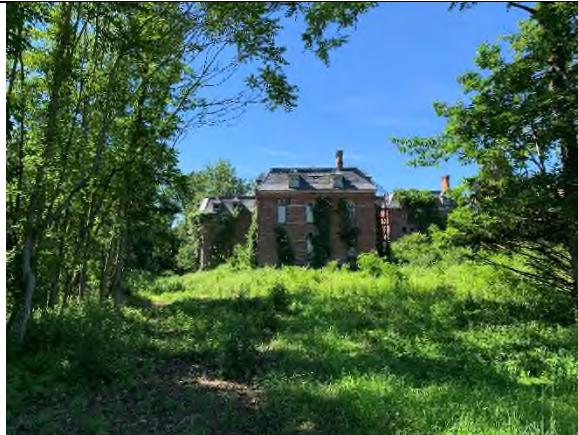
Photo 13 –

Structures in southwest corner of BCP boundary, facing south.

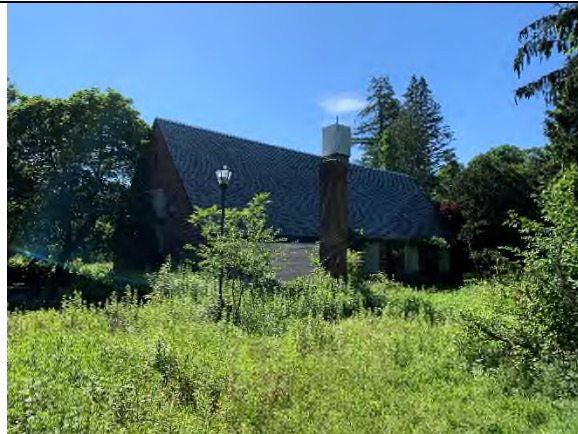
Photo 14 –

Rectory south of the Recreational Hall building.

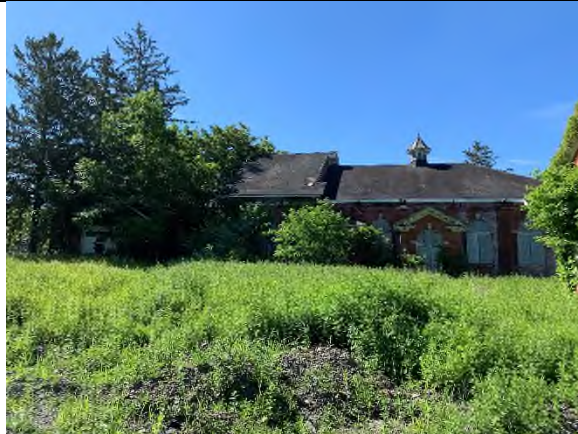
Photo 15 –

Recreational Hall. Backfilled trench observed north of Recreational Hall extending east to west.

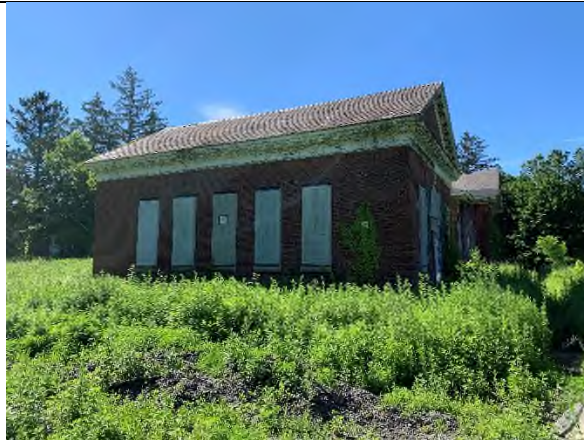
Photo 16 –

Library. Backfilled trench  
observed north of Library,  
extending east to west.

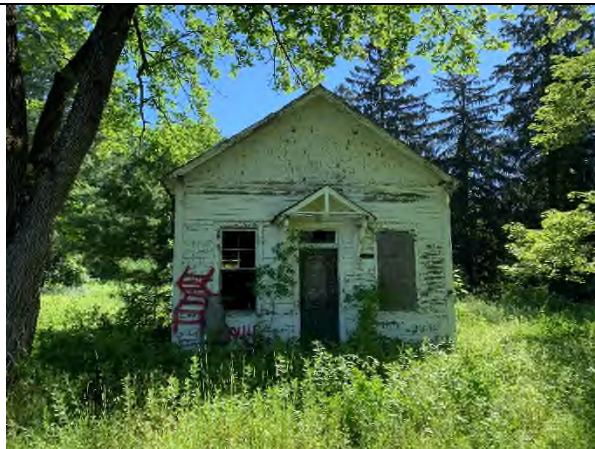
Photo 17 –

Small structure east of the Library.

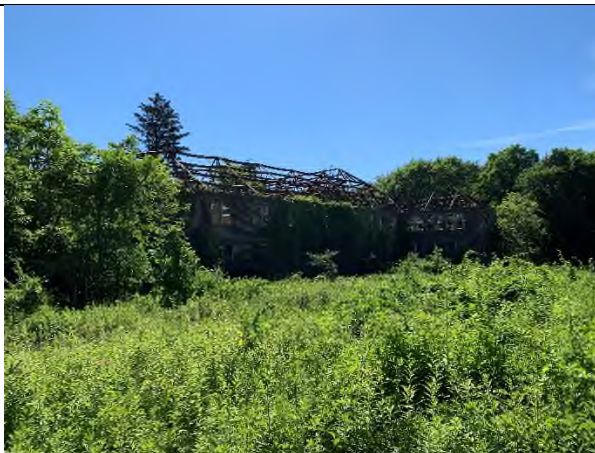
Photo 18 –

Brookside structure, severe  
deterioration of roof.

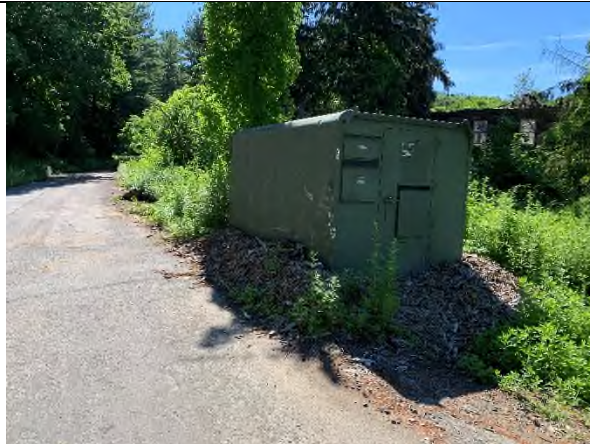
Photo 19 –

Metal container placed over fire hydrant. Base of container is bordered with wood chips.

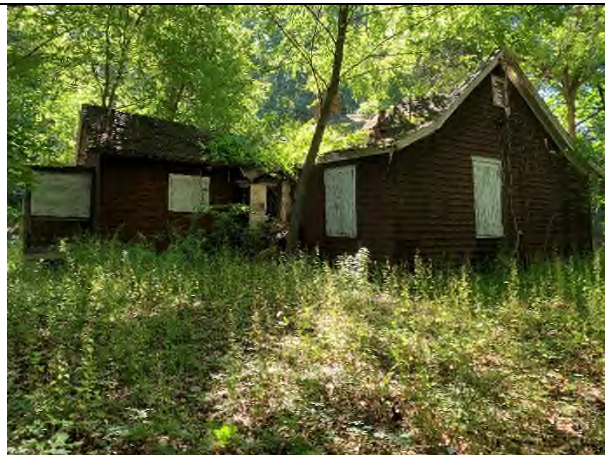
Photo 20 –

Staff House, severe deterioration of roof and interior floor.

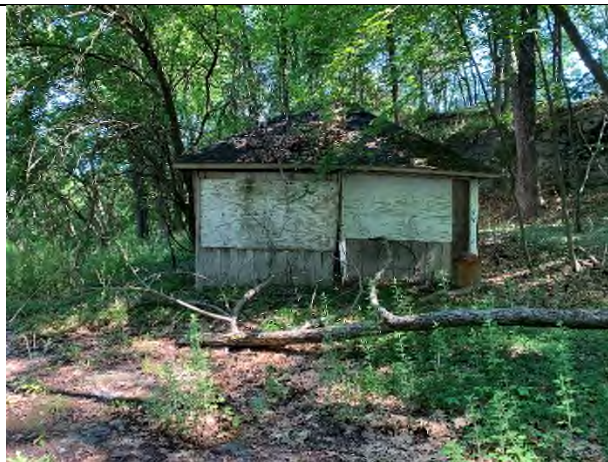
Photo 21 –

Small structure east of the Staff House.
