## MONTHLY STATUS REPORT

| BCP No.: | C314121 | PVE Project No.: | 560909 | Date: | 8/24/2021 |
| Project Name: | 3532 North Road, Dutchess County, Poughkeepsie, New York | | | | |

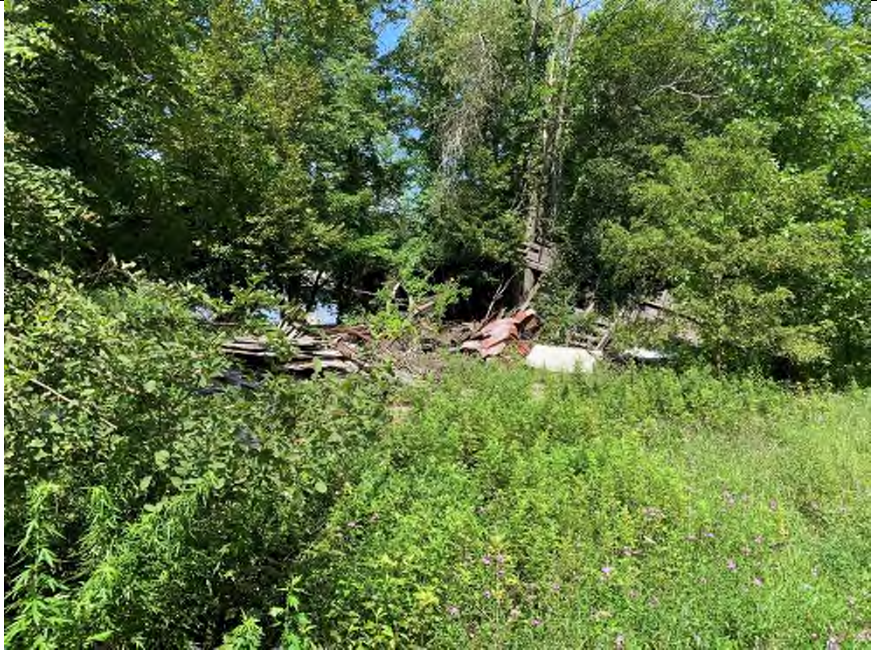
Photo 1 –  
Auto Garage East (Collapsed).

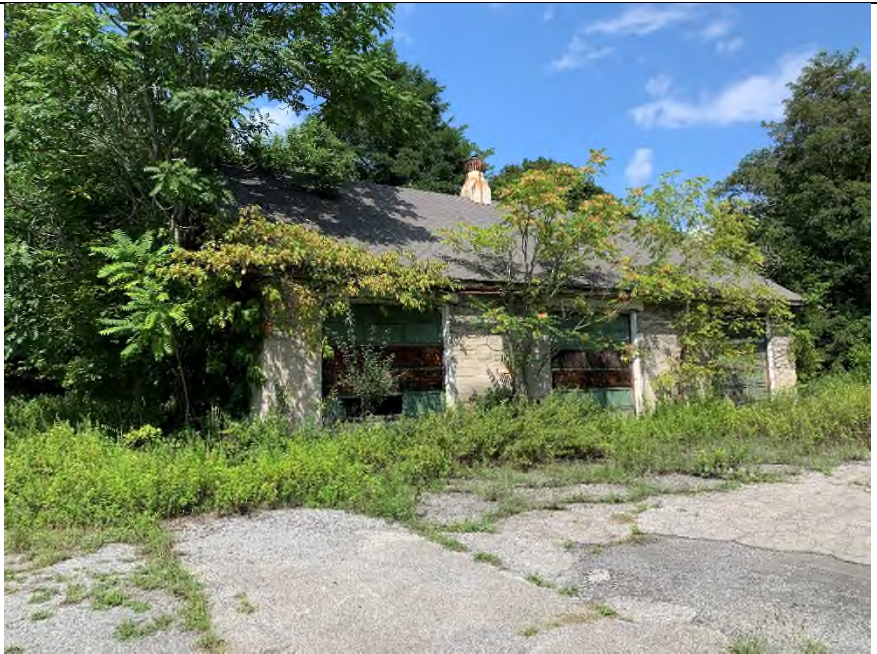
Photo 2 –  
Auto Garage West.

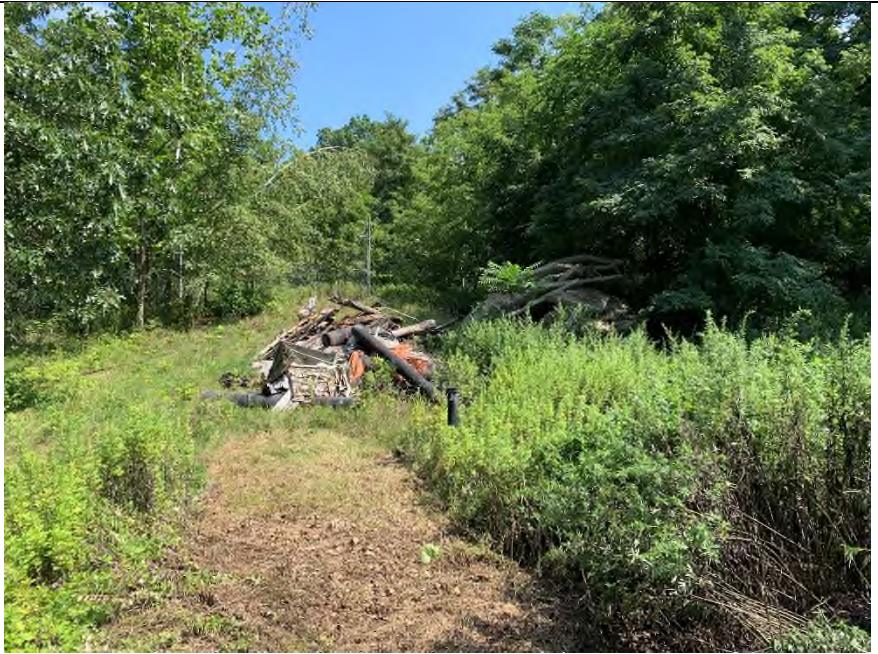
Photo 3 –

Pile of debris located south of Auto Garage East.

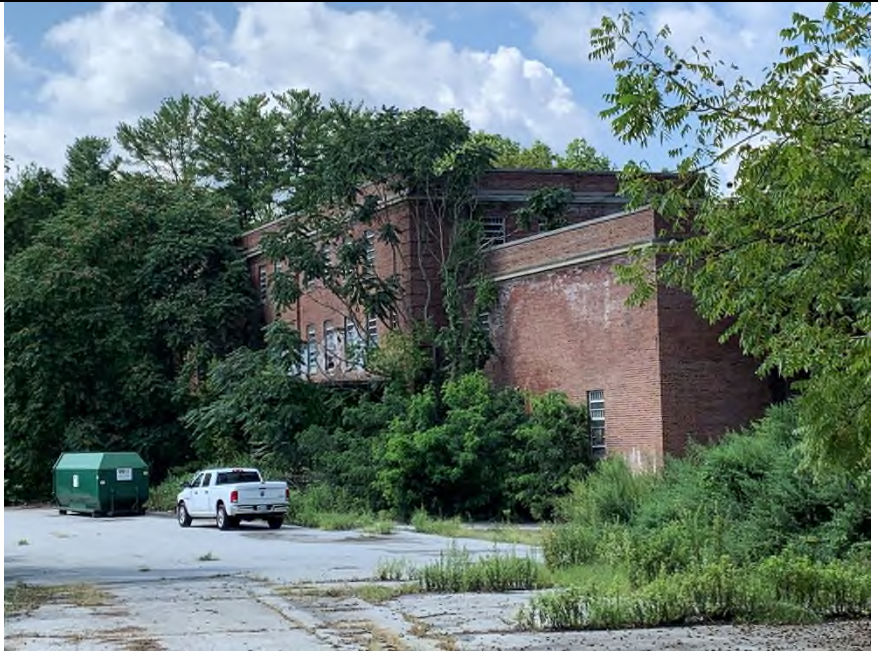
Photo 4 –

Bakery/Storage structure.  
Dumpster located south of structure.

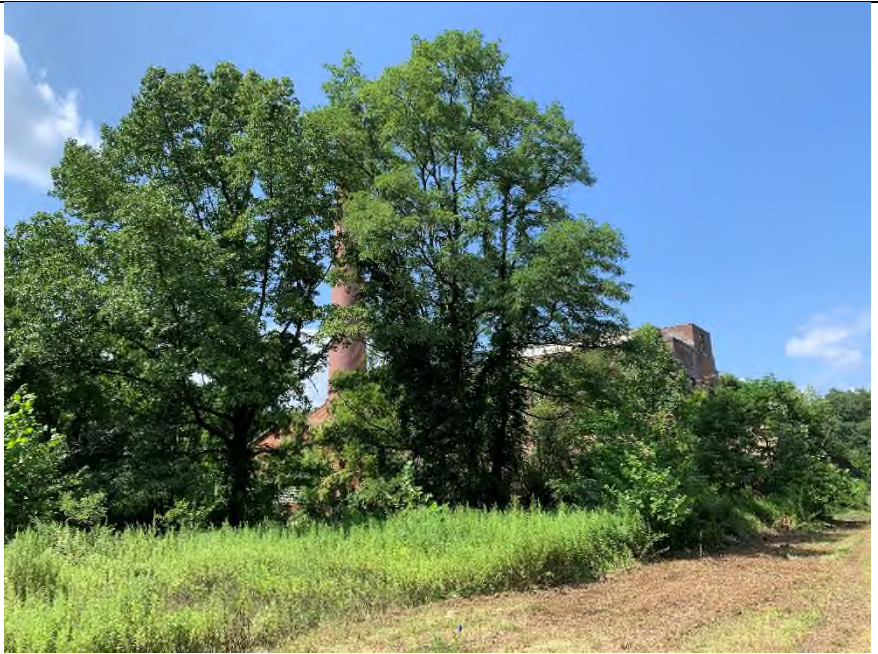
Photo 5 –

Powerhouse.

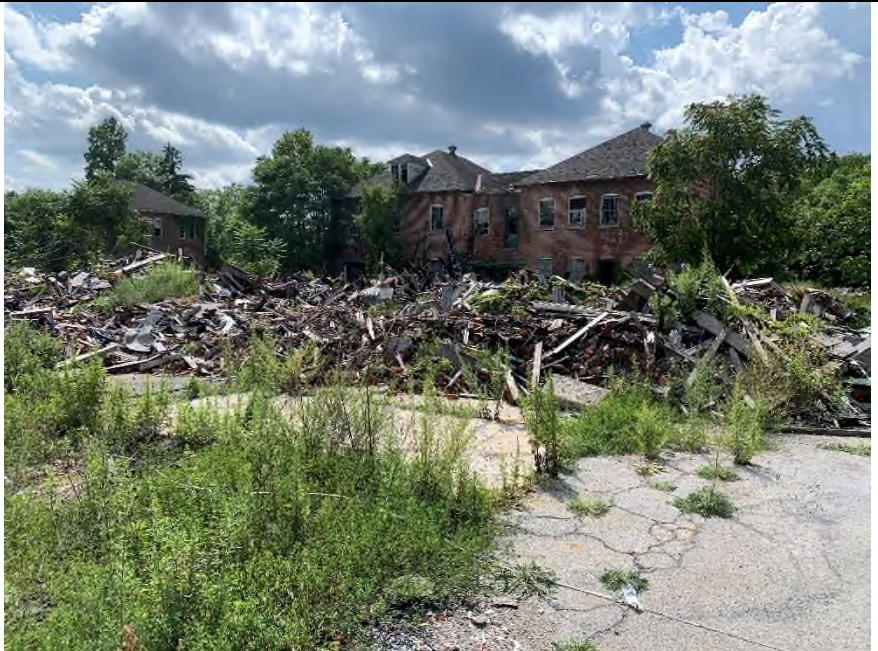
Photo 6 –

Engineer's Office (Demolished).

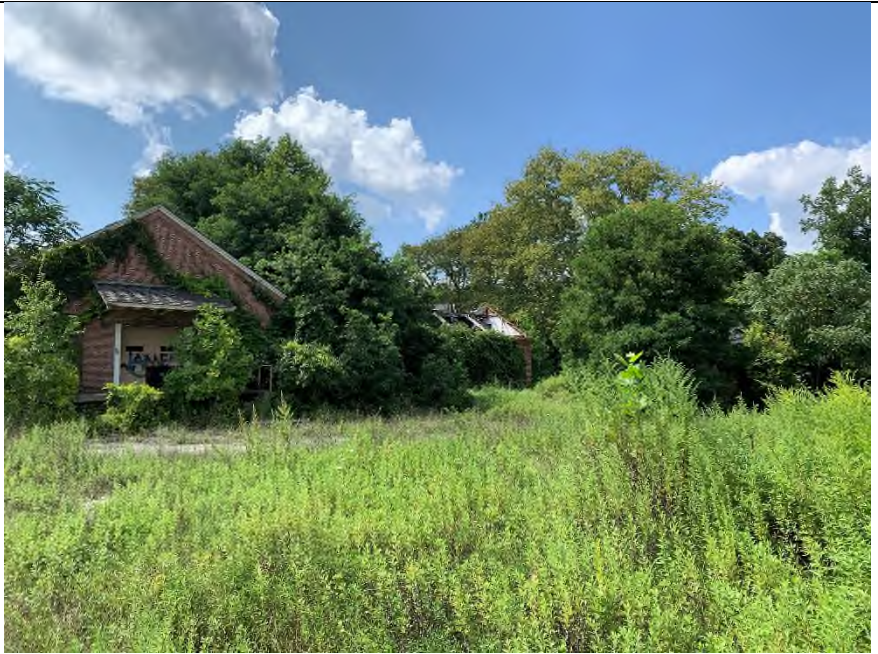
Photo 7 –

Carwash (pictured left) with shed (pictured right).

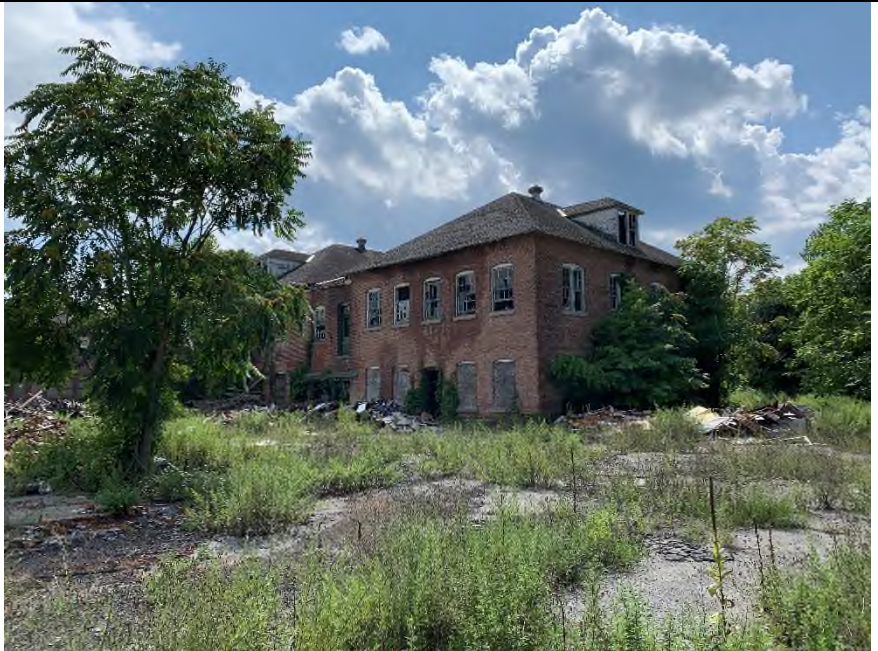
Photo 8 –

Maintenance Building with debris located east side of structure.

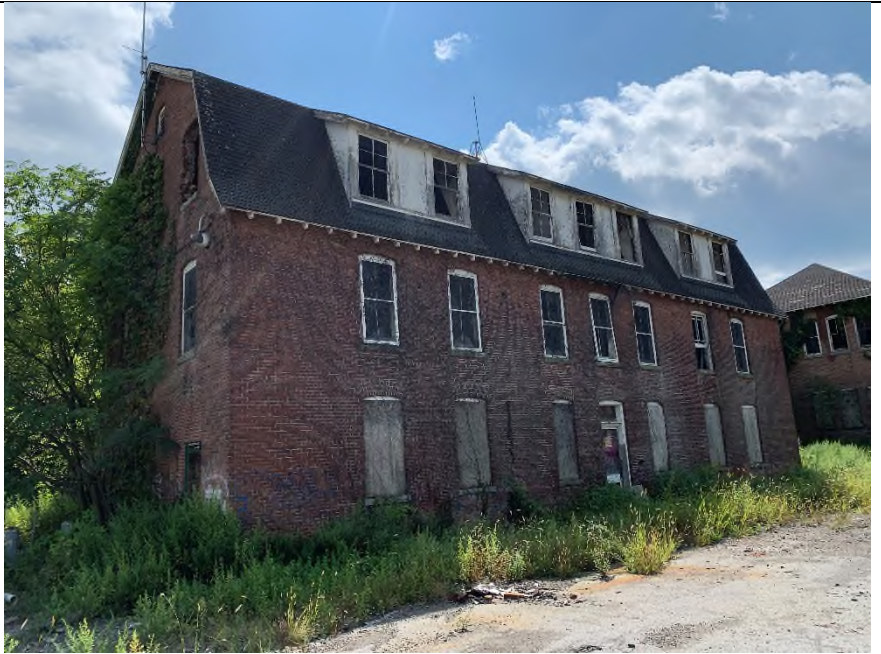
Photo 9 –

Fire House.

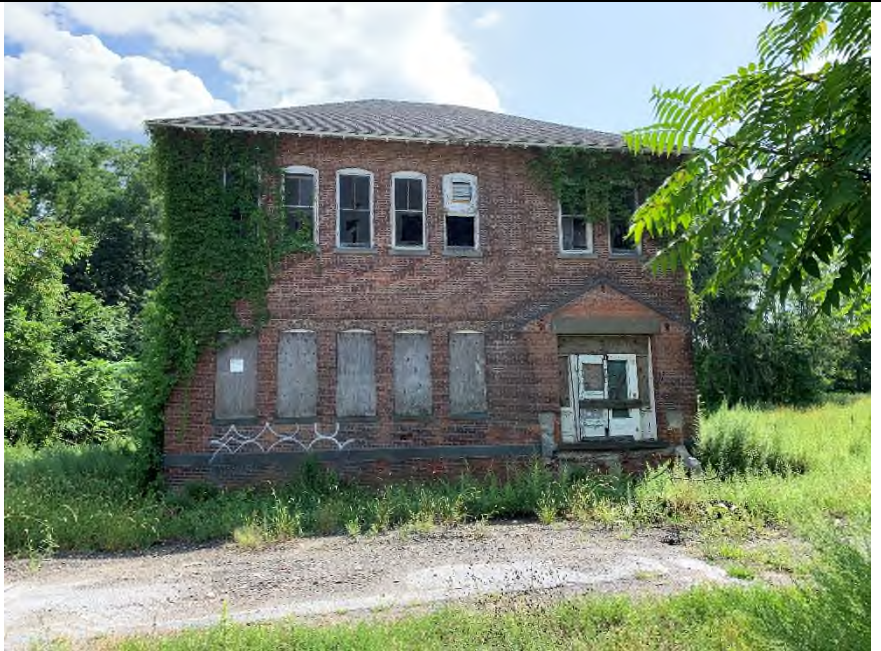
Photo 10 –

Mortuary Building.

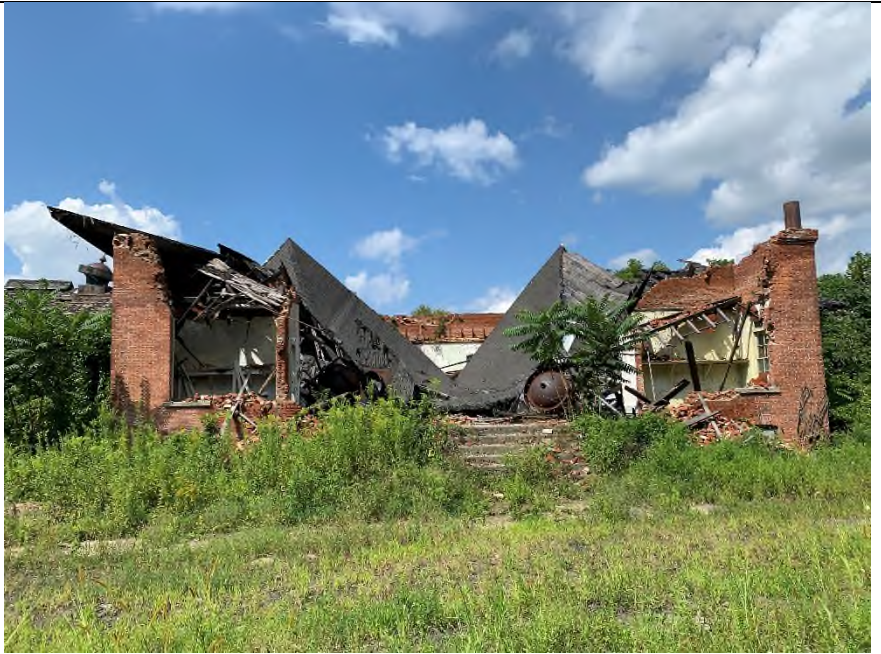
Photo 11 –

Structure west of the Mortuary Building, facing north (collapsed).

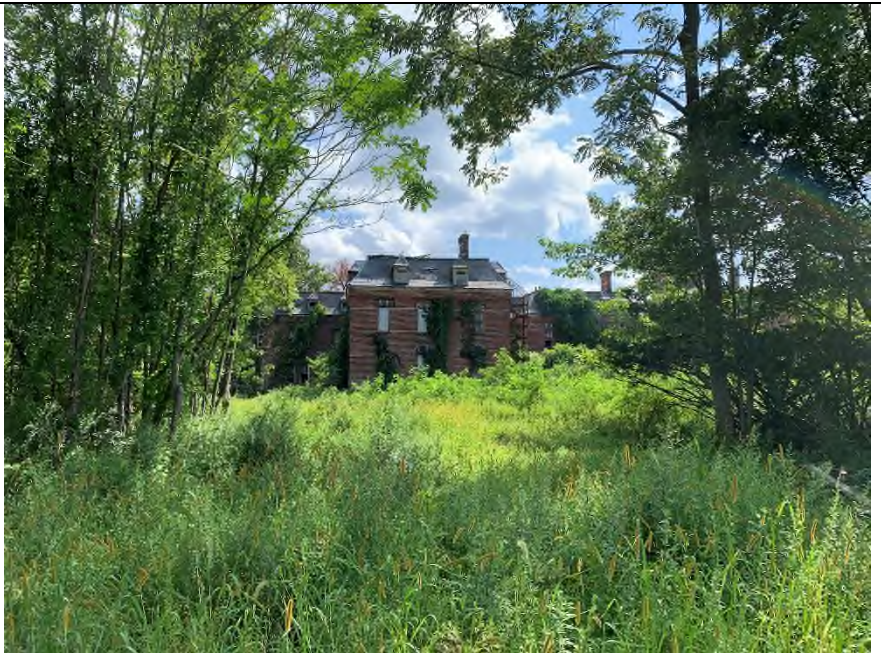
Photo 12 –

Structures in southwest corner of BCP boundary, facing south.

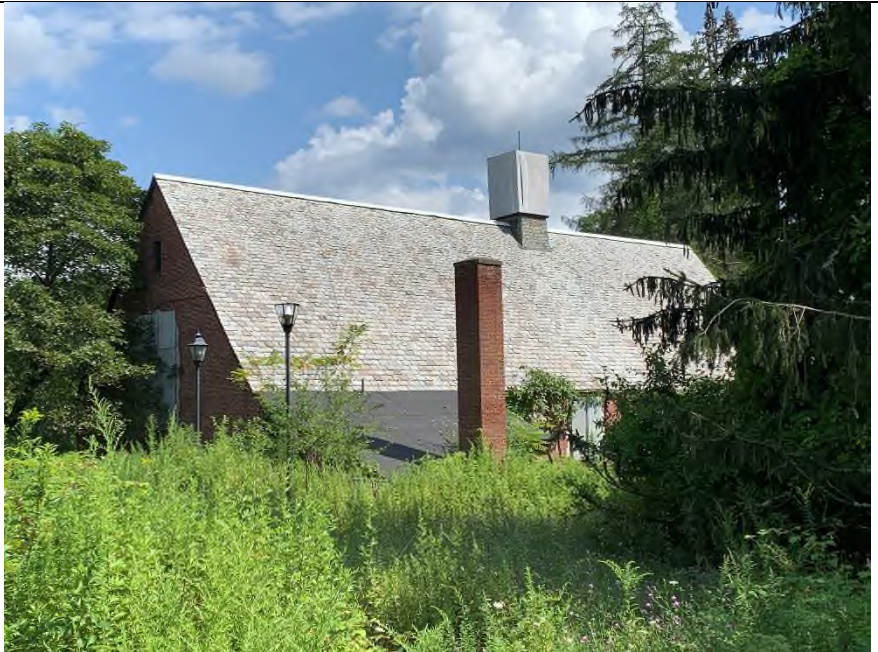
Photo 13 –

Rectory south of the Recreational Hall building.

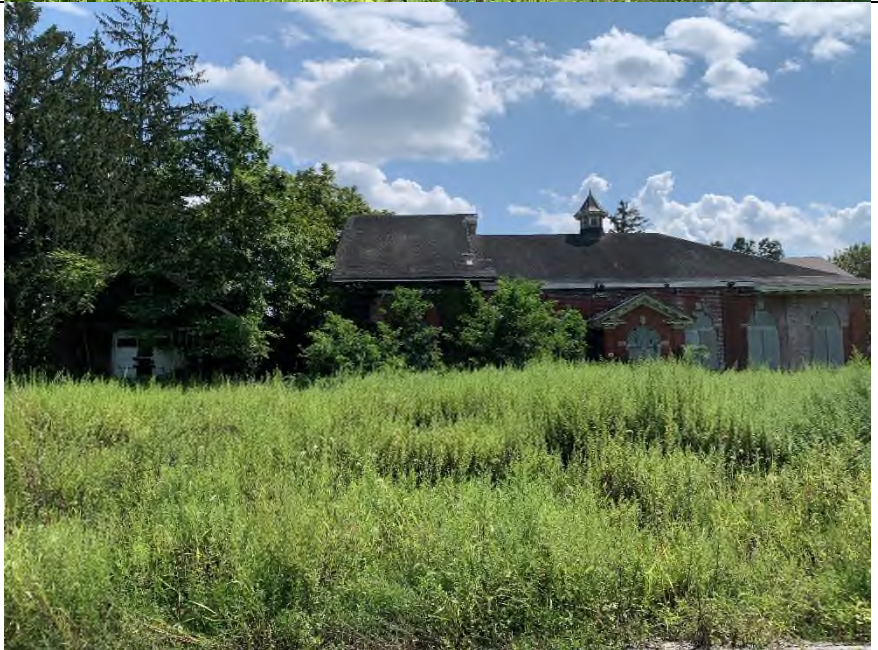
Photo 14 –

Recreational Hall. Backfilled trench observed north of Recreational Hall extending east to west.

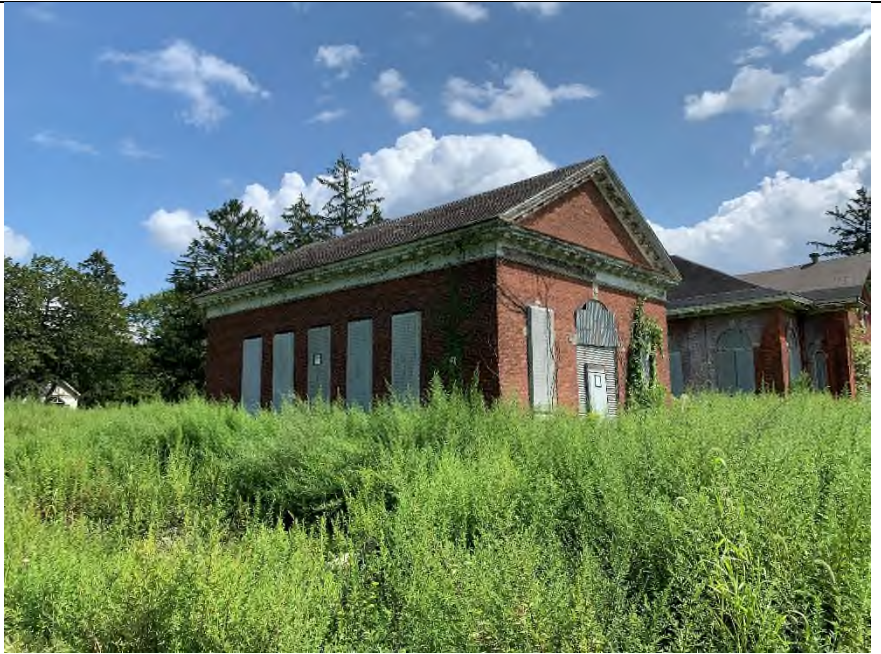
Photo 15 –

Library. Backfilled trench  
observed north of Library,  
extending east to west.

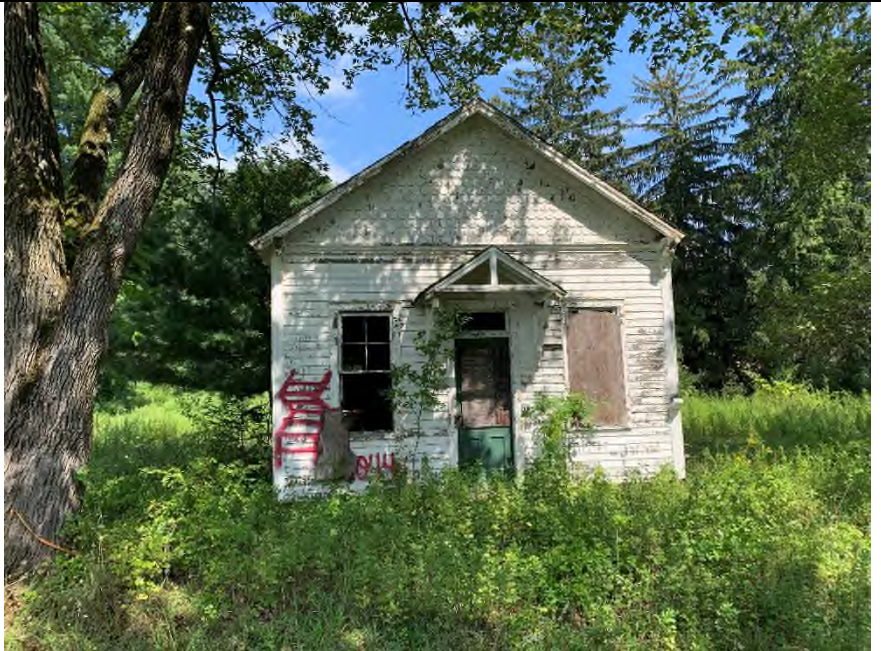
Photo 16 –

Small structure east of the Library.

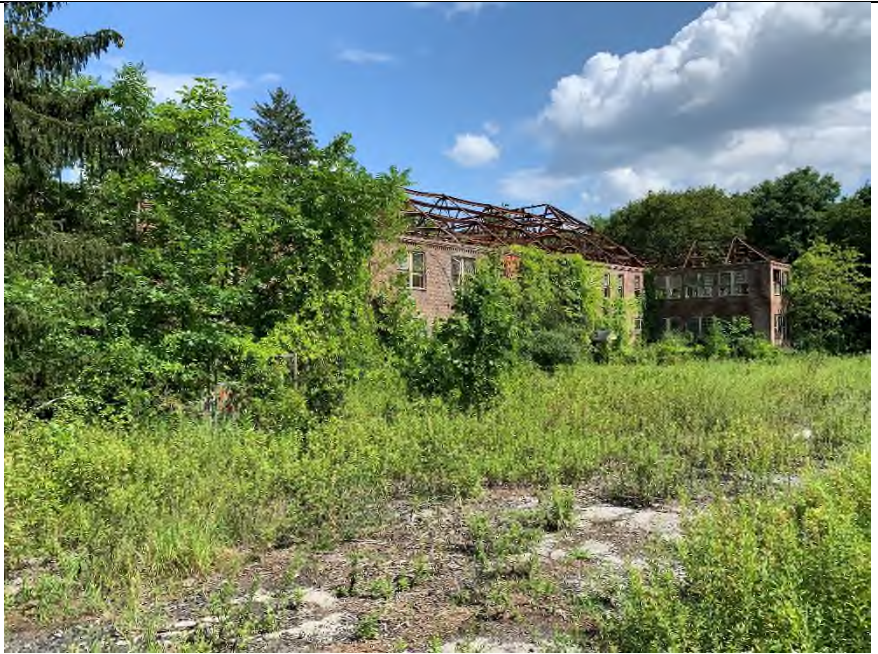
Photo 17 –

Brookside structure, severe deterioration of roof.

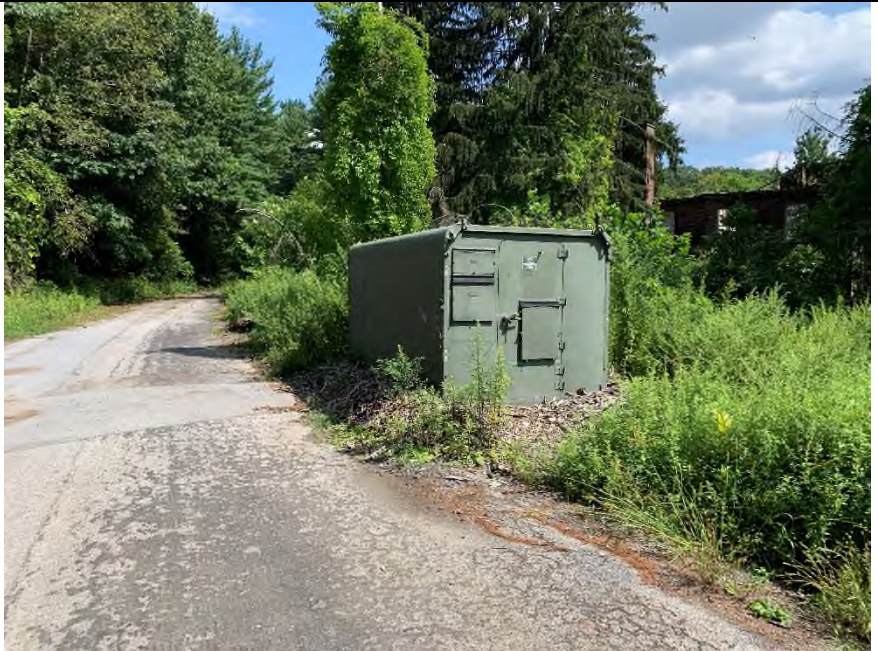
Photo 18 –

Metal container placed over fire hydrant. Base of container is bordered with wood chips.

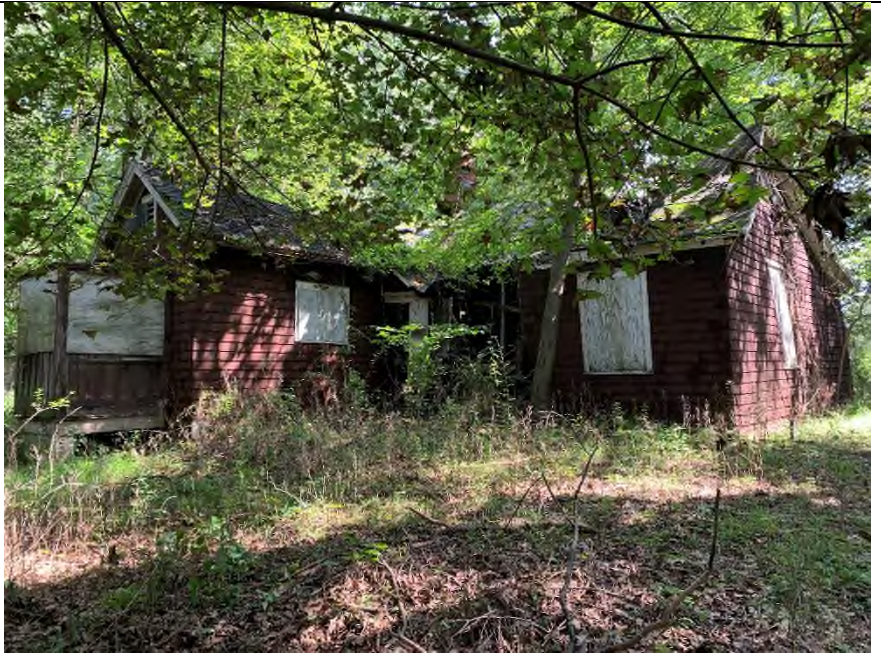
Photo 19 –

Staff House, severe deterioration of roof and interior floor.

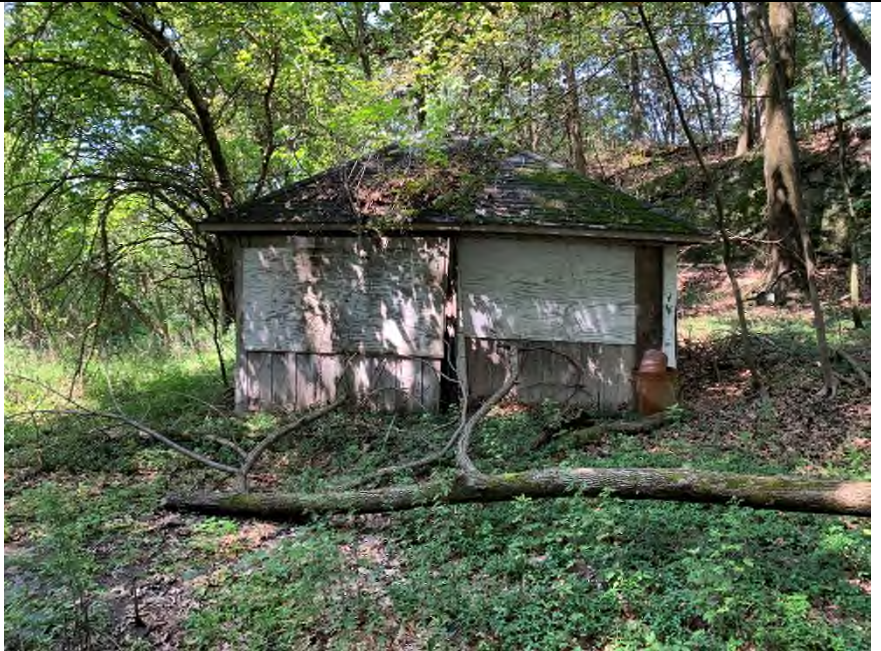
Photo 20 –

Small structure east of the Staff House.
