## MONTHLY STATUS REPORT

| BCP No.: | C314121 | PVE Project No.: | 560909 | Date: | 10/27/2021 |
| Project Name: | 3532 North Road, Dutchess County, Poughkeepsie, New York | | | | |

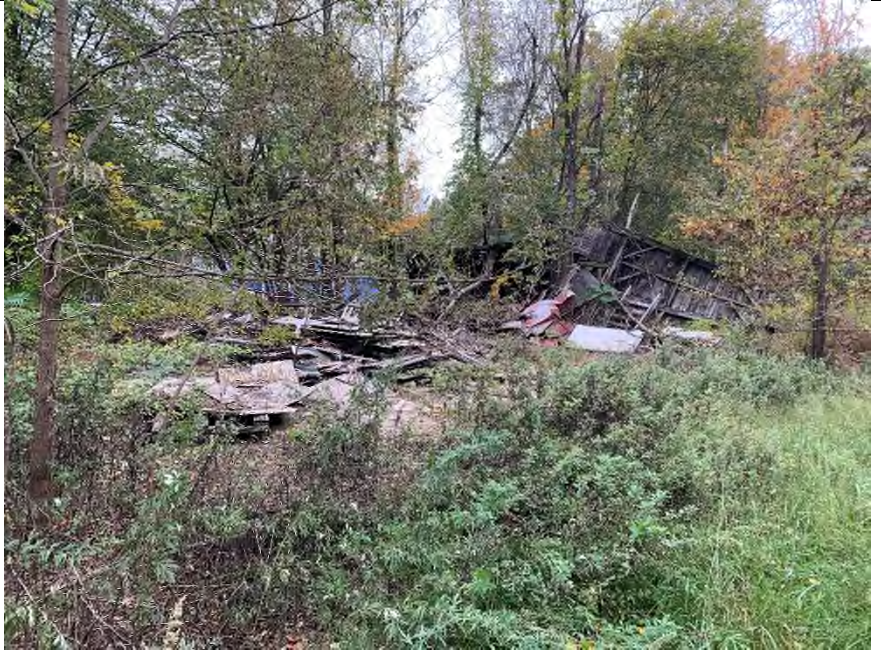
Photo 1 –  
Auto Garage East (Collapsed).

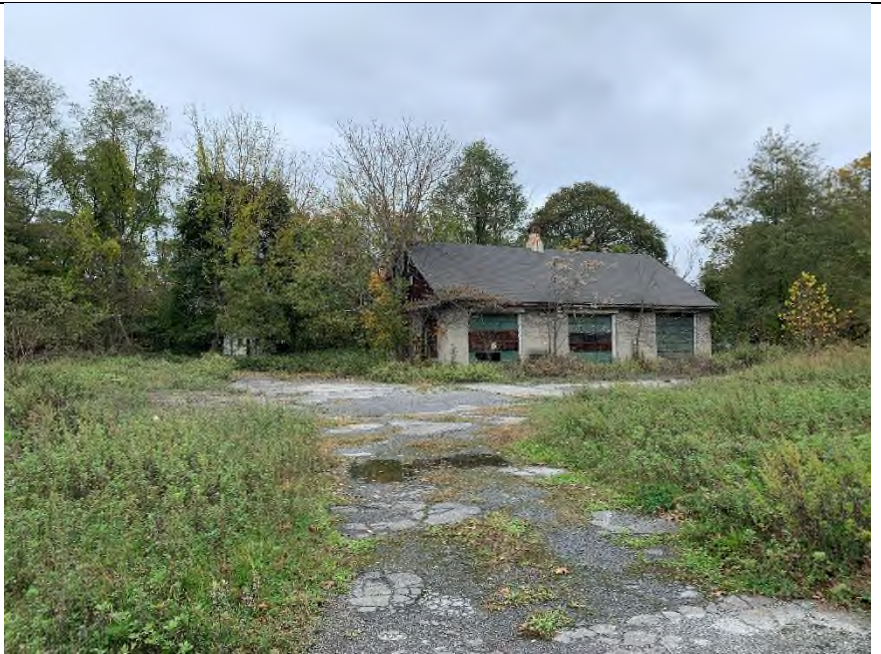
Photo 2 –  
Auto Garage West.

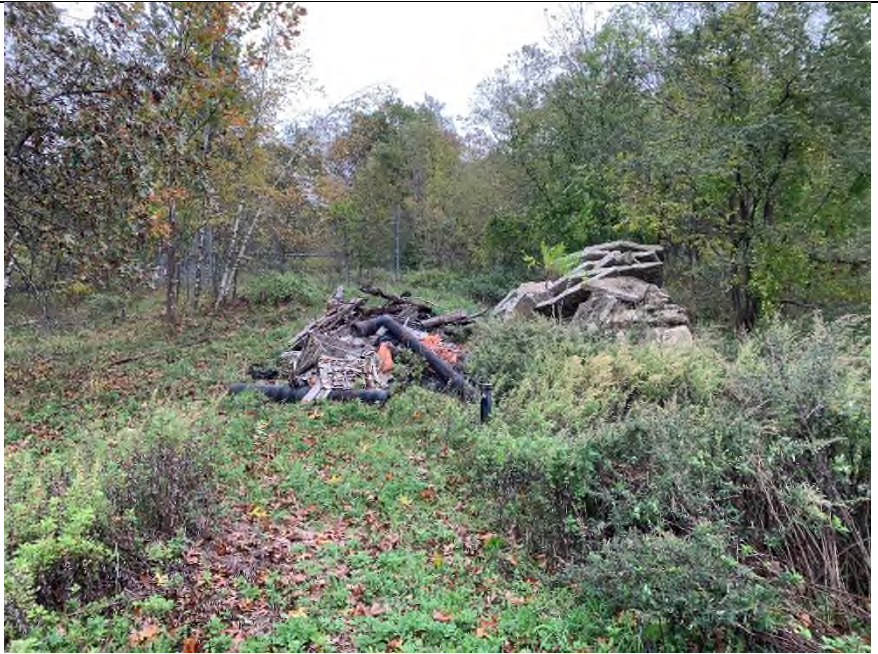
Photo 3 –

Pile of debris located south of Auto Garage East.

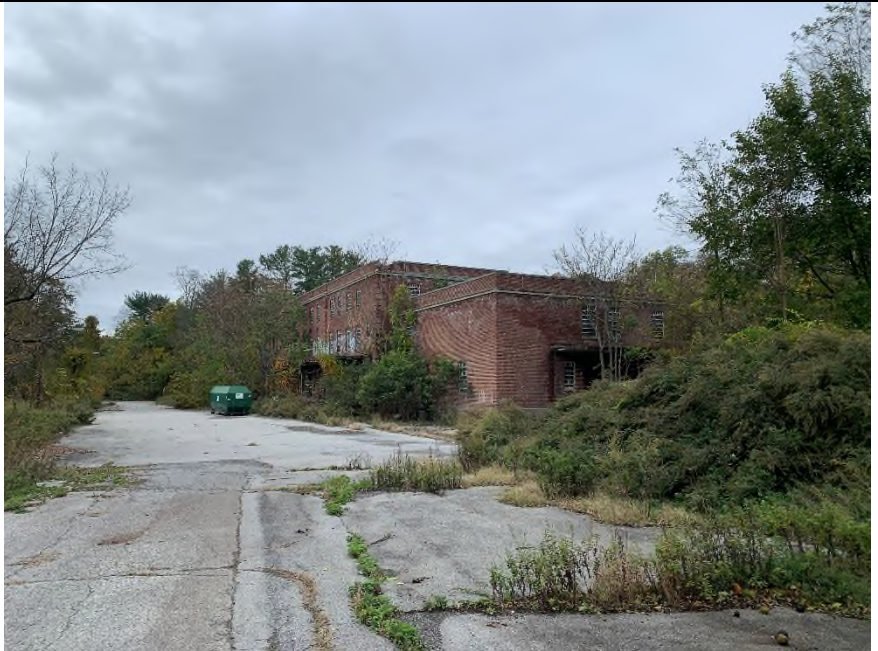
Photo 4 –

Bakery/Storage structure.  
Dumpster located south of structure.

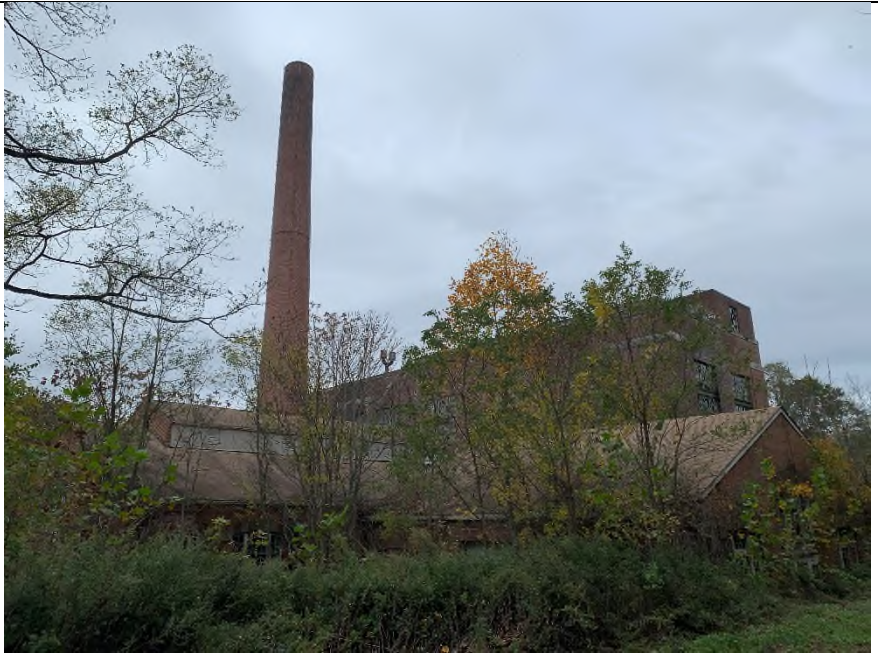
Photo 5 –

Powerhouse.

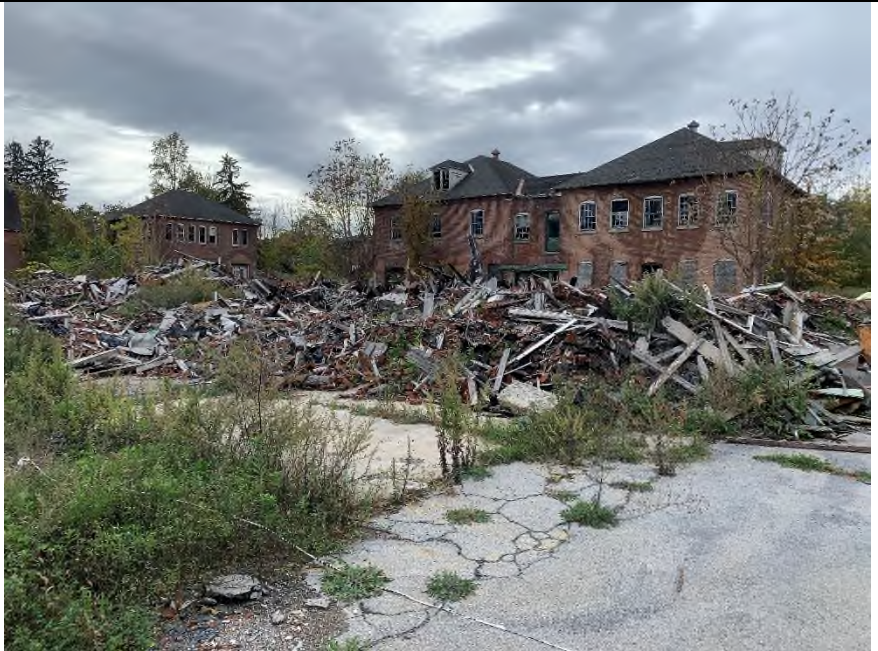
Photo 6 –

Engineer's Office (Demolished).

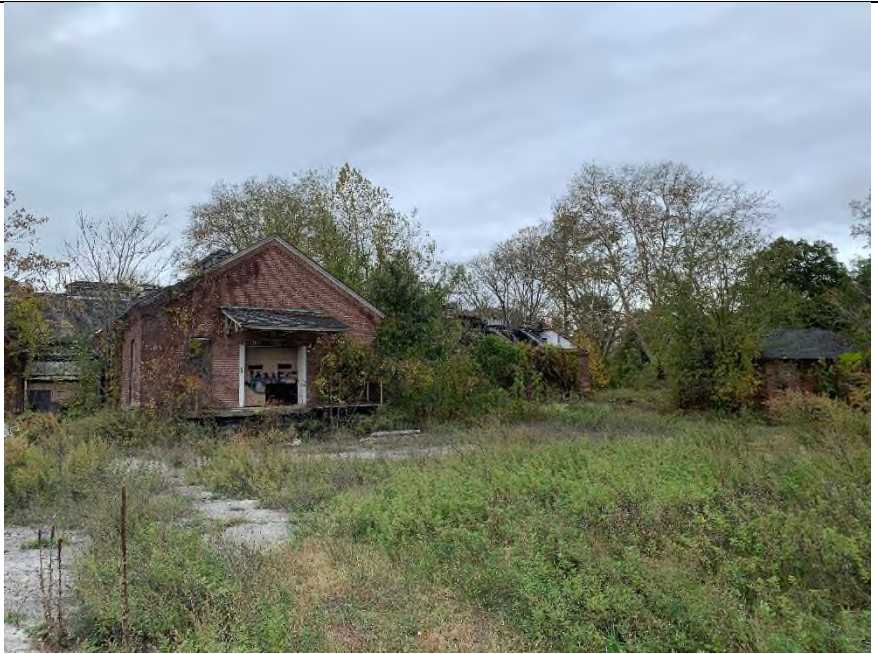
Photo 7 –

Carwash (pictured left) with shed (pictured right).

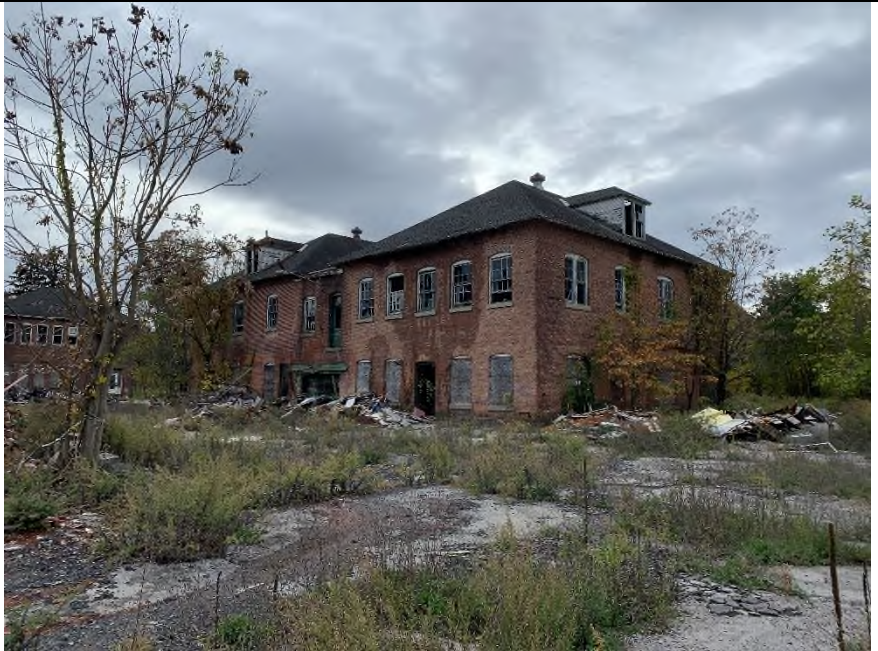
Photo 8 –

Maintenance Building with debris located east side of structure.

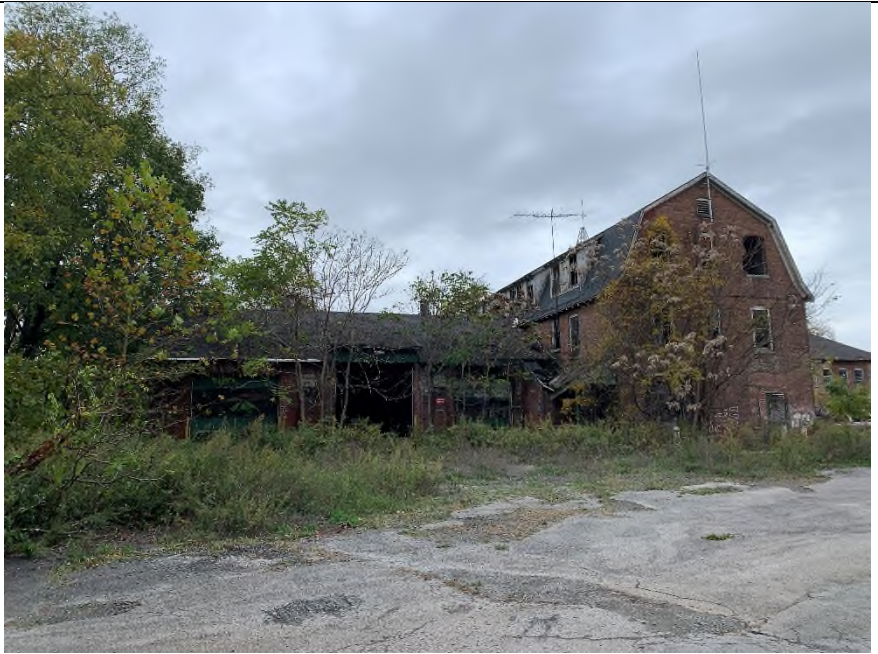
Photo 9 –

Fire House.

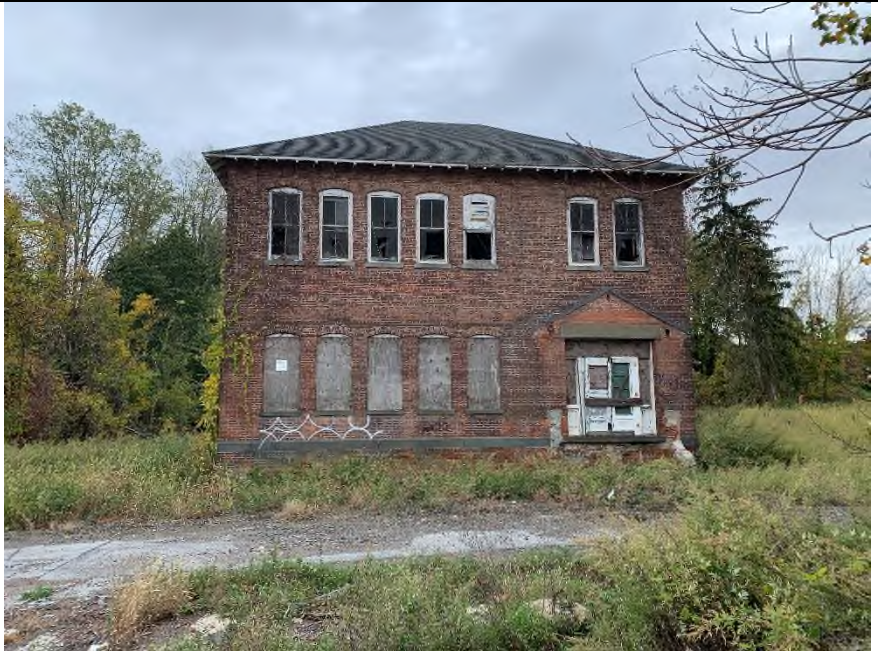
Photo 10 –

Mortuary Building.

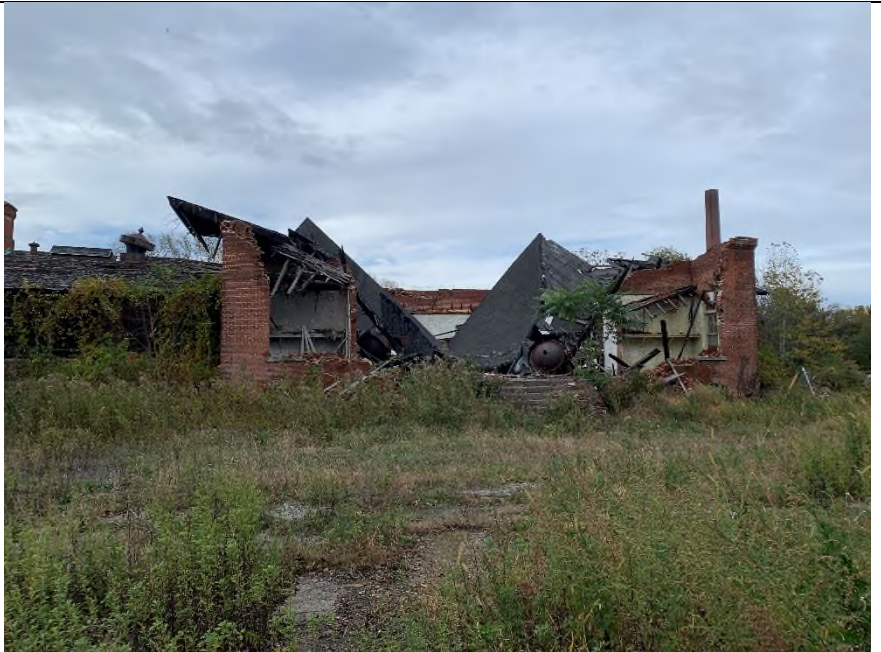
Photo 11 –

Structure west of the Mortuary Building, facing north (collapsed).

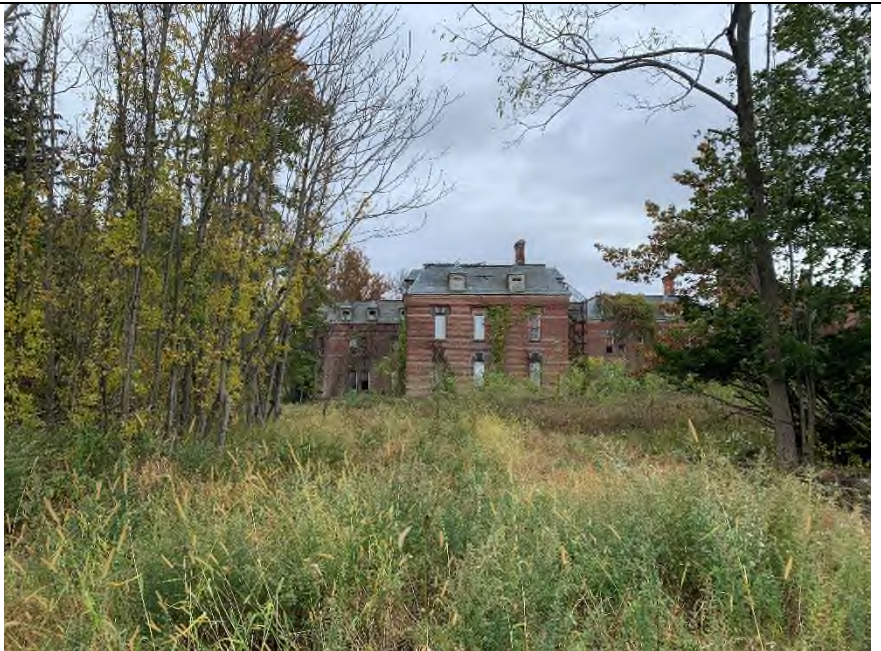
Photo 12 –

Structures in southwest corner of BCP boundary, facing south.

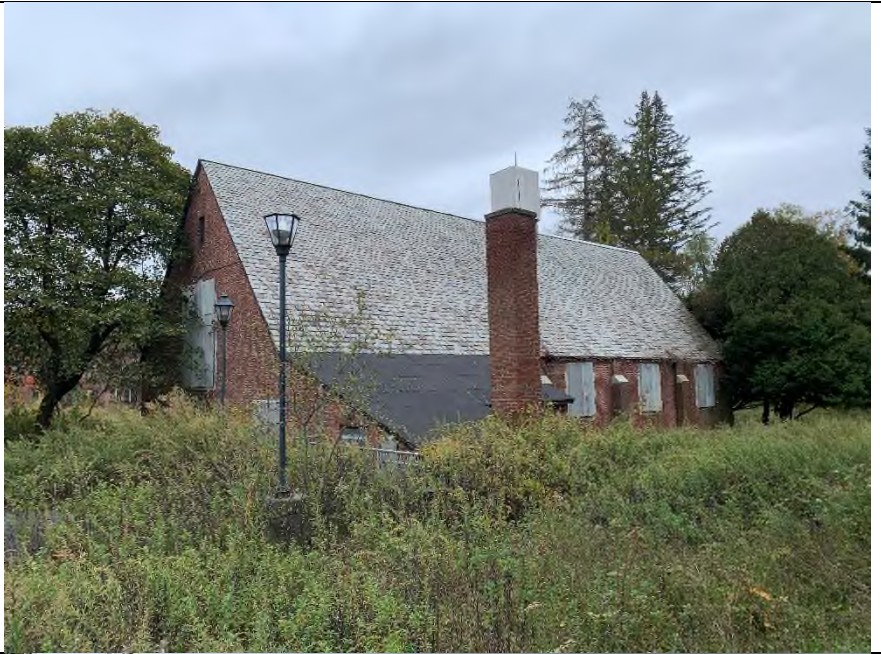
Photo 13 –

Rectory south of the Recreational Hall building.

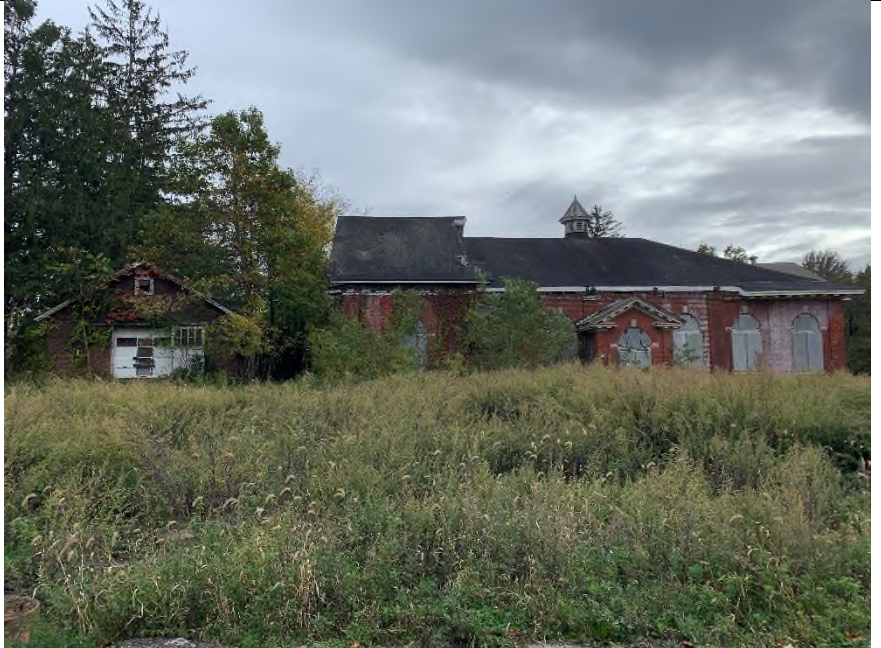
Photo 14 –

Recreational Hall.

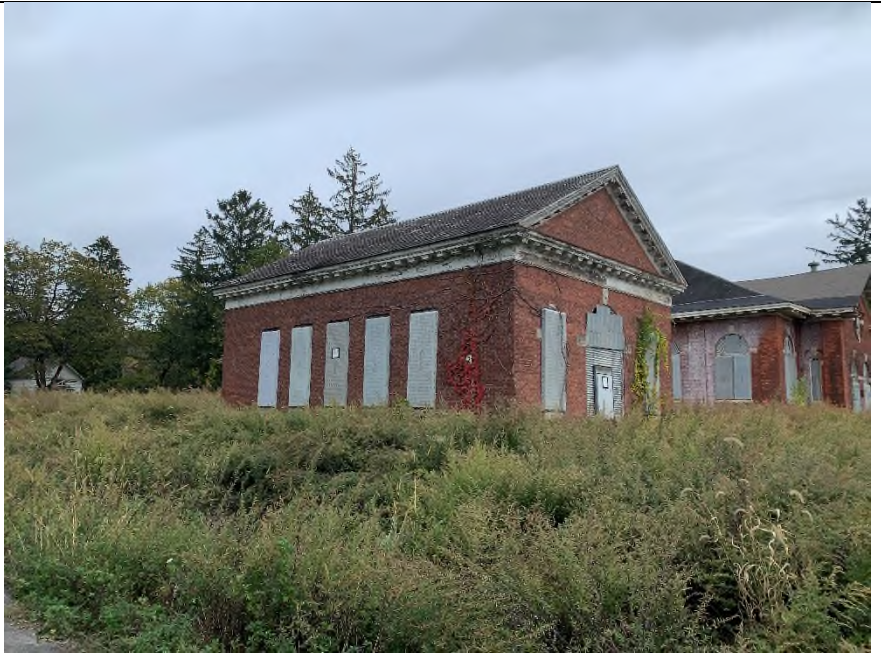
Photo 15 –

Library.

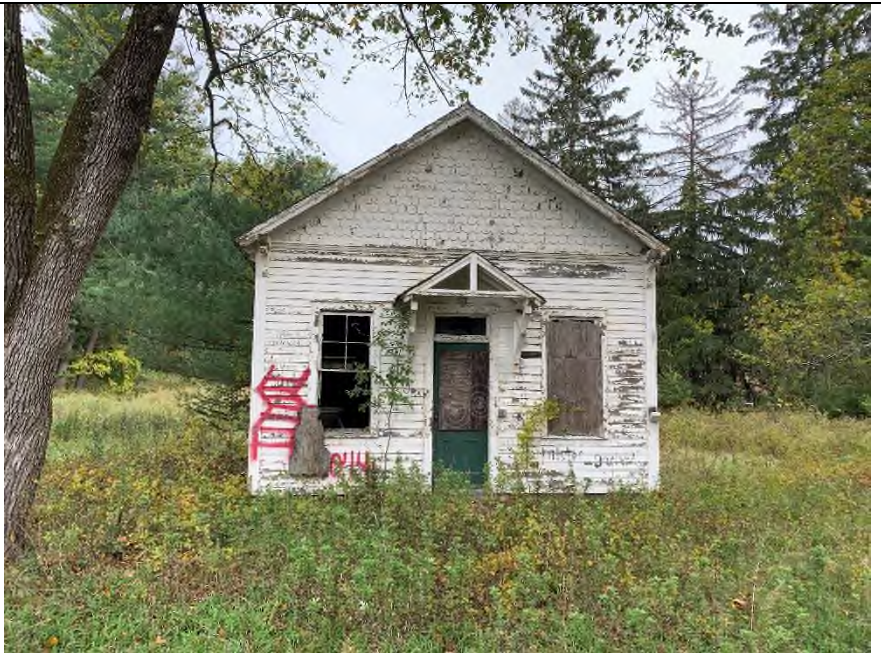
Photo 16 –

Small structure east of the Library.

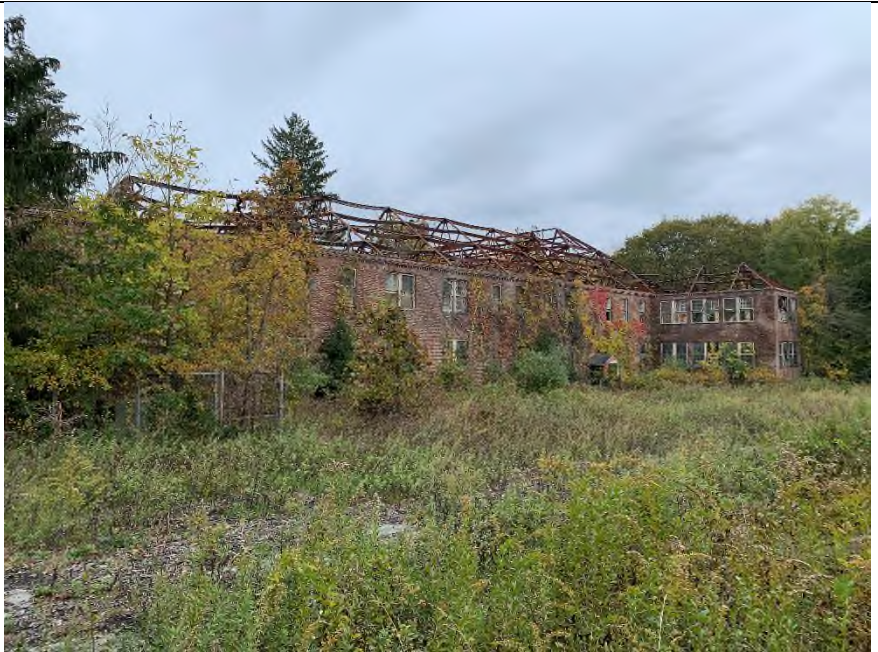
Photo 17 –

Brookside structure, severe deterioration of roof.

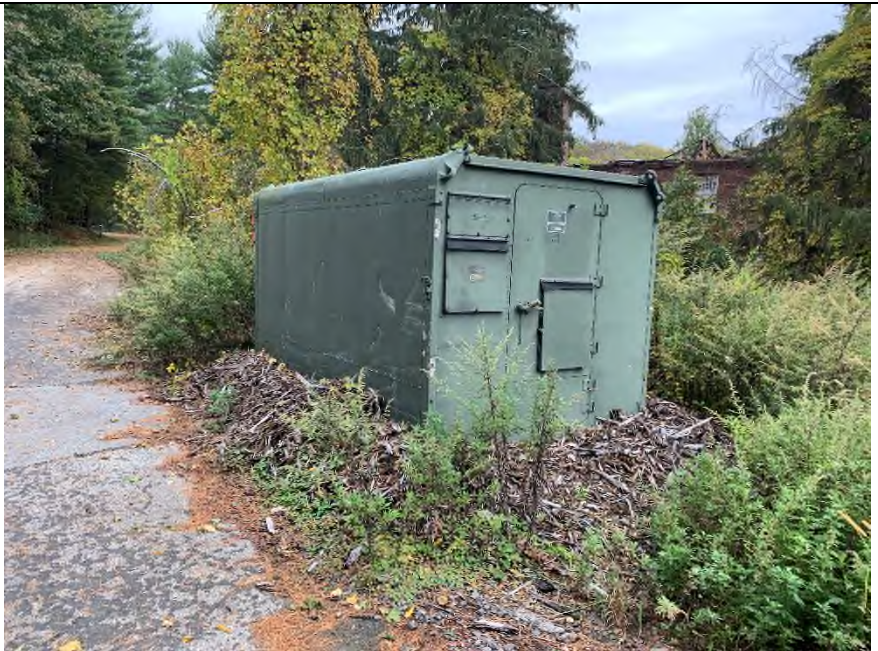
Photo 18 –

Metal container placed over fire hydrant. Base of container is bordered with wood chips.

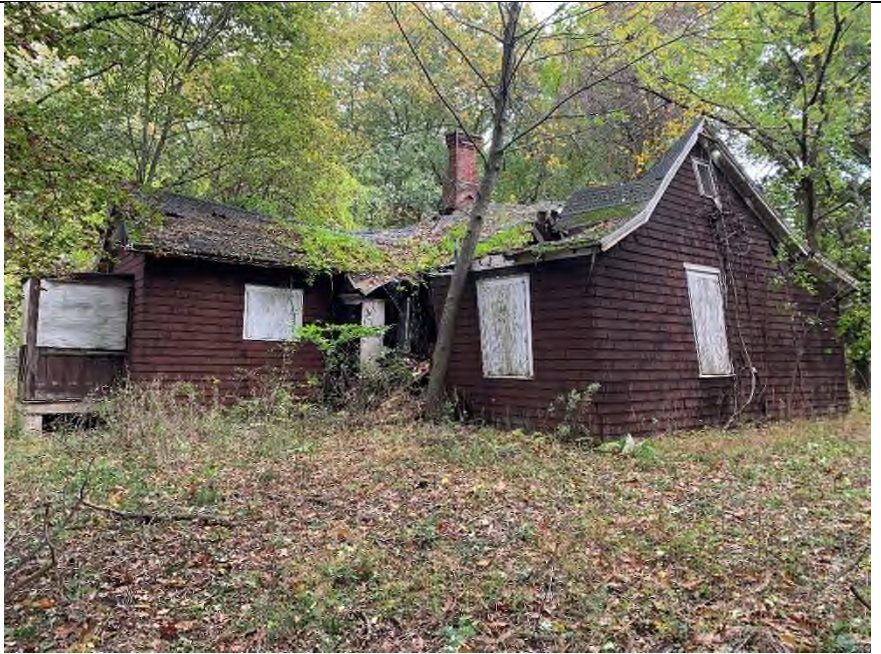
Photo 19 –

Staff House, severe deterioration of roof and interior floor.

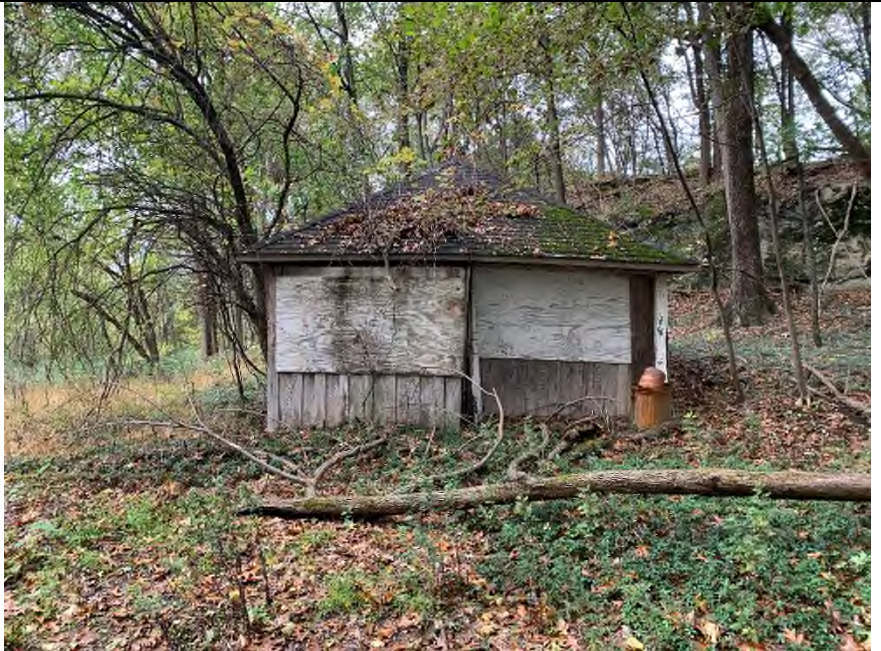
Photo 20 –

Small structure east of the Staff House.
