## MONTHLY STATUS REPORT

| BCP No.: | C314121 | PVE Project No.: | 560909 | Date: | 11/22/2021 |
| Project Name: | 3532 North Road, Dutchess County, Poughkeepsie, New York | | | | |

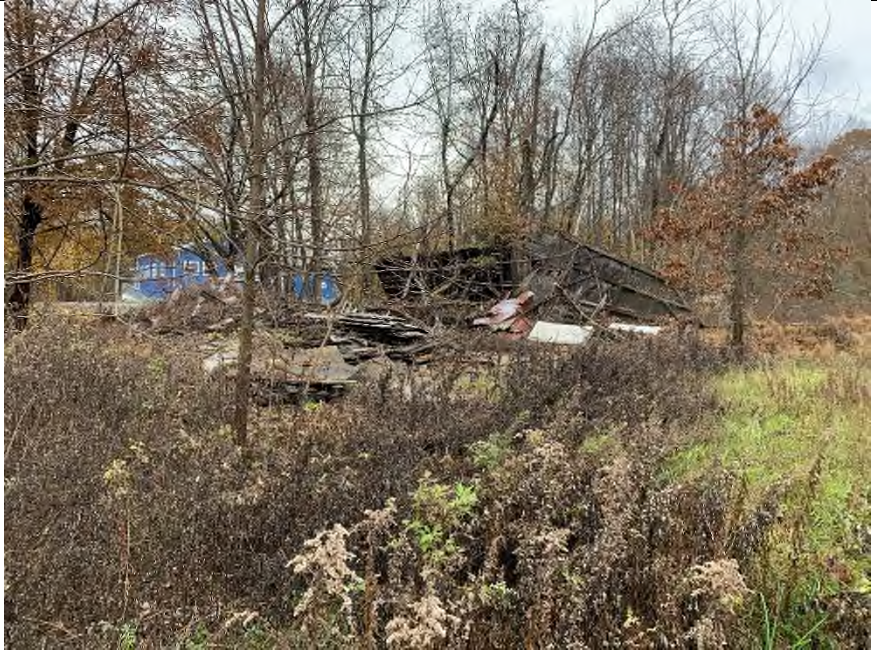
Photo 1 –  
Auto Garage East (Collapsed).

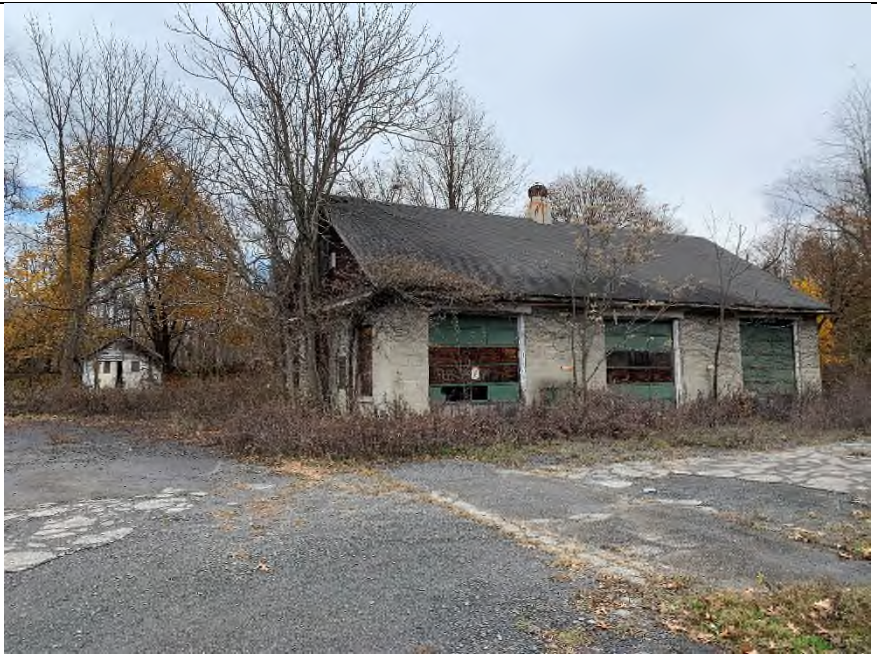
Photo 2 –  
Auto Garage West.

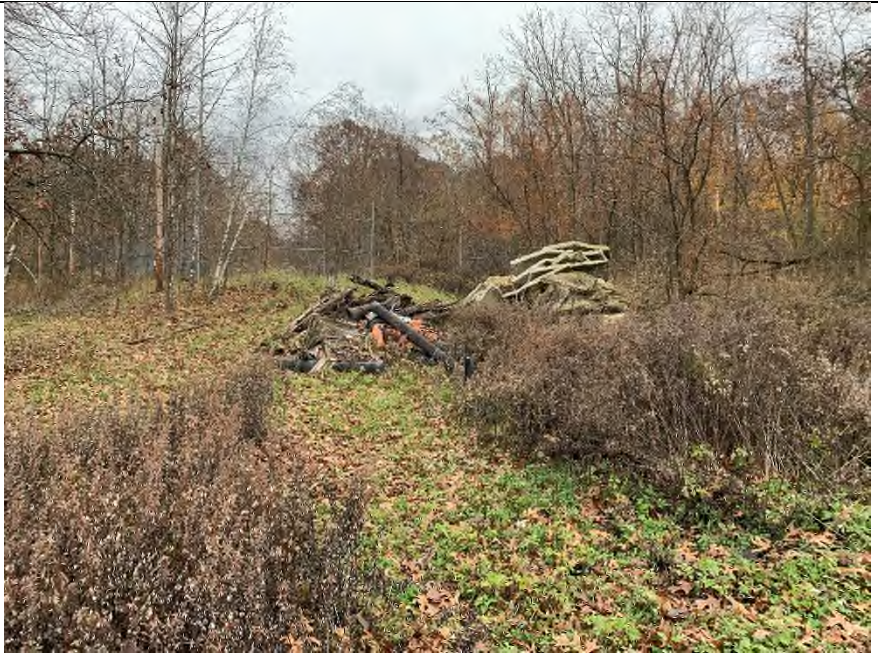
Photo 3 –

Pile of debris located south of Auto Garage East.

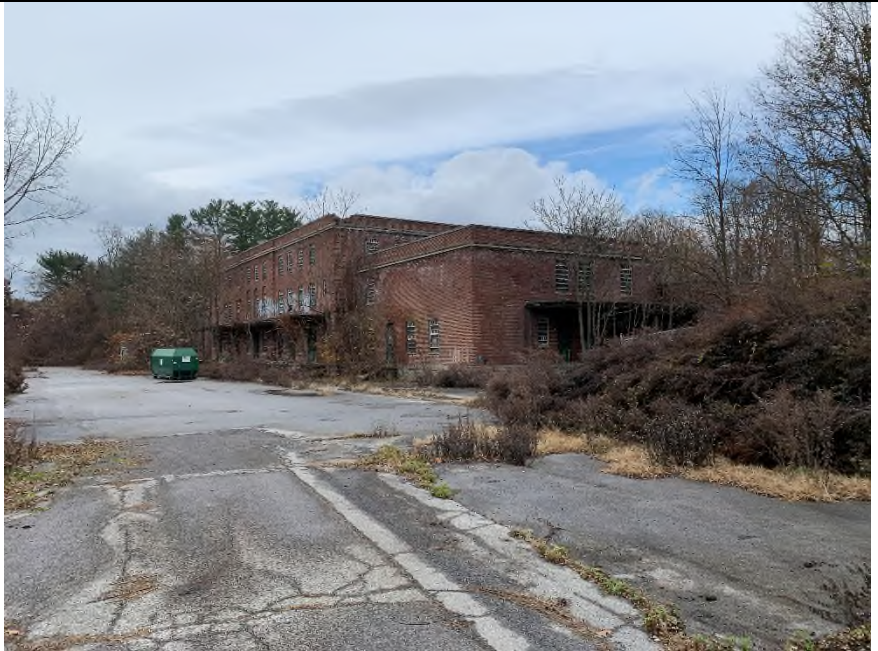
Photo 4 –

Bakery/Storage structure.  
Dumpster located south of structure.

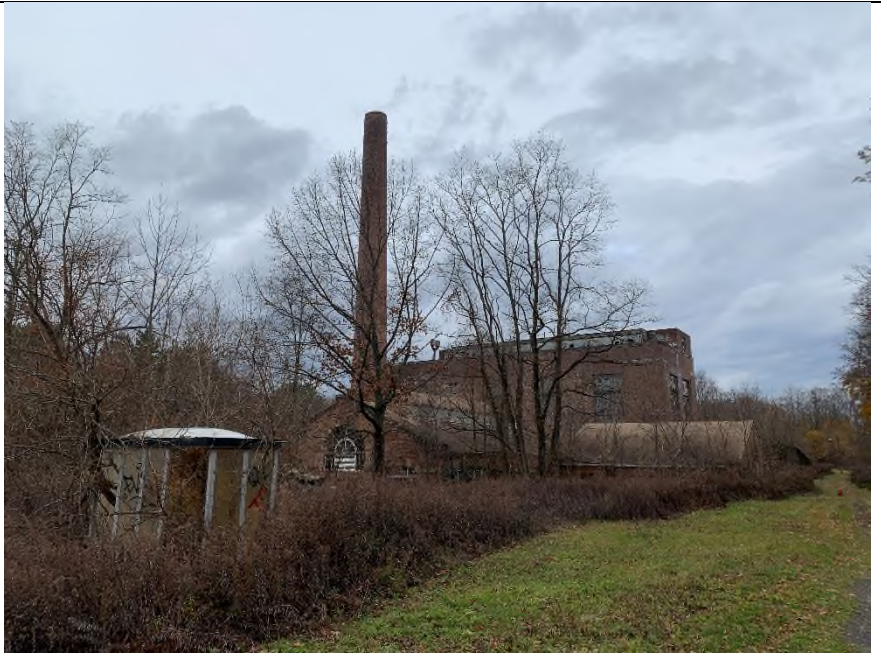
Photo 5 –

Powerhouse.

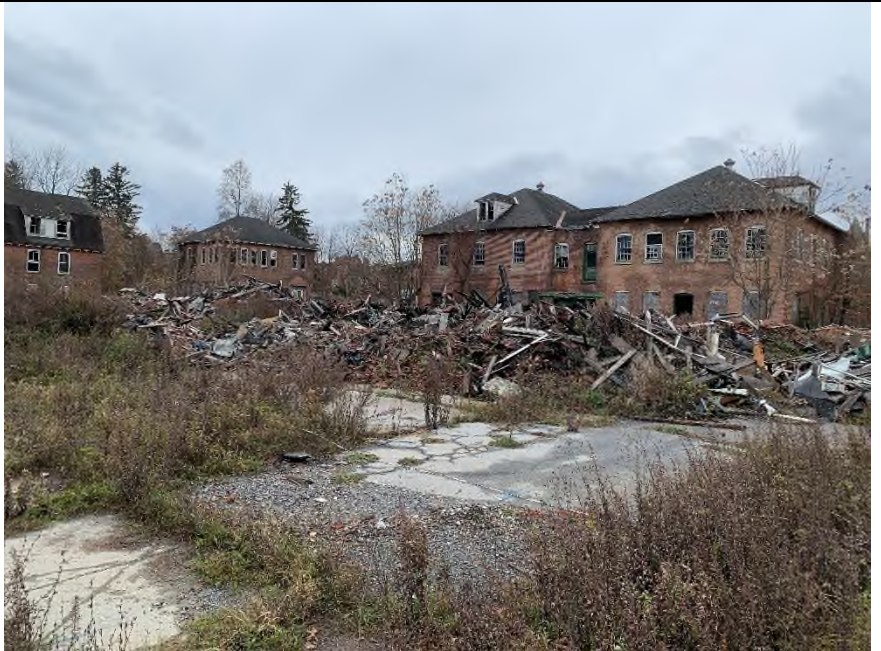
Photo 6 –

Engineering Building  
(Demolished).

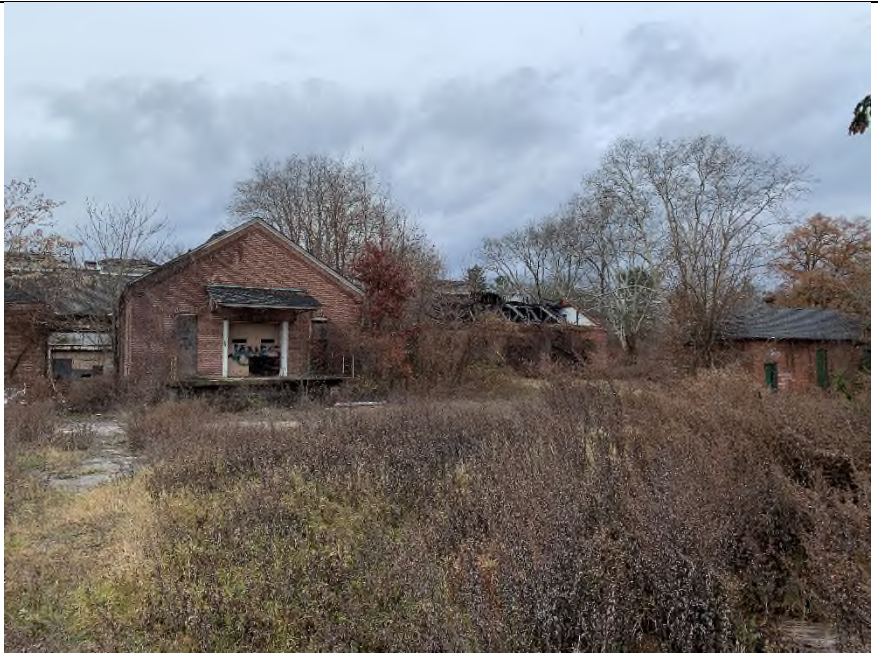
Photo 7 –

Carwash (pictured left) with shed (pictured right).

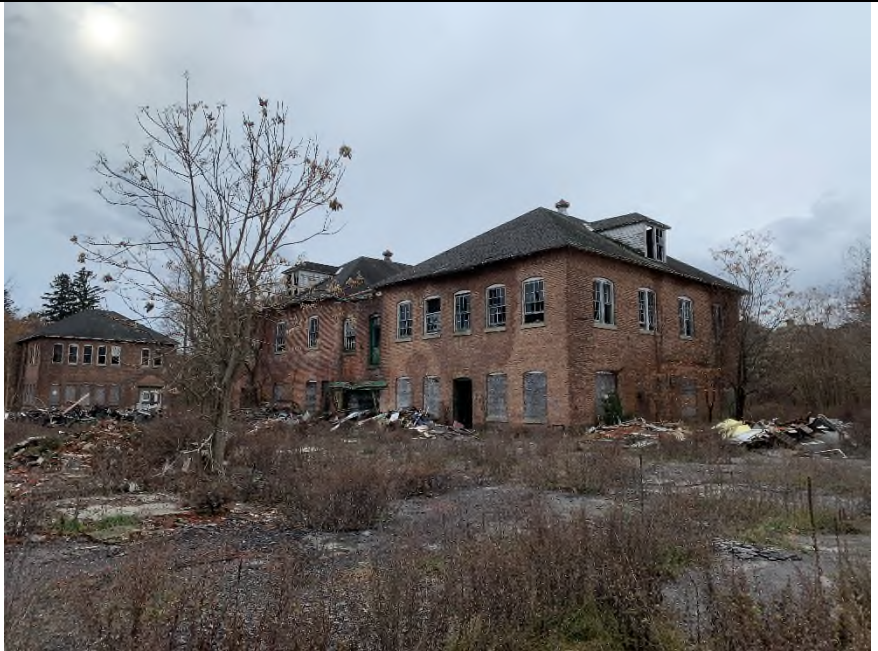
Photo 8 –

Maintenance Building with debris located east side of structure.

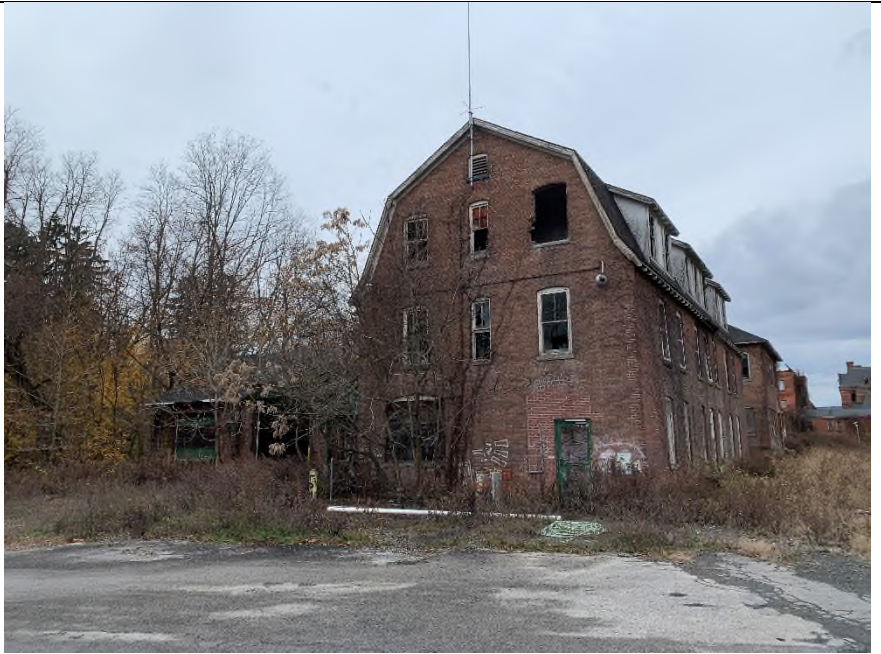
Photo 9 –

Fire House.

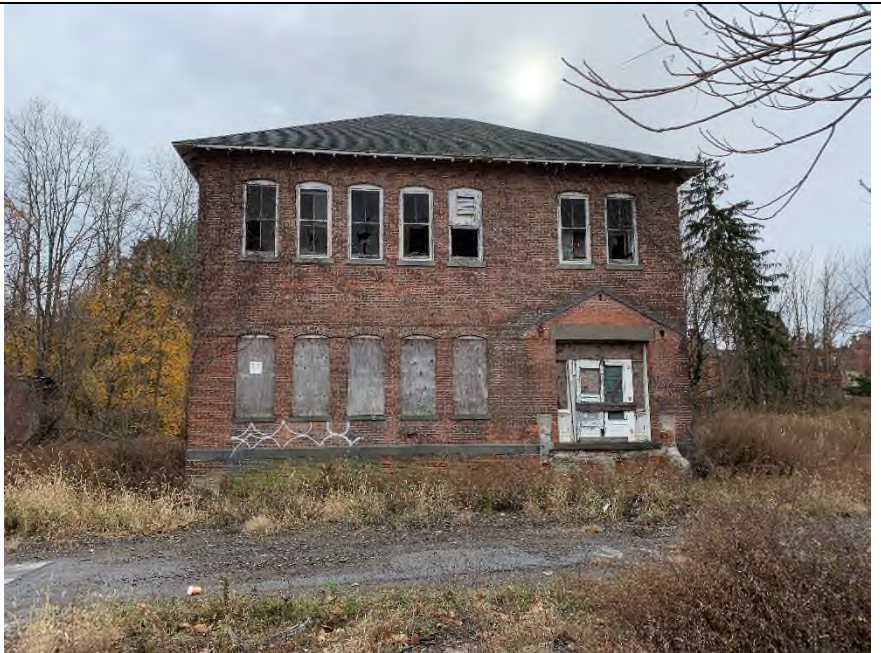
Photo 10 –

Mortuary Building.

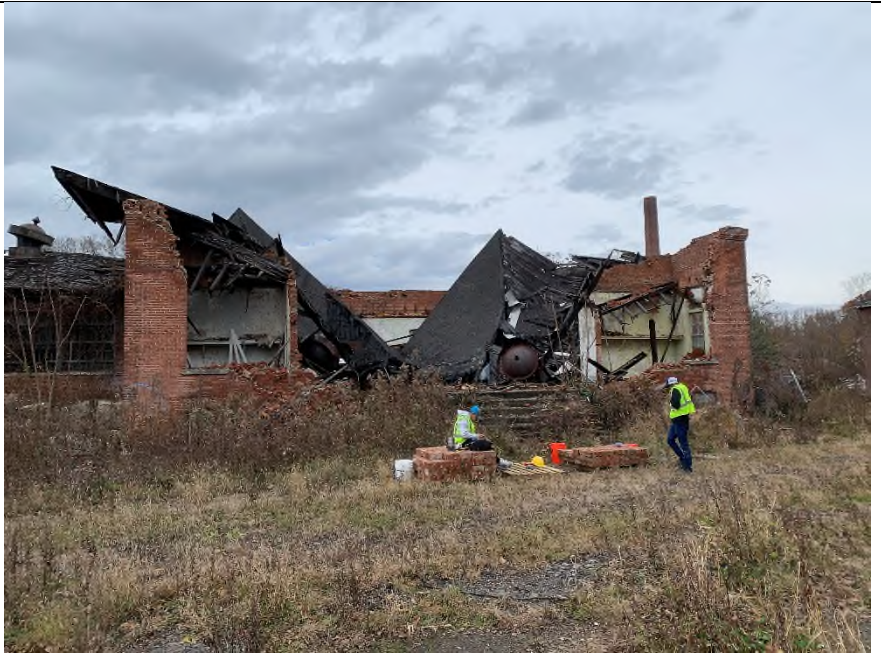
Photo 11 –

Structure west of the Mortuary Building, facing north (collapsed).

Bricks from structure being staged on pallets. This activity was stopped.

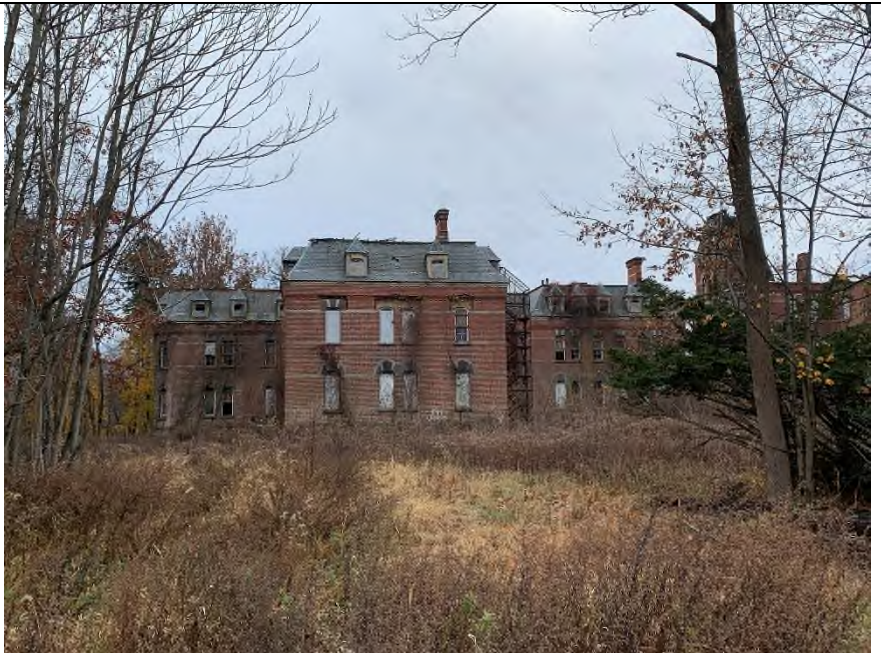
Photo 12 –

Structures in southwest corner of BCP Site, facing south.

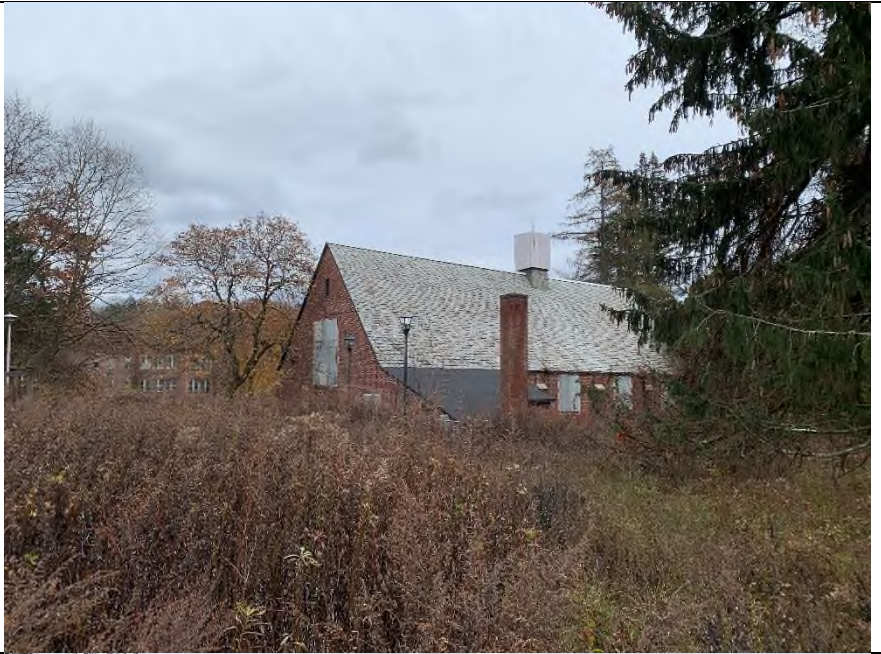
Photo 13 –

Rectory south of the Recreational Hall building.

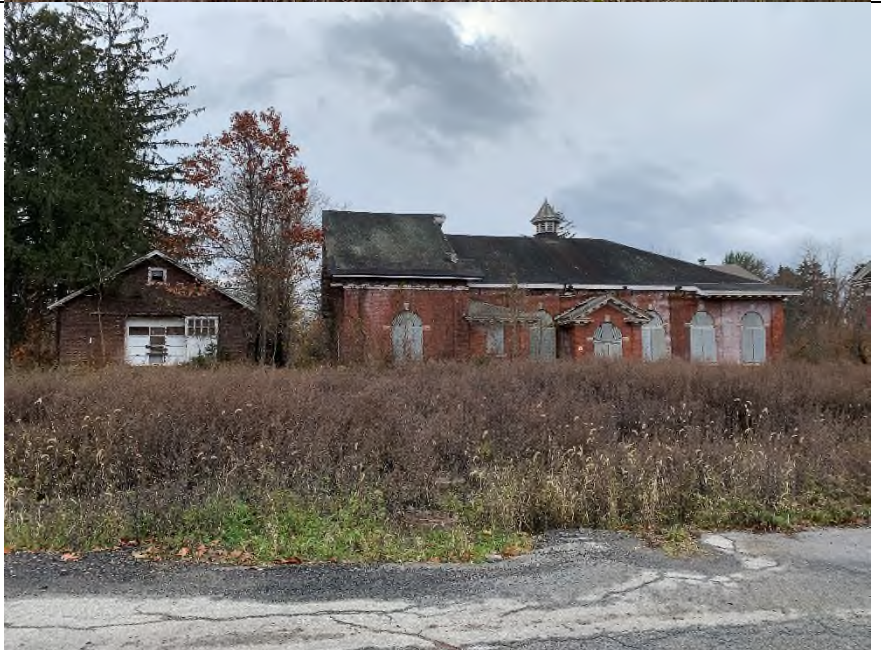
Photo 14 –

Recreational Hall.

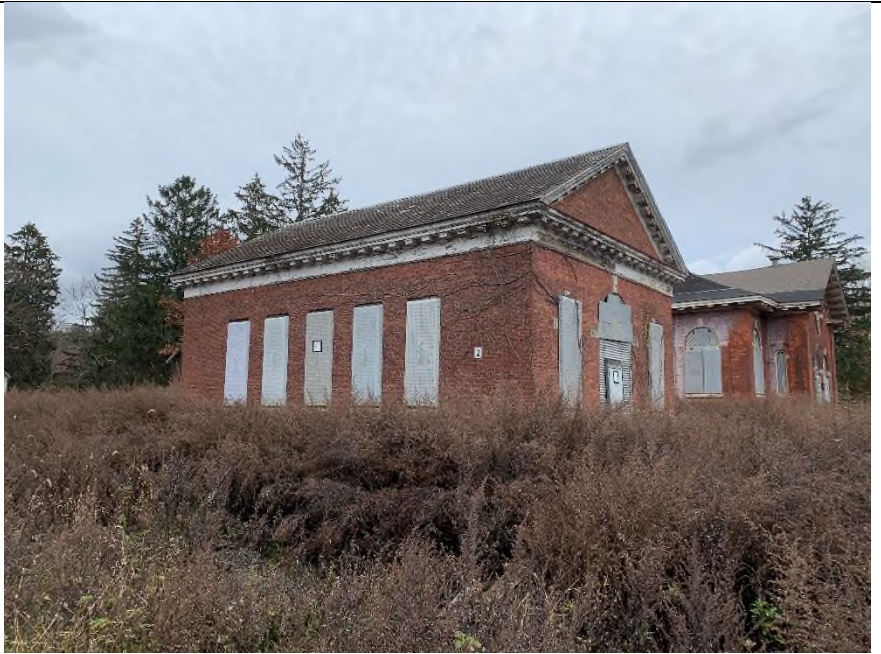
Photo 15 –

Library.

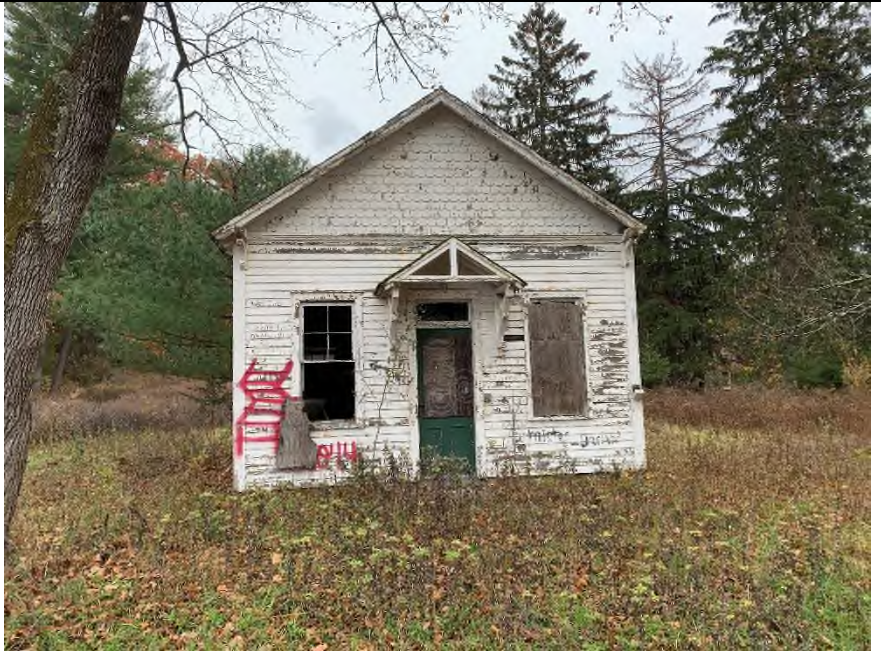
Photo 16 –

Small structure east of the Library.

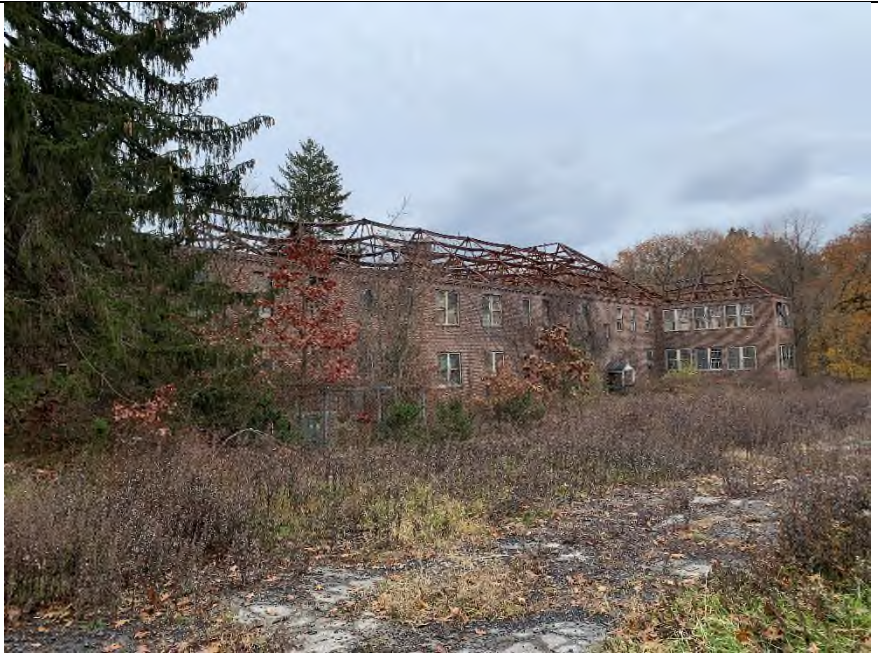
Photo 17 –

Brookside structure, severe deterioration of roof.

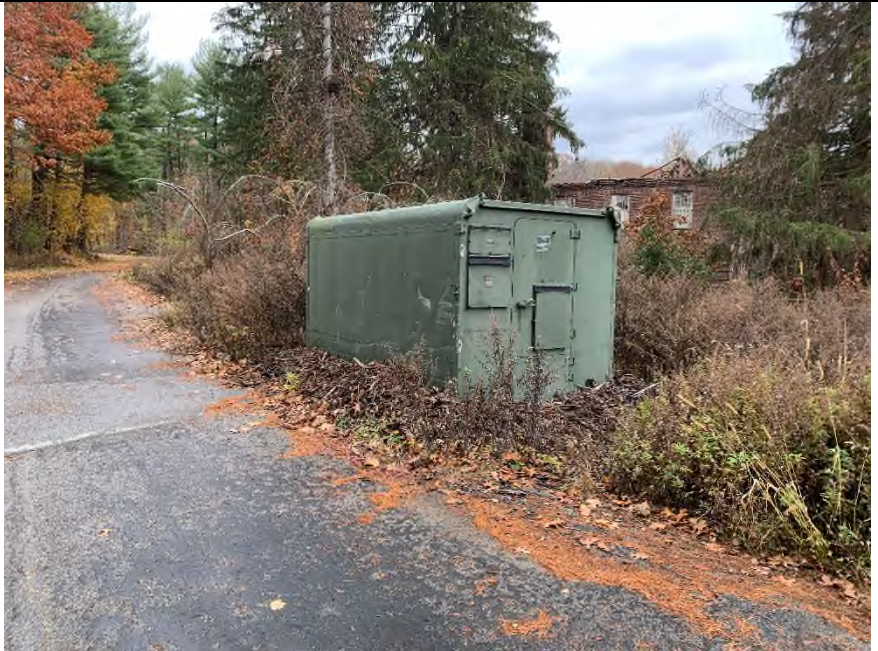
Photo 18 –

Metal container placed over fire hydrant. Base of container is bordered with wood chips.

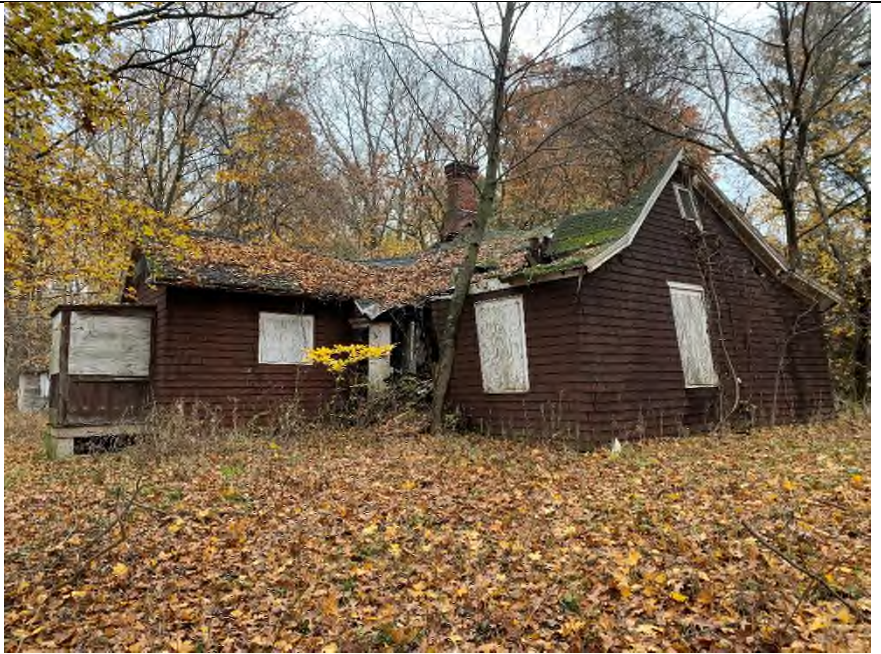
Photo 19 –

Staff House, severe deterioration of roof and interior floor.

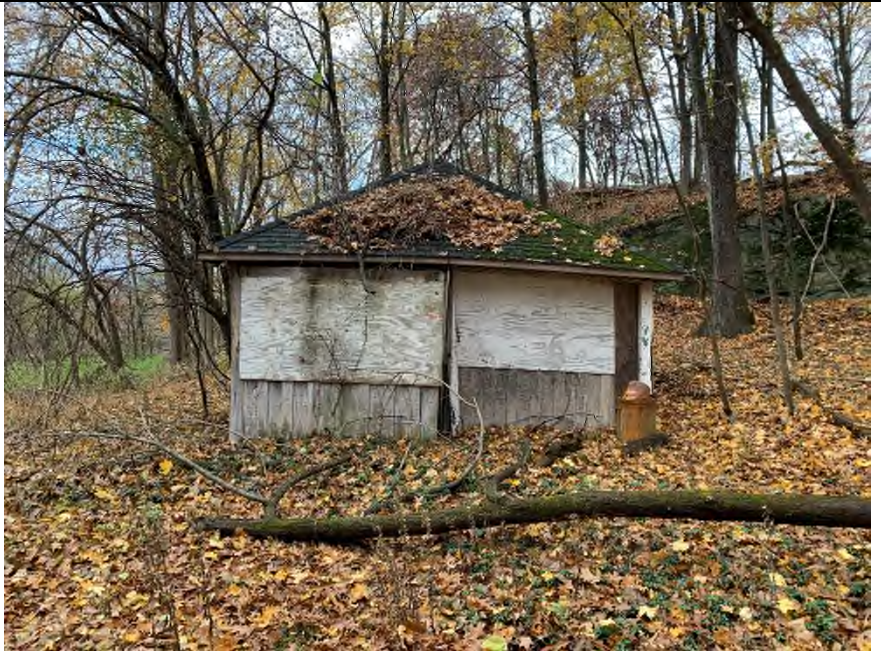
Photo 20 –

Small structure east of the Staff House.
