## MONTHLY STATUS REPORT

| BCP No.: | C314121 | PVE Project No.: | 560909 | Date: | 12/20/2021 |
| Project Name: | 3532 North Road, Dutchess County, Poughkeepsie, New York | | | | |

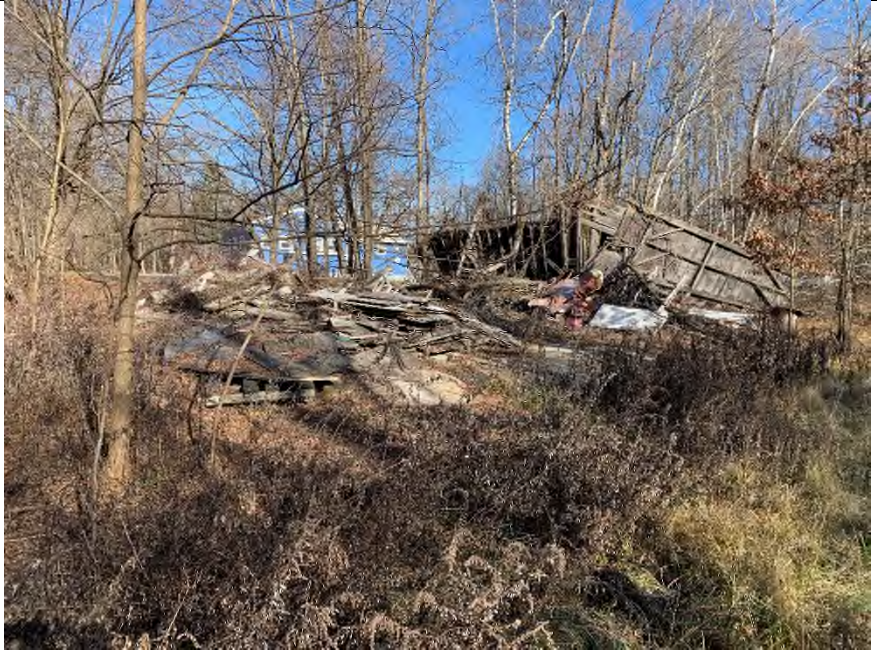
Photo 1 –  
Auto Garage East (Collapsed).

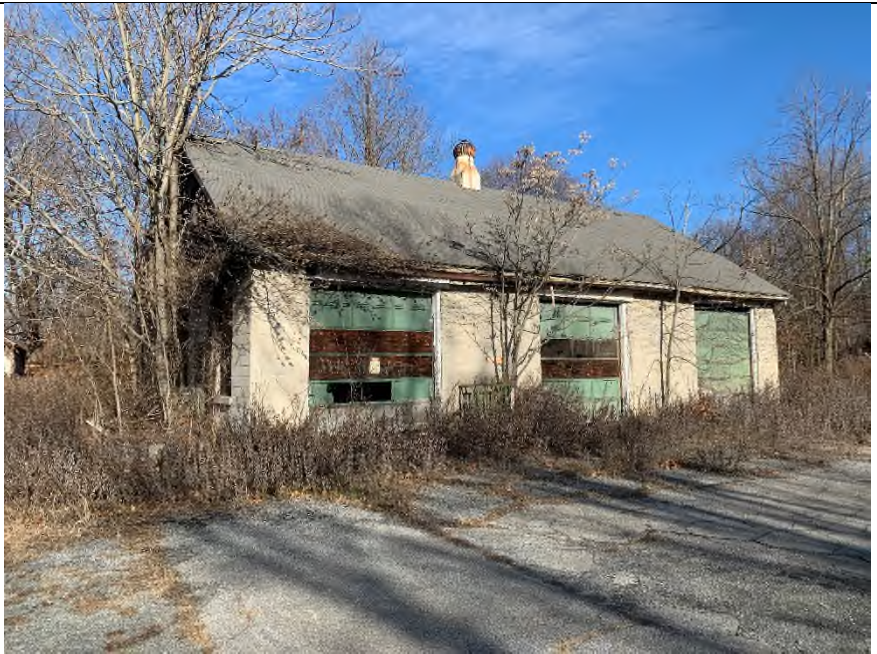
Photo 2 –  
Auto Garage West.

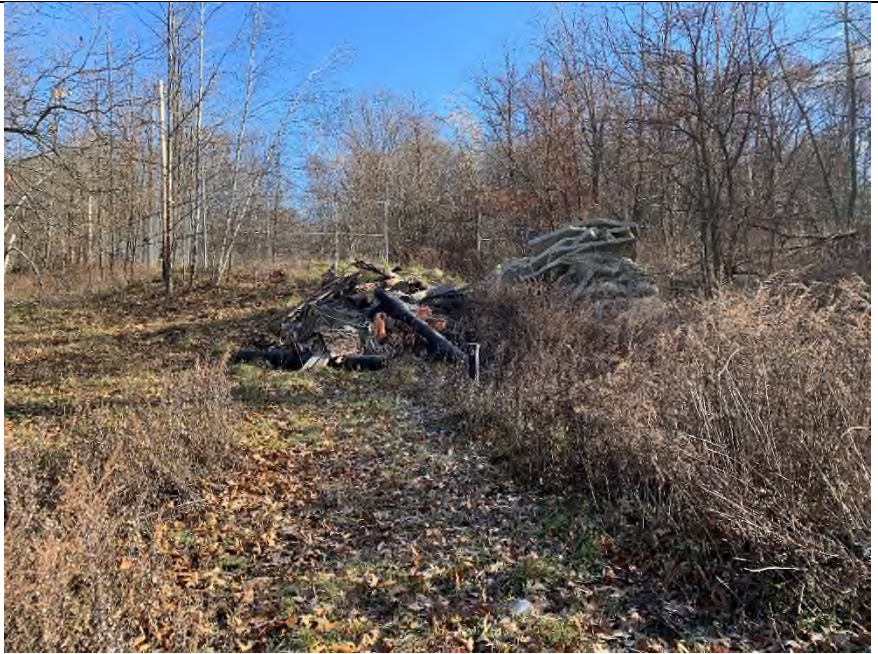
Photo 3 –

Pile of debris located south of Auto Garage East.

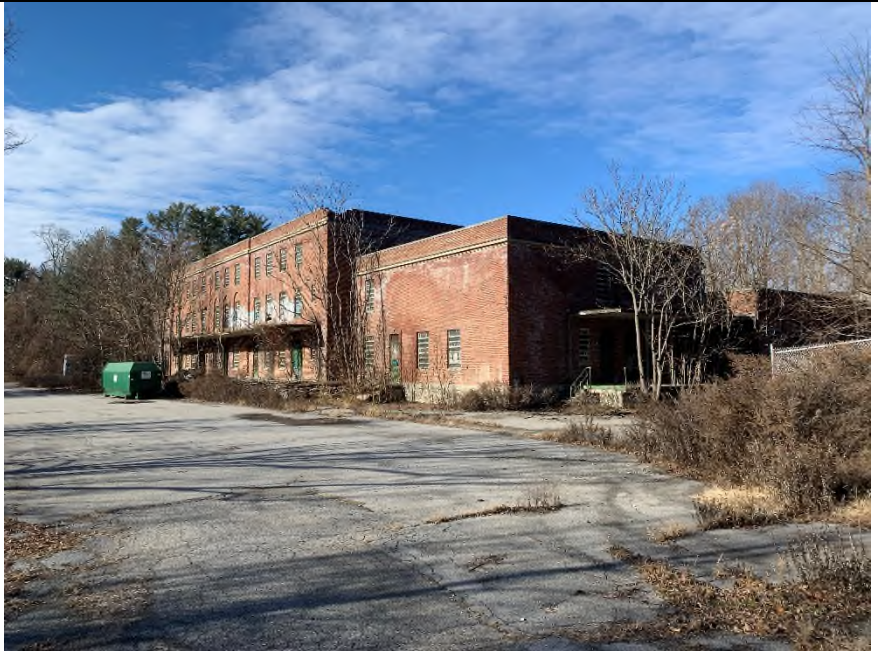
Photo 4 –

Bakery/Storage structure.  
Dumpster located south of structure.

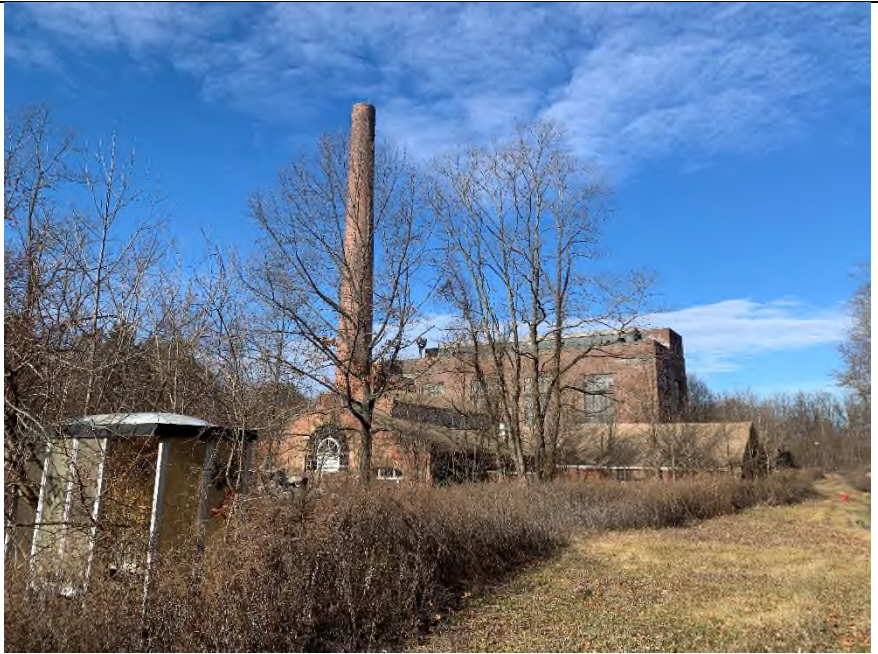
Photo 5 –

Powerhouse.

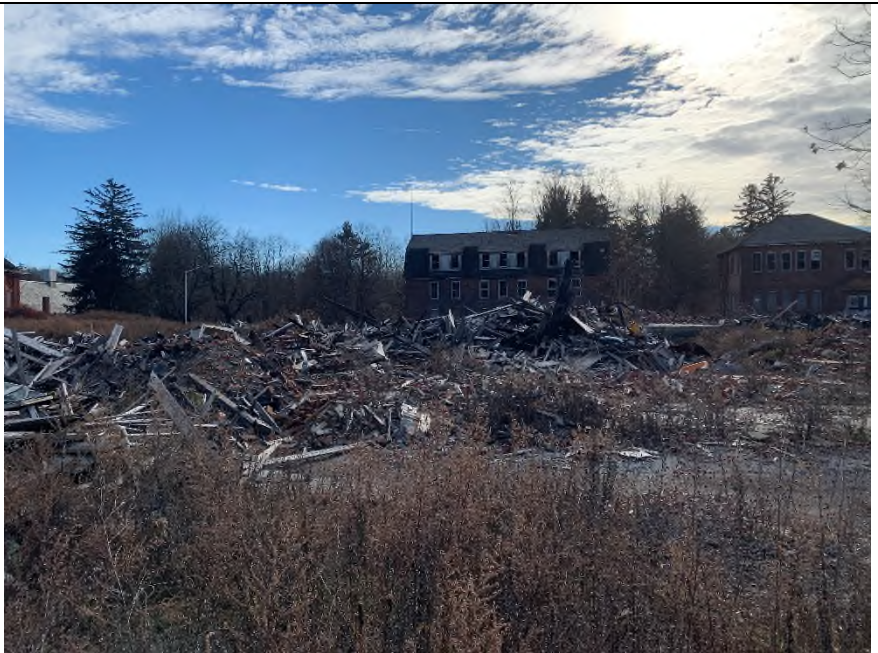
Photo 6 –

Engineering Building  
(Demolished).

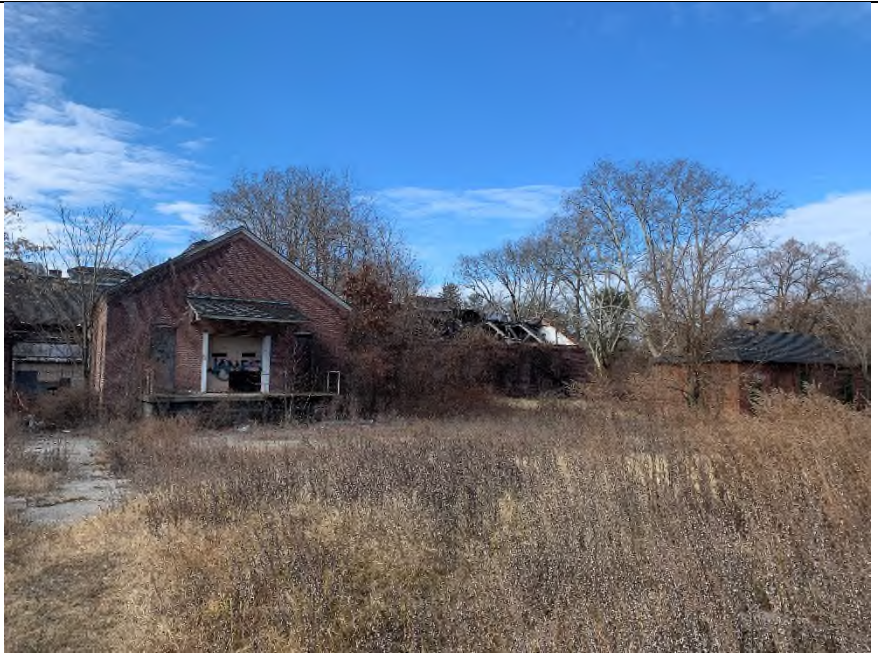
Photo 7 –

Carwash (pictured left) with shed (pictured right).

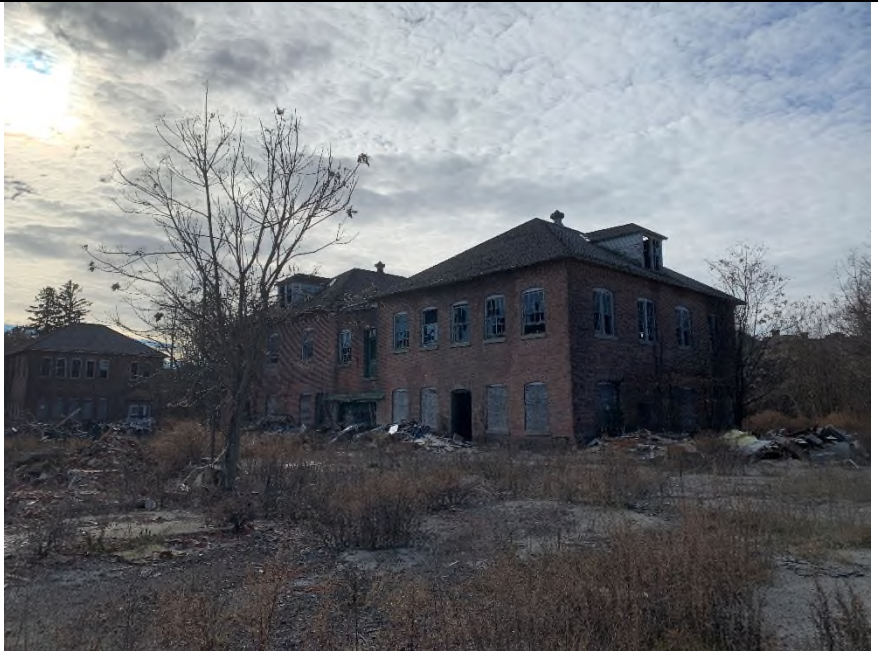
Photo 8 –

Maintenance Building with debris located east side of structure.

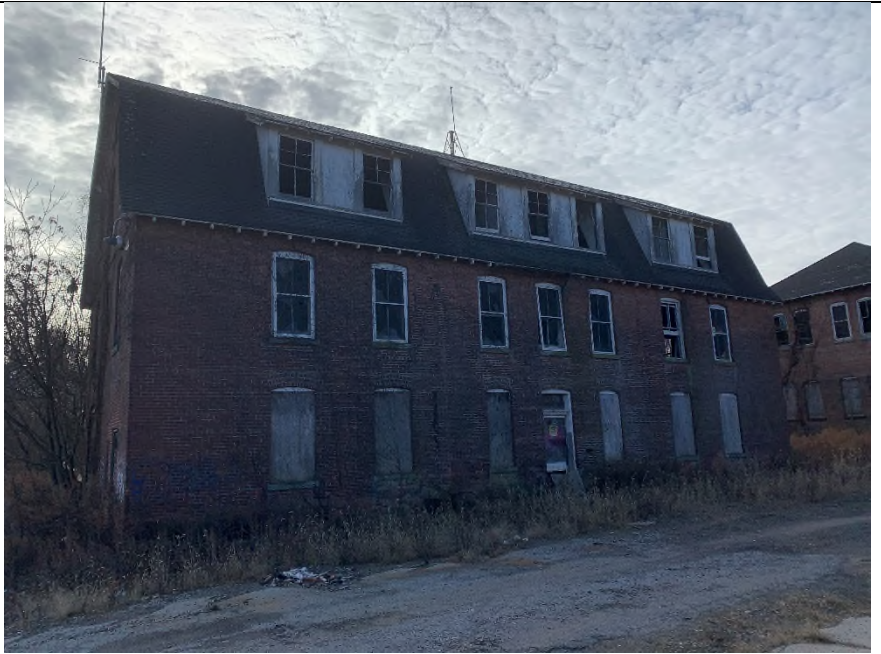
Photo 9 –

Fire House.

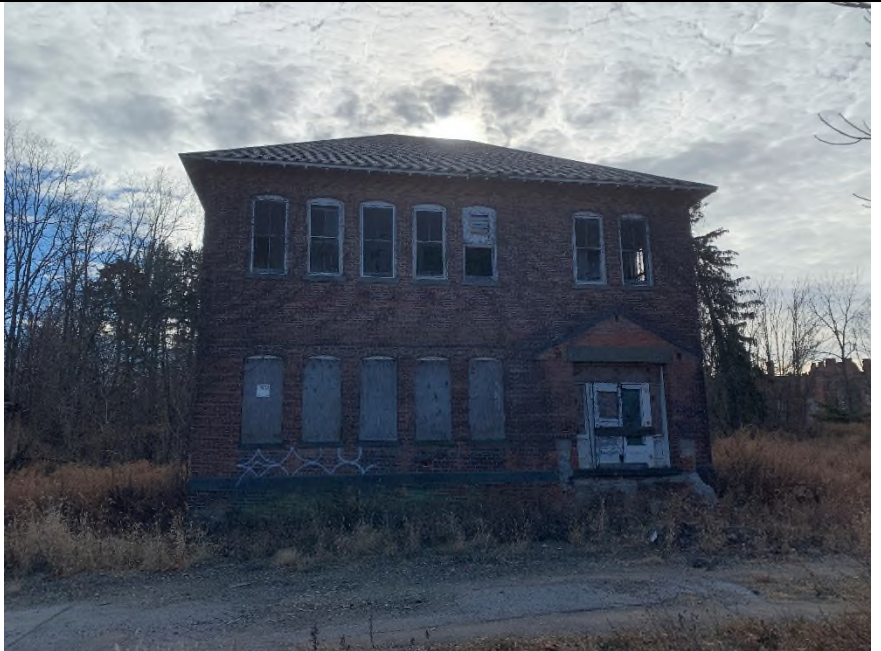
Photo 10 –

Mortuary Building.

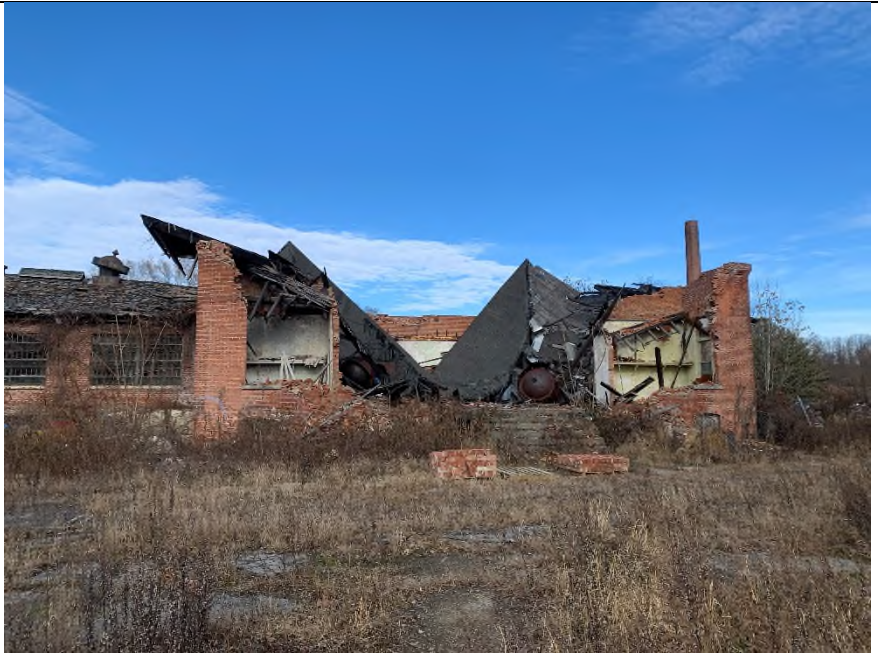
Photo 11 –

Structure west of the Mortuary Building, facing north (collapsed).

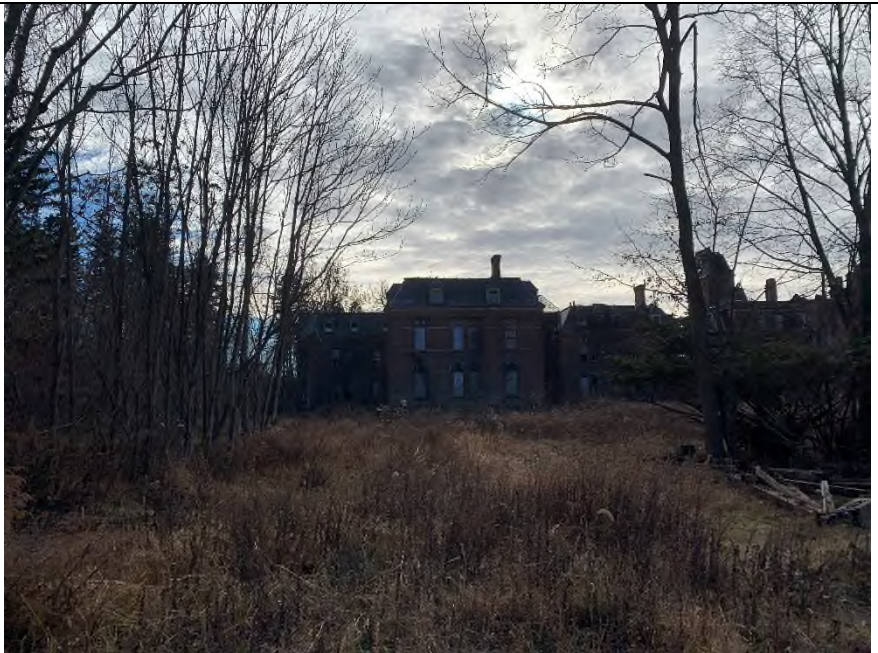
Photo 12 –

Structures in southwest corner of BCP Site, facing south.

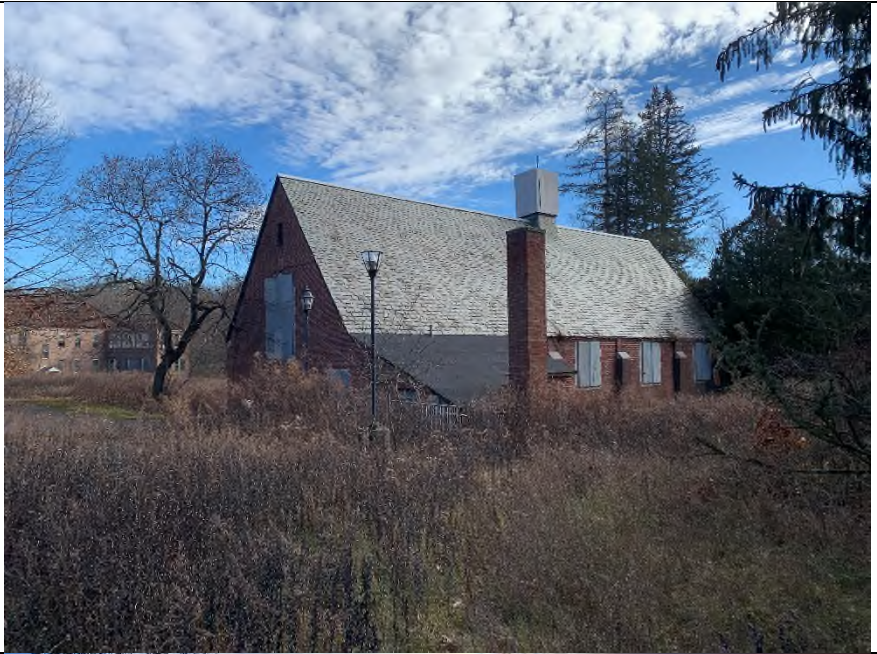
Photo 13 –

Rectory south of the Recreational Hall building.

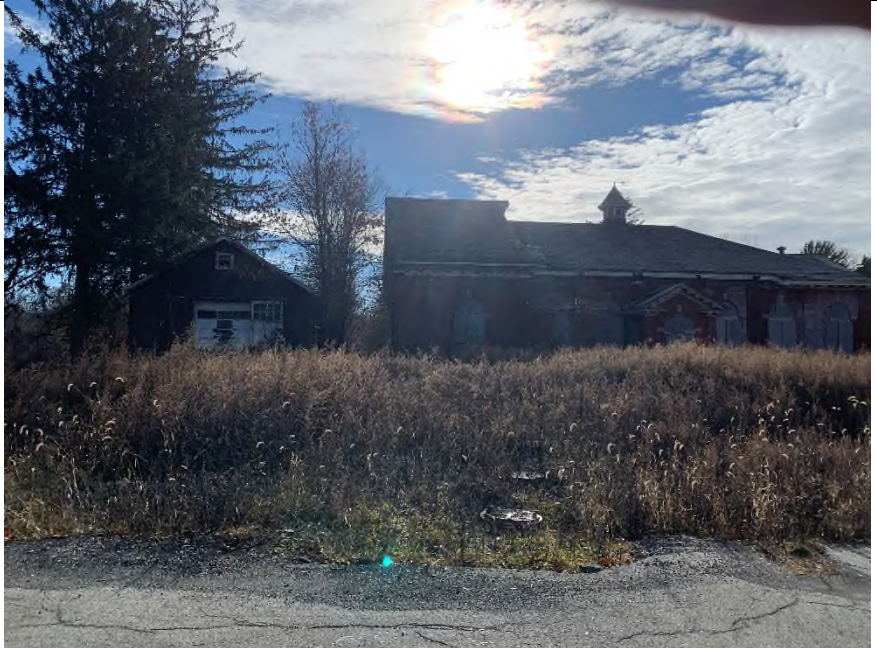
Photo 14 –

Recreational Hall.

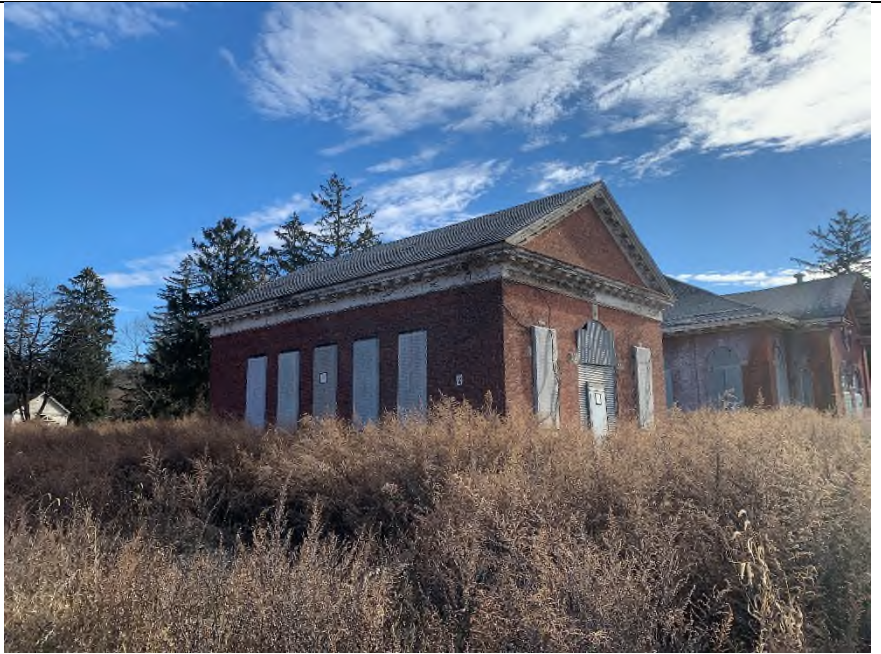
Photo 15 –

Library.

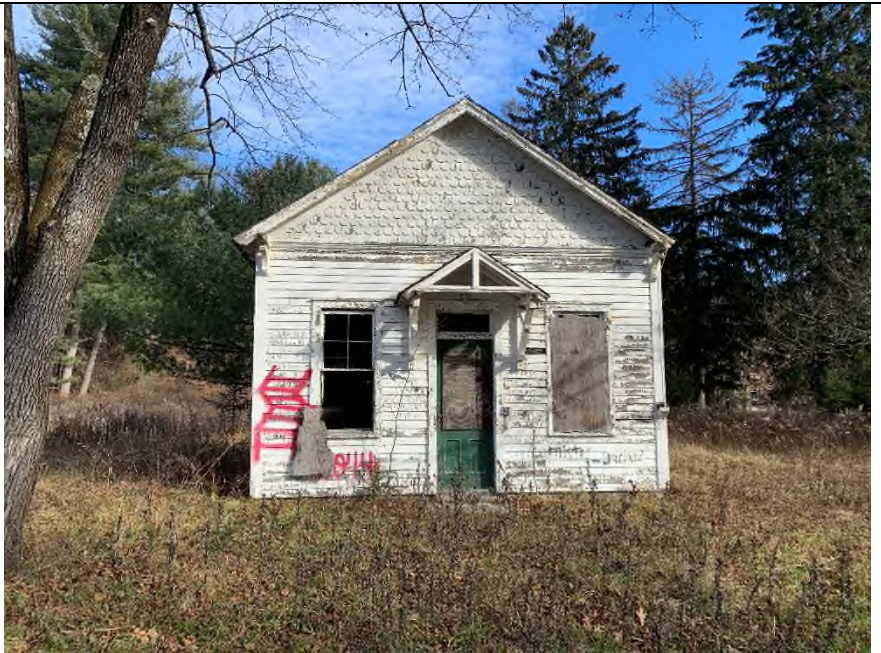
Photo 16 –

Small structure east of the Library.

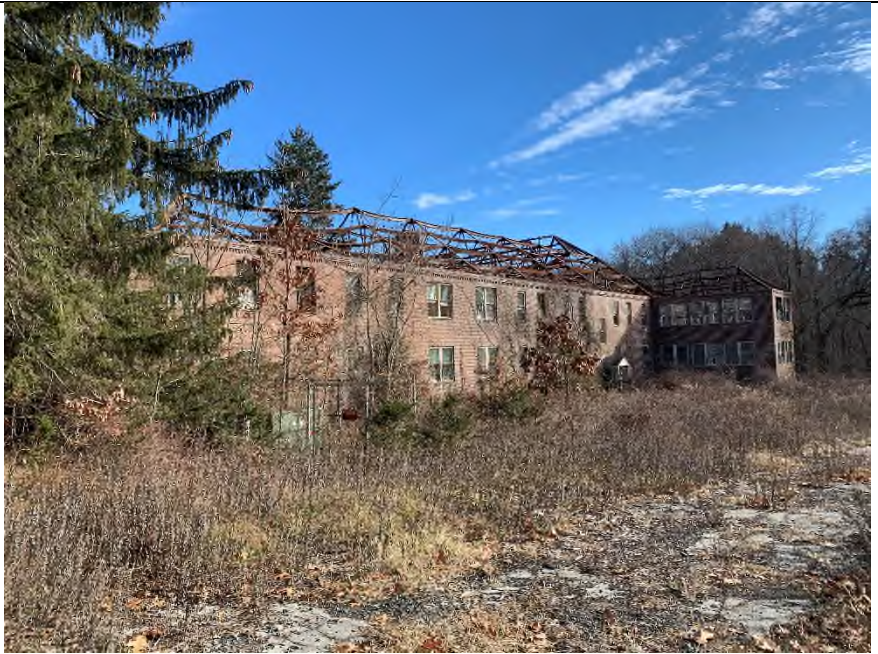
Photo 17 –

Brookside structure, severe deterioration of roof.

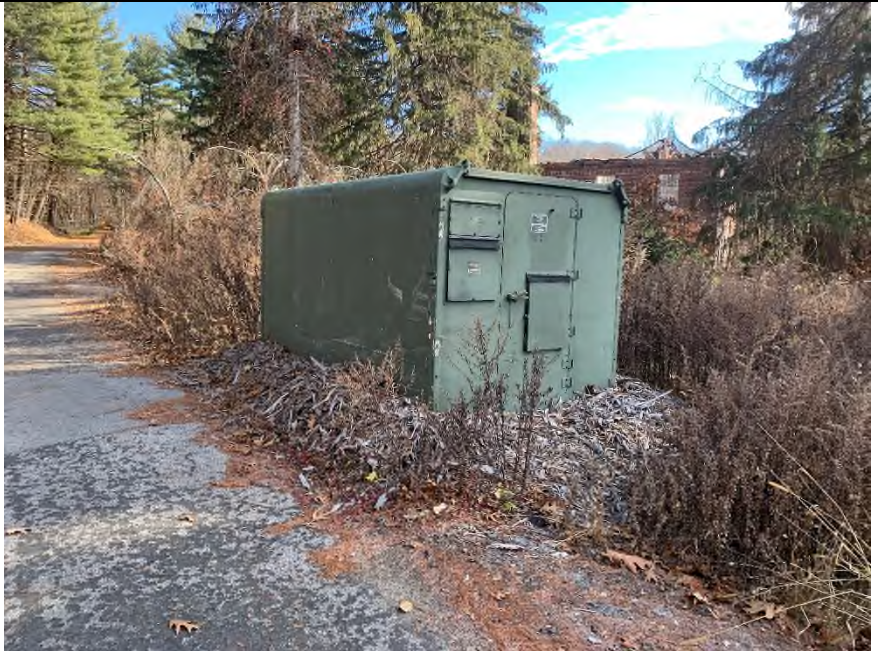
Photo 18 –

Metal container placed over fire hydrant. Base of container is bordered with wood chips.

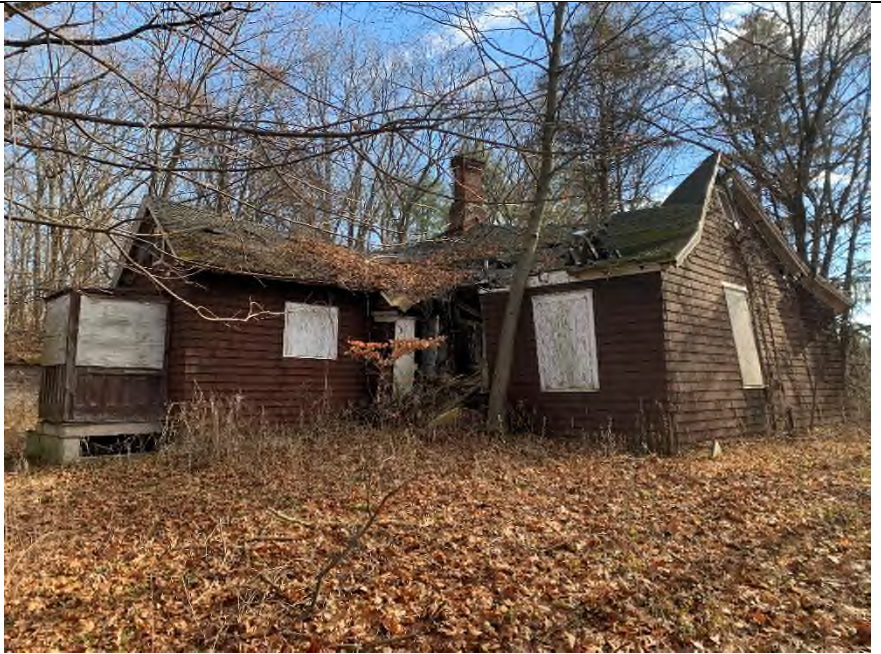
Photo 19 –

Staff House, severe deterioration of roof and interior floor.

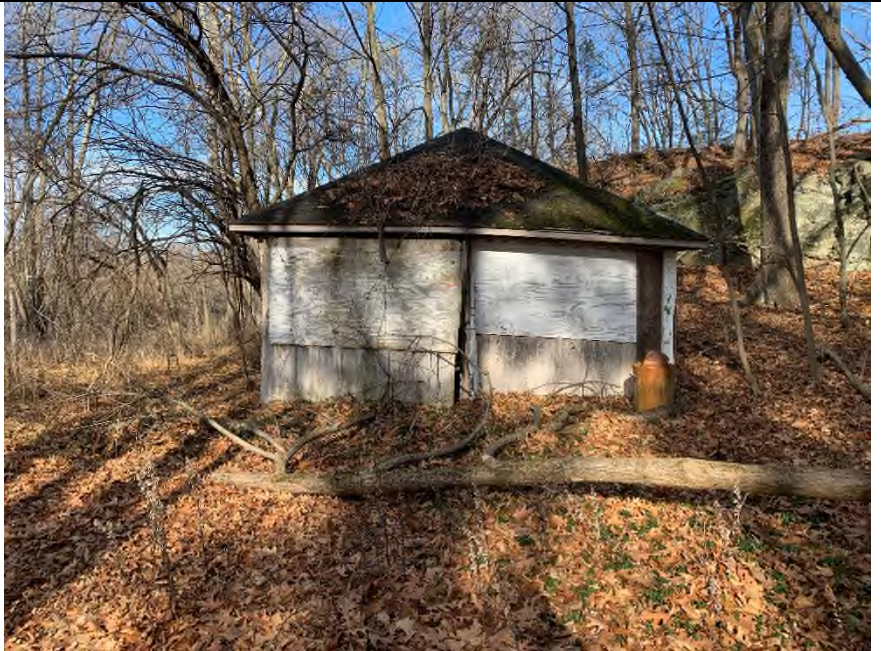
Photo 20 –

Small structure east of the Staff House.
