## MONTHLY STATUS REPORT

| BCP No.: | C314121 | PVE Project No.: | 560909 | Date: | 1/24/2022 |
| Project Name: | 3532 North Road, Dutchess County, Poughkeepsie, New York | | | | |

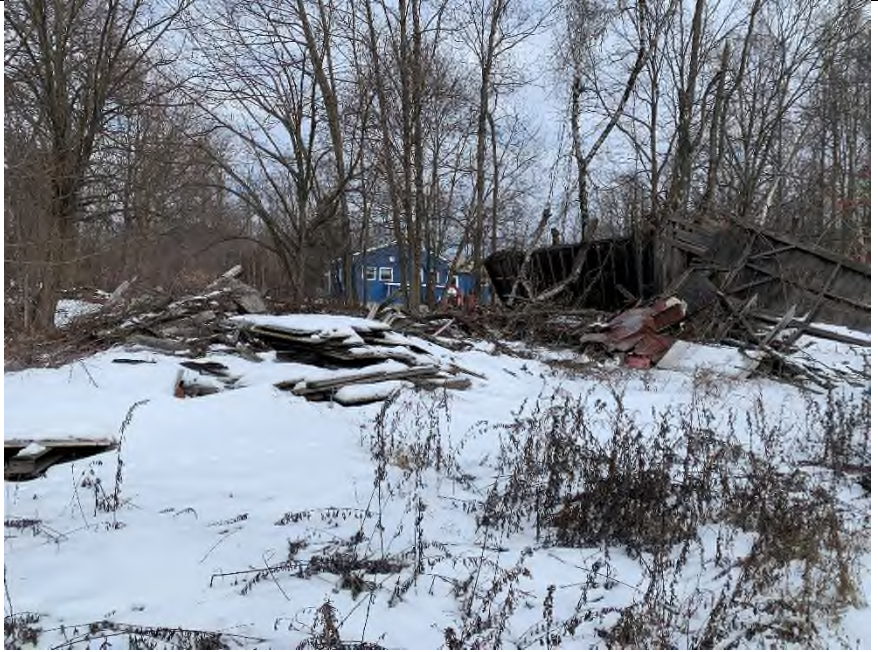
Photo 1 –  
Auto Garage East (Collapsed).

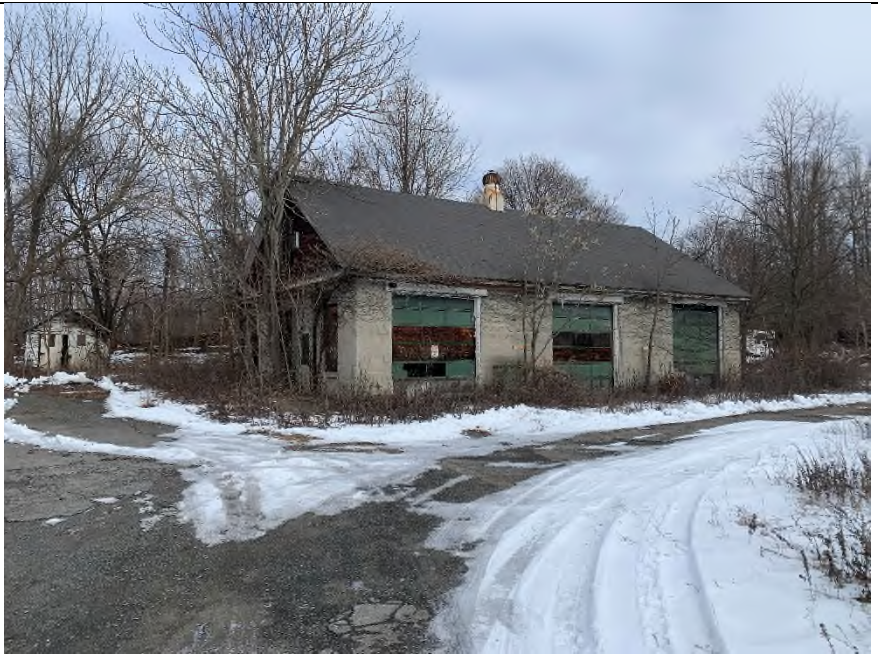
Photo 2 –  
Auto Garage West.

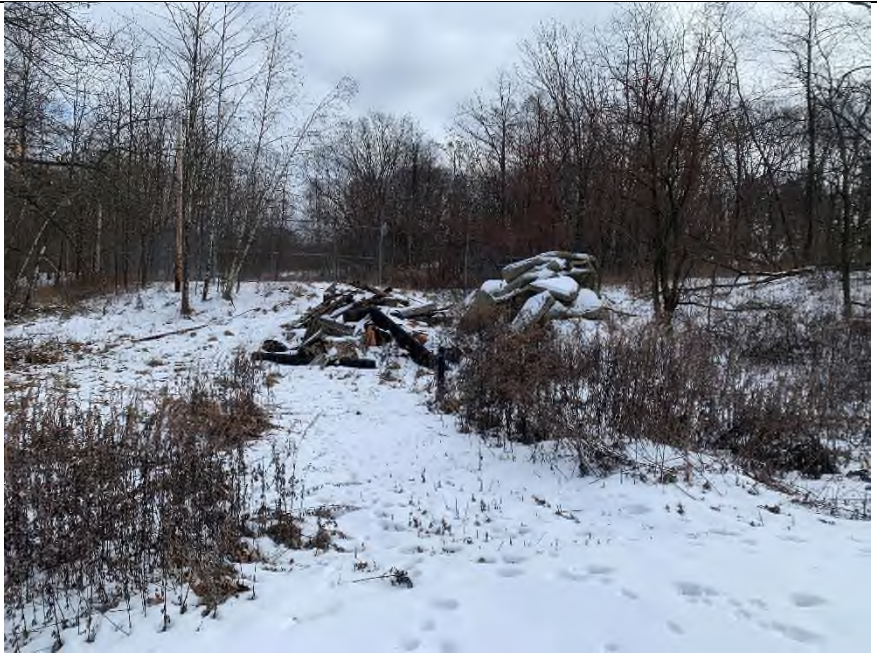
Photo 3 –

Pile of debris located south of Auto Garage East.

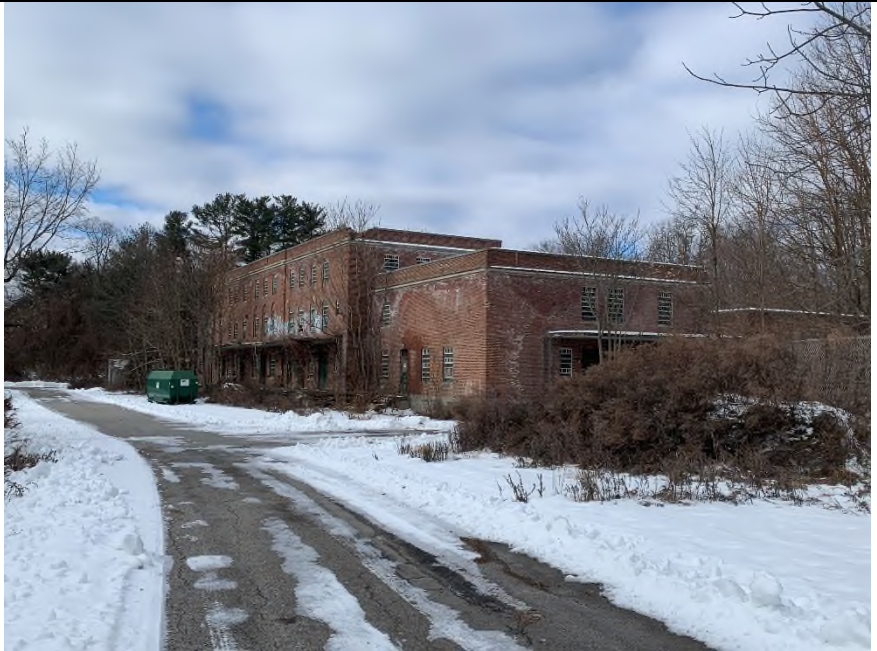
Photo 4 –

Bakery/Storage structure.  
Dumpster located south of structure.

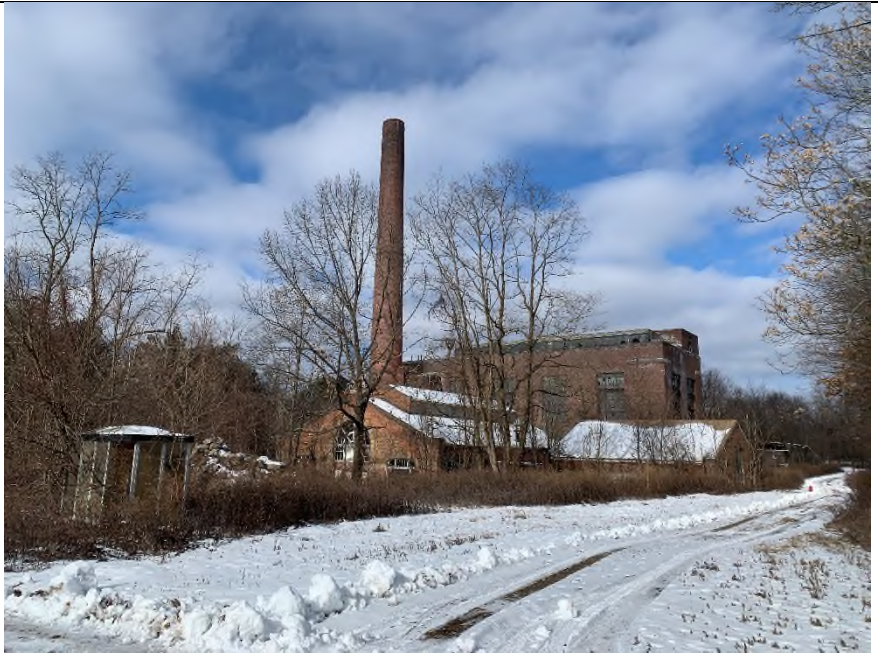
Photo 5 –

Powerhouse.

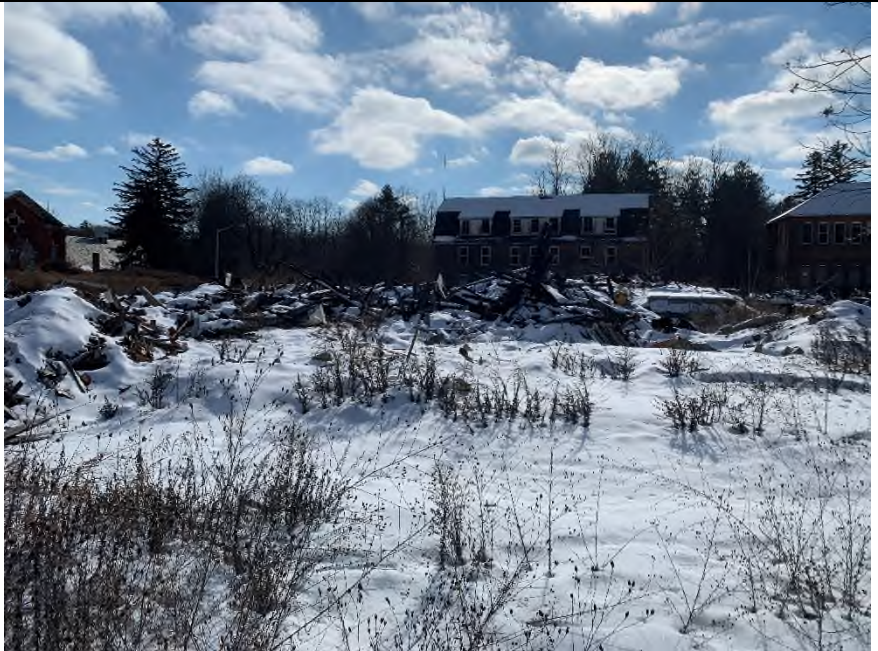
Photo 6 –

Engineering Building  
(Demolished).

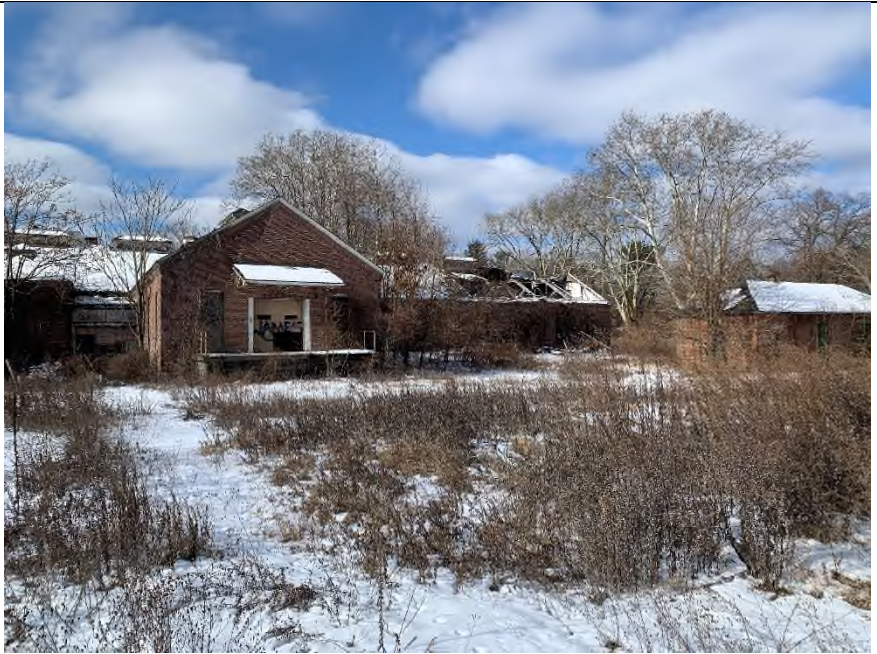
Photo 7 –

Carwash (pictured left) with shed (pictured right).

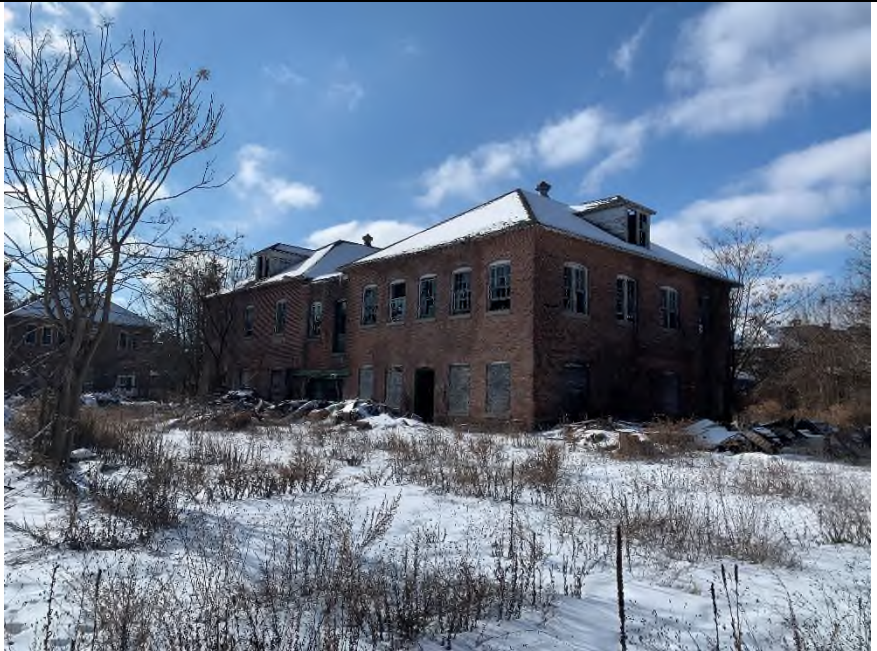
Photo 8 –

Maintenance Building with debris located east side of structure.

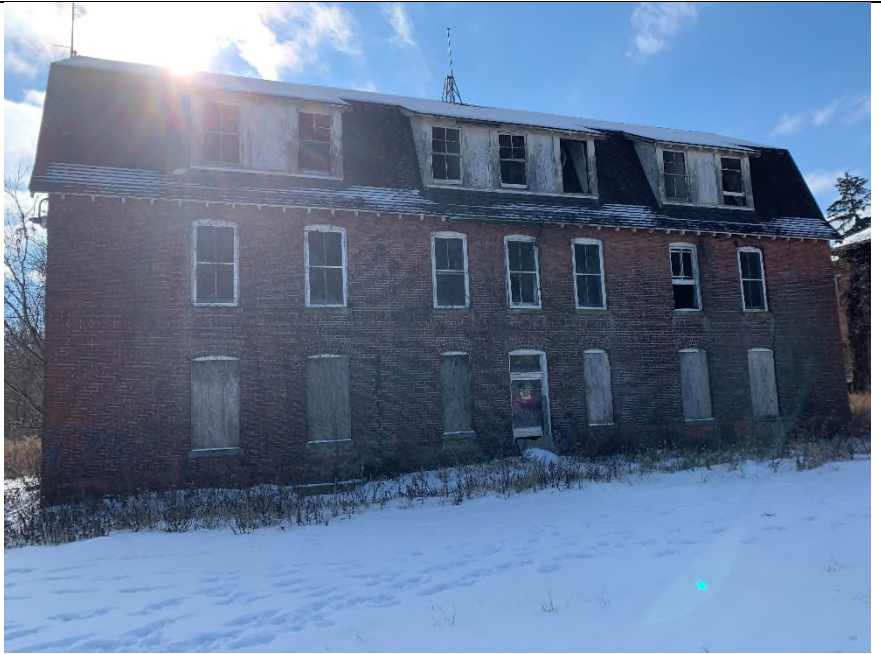
Photo 9 –

Fire House.

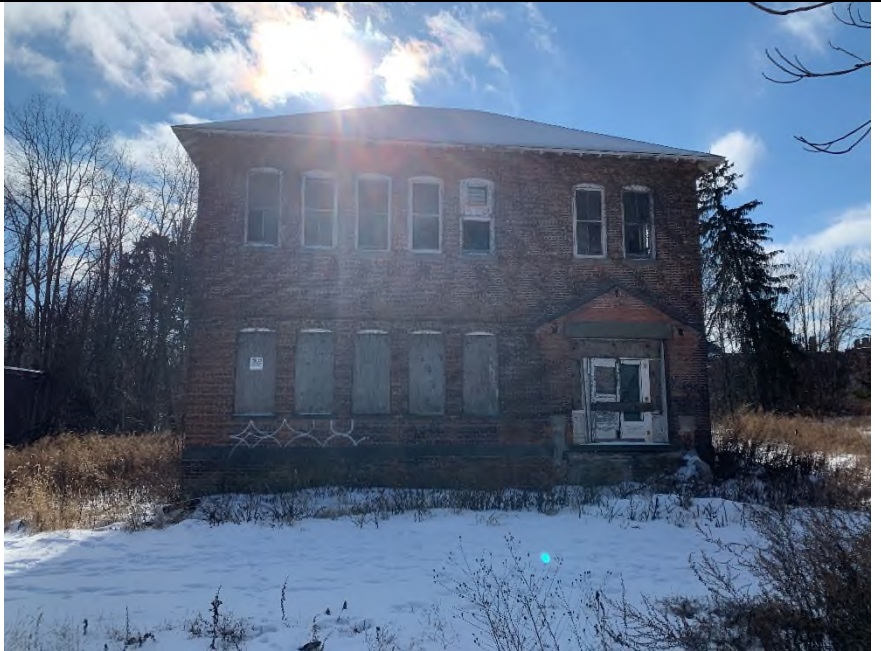
Photo 10 –

Mortuary Building.

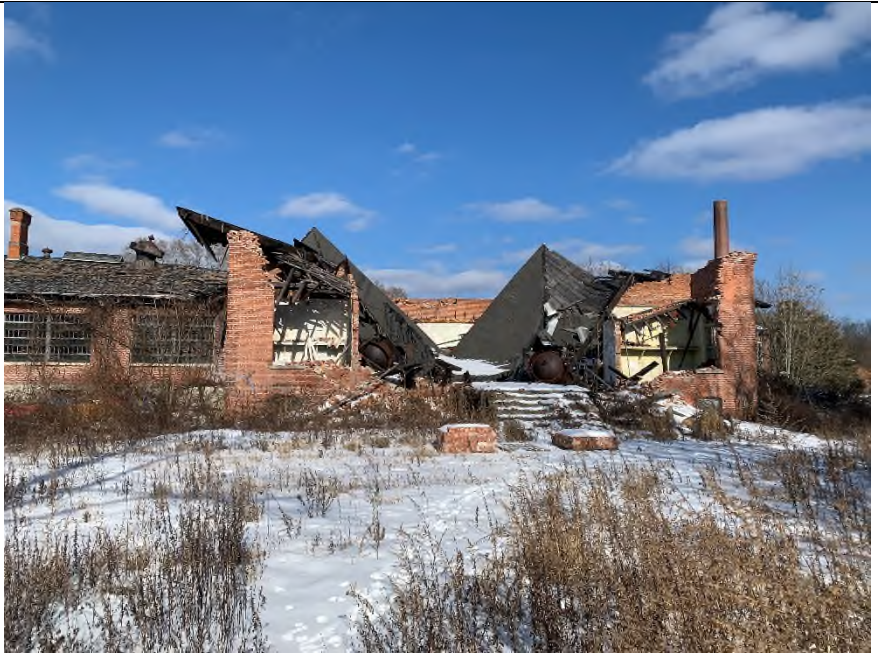
Photo 11 –

Structure west of the Mortuary Building, facing north (collapsed).

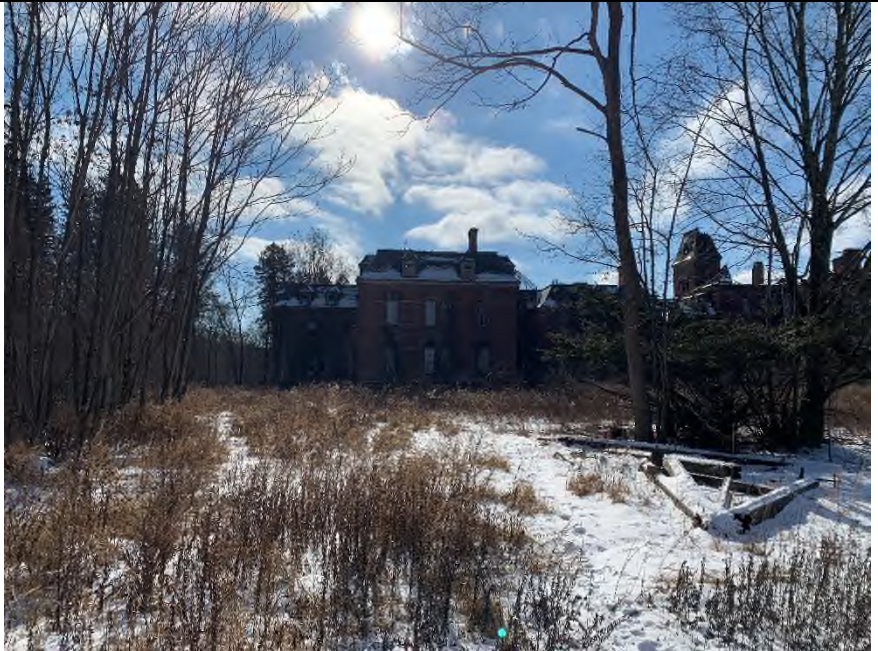
Photo 12 –

Structures in southwest corner of BCP Site, facing south.

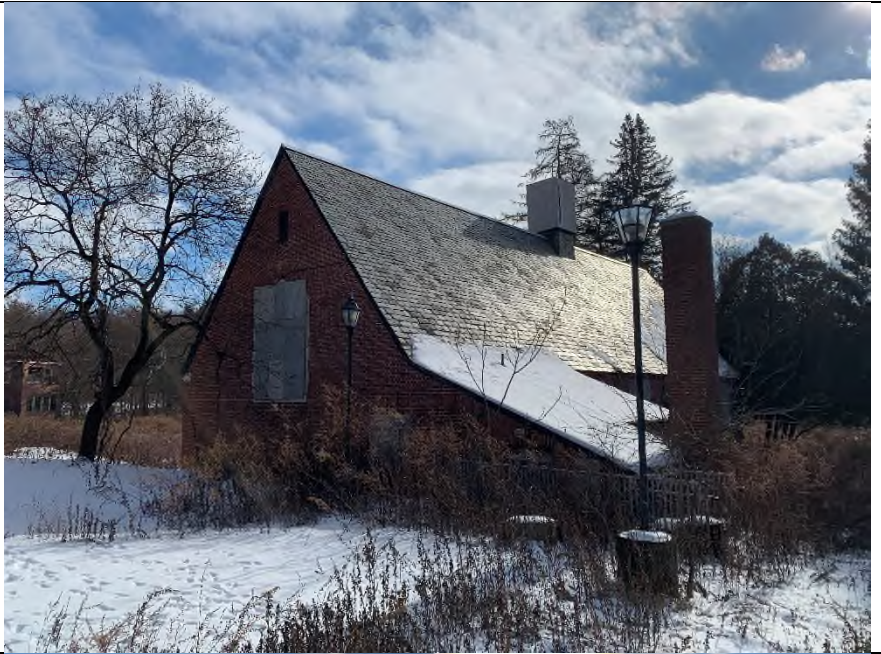
Photo 13 –

Rectory south of the Recreational Hall building.

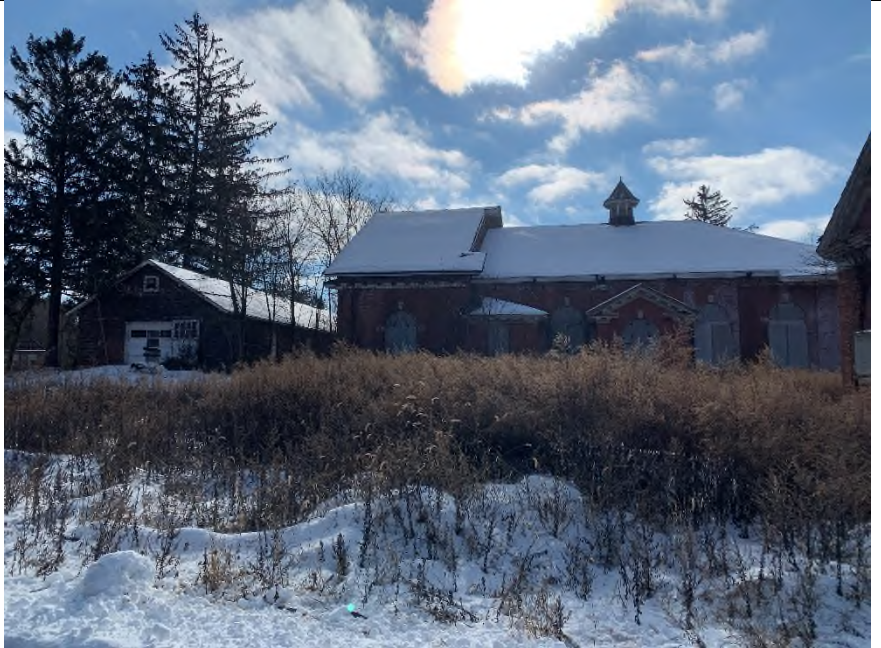
Photo 14 –

Recreational Hall.

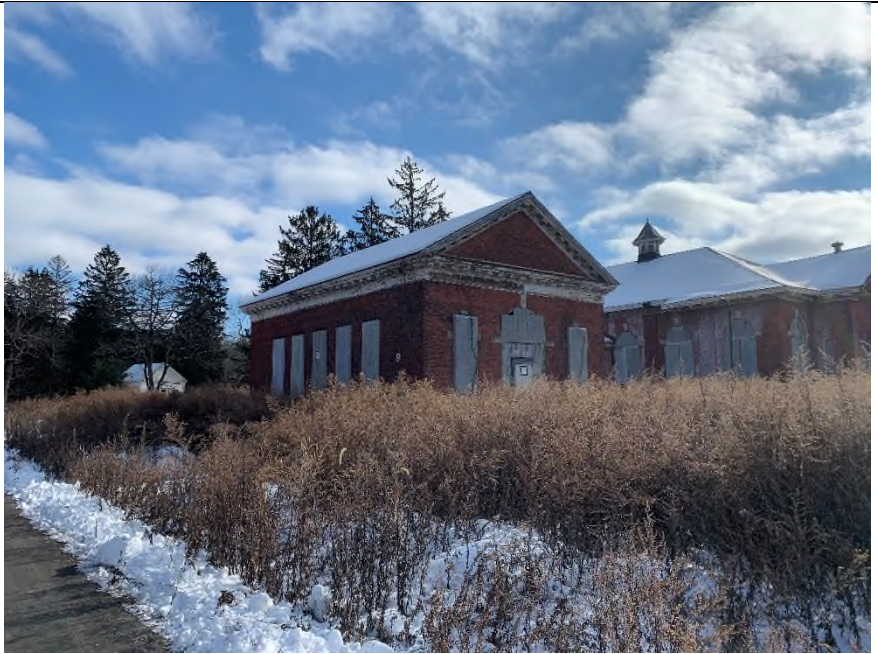
Photo 15 –

Library.

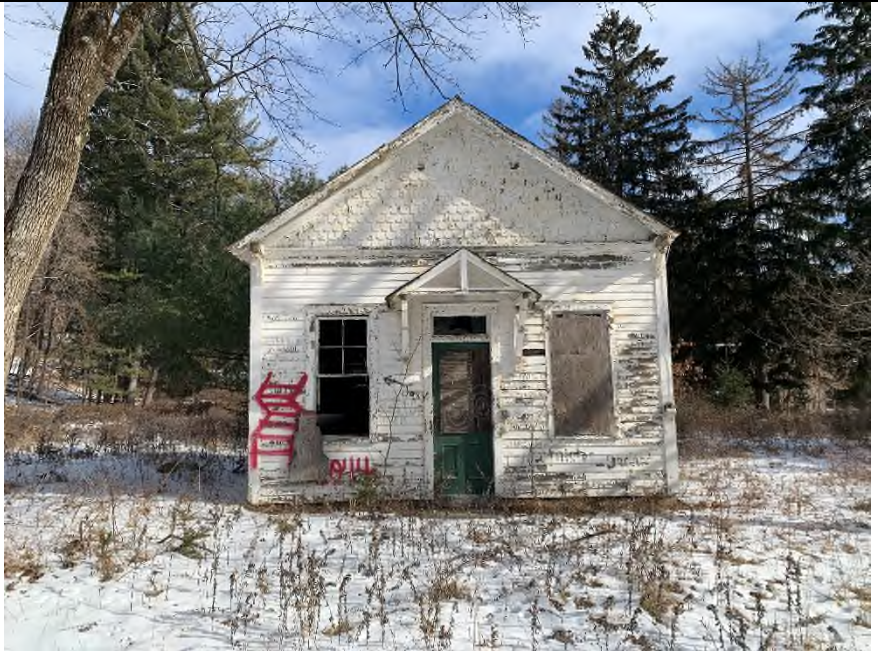
Photo 16 –

Small structure east of the Library.

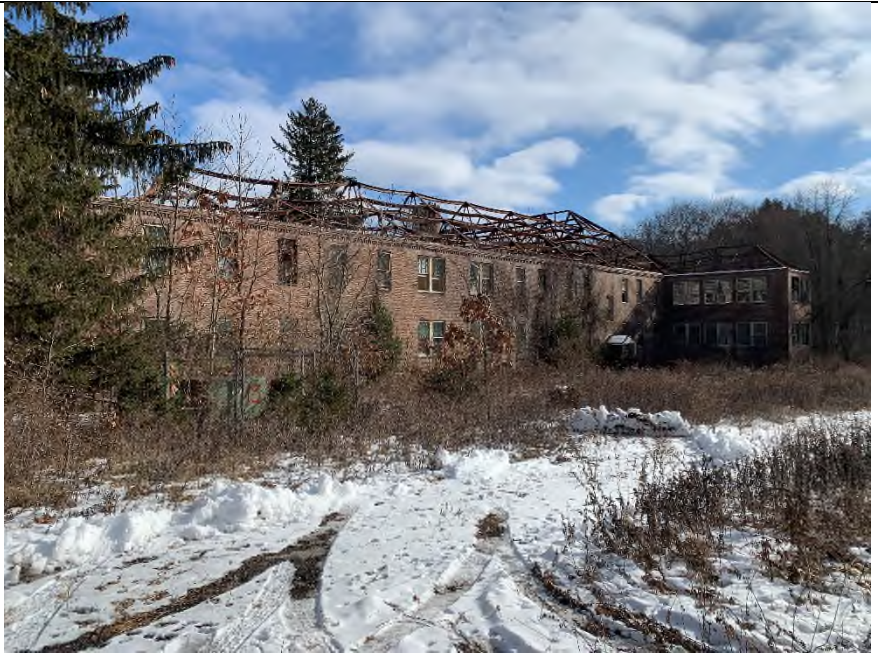
Photo 17 –

Brookside structure, severe deterioration of roof.

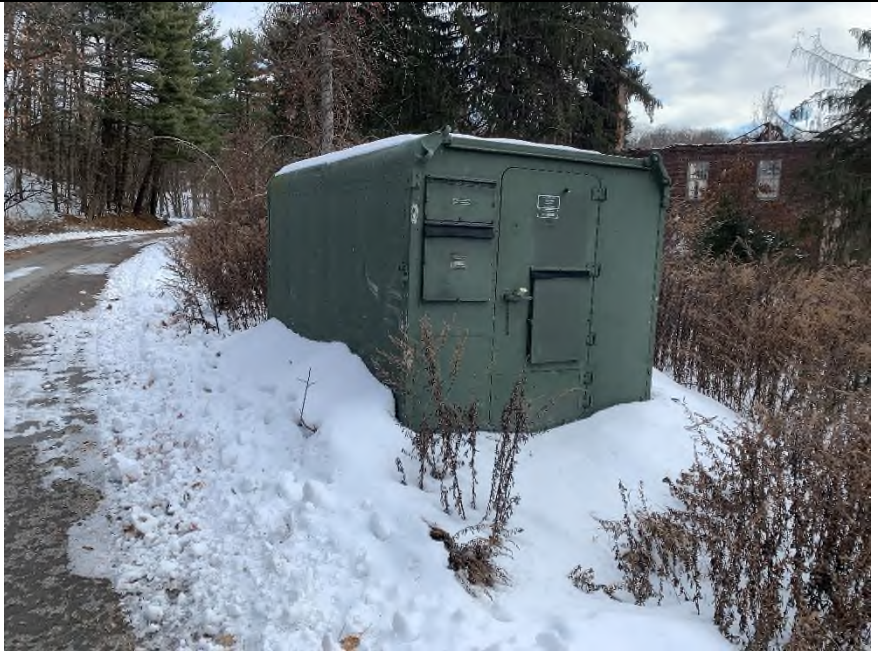
Photo 18 –

Metal container placed over fire hydrant. Base of container is bordered with wood chips.

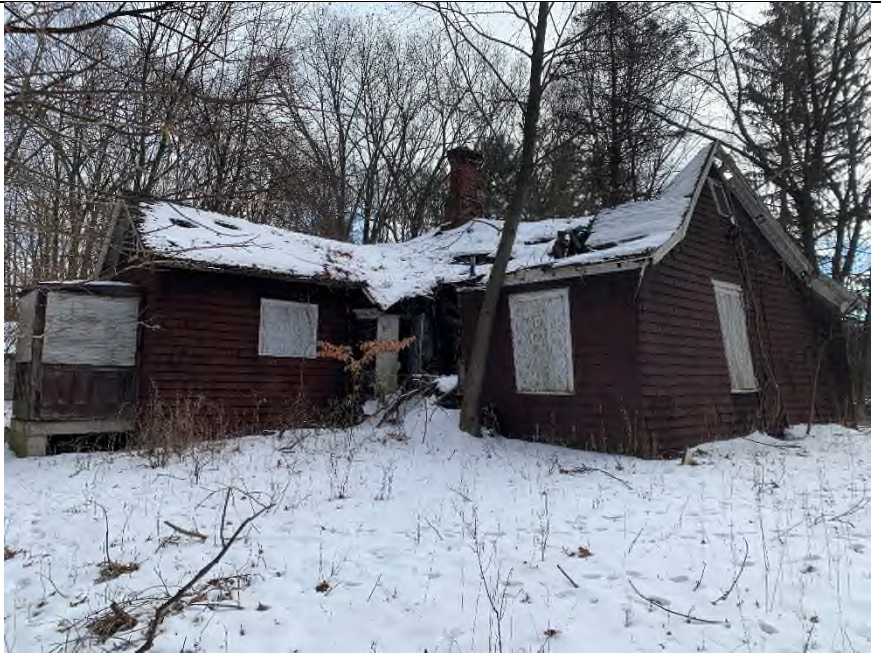
Photo 19 –

Staff House, severe deterioration of roof and interior floor.

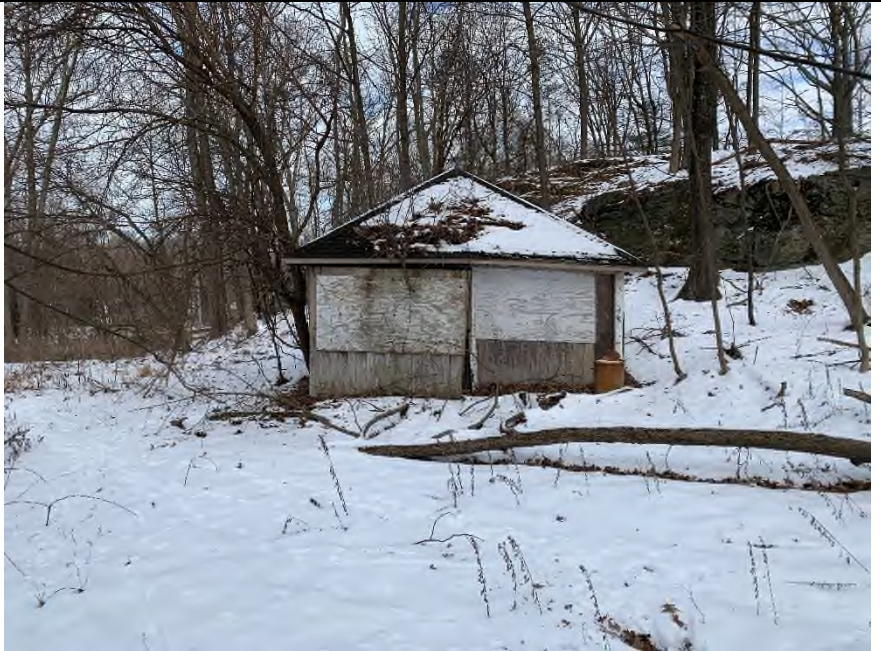
Photo 20 –

Small structure east of the Staff House.
