MONTHLY STATUS REPORT

BCP No.:	C314121	PVE Project No.:	560909	Date:	2/17/2022
Project Name:	3532 North Road, Dutchess County, Poughkeepsie, New York

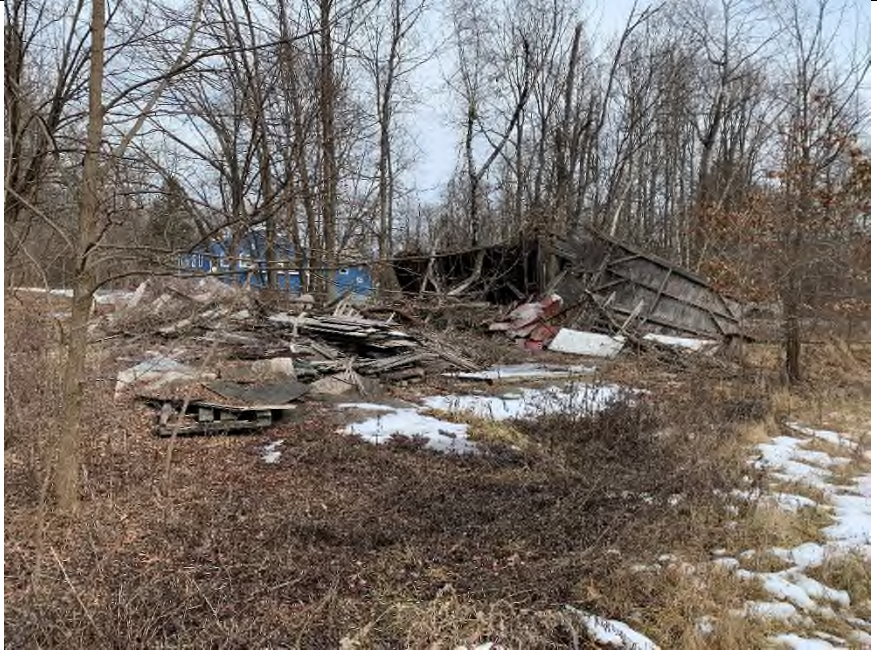
Photo 1 –

Auto Garage East (Collapsed).

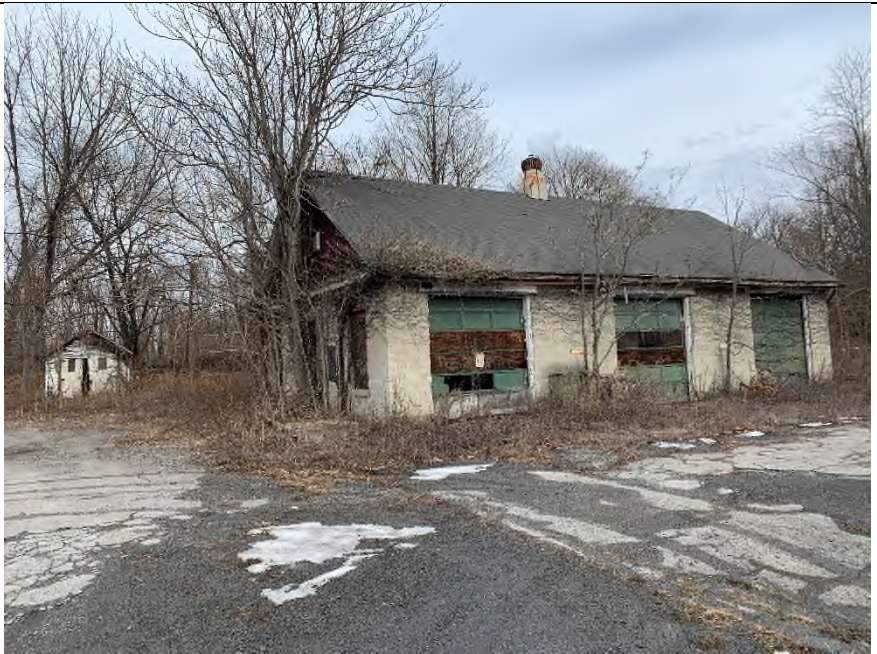
Photo 2 –

Auto Garage West.

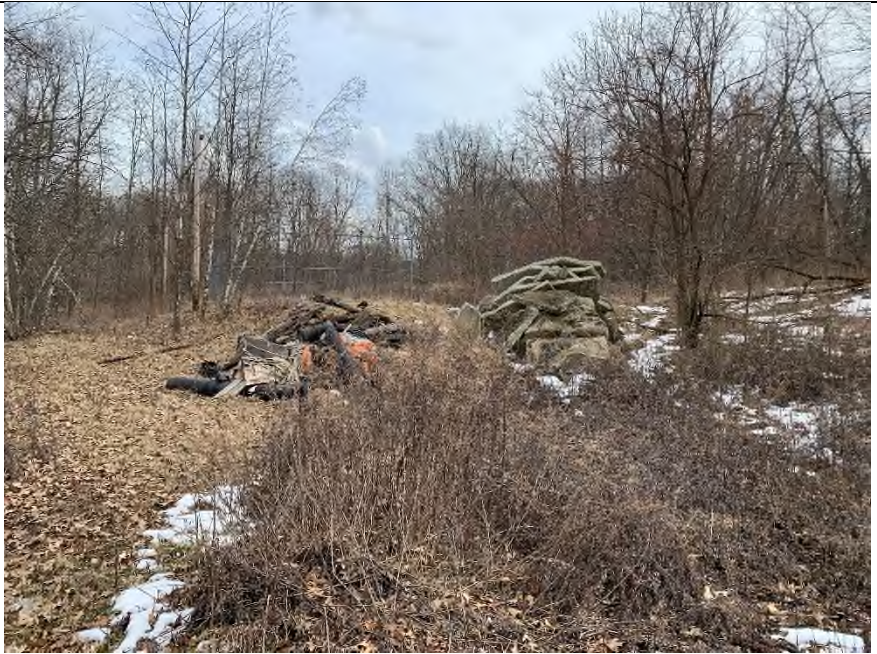
Photo 3 –

Pile of debris located south of Auto Garage East.

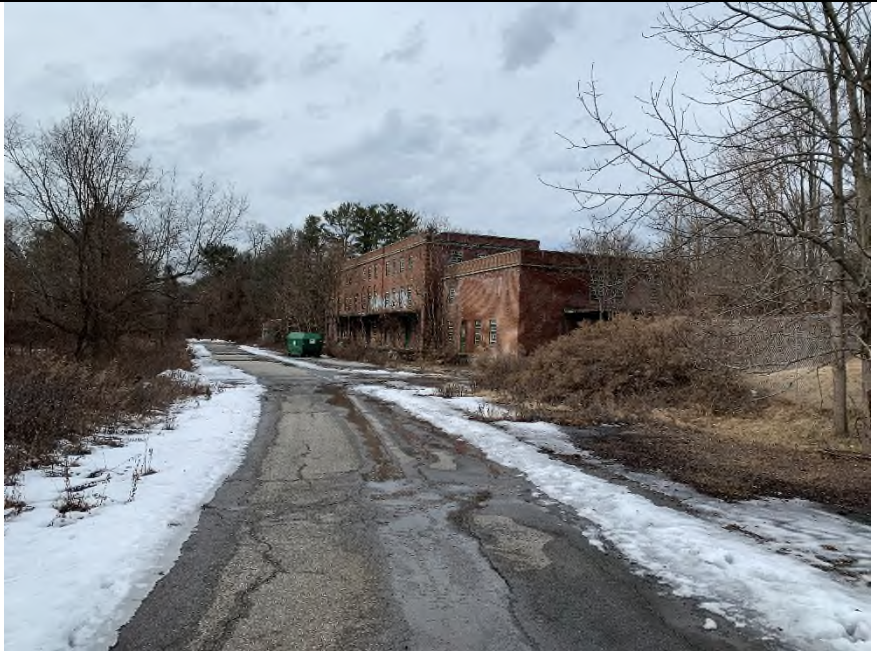
Photo 4 –

Bakery/Storage structure.
Dumpster located south of structure.

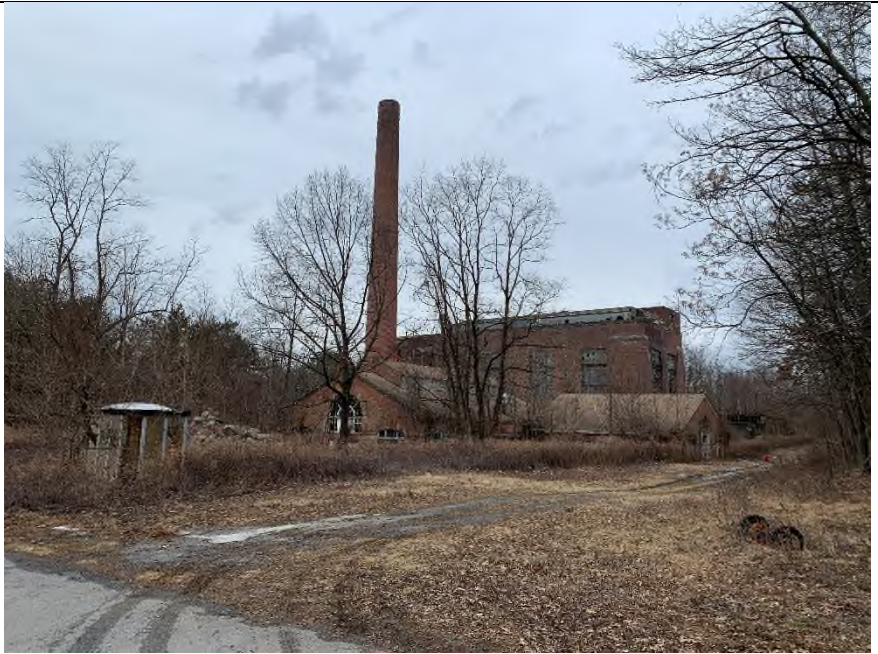
Photo 5 –

Powerhouse.

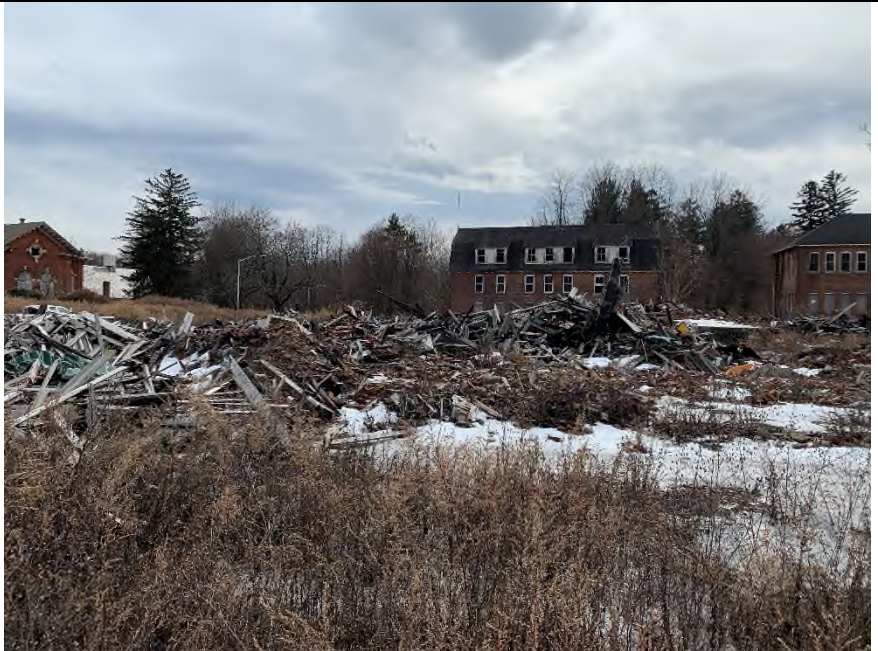
Photo 6 –

Engineering Building
(Demolished).

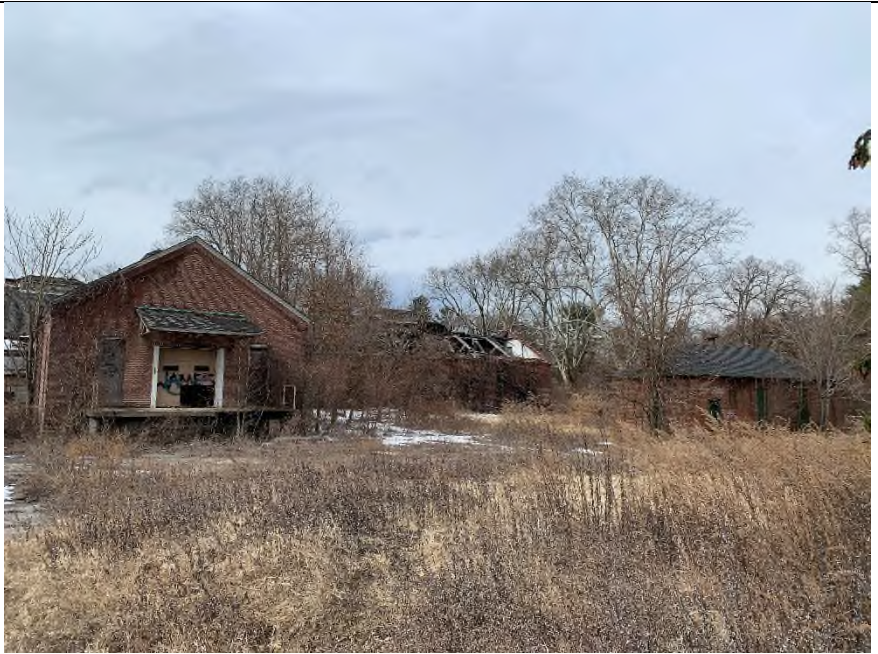
Photo 7 –

Carwash (pictured left) with shed (pictured right).

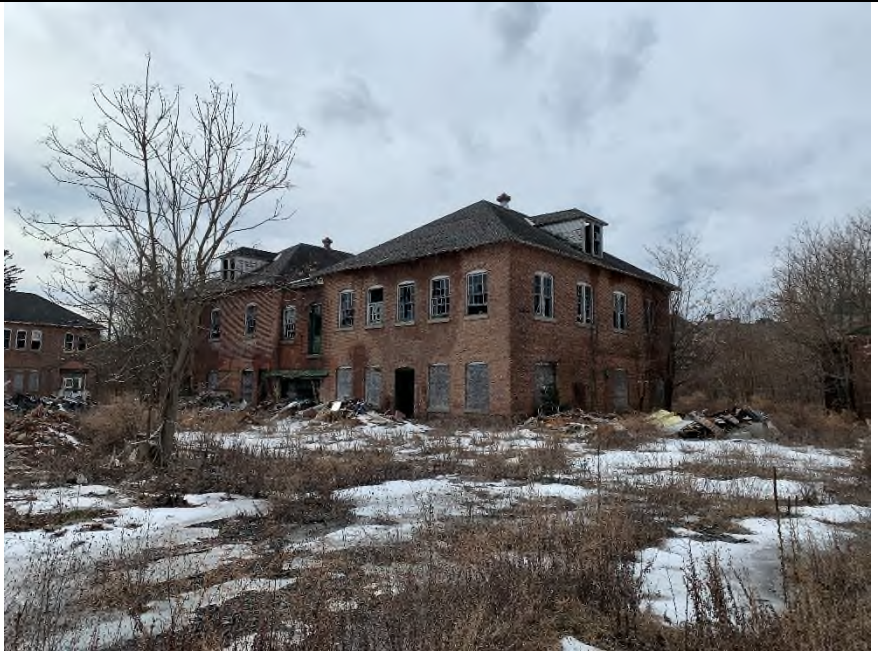
Photo 8 –

Maintenance Building with debris located east side of structure.

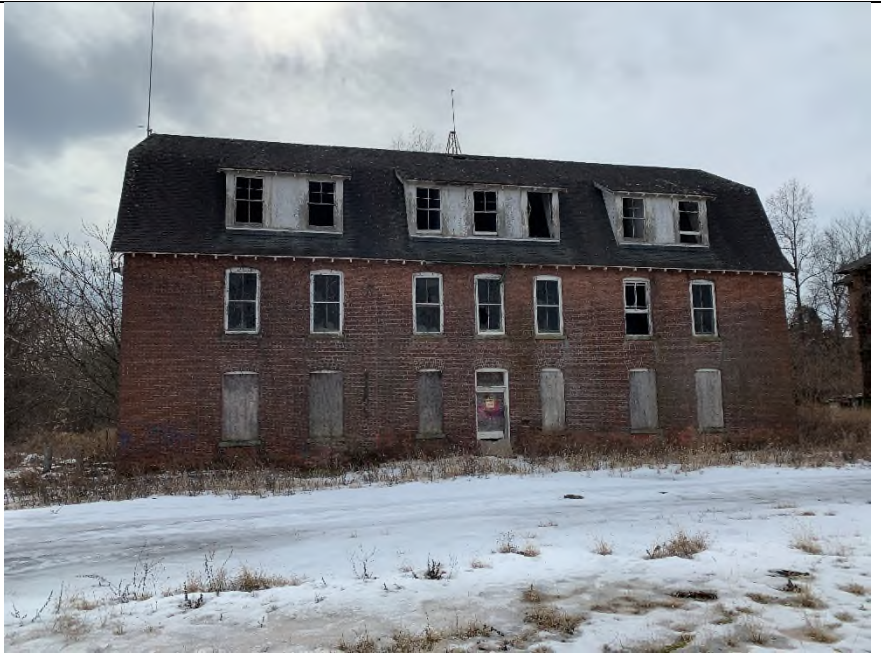
Photo 9 –

Fire House.

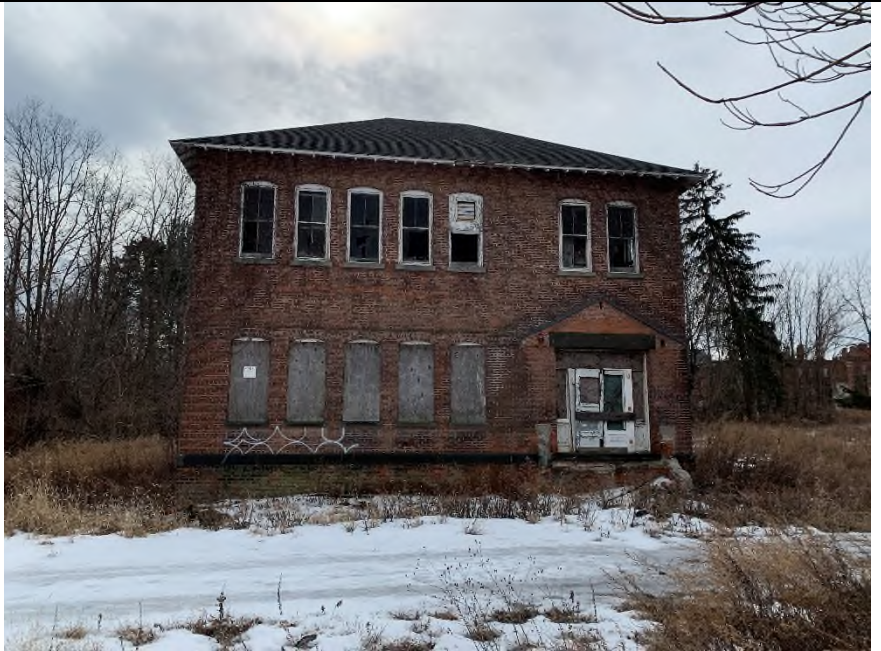
Photo 10 –

Mortuary Building.

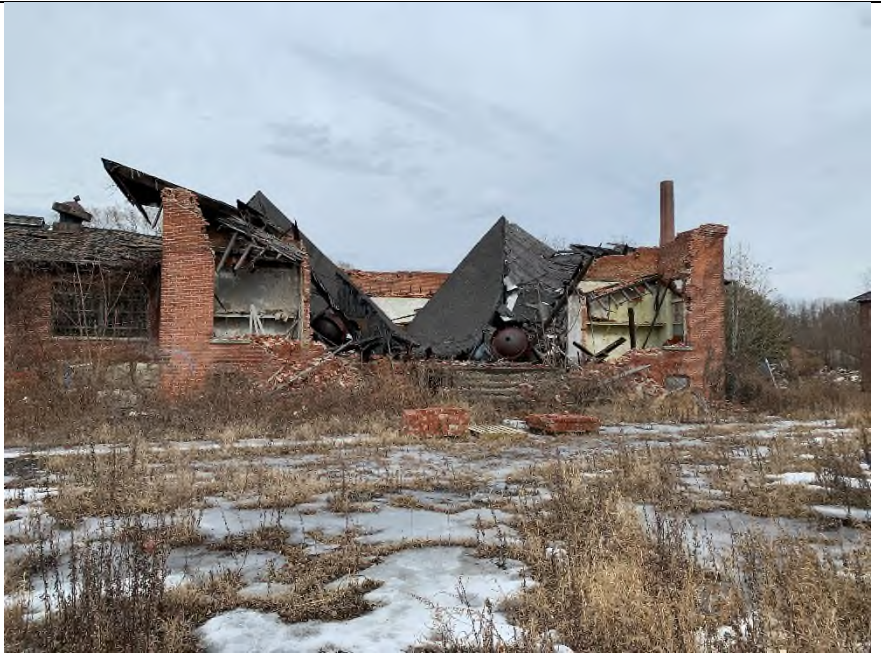
Photo 11 –

Structure west of the Mortuary Building, facing north (collapsed).

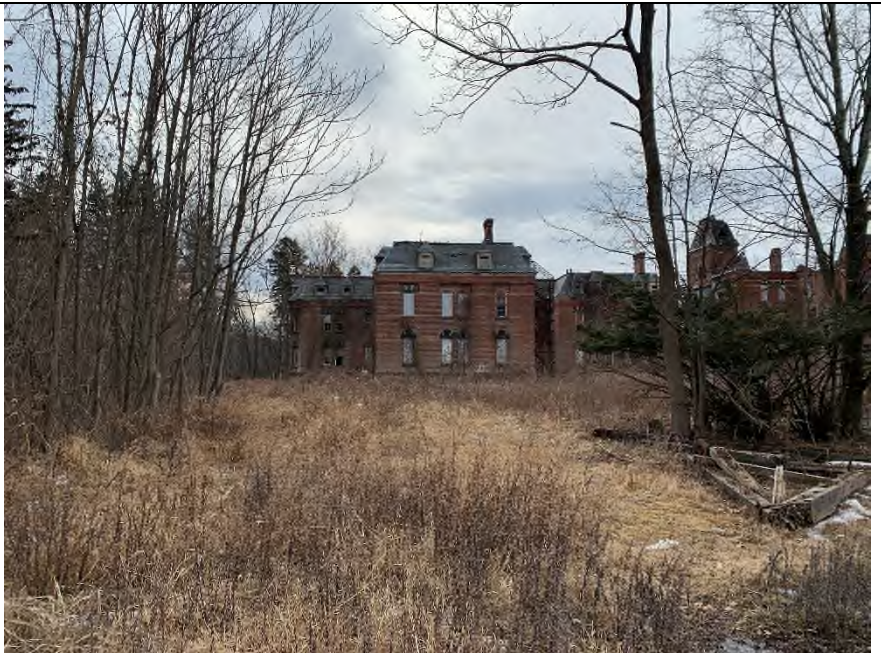
Photo 12 –

Structures in southwest corner of BCP Site, facing south.

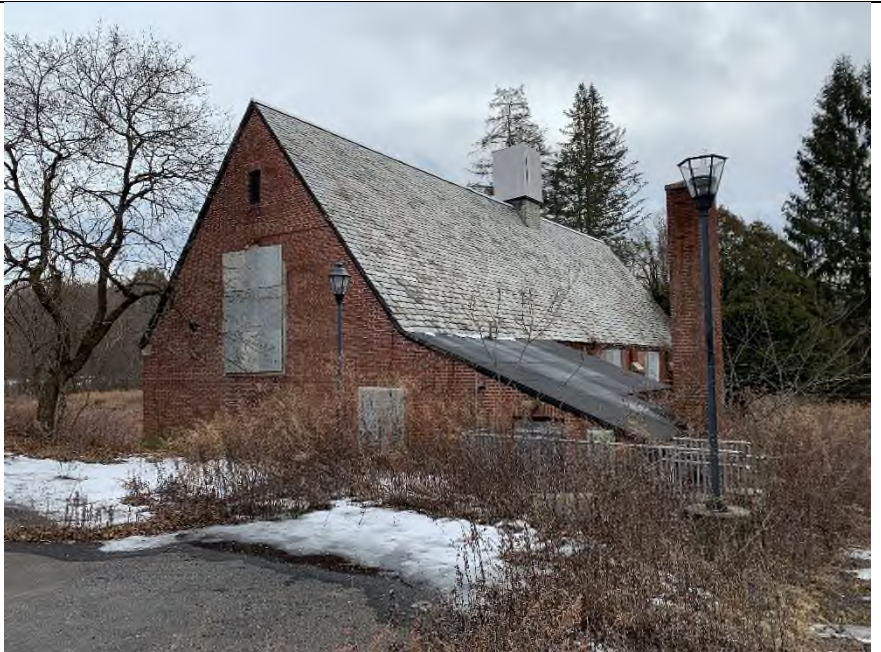
Photo 13 –

Rectory south of the Recreational Hall building.

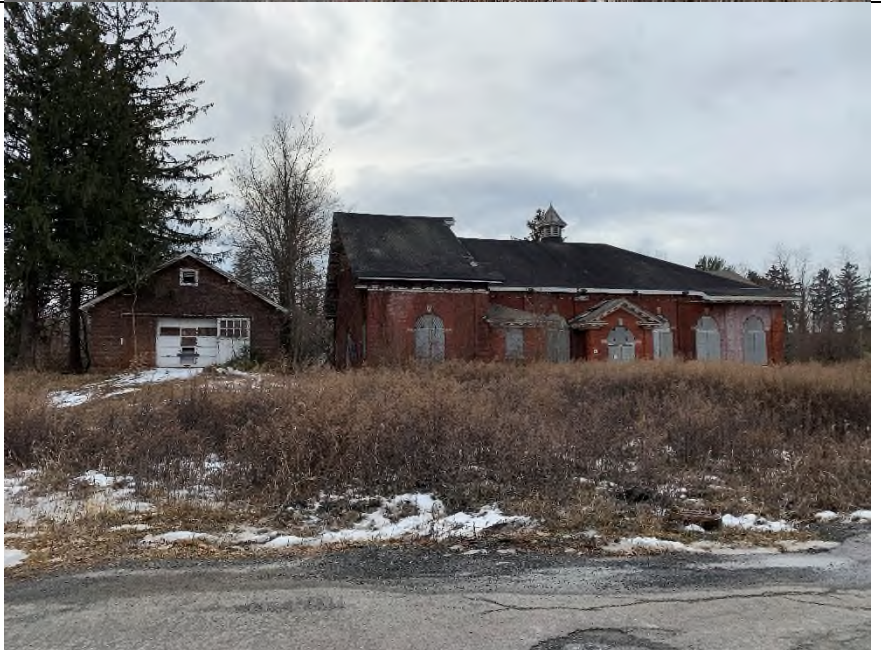
Photo 14 –

Recreational Hall.

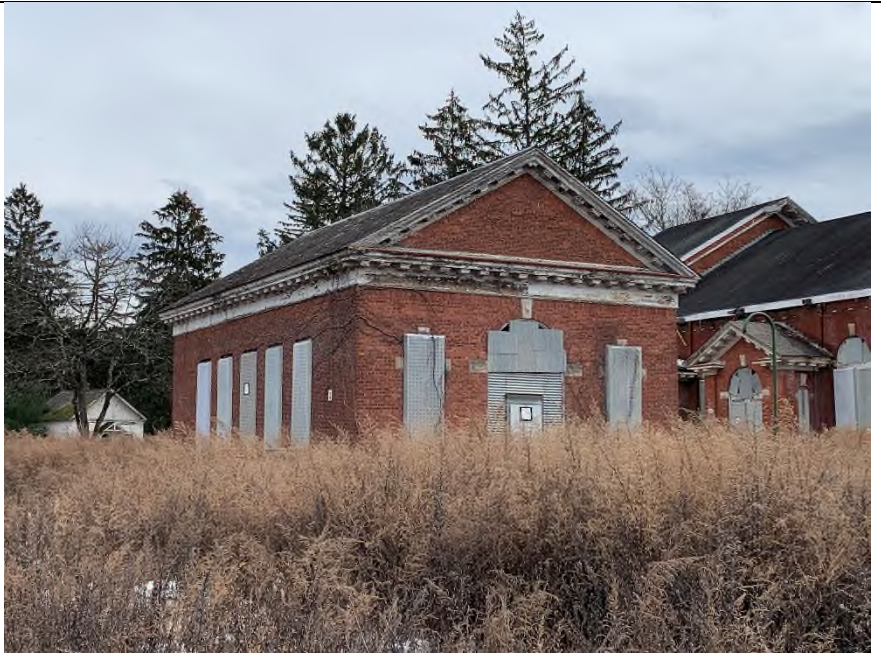
Photo 15 –

Library.

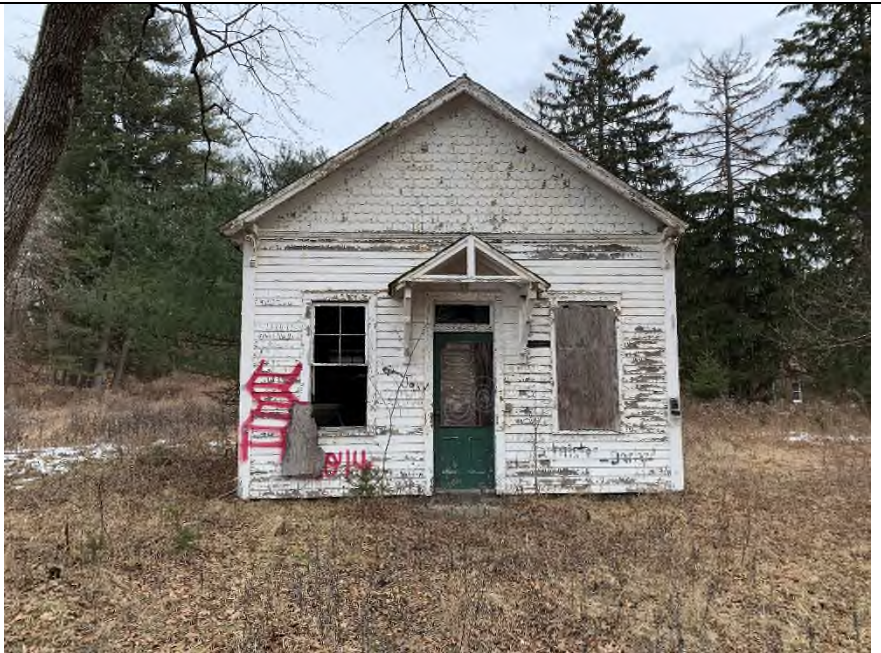
Photo 16 –

Small structure east of the Library.

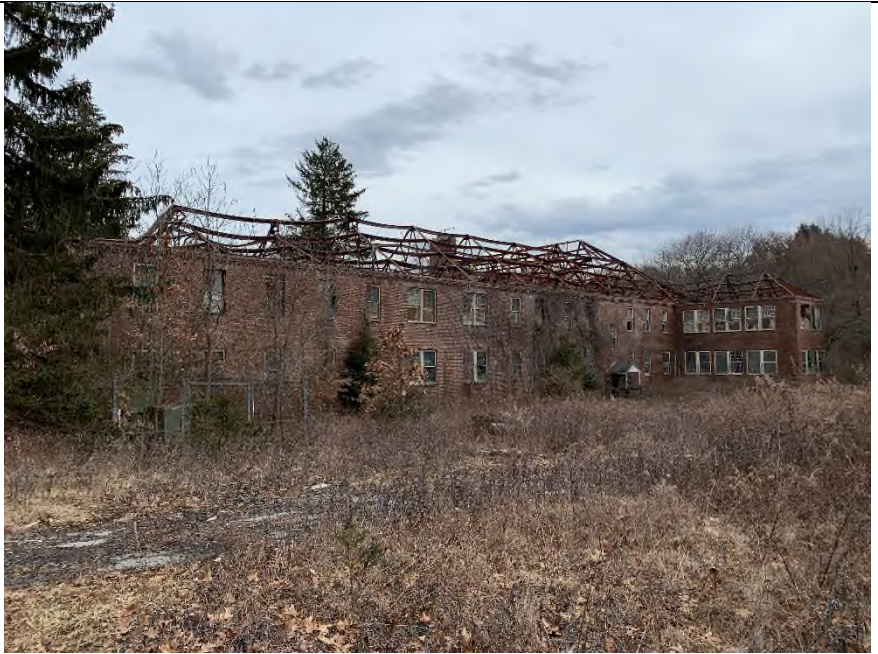
Photo 17 –

Brookside structure, severe deterioration of roof.

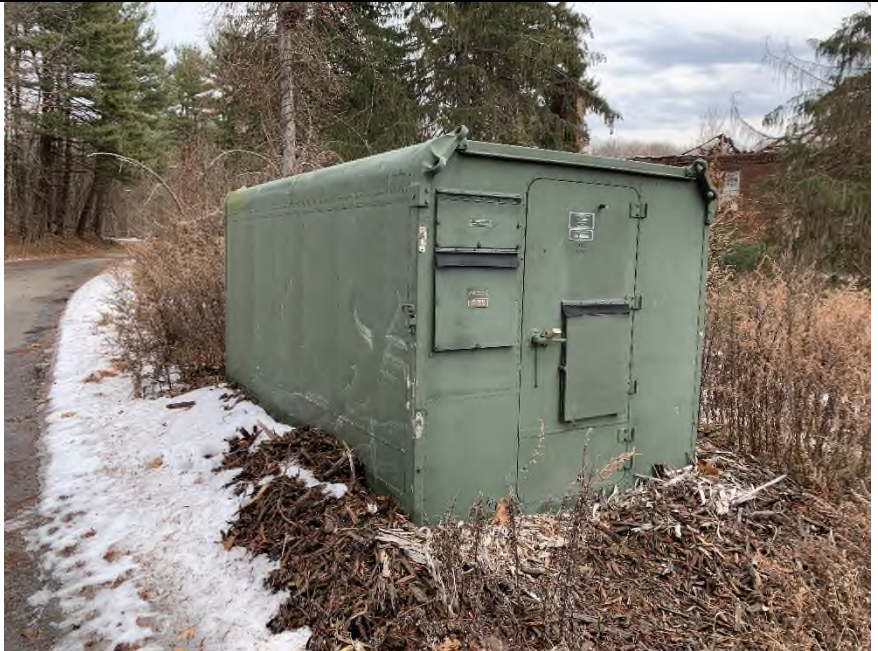
Photo 18 –

Metal container placed over fire hydrant. Base of container is bordered with wood chips.

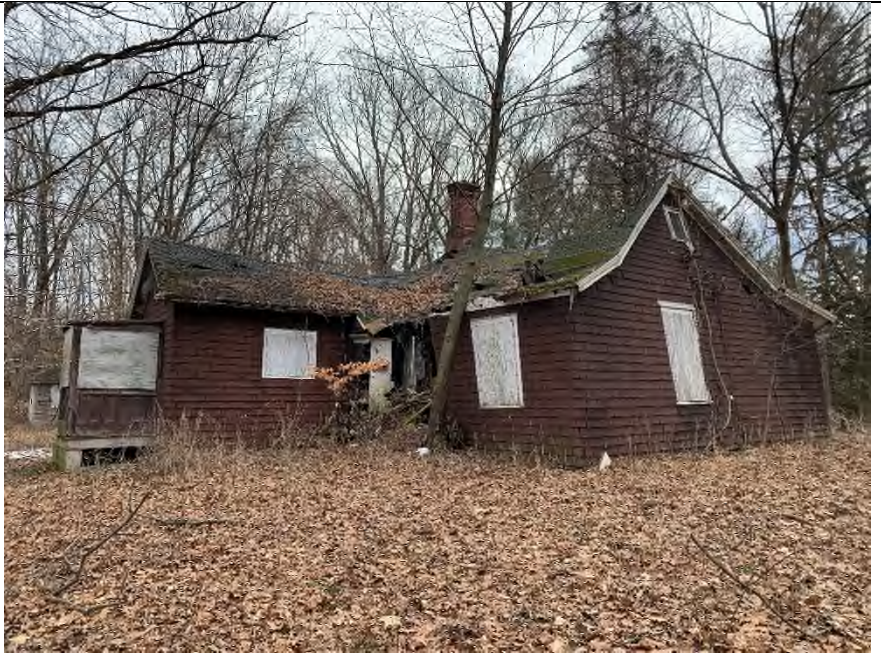
Photo 19 –

Staff House, severe deterioration of roof and interior floor.

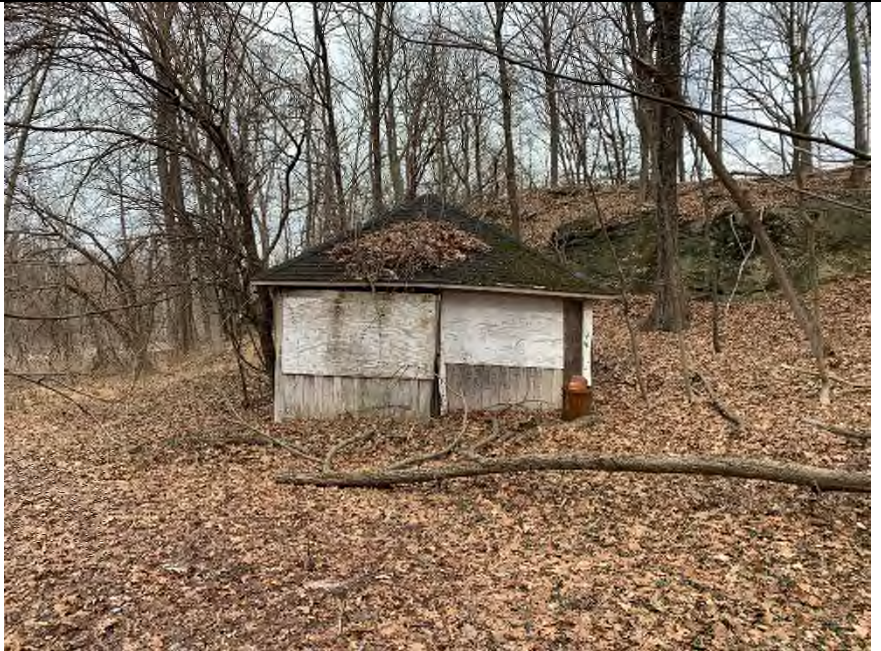
Photo 20 –

Small structure east of the Staff House.
