## MONTHLY STATUS REPORT

| BCP No.: | C314121 | PVE Project No.: | 560909 | Date: | 3/29/2022 |
| Project Name: | 3532 North Road, Dutchess County, Poughkeepsie, New York | | | | |

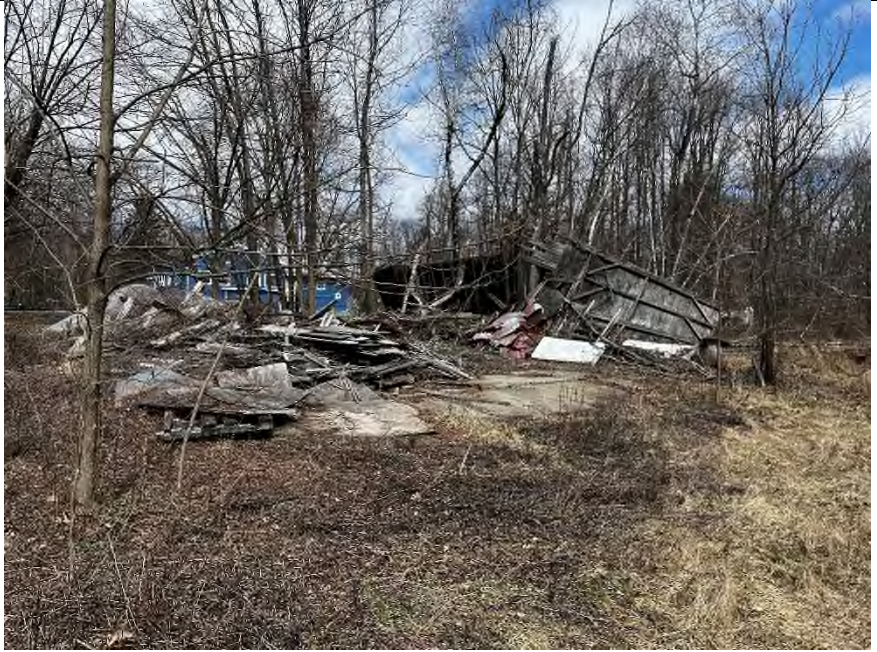
Photo 1 –  
Auto Garage East (Collapsed).

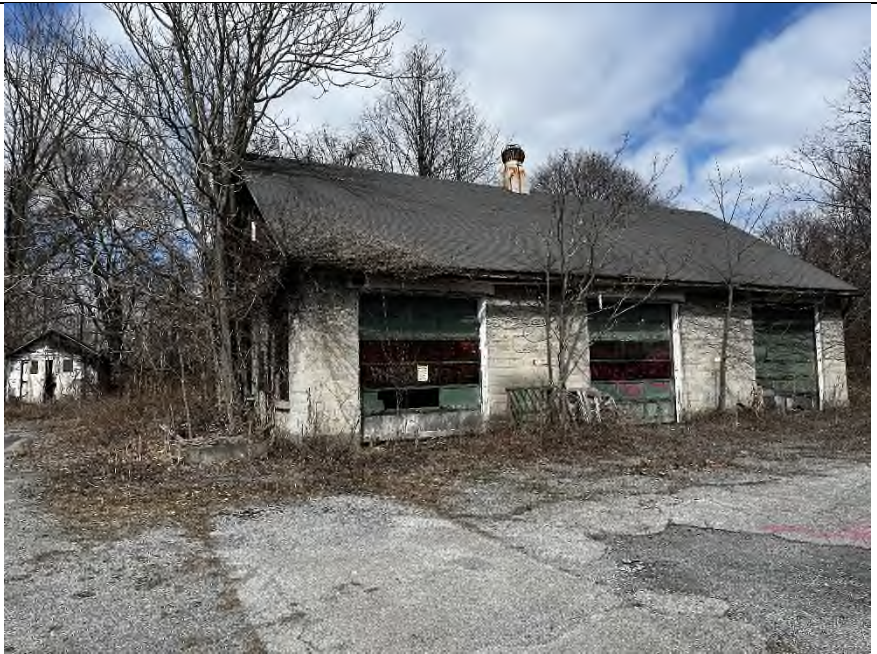
Photo 2 –  
Auto Garage West.

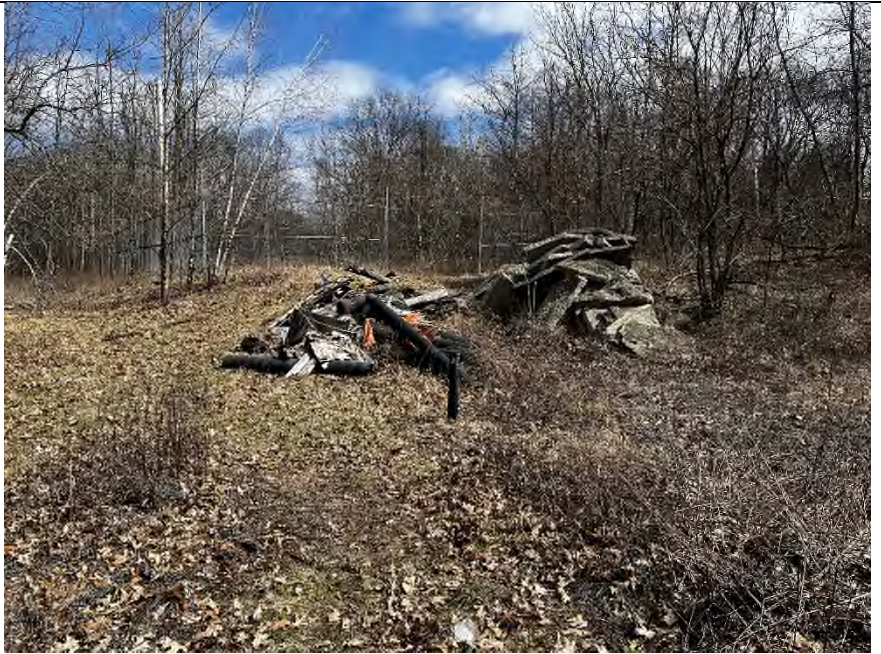
Photo 3 –

Pile of debris located south of Auto Garage East.

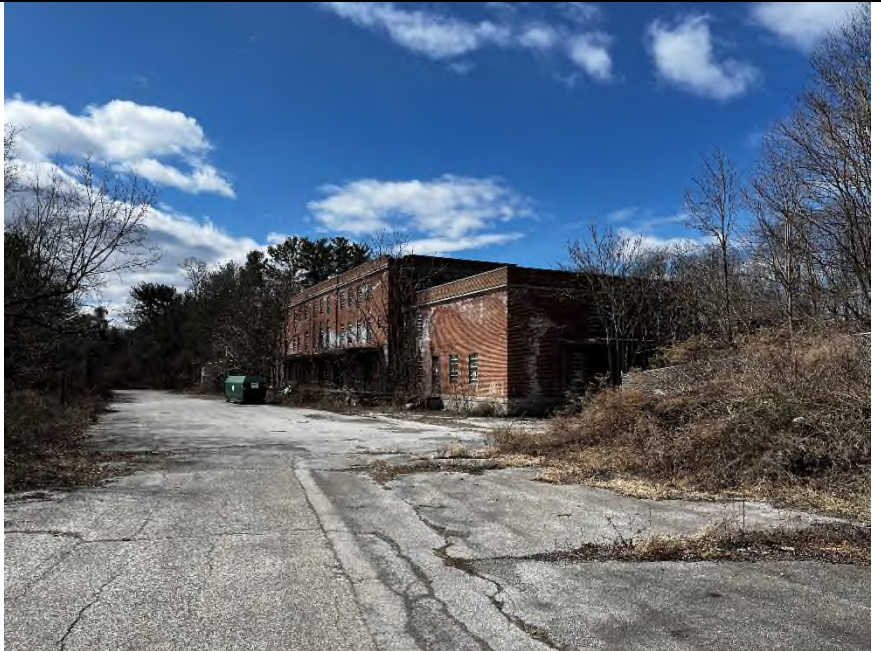
Photo 4 –

Bakery/Storage structure.  
Dumpster located south of structure.

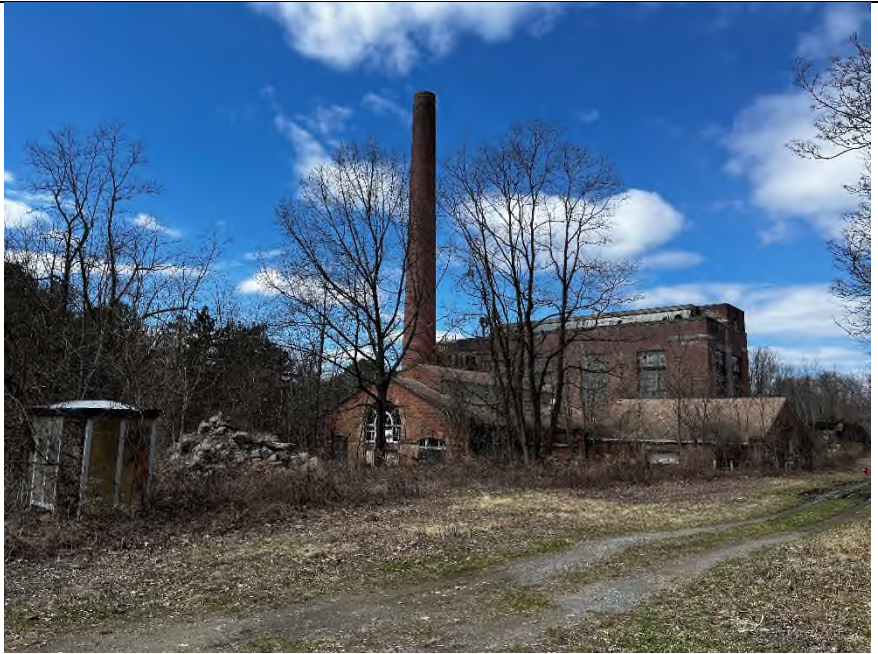
Photo 5 –

Powerhouse.

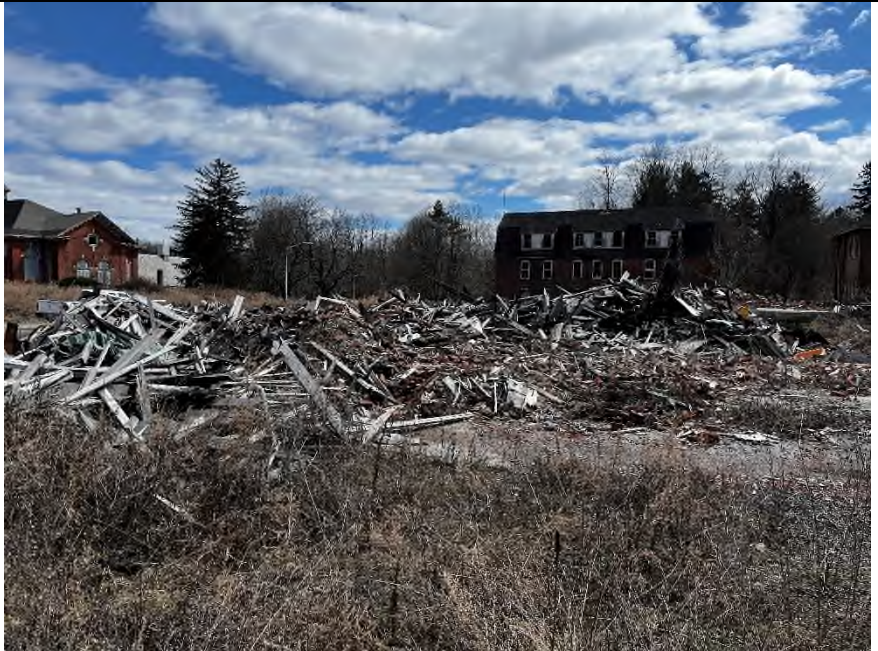
Photo 6 –

Engineering Building  
(Demolished).

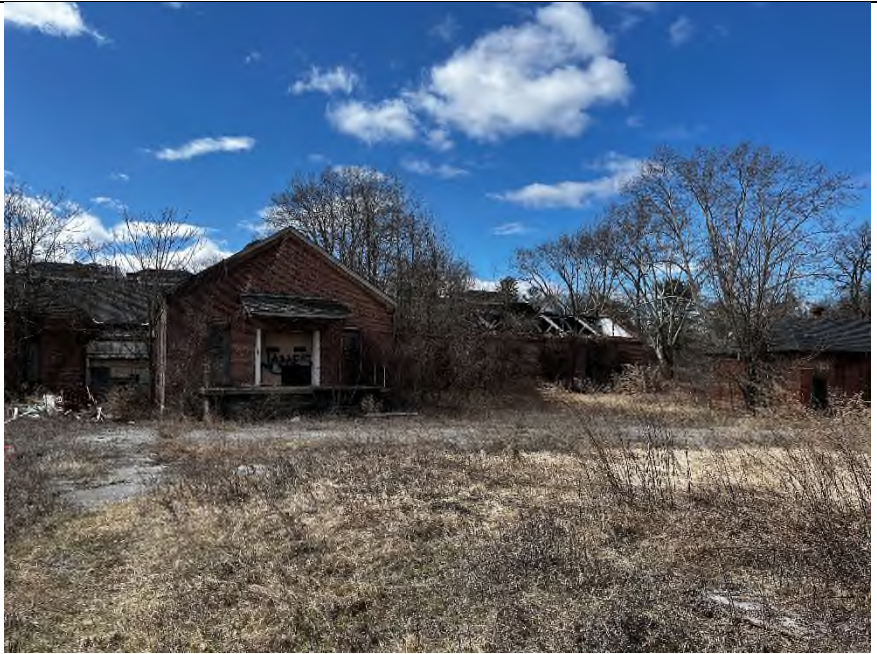
Photo 7 –

Carwash (pictured left) with shed (pictured right).

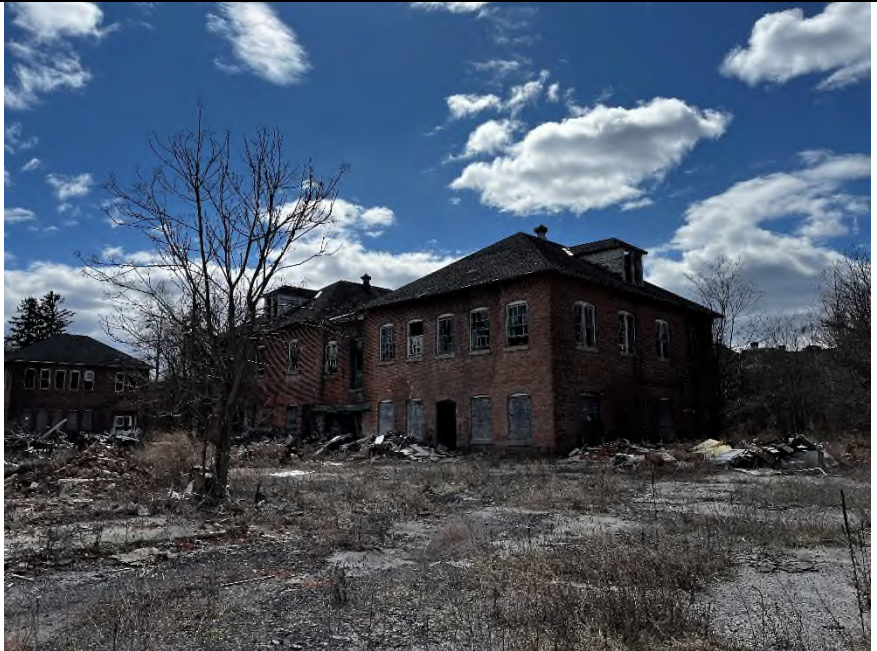
Photo 8 –

Maintenance Building with debris located east side of structure.

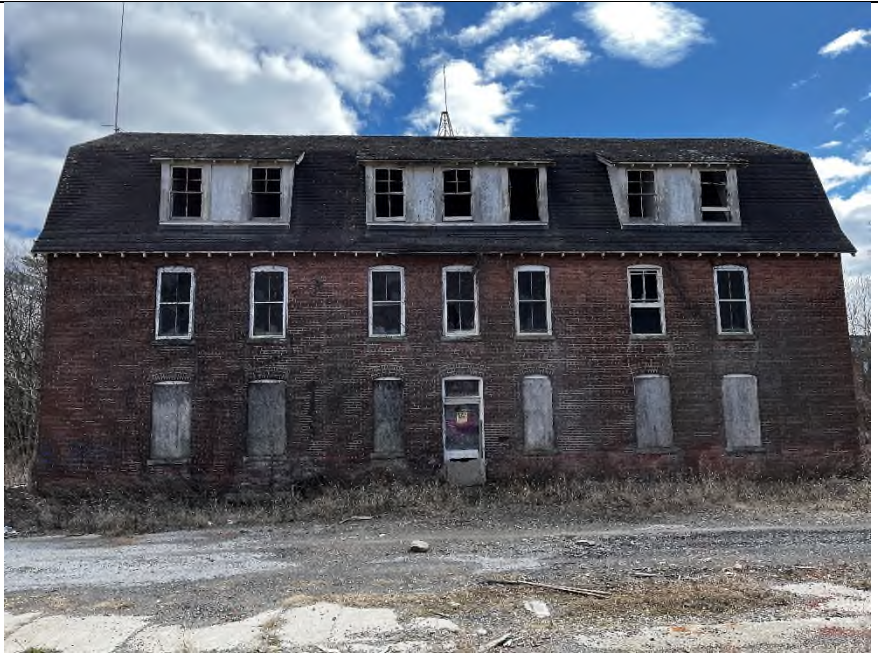
Photo 9 –

Fire House.

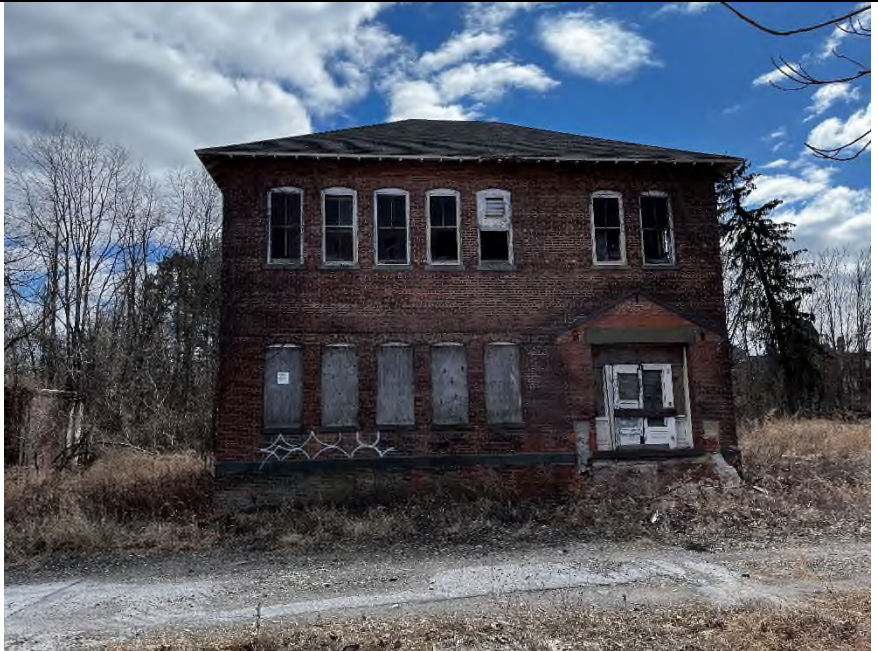
Photo 10 –

Mortuary Building.

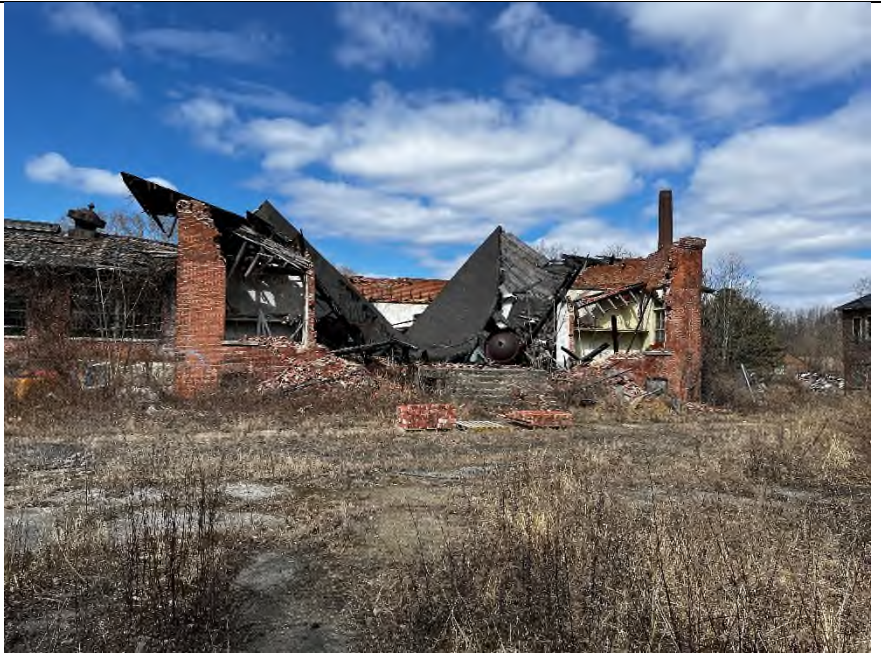
Photo 11 –

Structure west of the Mortuary Building, facing north (collapsed).

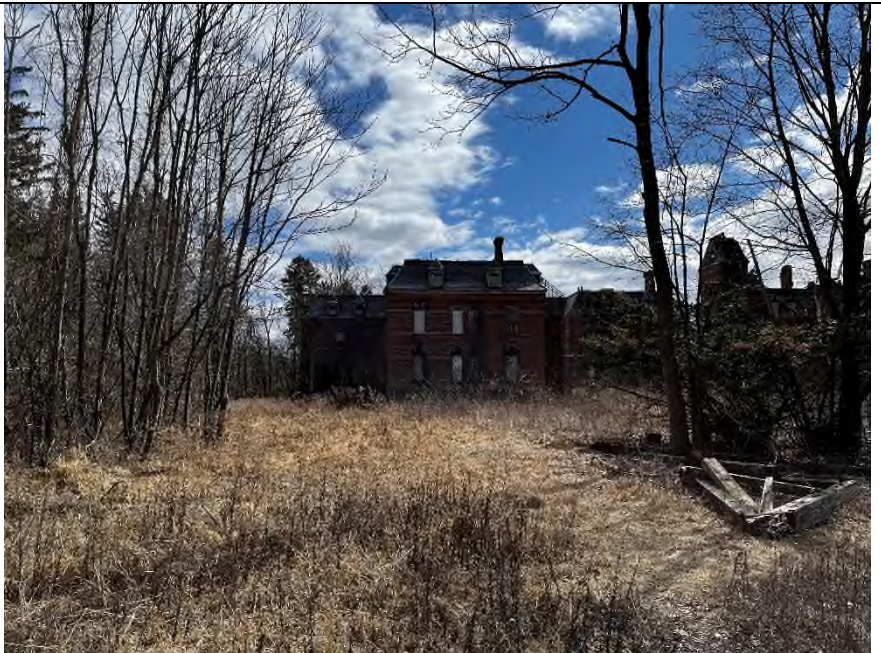
Photo 12 –

Structures in southwest corner of BCP Site, facing south.

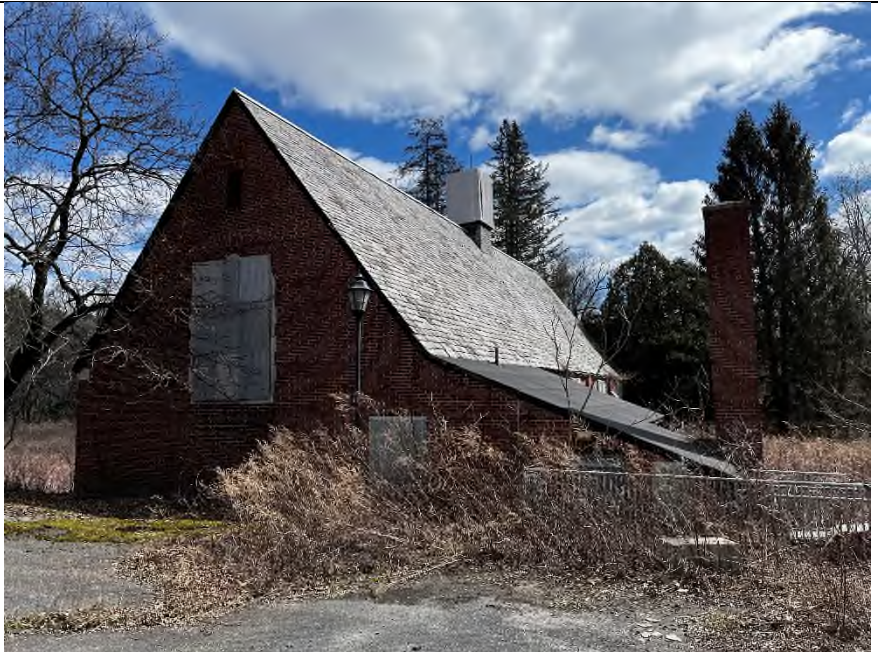
Photo 13 –

Rectory south of the Recreational Hall building.

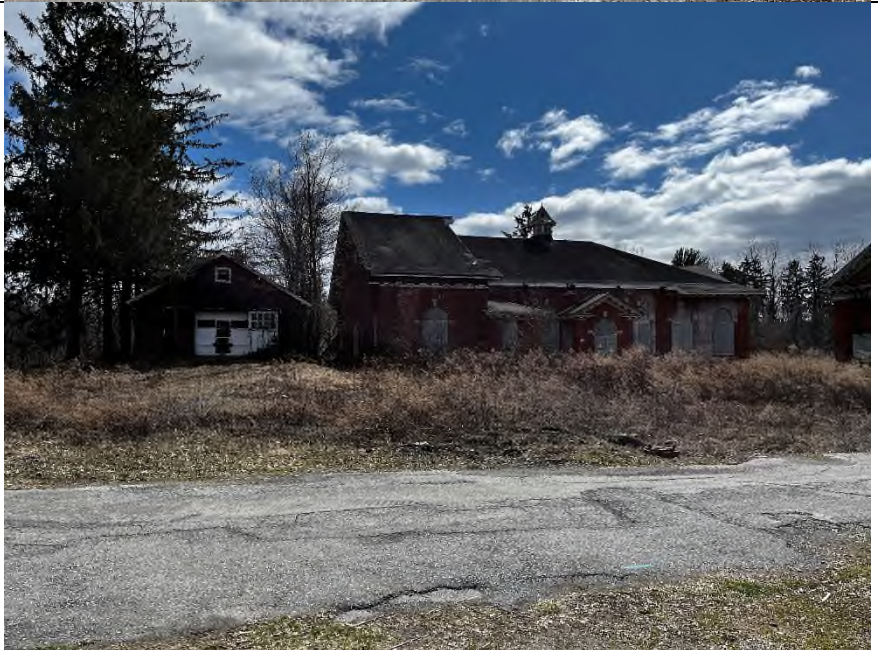
Photo 14 –

Recreational Hall.

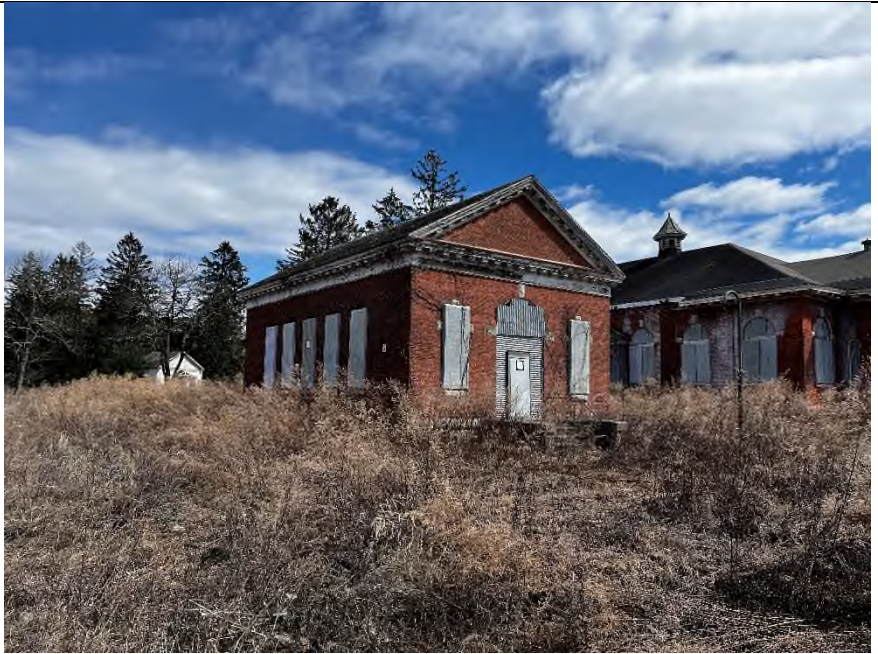
Photo 15 –

Library.

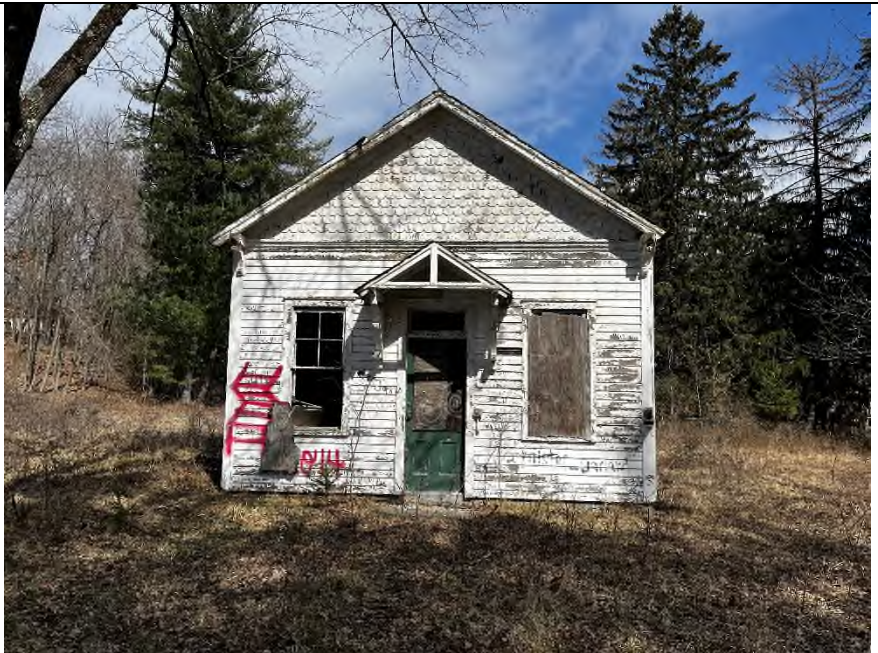
Photo 16 –

Small structure east of the Library.

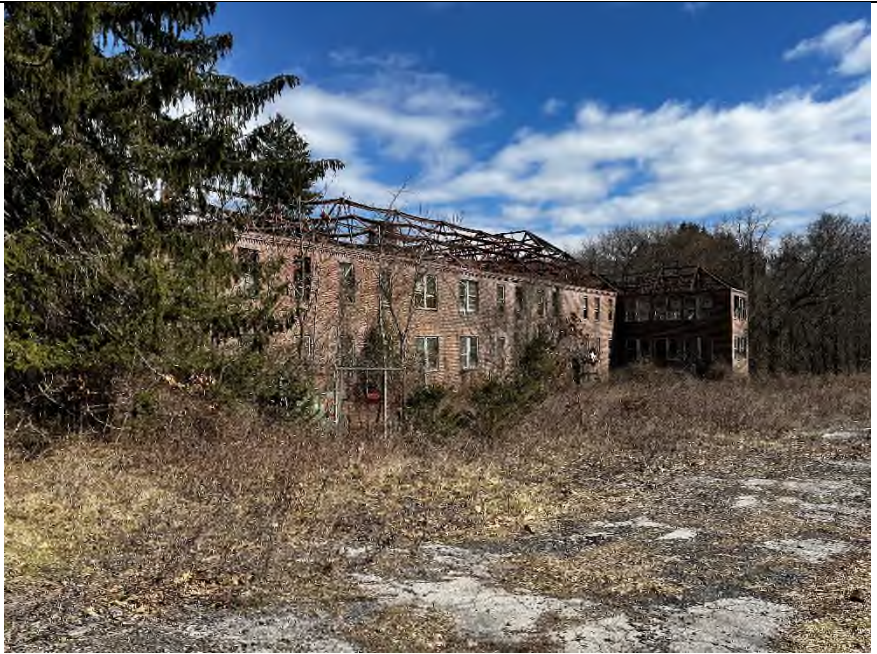
Photo 17 –

Brookside structure, severe deterioration of roof.

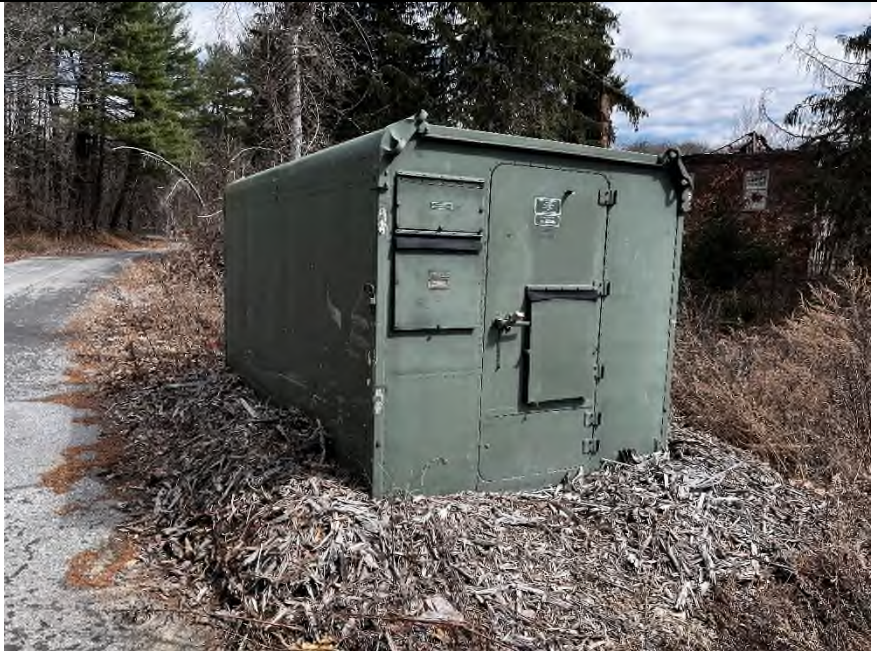
Photo 18 –

Metal container placed over fire hydrant. Base of container is bordered with wood chips.

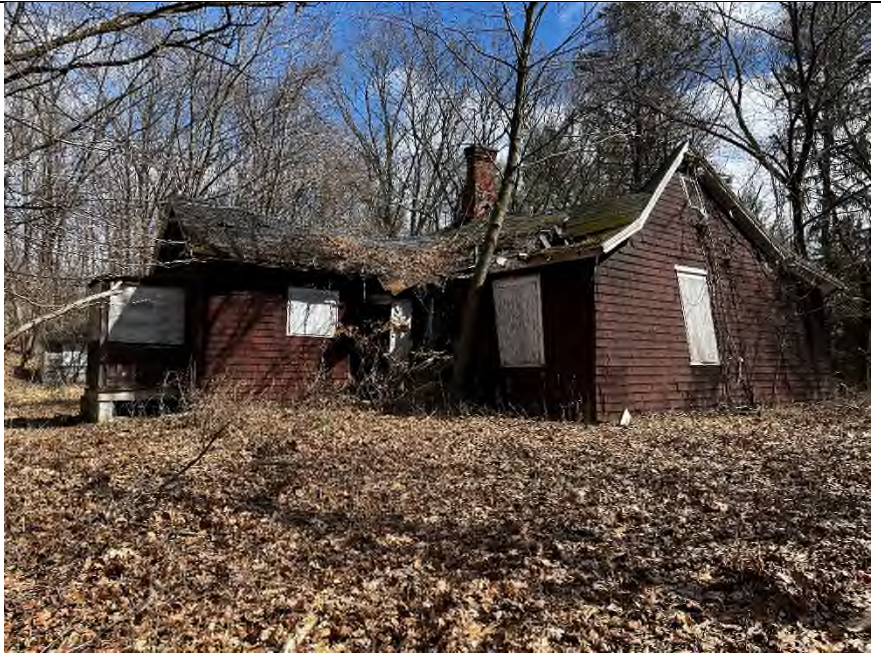
Photo 19 –

Staff House, severe deterioration of roof and interior floor.

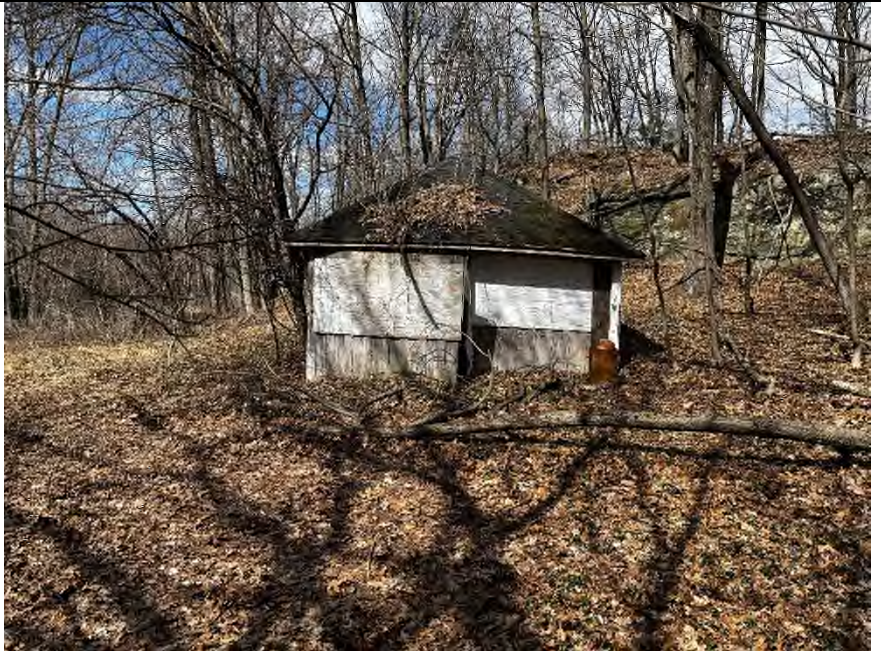
Photo 20 –

Small structure east of the Staff House.
