## MONTHLY STATUS REPORT

| BCP No.: | C314121 | PVE Project No.: | 560909 | Date: | 4/11/2022 |
| Project Name: | 3532 North Road, Dutchess County, Poughkeepsie, New York | | | | |

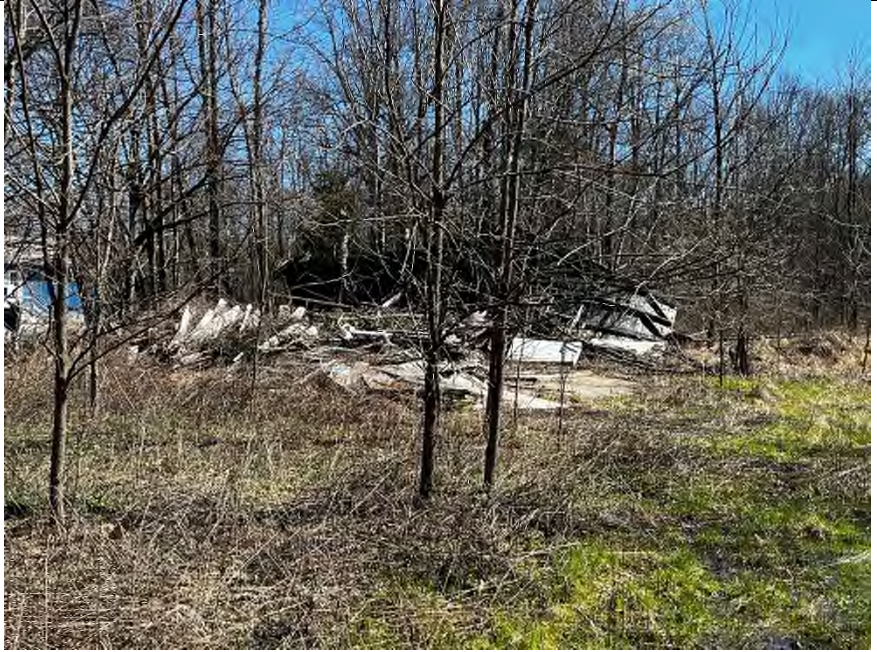
Photo 1 –  
Auto Garage East (Collapsed).

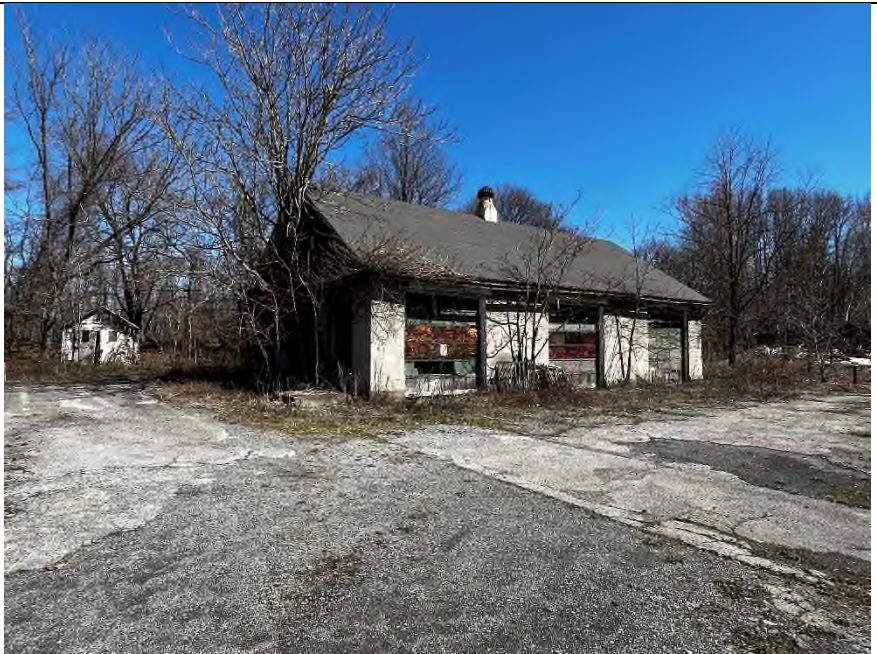
Photo 2 –  
Auto Garage West.

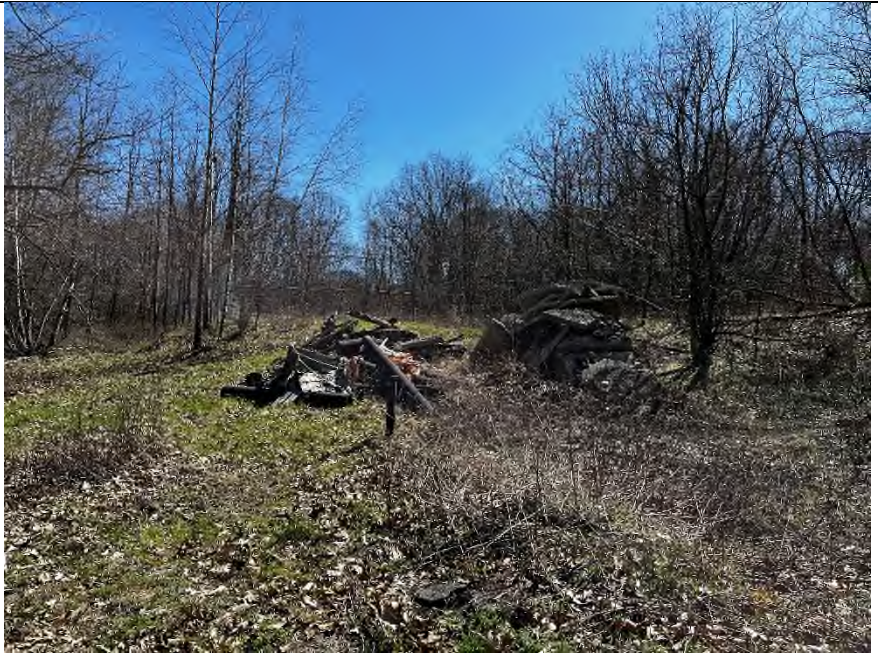
Photo 3 –

Pile of debris located south of Auto Garage East.

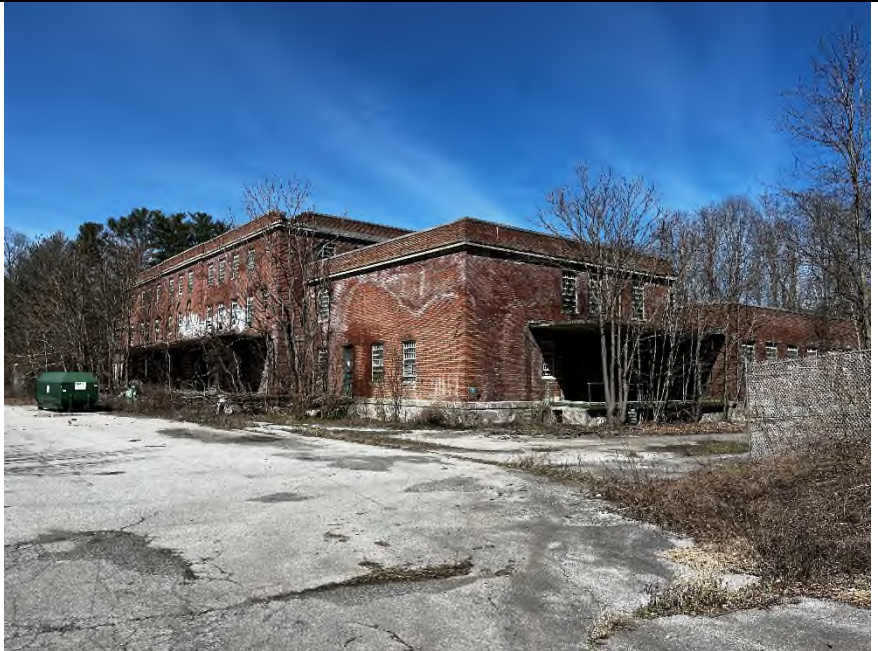
Photo 4 –

Bakery/Storage structure.  
Dumpster located south of structure.

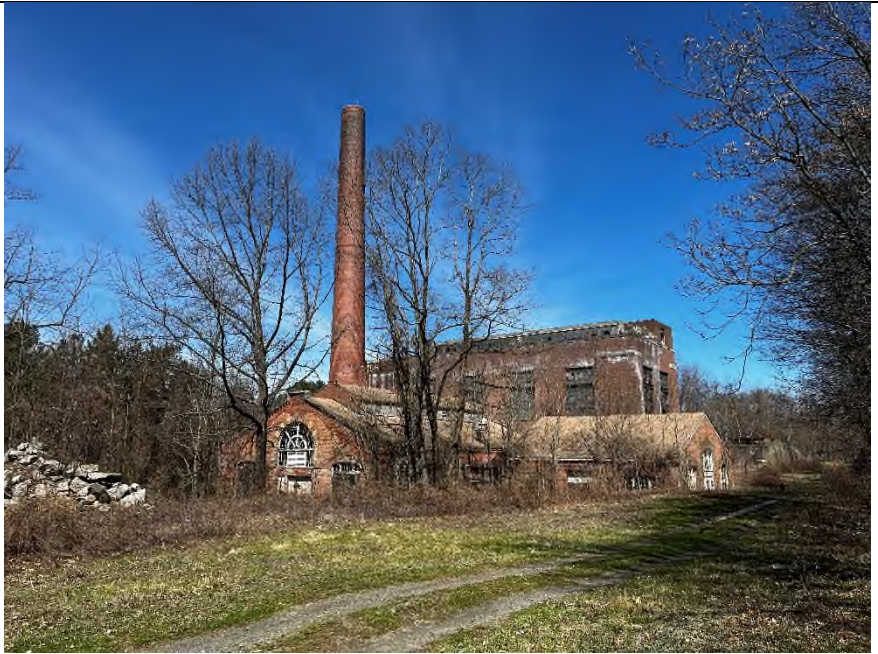
Photo 5 –

Powerhouse.

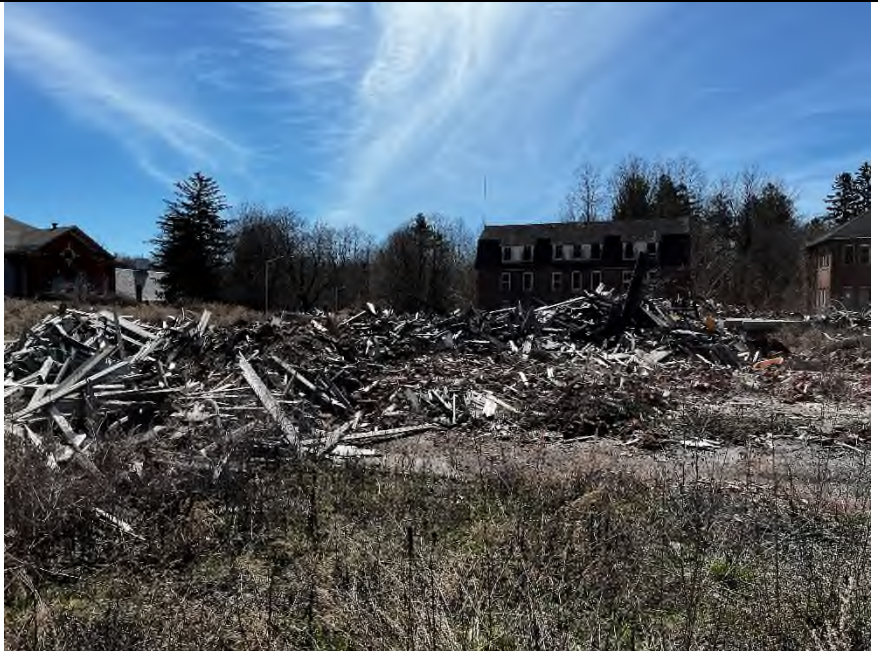
Photo 6 –

Engineering Building  
(Demolished).

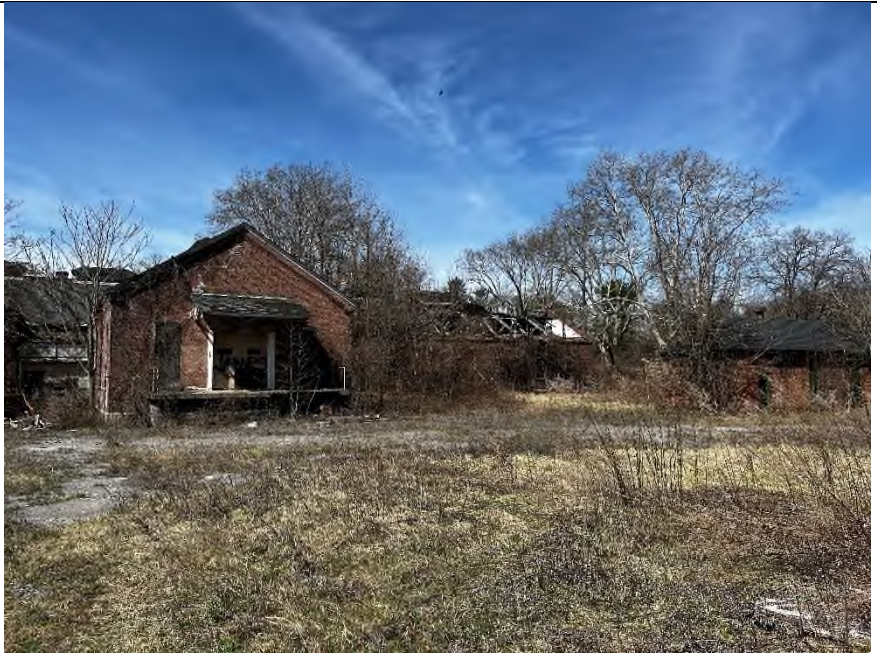
Photo 7 –

Carwash (pictured left) with shed (pictured right).

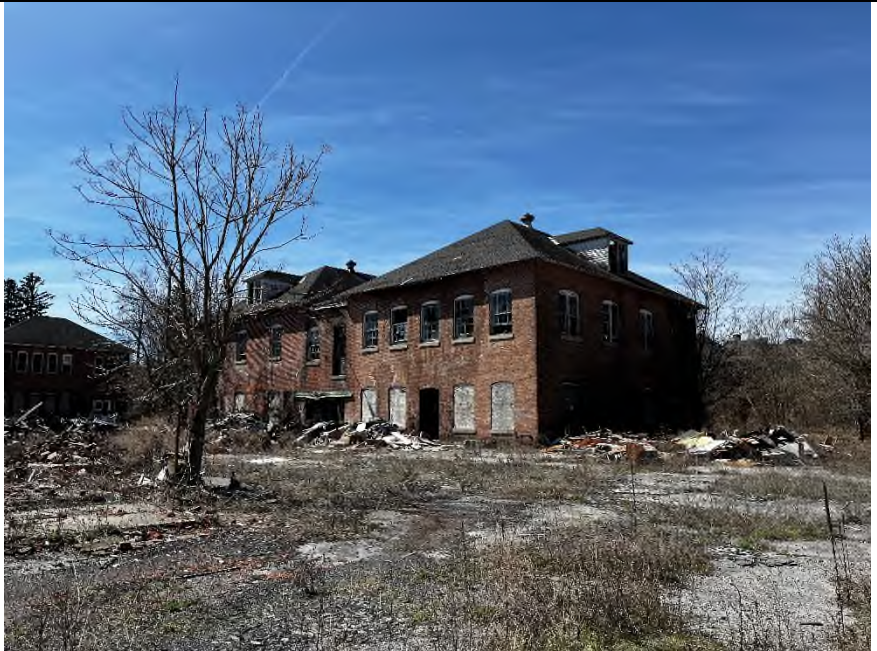
Photo 8 –

Maintenance Building with debris located east side of structure.

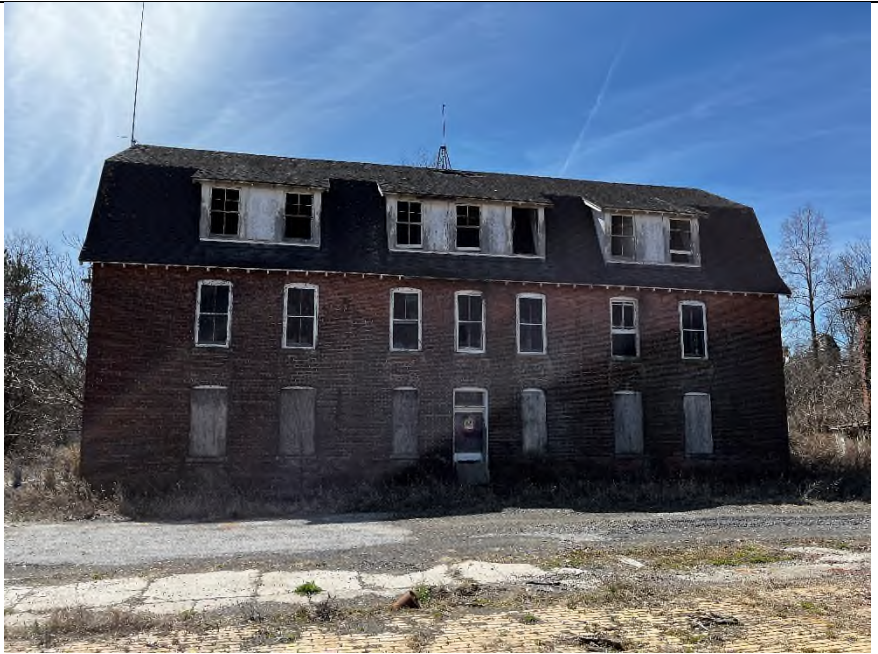
Photo 9 –

Fire House.

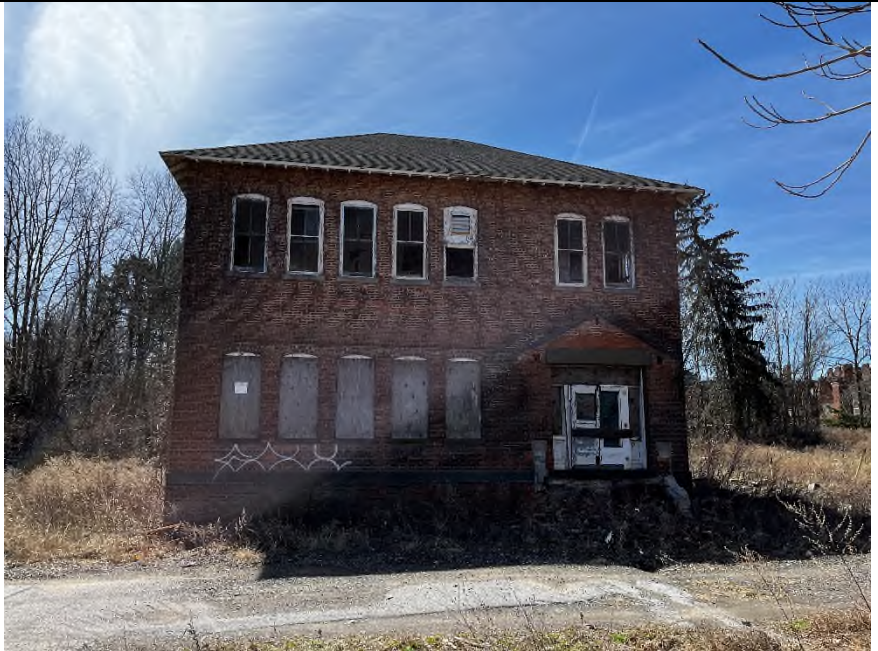
Photo 10 –

Mortuary Building.

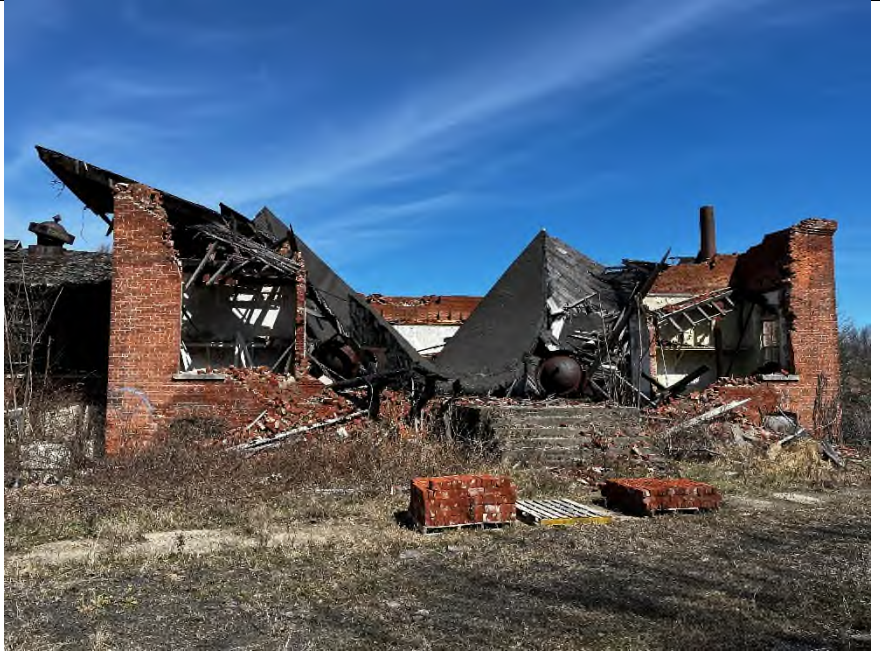
Photo 11 –

Structure west of the Mortuary Building, facing north (collapsed).

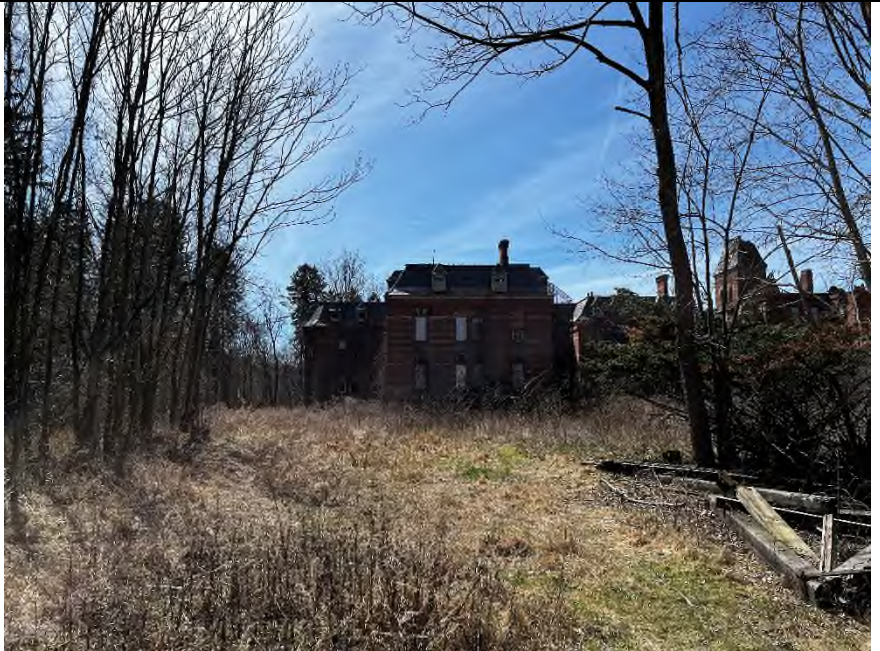
Photo 12 –

Structures in southwest corner of BCP Site, facing south.

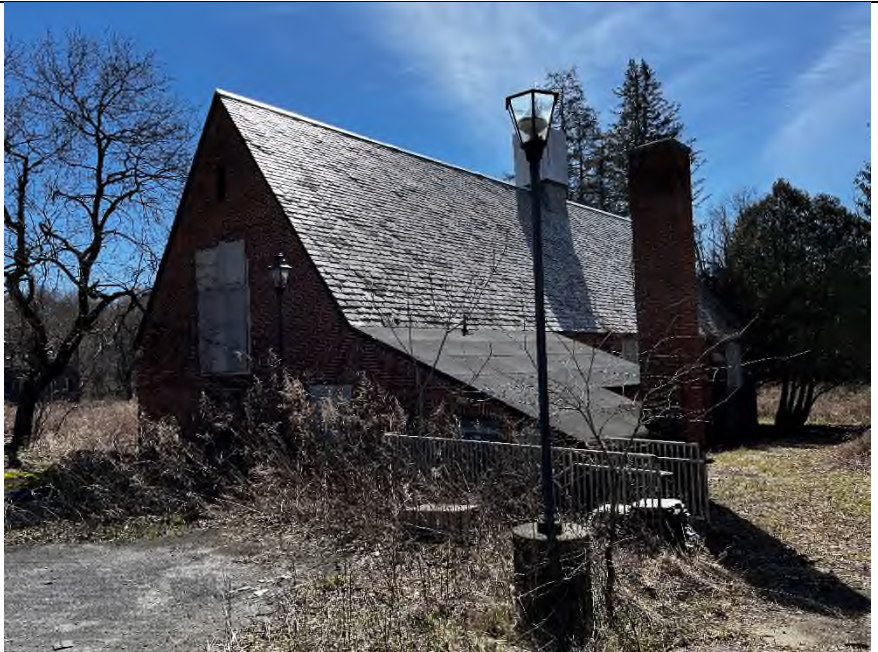
Photo 13 –

Rectory south of the Recreational Hall building.

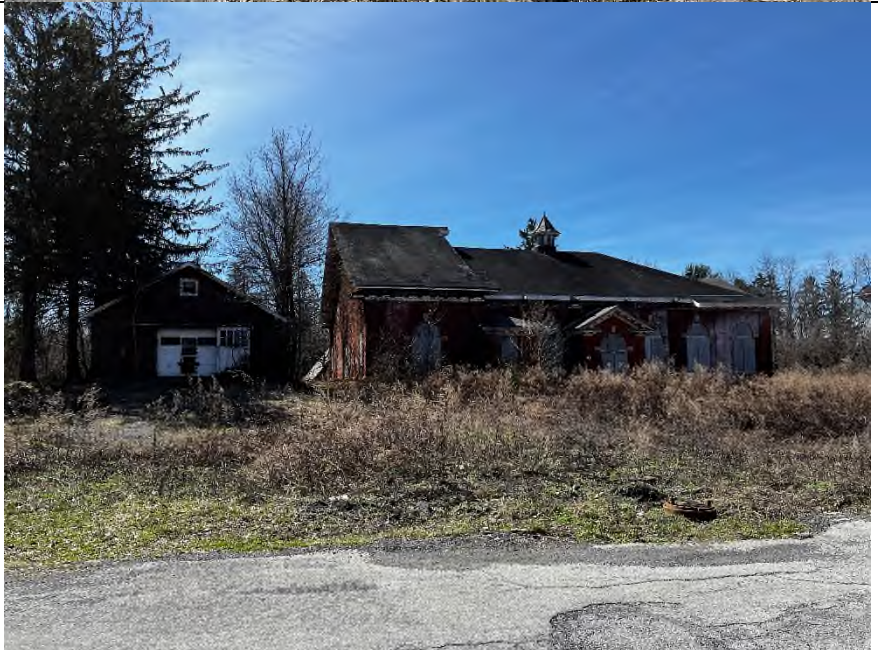
Photo 14 –

Recreational Hall.

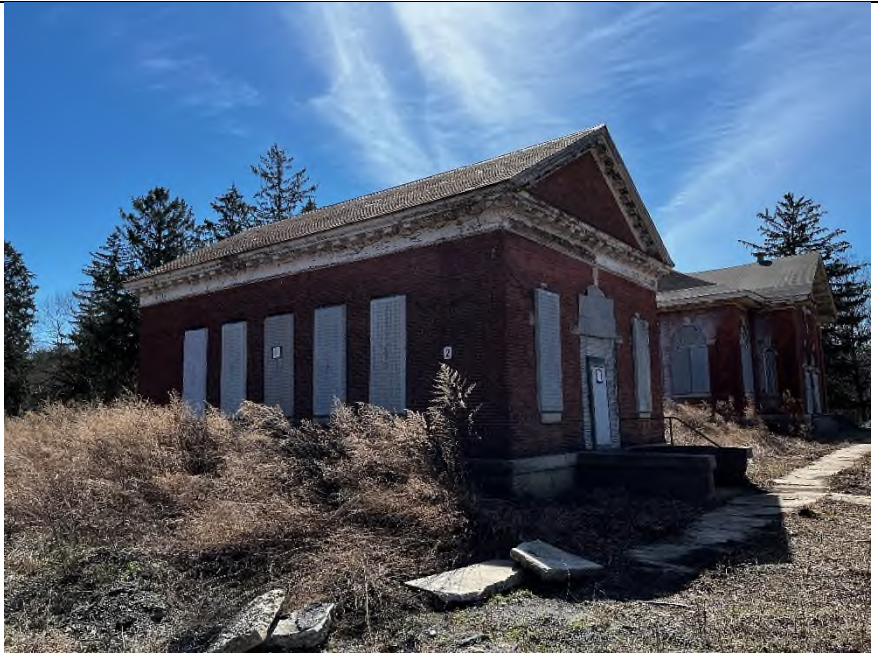
Photo 15 –

Library.

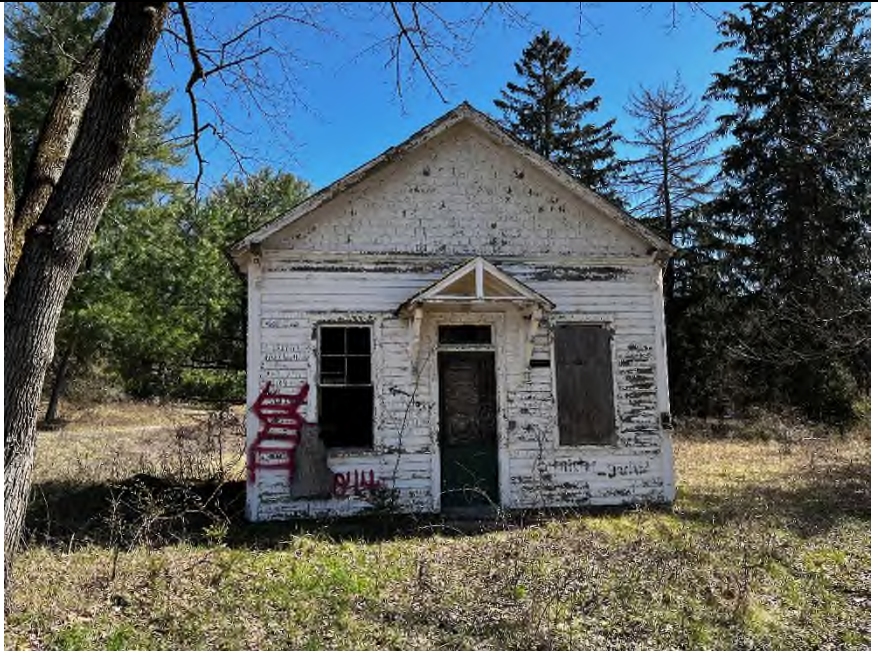
Photo 16 –

Small structure east of the Library.

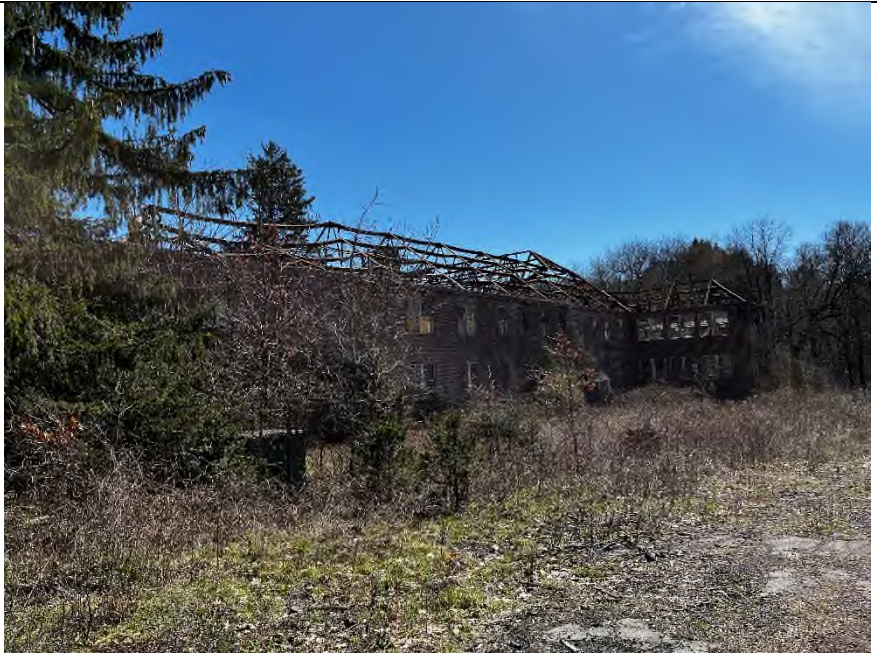
Photo 17 –

Brookside structure, severe deterioration of roof.

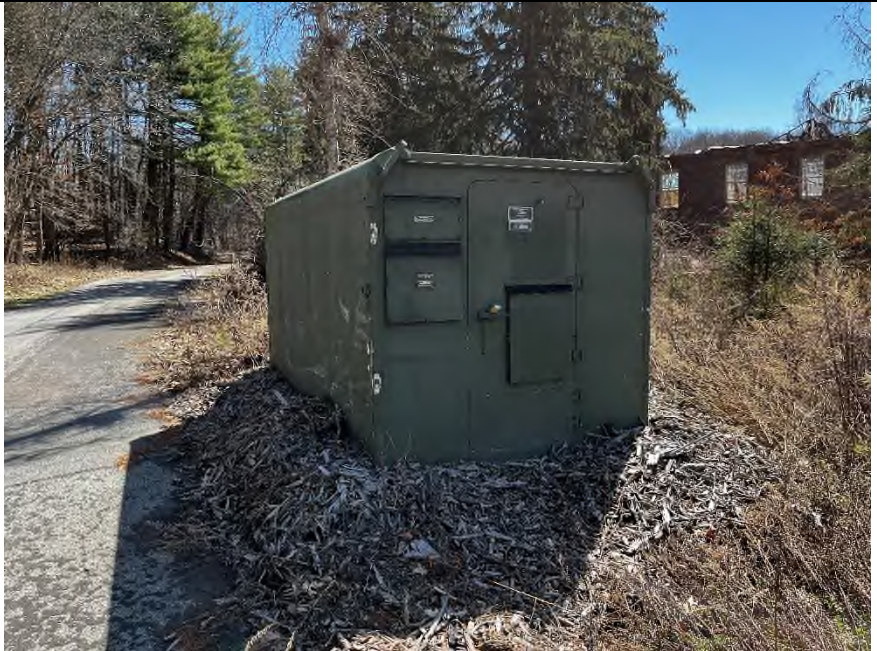
Photo 18 –

Metal container placed over fire hydrant. Base of container is bordered with wood chips.

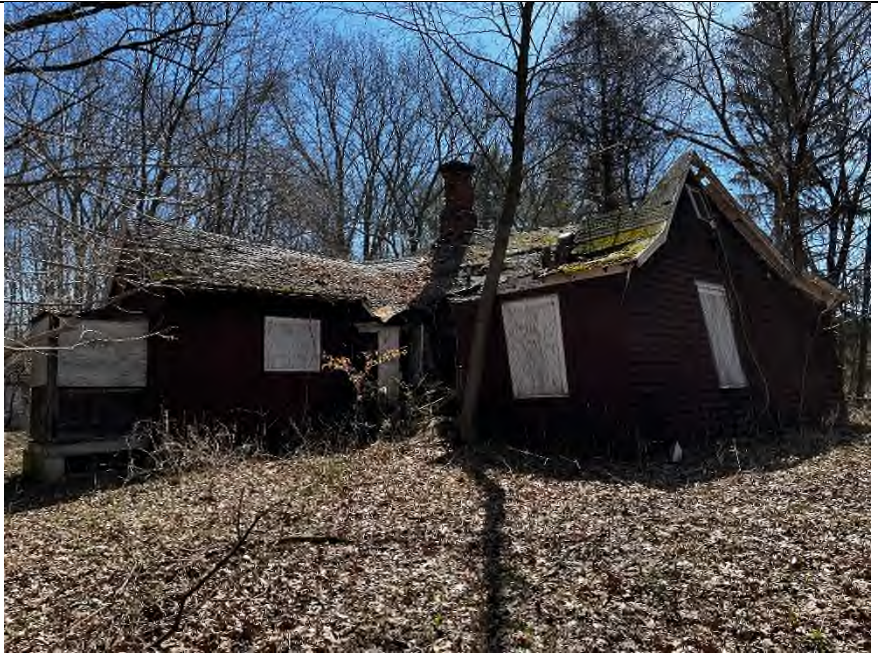
Photo 19 –

Staff House, severe deterioration of roof and interior floor.

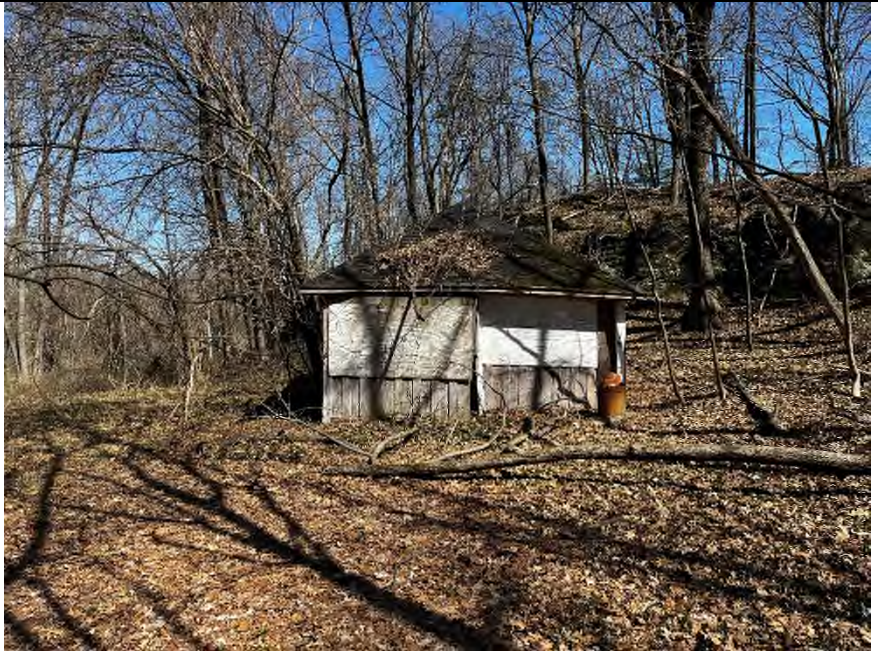
Photo 20 –

Small structure east of the Staff House.
