## MONTHLY STATUS REPORT

| BCP No.: | C314121 | PVE Project No.: | 560909 | Date: | 6/30/2022 |
| Project Address: | 3532 North Road, Dutchess County, Poughkeepsie, New York | | | | |

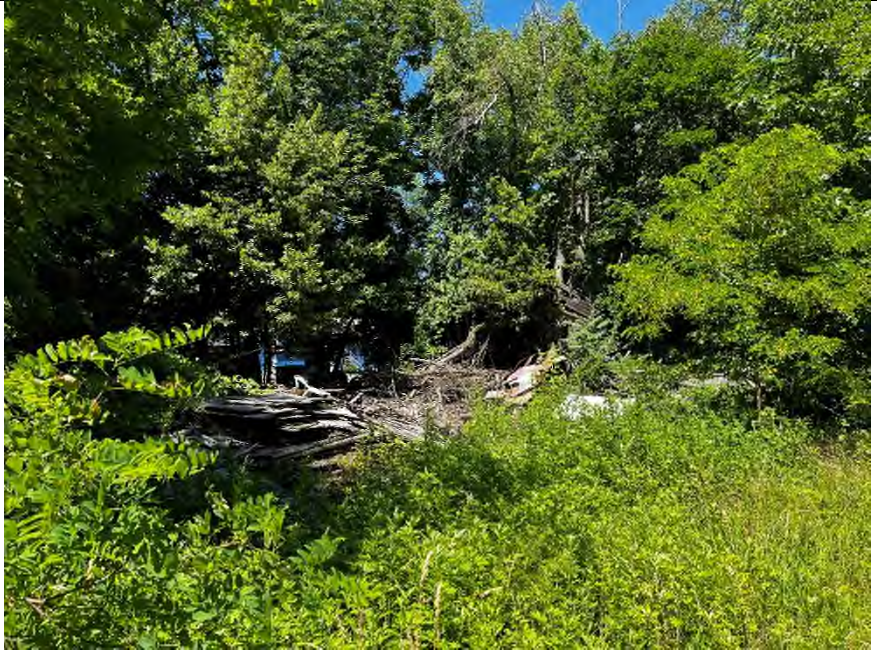
Photo 1 –  
Auto Garage East (Collapsed).

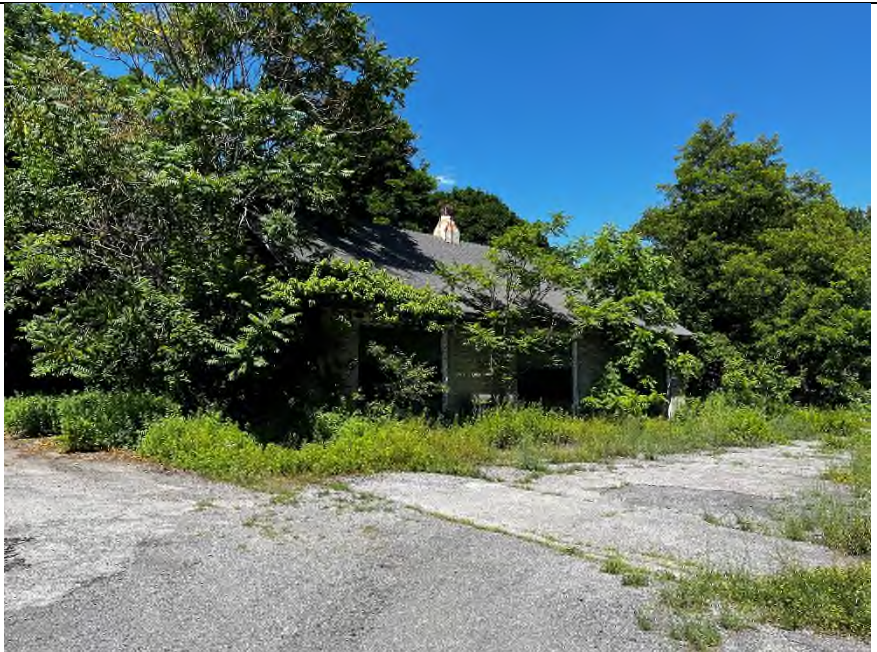
Photo 2 –  
Auto Garage West.

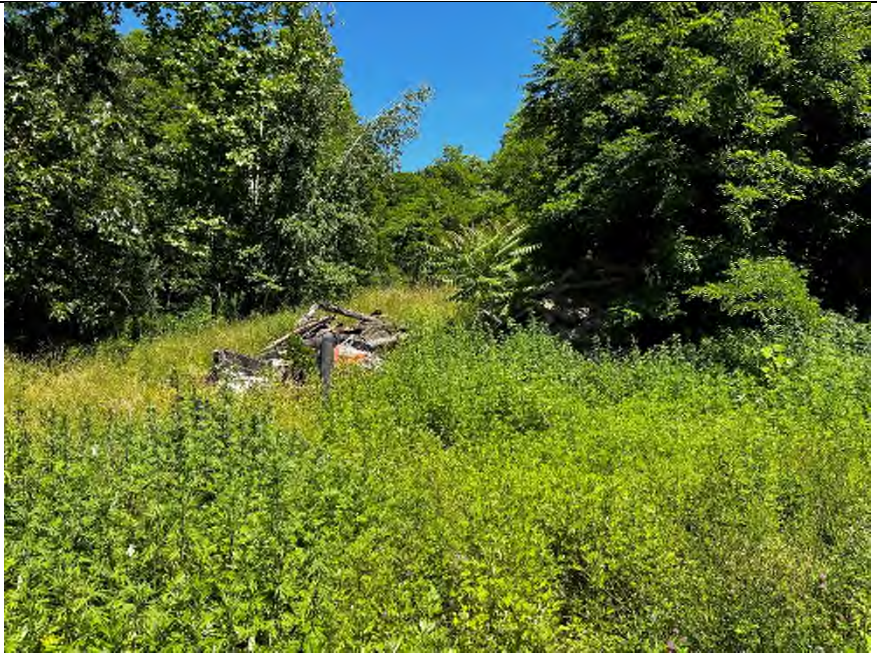
Photo 3 –

Pile of debris located south of Auto Garage East.

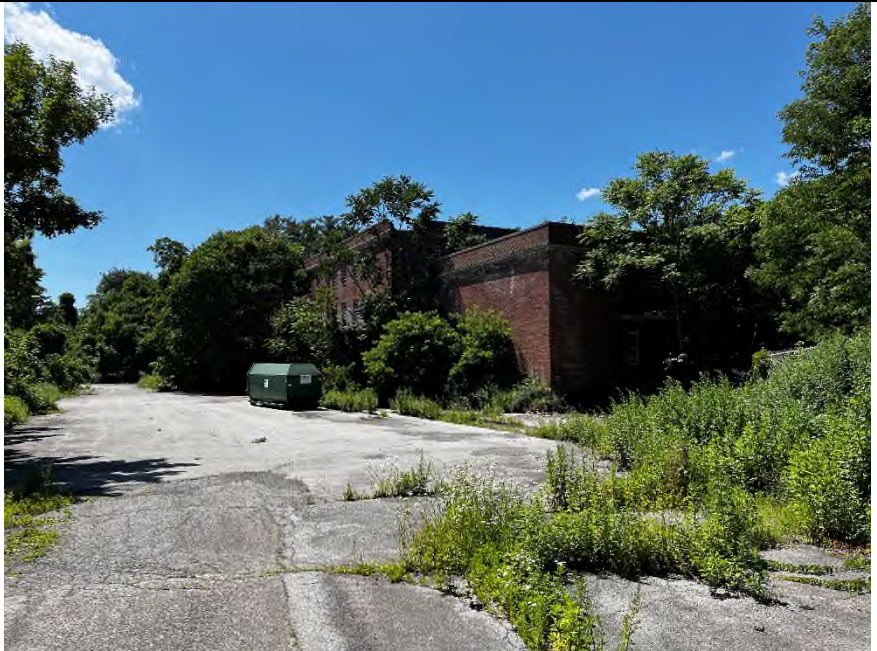
Photo 4 –

Bakery/Storage structure.  
Dumpster located south of structure.

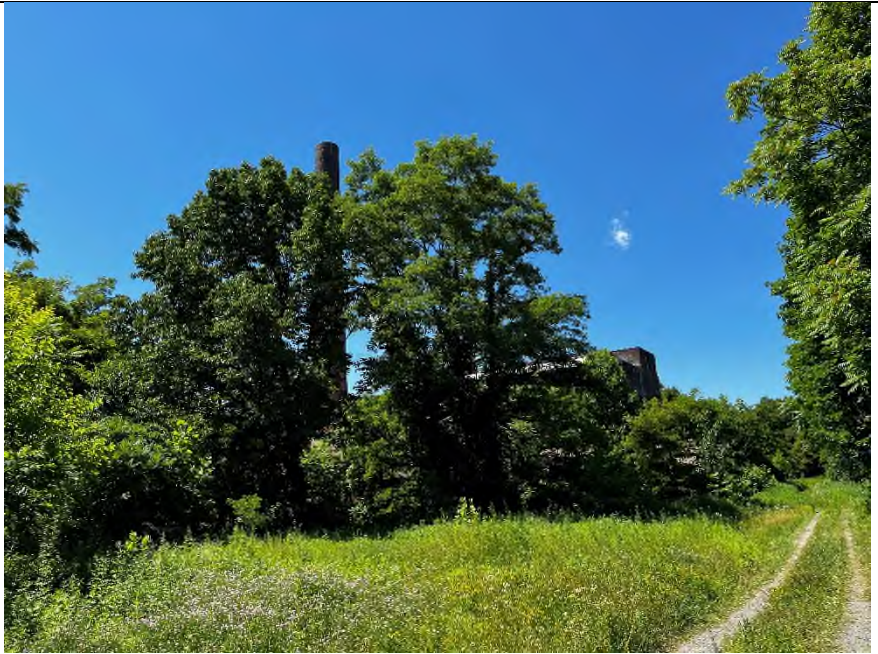
Photo 5 –

Powerhouse.

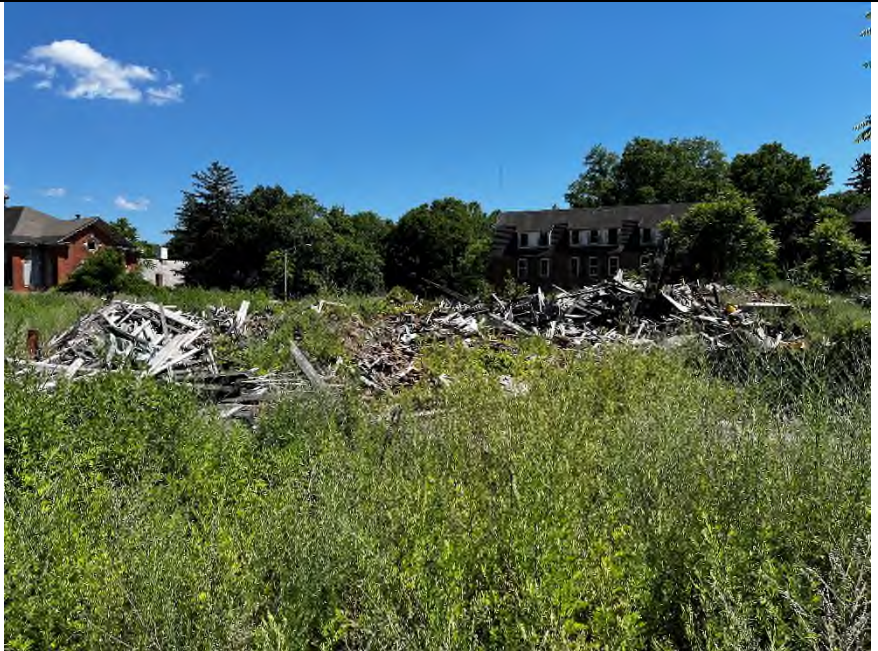
Photo 6 –

Engineering Building  
(Demolished).

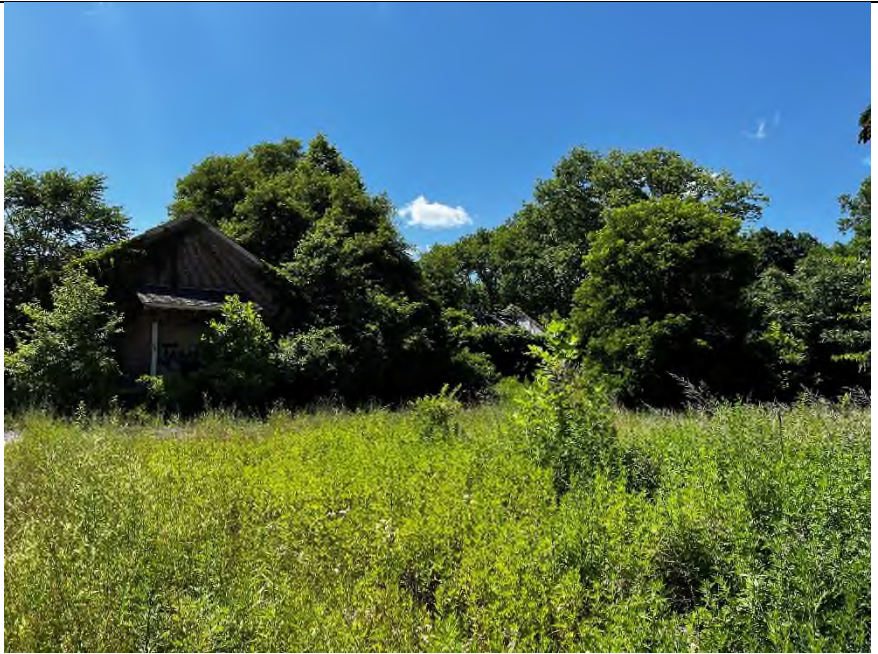
Photo 7 –

Carwash (pictured left) with shed (pictured right).

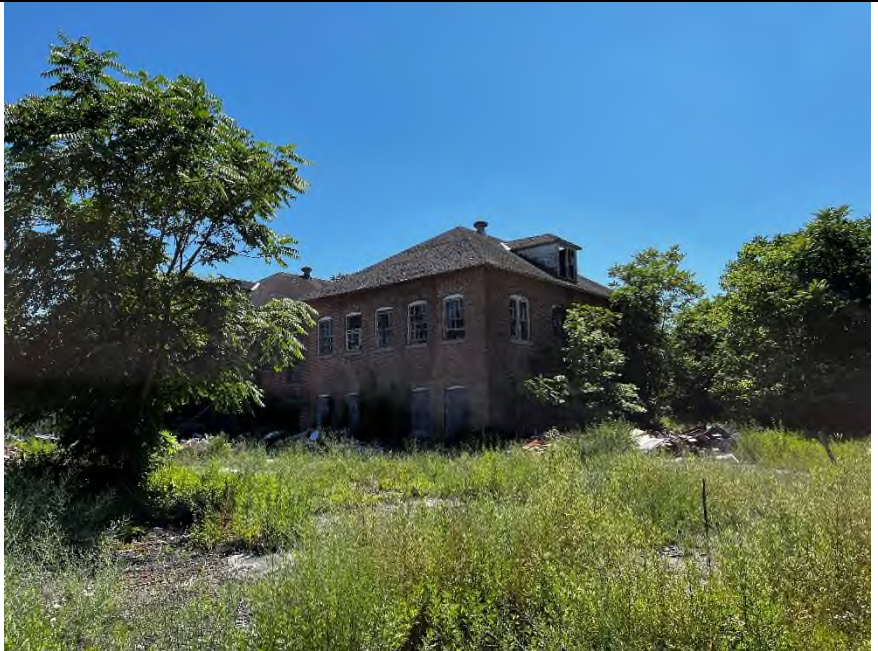
Photo 8 –

Maintenance Building with debris located east side of structure.

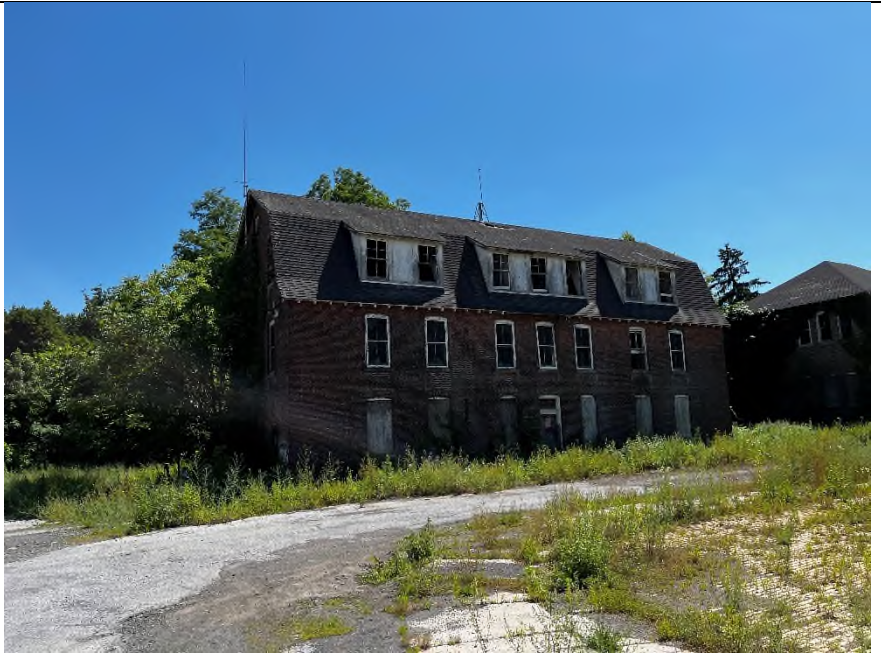
Photo 9 –

Fire House.

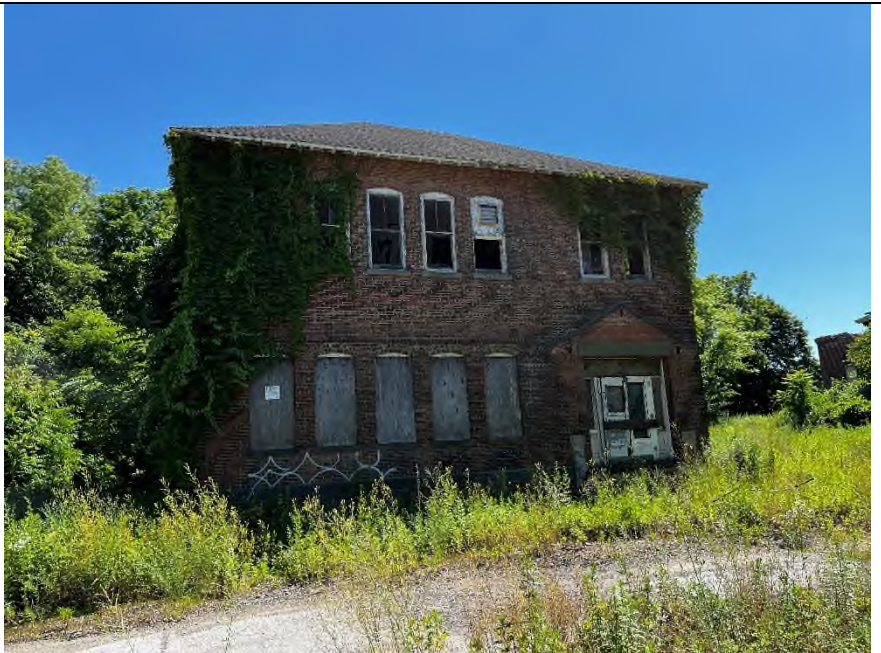
Photo 10 –

Mortuary Building.

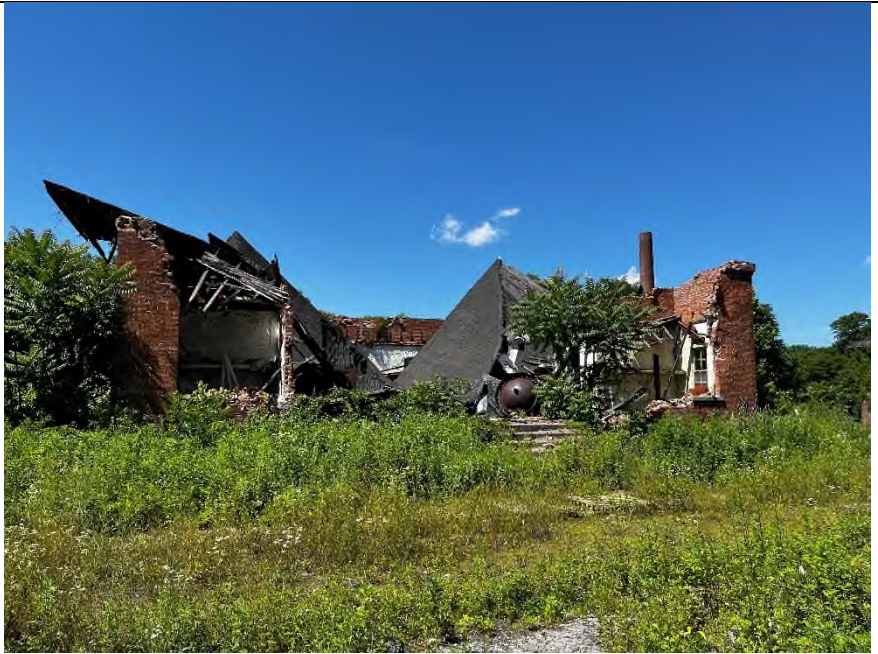
Photo 11 –

Structure west of the Mortuary Building, facing north (collapsed).

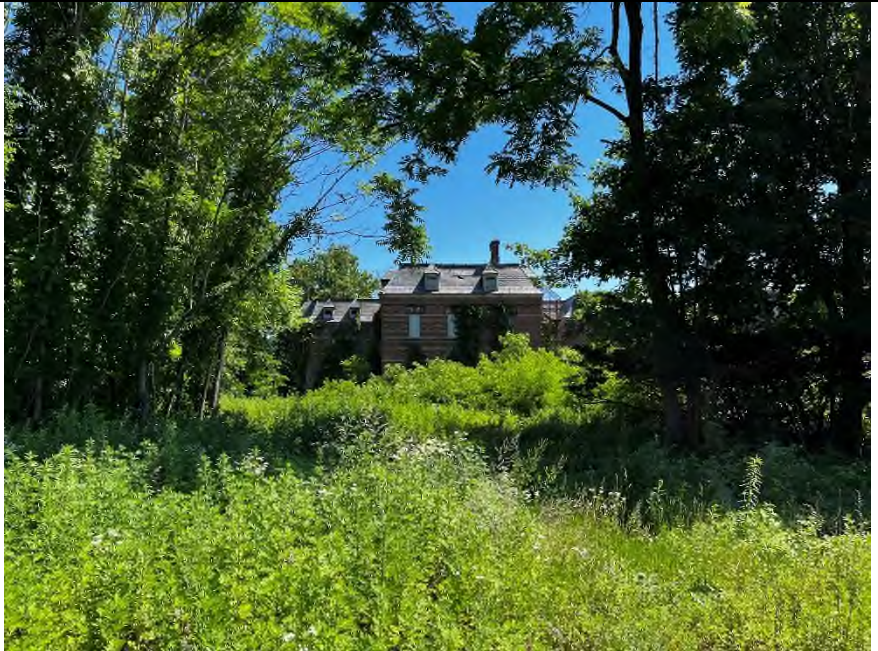
Photo 12 –

Structures in southwest corner of BCP Site, facing south.

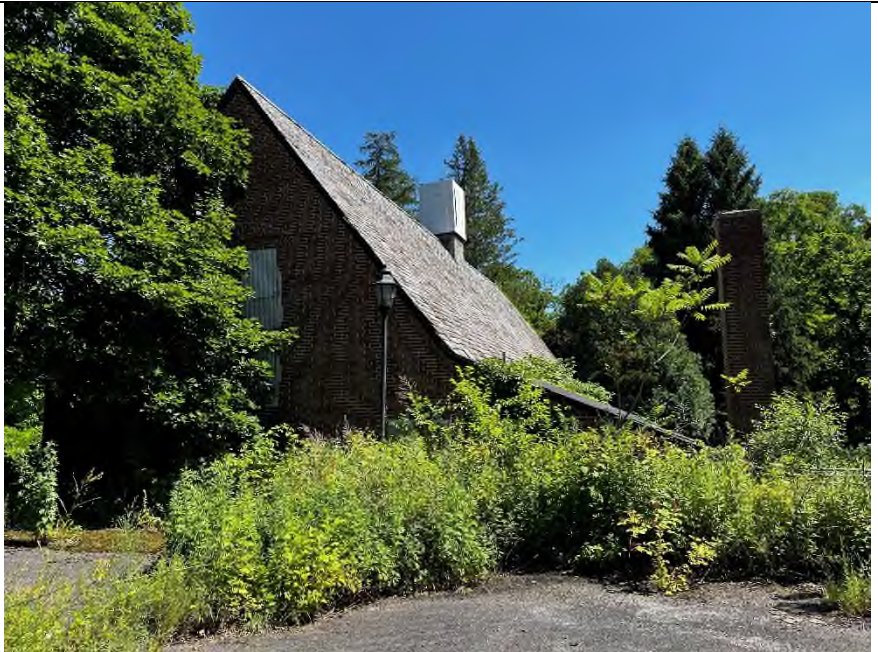
Photo 13 –

Rectory south of the Recreational Hall building.

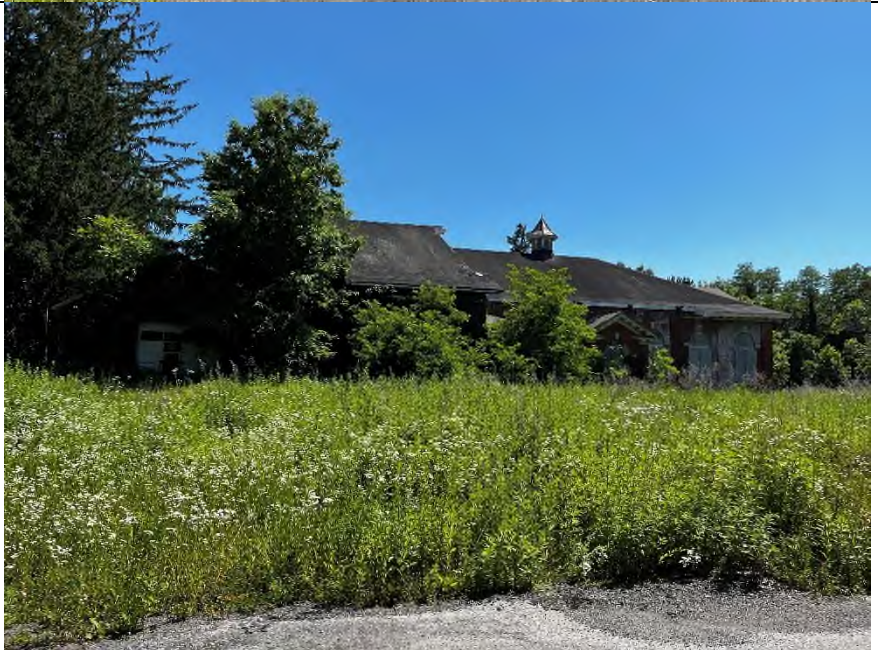
Photo 14 –

Recreational Hall.

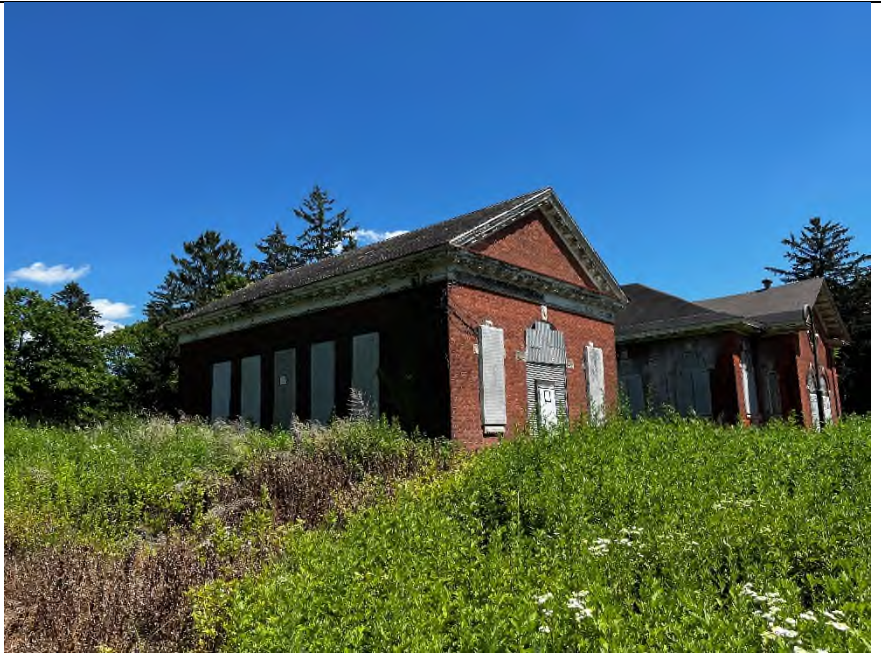
Photo 15 –

Library.

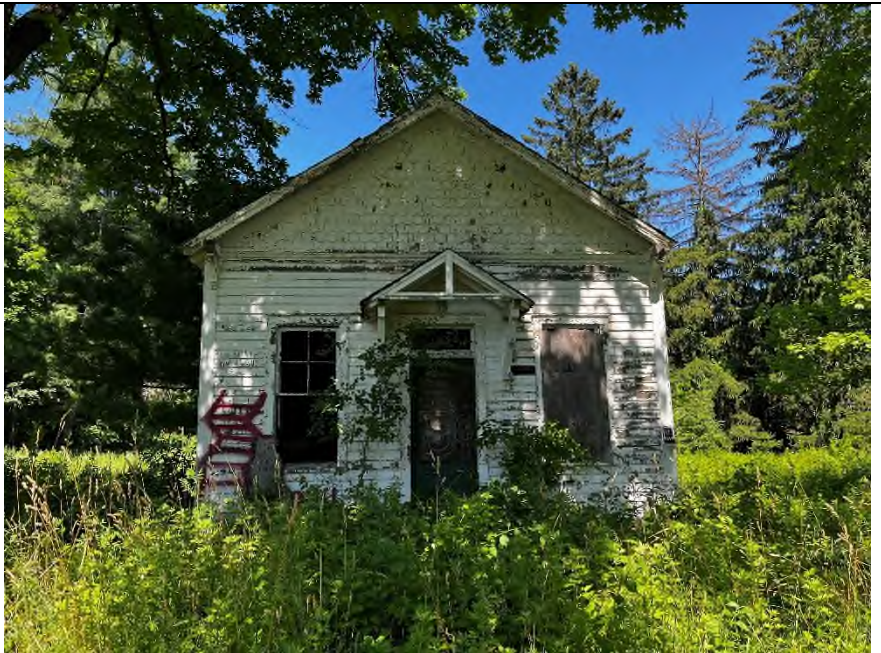
Photo 16 –

Small structure east of the Library.

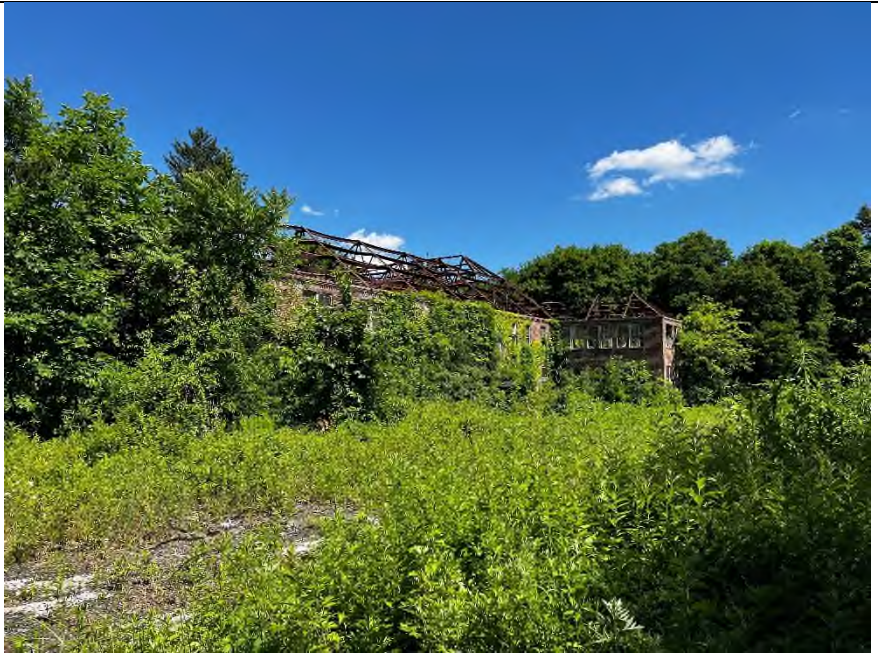
Photo 17 –

Brookside structure, severe deterioration of roof.

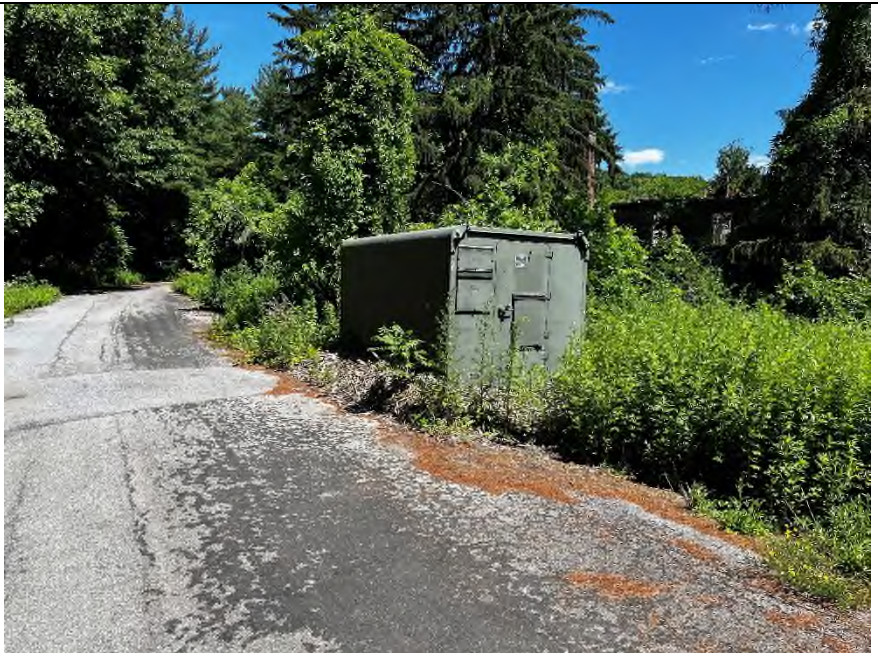
Photo 18 –

Metal container placed over fire hydrant. Base of container is bordered with wood chips.

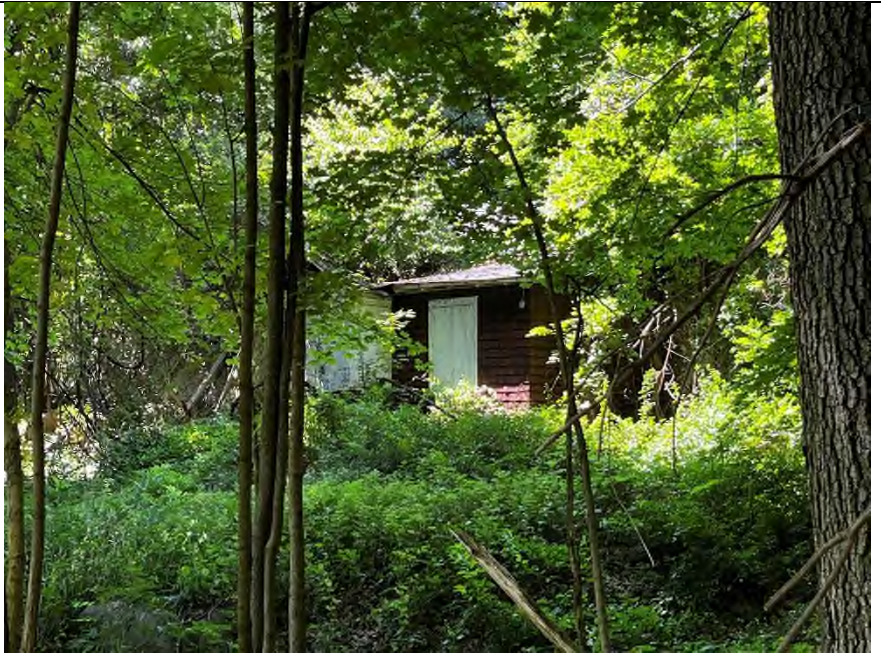
Photo 19 –

Staff House, severe deterioration  
of roof and interior floor.

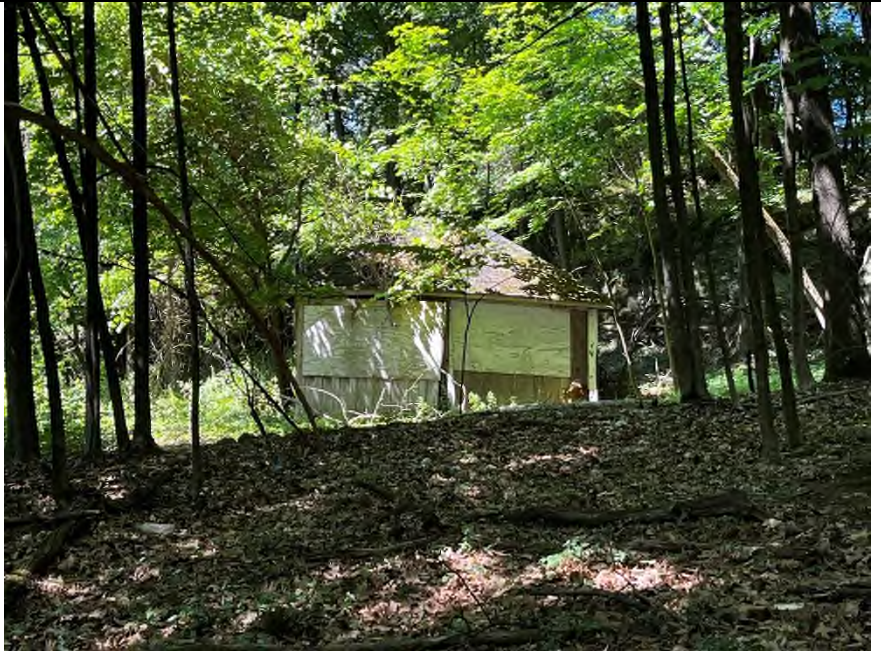
Photo 20 –

Small structure east of the Staff  
House.

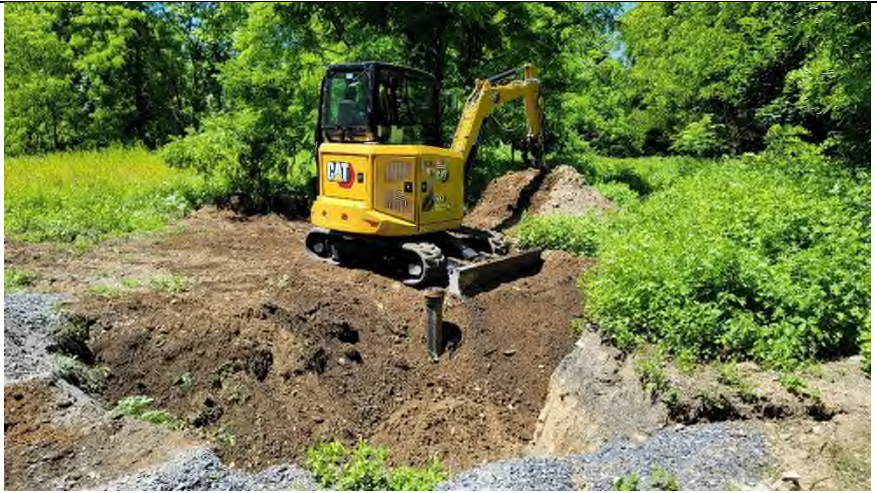
Photo 21 –

- Town of Poughkeepsie Water Department conducted backfilling of the water main on June 6, 2022. Approximately 3-4 yards of DOT ITEM #4 was imported to the site used as specified fill around the watermain. No on-site soils were removed from the subject property.
- On-site structures continue to deteriorate within the BCP boundary.

Backfilling of water main.

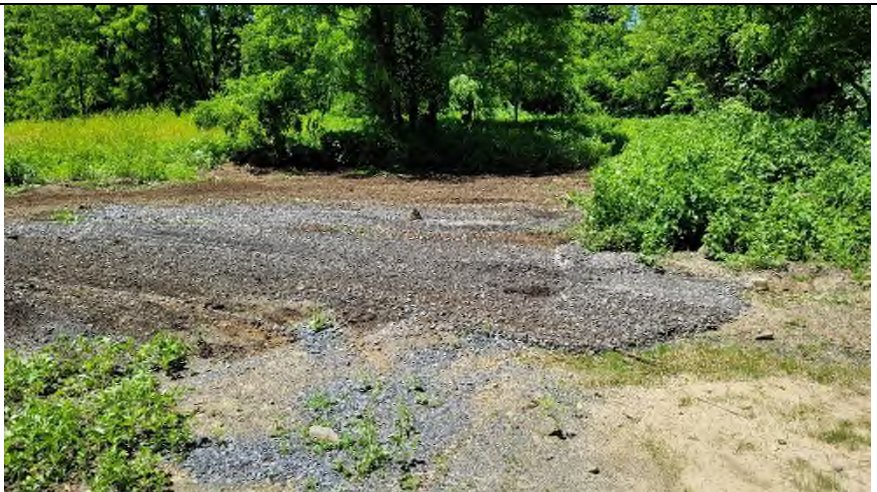
Photo 22 –

Backfilling of water main complete.
