## MONTHLY STATUS REPORT

| BCP No.: | C314121 | PVE Project No.: | 560909 | Date: | 7/14/2022 |
| Project Address: | 3532 North Road, Dutchess County, Poughkeepsie, New York | | | | |

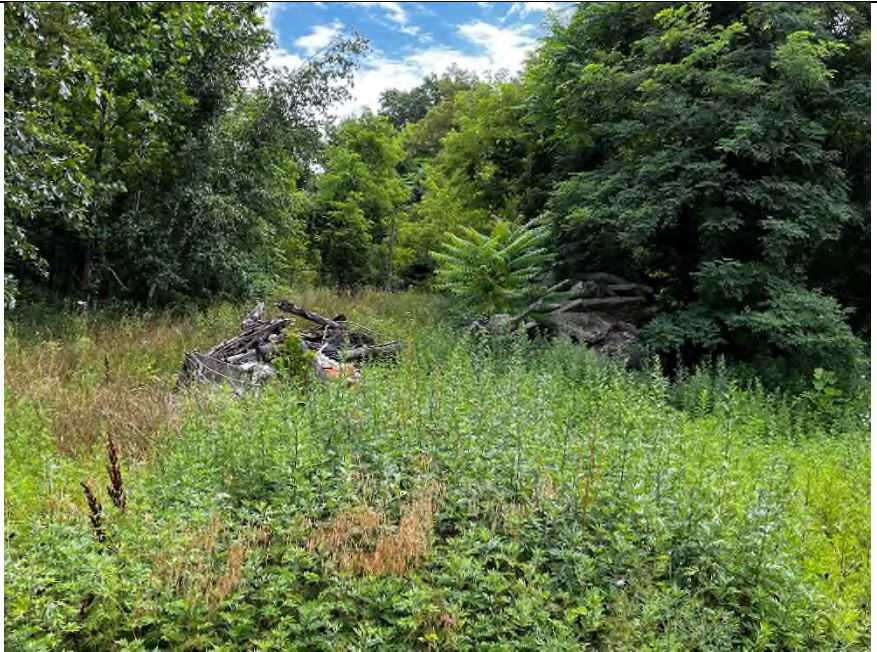
Photo 1 –  
Auto Garage East (Collapsed).

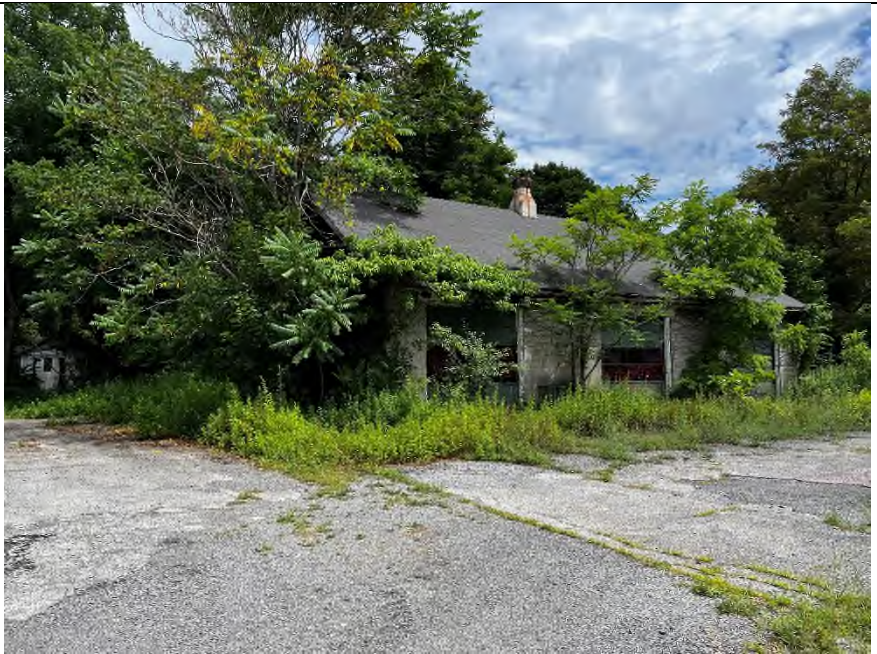
Photo 2 –  
Auto Garage West.

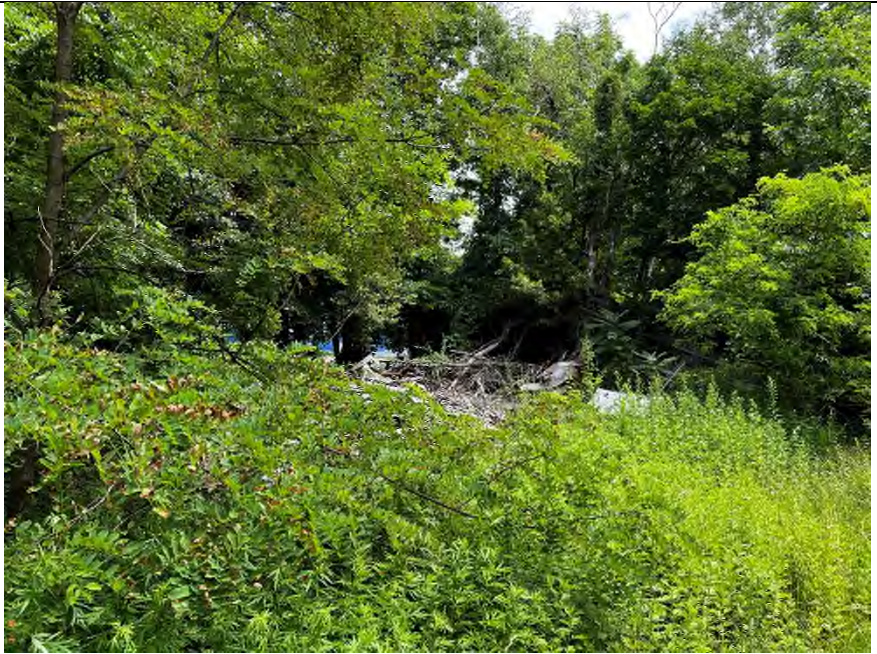
Photo 3 –

Pile of debris located south of Auto Garage East.

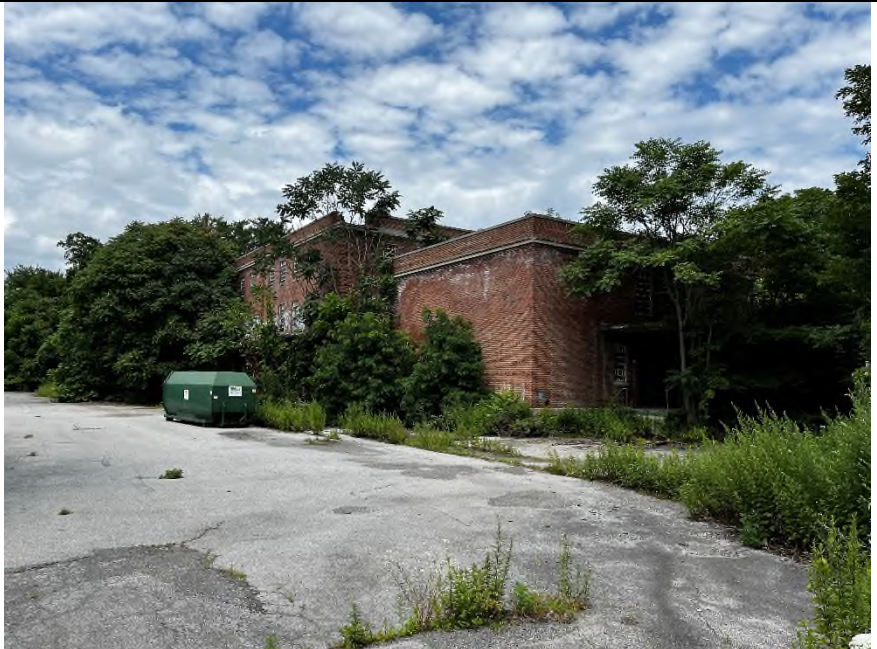
Photo 4 –

Bakery/Storage structure.  
Dumpster located south of structure.

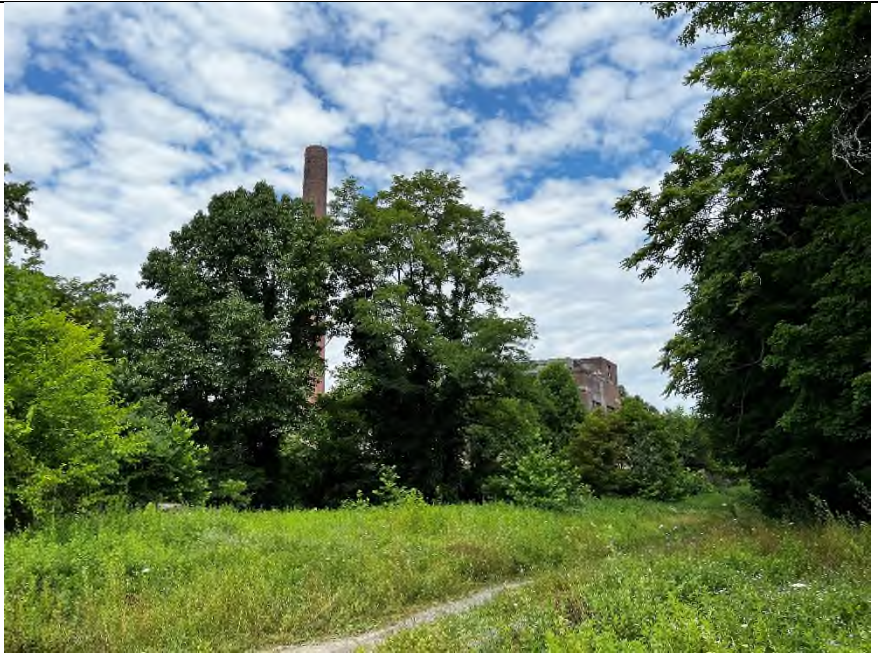
Photo 5 –

Powerhouse.

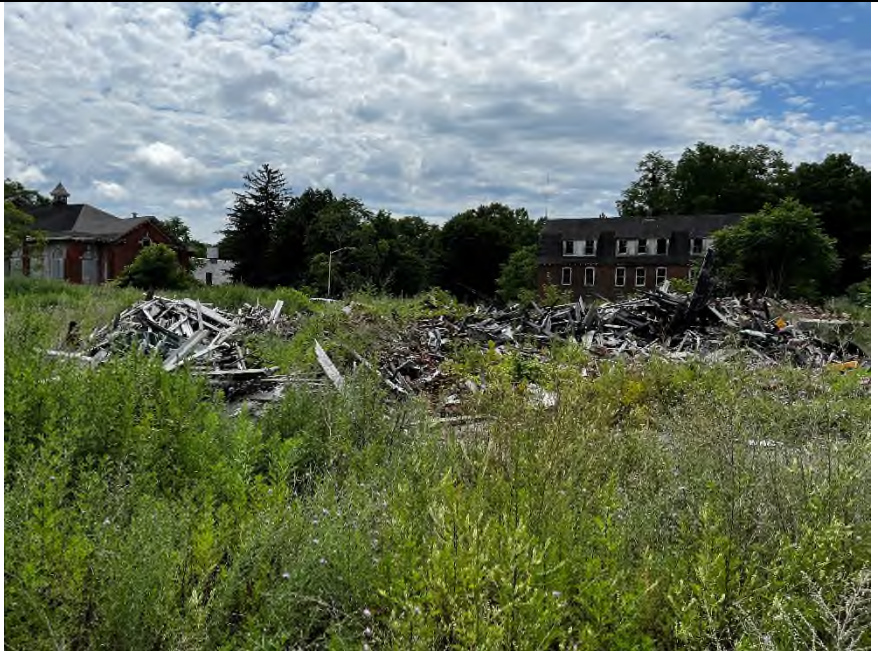
Photo 6 –

Engineering Building  
(Demolished).

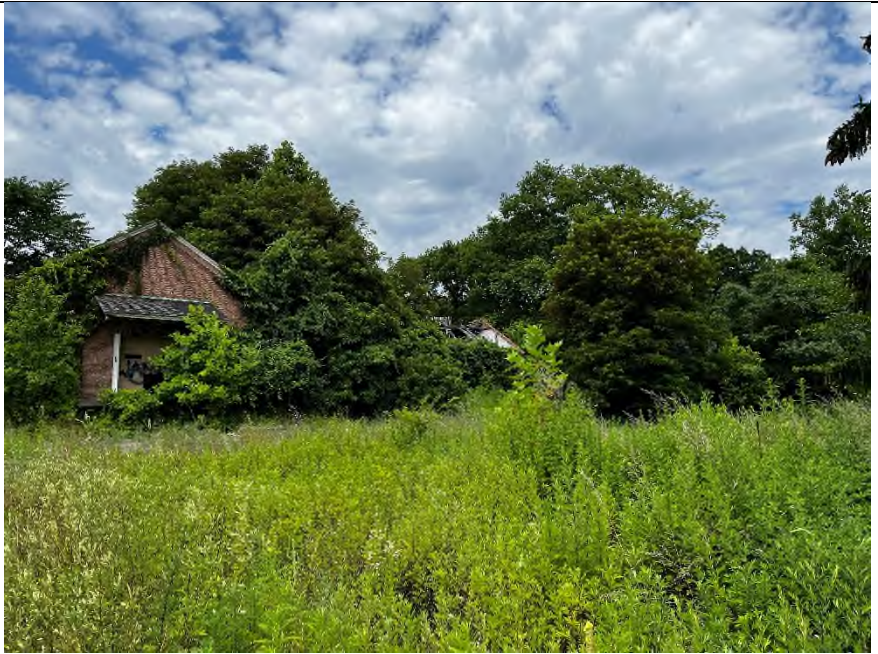
Photo 7 –

Carwash (pictured left) with shed (pictured right).

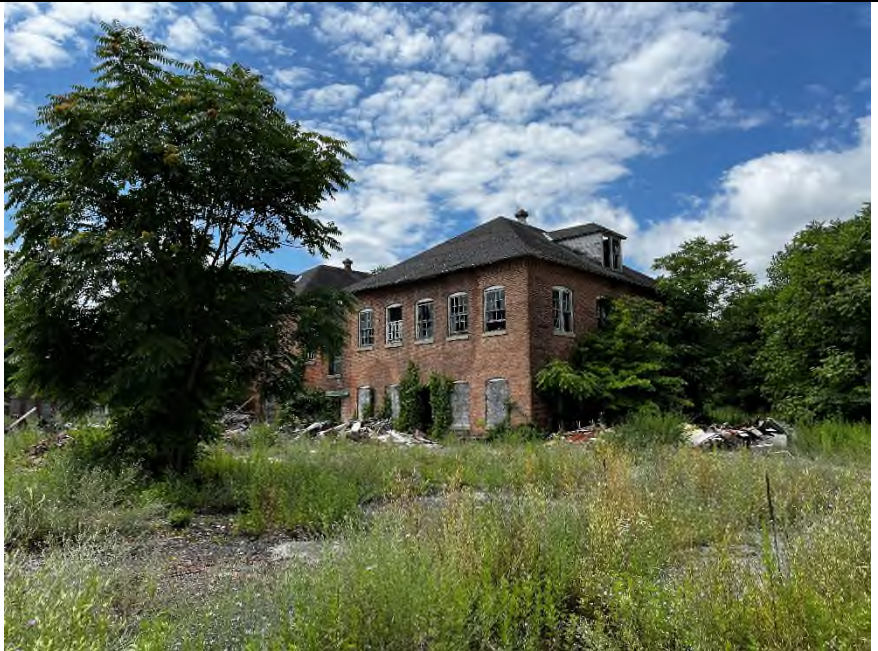
Photo 8 –

Maintenance Building with debris located east side of structure.

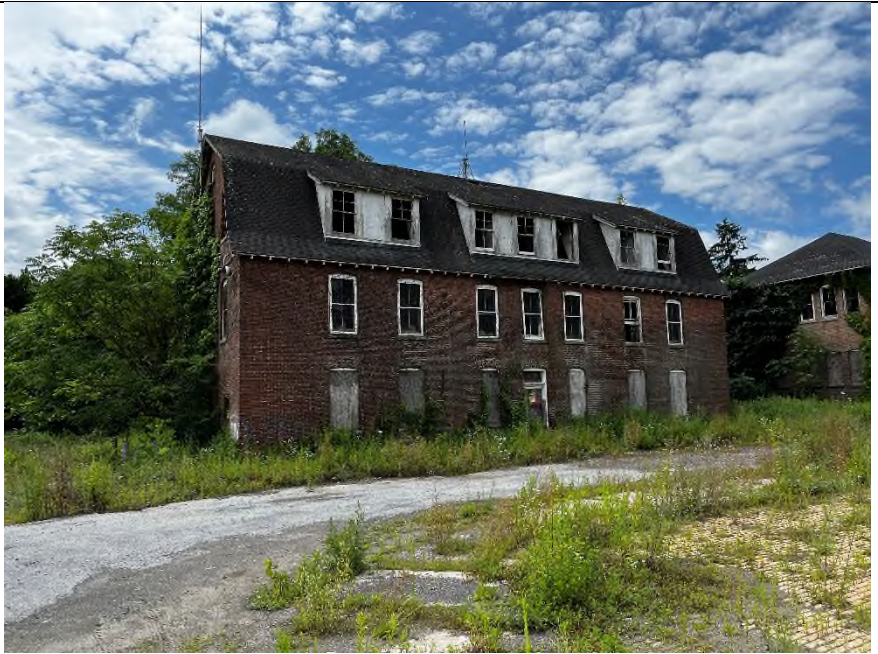
Photo 9 –

Fire House.

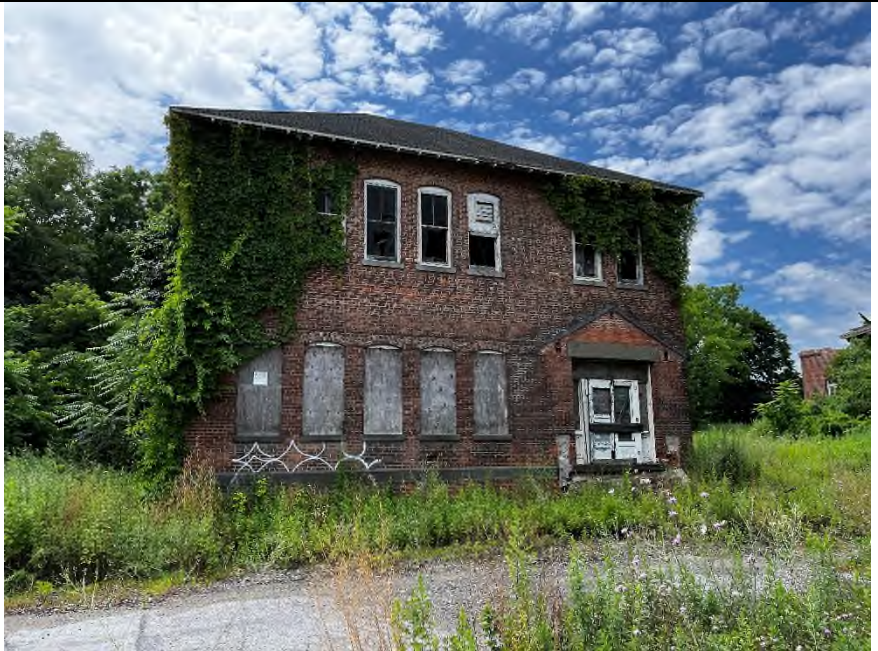
Photo 10 –

Mortuary Building.

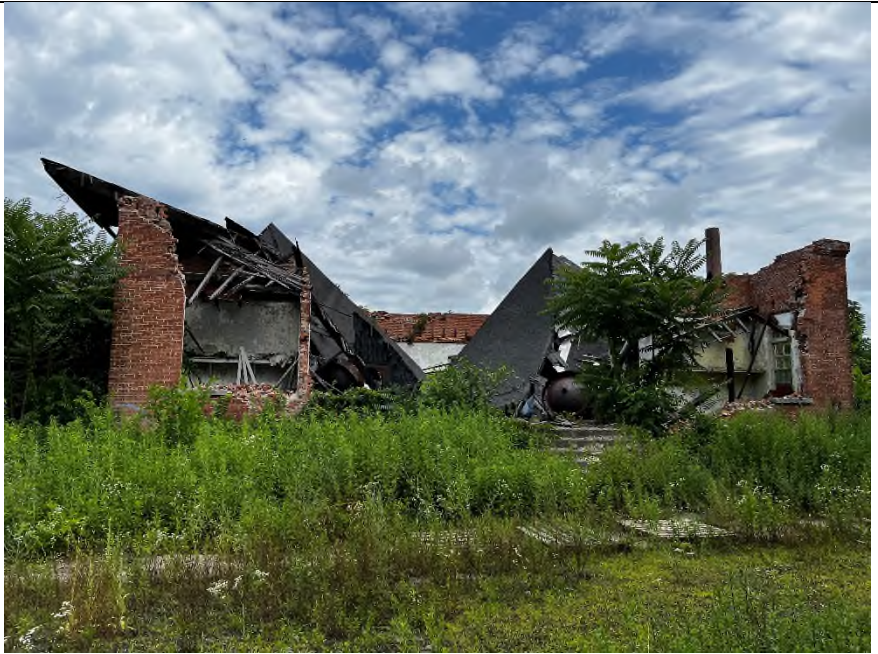
Photo 11 –

Structure west of the Mortuary Building, facing north (collapsed).

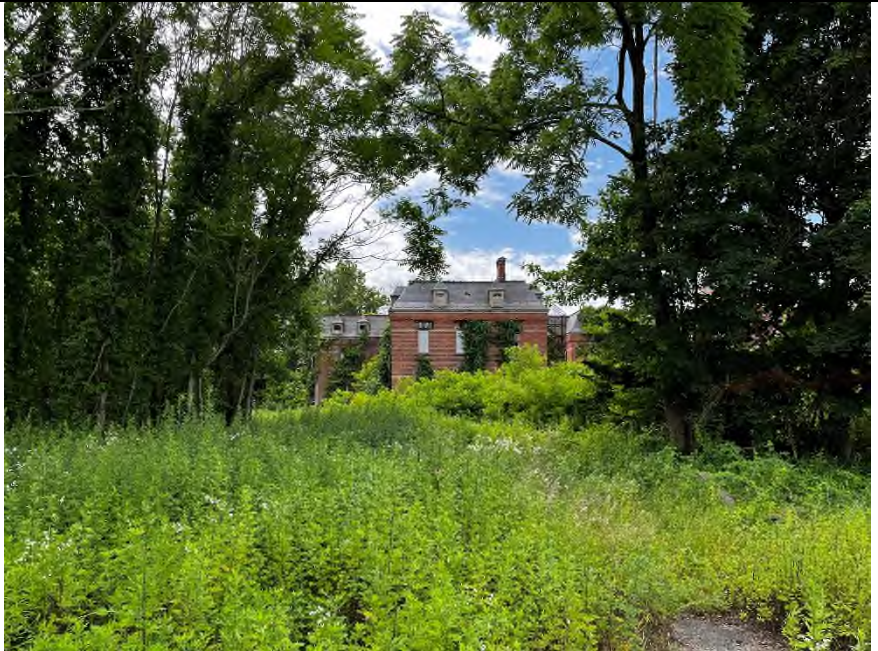
Photo 12 –

Structures in southwest corner of BCP Site, facing south.

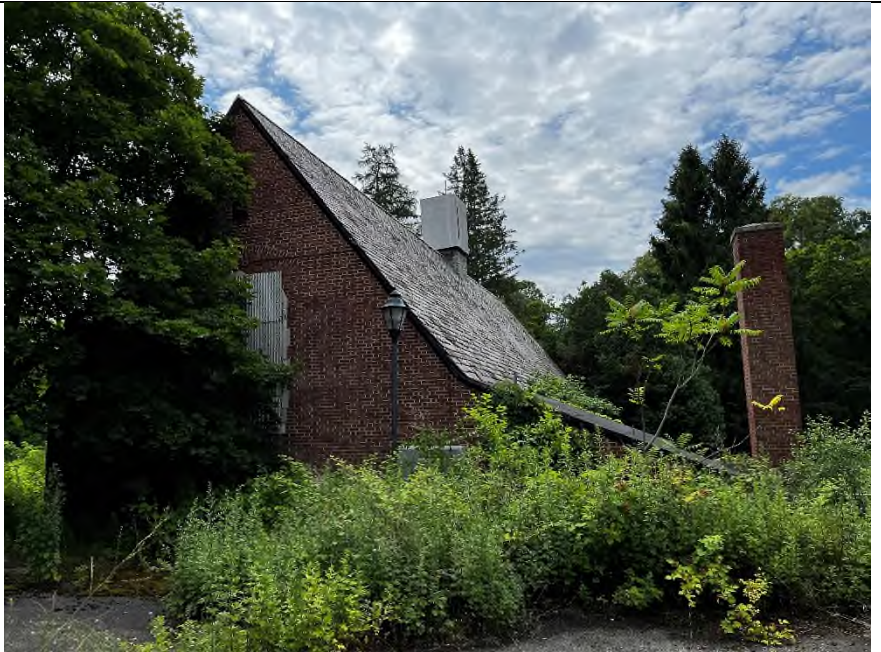
Photo 13 –

Rectory south of the Recreational Hall building.

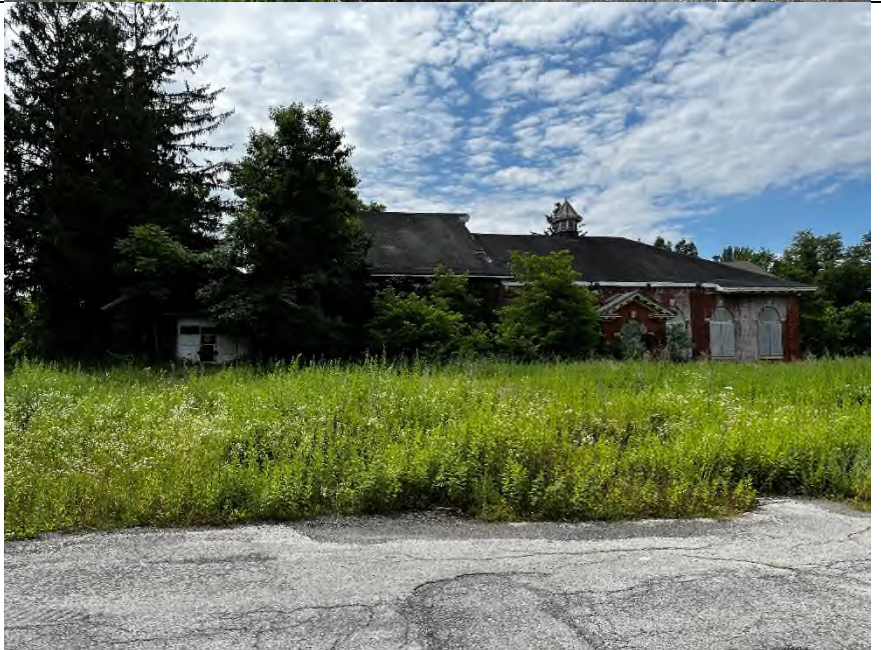
Photo 14 –

Recreational Hall.

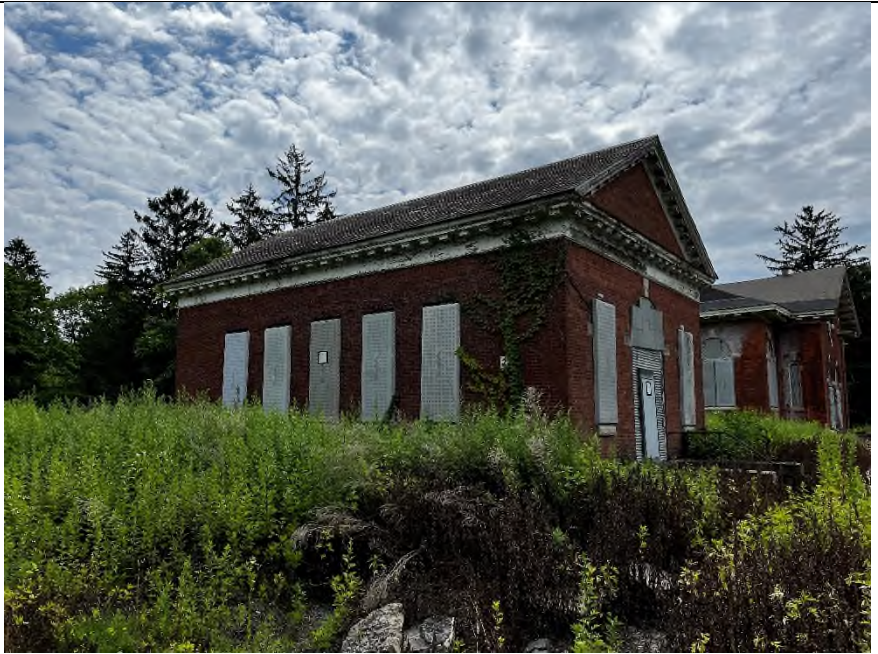
Photo 15 –

Library.

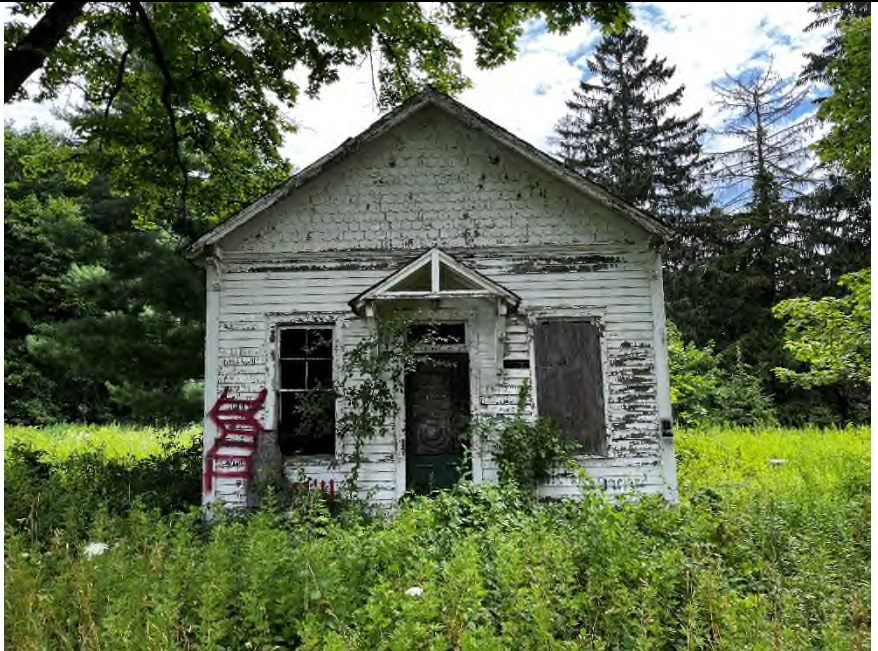
Photo 16 –

Small structure east of the Library.

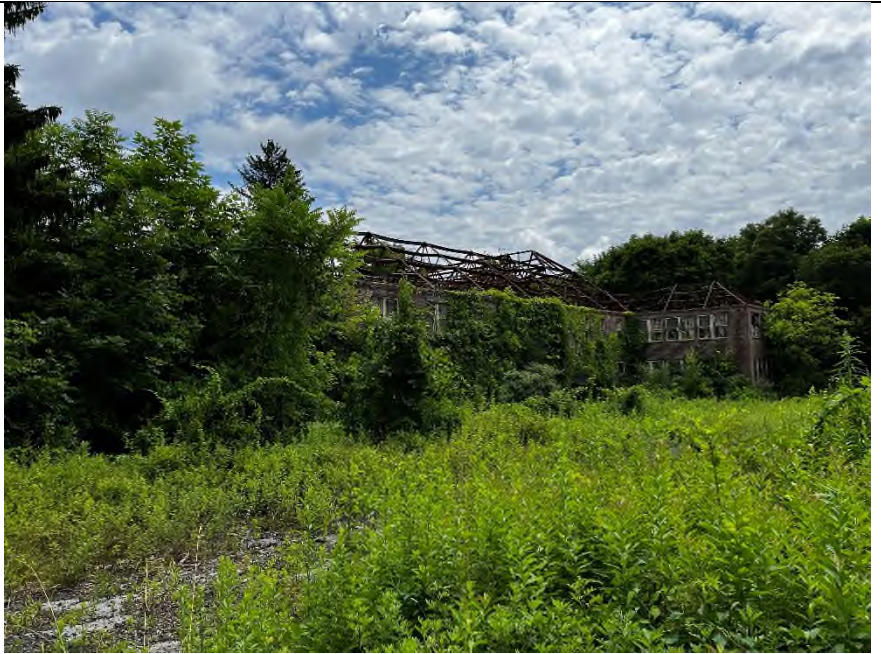
Photo 17 –

Brookside structure, severe deterioration of roof.

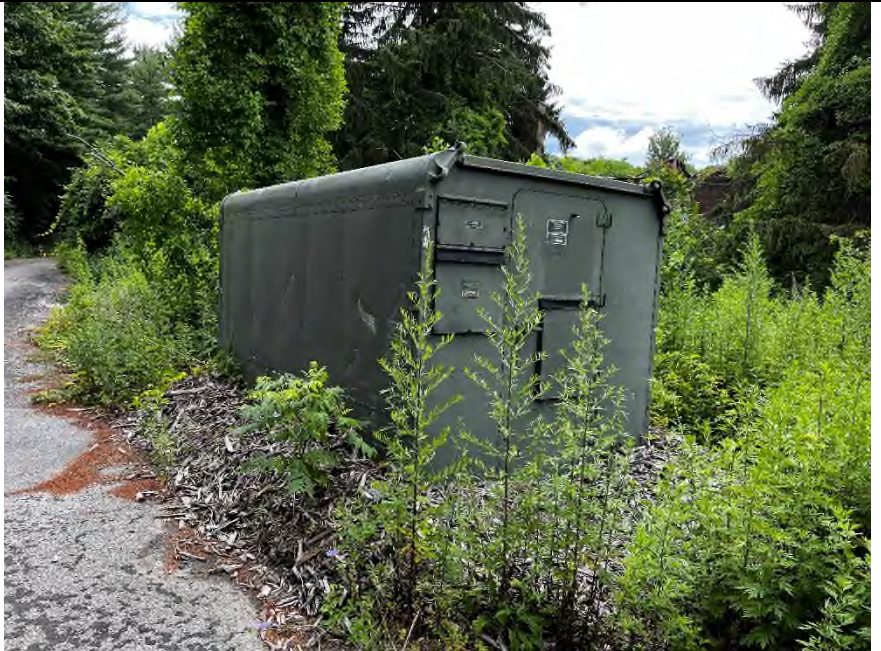
Photo 18 –

Metal container placed over fire hydrant. Base of container is bordered with wood chips.

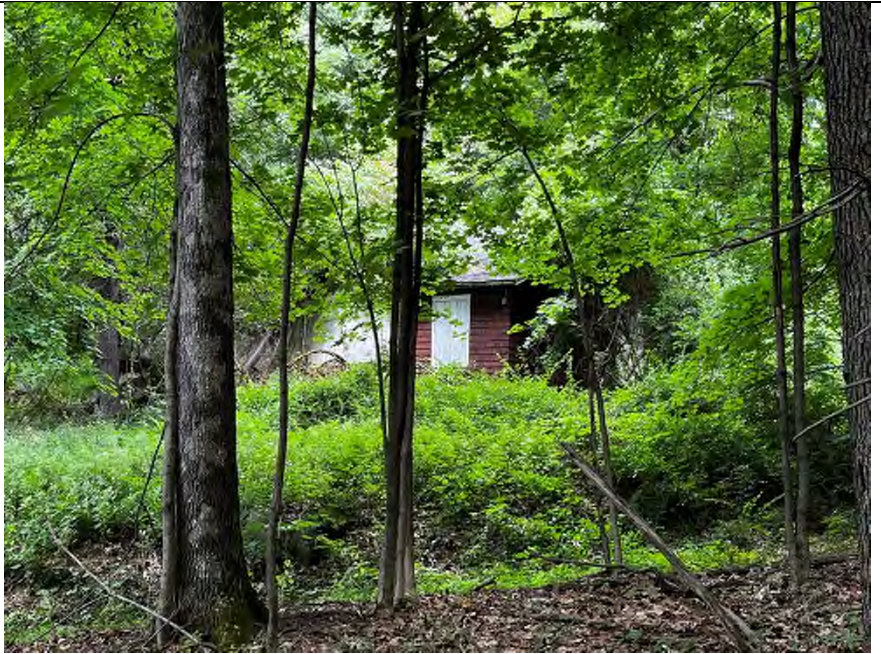
Photo 19 –

Staff House, severe deterioration  
of roof and interior floor.

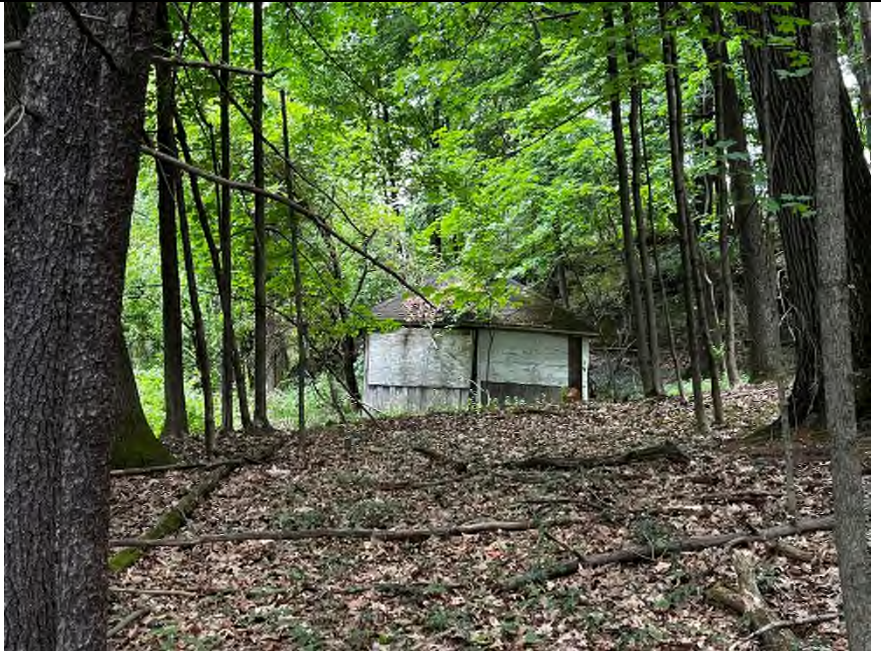
Photo 20 –

Small structure east of the Staff  
House.
