## MONTHLY STATUS REPORT

| BCP No.: | C314121 | PVE Project No.: | 560909 | Date: | 8/23/2022 |
| Project Address: | 3532 North Road, Poughkeepsie, Dutchess County New York | | | | |

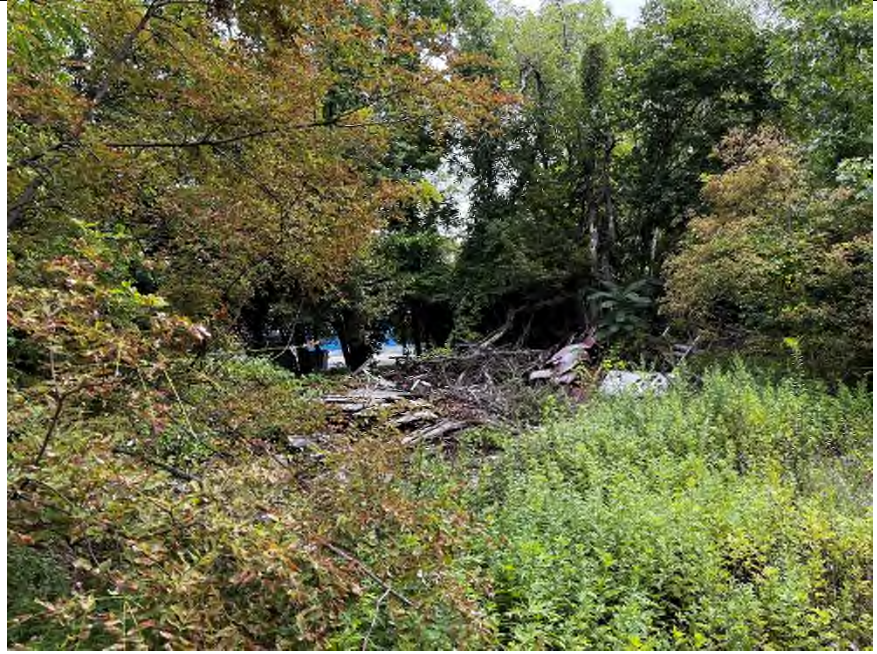
Photo 1 –

Auto Garage East (Collapsed).

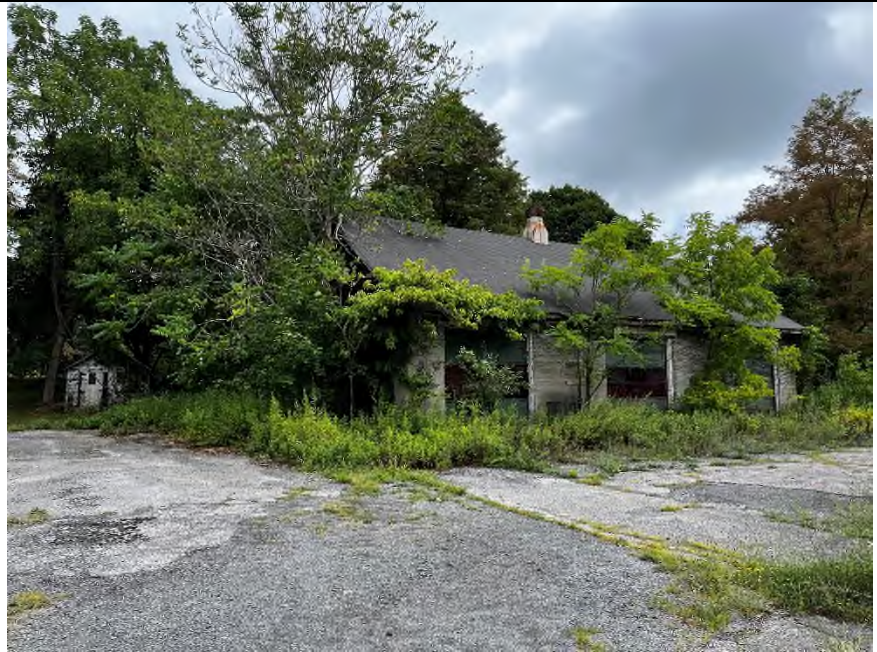
Photo 2 –

Auto Garage West.

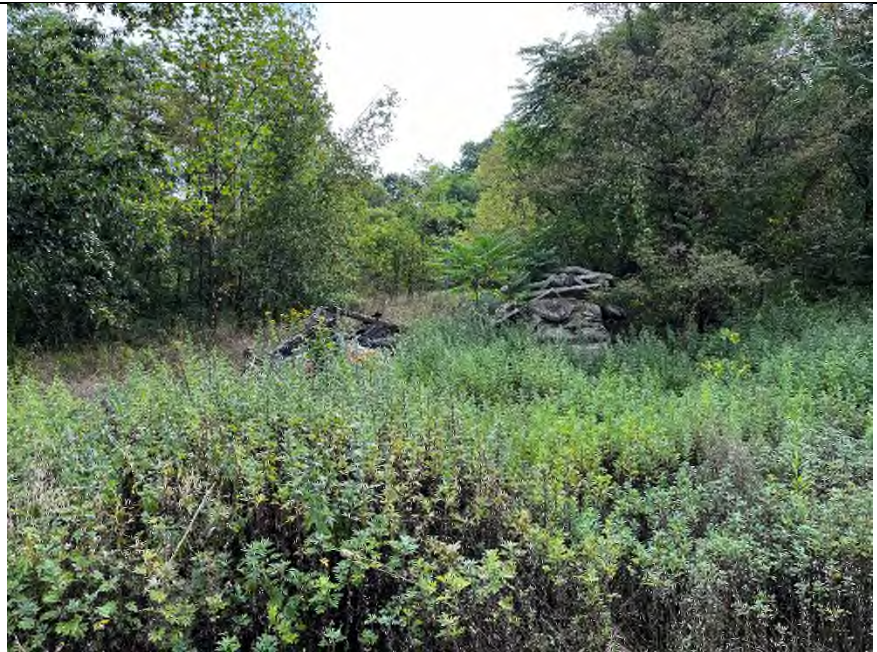
Photo 3 –

Pile of debris located south of Auto Garage East.

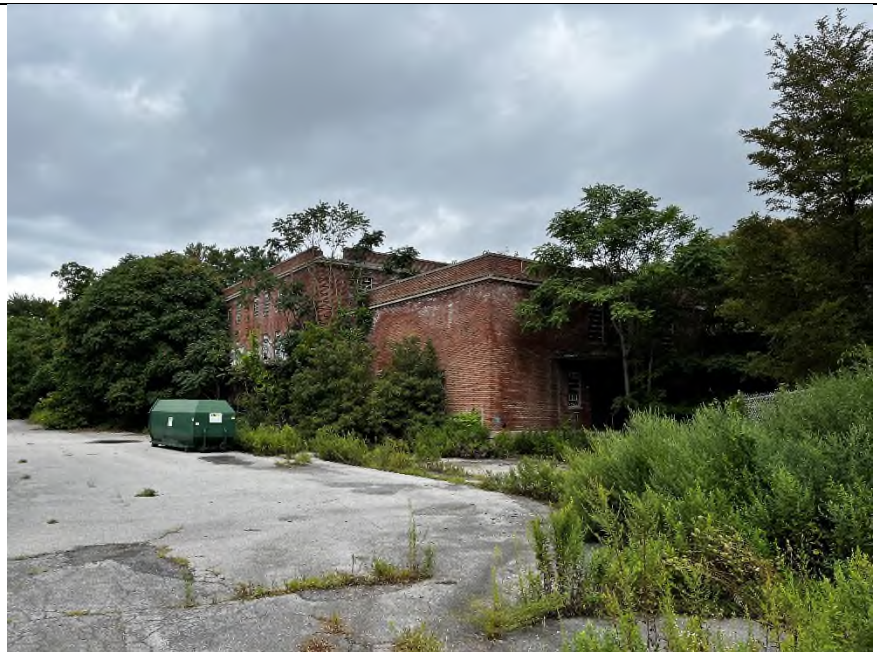
Photo 4 –

Bakery/Storage structure.  
Dumpster located south of structure.

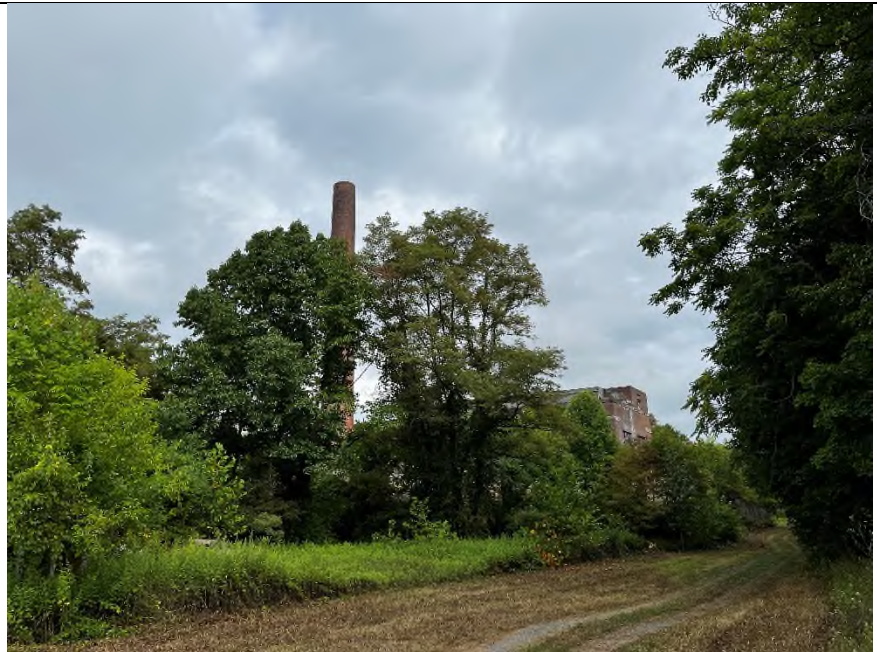
Photo 5 –  
Powerhouse.

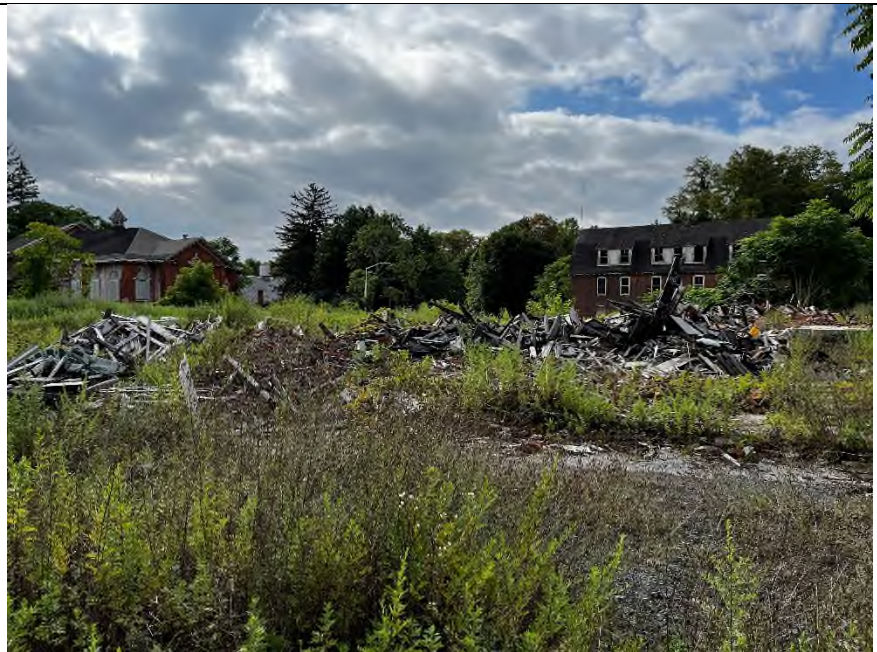
Photo 6 –  
Engineering Building  
(Demolished).

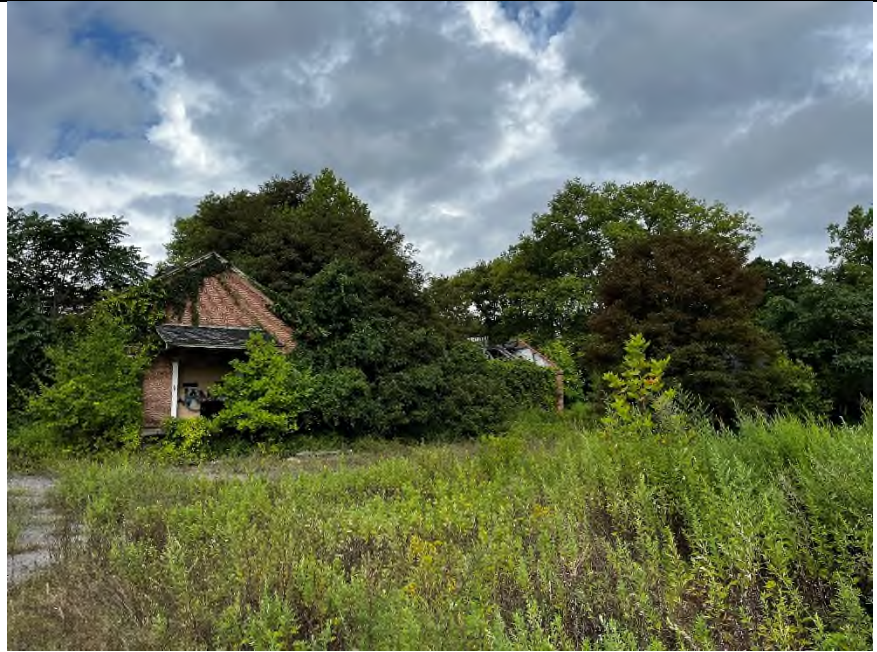
Photo 7 –

Carwash (pictured left) with shed (pictured right).

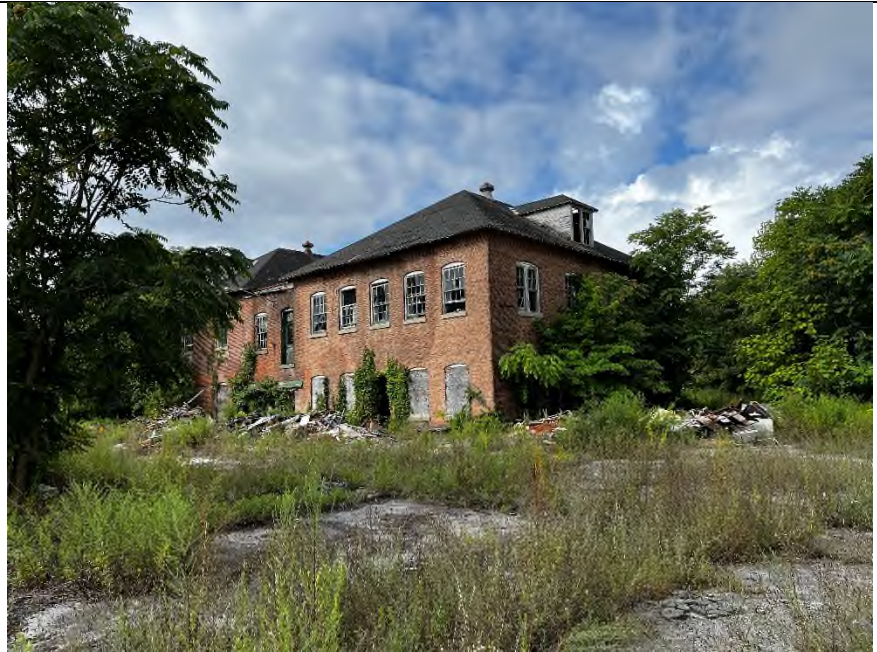
Photo 8 –

Maintenance Building with debris located east side of structure.

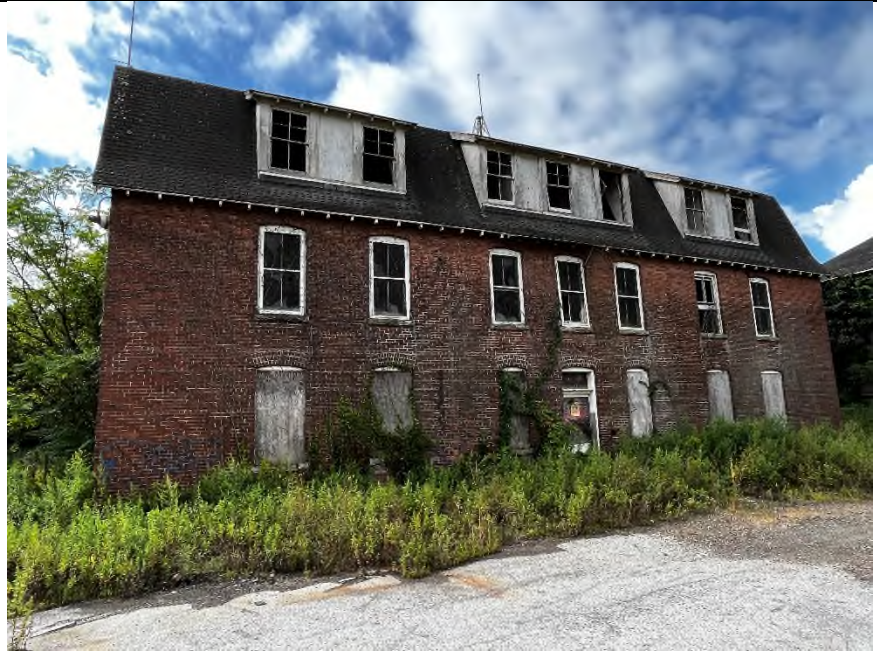
Photo 9 –  
Fire House.

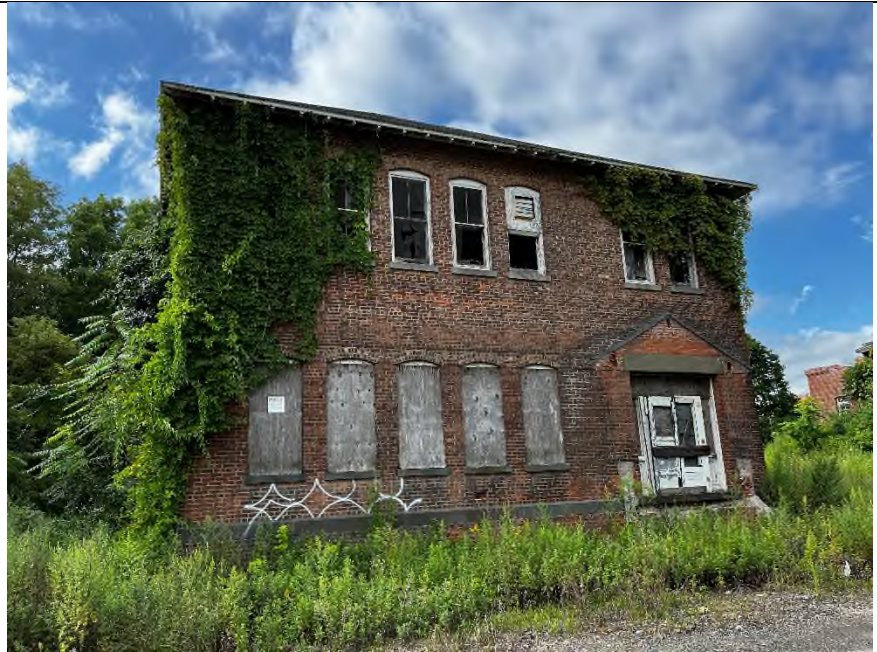
Photo 10 –  
Mortuary Building.

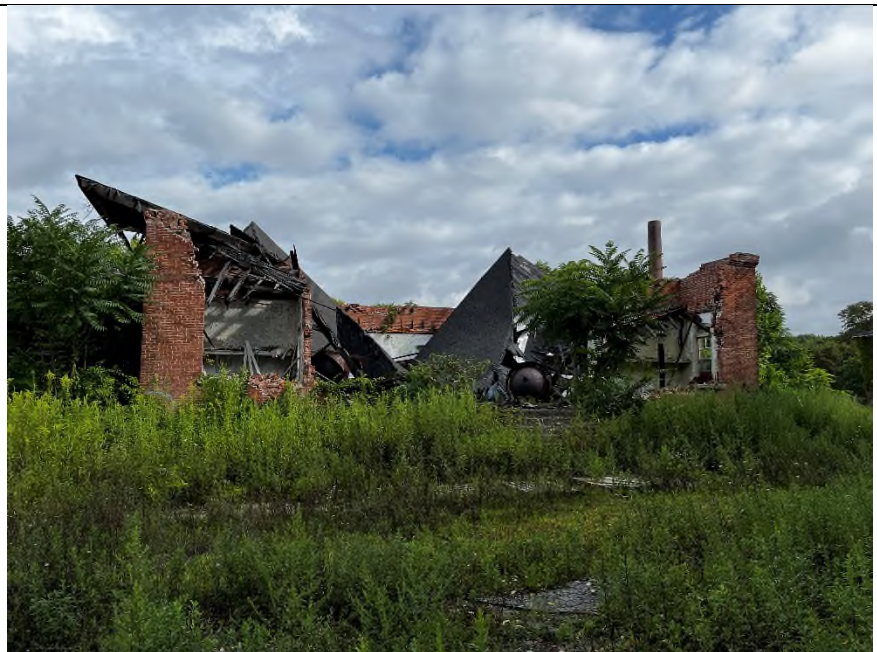
Photo 11 –

Structure west of the Mortuary Building, facing north (collapsed).

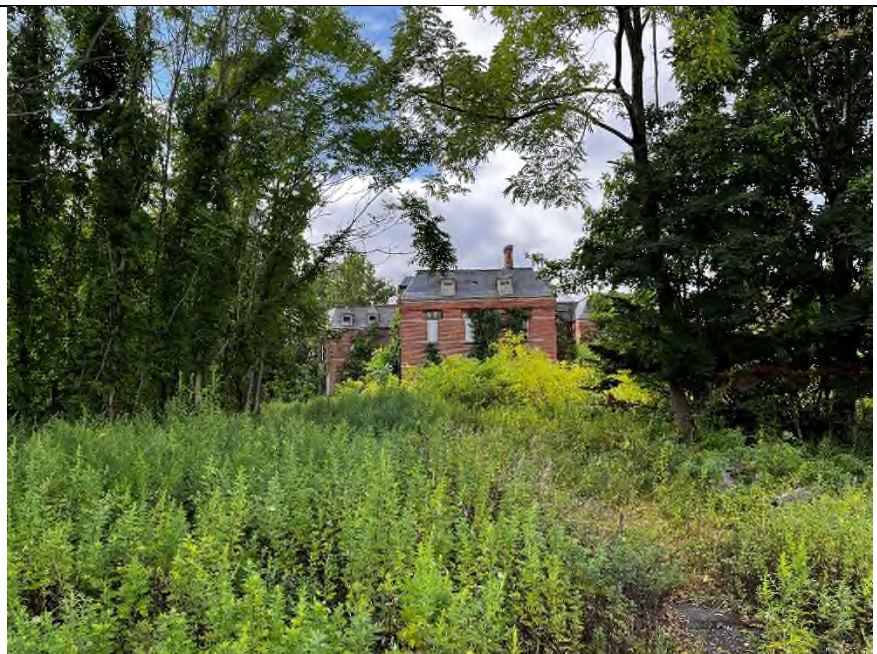
Photo 12 –

Structures in southwest corner of BCP Site, facing south.

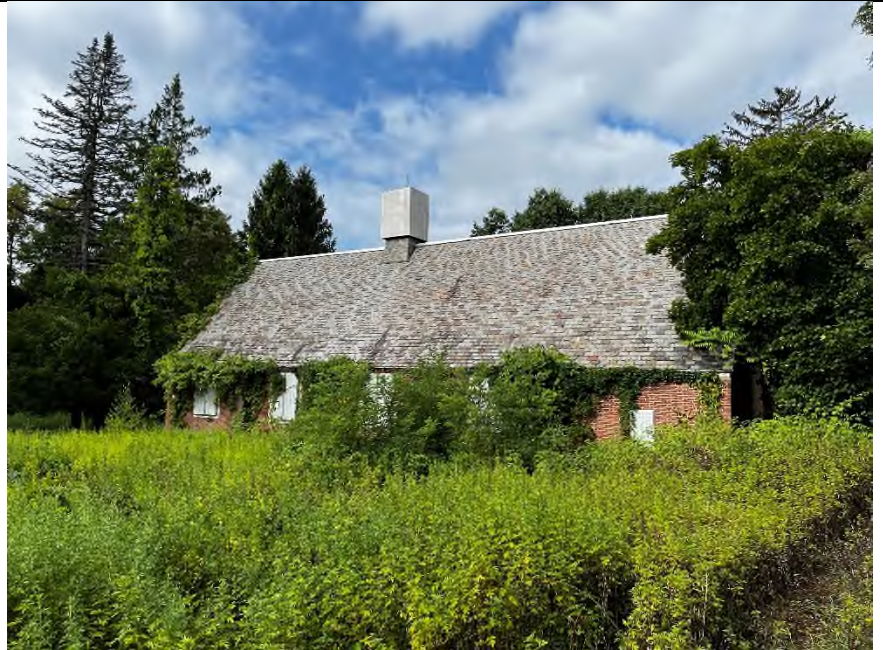
Photo 13 –

Rectory south of the Recreational  
Hall building.

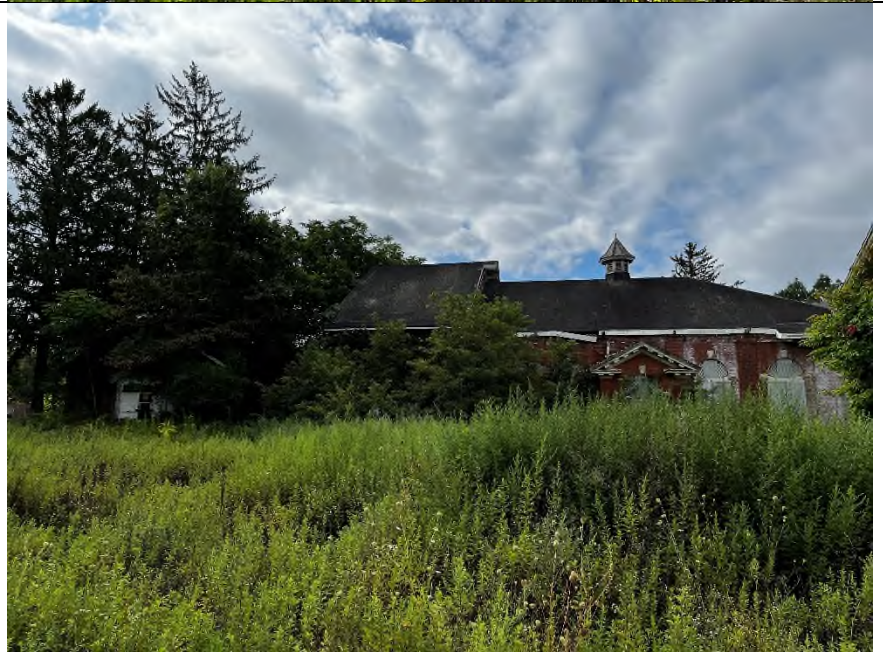
Photo 14 –

Recreational Hall.

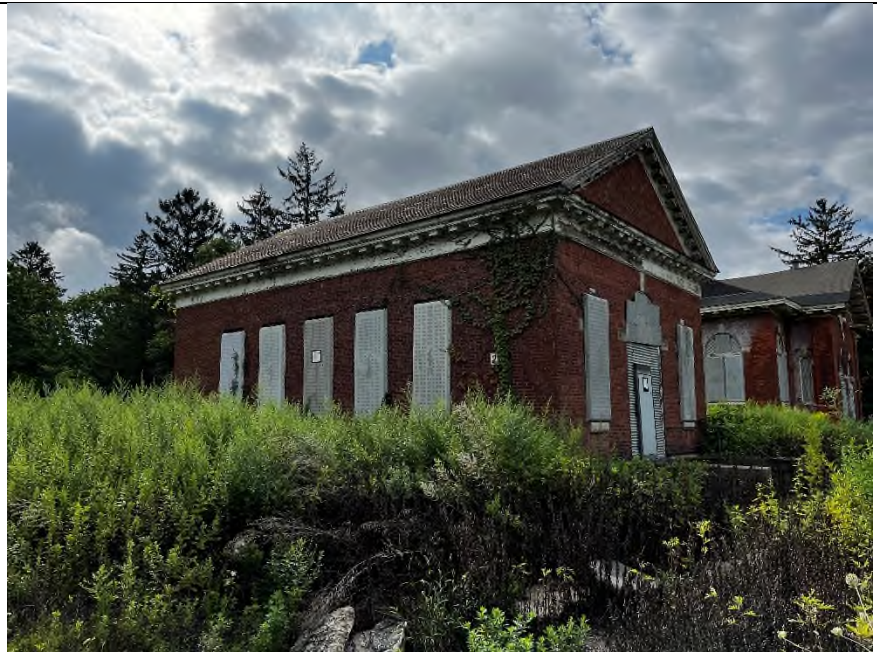
Photo 15 –  
Library.

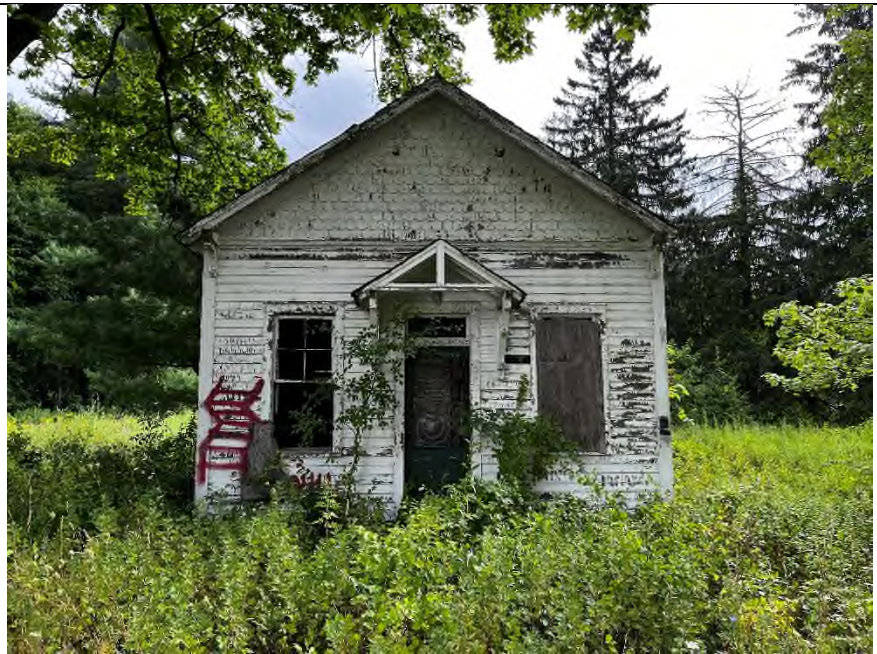
Photo 16 –  
Small structure east of the Library.

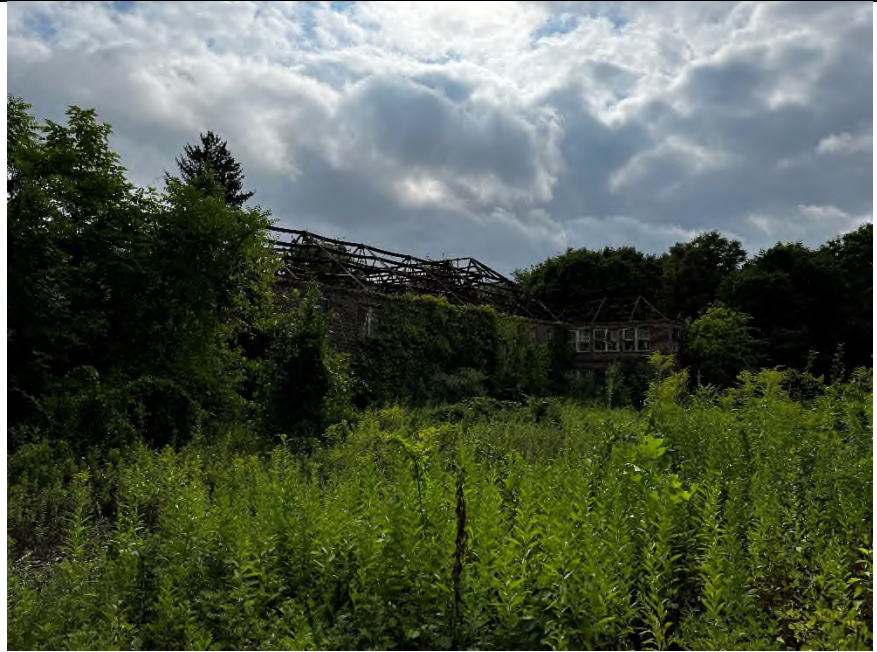
Photo 17 –

Brookside structure, severe deterioration of roof.

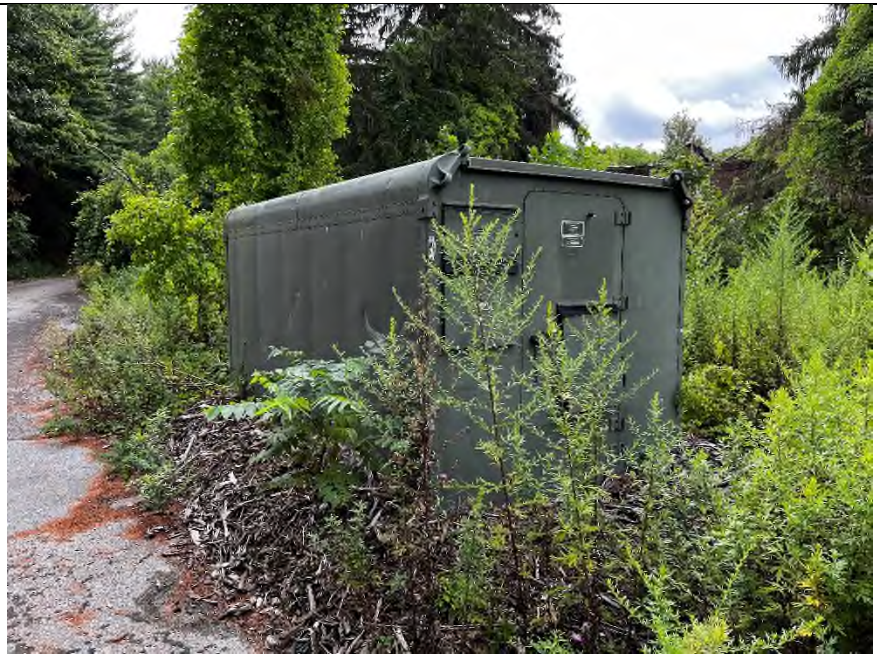
Photo 18 –

Metal container placed over fire hydrant. Base of container is bordered with wood chips.

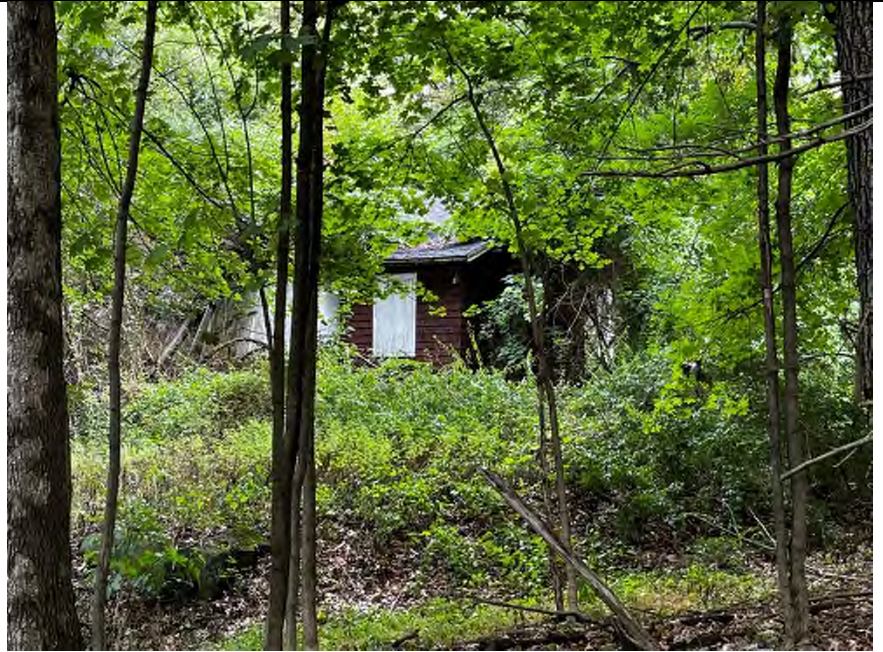
Photo 19 –

Staff House, severe deterioration  
of roof and interior floor.

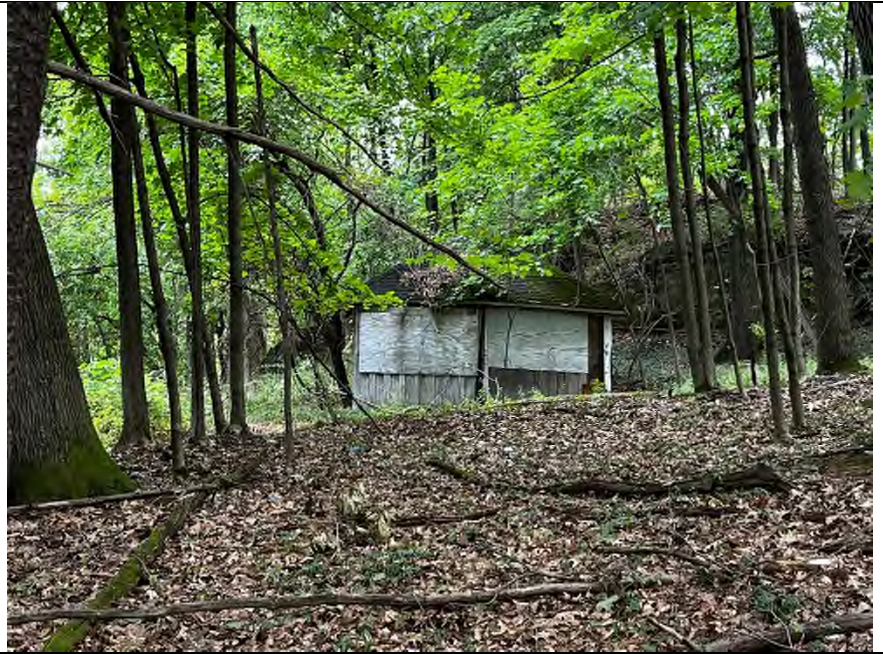
Photo 20 –

Small structure east of the Staff  
House.
