MONTHLY STATUS REPORT

Prepared By: Trevor Treglia

BCP No.:	C314121	PVE Project No.:	560909	Date:	9/21/2022
Project Address:	3532 North Road, Poughkeepsie, Dutchess County New York

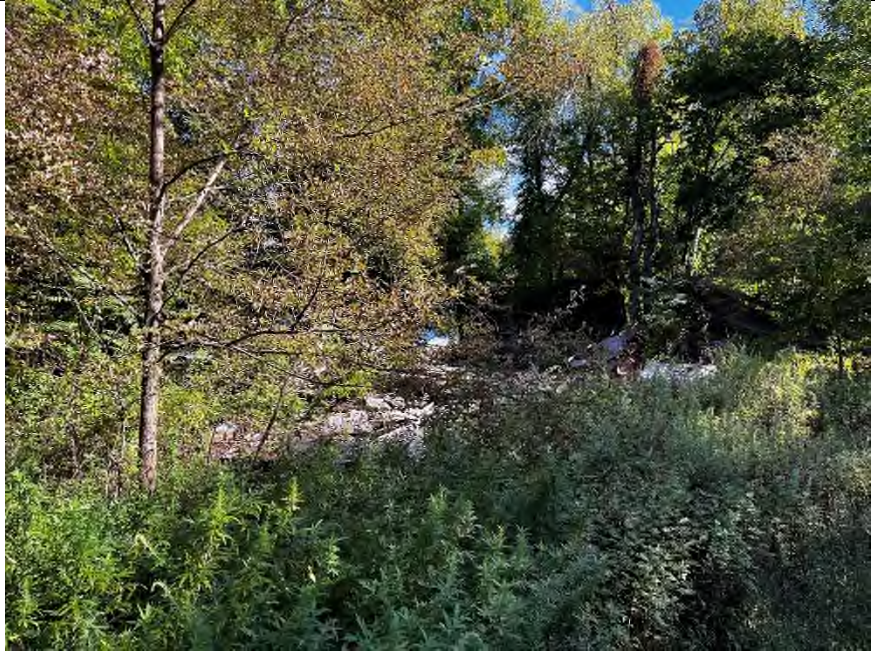
Photo 1 –

Auto Garage East (Collapsed).

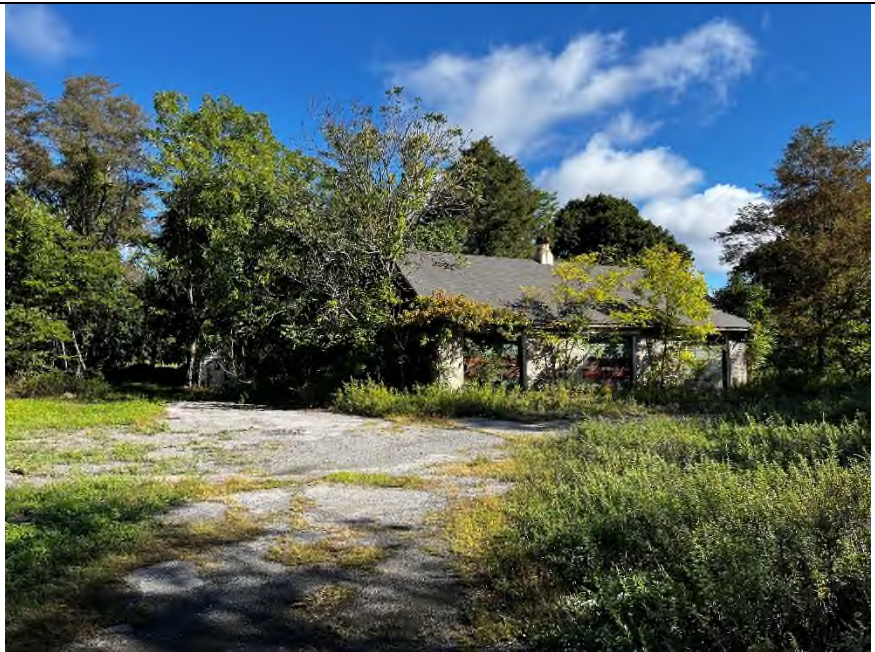
Photo 2 –

Auto Garage West.

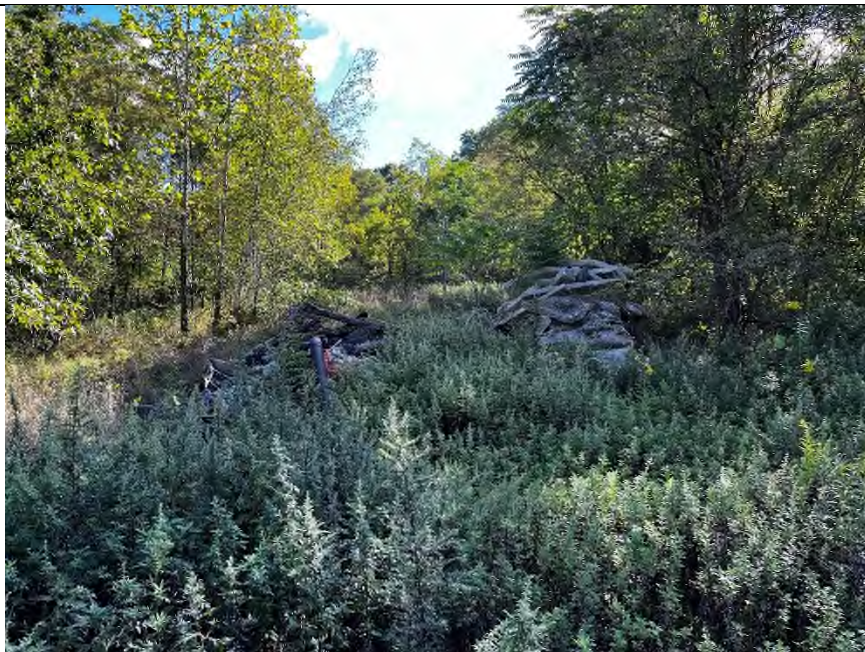
Photo 3 –

Pile of debris located south of
Auto Garage East.

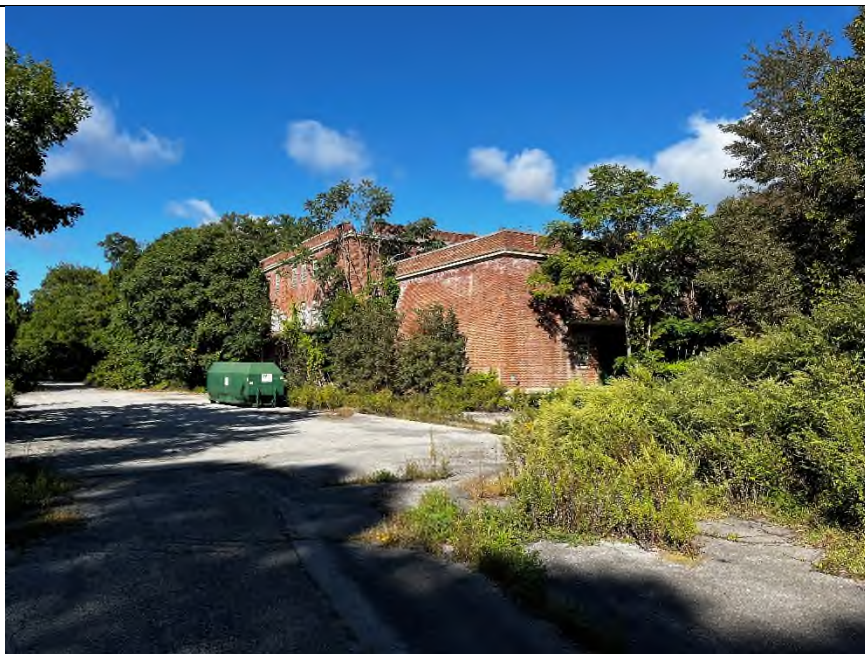
Photo 4 –

Bakery/Storage structure.
Dumpster located south of
structure.

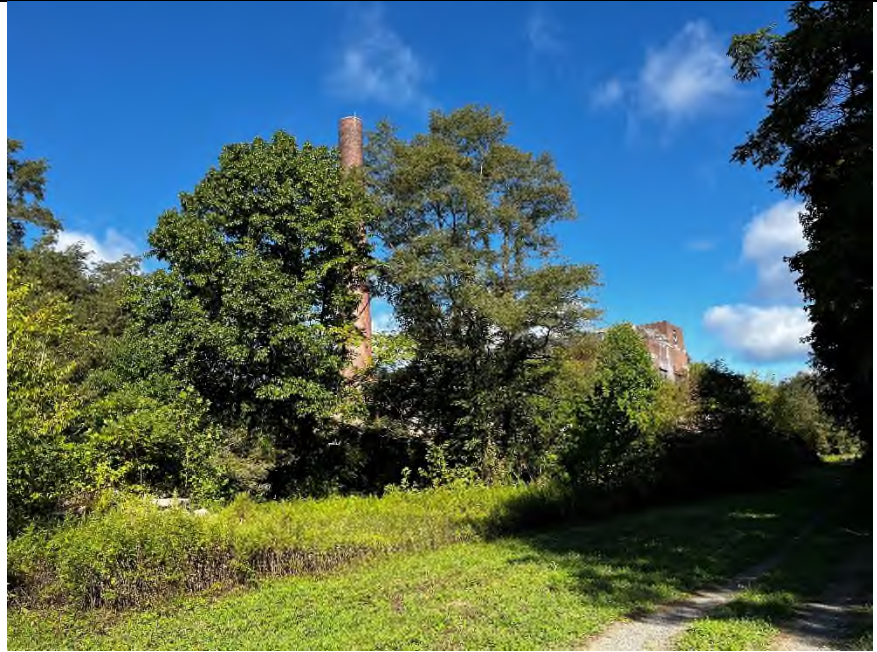
Photo 5 –
Powerhouse.

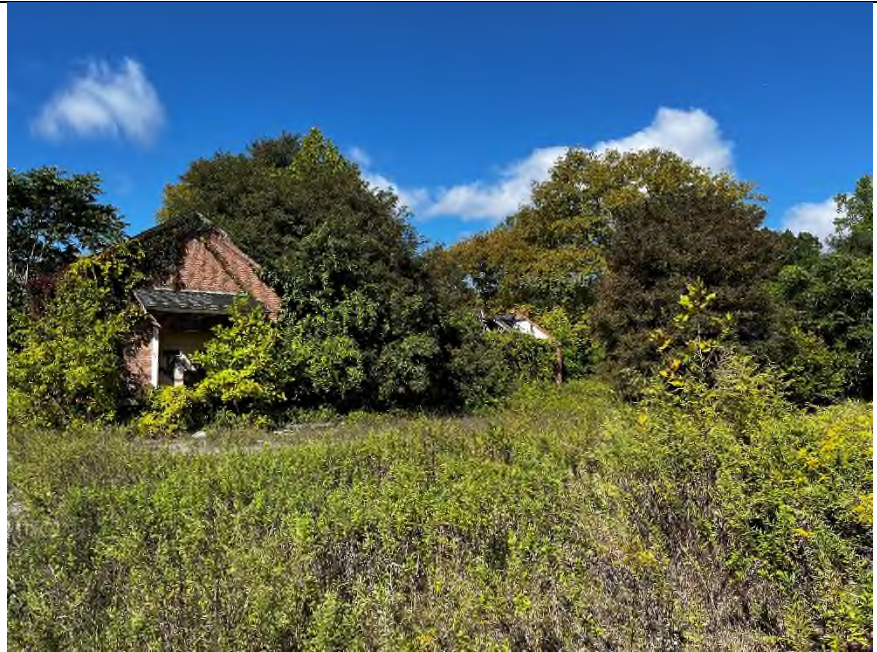
Photo 6 –
Carwash (pictured left) with shed
(pictured right).

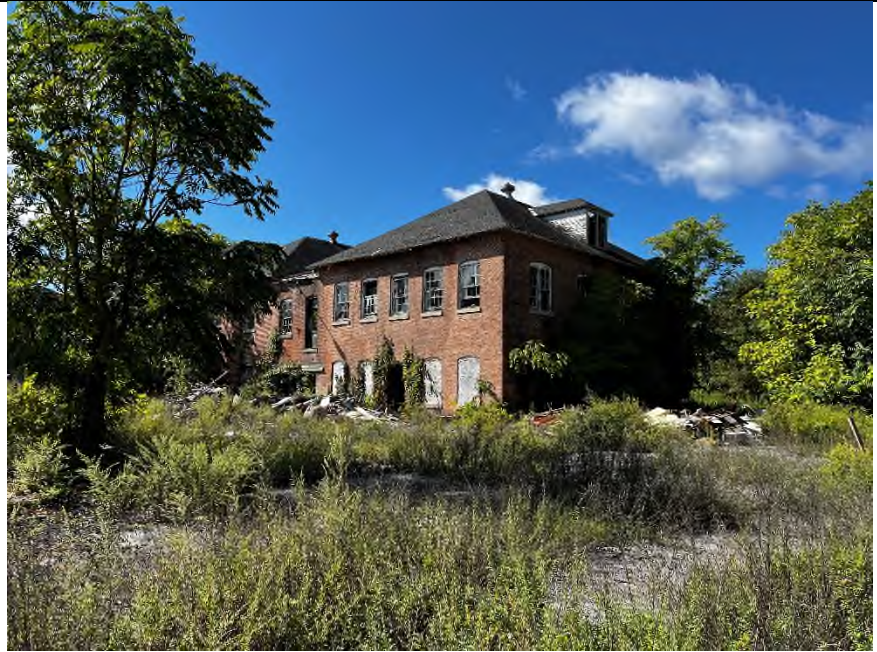
Photo 7 –

Maintenance Building with debris located east side of structure.

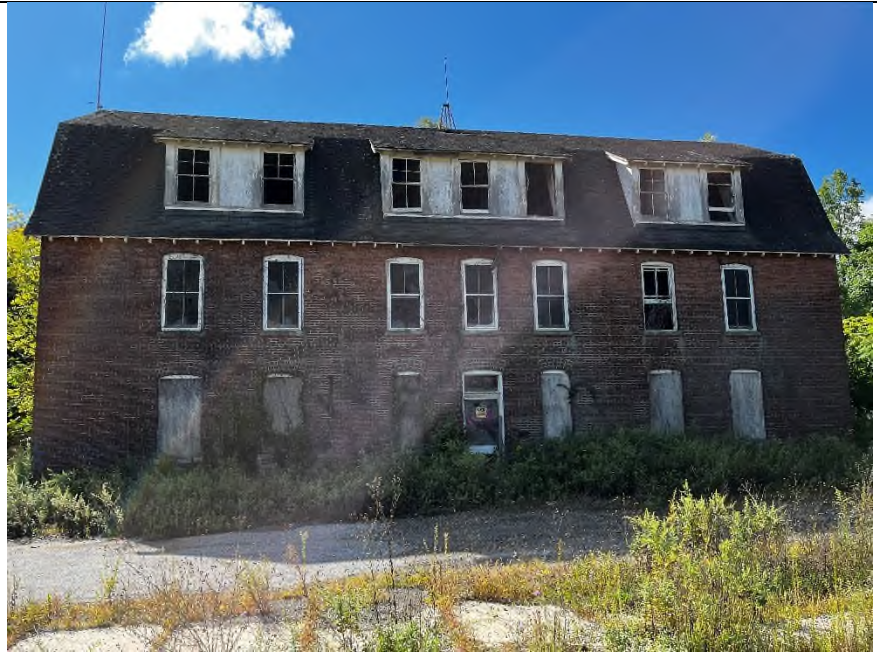
Photo 8 –

Fire House.

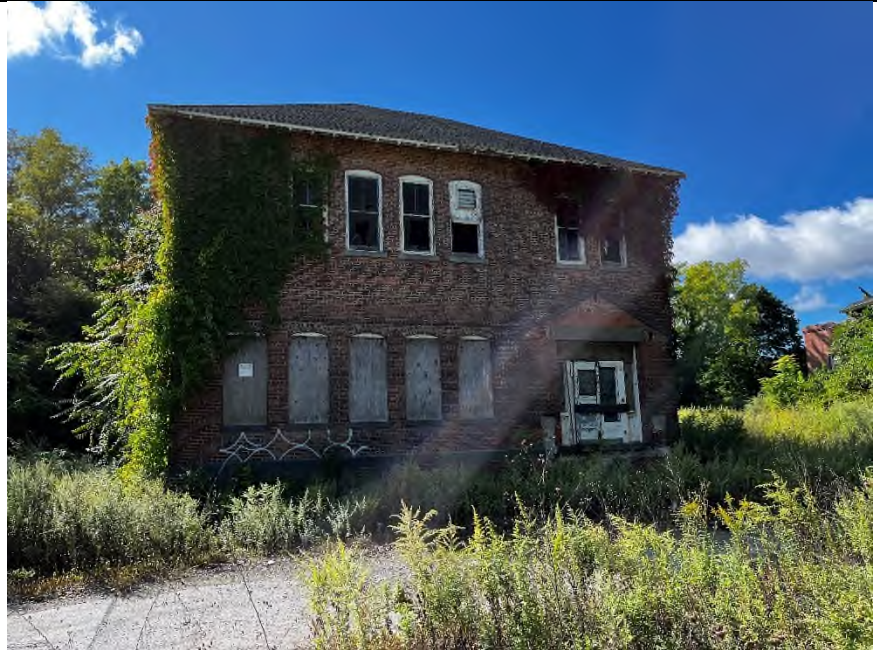
Photo 9 –
Mortuary Building.

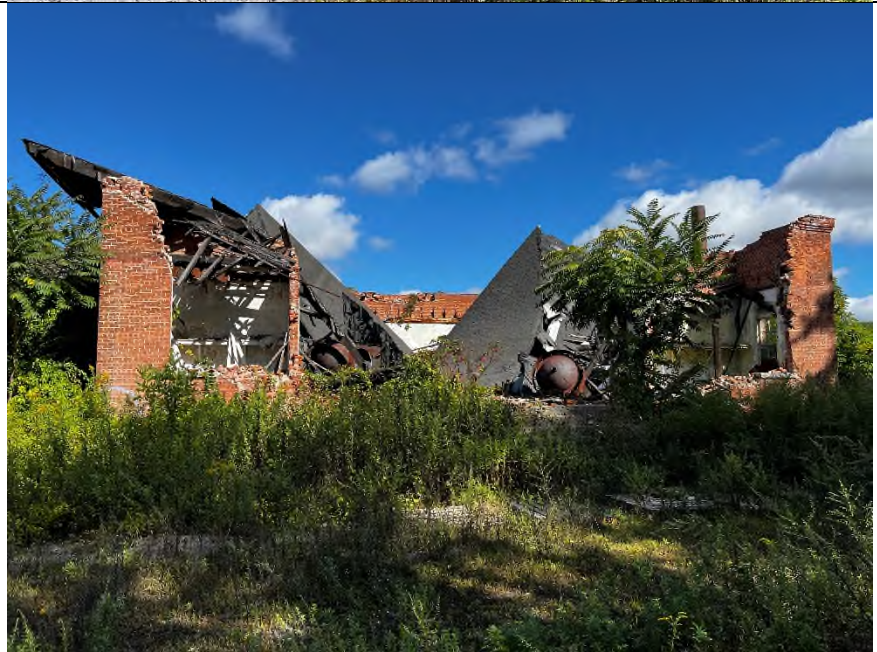
Photo 10 –
Structure west of the Mortuary
Building, facing north (collapsed).

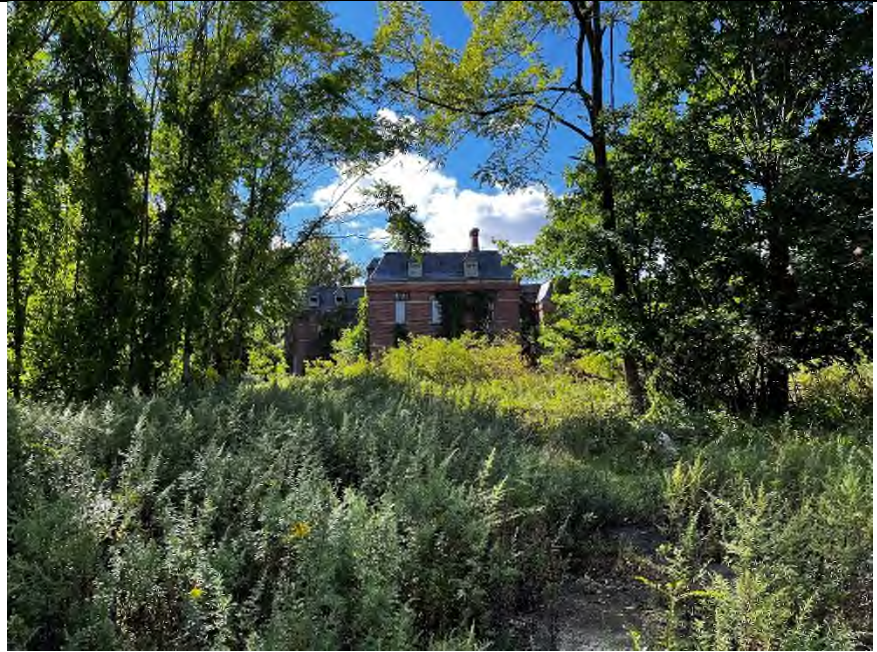
Photo 11 –

Structures in southwest corner of
BCP Site, facing south.

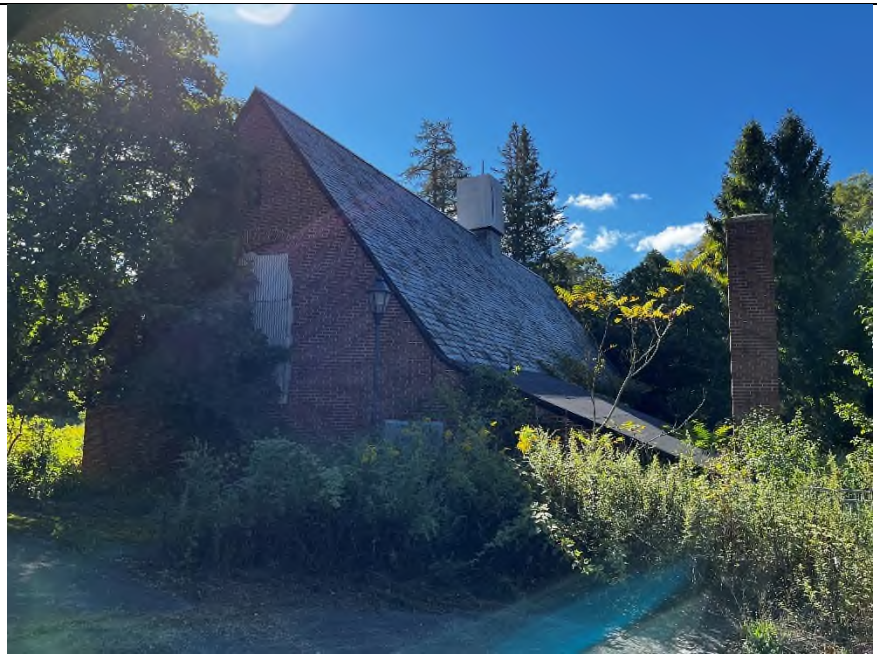
Photo 12 –

Rectory south of the Recreational
Hall building.

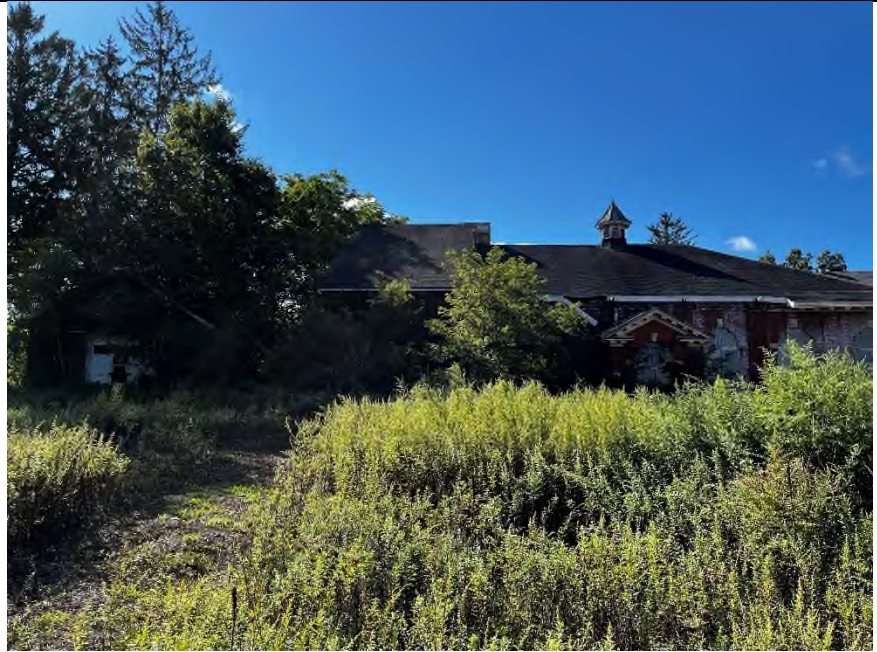
Photo 13 –
Recreational Hall.

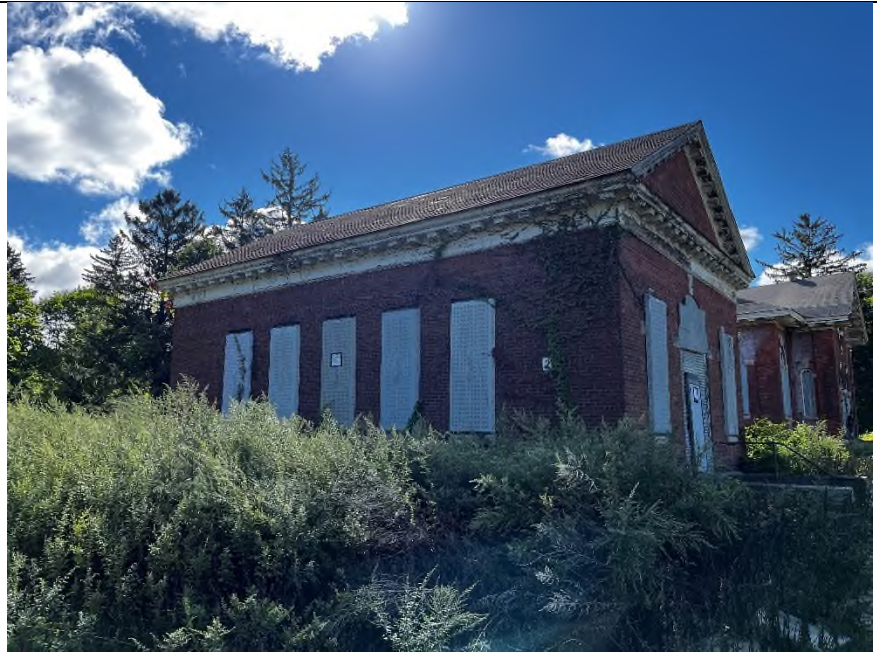
Photo 14 –
Library.

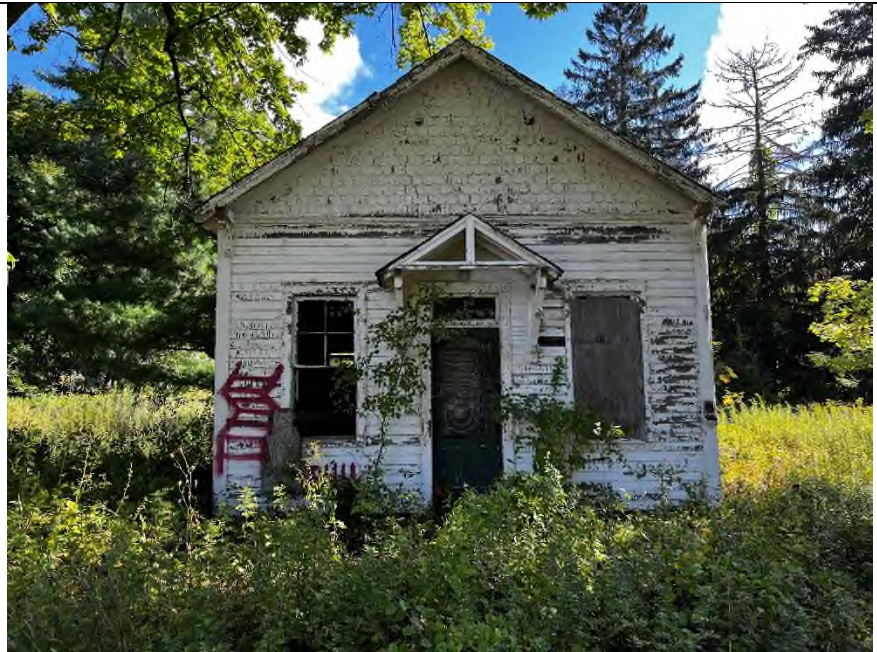
Photo 15 –
Small structure east of the Library.

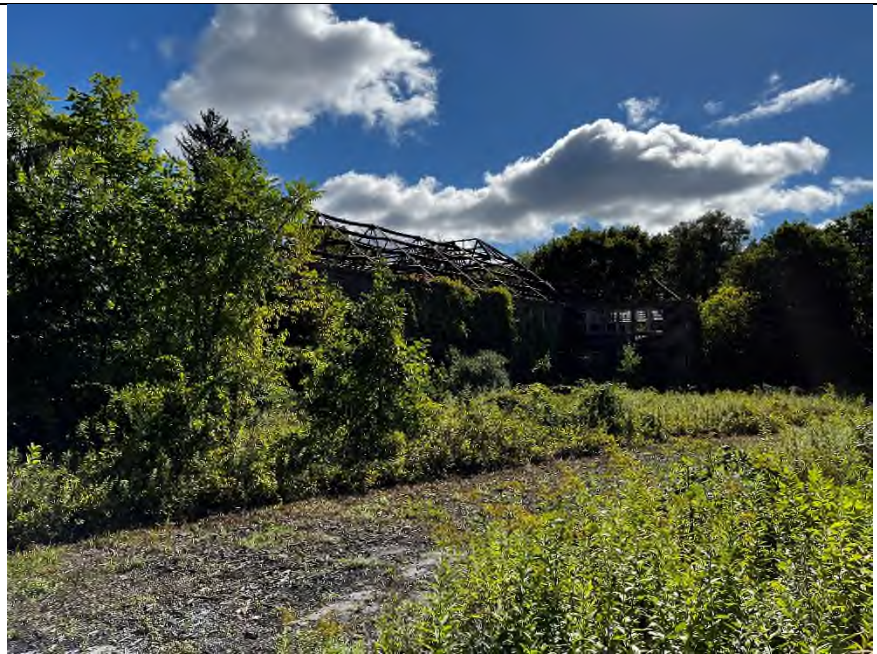
Photo 16 –
Brookside structure, severe deterioration of roof.

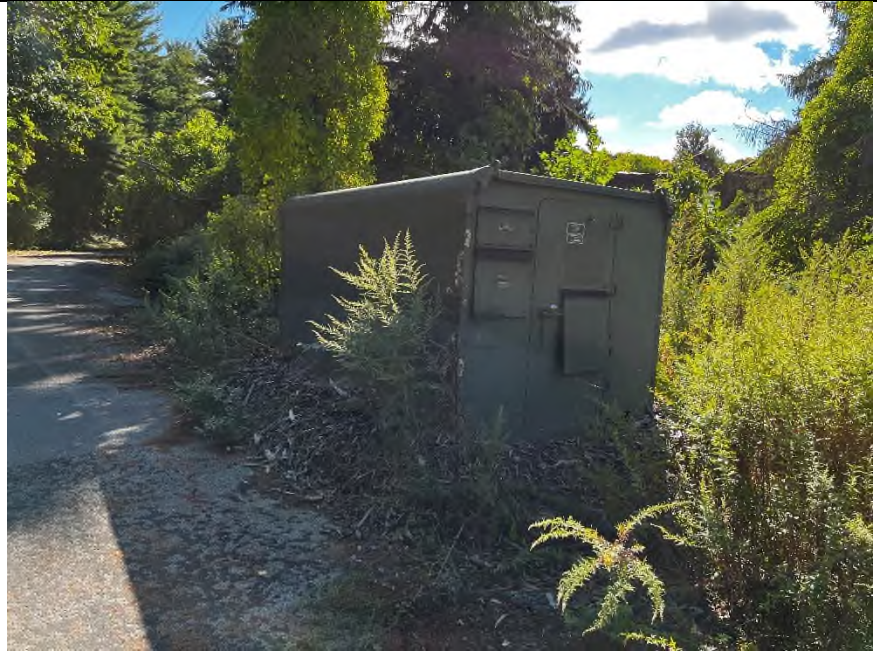
Photo 17 –

Metal container placed over fire hydrant. Base of container is bordered with wood chips.

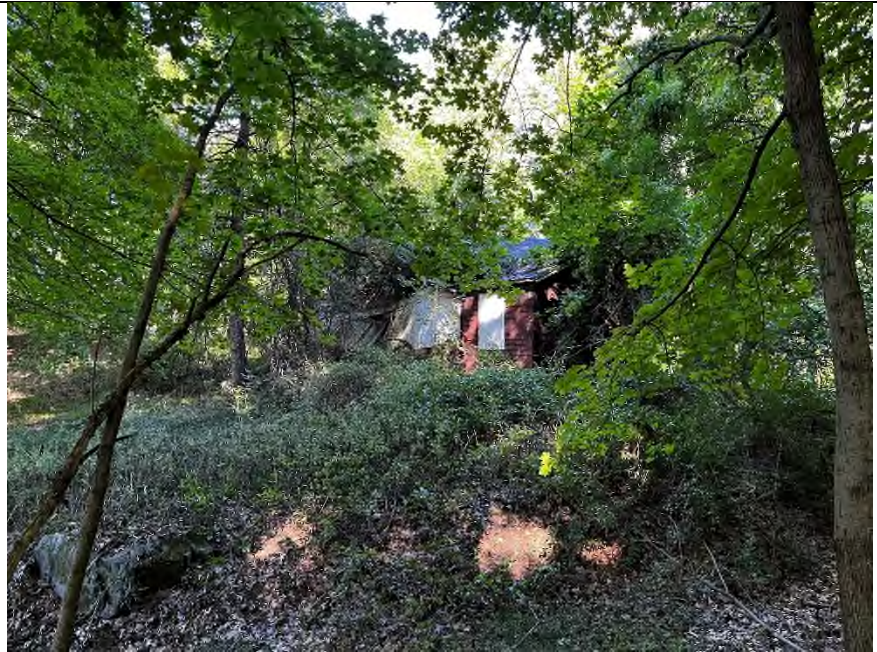
Photo 18 –

Staff House, severe deterioration of roof and interior floor.

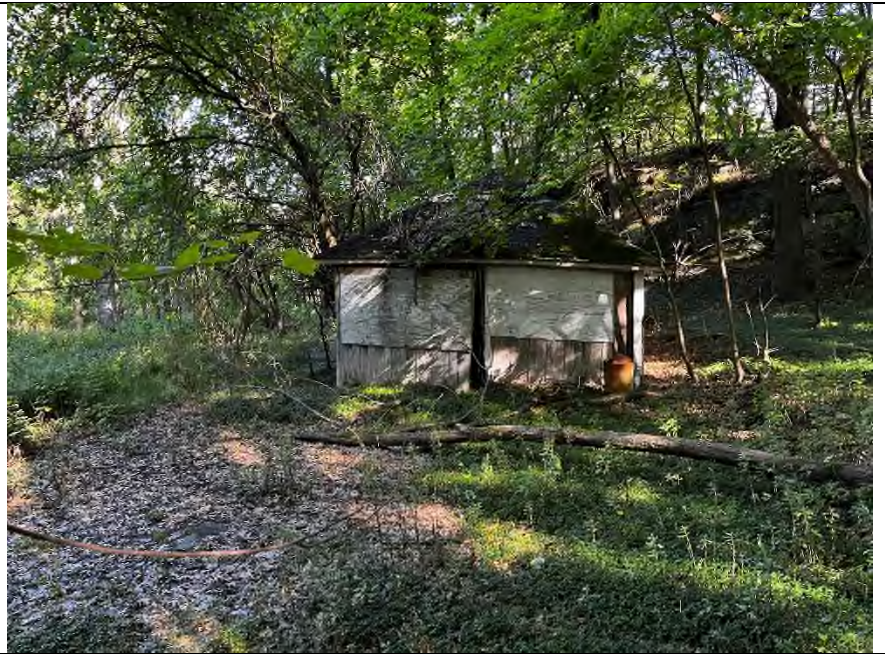
Photo 19 –

Small structure east of the Staff House.
