MONTHLY STATUS REPORT

BCP No.:	C314121	PVE Project No.:	560909	Date:	12/15/2022
Project Address:	3532 North Road, Poughkeepsie, Dutchess County New York

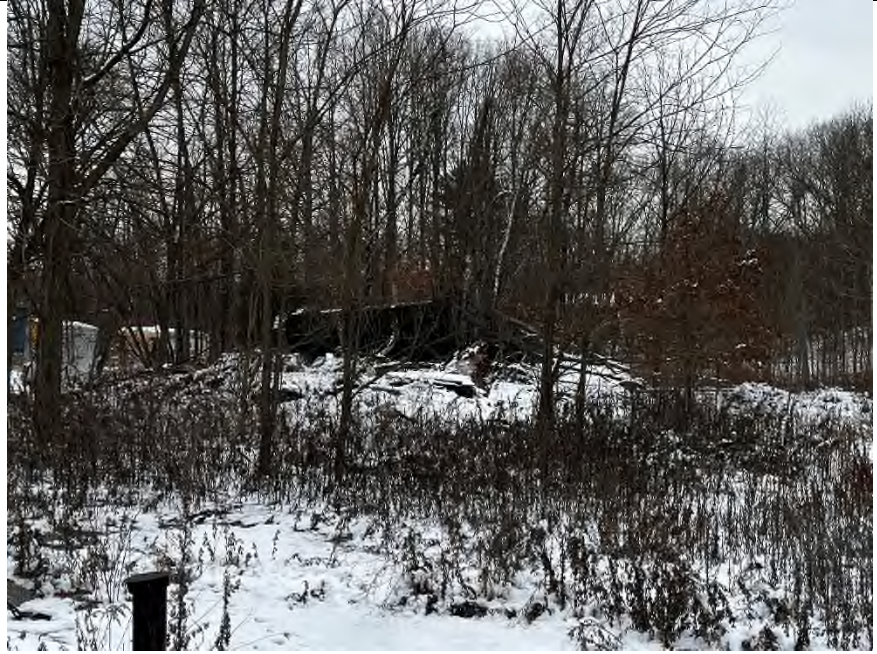
Photo 1 –

Auto Garage East (Collapsed).

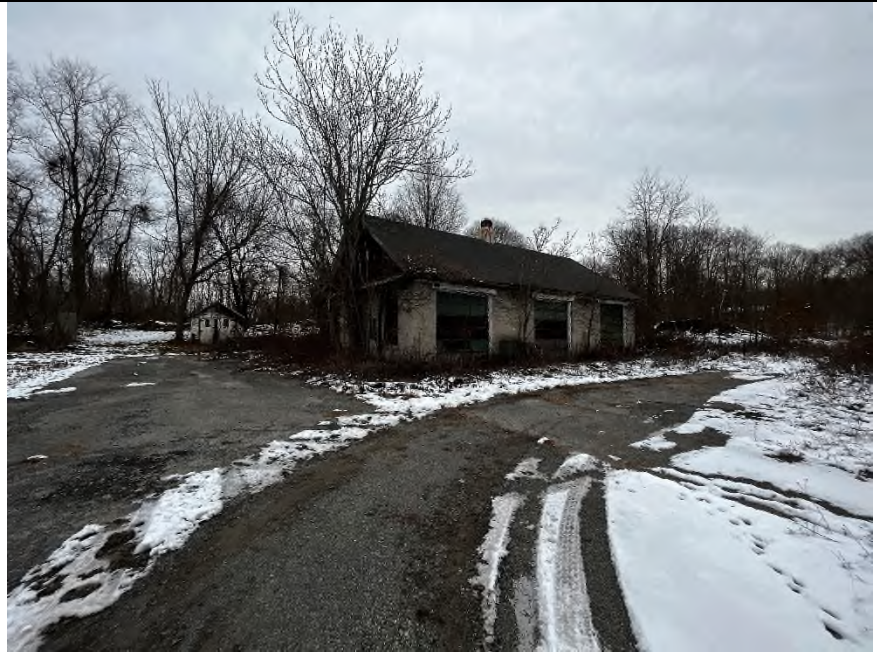
Photo 2 –

Auto Garage West.

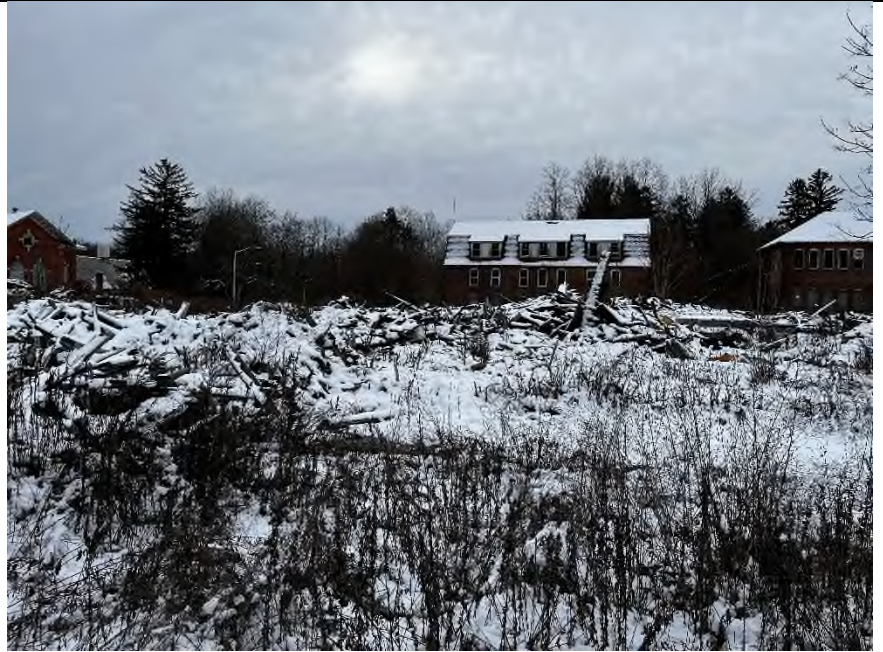
Photo 3 – Engineering building

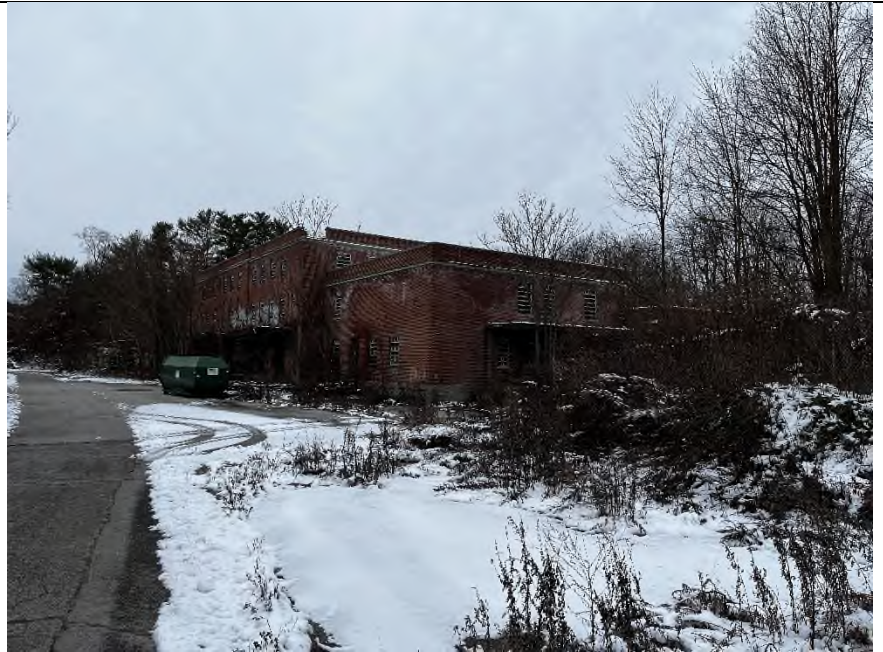
Photo 4 –

Bakery/Storage structure.
Dumpster located south of
structure.

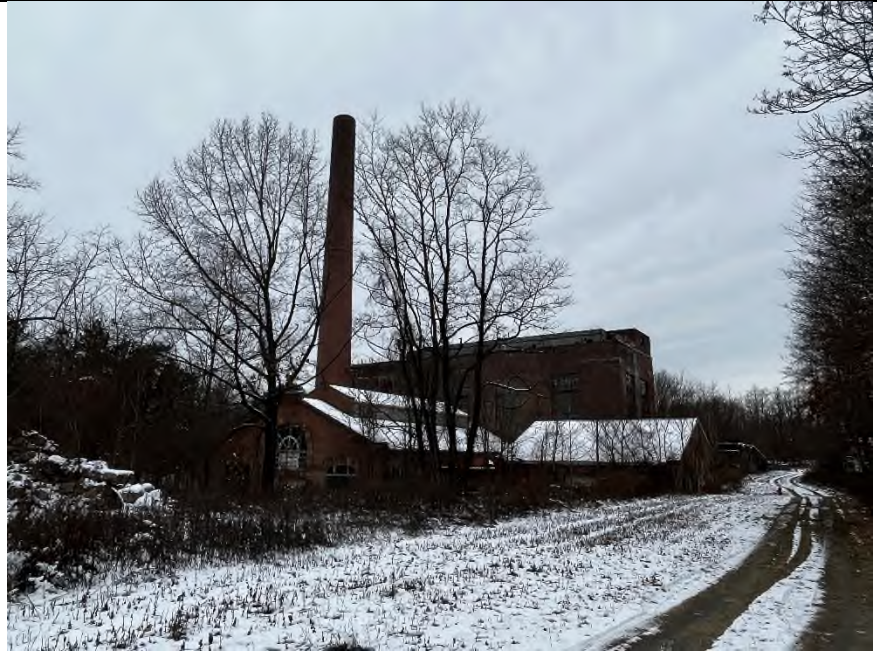
Photo 5 –
Powerhouse.

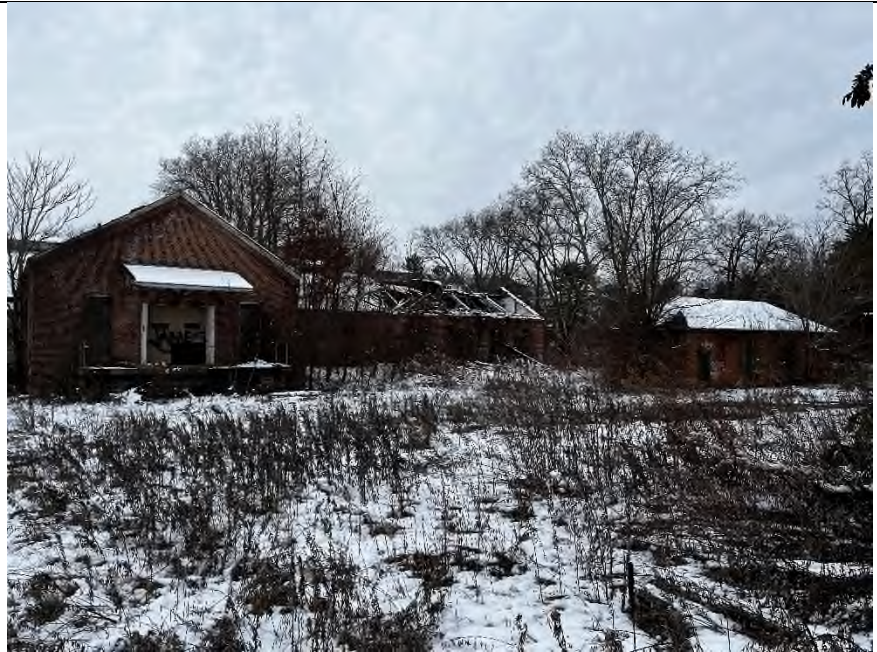
Photo 6 –
Carwash (pictured left) with shed
(pictured right).

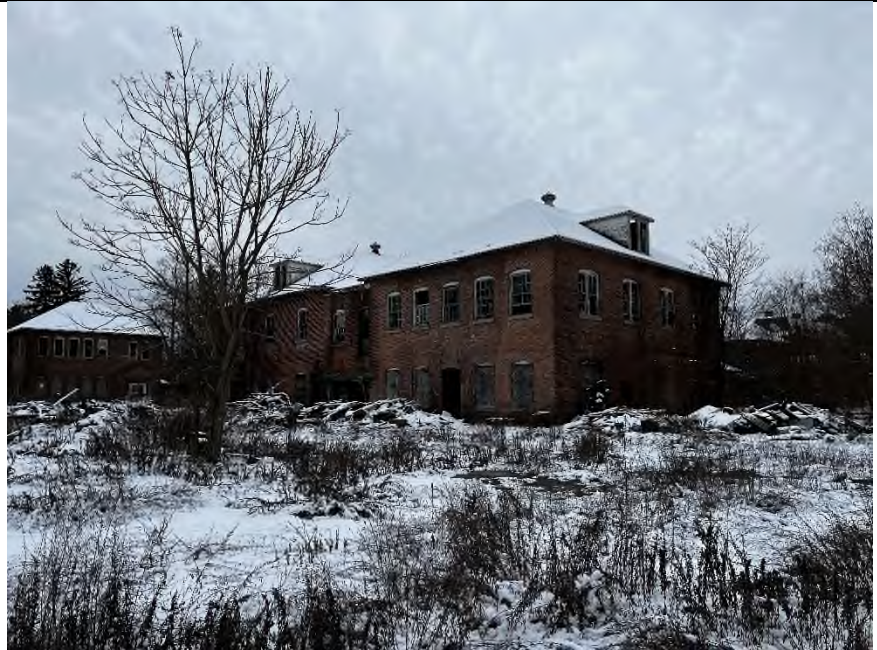
Photo 7 –

Maintenance Building with debris located east side of structure.

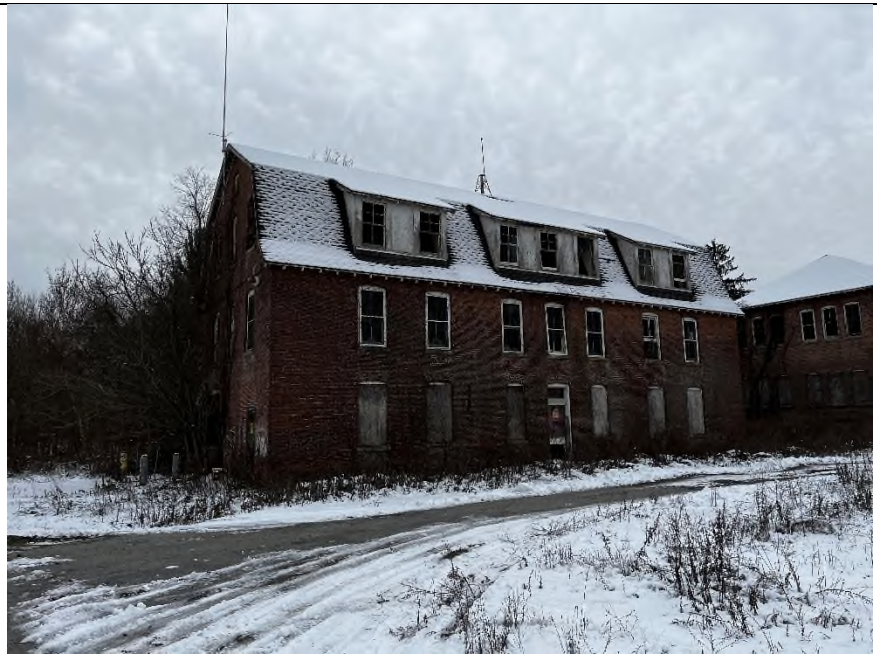
Photo 8 –

Fire House.

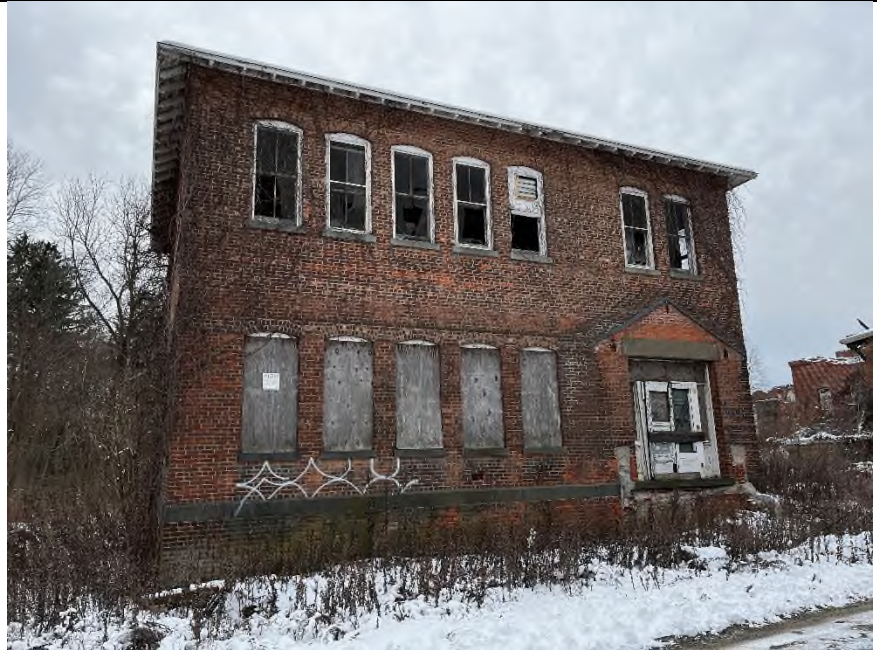
Photo 9 –
Mortuary Building.

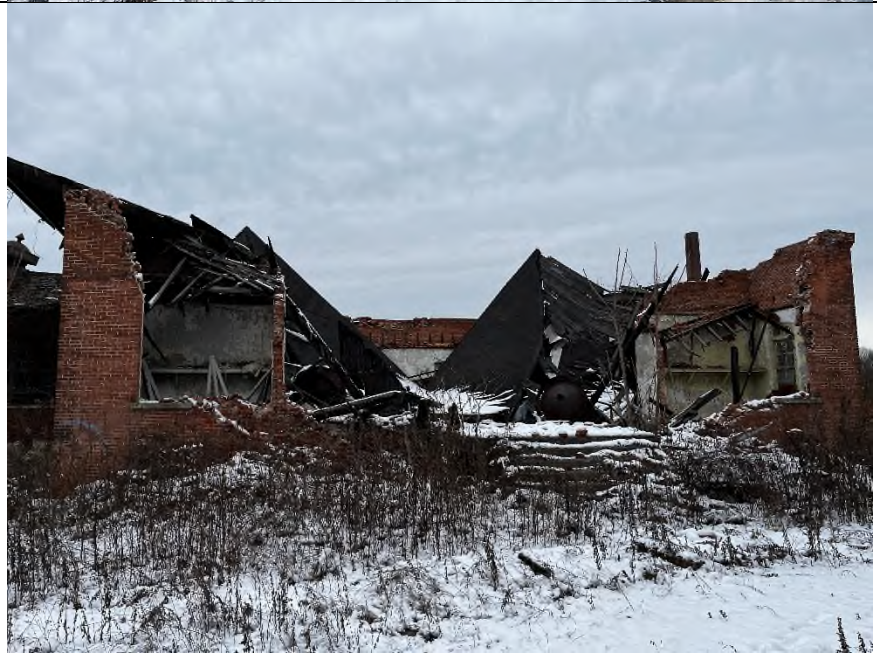
Photo 10 –
Structure west of the Mortuary
Building, facing north (collapsed).

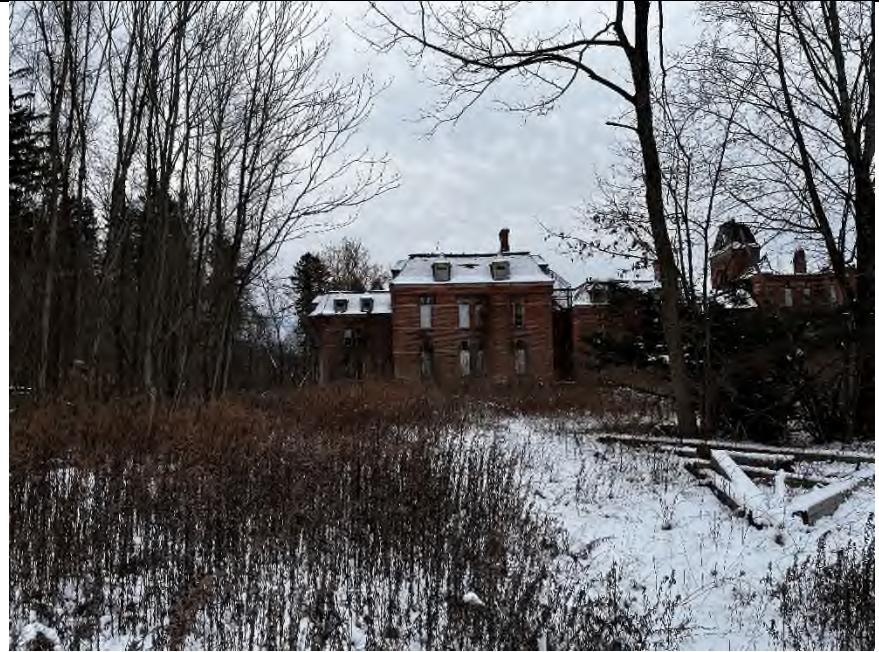
Photo 11 –

Structures in southwest corner of
BCP Site, facing south.

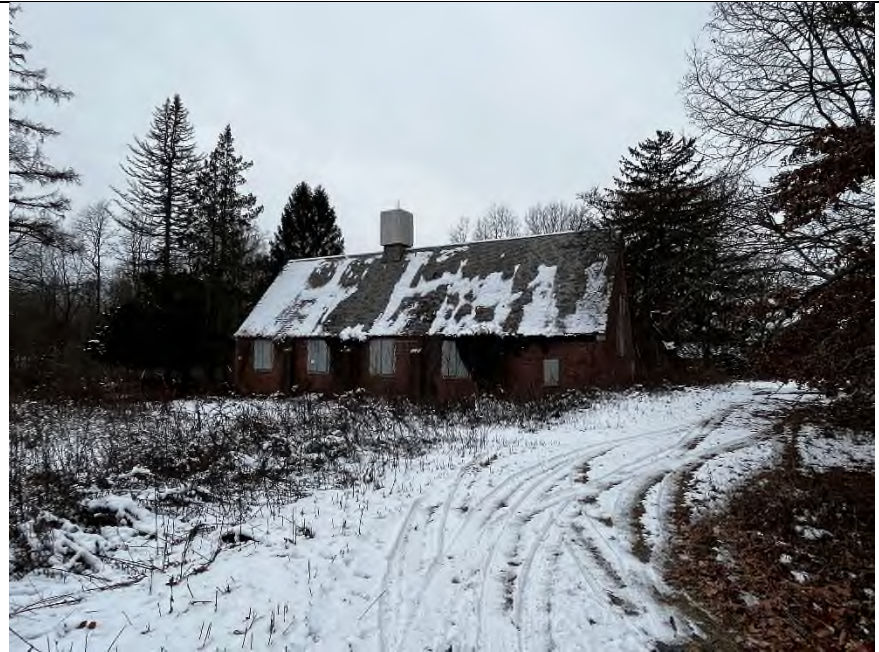
Photo 12 –

Rectory south of the Recreational
Hall building.

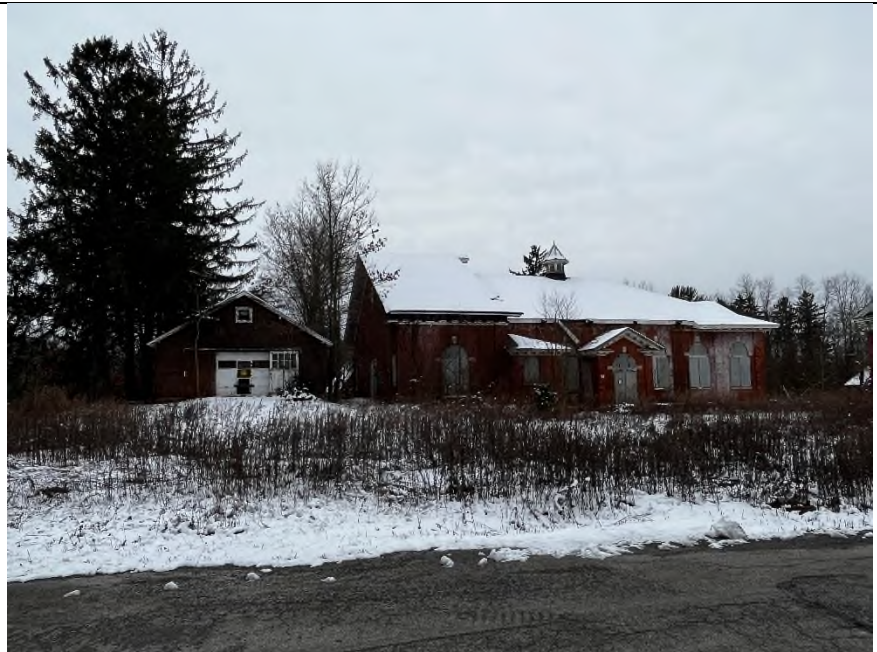
Photo 13 –
Recreational Hall.

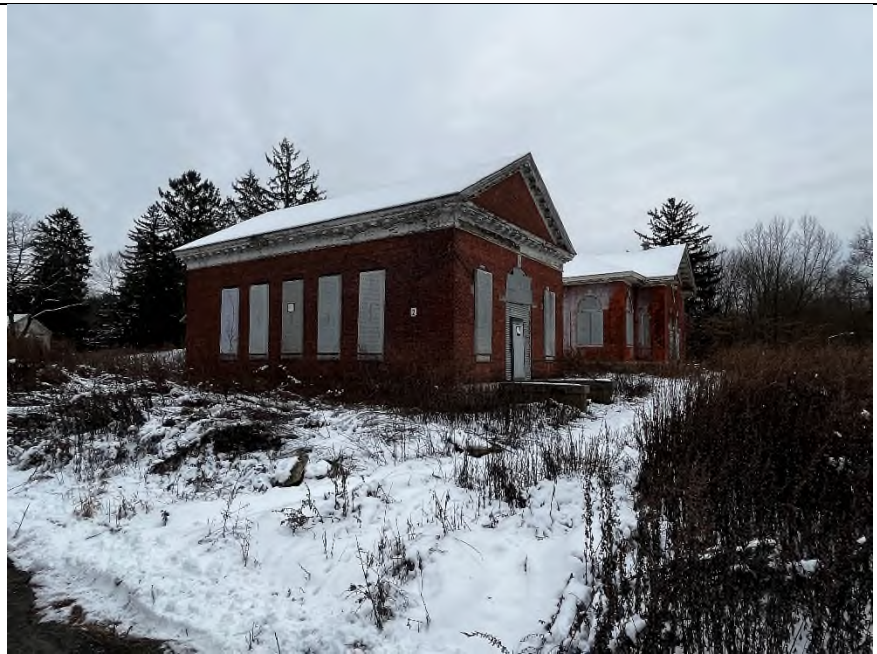
Photo 14 –
Library.

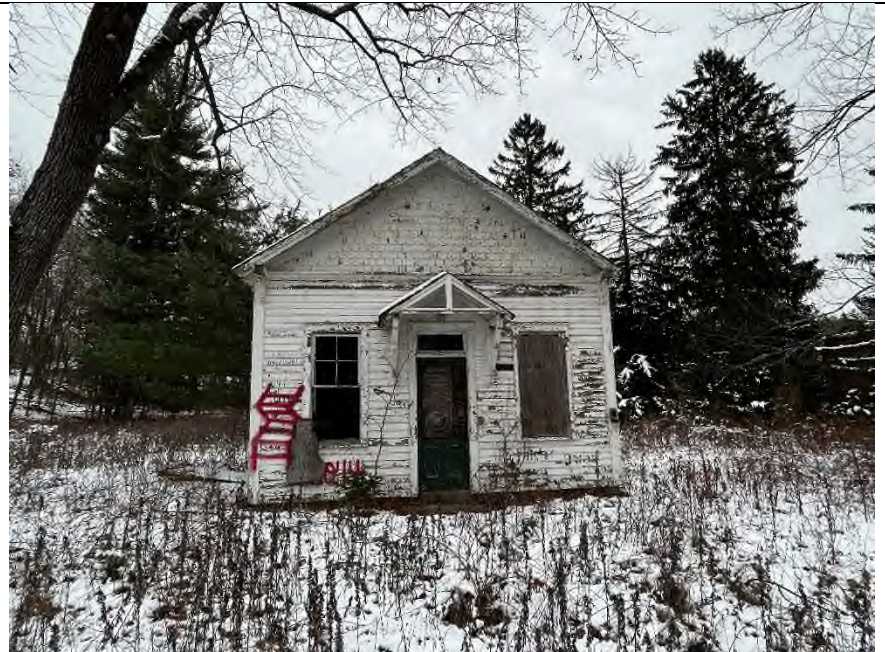
Photo 15 –
Small structure east of the Library.

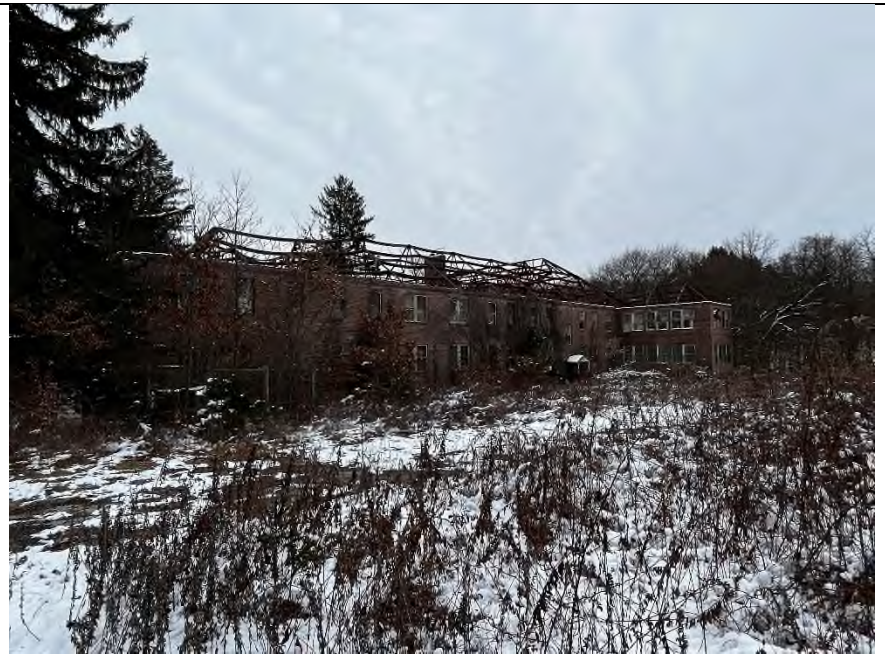
Photo 16 –
Brookside structure, severe deterioration of roof.

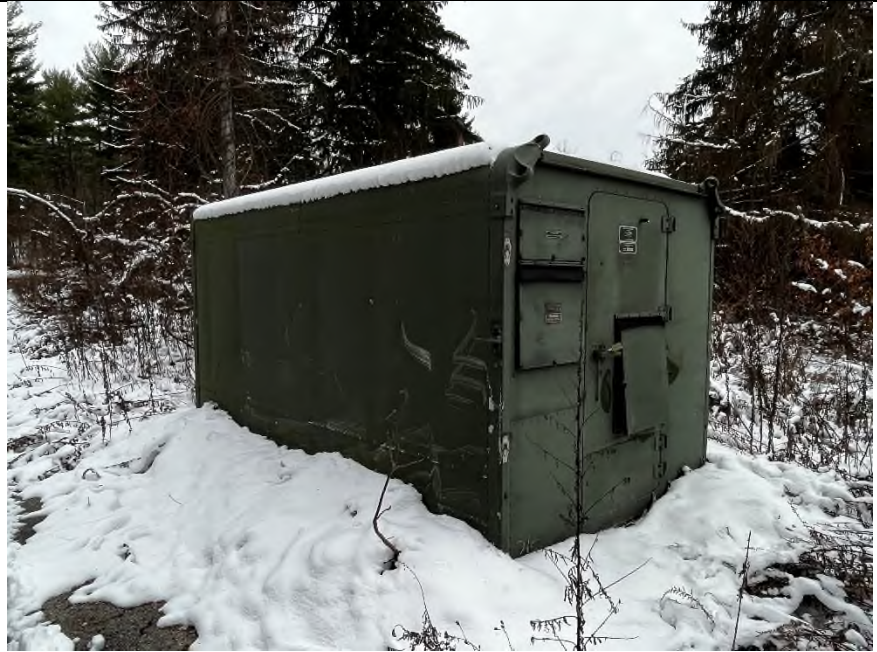
Photo 17 –

Metal container placed over fire hydrant. Base of container is bordered with wood chips.

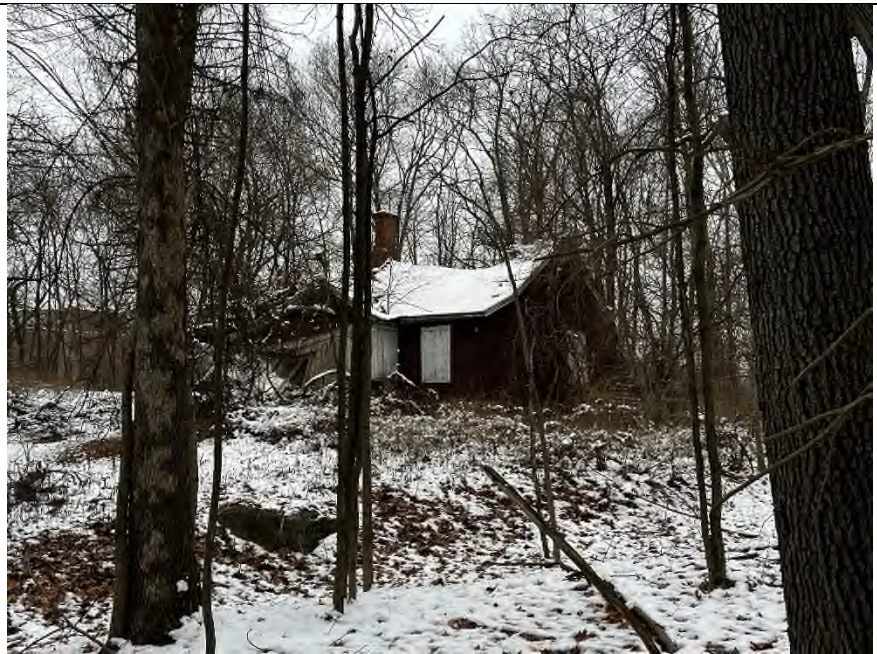
Photo 18 –

Staff House, severe deterioration of roof and interior floor.

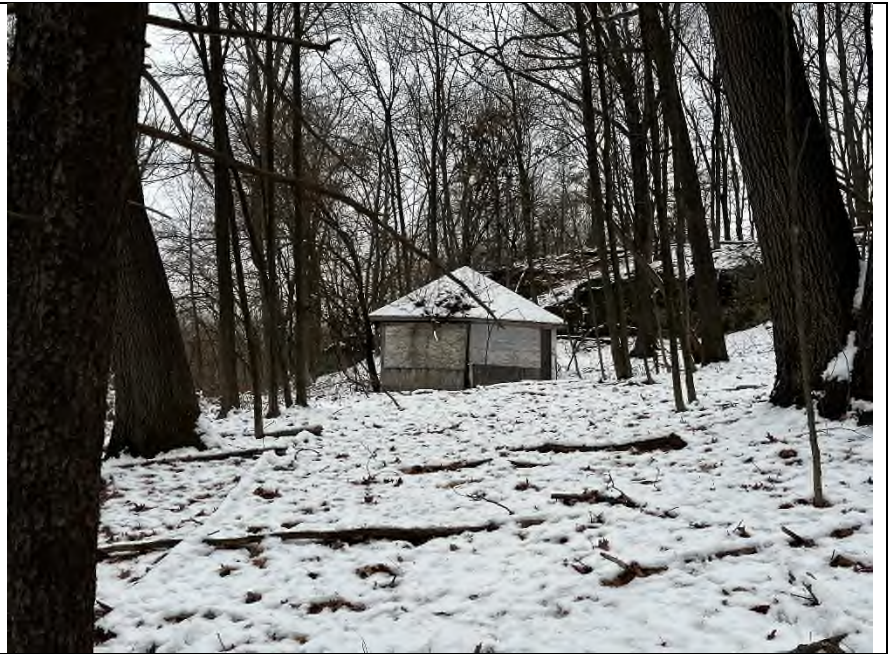
Photo 19 –

Small structure east of the Staff House.
