**PRE-DEMOLITION SURVEY REPORT
FOR
ASBESTOS-CONTAINING MATERIALS (ACM)**

**58 Parker Avenue
Poughkeepsie, NY 12601**

QuES&T Project #Q20-3106

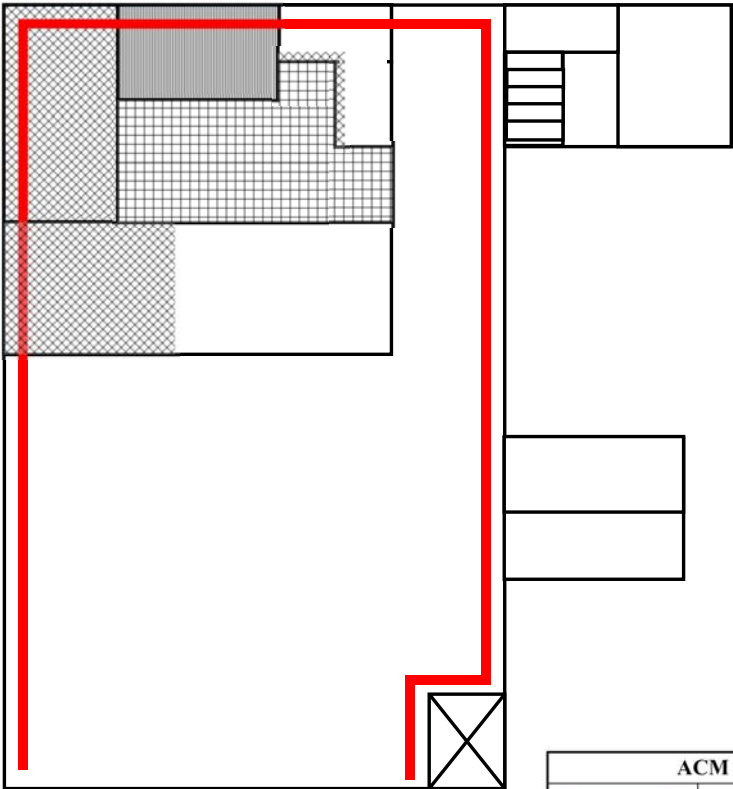
ASB-01

ACM LEGEND: (see report for details)	
	ACM Pipe Insulation on Metal Pipes
NOTE	ACM Pipe Insulation Debris is Present on Floor Throughout Area
	ACM 9" x 9" Floor Tile & Mastic on Slab
	ACM 9" x 9" Floor Tile & Mastic Under Carpet
	ACM Sheet Flooring on Wood

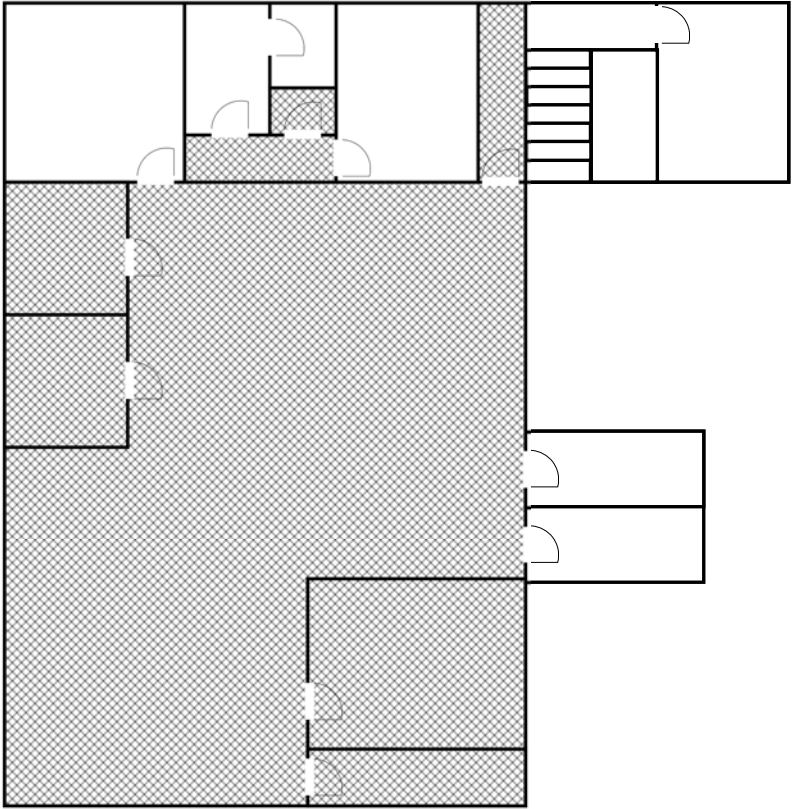
ASB-03

ACM 9" x 9" Floor Tile & Mastic on Slab

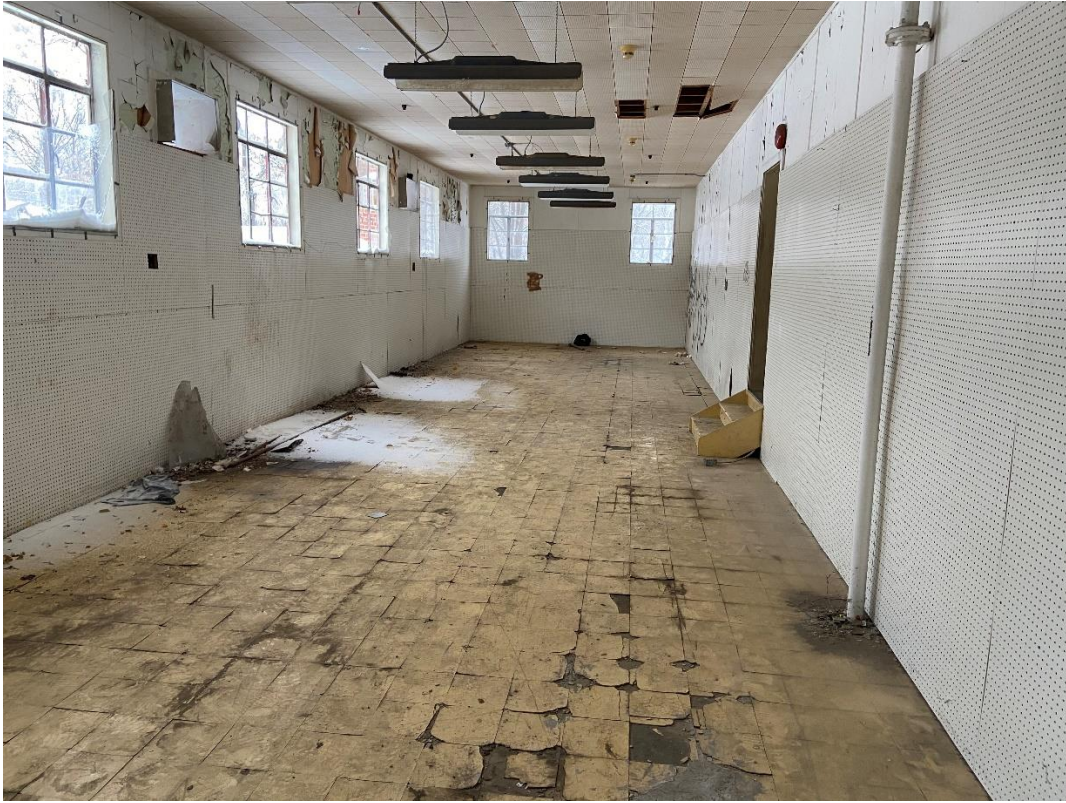
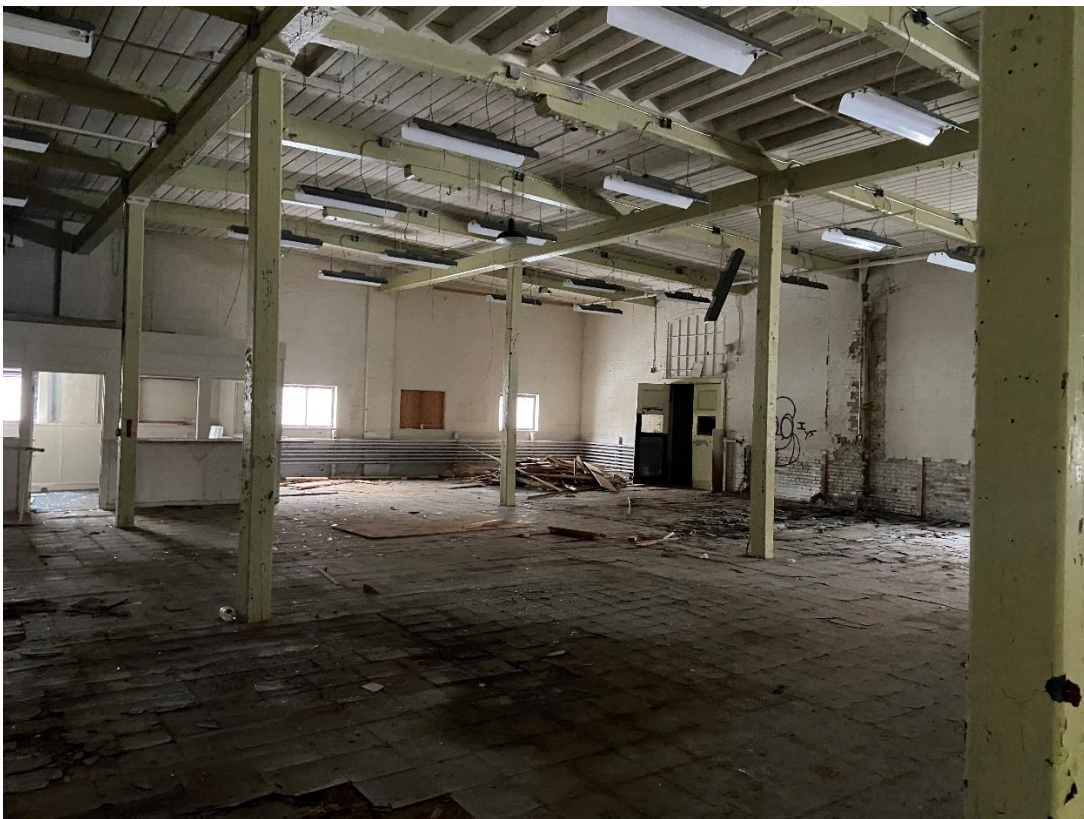
(Significantly Damaged ACM 9" x 9" Floor Tile & Mastic)

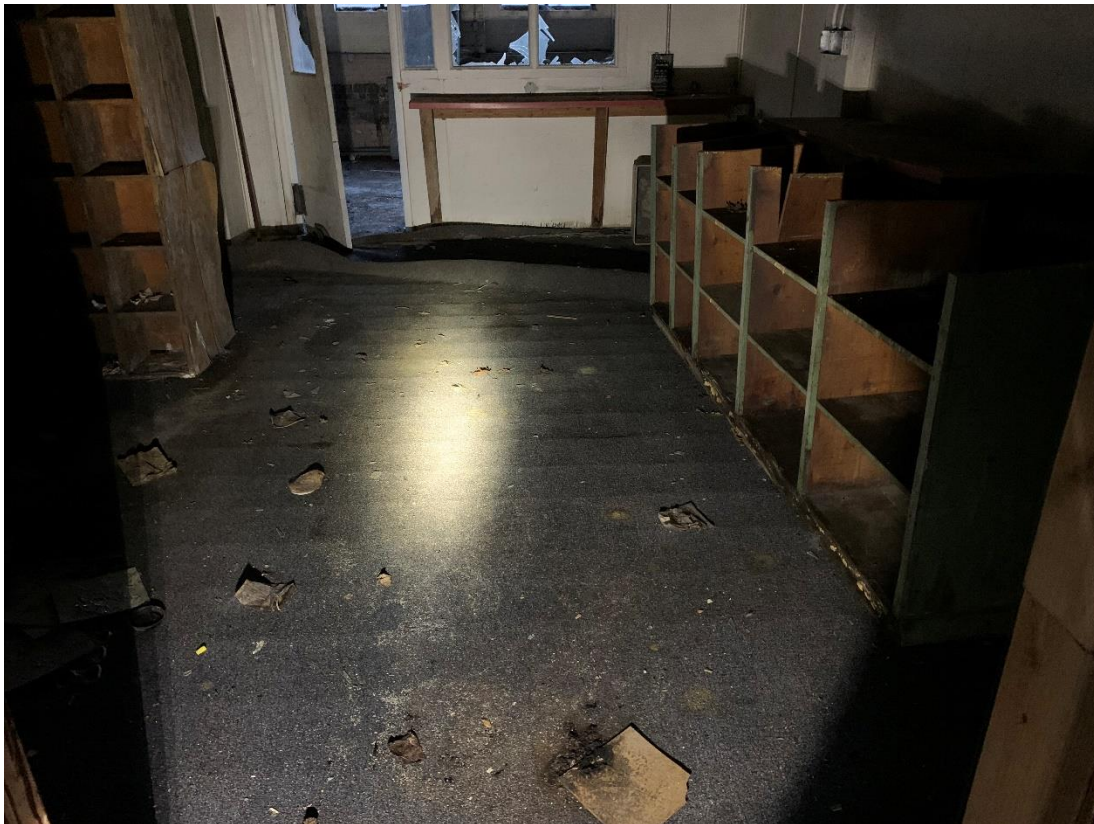
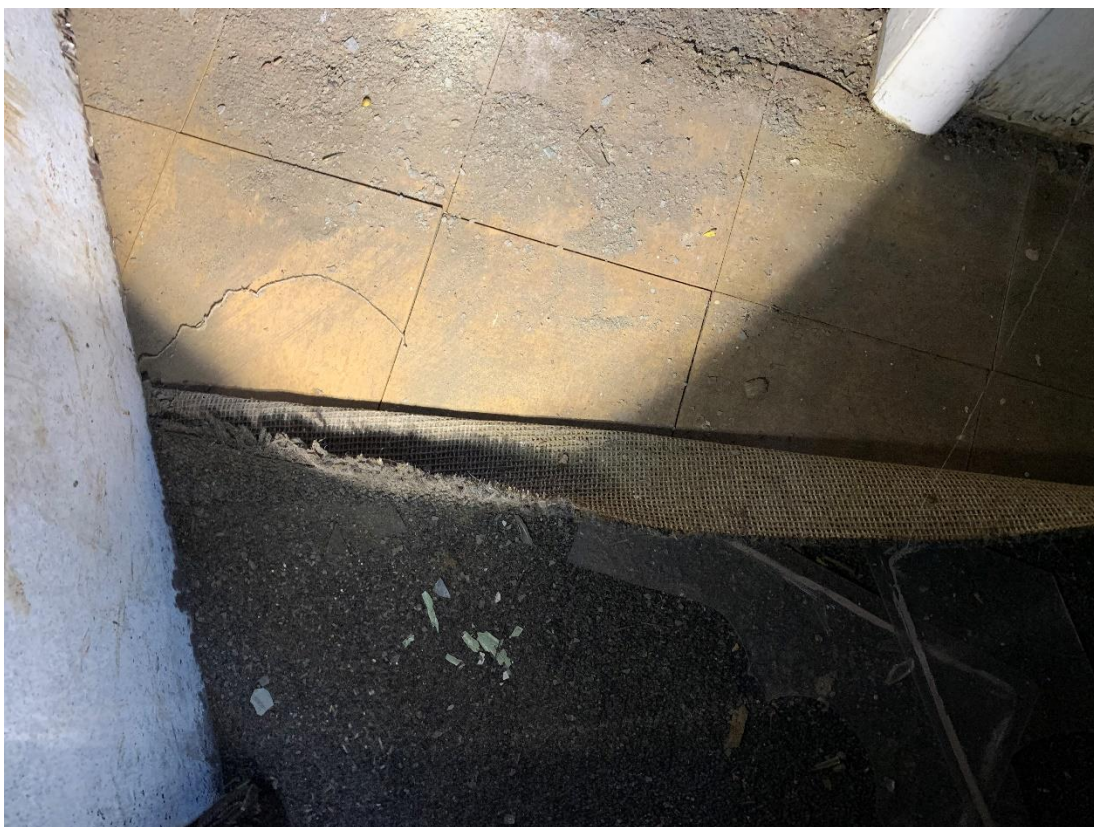
(ACM 9" x 9" Floor Tile & Mastic Under Carpet)

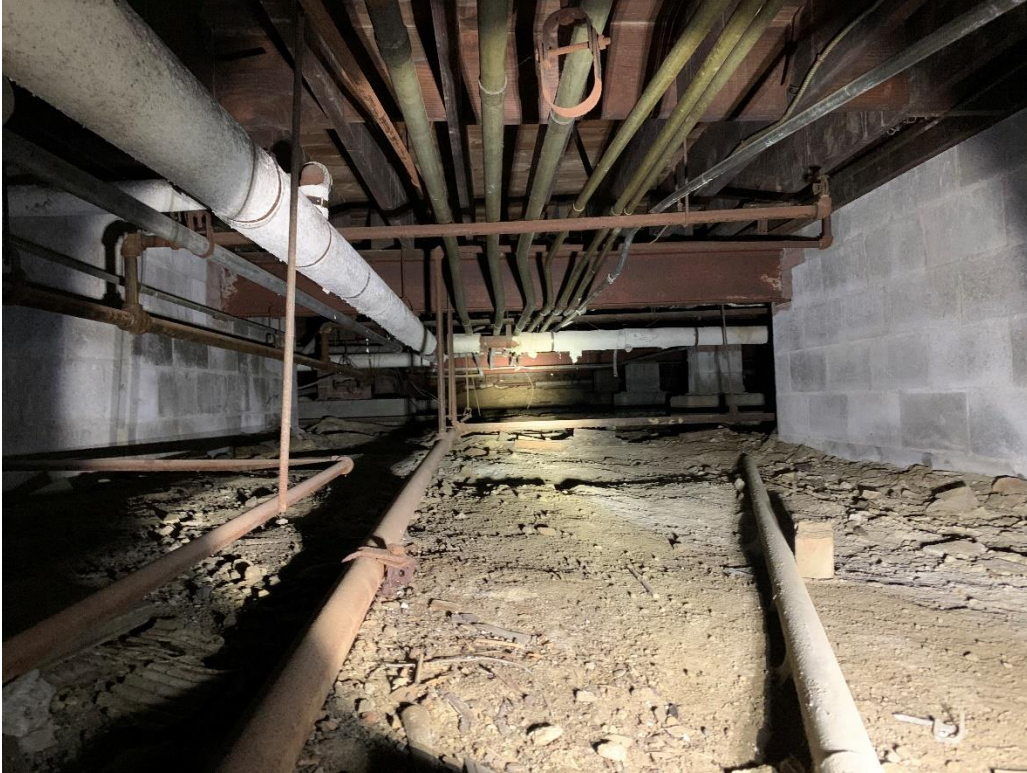
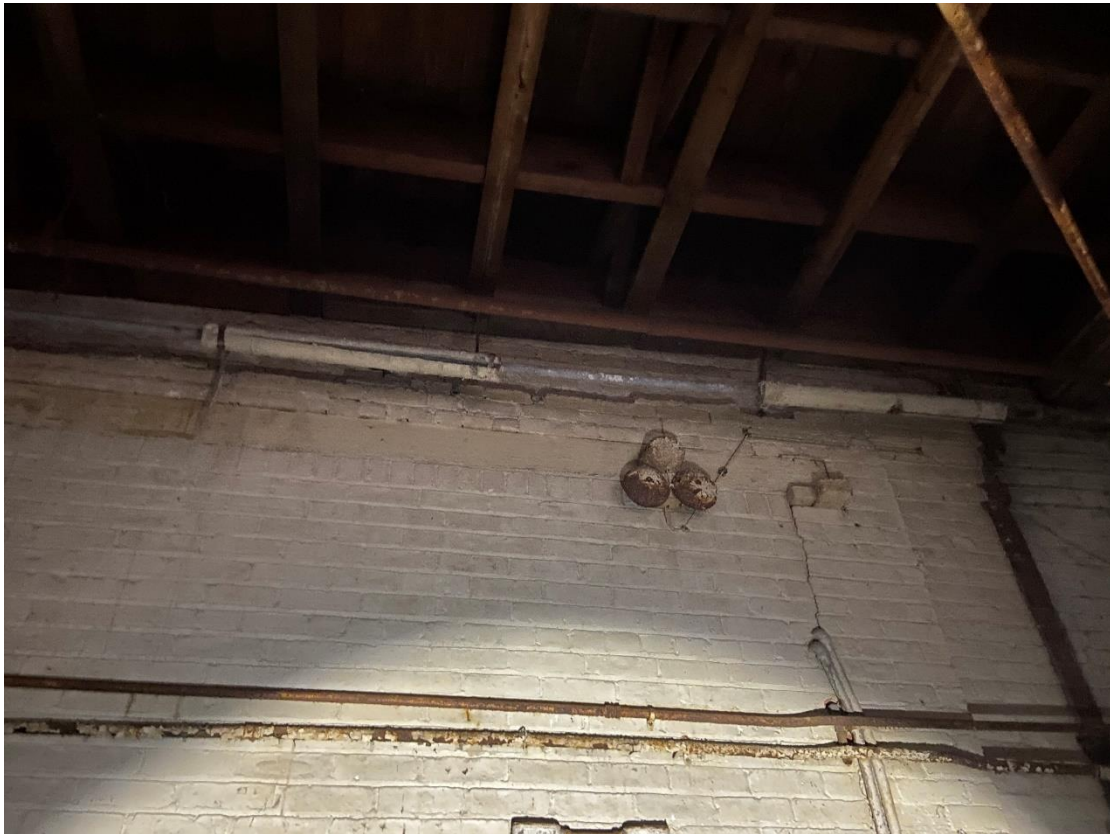
(Significantly Damaged Pipe Insulation/Mudded Joint Packing with Debris on 1st Floor)

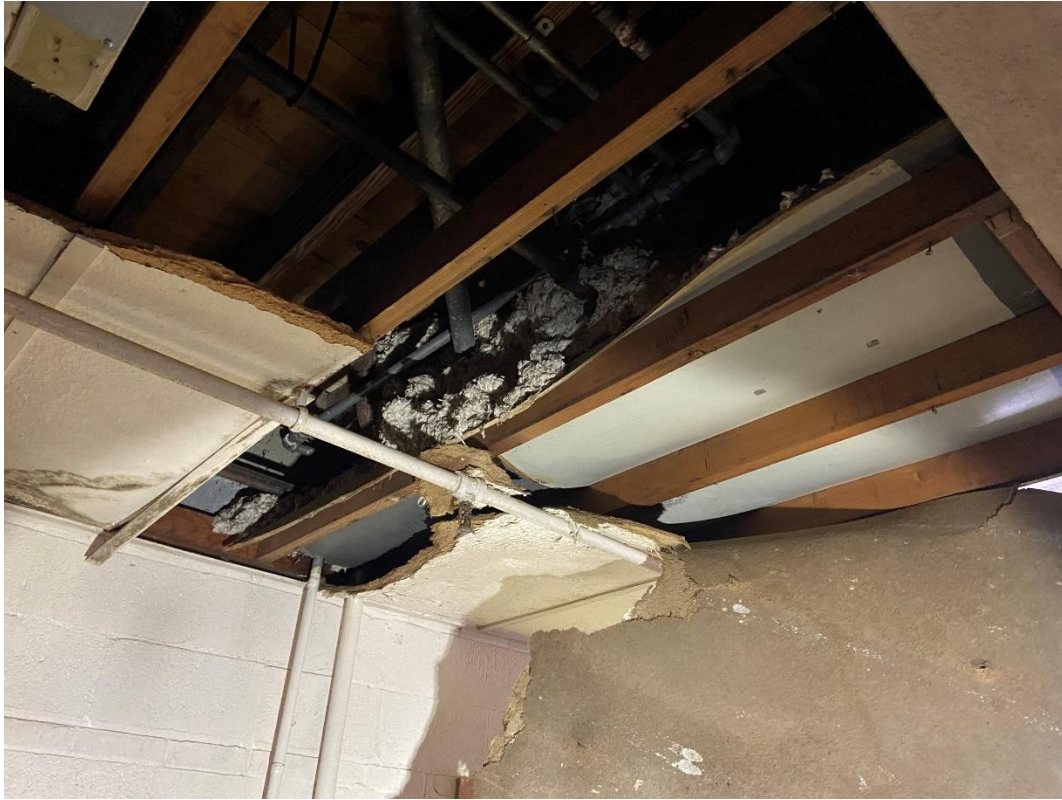
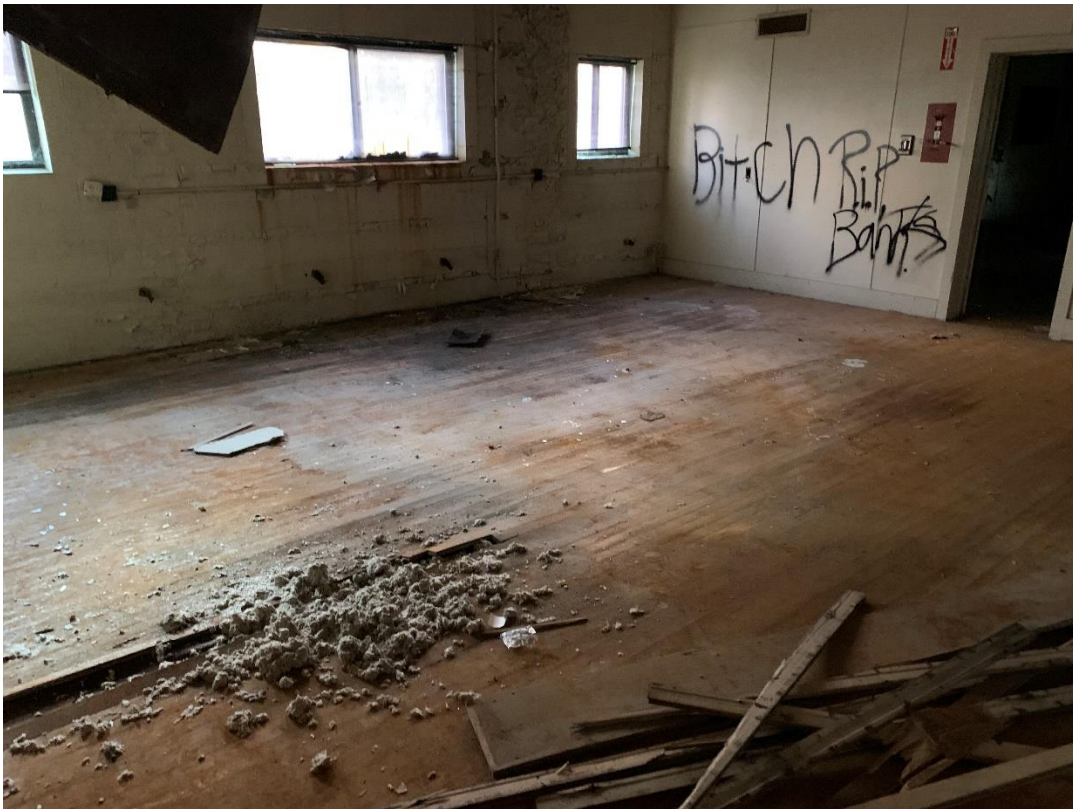
(ACM Blown-In Insulation Inside Ceiling Soffit and on Wood Floor)

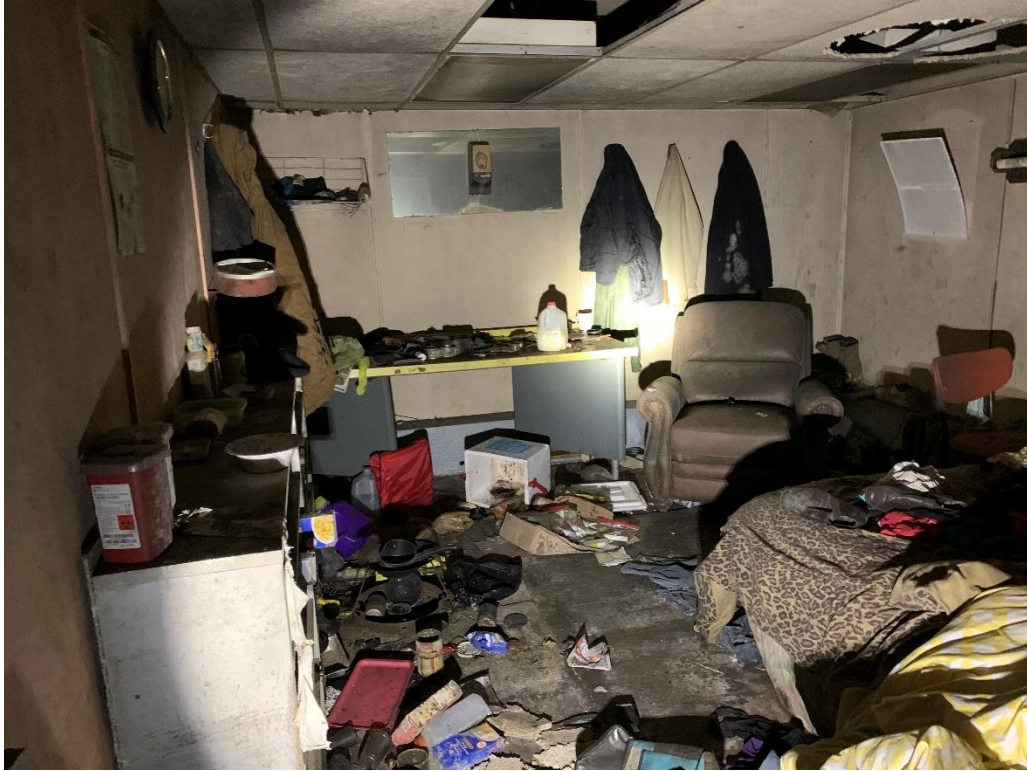
(ACM Sheet Flooring on 1st Floor of Building 1)

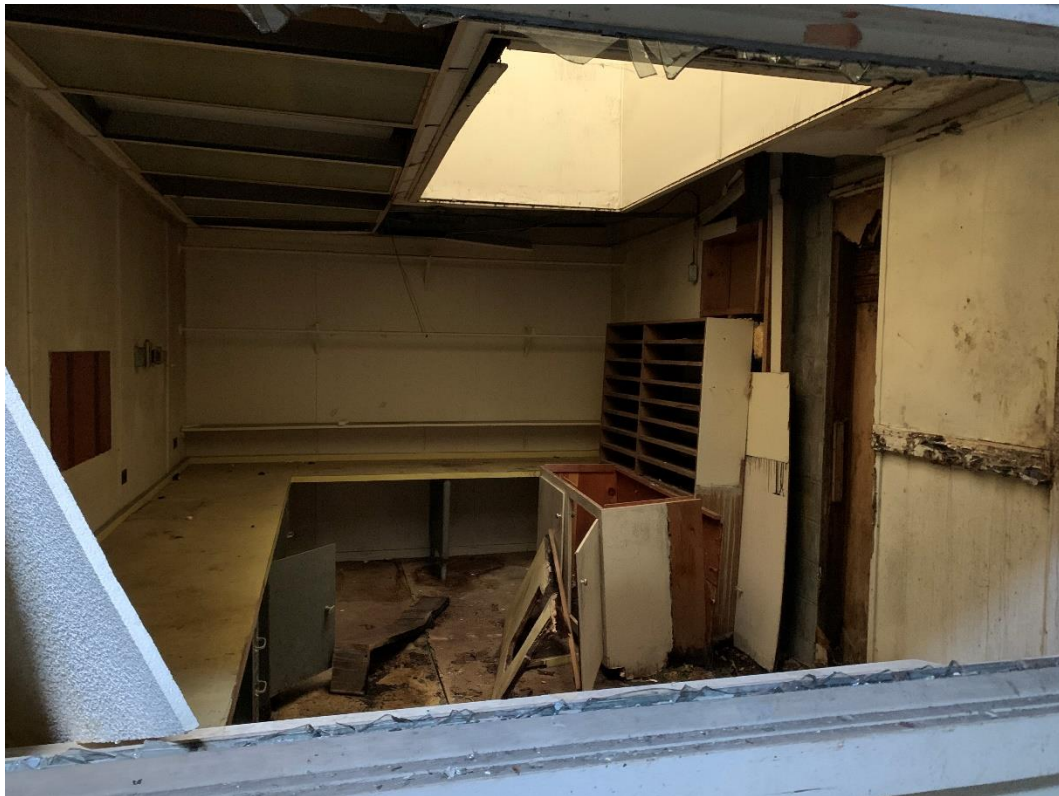
(ACM Sheet Flooring in Building 4)

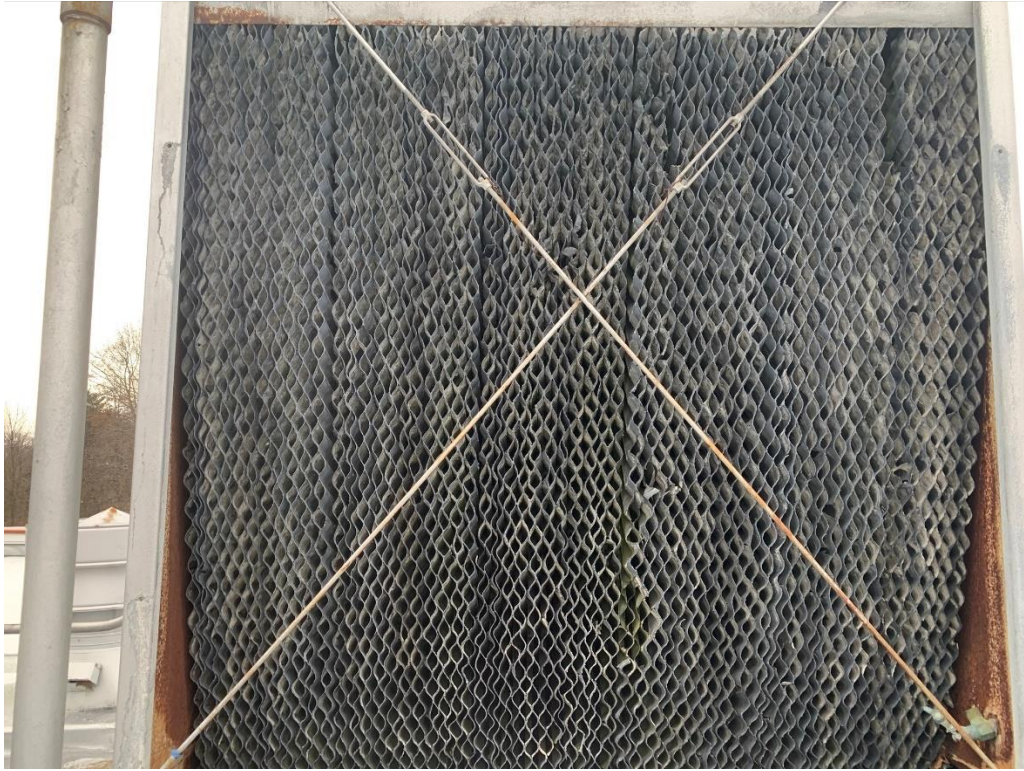
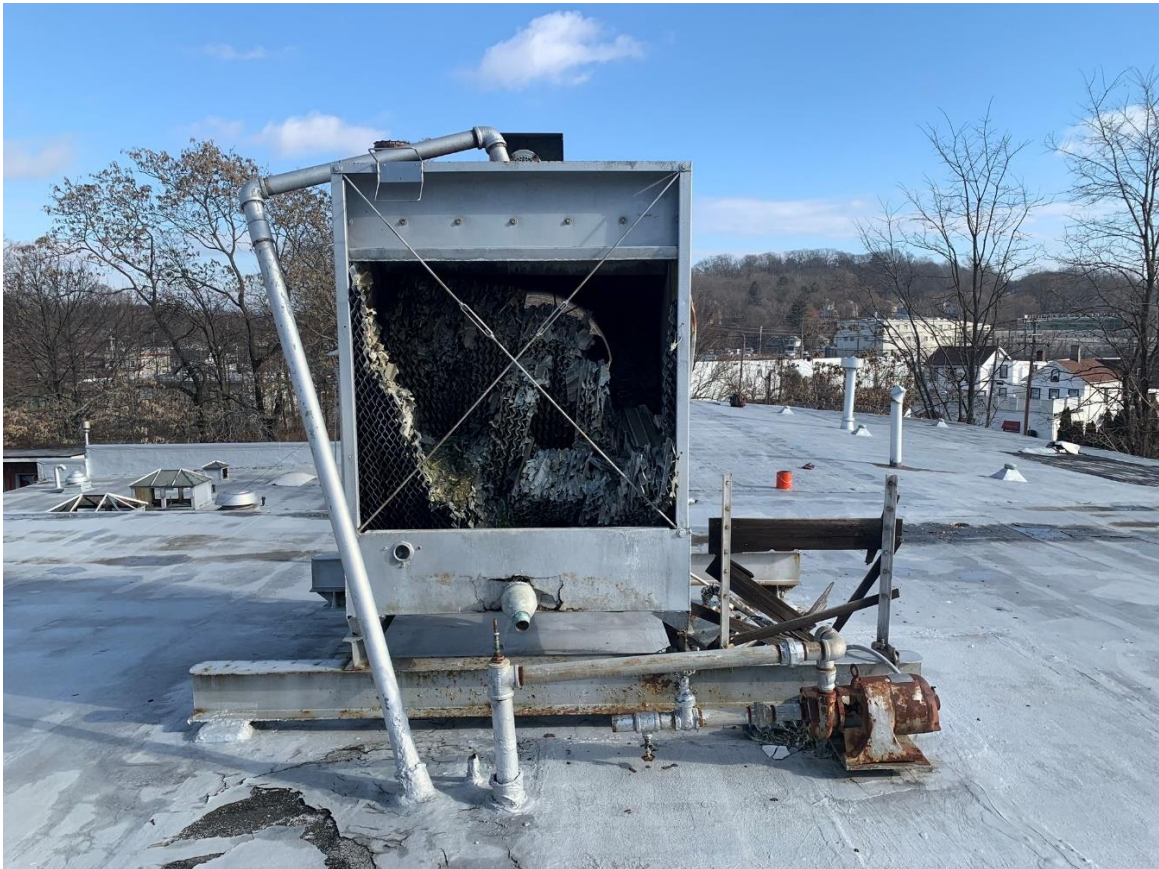
(Significantly Damaged ACM Vent Filters on Roof 1 & 3)

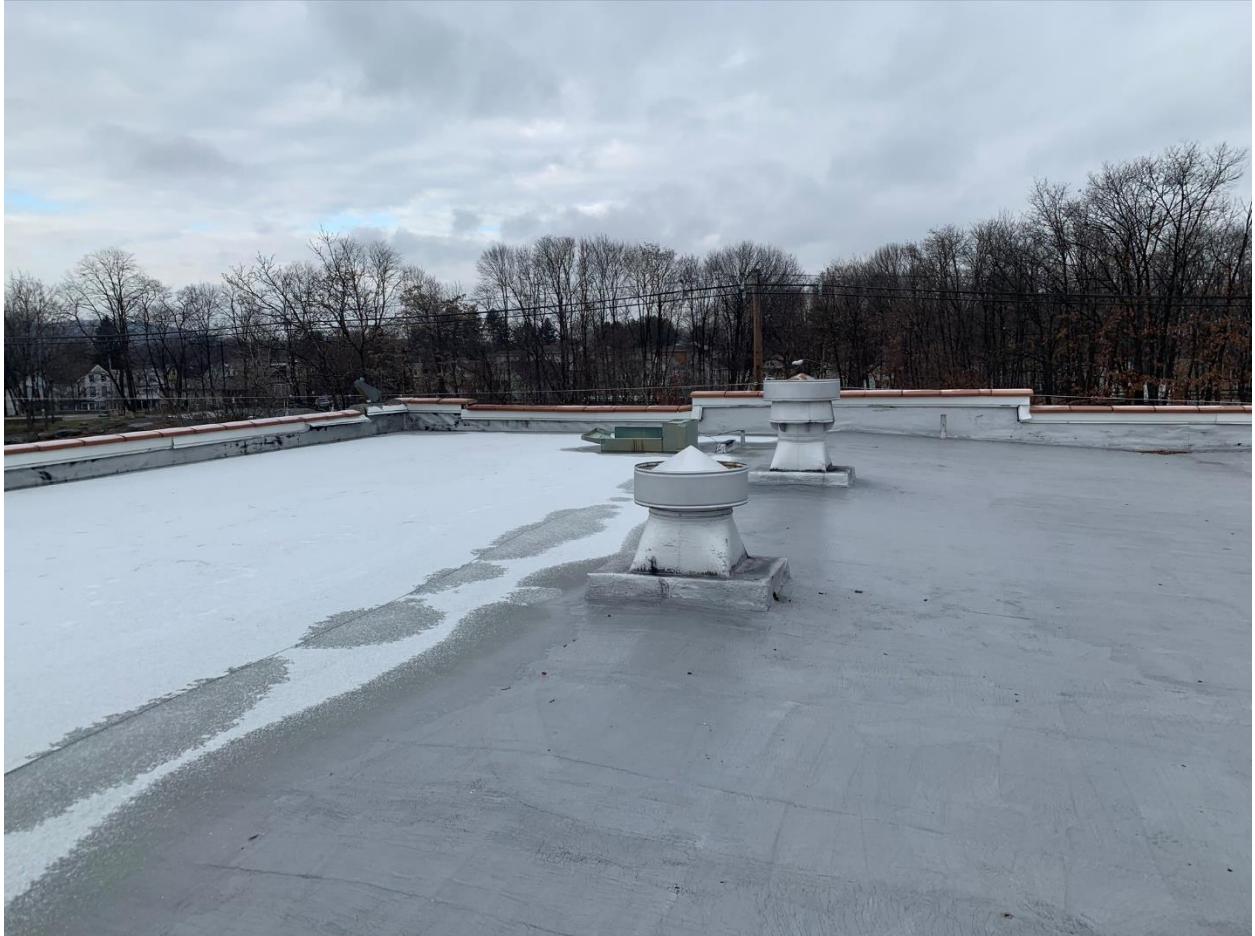
(Roof 1, ACM Flashing Tar- Parapet Wall, Equipment, Perimeter Flashing under Rolled Roofing)

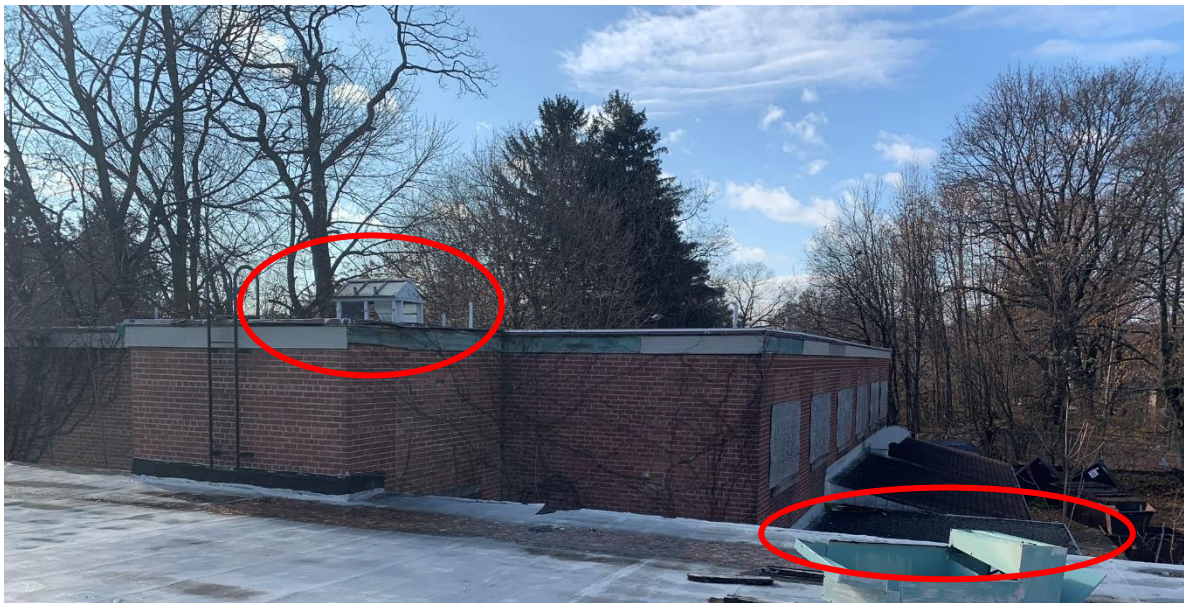
(Roof 2, Skylight Flashing ACM Vapor Barrier (Left) & Roof 2A ACM Flashing Tar (Right))

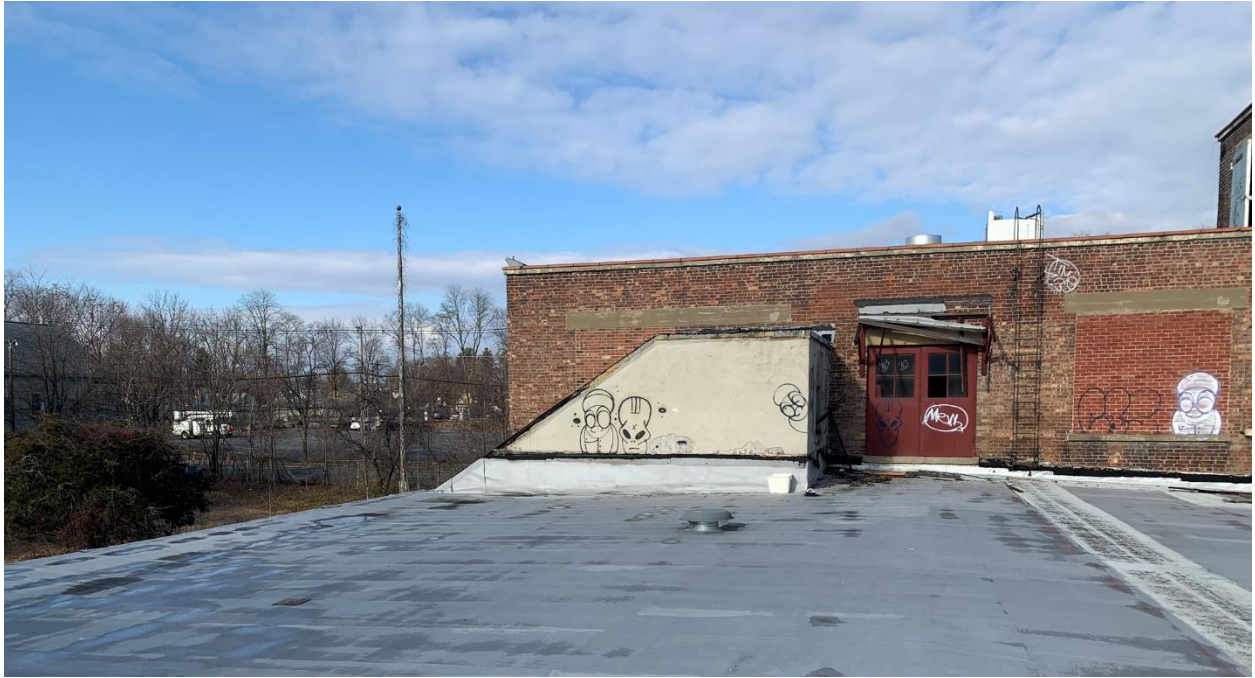
(Roof 3, Building ACM Flashing Tar, On Brick and Stucco, Bottom Layer)

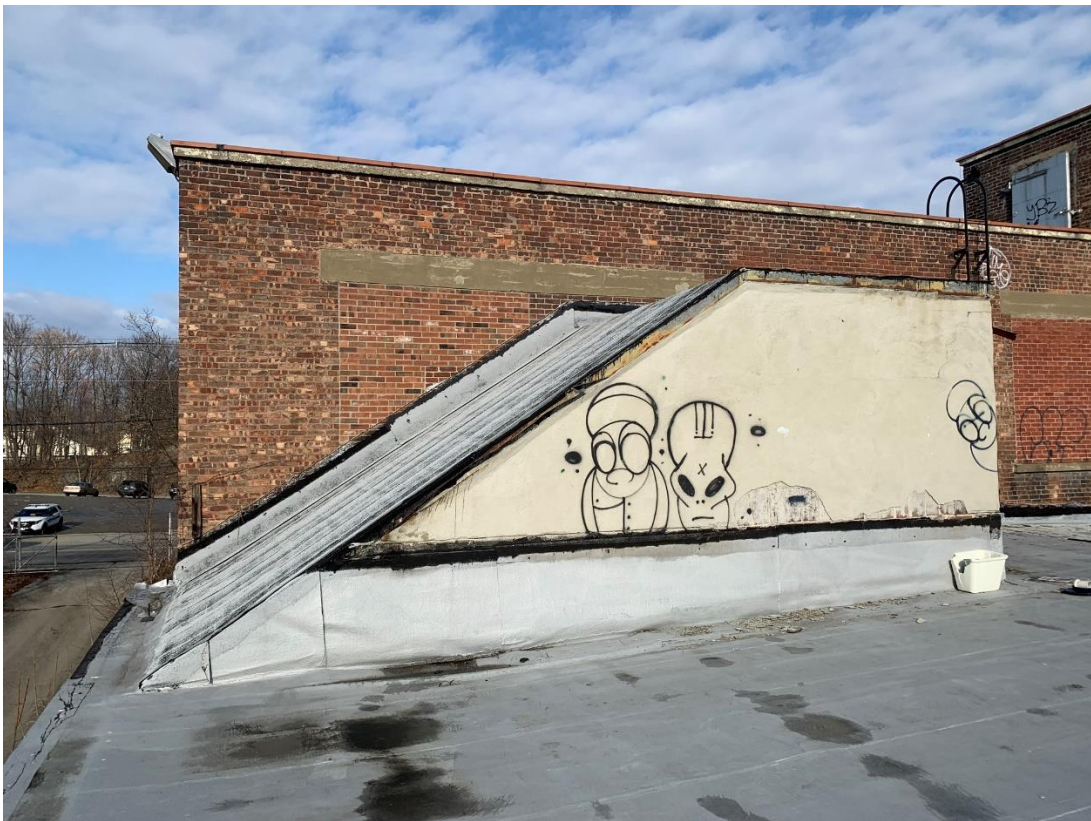
(Roof 3, Stair Tower Roof, Bottom Layer ACM Built-Up Roofing, on metal)

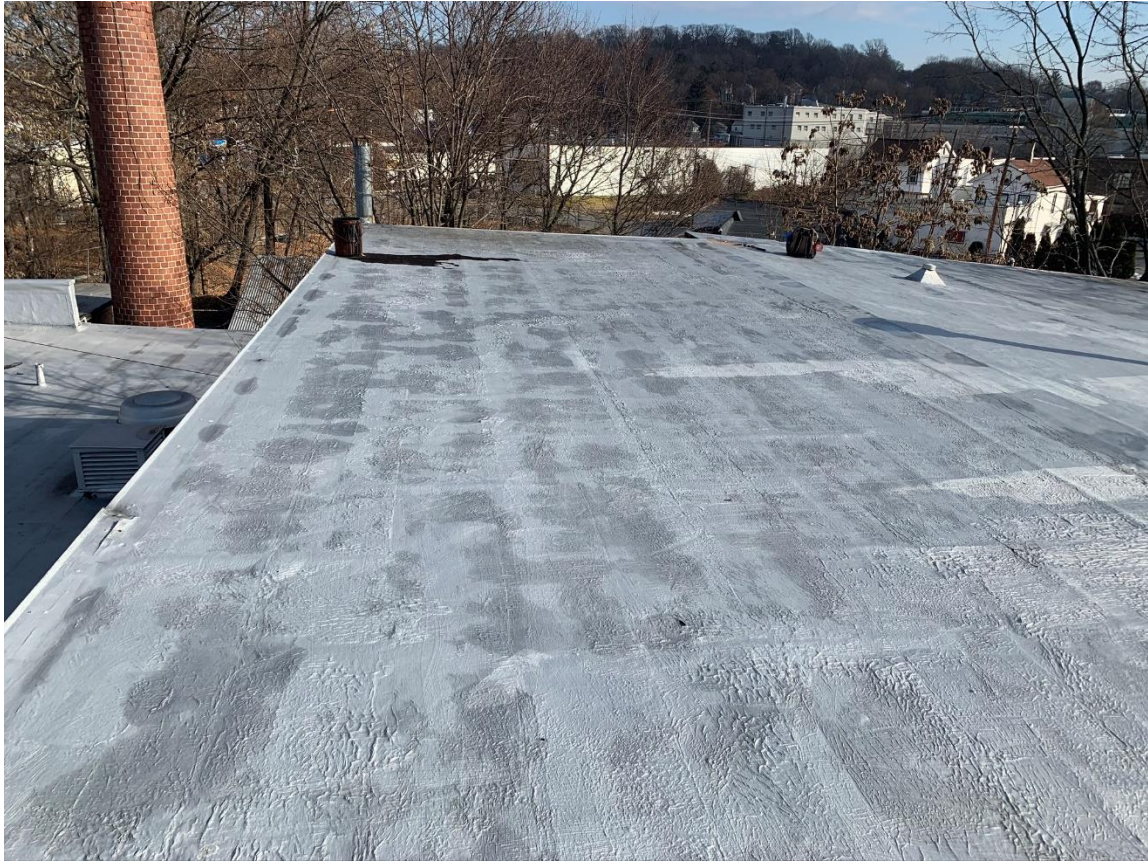
(Roof 4, Flat Side, Top Layer ACM Tar Roofing)

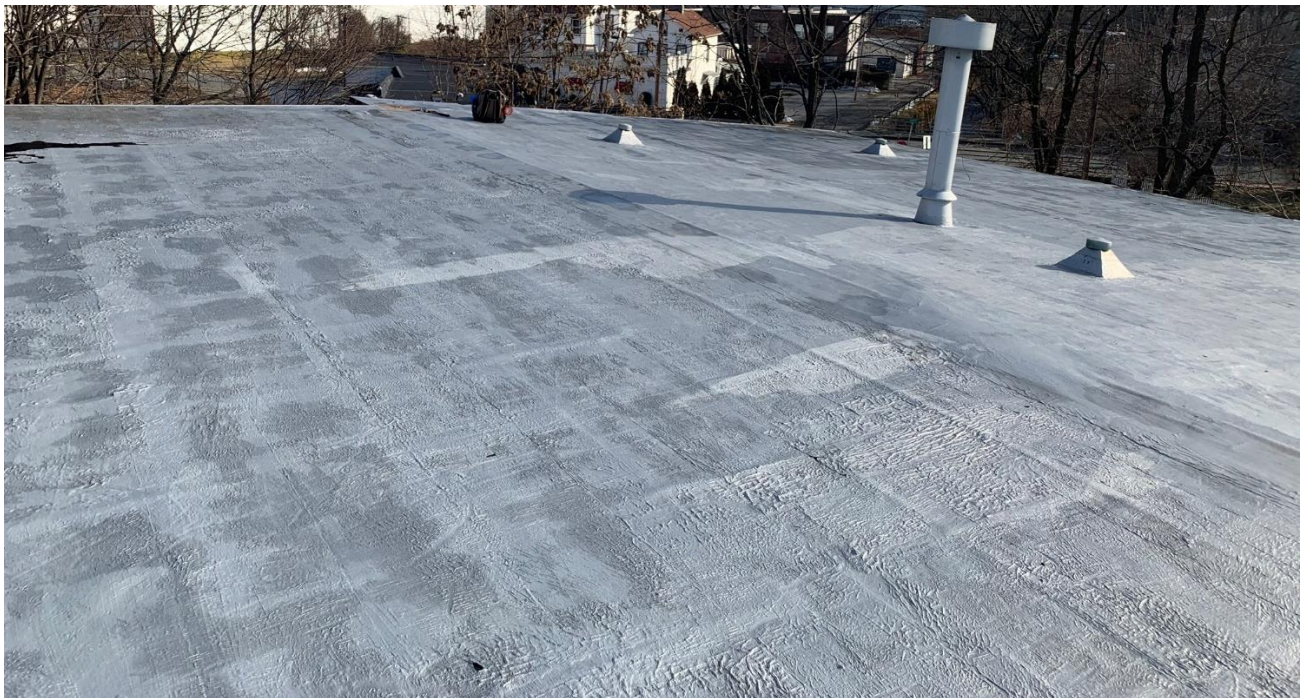
(Roof 4, Pitched Side, 3rd Layer, ACM Vapor Barrier)

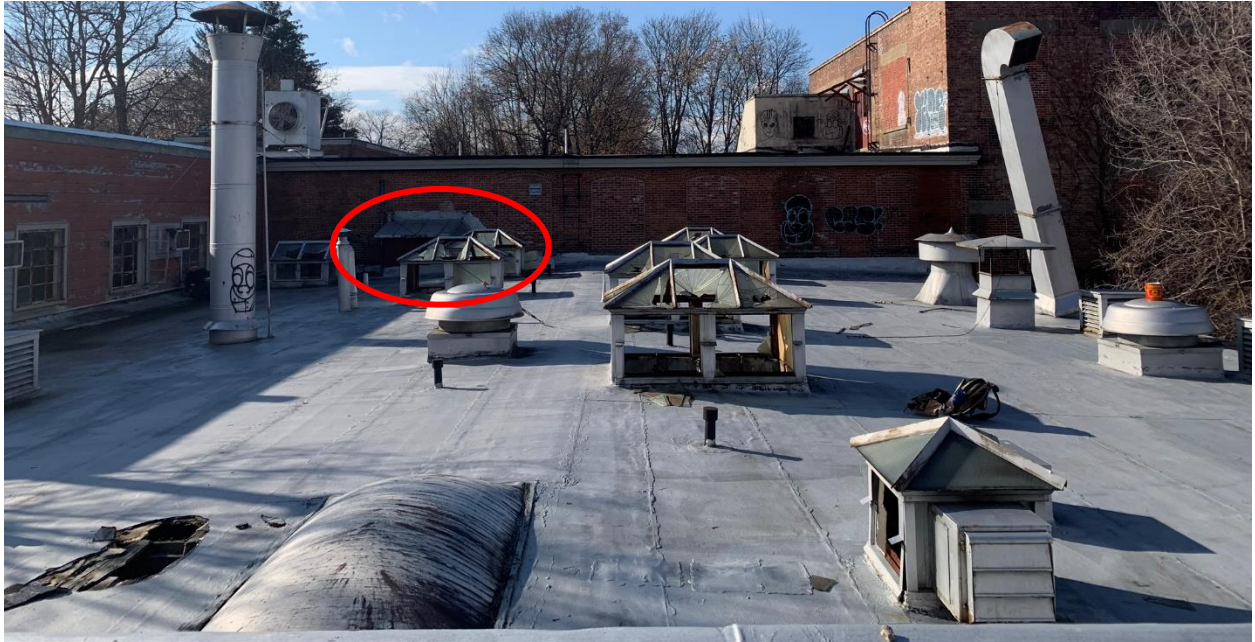
(Roof 5, Dormer Roof (Circled), Building & Equipment ACM Flashing Tar)

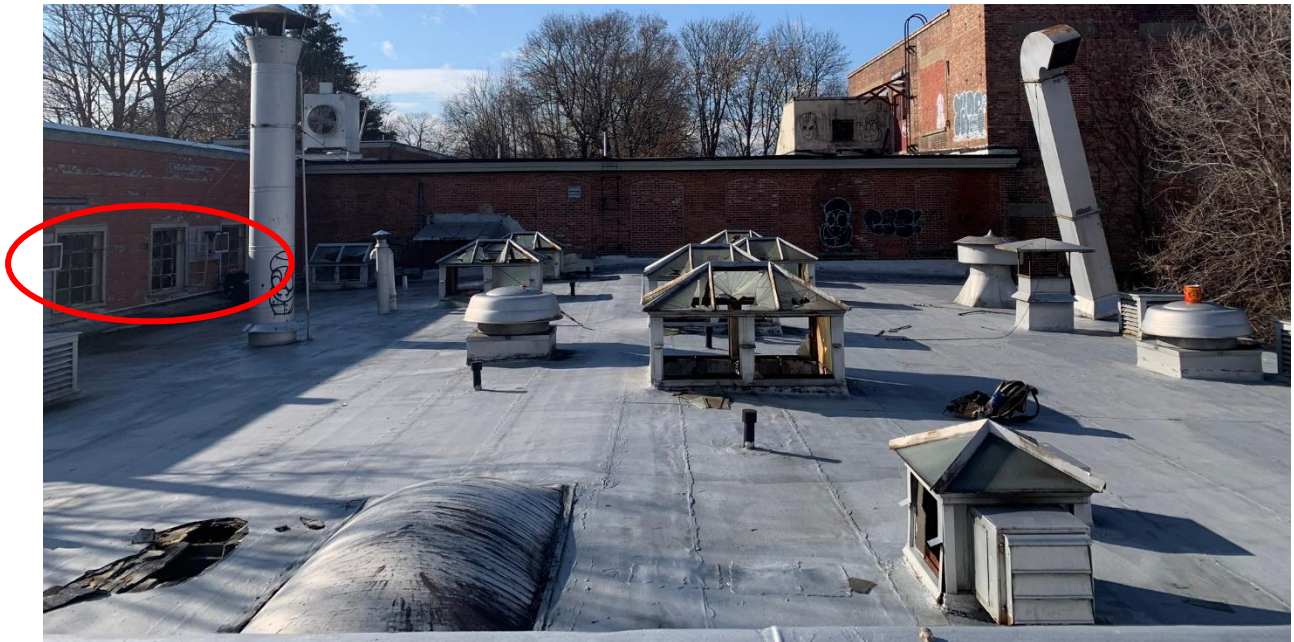
(Roof 5, Windows, ACM Glazing Compound)

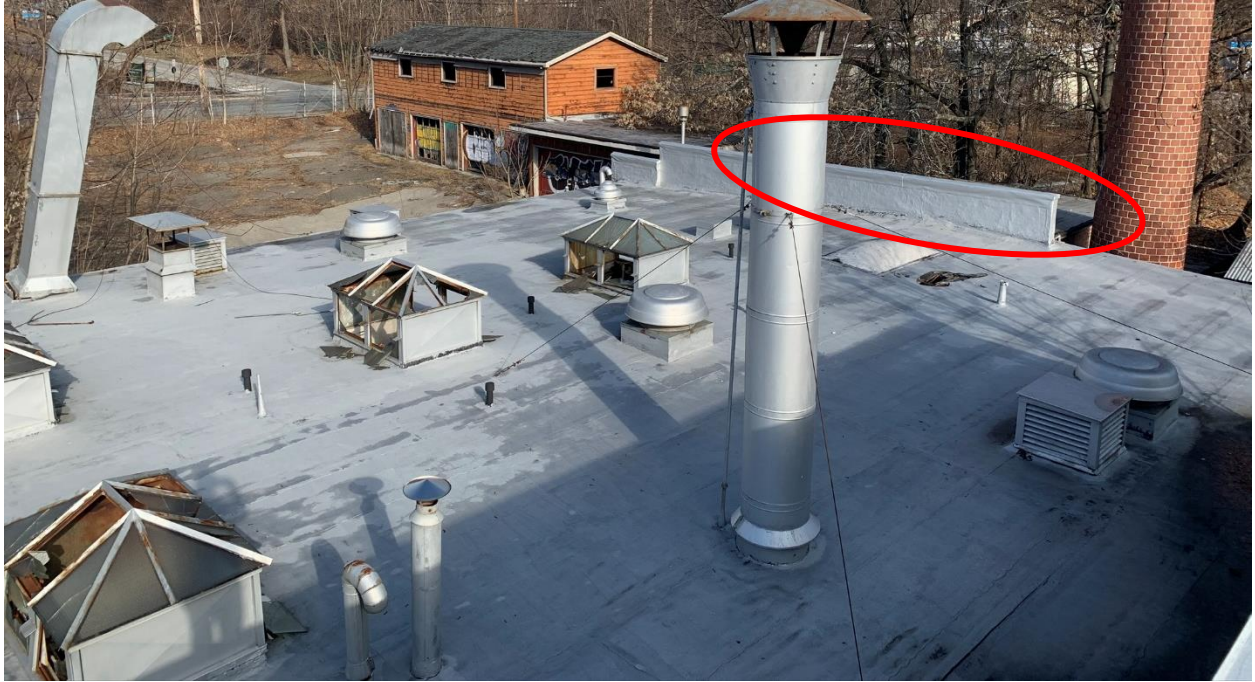
(Roof 6, (Circled) Field & Perimeter, ACM Rolled Roofing on Wood)

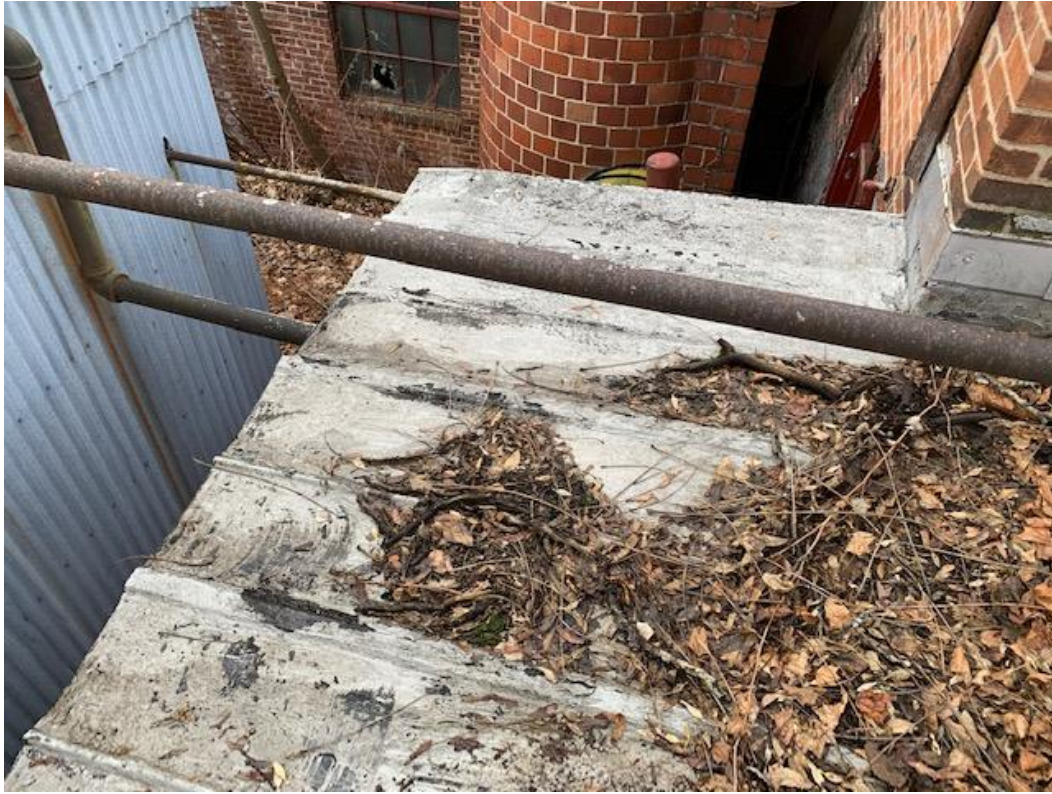
(Roof 7, ACM Tar Roofing on Metal Deck)

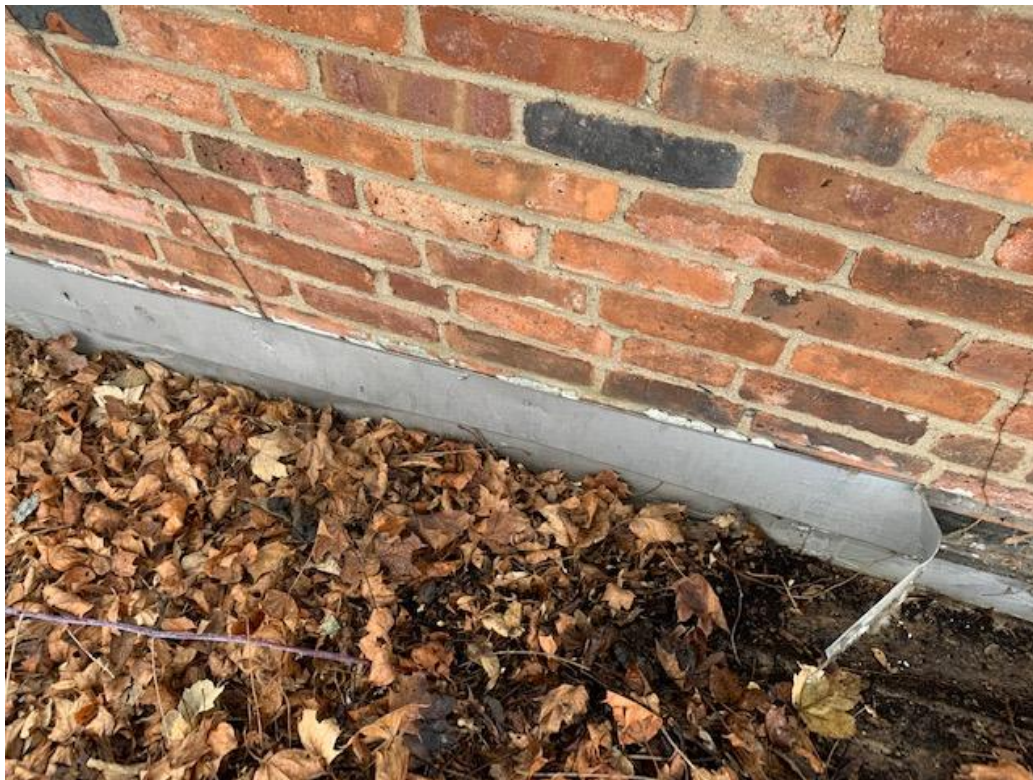
(Roof 7, Flashing to Roof 6, ACM Caulk on Brick & Metal)
