**HAZARD EVALUATION  
UNIVERSAL/HAZARD/REGULATED  
WASTES**

**PVE LLC  
48 Springside Avenue  
Poughkeepsie, NY 12603**

**58 Parker Avenue  
Poughkeepsie, NY 12601**

*Project Number: Q20-3106  
Report Date: February 3, 2020  
Report Prepared by: James Klemm*

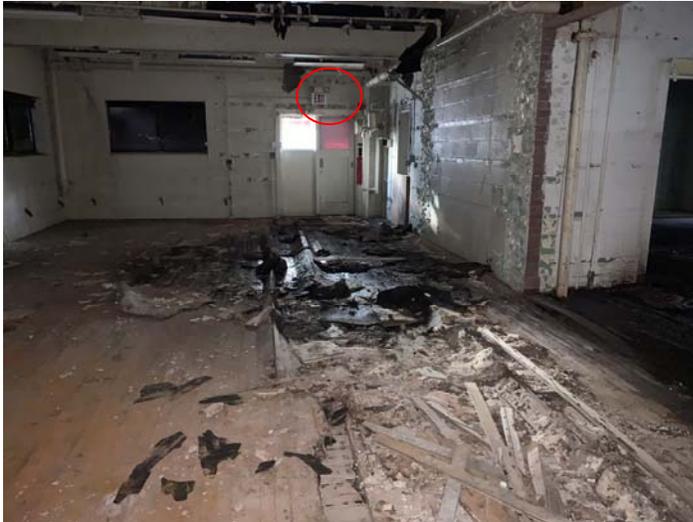
**Picture 1.0-1.1:** Emergency Light & Exit Sign

- All Universal/Miscellaneous Waste Materials should be recycled/disposed of in accordance with the requirements of the Universal Waste rule of the EPA and NYSDEC.

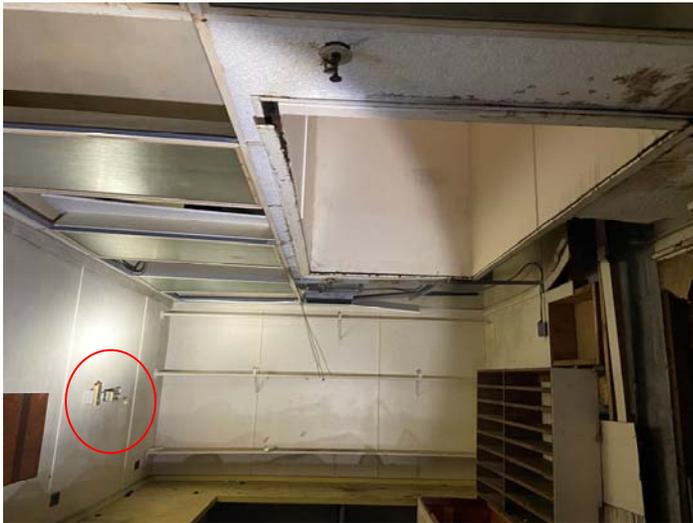
**Picture 2.0-2.1:** Thermostats

- All Mercury-containing devices should be properly disposed of in accordance with all Federal, State and Local Regulations.
- Suspect PCB-containing items should be tested to determine if they are classified as a PCB-containing material prior to removal and disposal.

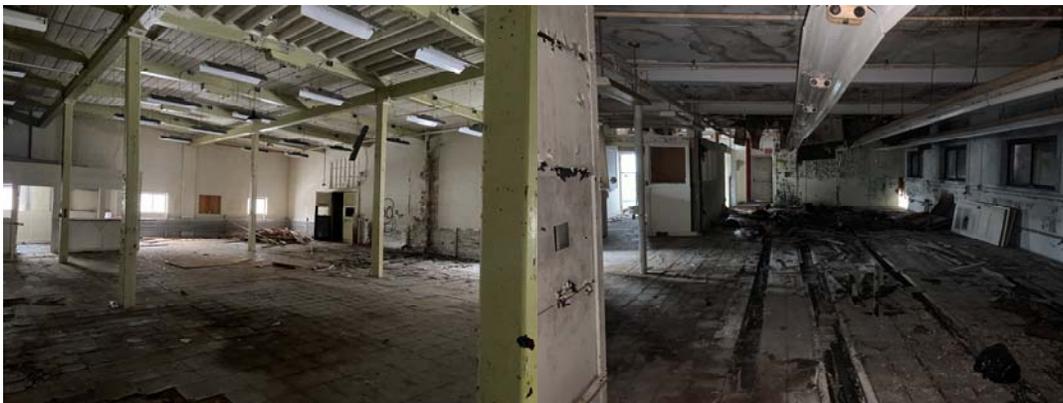
Much of the building is lighted by fluorescent light fixtures. These fixtures typically contain bulbs that contain Mercury and ballasts that would be suspected of containing Polychlorinated Biphenyls.

**Picture 3.0:** Fluorescent Bulbs in Ballasts
