Re: Status Report of Environmental Conditions at the property located at  
317 Main Street, Cornwall, Orange County, NY  
NYSDEC Spill #: 18-01592; WCD File: SC18035

## Fieldwork Map

317 Main Street  
Cornwall, New York

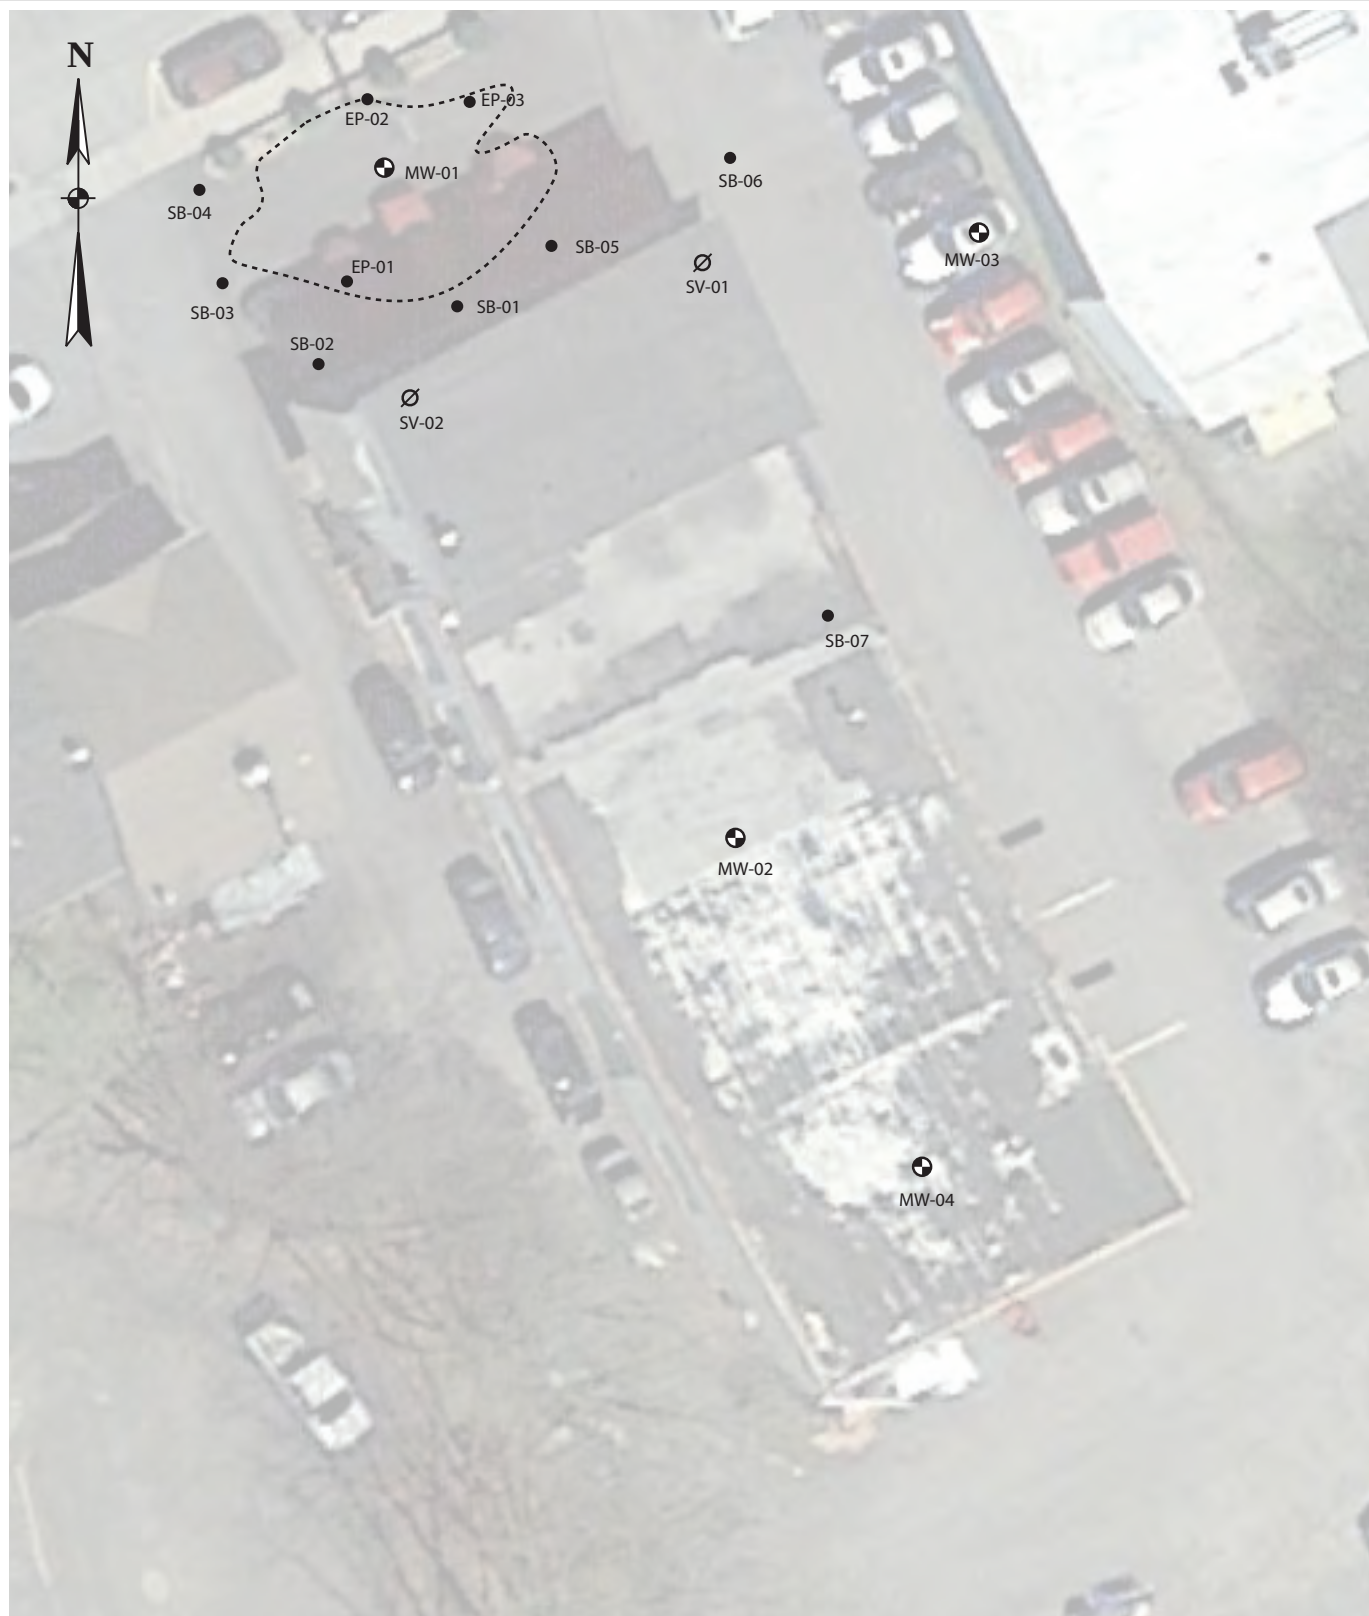
- All readily accessible petroleum-impacted soil was excavated and disposed off-site; significant residual soil contamination, however, remains (except to the east) and groundwater is contaminated. Impacted soil appears to extend under the surface at the adjoining properties to the north (public road) and west (former filling station), and may extend somewhat under the northern portion of the on-site structure.

Relatively high levels of tetrachloroethene (PCE; a chlorinated solvent) and total BTEX (petroleum compounds associated with gasoline) were detected in samples SV-03 and SV-04 at the central portion of the building (peak values of 490 and 6,610  $\mu\text{g}/\text{m}^3$ , respectively). Peak values for these compounds were much lower in samples SV-01 and SV-02 at the northern portion of the building outside the repair area (99 and 32  $\mu\text{g}/\text{m}^3$ , respectively).

Field evidence of contamination was observed at SB-07 from 4 to 8 feet (mild petroleum odor and PID readings [77 ppm]) and at MW-03 from the surface to 12 feet (staining, mild to moderate petroleum odor, and high PID readings [peak 698 ppm]). Groundwater was encountered in borings at 8 to 9 feet (no sheens were observed).

Total VOCs were reported at MW-02 at approximately 607 ppb, including 1,4-dioxane (compound typically associated with chlorinated solvents, 140 ppb, AWQS not established), tert-butyl alcohol (TBA, non-chlorinated solvent, 71 ppb, AWQS not established), and an elevated concentration of MTBE (a gasoline additive, 390 ppb, AWQS 10 ppb). No significant contamination was reported at upgradient well MW-04 (notable detections include trace concentrations of the solvent trichloroethylene [TCE] and its breakdown products).

Total VOCs were reported at MW-03 at approximately 248 ppb, including elevated concentrations of multiple petroleum compounds (peak values reported for 1,2,4-trimethylbenzene at 56 ppb and cyclohexane at 57 ppb).

Additional subsurface investigation is required at and near the central and southern portions of the building (it is estimated that one to two days of fieldwork would be required).
