Re: Periodic Review Report | CH - Kingston Gas Works | NYSDEC

Site No. C356017 | Kingston, New York

Engineering Controls Monitoring Checklist - Soil Cover and Sediment Cap Site Management Plan Central Hudson Gas & Electric Corporation

Kingston Former MGP Site, Kingston, New York

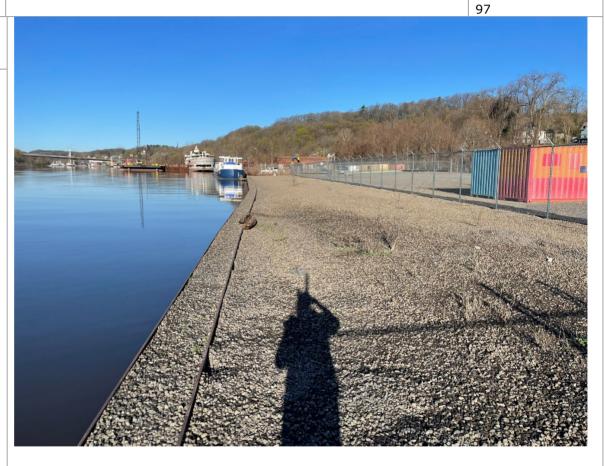
Bulkhead on south boundary of site. Signs of settlement noted in minimal areas.

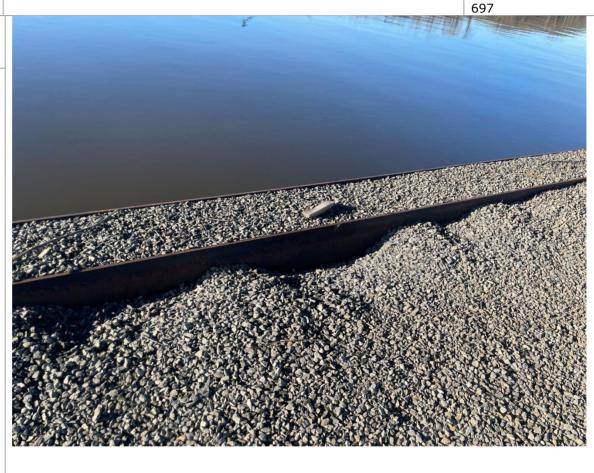
Area of noted settlement along the Bulkhead on south boundary of site.

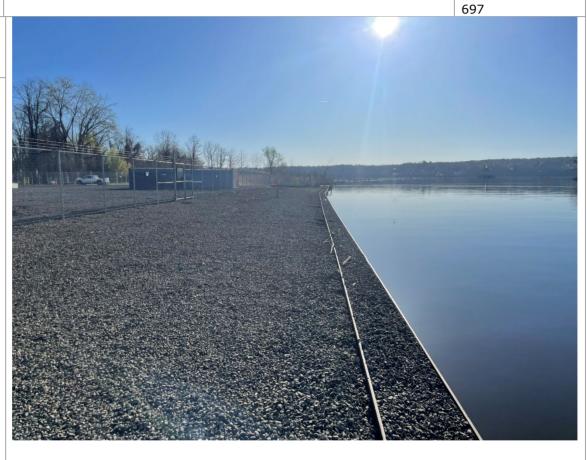
Bulkhead on south boundary of Site facing east.

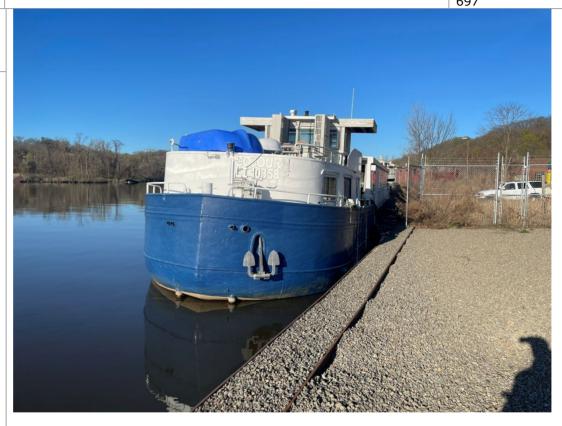
Vessels moored adjacent to site on Rondout Creek limiting extents of bathymetric survey.

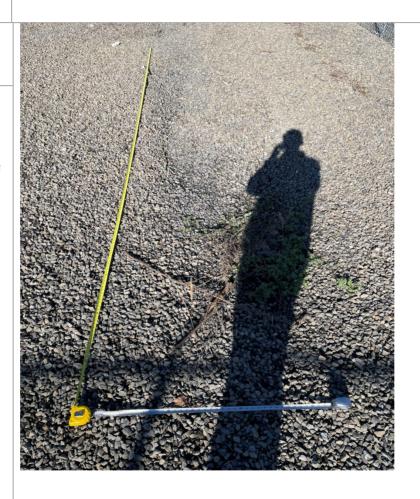
Limits of minor settlement at southeast portion of the site between the bulkhead and fence line.

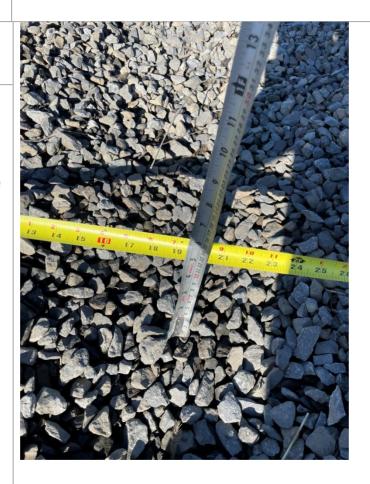
Photo showing approximately 5 inches of settlement within southeast portion of the site between the bulkhead and fence line.

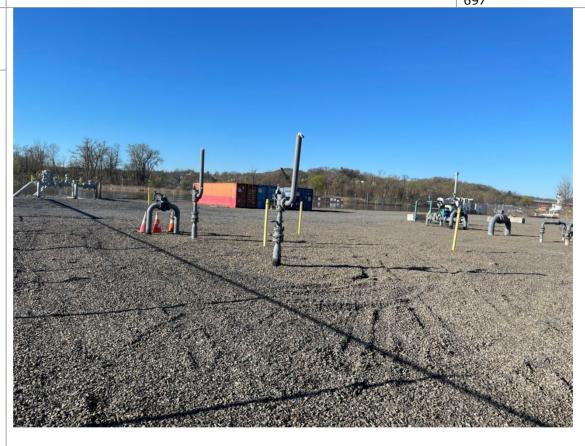
Cover within exclusion zone.

Photo taken in northeast corner
of Central Hudson Property
facing southwest.

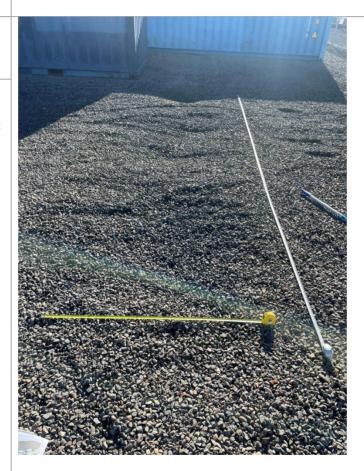
Limits of settlement at southeast portion of the Site within the fence line. This area has been noted previously since 2022. The limits and depth do not appear to have expanded.

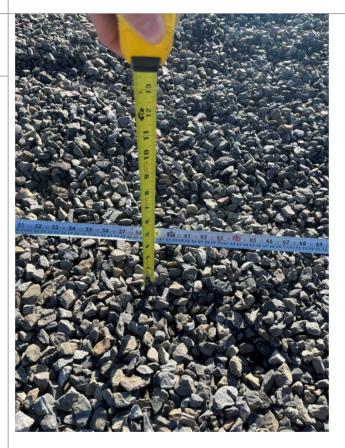
Photo showing approximately 4 inches of settlement at southeast portion of the Site within the fence line.

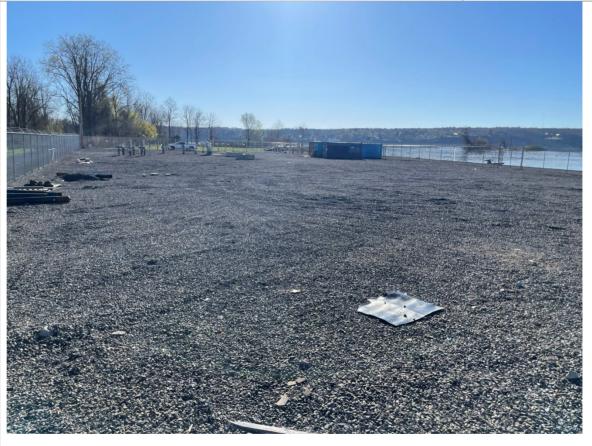
**PHOTO NO.** 10

View of site from northwest corner showing a majority of the cover system. Site is currently being used as a laydown area for off-site natural gas line installation.

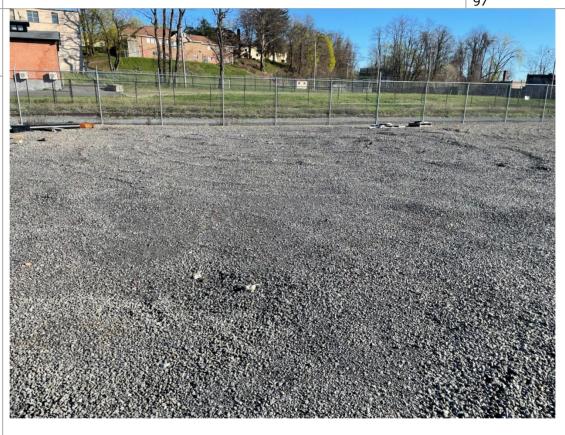
11

View of northside of the Site, just west of the exclusion zone where some minor depression/settlement is noted. Expected that the area was utilized for storing materials and/or equipment.

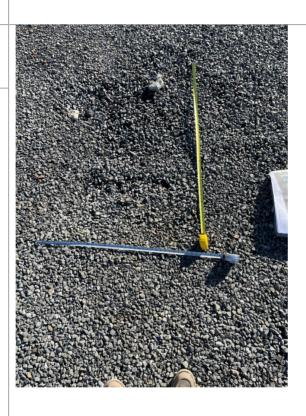
PHOTO NO. 12

Area of minor settlement at north side of the Site.

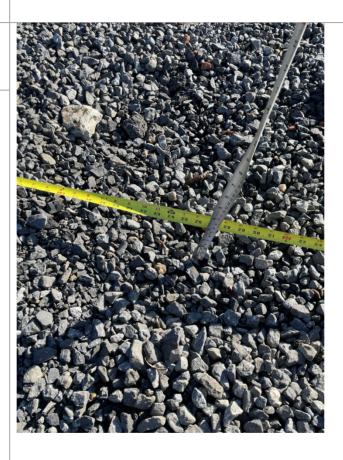
13

Photo showing approximately 3 inches of settlement at north side of the Site.

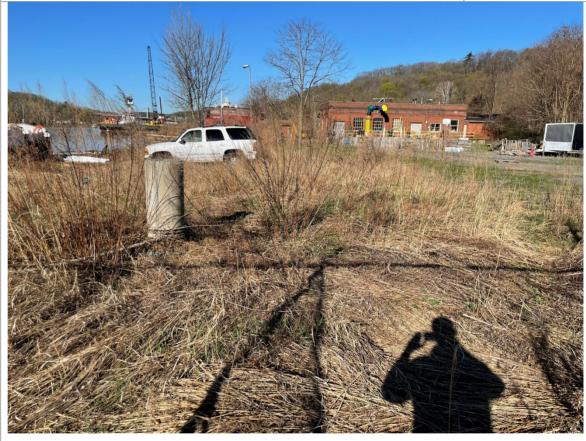
Soil cover on property west of Central Hudson Property. Photo taken from west side of Central Hudson Property facing west.

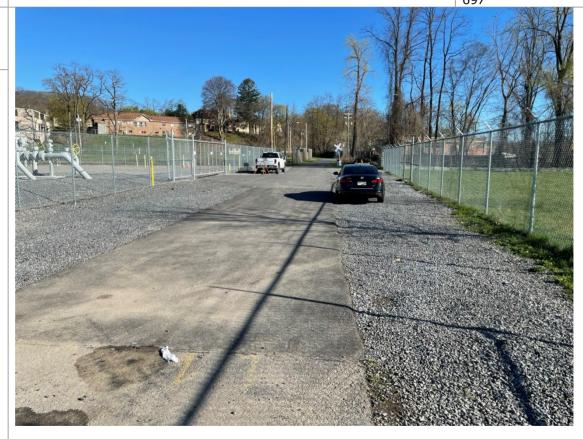
**РНОТО NO.** 15

Soil cover east of the Central Hudson property. Photo taken east of property facing north.

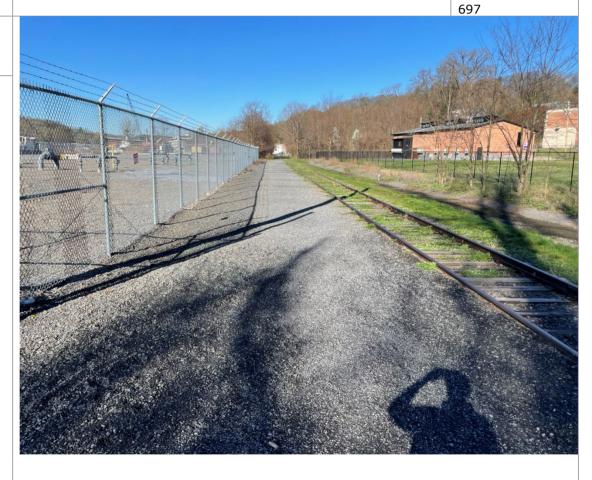
**PHOTO NO.** 16

Northern boundary of Site. Photo taken in northeast corner of site facing west.

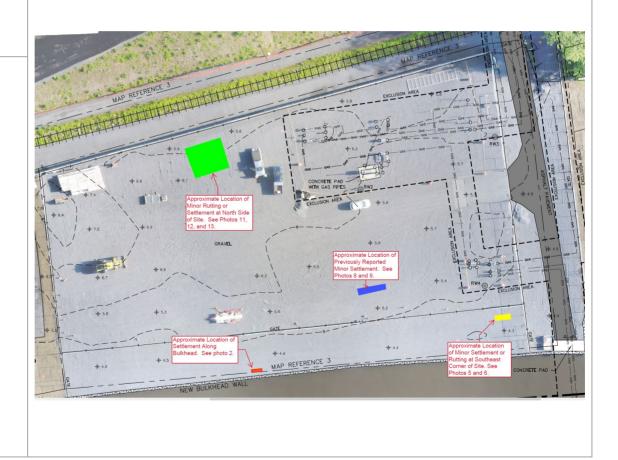
PHOTO NO. 17

Location plan of noted settlement.
