Re: Periodic Review Report | CH – Kingston Gas Works | NYSDEC
Site No. C356017 | Kingston, New York
File: 1126476.1940113868

ATTACHMENT 1
ENGINEERING CONTROLS MONITORING CHECKLIST

Engineering Controls Monitoring Checklist – Soil Cover and Sediment Cap Site Management Plan Central Hudson Gas & Electric Corporation Kingston Former MGP Site, Kingston, New York				
Date Monitoring Performed: April 24, 2025			Weather: 81° F, Sunny	
Section I: Engineering Controls (to be completed in the field at the time of the monitoring. Use additional space if necessary).				
<i>The site engineering controls consist of a soil cover and a sediment cap. The engineering controls will be monitored to verify their integrity and to identify areas that may require maintenance.</i>				
Observation	Yes	No	N/A	Comments

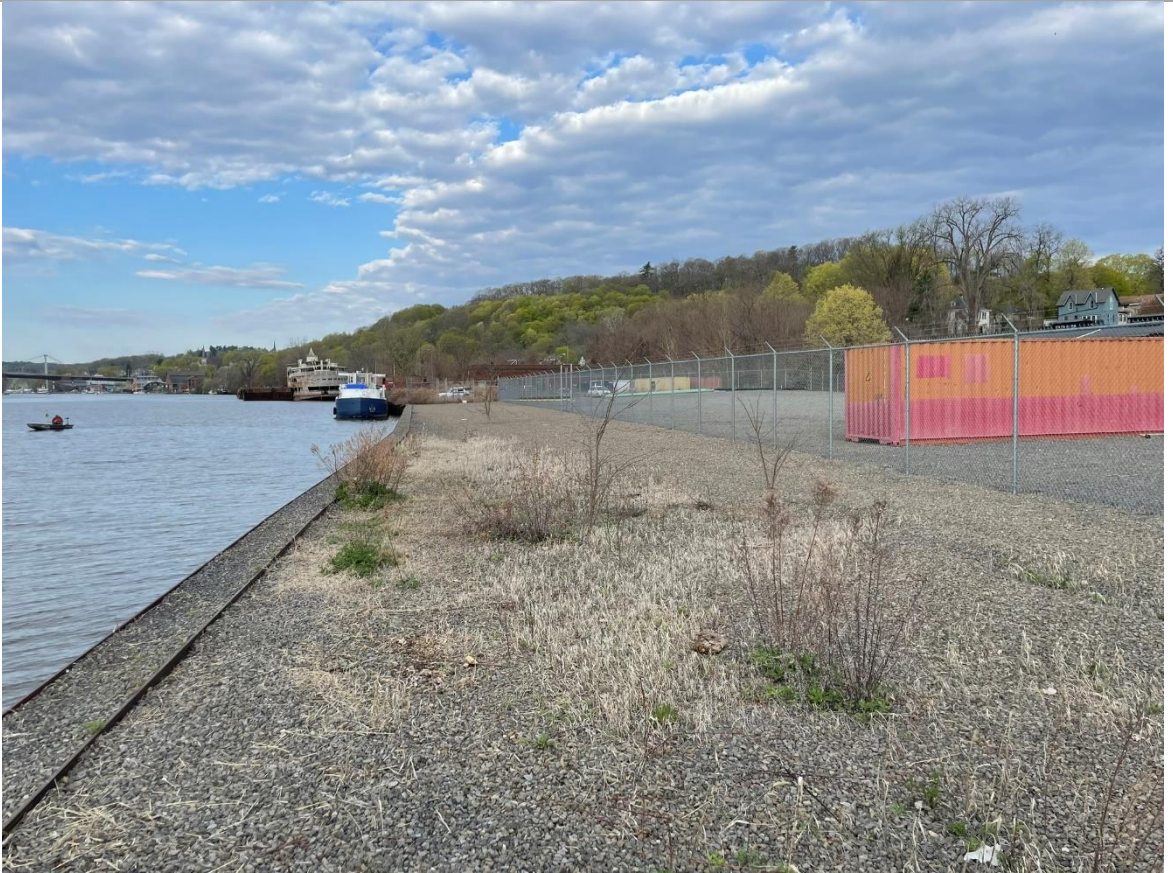
CLIENT NAME: CENTRAL HUDSON GAS & ELECTRIC		SITE LOCATION: FORMER KINGSTON MGP SITE	PROJECT NO. 1126476 19401138 68
PHOTO NO. 1	DATE: 4/24/2025

DESCRIPTION Bulkhead on south boundary of site. Signs of settlement noted in minimal areas. Increased vegetation noted as compared to previous year.

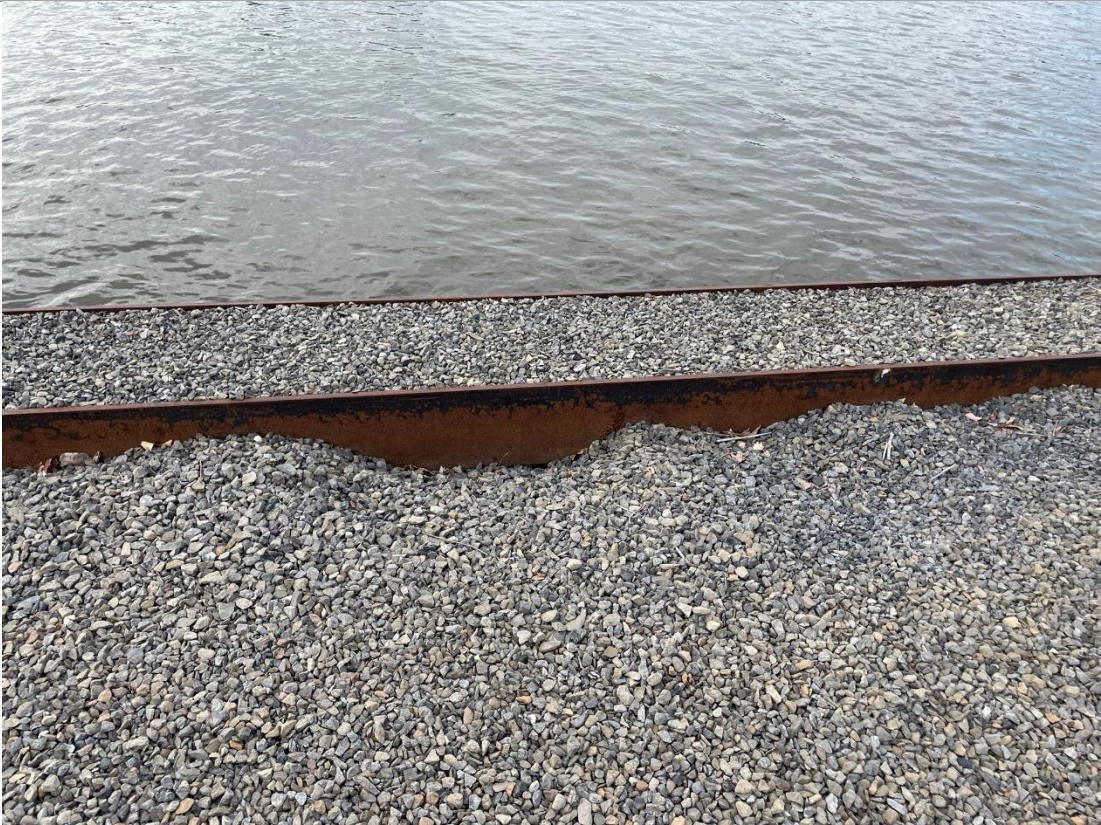
CLIENT NAME: CENTRAL HUDSON GAS & ELECTRIC		SITE LOCATION: FORMER KINGSTON MGP SITE	PROJECT NO. 1126476 1940113 868
PHOTO NO. 2	DATE: 4/24/2025

Soil Cover: The soil/stone cover remains intact but there are areas of noted minor settlement or rutting as shown in photos 2,5, 6, 8, 9, and 11 through 13. The noted settlements range between 2 and 10 inches deep. Areas of vegetative cover show established vegetation (Photo 14). Areas of asphalt or concrete show no signs of deterioration (Photo 15). The settlement will continue to be monitored and if required, corrective actions will be implemented.

DESCRIPTION Area of noted settlement along the Bulkhead on south boundary of site.

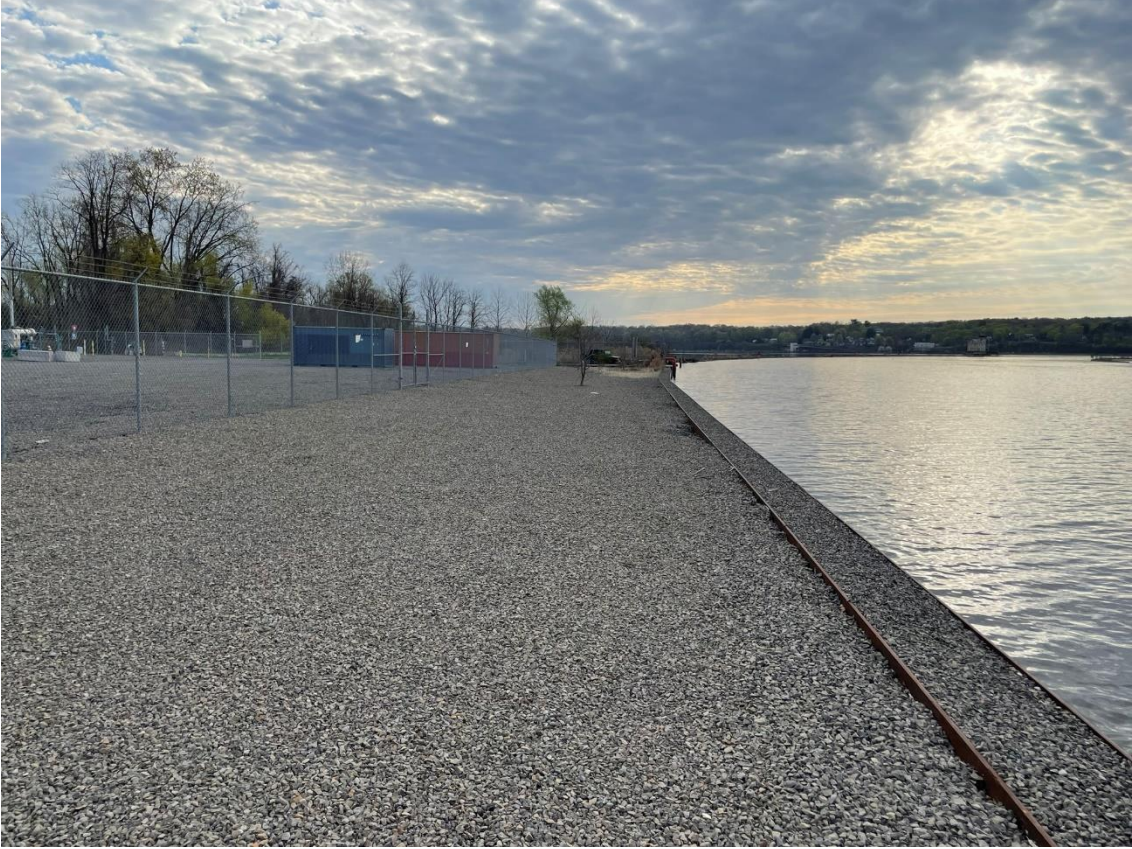
CLIENT NAME: CENTRAL HUDSON GAS & ELECTRIC		SITE LOCATION: FORMER KINGSTON MGP SITE	PROJECT NO. 1126476 1940113 868
PHOTO NO. 3	DATE: 4/24/2025

DESCRIPTION Bulkhead on south boundary of Site facing east.

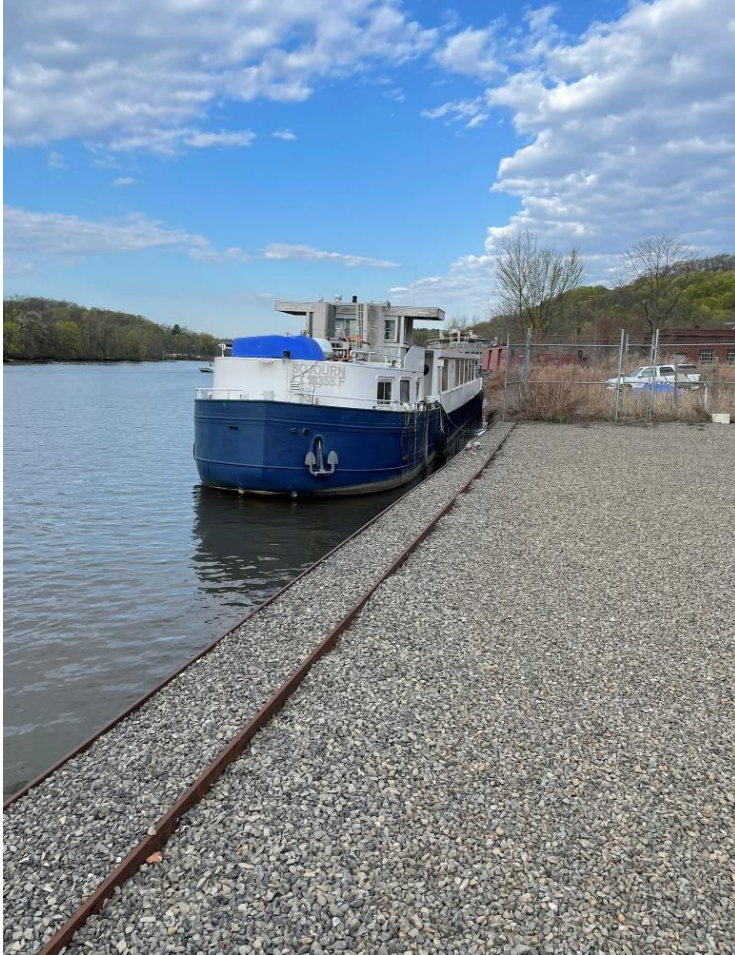
CLIENT NAME: CENTRAL HUDSON GAS & ELECTRIC		SITE LOCATION: FORMER KINGSTON MGP SITE	PROJECT NO. 1126476 1940113 868
PHOTO NO. 4	DATE: 4/24/2025

DESCRIPTION Vessels moored adjacent to site on Rondout Creek limiting extents of bathymetric survey.

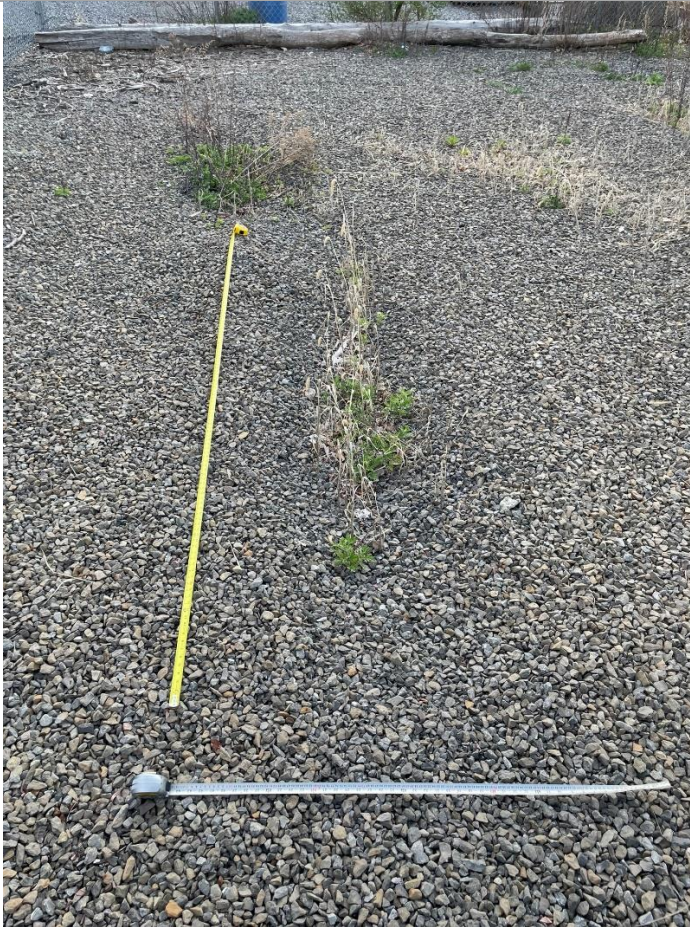
CLIENT NAME: CENTRAL HUDSON GAS & ELECTRIC		SITE LOCATION: FORMER KINGSTON MGP SITE	PROJECT NO. 1126476 1940113 868
PHOTO NO. 5	DATE: 4/24/2025

DESCRIPTION Limits of previously noted settlement at southeast portion of the site between the bulkhead and fence line.

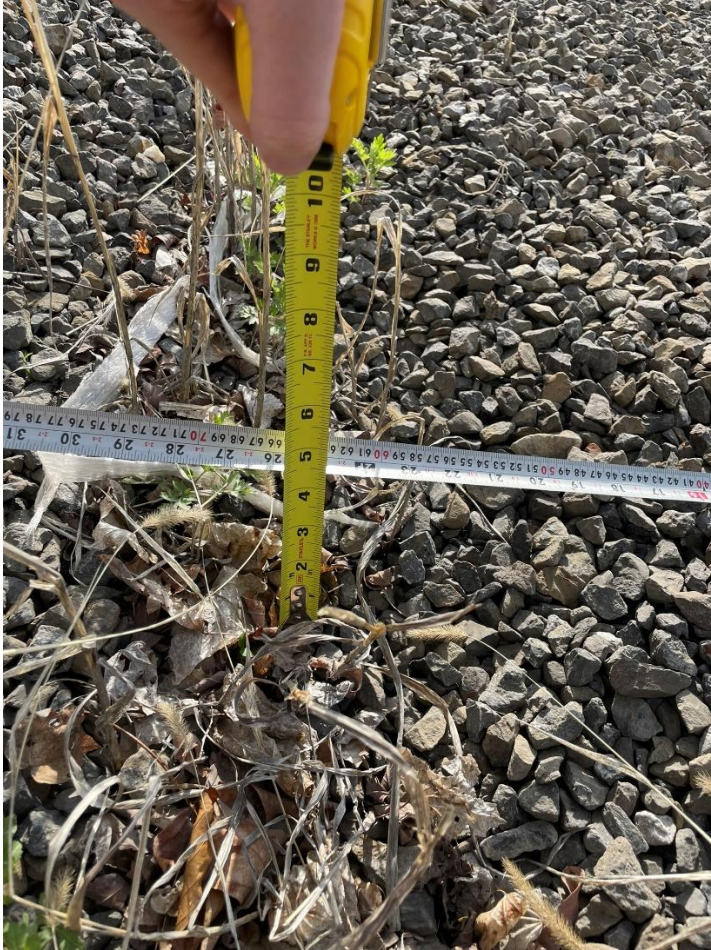
CLIENT NAME: CENTRAL HUDSON GAS & ELECTRIC		SITE LOCATION: FORMER KINGSTON MGP SITE	PROJECT NO. 1126476 1940113 868
PHOTO NO. 6	DATE: 4/24/2025

DESCRIPTION Photo showing approximately 5.0 inches of settlement within southeast portion of the site between the bulkhead and fence line.

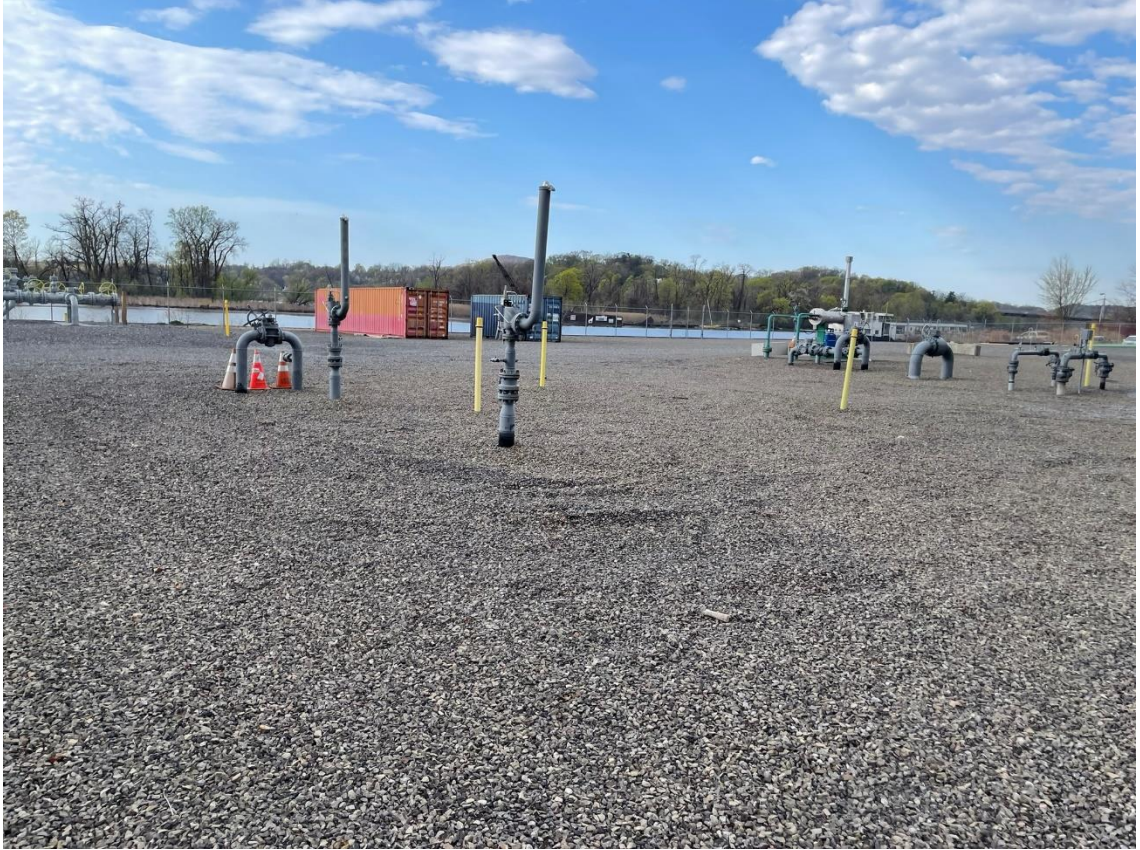
CLIENT NAME: CENTRAL HUDSON GAS & ELECTRIC		SITE LOCATION: FORMER KINGSTON MGP SITE	PROJECT NO. 1126476 1940113 868
PHOTO NO. 7	DATE: 4/24/2025

DESCRIPTION Cover within exclusion zone. Photo taken in northeast corner of Central Hudson Property facing southwest.

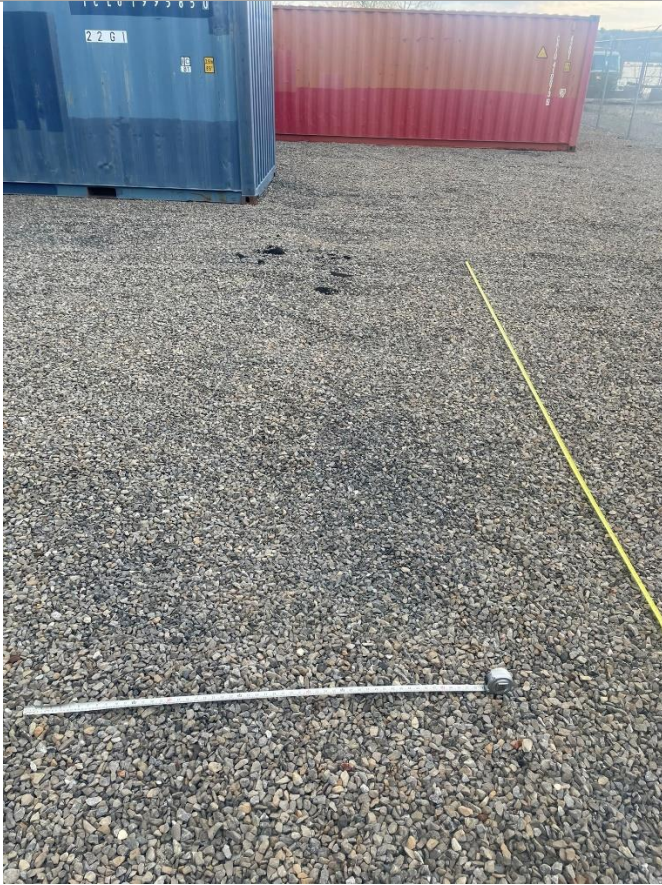
CLIENT NAME: CENTRAL HUDSON GAS & ELECTRIC		SITE LOCATION: FORMER KINGSTON MGP SITE	PROJECT NO. 1126476 1940113 868
PHOTO NO. 8	DATE: 4/24/2025

DESCRIPTION Limits of settlement at southeast portion of the Site within the fence line. This area has been noted previously since 2022. The limits and depth do not appear to have expanded.

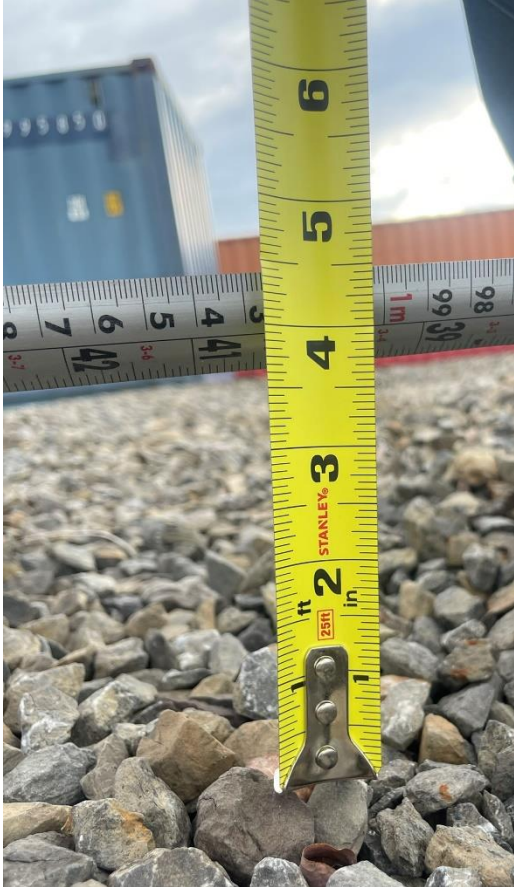
CLIENT NAME: CENTRAL HUDSON GAS & ELECTRIC		SITE LOCATION: FORMER KINGSTON MGP SITE	PROJECT NO. 1126476 1940113 868
PHOTO NO. 9	DATE: 4/24/2025	<div data-bbox="682 430 1192 1312" data-label="Image">

</div>	
DESCRIPTION Photo showing approximately 4 inches of settlement at southeast portion of the Site within the fence line.

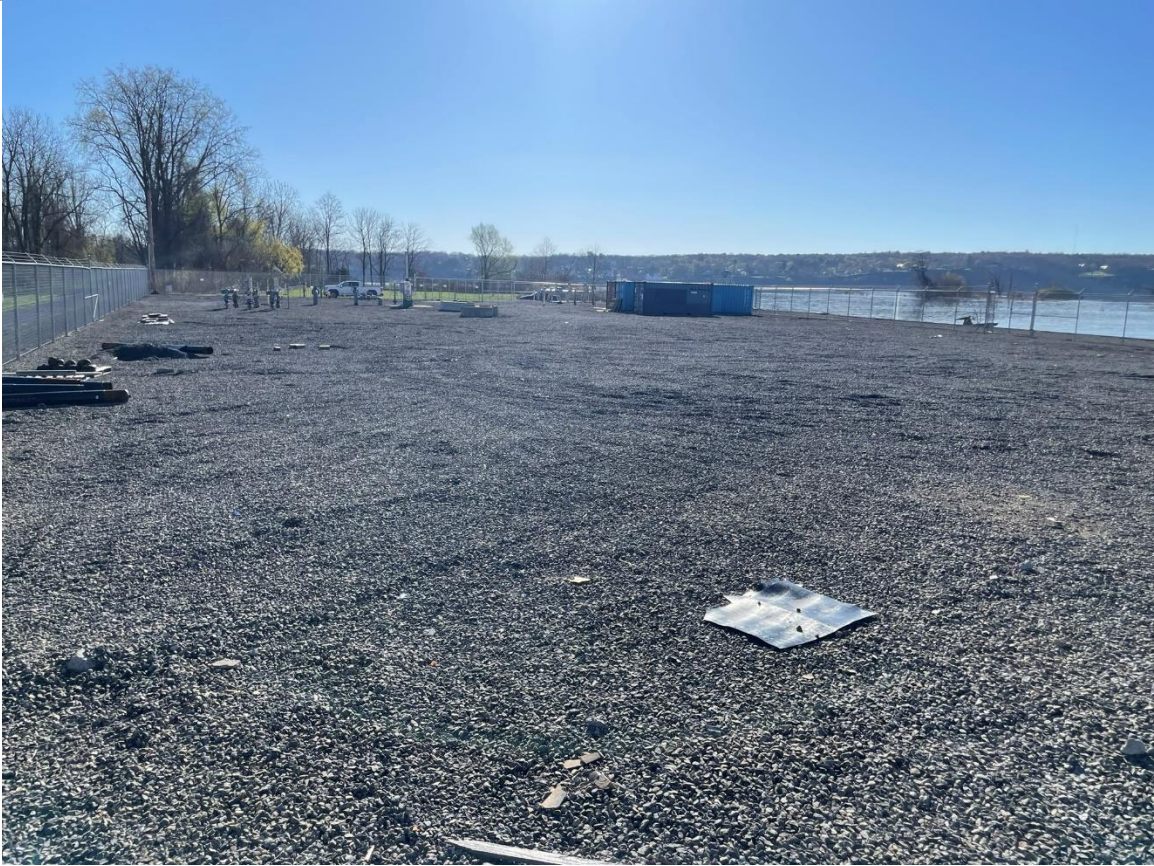
CLIENT NAME: CENTRAL HUDSON GAS & ELECTRIC		SITE LOCATION: FORMER KINGSTON MGP SITE	PROJECT NO. 1126476 1940113868
PHOTO NO. 10	DATE: 4/24/2025

DESCRIPTION View of site from northwest corner showing the majority of the cover system. Site is currently being used as a laydown area for off-site natural gas line installation.

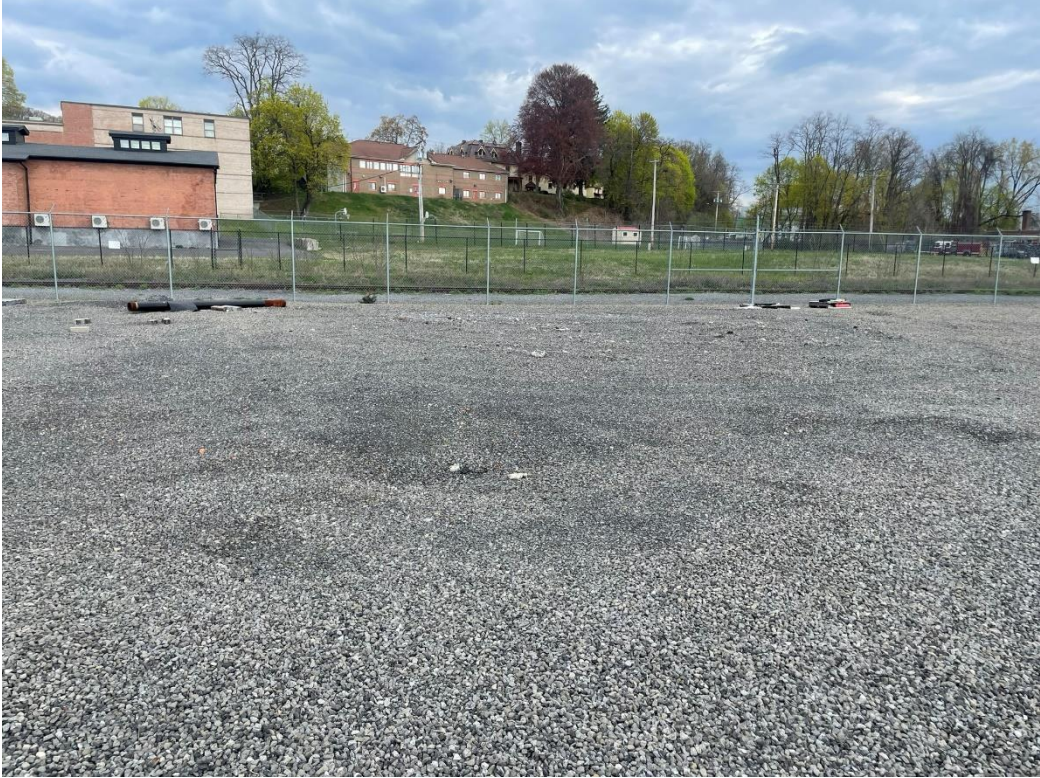
CLIENT NAME: CENTRAL HUDSON GAS & ELECTRIC		SITE LOCATION: FORMER KINGSTON MGP SITE	PROJECT NO. 1126476 19401138 68
PHOTO NO. 11	DATE: 4/24/2025

DESCRIPTION View of northside of the Site, just west of the exclusion zone where some minor rutting and/or settlement is noted. This area was previously noted in the 2023 report. The limits and depth do not appear to have expanded

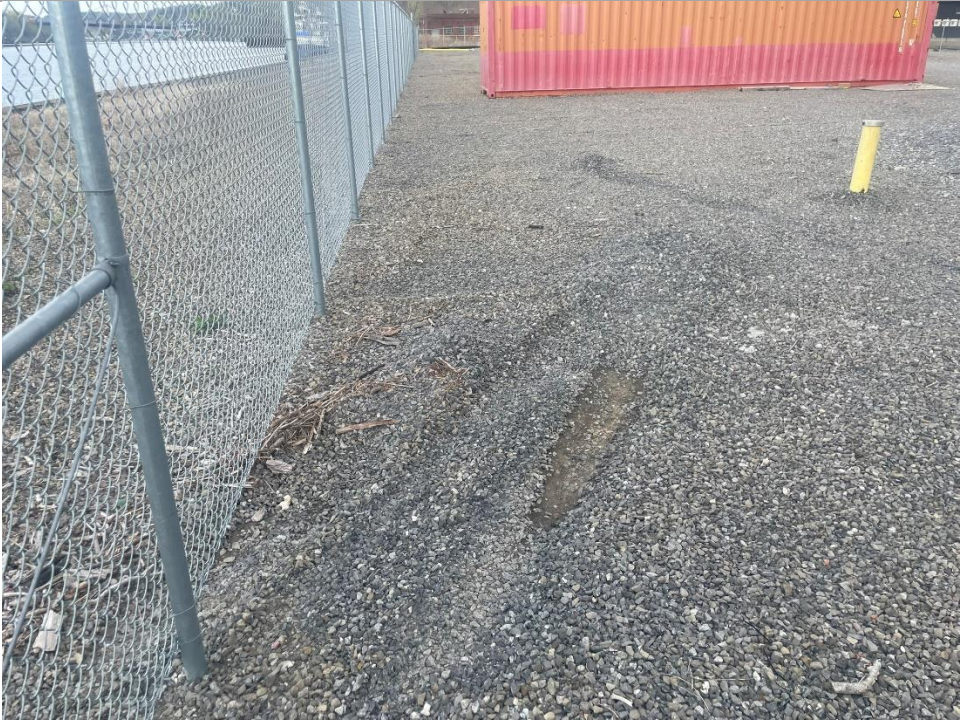
CLIENT NAME: CENTRAL HUDSON GAS & ELECTRIC		SITE LOCATION: FORMER KINGSTON MGP SITE	PROJECT NO. 1126476 1940113 868
PHOTO NO. 12	DATE: 4/24/2025

DESCRIPTION Area of rutting in the southeast corner of the site between the fence line and recovery well RW-04.

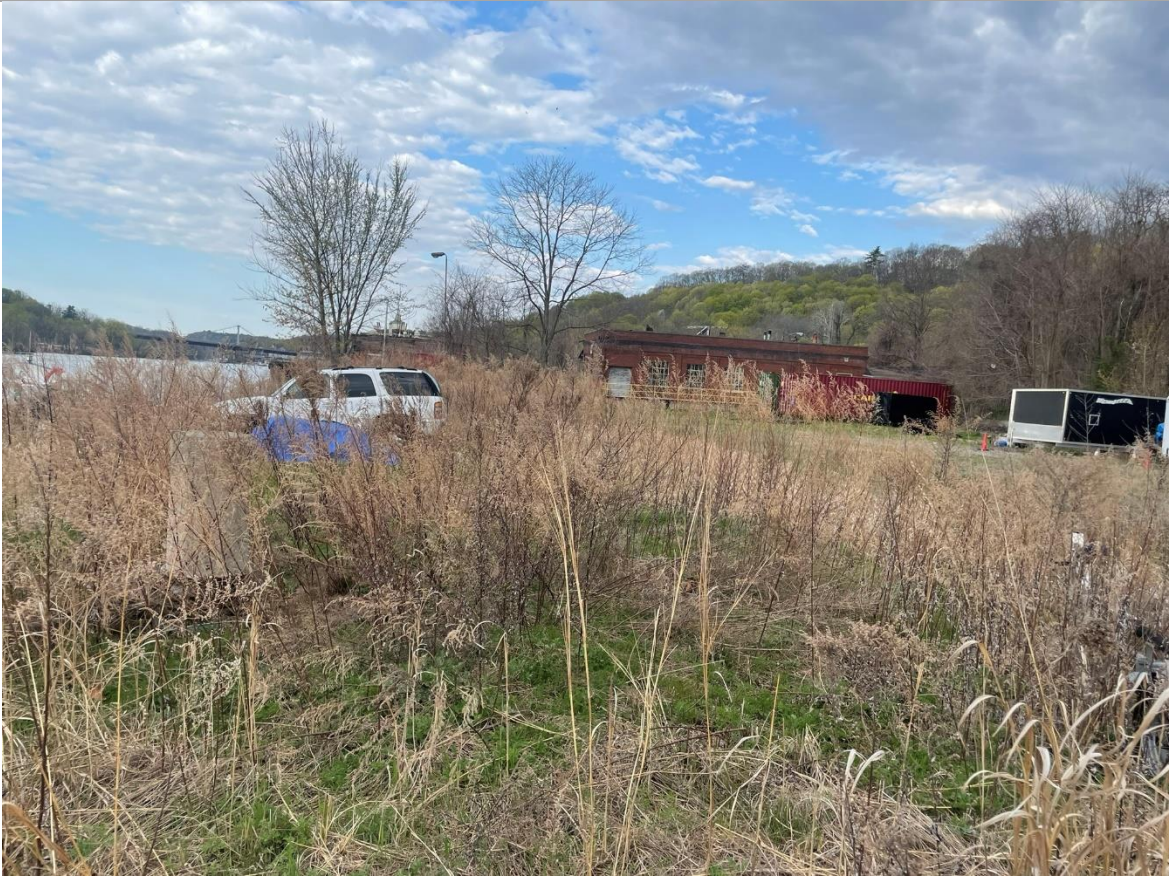
CLIENT NAME: CENTRAL HUDSON GAS & ELECTRIC		SITE LOCATION: FORMER KINGSTON MGP SITE	PROJECT NO. 1126476 19401138 68
PHOTO NO. 14	DATE: 4/24/2025

DESCRIPTION Soil cover on property west of Central Hudson Property. Photo taken from west side of Central Hudson Property facing west.

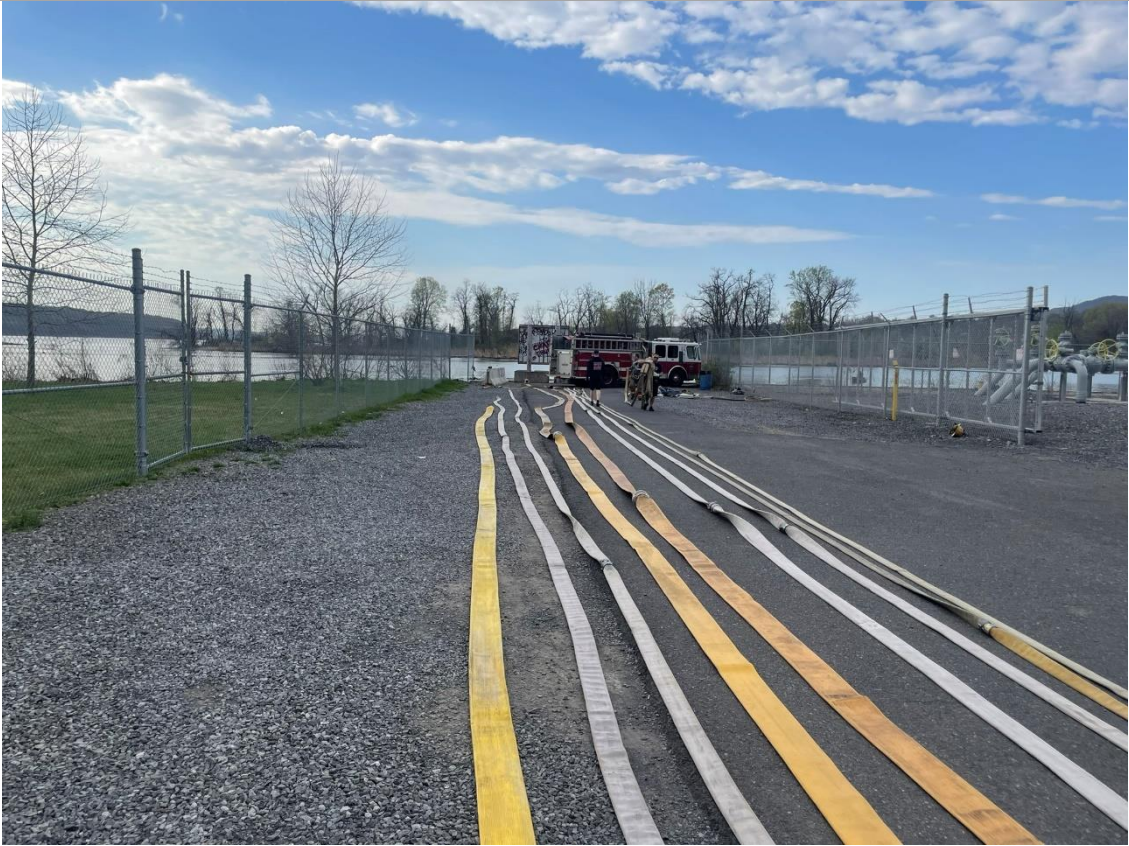
CLIENT NAME: CENTRAL HUDSON GAS & ELECTRIC		SITE LOCATION: FORMER KINGSTON MGP SITE	PROJECT NO. 1126476 1940113 868
PHOTO NO. 15	DATE: 4/24/2025

DESCRIPTION Soil cover east of the Central Hudson property. Photo taken east of property facing south.

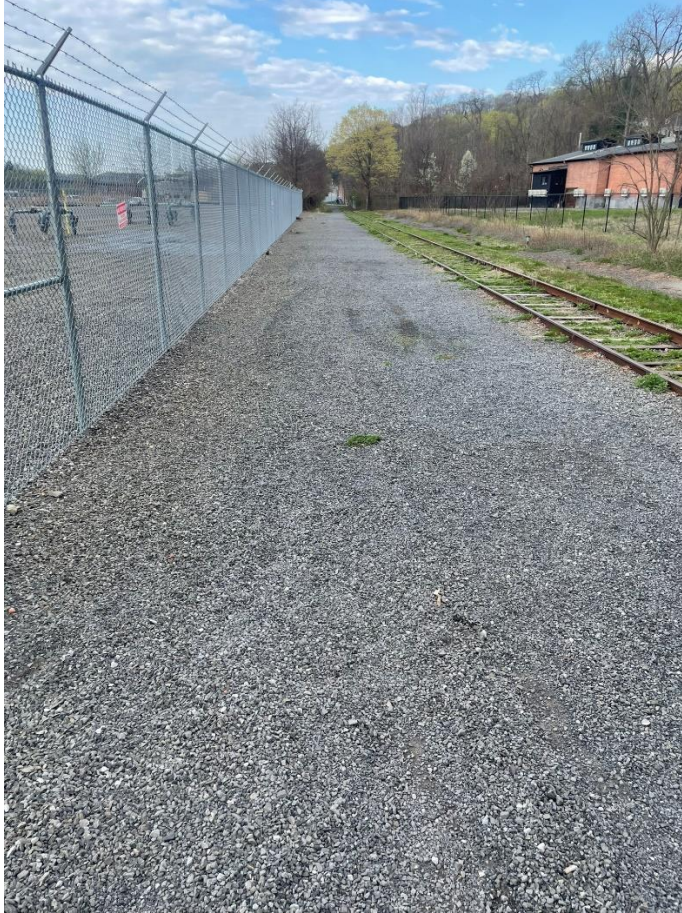
CLIENT NAME: CENTRAL HUDSON GAS & ELECTRIC		SITE LOCATION: FORMER KINGSTON MGP SITE	PROJECT NO. 1126476 1940113 868
PHOTO NO. 16	DATE: 4/24/2025

DESCRIPTION Northern boundary of Site. Photo taken in northeast corner of site facing west.

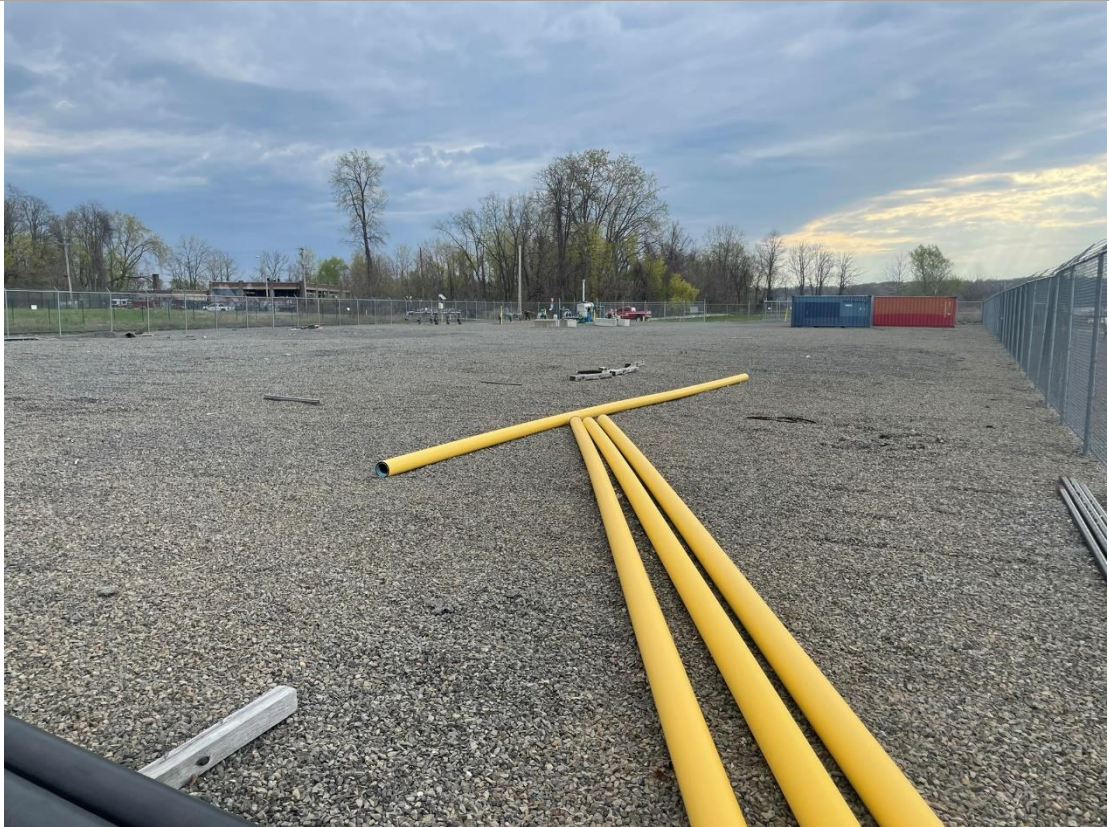
CLIENT NAME: CENTRAL HUDSON GAS & ELECTRIC		SITE LOCATION: FORMER KINGSTON MGP SITE	PROJECT NO. 1126476 1940113 868
PHOTO NO. 17	DATE: 4/24/2025

DESCRIPTION View of site from southwest corner showing the majority of the cover system. Site is currently being used as a laydown area for off-site natural gas line installation.

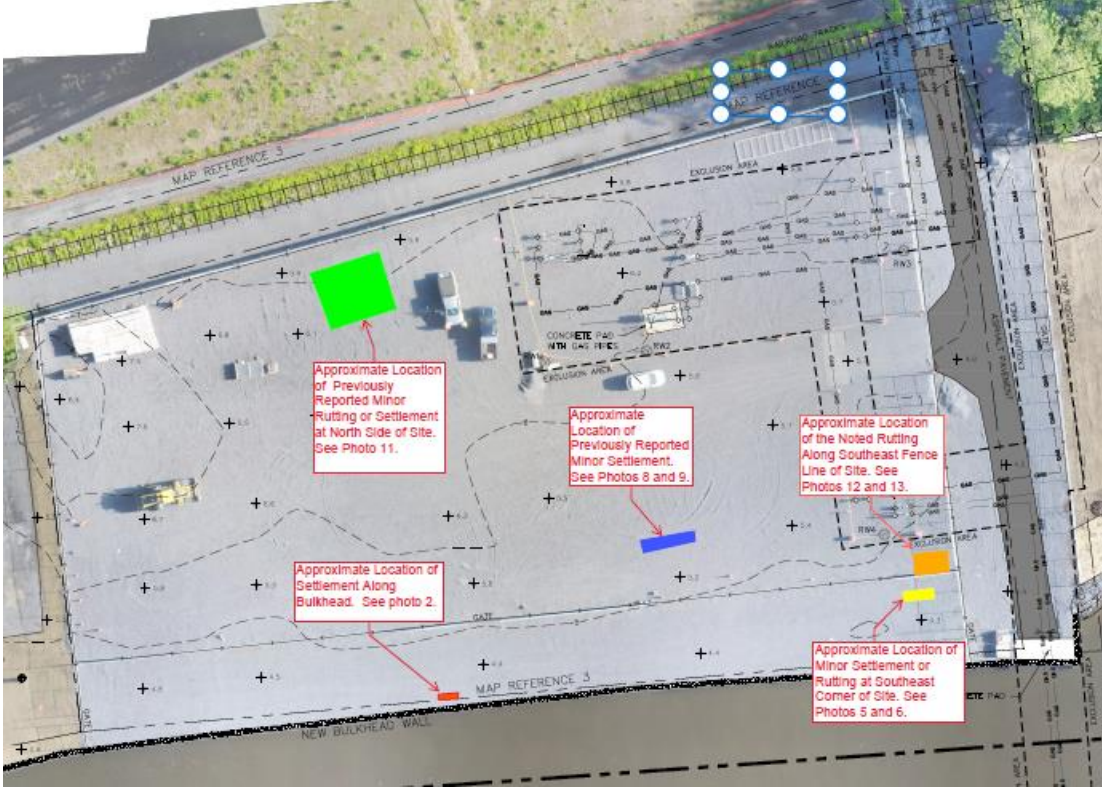
CLIENT NAME: CENTRAL HUDSON GAS & ELECTRIC		SITE LOCATION: FORMER KINGSTON MGP SITE	PROJECT NO. 1126476 1940113 868
PHOTO NO. 18	DATE: 4/24/2025

DESCRIPTION Site plan showing approximate location of noted settlement/rutting.
