Re: Periodic Review Report | CH – Kingston Gas Works | NYSDEC  
Site No. C356017 | Kingston, New York  
File: 1126476.1940120091

This Periodic Review Report (PRR) was prepared by Ramboll Americas Engineering Solutions, Inc. (Ramboll) at the request of Central Hudson Gas & Electric Corporation (Central Hudson) to document the status of the Engineering Controls (ECs) and Institutional Controls (ICs) established in accordance with the November 2017, updated November 2021, Site Management Plan (SMP) for the Kingston Former Manufactured Gas Plant (MGP) Site (New York State Department of Environmental Conservation (NYSDEC) Site Number: C356017) located in Kingston, New York, and to provide a summary of information generated during the reporting period for the site. The reporting period for this PRR is May 25, 2025 through May 25, 2026. The SMP addressed the means for implementing and periodically inspecting ECs/ICs required by the remedy for the site.

**ATTACHMENT 1**  
**ENGINEERING CONTROLS MONITORING CHECKLIST**

| Engineering Controls Monitoring Checklist – Soil Cover and Sediment Cap Site Management Plan<br>Central Hudson Gas & Electric Corporation<br>Kingston Former MGP Site, Kin

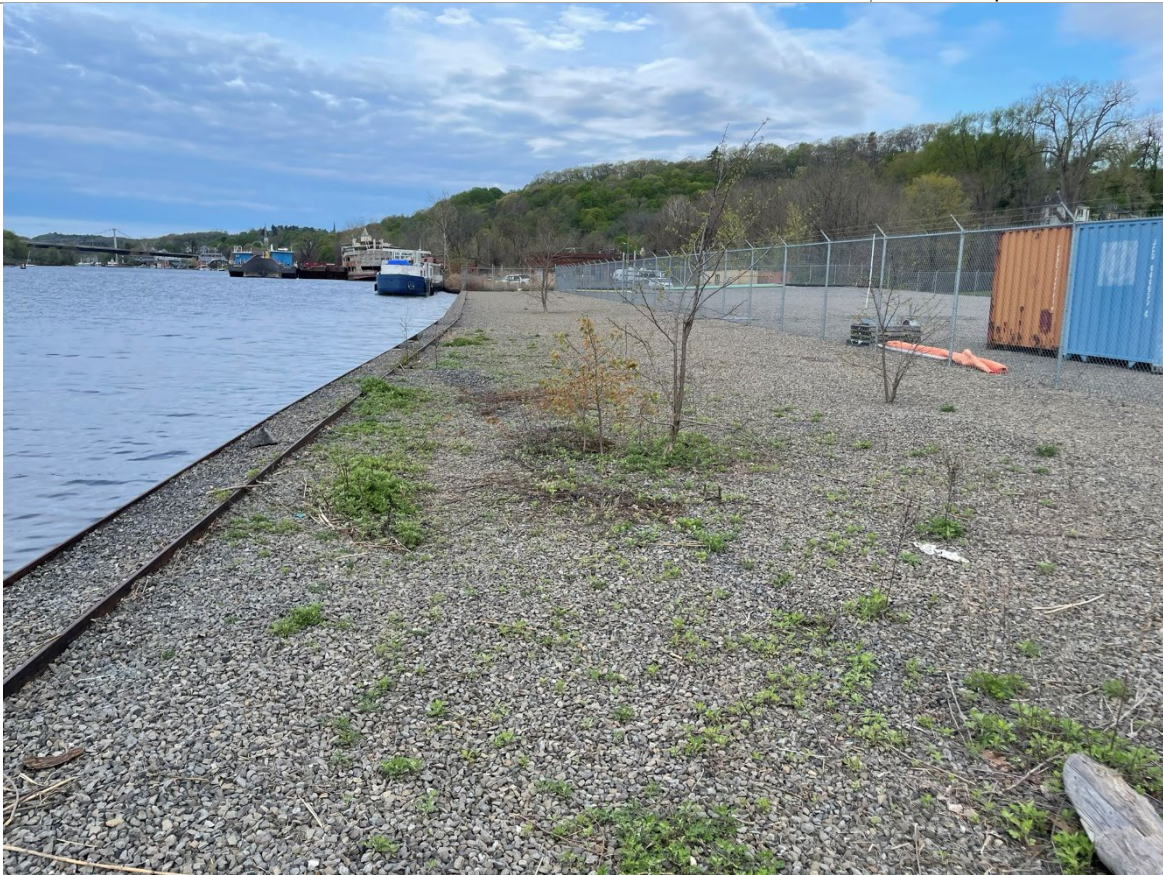
| Photograph | Date | Photograph Description | Direction Facing |
|---|---|---|---|
| 1 | 4/24/26 | Bulkhead on south boundary of Site. Signs of minimal settlement and rutting noted in isolated areas. Increased vegetation noted as compared to previous year. | West |

| <b>PHOTO NO.</b><br>1 | <b>DATE:</b><br>4/24/2026 | <div> <div> <b>DESCRIPTION</b><br/> Bulkhead on south boundary of Site. Signs of minimal settlement and rutting noted in isolated areas. Increased vegetation noted as compared to previous year. </div> </div> | |

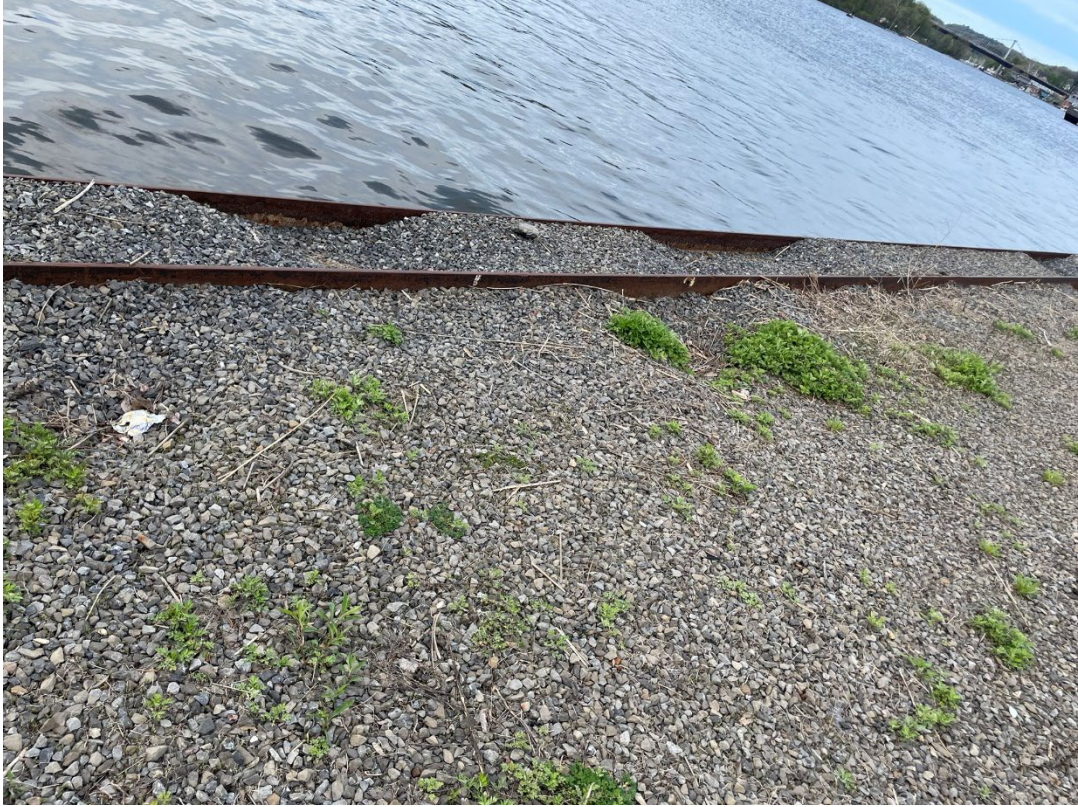
| <b>PHOTO NO.</b><br>2 | <b>DATE:</b><br>4/24/2026 | | |

| Photograph | Date | Photograph Description | Direction Facing |
|---|---|---|---|
| 2 | 4/24/26 | Area of noted erosion and settlement along the bulkhead on south boundary of Site. | South |

| <b>DESCRIPTION</b><br>Area of noted erosion and settlement along the Bulkhead on south boundary of Site. | | | |

- Nothing has occurred that would impair the ability of the control to protect the public health and environment. It is recommended that the noted hole in the southeast portion of the site and erosion and settlement along the bulkhead be backfilled back to original grade in accordance with the Site Management Plan;

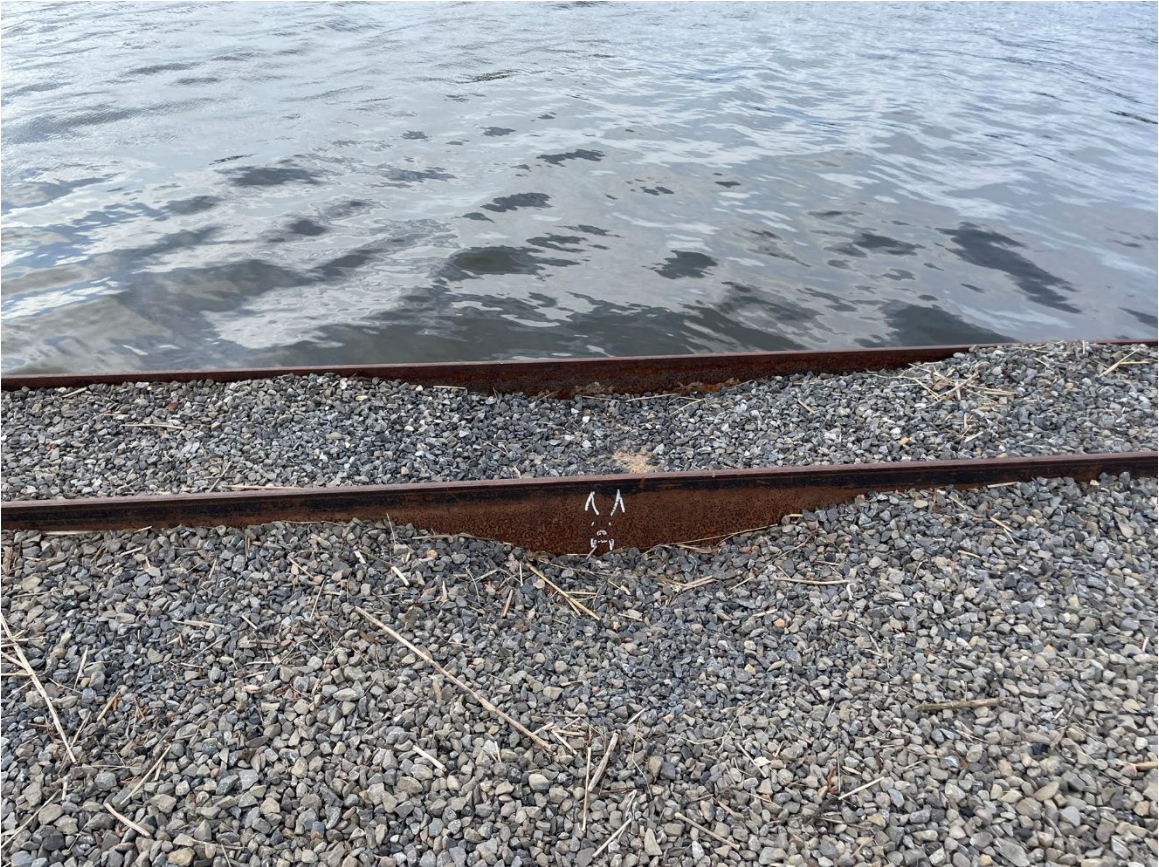
| <b>PHOTO NO.</b><br>3 | <b>DATE:</b><br>4/24/2026 | | |

| Photograph | Date | Photograph Description | Direction Facing |
|---|---|---|---|
| 3 | 4/24/26 | Area of noted erosion and settlement along the bulkhead on south boundary of Site. | South |

| <b>DESCRIPTION</b><br>Area of noted erosion and settlement along the Bulkhead on south boundary of Site. | | | |

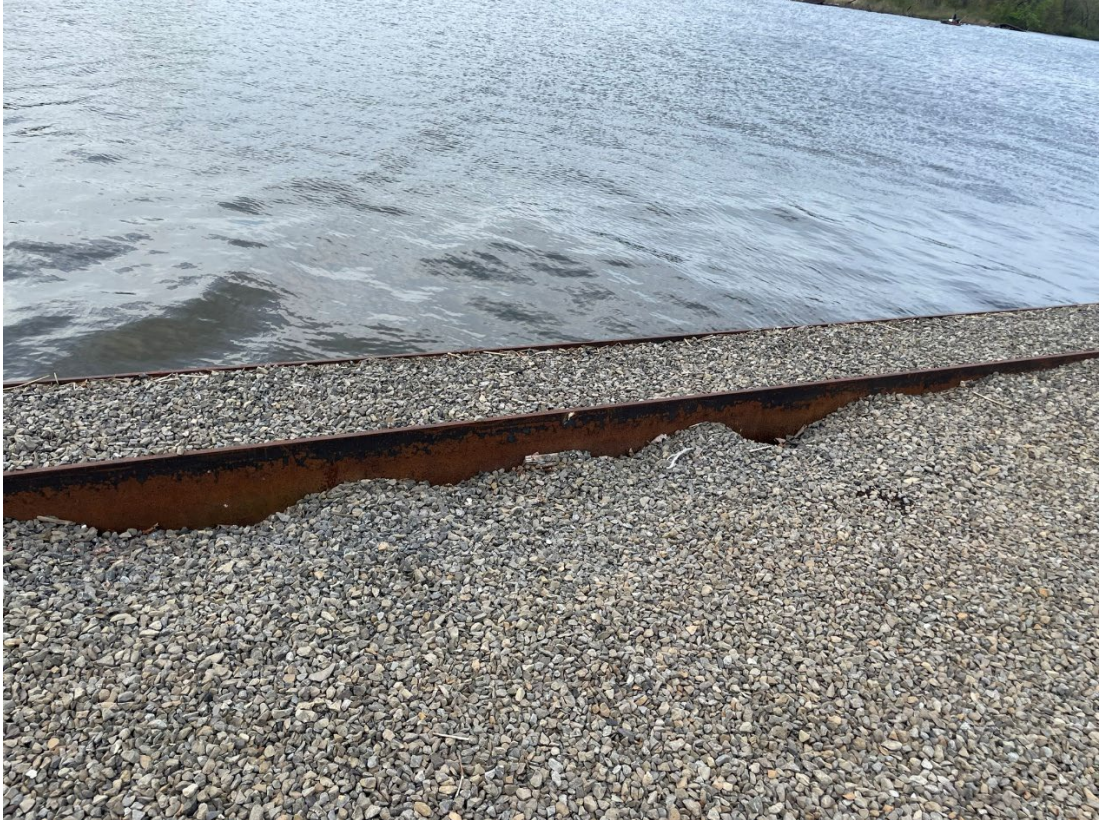
| <b>PHOTO NO.</b><br>4 | <b>DATE:</b><br>4/24/2026 | | |

| Photograph | Date | Photograph Description | Direction Facing |
|---|---|---|---|
| 4 | 4/24/26 | Area of noted erosion and settlement along the bulkhead on south boundary of Site. | South |

| <b>DESCRIPTION</b><br>Area of noted erosion and settlement along the bulkhead on south boundary of Site. | | | |

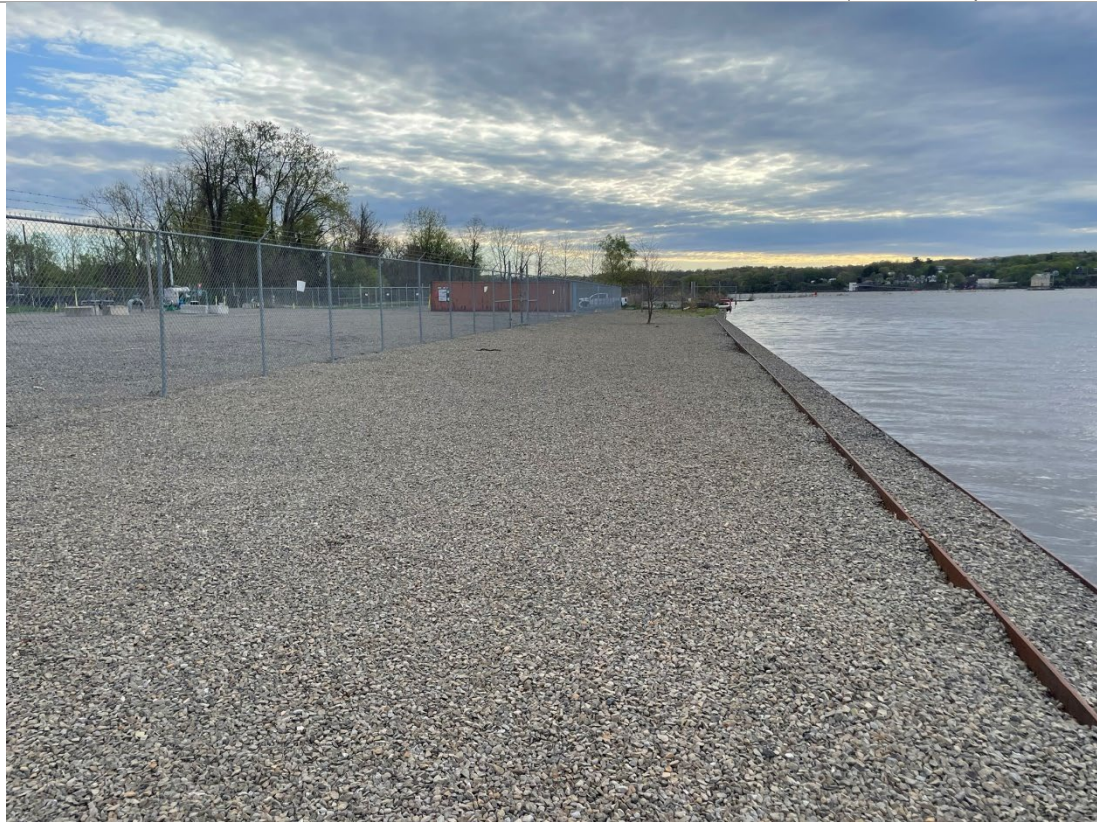
| <b>PHOTO NO.</b><br>5 | <b>DATE:</b><br>4/24/2026 | | |

| Photograph | Date | Photograph Description | Direction Facing |
|---|---|---|---|
| 5 | 4/24/26 | Bulkhead on south boundary of Site facing east. | East |

| <b>DESCRIPTION</b><br>Bulkhead on south boundary of Site facing east. | | | |

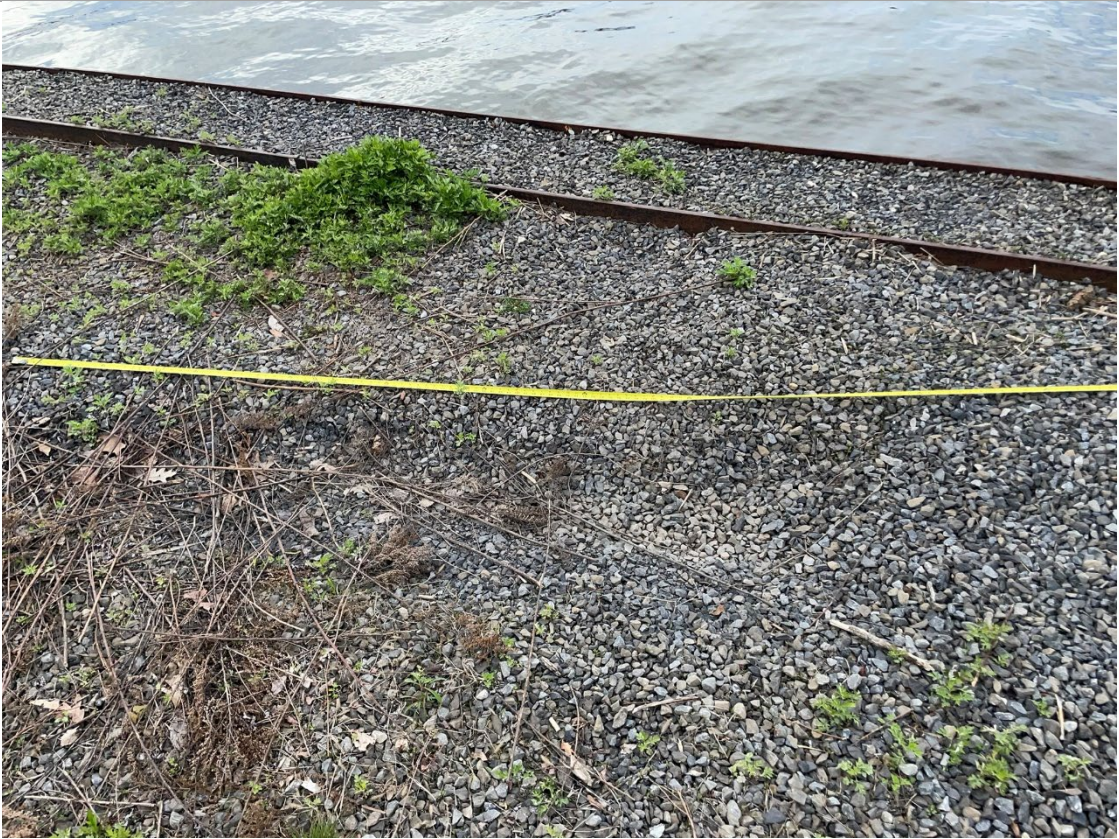
| <b>PHOTO NO.</b><br>6 | <b>DATE:</b><br>4/24/2026 | | |

| Photograph | Date | Photograph Description | Direction Facing |
|---|---|---|---|
| 6 | 4/24/26 | Area of noted rutting adjacent to bulkhead on south boundary of the Site | South |

| <b>DESCRIPTION</b><br>Area of noted rutting adjacent to the bulkhead on the south boundary of the Site. | | | |

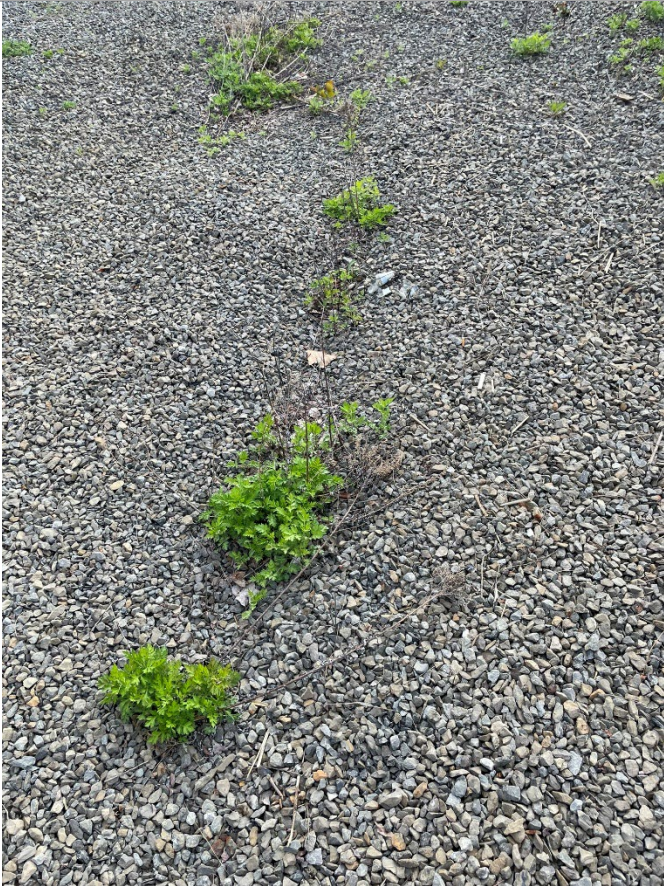
| <b>PHOTO NO.</b><br>7 | <b>DATE:</b><br>4/24/2026 | | |

| Photograph | Date | Photograph Description | Direction Facing |
|---|---|---|---|
| 7 | 4/24/26 | Limits of previously noted settlement at southeast portion of the Site between bulkhead and fence line. | East |

| <b>DESCRIPTION</b><br>Limits of previously noted settlement at southeast portion of the Site between the bulkhead and fence line. | | | |

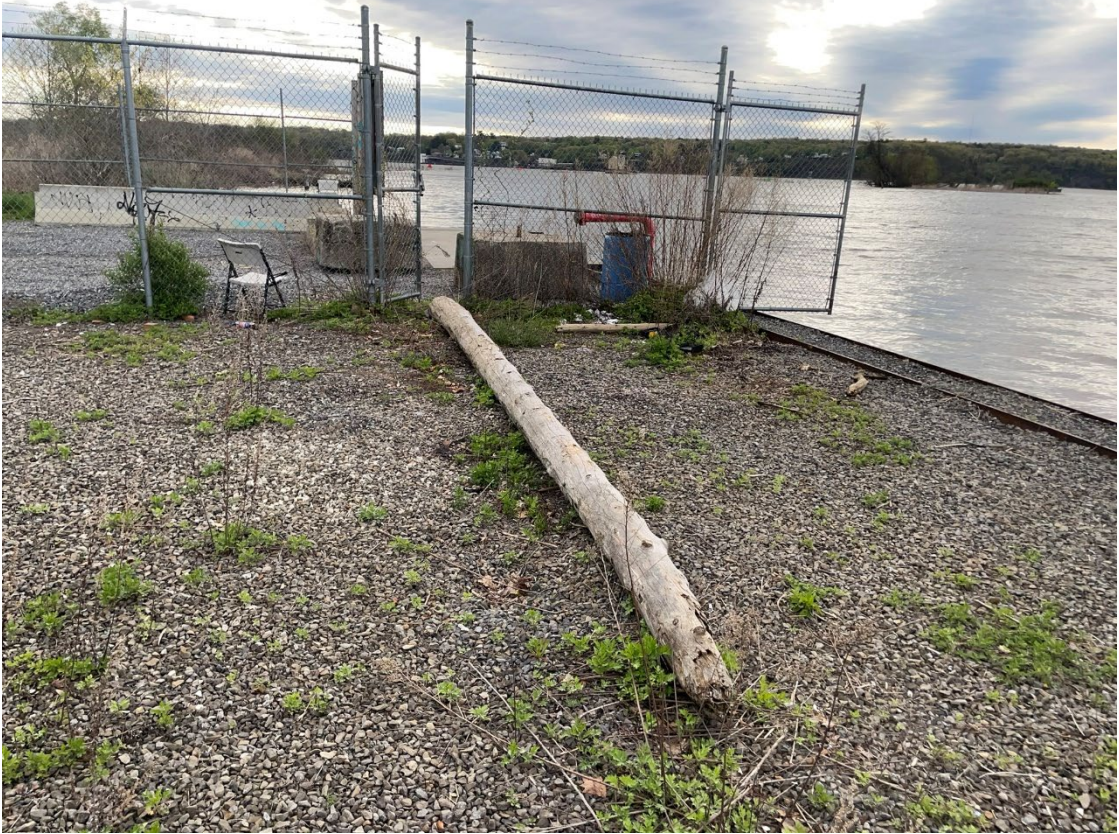
| <b>PHOTO NO.</b><br>8 | <b>DATE:</b><br>4/24/2026 | | |

| Engineering Controls Monitoring Checklist – Soil Cover and Sediment Cap Site Management Plan<br>Central Hudson Gas & Electric Corporation<br>Kingston Former MGP Site, Kingston, New York | | | | |
|---|---|---|---|---|
| 4. Are there any areas of accumulated large debris or obstructions (e.g., logs, railroad ties, etc.)? If yes, describe type and location | X | | | Log noted in area between bulkhead and fenceline. Refer to the attached Photo 8 |

| Photograph | Date | Photograph Description | Direction Facing |
|---|---|---|---|
| 8 | 4/24/26 | Increased vegetation and log at southern limits of the Site between the bulkhead and fence line. | West |

| <b>DESCRIPTION</b><br>Increased vegetation and log at southeast corner of site between bulkhead and fence line. | | | |

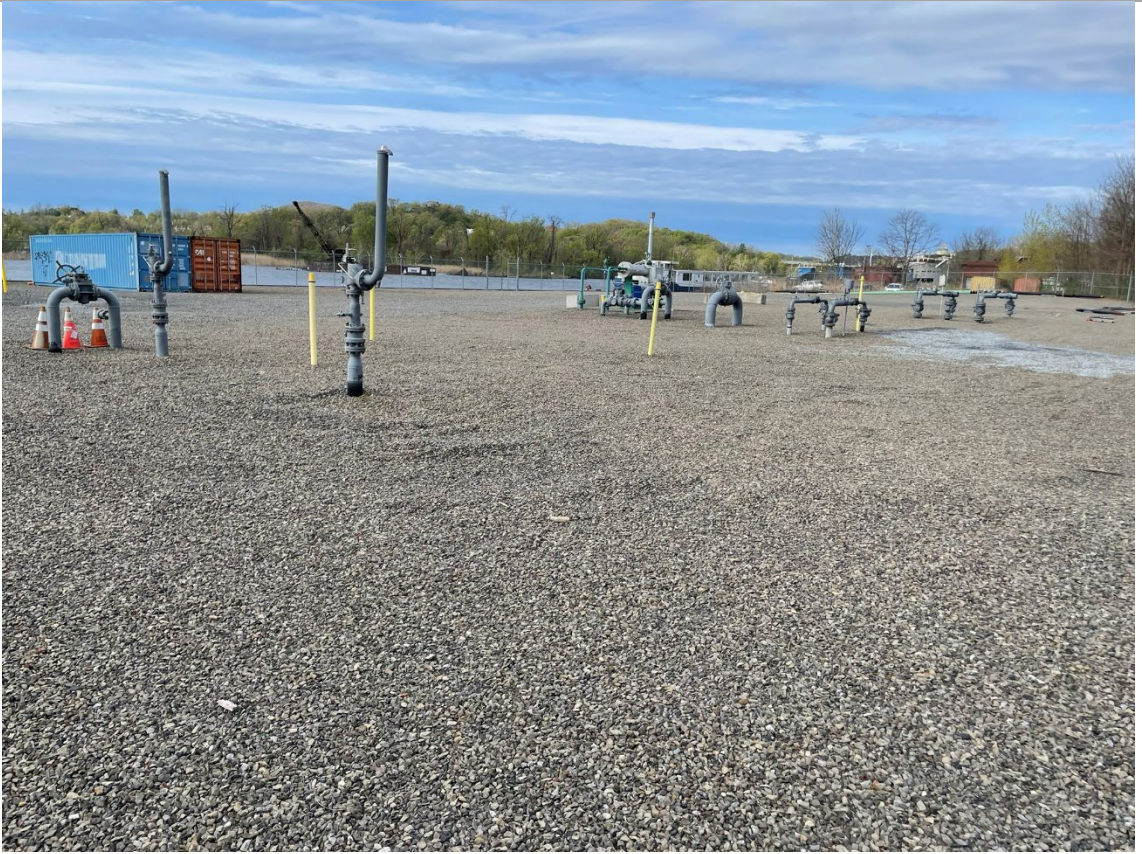
| <b>PHOTO NO.</b><br>9 | <b>DATE:</b><br>4/24/2026 | | |

| Photograph | Date | Photograph Description | Direction Facing |
|---|---|---|---|
| 9 | 4/24/26 | Cover within exclusion zone. Photo taken in northeast corner of Central Hudson Property facing southwest. | Southwest |

| <b>DESCRIPTION</b><br>Cover within exclusion zone.<br>Photo taken in northeast corner of Central Hudson Property facing southwest. | | | |

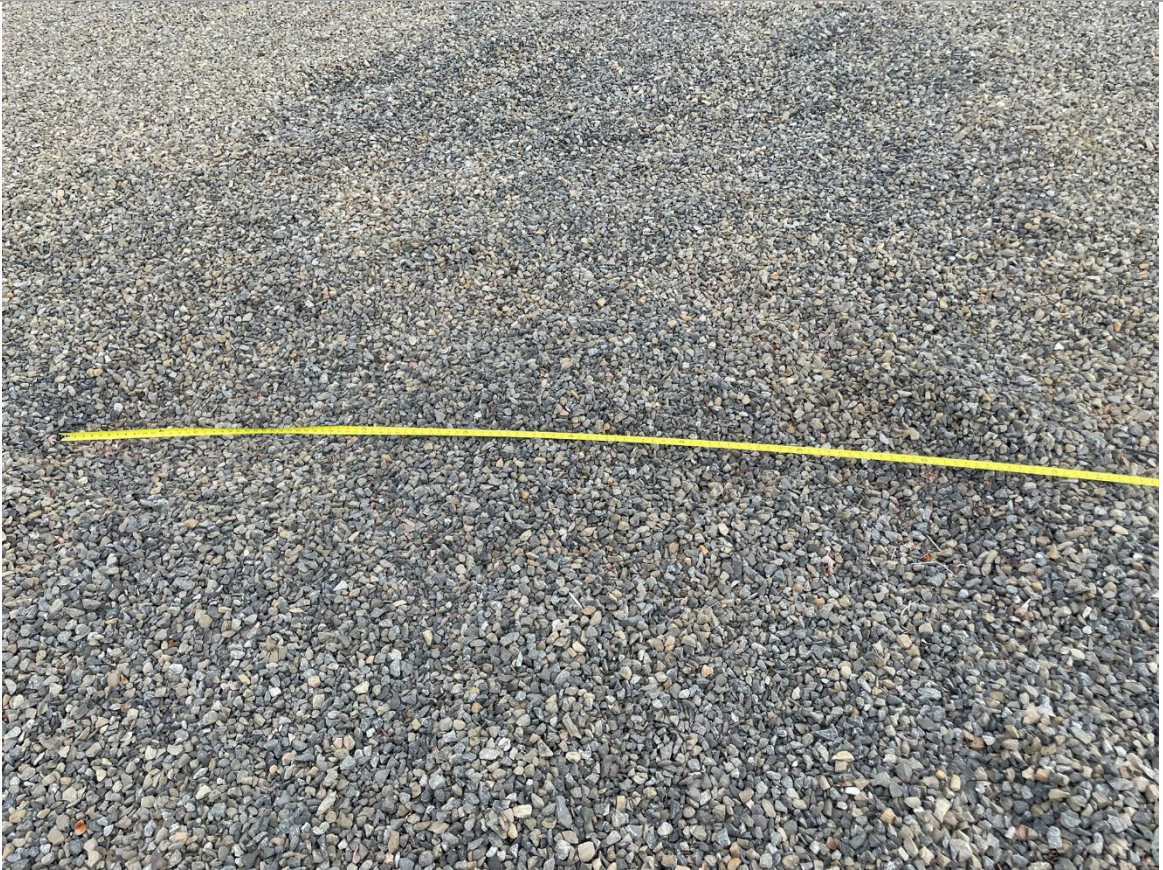
| <b>PHOTO NO.</b><br>10 | <b>DATE:</b><br>4/24/2026 | | |

| Photograph | Date | Photograph Description | Direction Facing |
|---|---|---|---|
| 10 | 4/24/26 | Limits of settlement at southeast portion of the Site within the fence line. This area has been previously noted since 2022. The limits and depth do not appear to have expanded. | East |

| <b>DESCRIPTION</b><br>Limits of settlement at southeast portion of the Site within the fence line. This area has been previously noted since 2022. The limits and depth do not appear to have expanded. | | | |

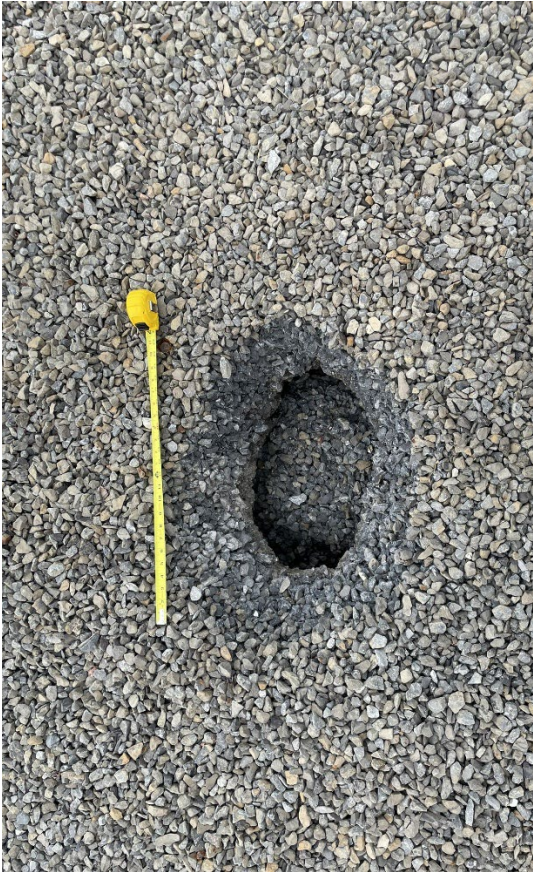
| <b>PHOTO NO.</b><br>11 | <b>DATE:</b><br>4/24/2026 | <div> </div> | |

As documented in Attachment 1, a hole measuring approximately 10 inches by 18 inches at the surface formed in the soil cover in the southeast portion of the site. Below the surface, a void was noted that extended approximately 18 inches in the east and west directions. The total depth below the surface was approximately 2.0 feet. The soil cover in this area is 4 feet thick, so the settlement did not fully penetrate the cap. In addition to the hole, some additional erosion and settlement was observed along the bulkhead beyond that which was noted during last year's inspection.

**Soil Cover:** A hole within the soil cover was noted in the southeast portion of the site. The hole measures at the surface approximately 10x18 inches. Below the surface the hole expands approximately 18 inches in both the east and west directions and to a total depth of approximately 2.0 ft. The soil cover in this area is 4 ft. thick. Refer to photos 11 and 12. The remaining soil/stone cover remains intact but there are areas of noted minor settlement, erosion, or rutting as shown in photos 2,3, 4, 6, 7, 10, 15 and 16. The noted settlements range between 2 and 10 inches deep. Areas of vegetative cover show established vegetation (Photo 17). Areas of asphalt or concrete show no signs of deterioration (Photo 18). The hole through the cover and noted settlement areas should be backfilled with suitable material.

| Photograph | Date | Photograph Description | Direction Facing |
|---|---|---|---|
| 11 | 4/24/26 | Photo showing approximately 10 inch by 18 inch by 24 inch hole in the soil cover at southeast portion of the Site within fence line. The cover in this area is 4 ft. thick. | N/A |

| <b>DESCRIPTION</b><br>Photo showing an approximately 10-inch by 18-inch by 24 inch hole in the soil cover at the southeast portion of the Site within the fence line. The Cover in this area is 4 ft. thick. | | | |

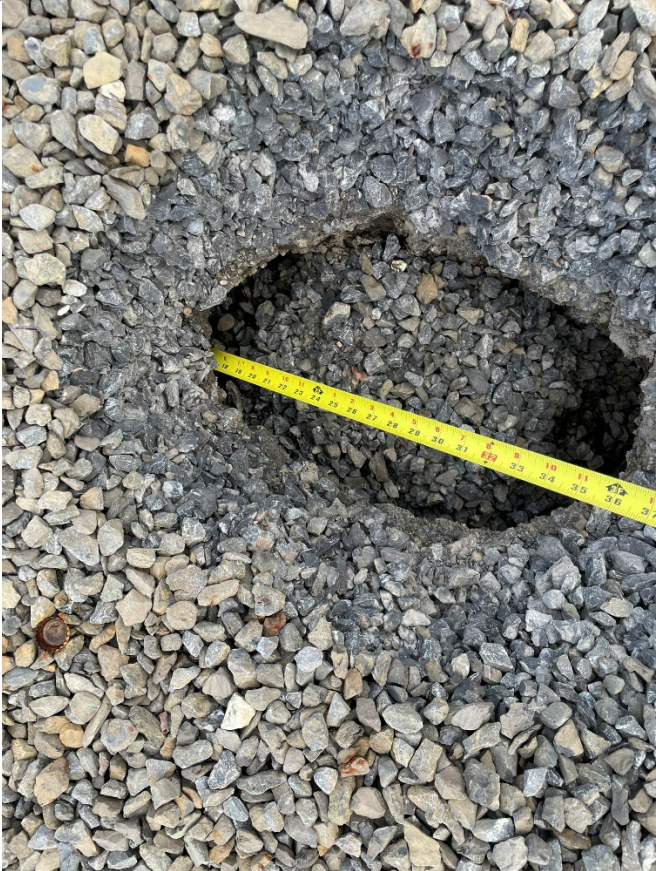
| 12 | 4/24/26 | Photo showing the lateral extent of settlement of approximately 18 inches within the soil cover at southeast portion of the Site within fence line. | N/A |

| <div> <div>PHOTO NO.</div> <div>12</div> </div> | <div> <div>DATE:</div> <div>4/24/2026</div> </div> | <div> <div>DESCRIPTION</div> <div>Photo showing the lateral extent of settlement of approximately 18-inches in the soil cover at the southeast portion of the Site within the fence line.</div> </div> | |

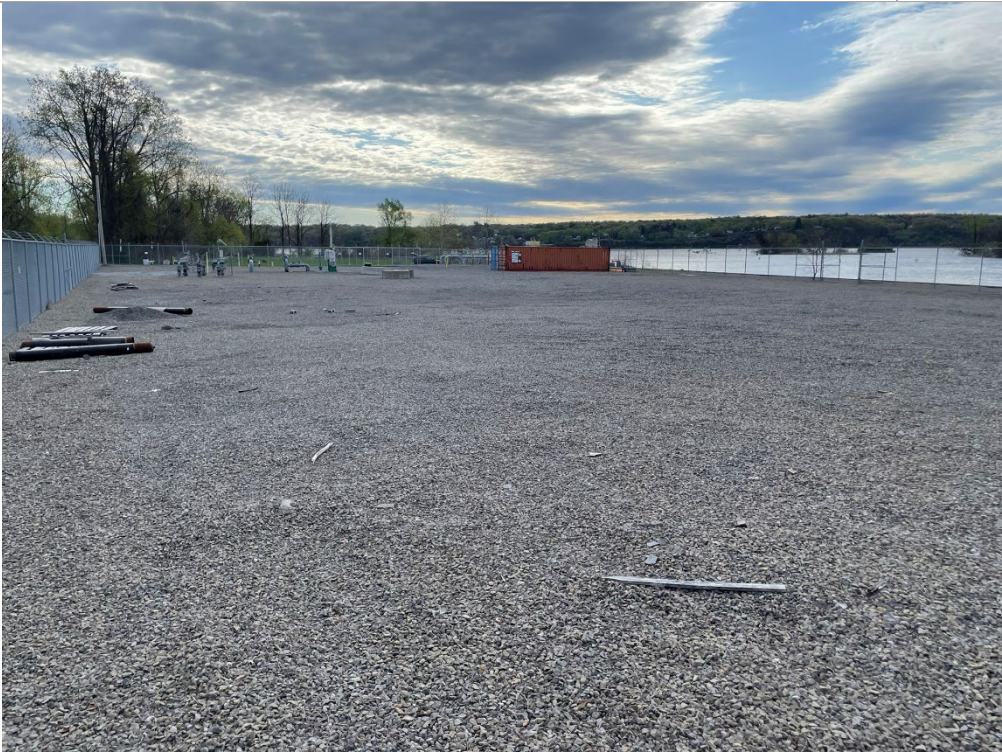
| 13 | 4/24/26 | View of the Site from northwest corner. | East |

| <div> <div> <div>PHOTO NO.</div> <div>13</div> </div> </div> | <div> <div> <div>DATE:</div> <div>4/24/2026</div> </div> </div> | <div> <div> <div>DESCRIPTION</div> <div>View of Site from northwest corner.</div> </div> </div> <div> </div> | |

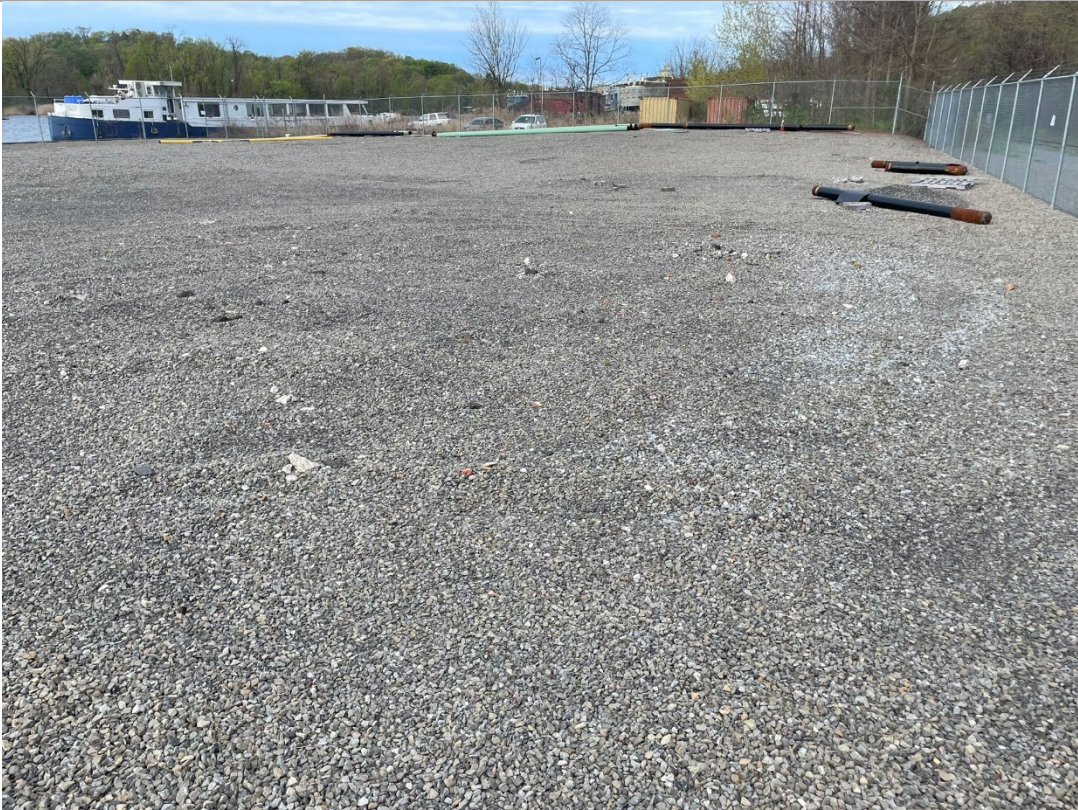
| 14 | 4/24/26 | View of northside of the Site, just west of the exclusion zone where some minor rutting and/or settlement is noted. This area of minor rutting and/or settlement was previously noted in the 2023 report. The limits and depth do not appear to have expanded | West |

| <b>DESCRIPTION</b><br>View of northside of the Site, just west of the exclusion zone where some minor rutting and/or settlement is noted. This area of minor rutting and/or settlement was previously noted in the 2023 report. The limits and depth do not appear to have expanded | | | |

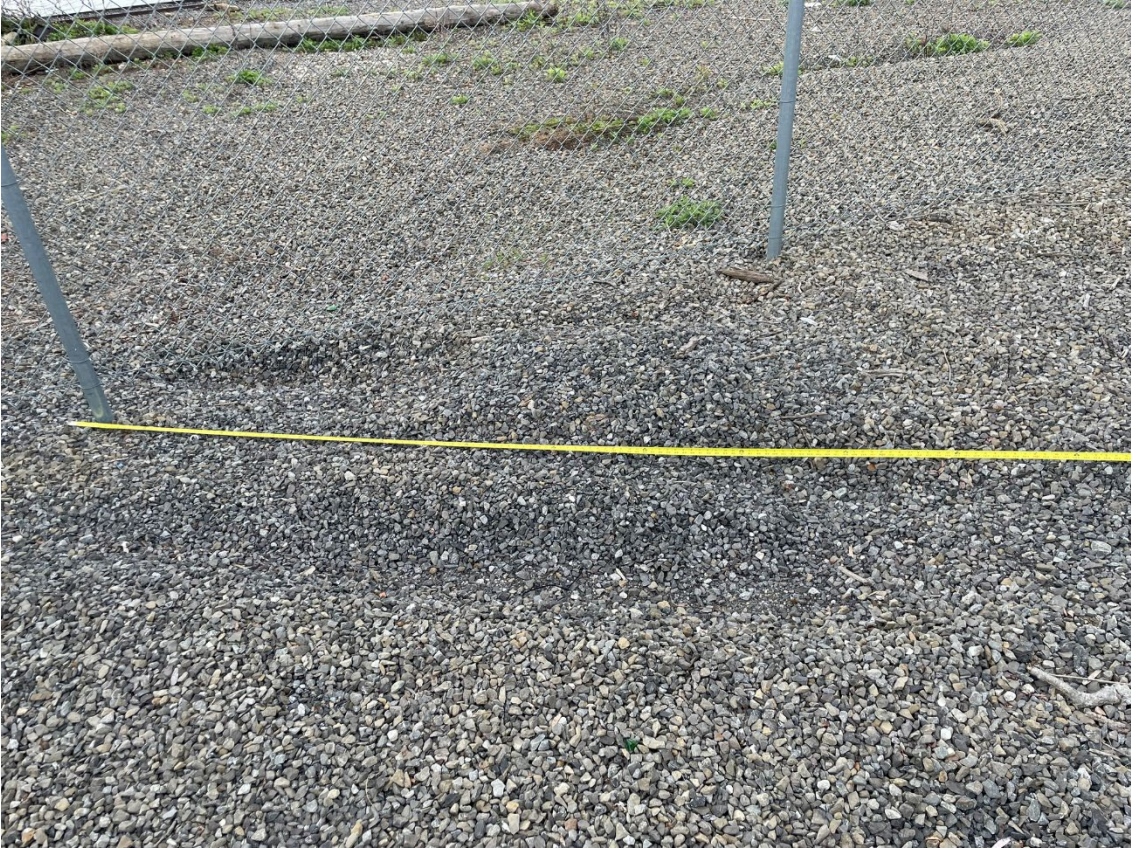
| <b>PHOTO NO.</b><br>15 | <b>DATE:</b><br>4/24/2026 | | |

| 15 | 4/24/26 | Area of rutting at southeast corner of site between fence line and recovery well RW-04. | South |

| <b>DESCRIPTION</b><br>Area of rutting in the southeast corner of the site between the fence line and recovery well RW-04. | | | |

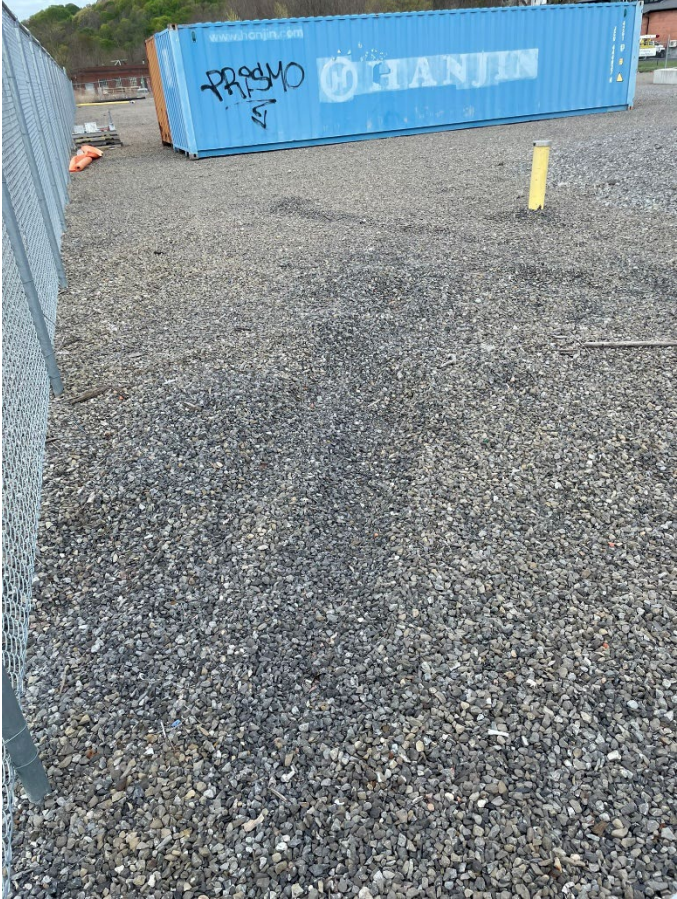
| <b>PHOTO NO.</b><br>16 | <b>DATE:</b><br>4/24/2026 | | |

| 16 | 4/24/26 | Area of rutting at southeast corner of site between the fence line and recovery well RW-04. | West |

| <b>DESCRIPTION</b><br>Area of rutting in the southeast corner of the site between the fence line and recovery well RW-04. | | | |

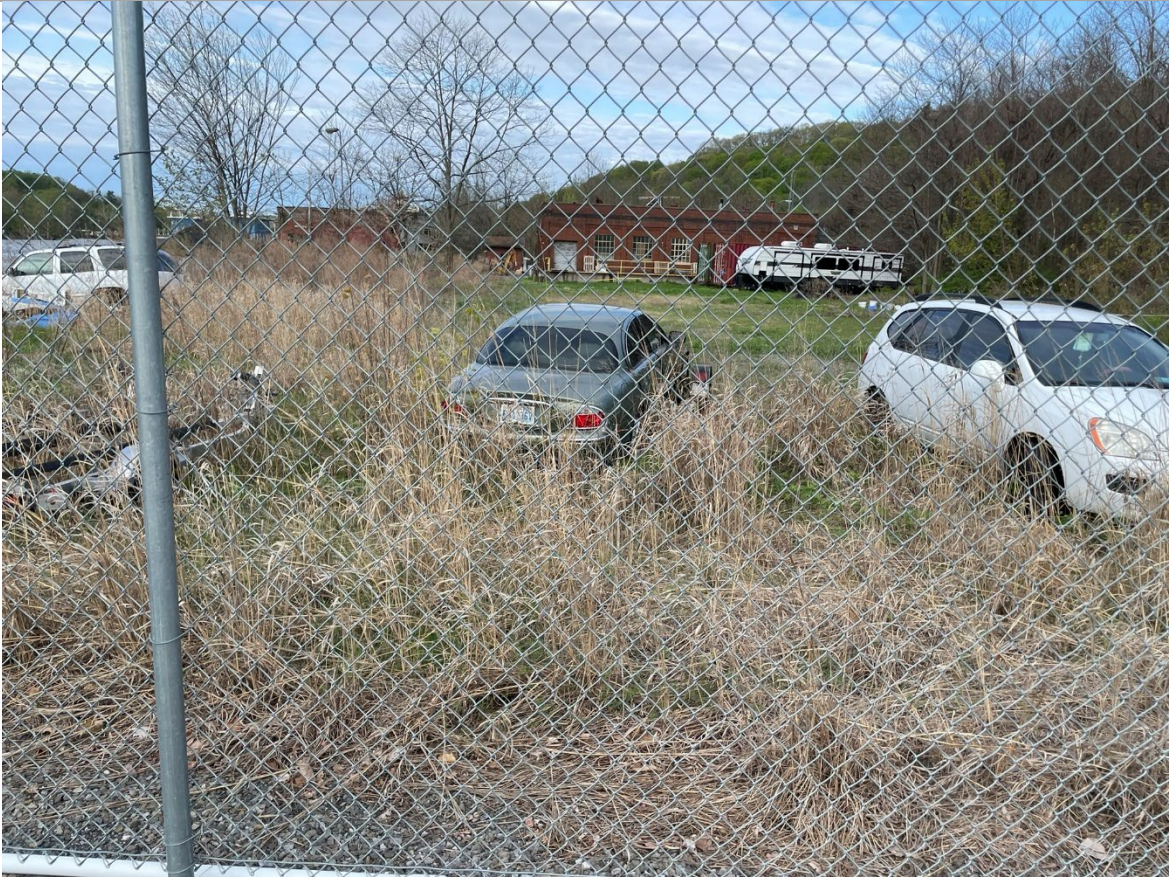
| <b>PHOTO NO.</b><br>17 | <b>DATE:</b><br>4/24/2026 | | |

| 17 | 4/24/26 | Soil cover on property west of Central Hudson Property. | West |

| <b>DESCRIPTION</b><br>Soil cover on property west of Central Hudson Property. | | | |

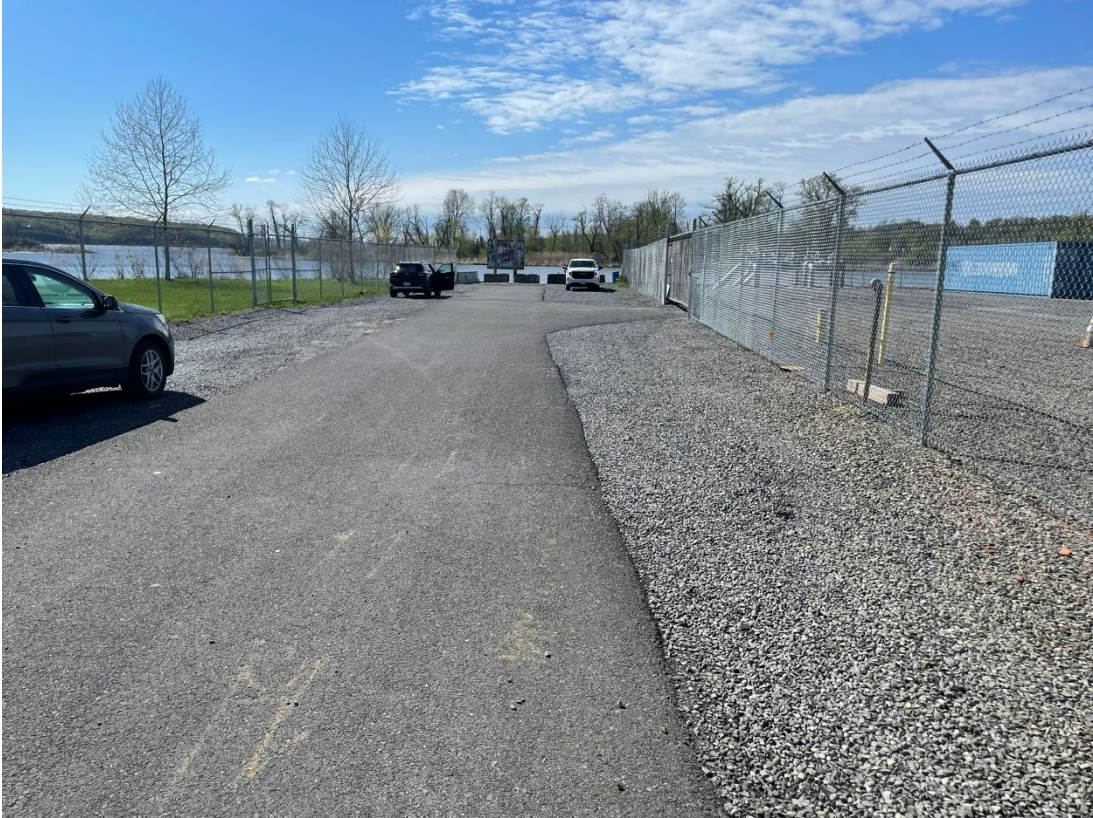
| <b>PHOTO NO.</b><br>18 | <b>DATE:</b><br>4/24/2026 | | |

| 18 | 4/24/26 | Soil cover east of the Central Hudson property. | North |

| <b>DESCRIPTION</b><br>Soil cover east of the Central Hudson property. | | | |

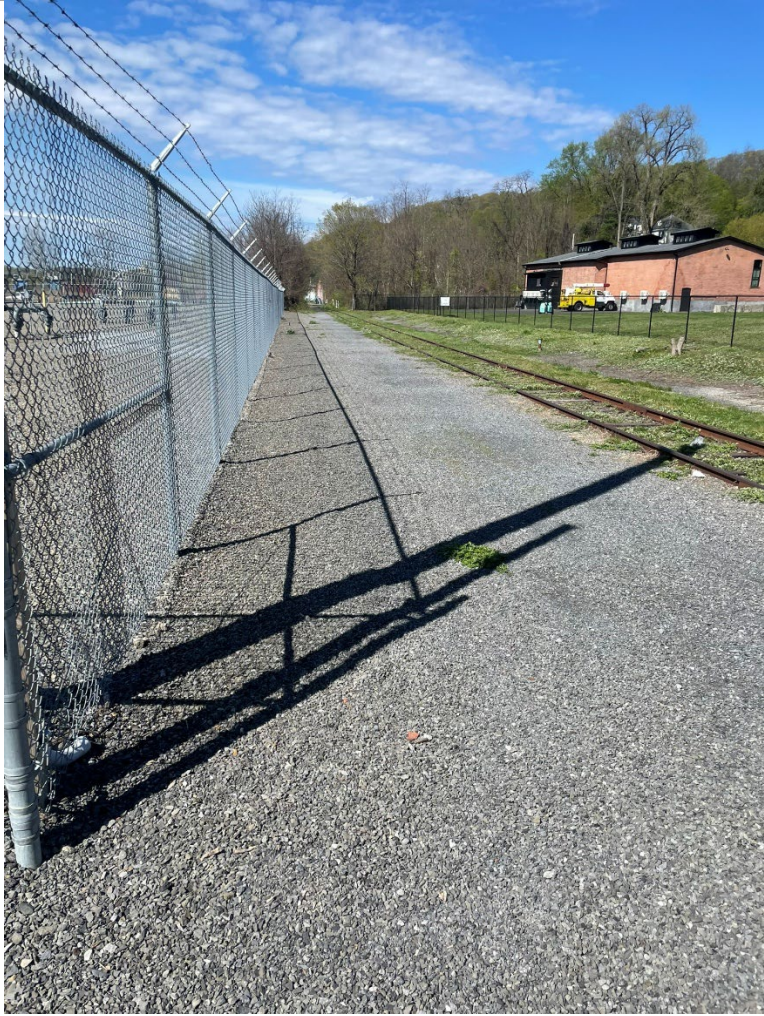
**PHOTO NO.**  
19

| 19 | 4/24/26 | Northern boundary of the Site, | West |

**DESCRIPTION**  
Northern boundary of Site.

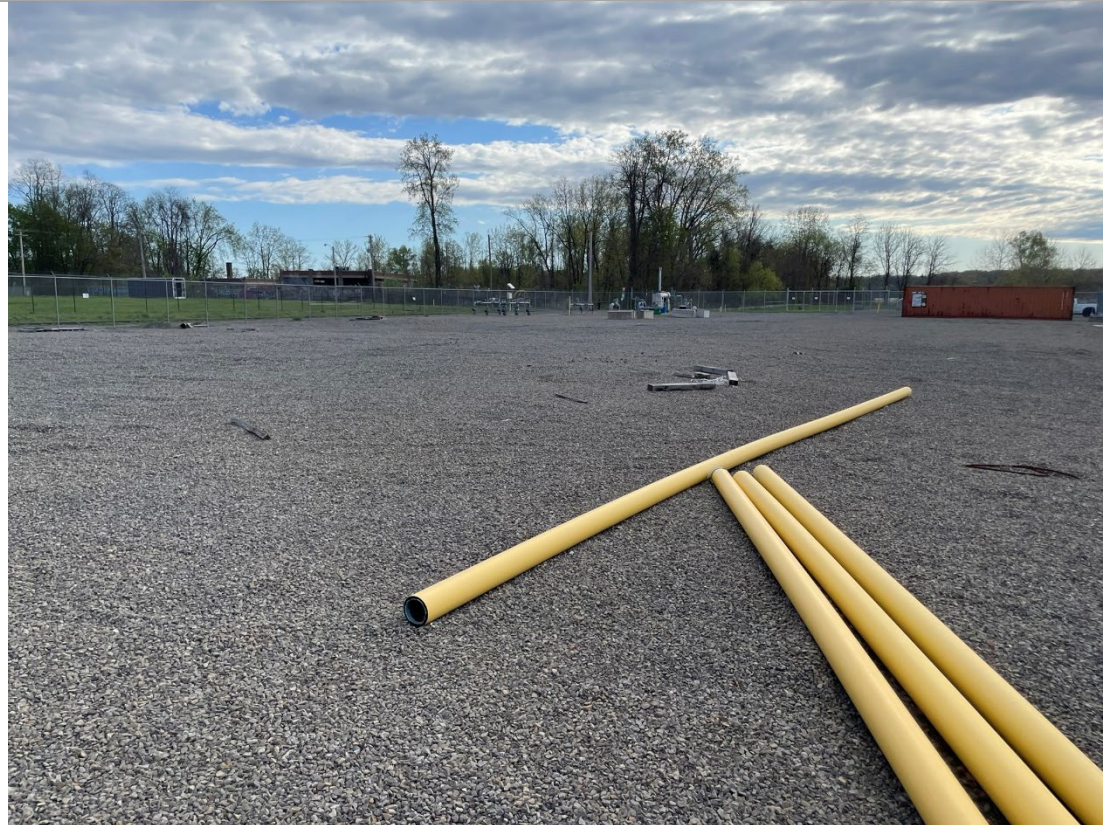
**PHOTO NO.**  
20

| 20 | 4/24/26 | View of the cover system from southwest corner. | Northeast |

View of site from southwest corner showing the majority of the cover system.

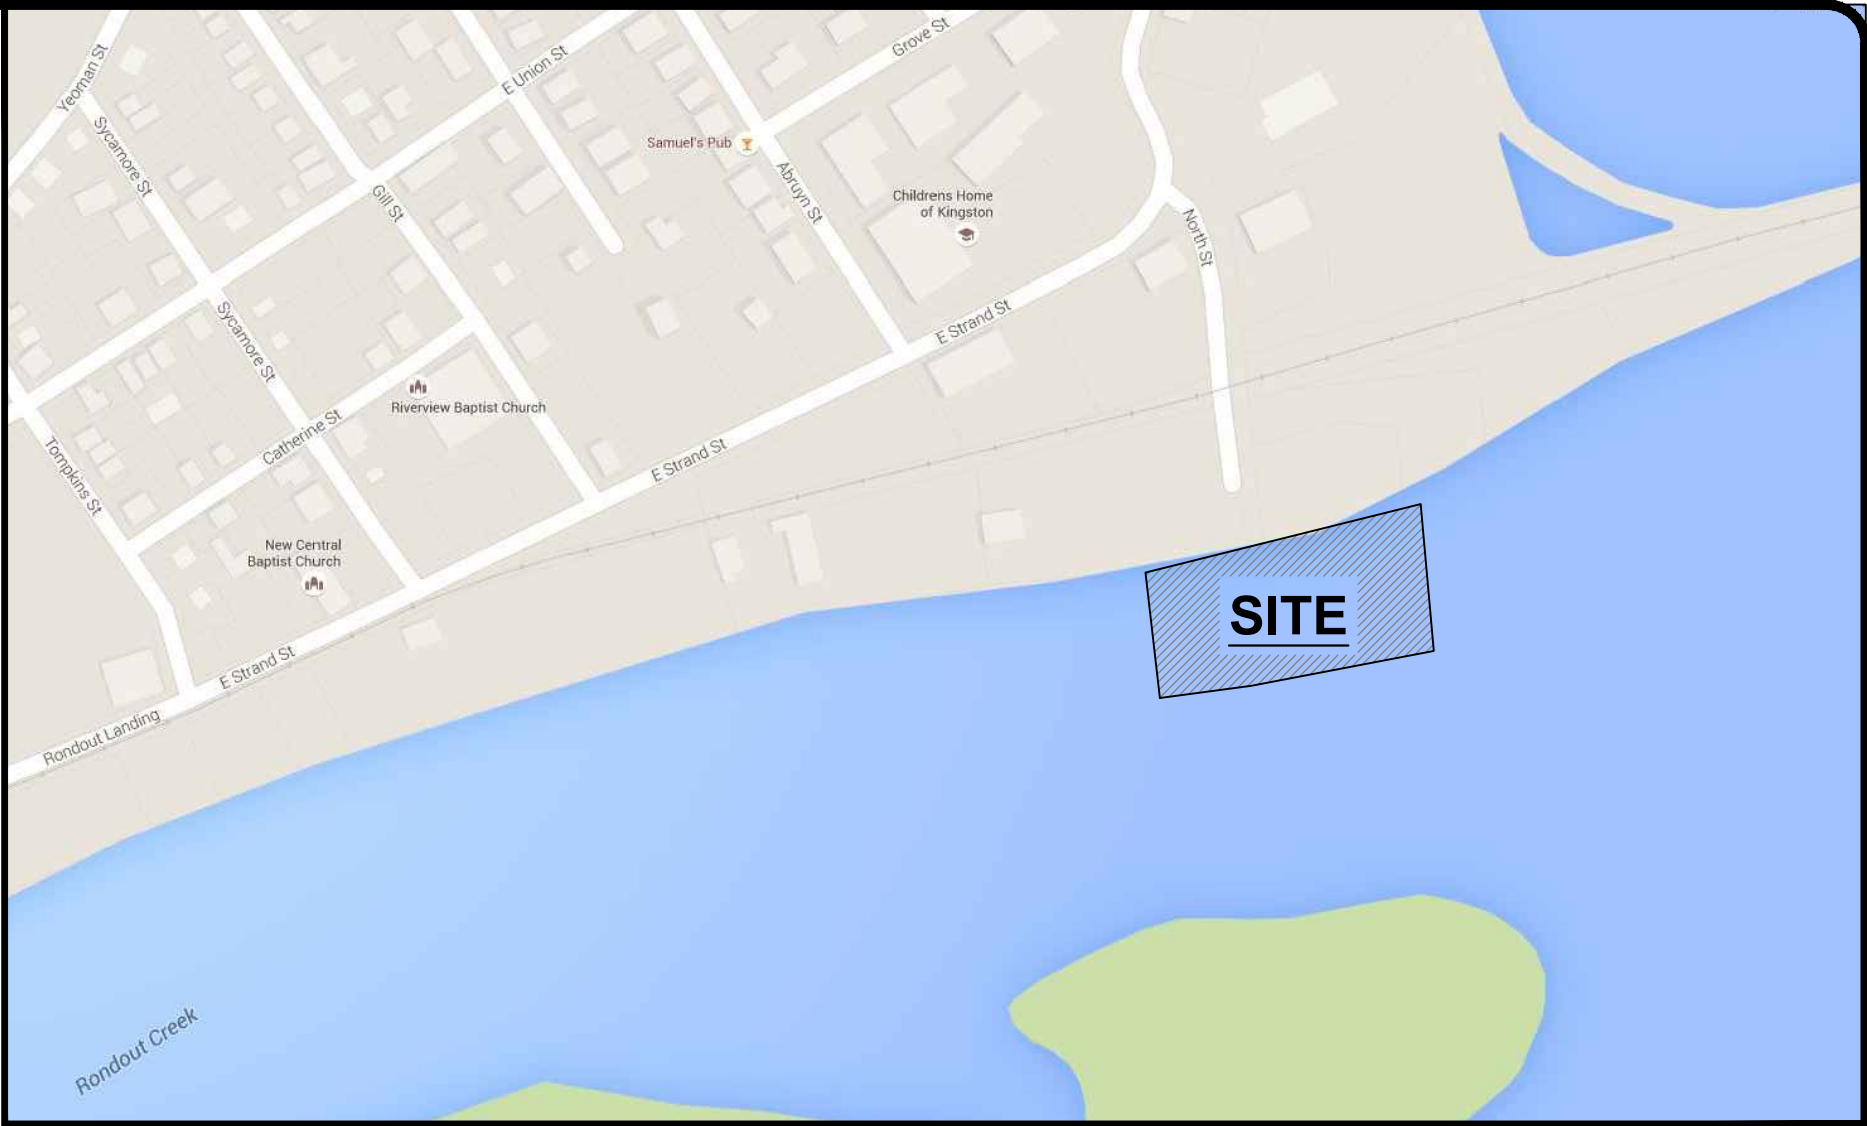
| <p><b>PHOTO NO.</b><br/>21</p> | <p><b>DATE:</b><br/>4/24/2026</p> | |

| 21 | 4/24/26 | Site plan showing approximate location of noted settlement, erosion, and rutting. | N/A |

Site plan showing approximate location of noted settlement, erosion and rutting.
