Re: Periodic Review Report | CH – Kingston Gas Works | NYSDEC  
Site No. C356017 | Kingston, New York  
File: 1126476.1940120091

This Periodic Review Report (PRR) was prepared by Ramboll Americas Engineering Solutions, Inc. (Ramboll) at the request of Central Hudson Gas & Electric Corporation (Central Hudson) to document the status of the Engineering Controls (ECs) and Institutional Controls (ICs) established in accordance with the November 2017, updated November 2021, Site Management Plan (SMP) for the Kingston Former Manufactured Gas Plant (MGP) Site (New York State Department of Environmental Conservation (NYSDEC) Site Number: C356017) located in Kingston, New York, and to provide a summary of information generated during the reporting period for the site. The reporting period for this PRR is May 25, 2025 through May 25, 2026. The SMP addressed the means for implementing and periodically inspecting ECs/ICs required by the remedy for the site.

**ATTACHMENT 1**  
**ENGINEERING CONTROLS MONITORING CHECKLIST**

| Engineering Controls Monitoring Checklist – Soil Cover and Sediment Cap Site Management Plan<br>Central Hudson Gas & Electric Corporation<br>Kingston Former MGP Site, Kin

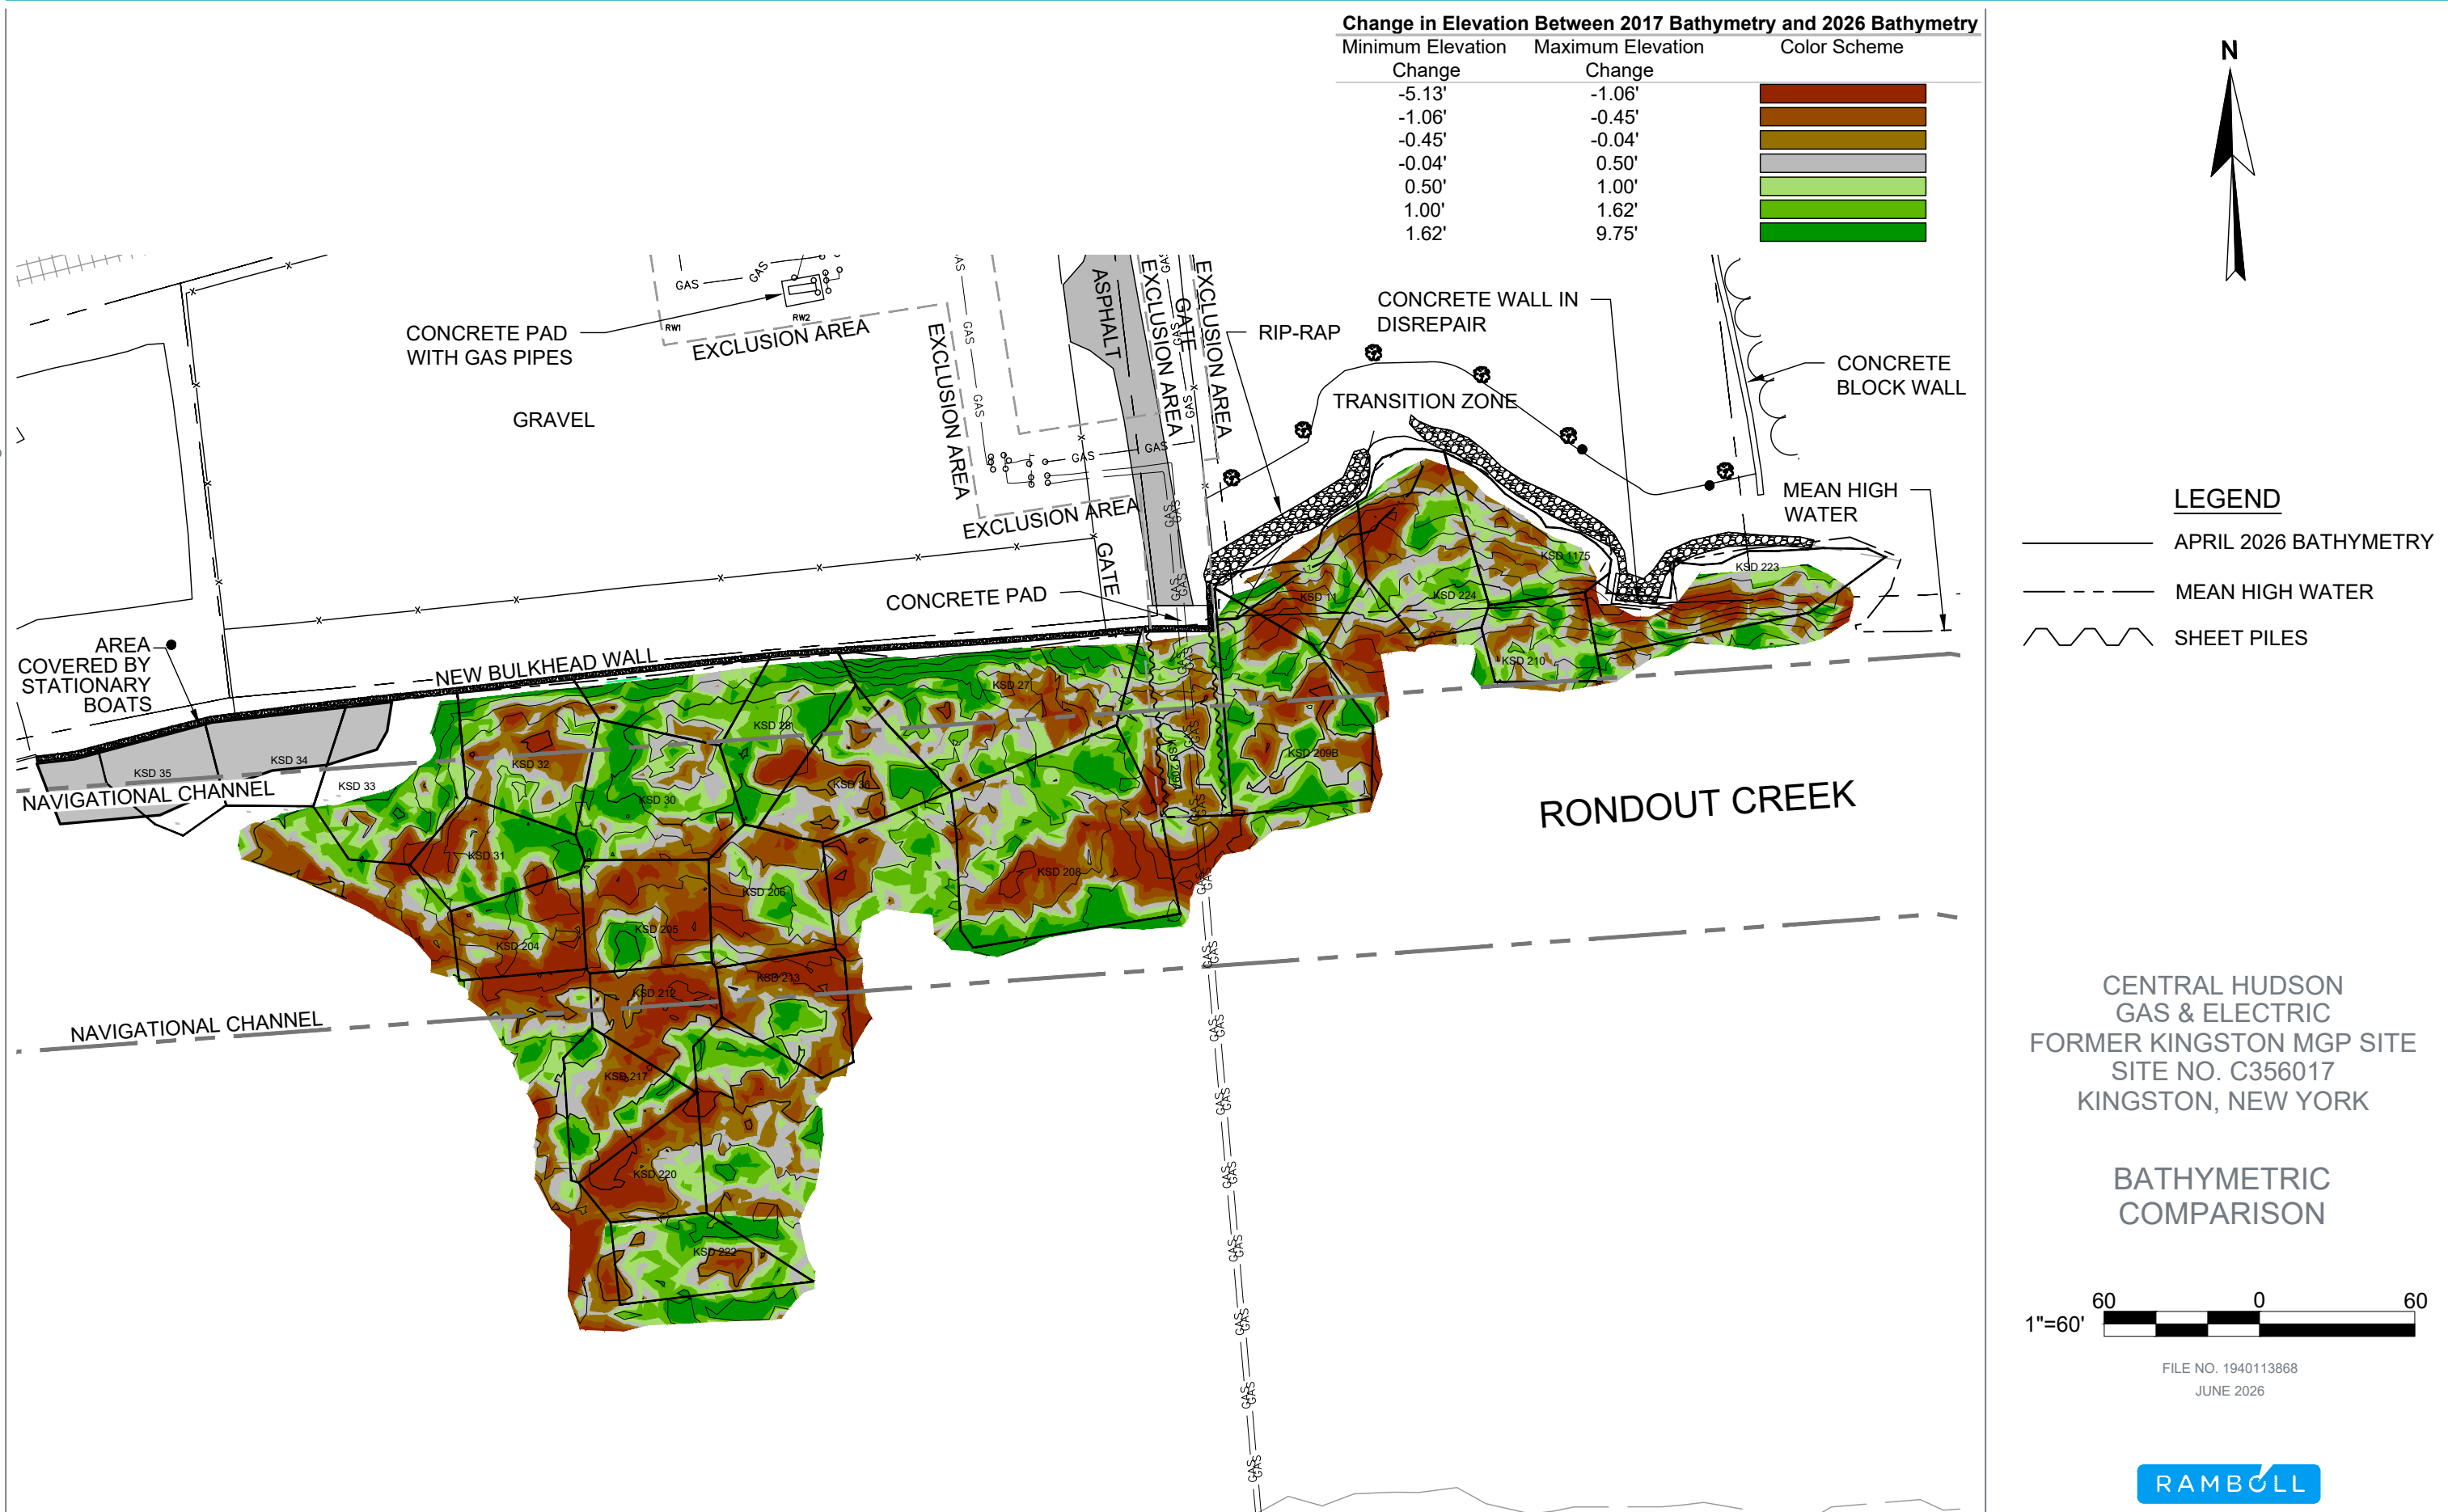
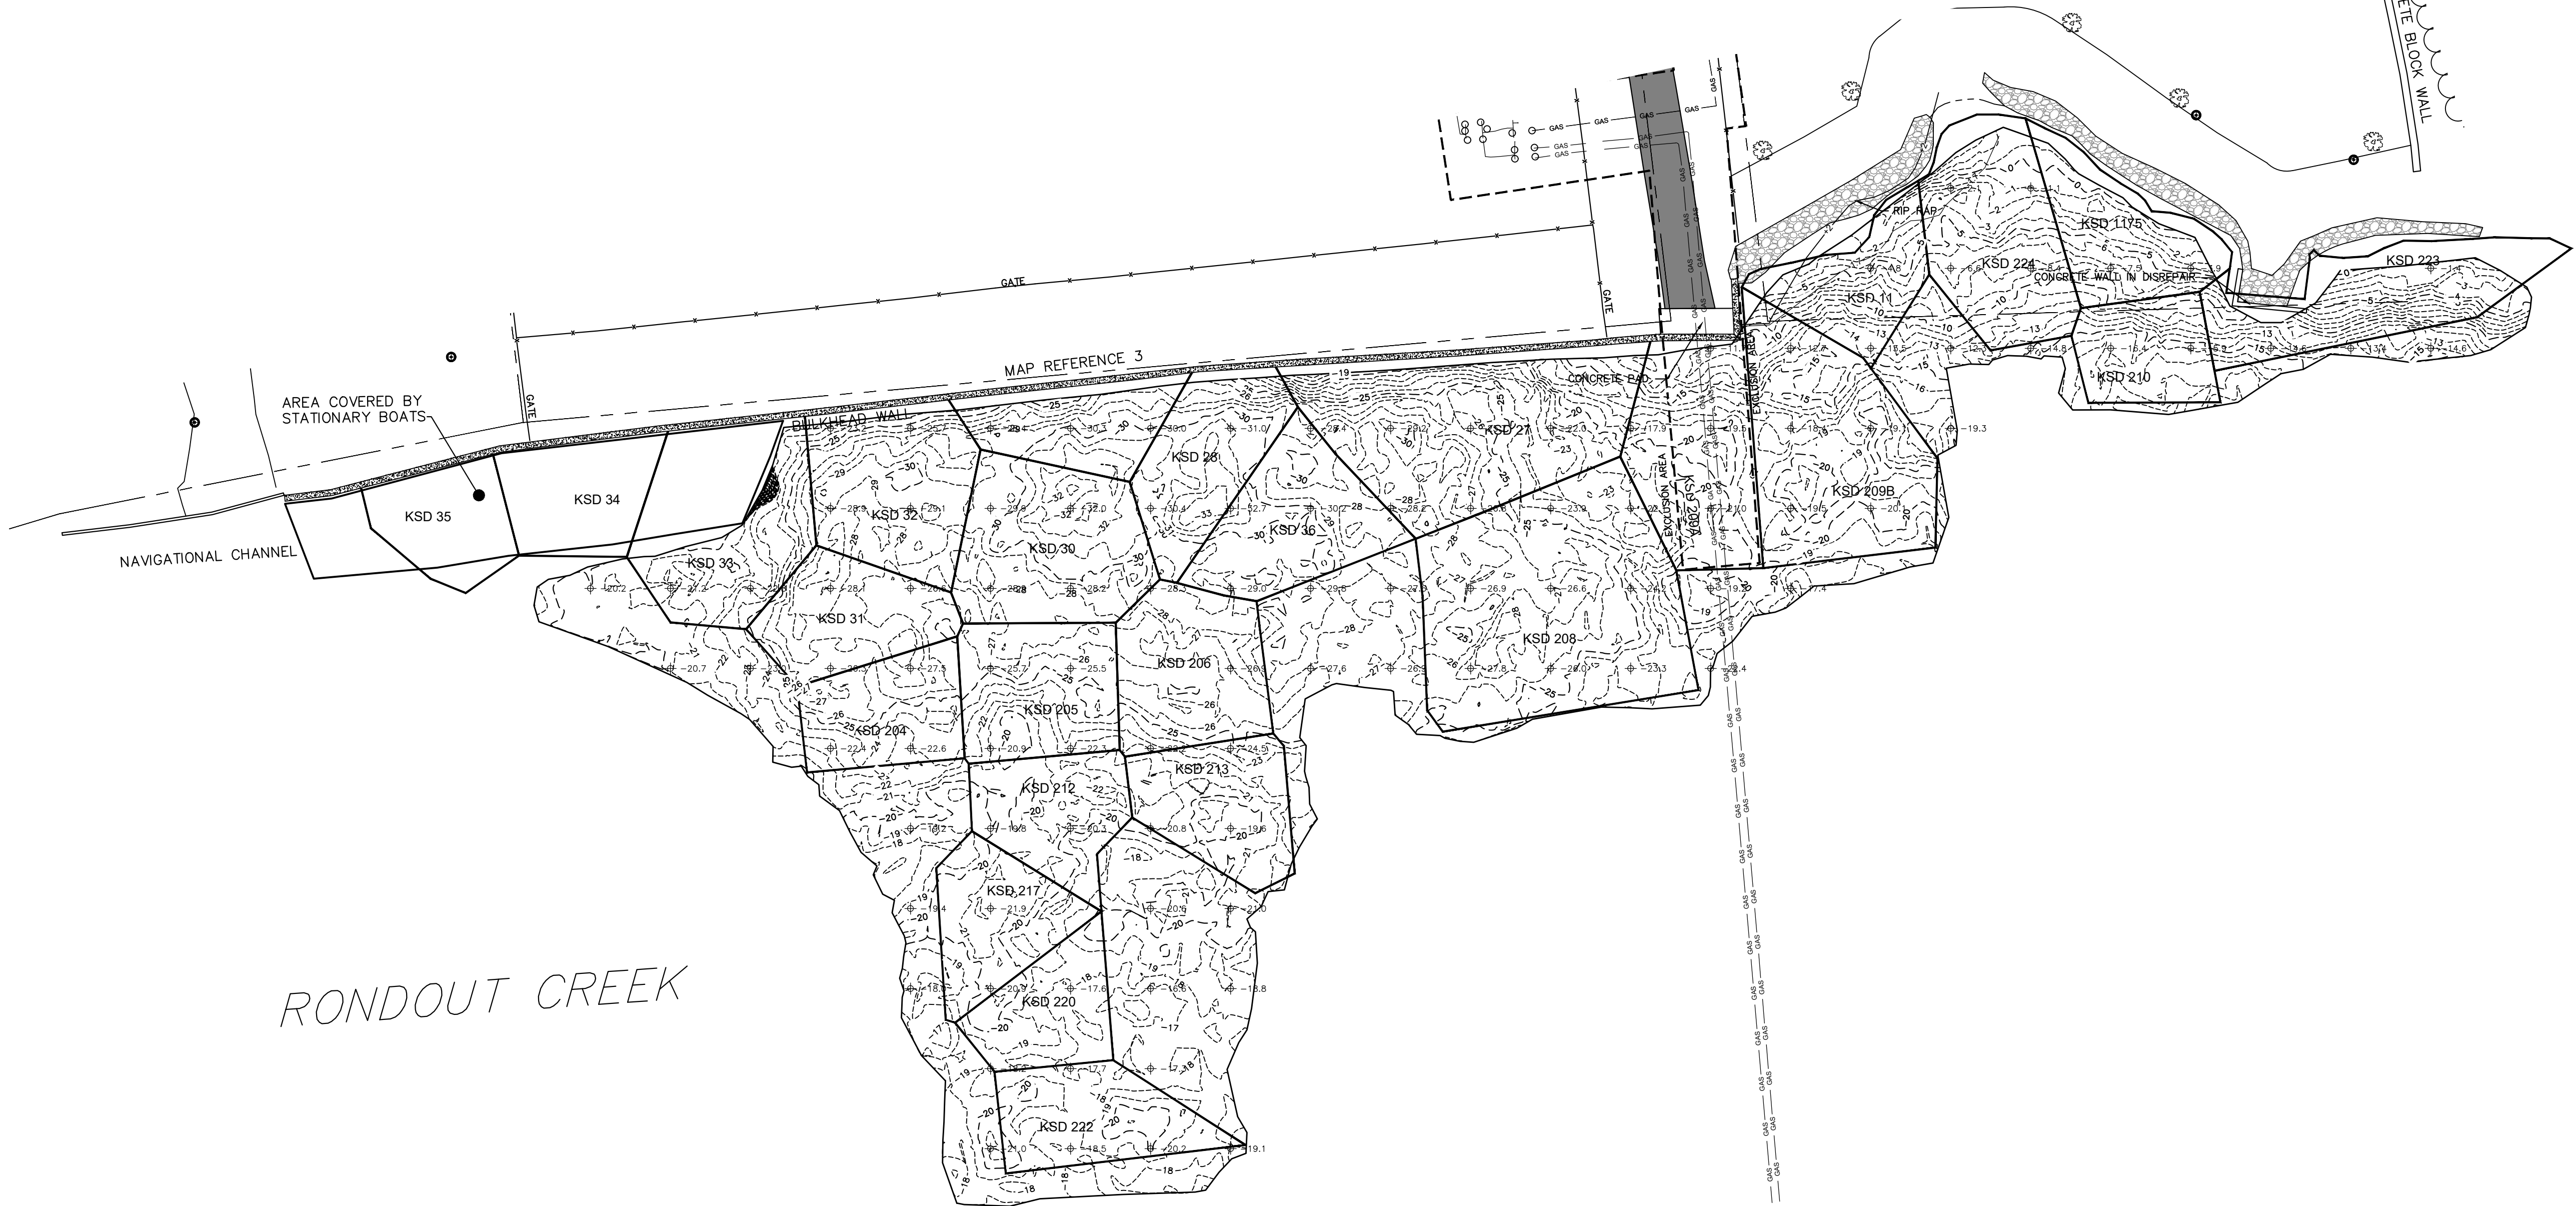
FIGURE 1

| Engineering Controls Monitoring Checklist – Soil Cover and Sediment Cap Site Management Plan<br>Central Hudson Gas & Electric Corporation<br>Kingston Former MGP Site, Kingston, New York | | | | |
|---|---|---|---|---|
| 5. Scour or holes within the limits of sheeting over sediment cap based on bathymetric survey? If yes, describe. | | X | | See bathymetric survey, bathymetric comparison (Figure 1), and additional information |

**Sediment Cap:** Based on the results of the bathymetric survey completed on April 24, 2026, changes in elevation in comparison to the 2017 bathymetric survey within the limits of pipeline crossing cap range between approximately 1.1 inches of erosion and/or settlement, and 1.7 inches of sediment deposits. These ranges are within the thickness of the light stone fill, signaling that the cap remains in place. The bathymetric survey and bathymetric comparison (Figure 1) are attached.
