**PERIODIC REVIEW REPORT  
PERIOD ENDING 31 AUGUST 2011  
TARRYTOWN FORMER MGP SITE  
TARRYTOWN, NEW YORK  
BROWNFIELD CLEANUP AGREEMENT NO. C3600064**

**Haley & Aldrich of New York  
Rochester, New York**

**Ferry Landings, LLC  
Greenwich, Connecticut**

**File No. 28590-020  
30 September 2011**

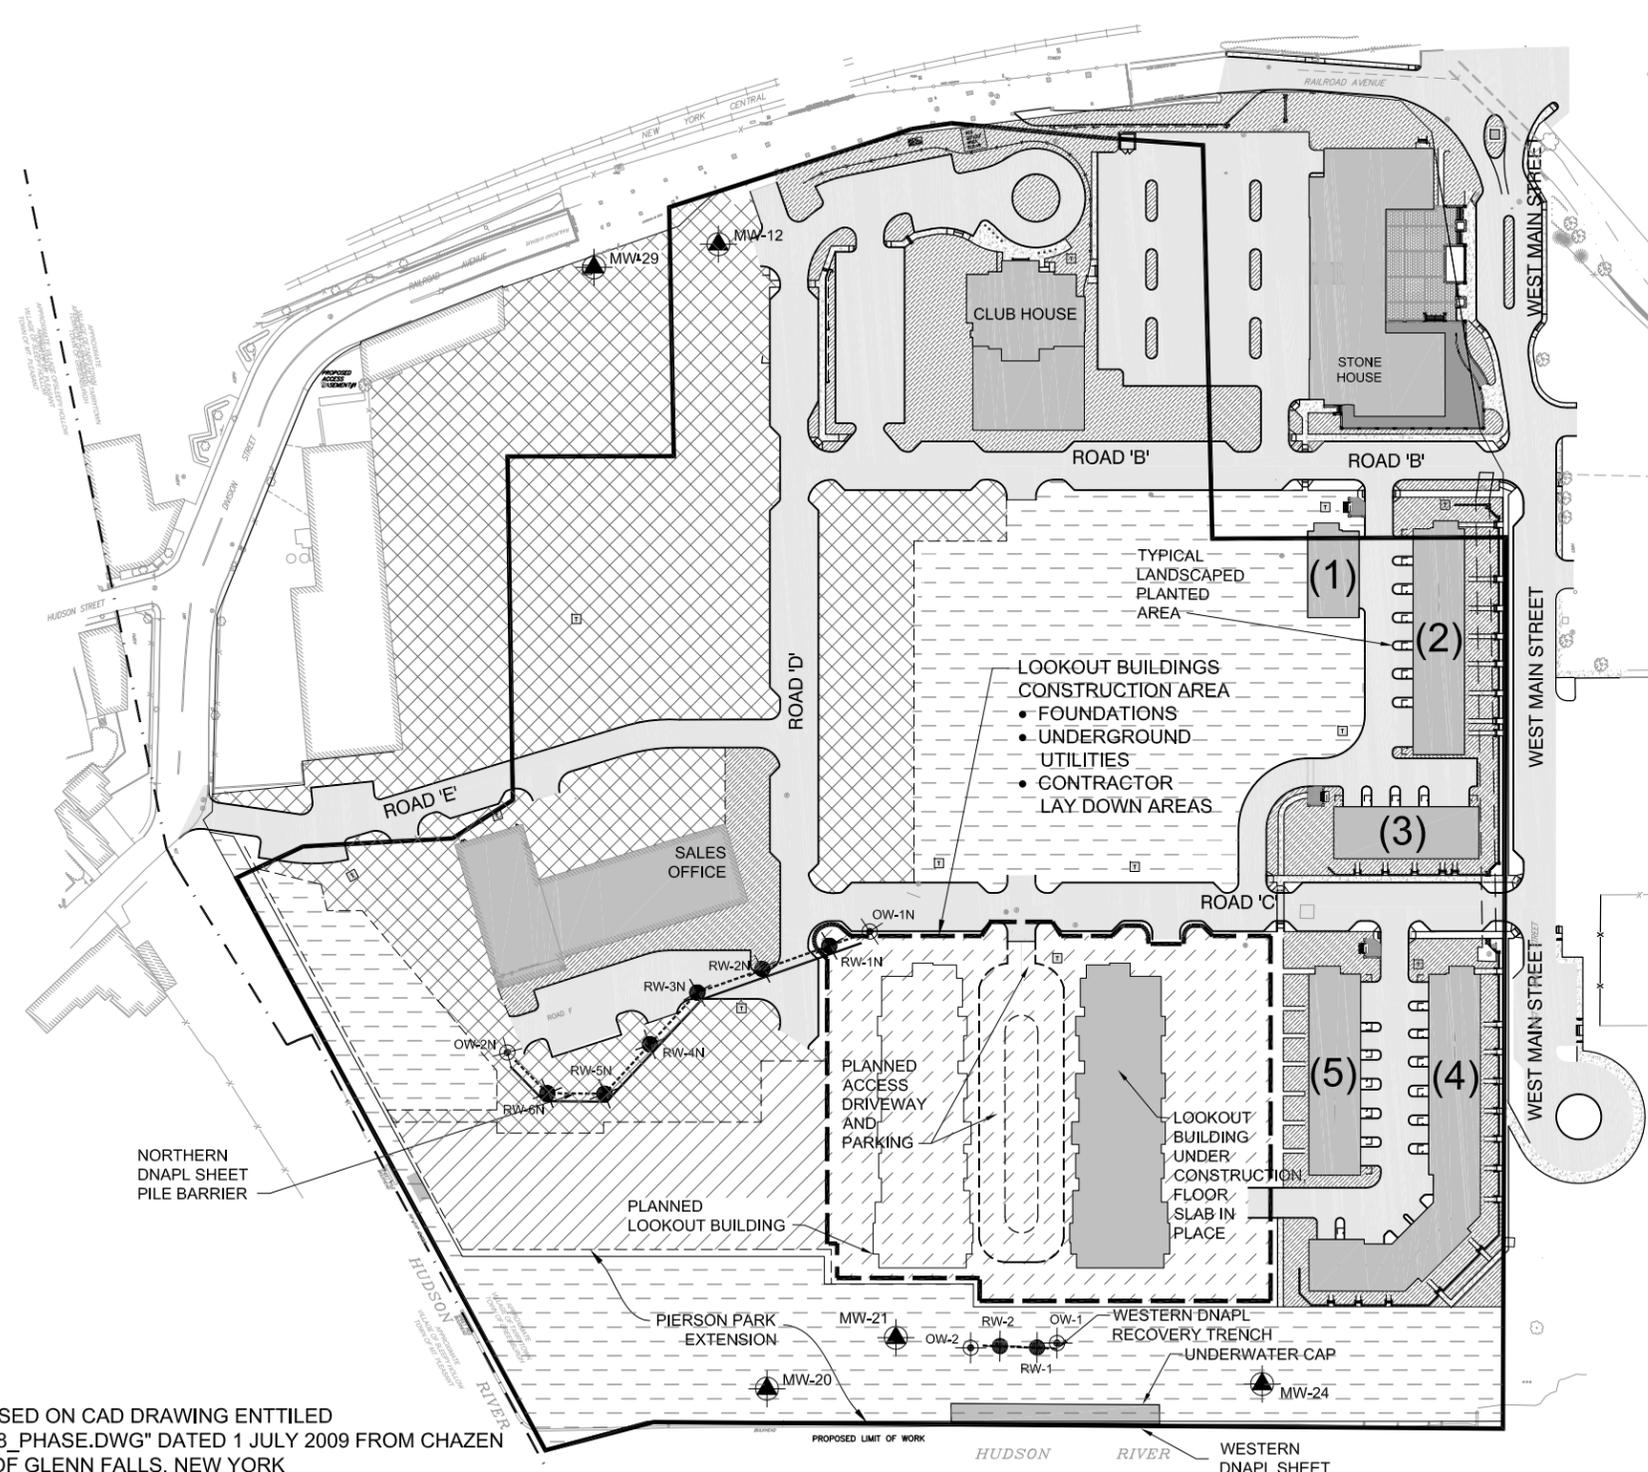
**SITE PLAN  
SITE COVER TYPES  
AUGUST 31, 2011**

One area of non-compliance with the SMP determined by NYSDEC is the maintenance of site cover as an engineering control in some areas of the site. Due to the construction for site development, there were parts of the site where the site cover was disturbed during the period ending 31 August 2011. The approximate extent of site cover disturbance was provided in the 2 September 2011 letter from Haley & Aldrich to NYSDEC. The disturbance included the a portion of the area north of Building 5 where two new buildings (Lookout Buildings) are being constructed. Notification of this construction was made to

Note that risks due to potential exposure to the exposed soil are low because the soils are not grossly contaminated and because the cover is missing in construction areas, not areas generally accessible to the public. The surface soils which were not covered may be characterized as urban fill, and based on soil sampling data from various locations at the site, do not contain BTEX or PAH compounds in concentrations greater than acceptable for re-use on site. The soils are above the water table, generally non-odorous, and when detectable readings are present, they exhibit very low readings on a photo-ionization detector. Workers who are involved in excavation of the soil must wear appropriate personal protective equipment as prescribed in the NYSDEC-approved Excavation Work Plan.

As stated in Section 2.3, NYSDEC requested a schedule for replacement of the site cover disturbed during the ongoing construction project be submitted no later than 4 October 2011. That submittal will present milestones and specific dates for each milestone for cover replacement and will constitute the Corrective Measures Work Plan.
