July 25, 2012

Re: Identification of Petroleum Product in Sump
Flamingo Cleaners, New Rochelle, NY

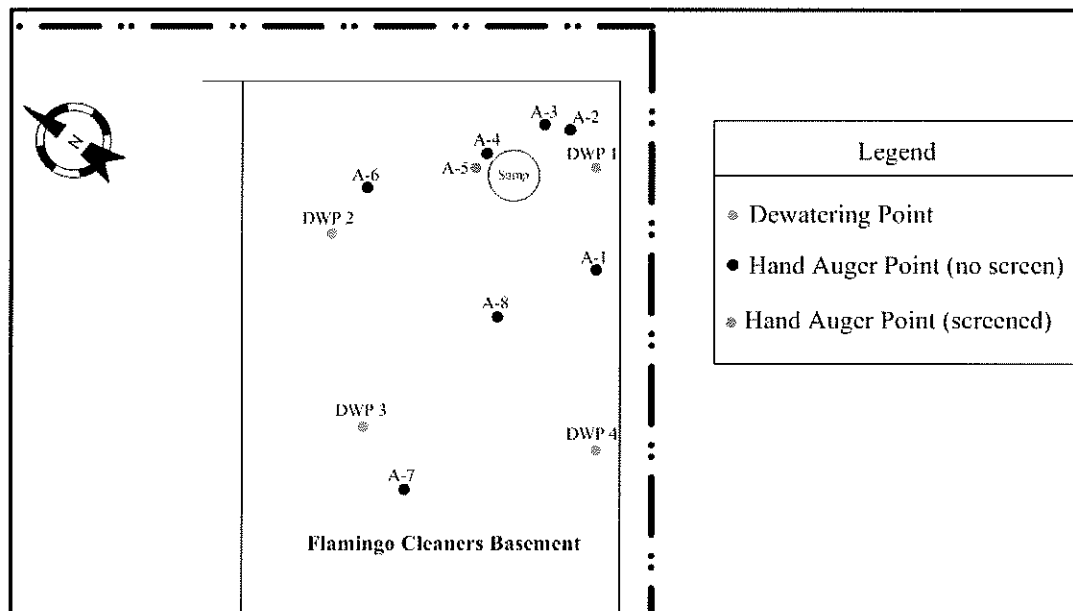
149 North Avenue – Groundwater Assessment Locations Surrounding Sump Area

Dorson advanced a total of eight (8) hand auger assessment holes (“A-1 – A-8”) surrounding the sump area. These holes were advanced to expose the groundwater table in order to evaluate the groundwater conditions to determine if petroleum product existed outside of the sump area. With the exception of A-5, all hand auger locations were advanced to a depth of approximately 2 feet below the basement slab with no PVC well material installed. A PVC well, slotted from grade through the terminus, was installed at the A-5 location to a depth of approximately 4 feet below grade. In addition to the hand auger holes, four (4) of the previously installed dewatering points were also inspected to evaluate groundwater conditions. Please note that the dewatering points were installed for groundwater depression only and are likely not slotted at the depth corresponding to the product layer interface and as such, will not be used as data collection points, however, the findings from the inspection of these points will be provided with regard to groundwater depth.

Groundwater was observed at a depth of approximately 11 inches below basement grade during the inspection of the hand auger holes and dewatering points. Groundwater samples were collected from the eight (8) hand auger locations and visually inspected for the presence of a petroleum product layer. Please note that the samples were not screened for olfactory evidence of contamination as the groundwater in the basement area is known to be contaminated with PCE. No visual evidence of a petroleum product layer was observed in any of the samples collected from the eight (8) hand auger locations. The only evidence of petroleum product that was observed existed on the surface of water within the sump pit.

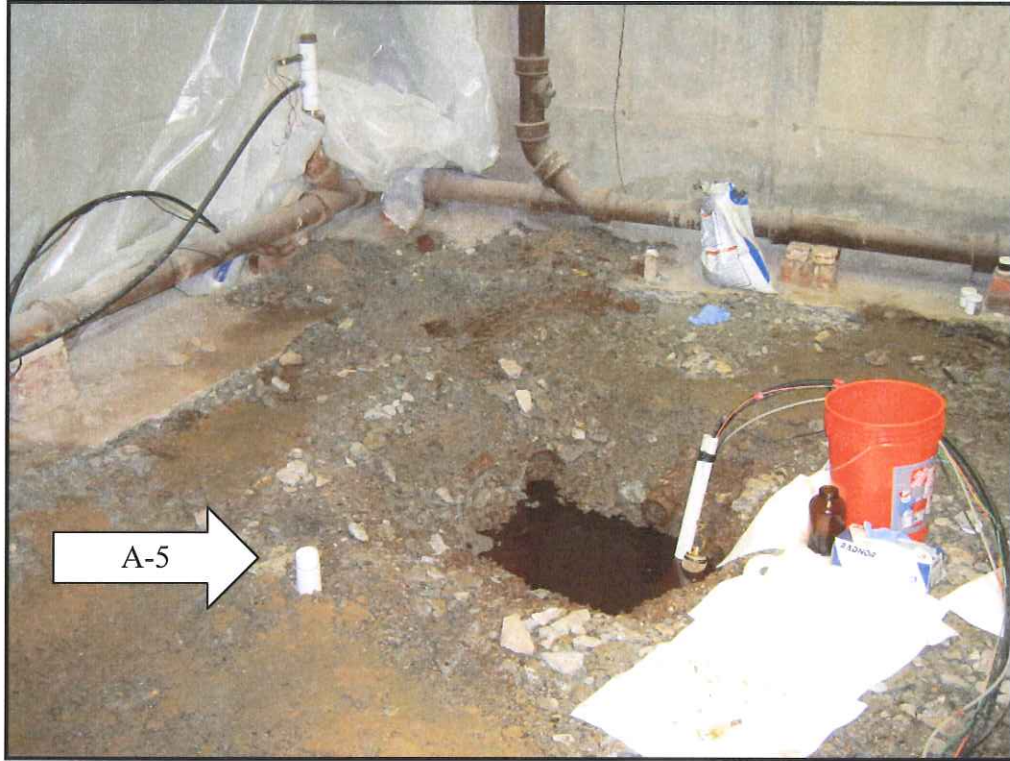
149 North Avenue – Sump Pit Location
(Note: Location of Hand Auger Assessment Hole (A-5))

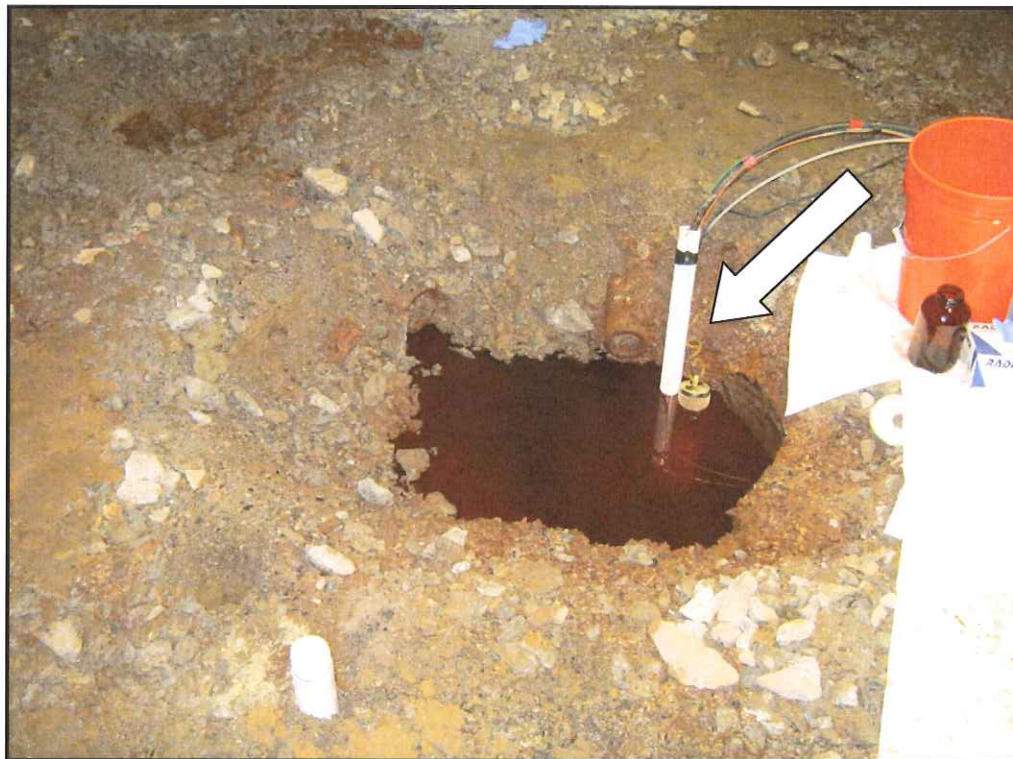
149 North Avenue – Petroleum Product within Sump
(Note: Dewatering Point and Product Only Skimmer Pump)

Following these preliminary assessment activities, Dorson proceeded with the installation of an automated product only skimmer system which will remove the product layer from groundwater periodically and transfer it to a 55 gallon collection drum. Additionally, Dorson has maintained the dewatering point located within the sump pit only in an effort to control the depth of groundwater at the sump so that the product can not migrate to the areas around the sump. The skimmer and dewatering systems work in concert so that petroleum product that is drawn into the sump area during the depression of groundwater can be skimmed and pumped into the collection drum. The contents of the drum will be removed for manifest disposal at a later date.
