July 25, 2012

Re: Identification of Petroleum Product in Sump  
Flamingo Cleaners, New Rochelle, NY

### Site Photographs

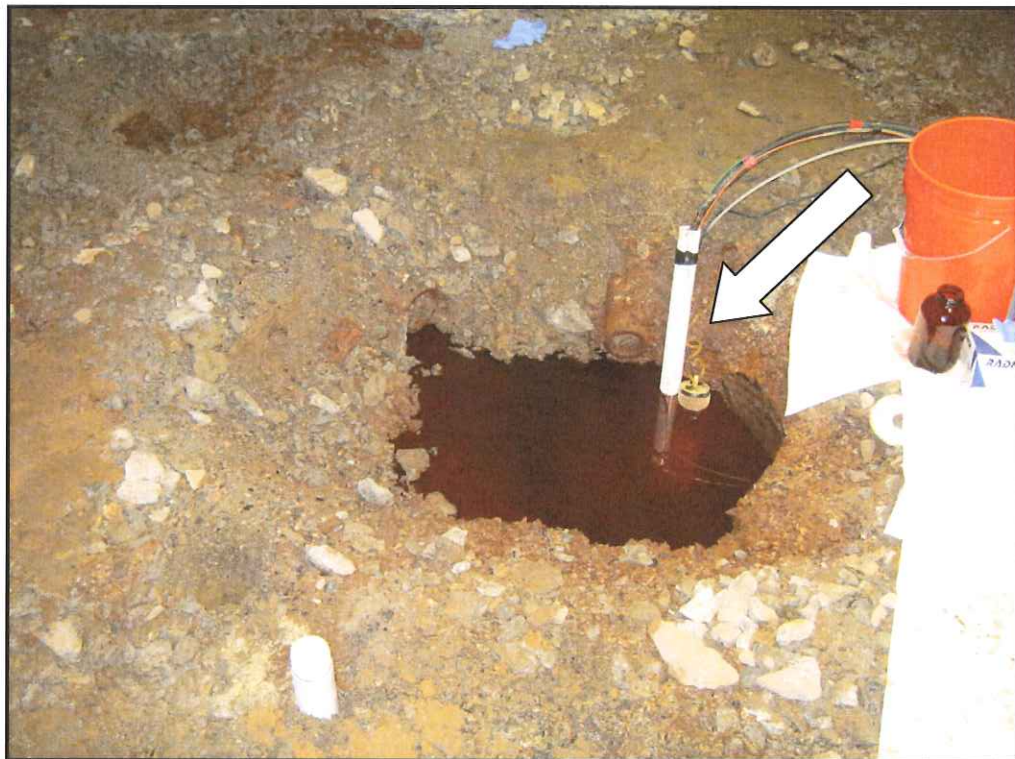
While conducting a routine inspection of the dewatering system at the above captioned location on Friday, July 20, 2012, Dorson Environmental Management, Inc. ("Dorson") observed a new contaminant of concern ("COC") on groundwater in the area of the former sump pit. Specifically, a red colored petroleum product measuring approximately 1/8" was found floating on the surface of water within the sump pit. **See Attachment 1** for Site Photographs. Following our notification call to your office, certain preliminary work was conducted in order to keep the project in order. These preliminary tasks included:

149 North Avenue – Petroleum Product within Sump  
(Note: Dewatering Point and Product Only Skimmer Pump)

Following these preliminary assessment activities, Dorson proceeded with the installation of an automated product only skimmer system which will remove the product layer from groundwater periodically and transfer it to a 55 gallon collection drum. Additionally, Dorson has maintained the dewatering point located within the sump pit only in an effort to control the depth of groundwater at the sump so that the product can not migrate to the areas around the sump. The skimmer and dewatering systems work in concert so that petroleum product that is drawn into the sump area during the depression of groundwater can be skimmed and pumped into the collection drum. The contents of the drum will be removed for manifest disposal at a later date.
