Project Name: VillaBXV Condominium

Project Number: C360081

Site Management Plan – 2023-2025 Periodic Review Report

ENGINEERING CONTROLS ANNUAL INSPECTION REPORT - 2023

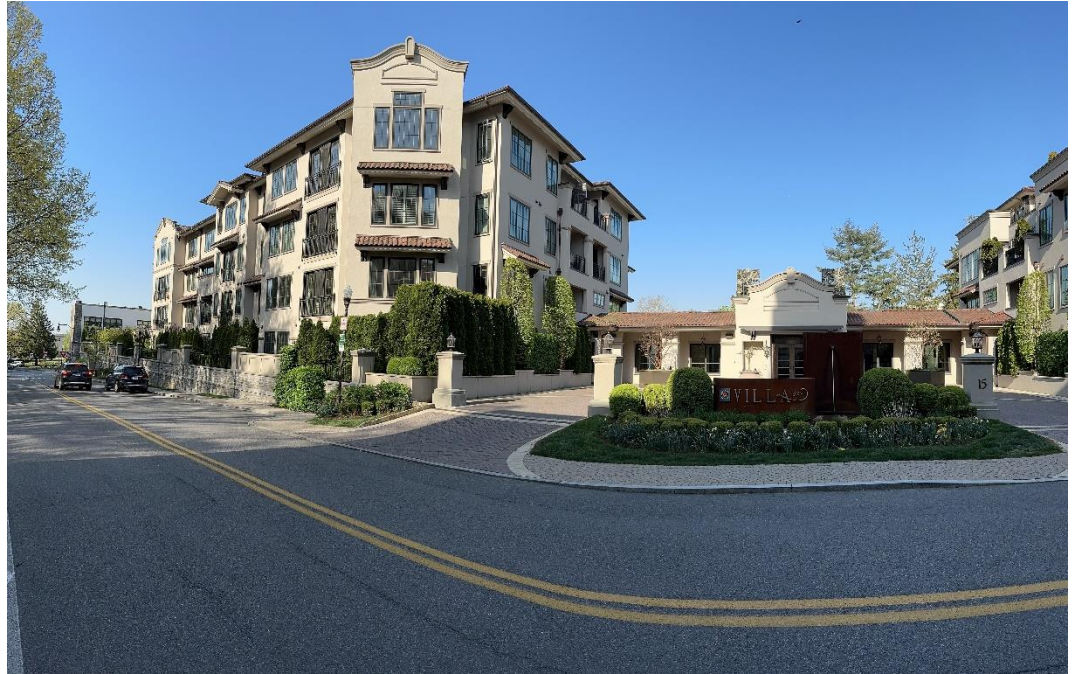
Photo 1 –

Photo showing the landscaped area along Kensington Road near the main building entrance.

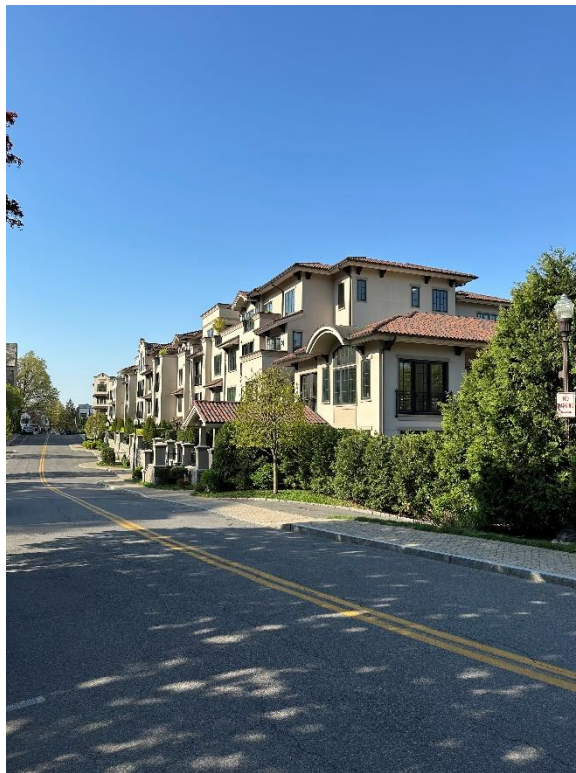
Photo 2 –

View facing south along Kensington Road of the landscaped areas along the front of the building.

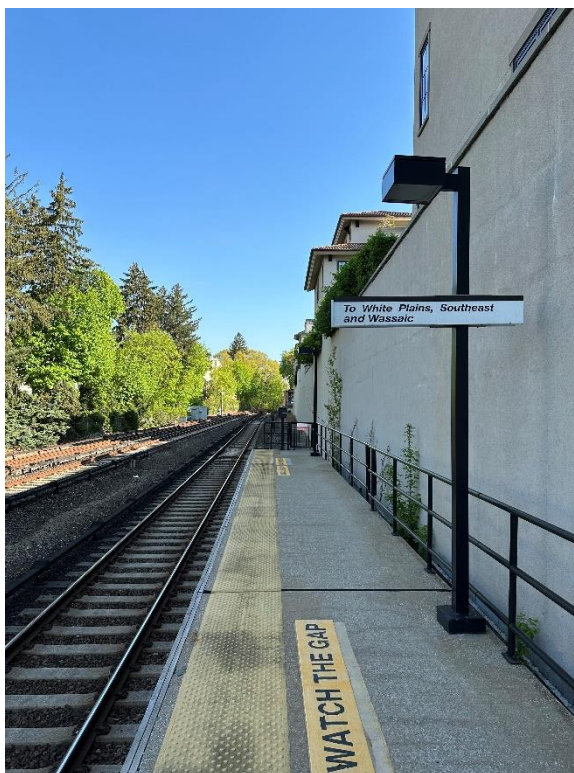
Photo 3 –

View facing north along east side of the Property adjoining the railway tracks

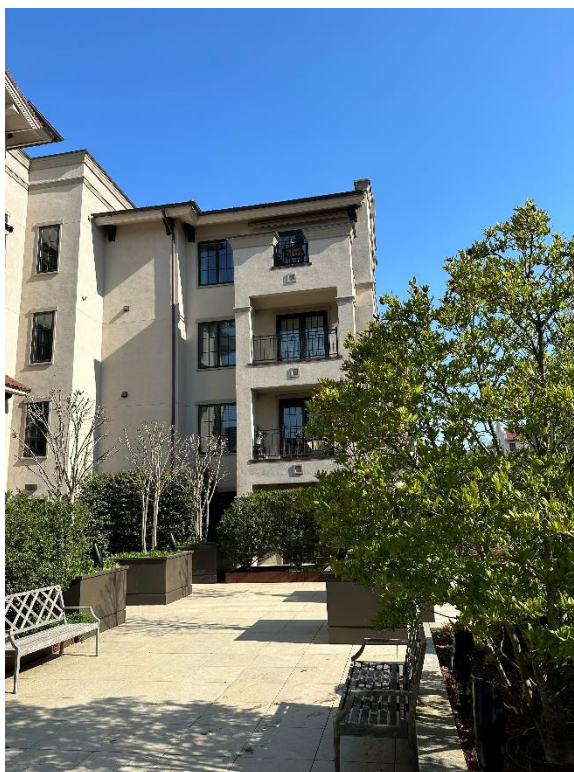
Photo 4 –

View of main communal courtyard area showing no signs of alterations or damage.

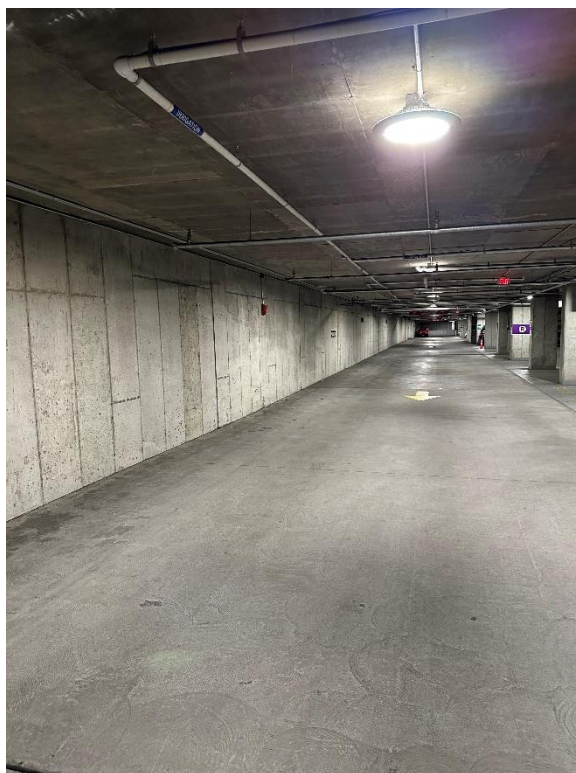
Photo 5 –

Photo of the main basement parking lot area showing no signs of alteration or damage

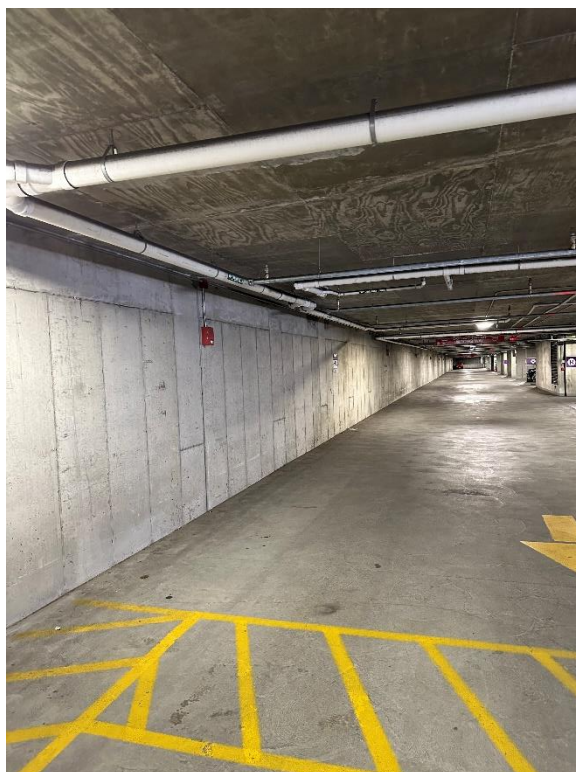
Photo 6 –

Photo of the basement walls in the parking lot showing no signs of damage

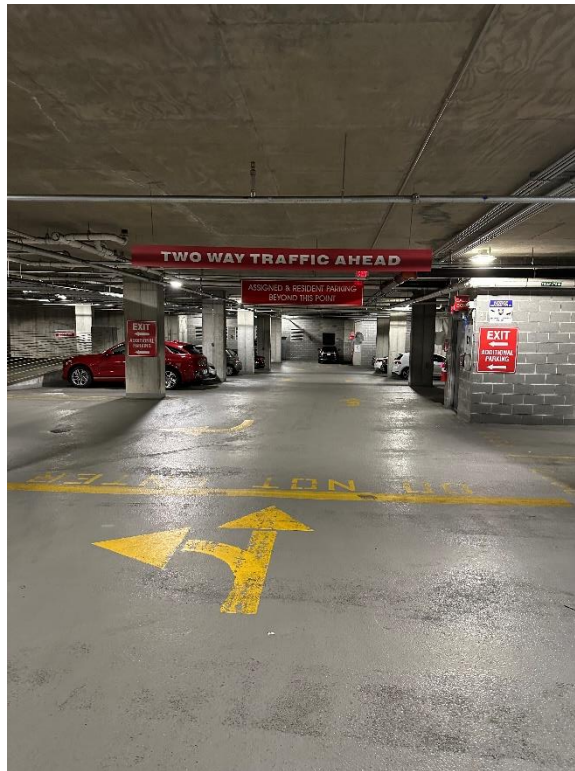
Photo 7 –

Photo showing the additional view of the parking lot floors showing no signs of significant damage.

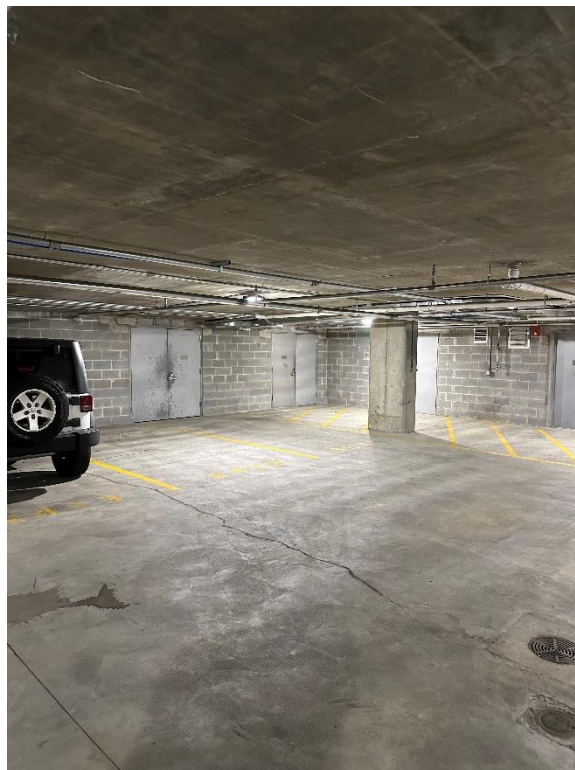
Photo 8 –

- The foundation slab presented with minor surficial hairline cracks likely caused by vehicle traffic, but not found to be affecting the integrity of the slab.

Photo within residential parking area showing cracks in the concrete slab. Cracks are all surficial with no evidence of undermining the structural integrity of the slab.

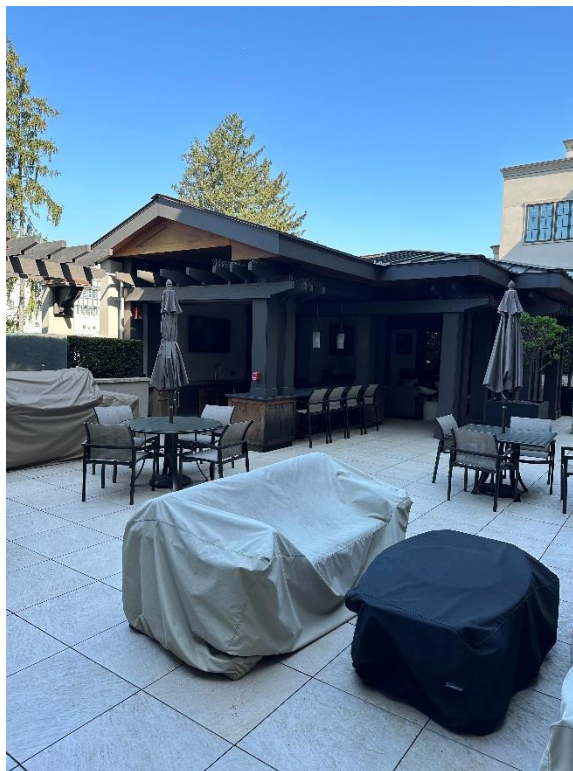
Photo 9 –

Photo showing typical terrace on ground floor showing no alterations or damage.

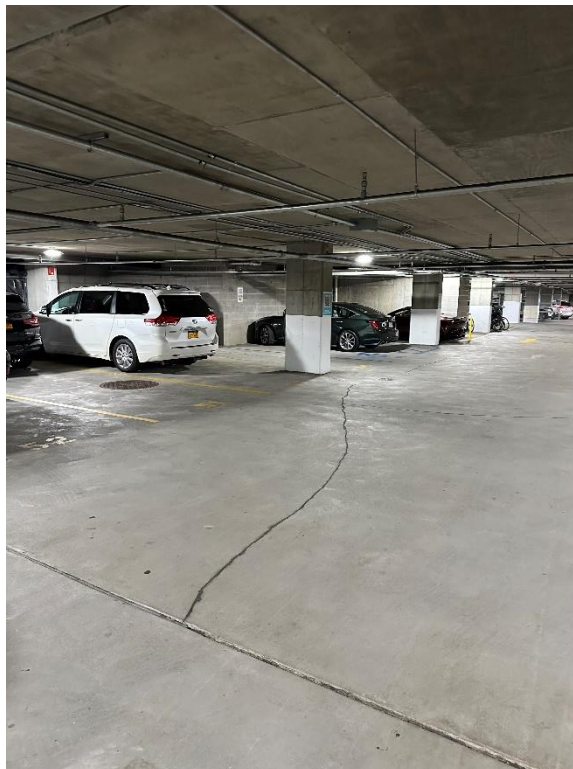
Photo 10 –

Photo showing the overall view of the residential parking area with surficial cracks.

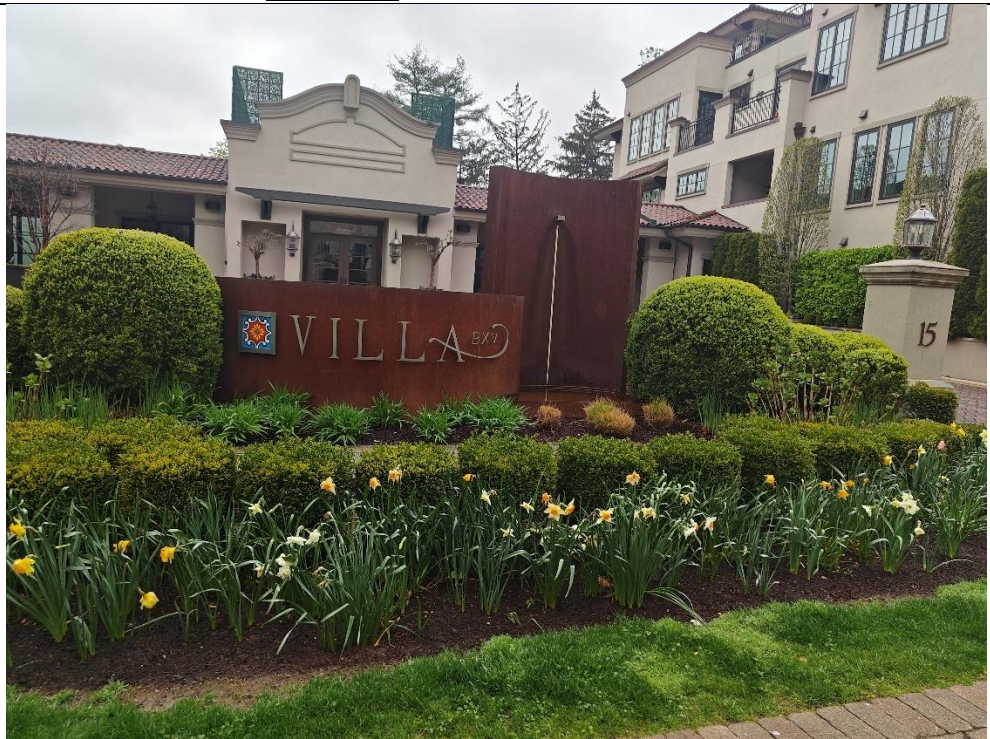
Photo 1 –

Photo showing the landscaped area along Kensington Road near the main building entrance.

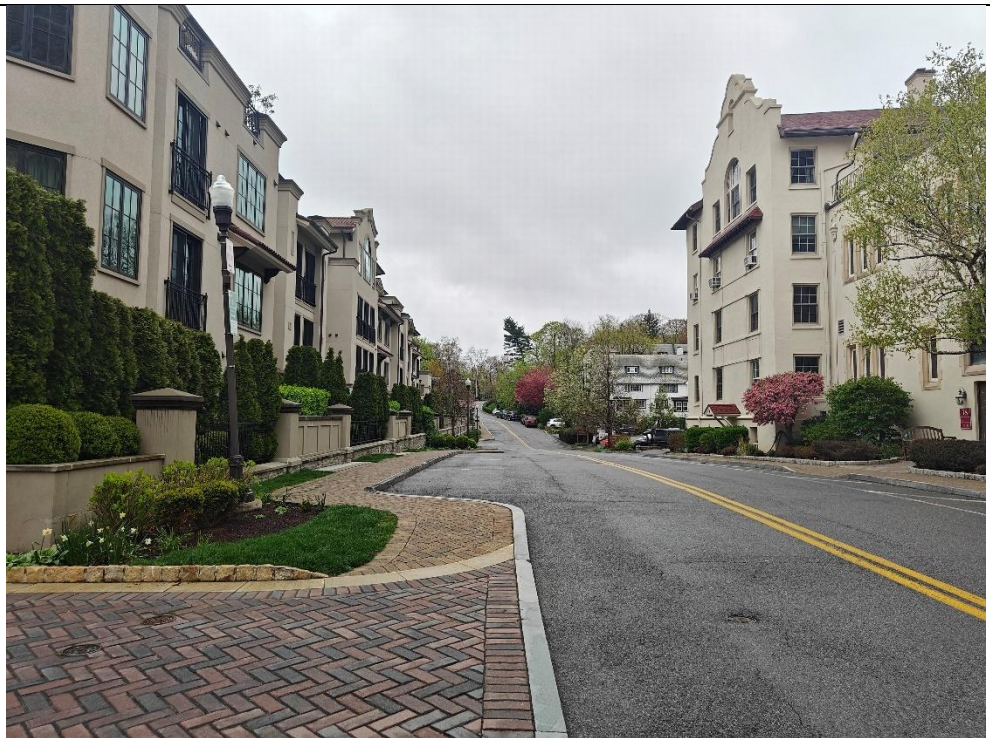
Photo 2 –

View facing north along Kensington Road of the landscaped areas along the front of the building.

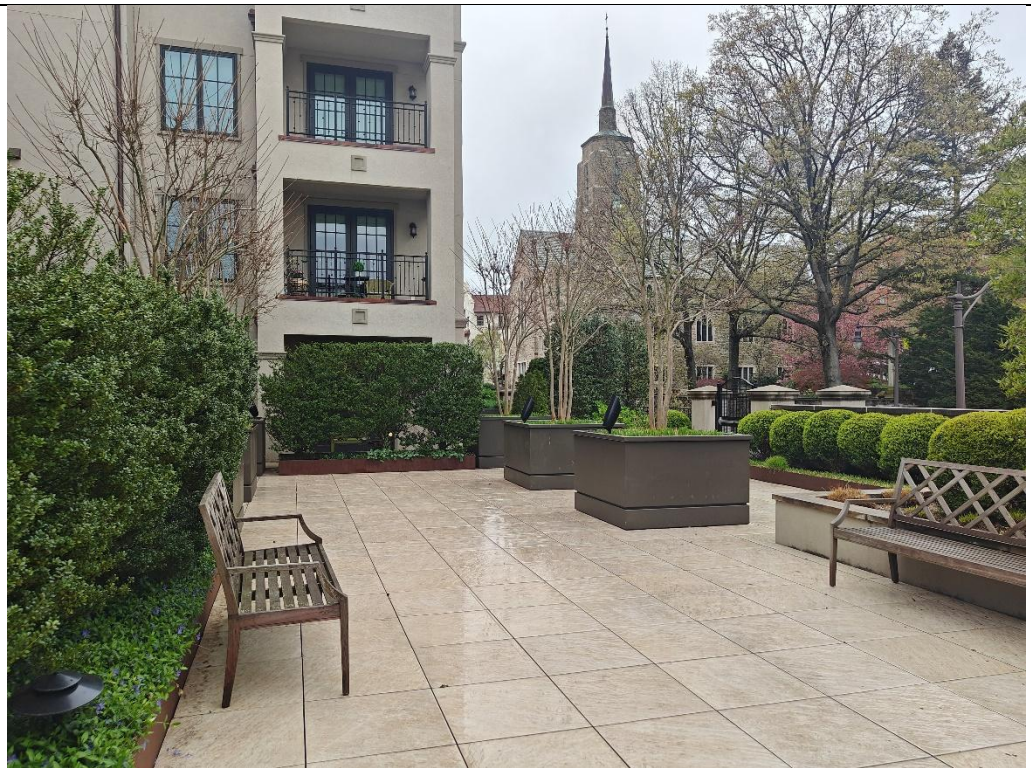
Photo 3 –

View of main communal courtyard area showing no signs of alterations or damage.

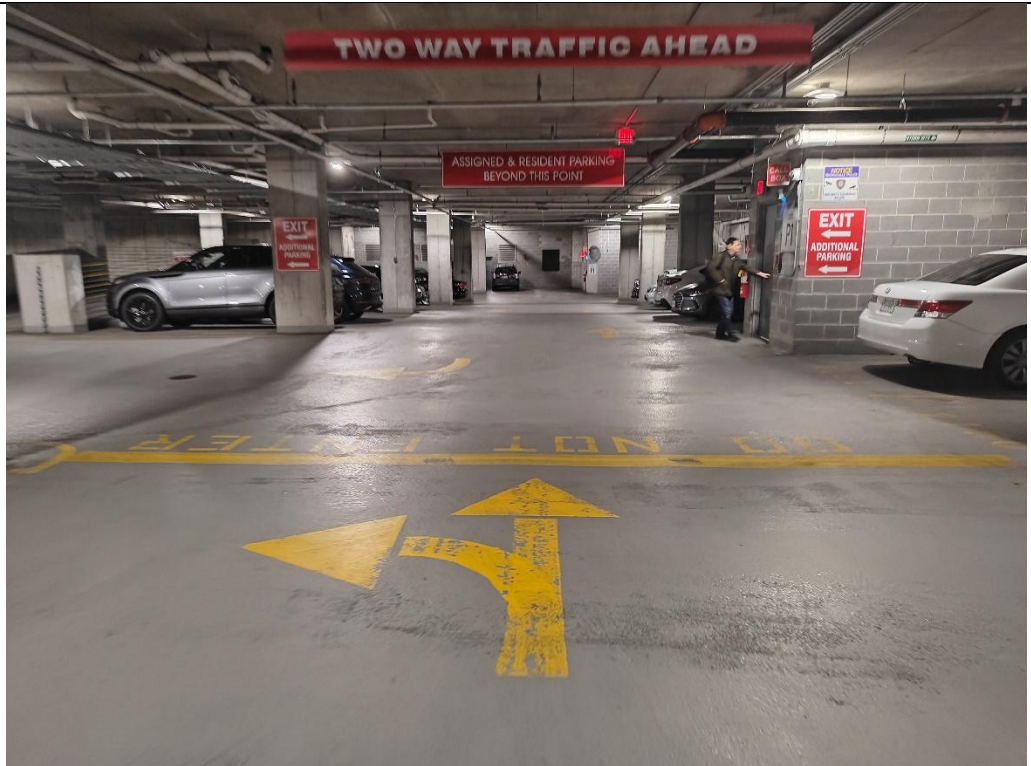
Photo 4 –

Photo of the main basement parking lot area showing no signs of alteration or damage

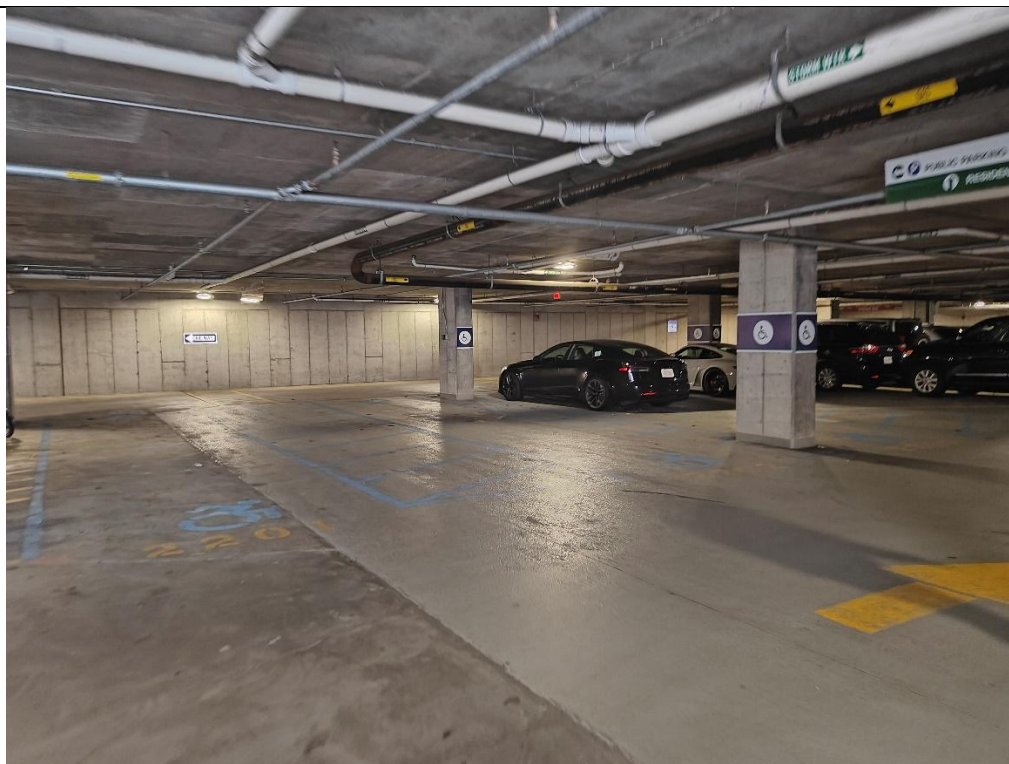
Photo 5 –

Photo of the basement walls in the parking lot showing no signs of damage

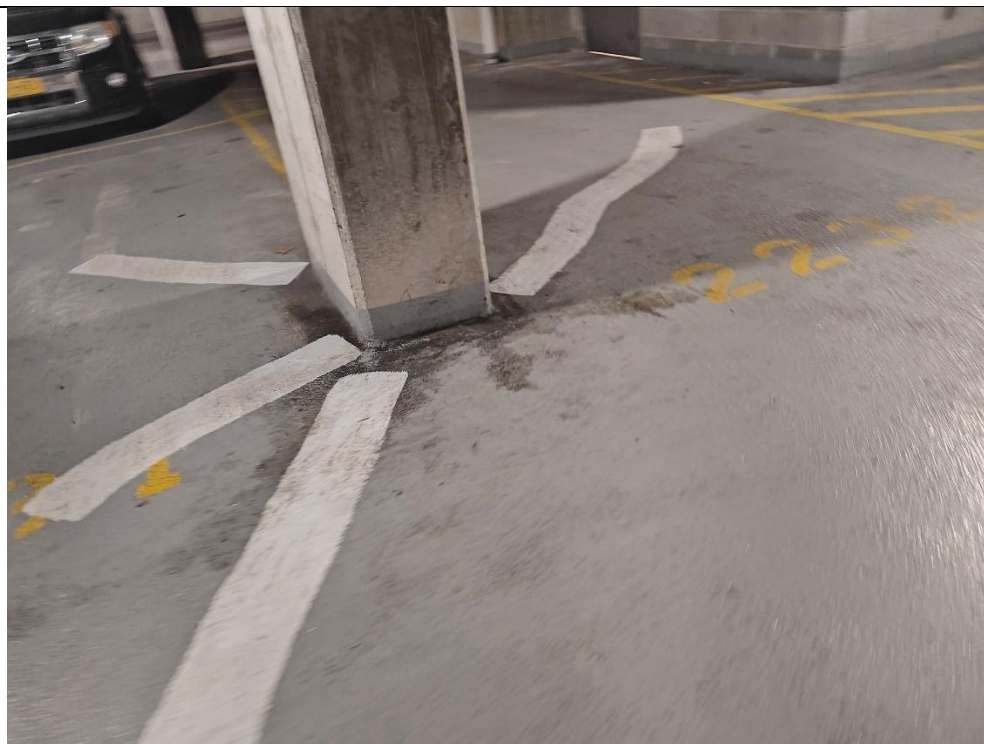
Photo 6 –

Photo showing the additional view of the parking lot floors repaired cracks.

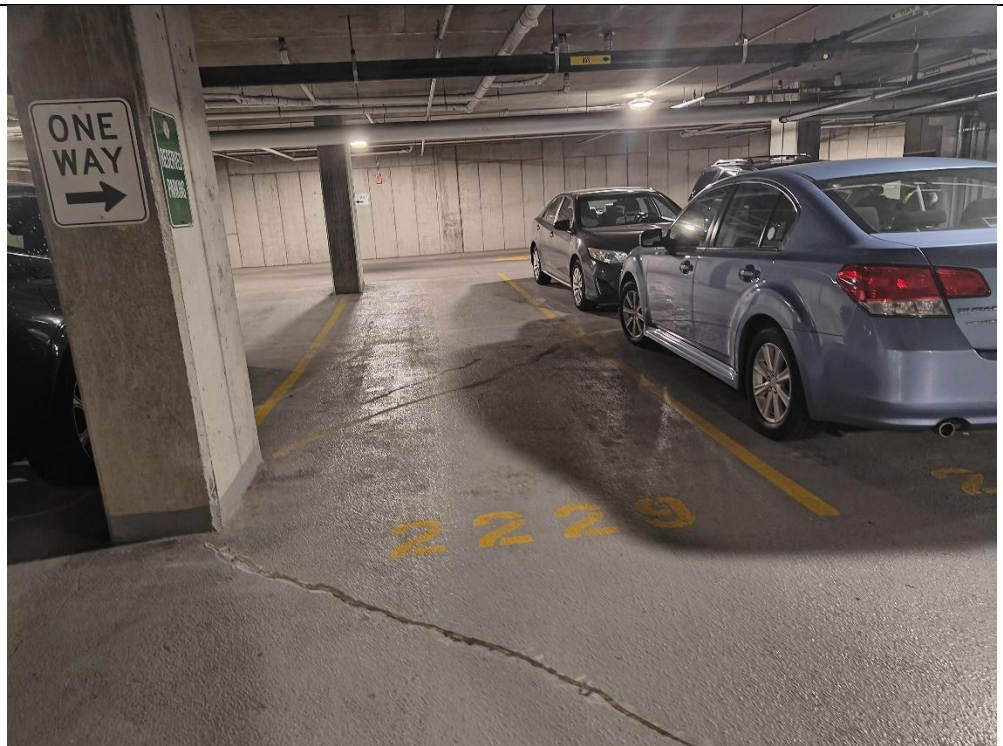
Photo 7 –

- The foundation slab presented with minor surficial hairline cracks likely caused by vehicle traffic, and proximity to the Bronxville Train Station, but not found to be affecting the integrity of the slab.

Photo within residential parking area showing cracks in the concrete slab. Cracks are all surficial with no evidence of undermining the structural integrity of the slab.

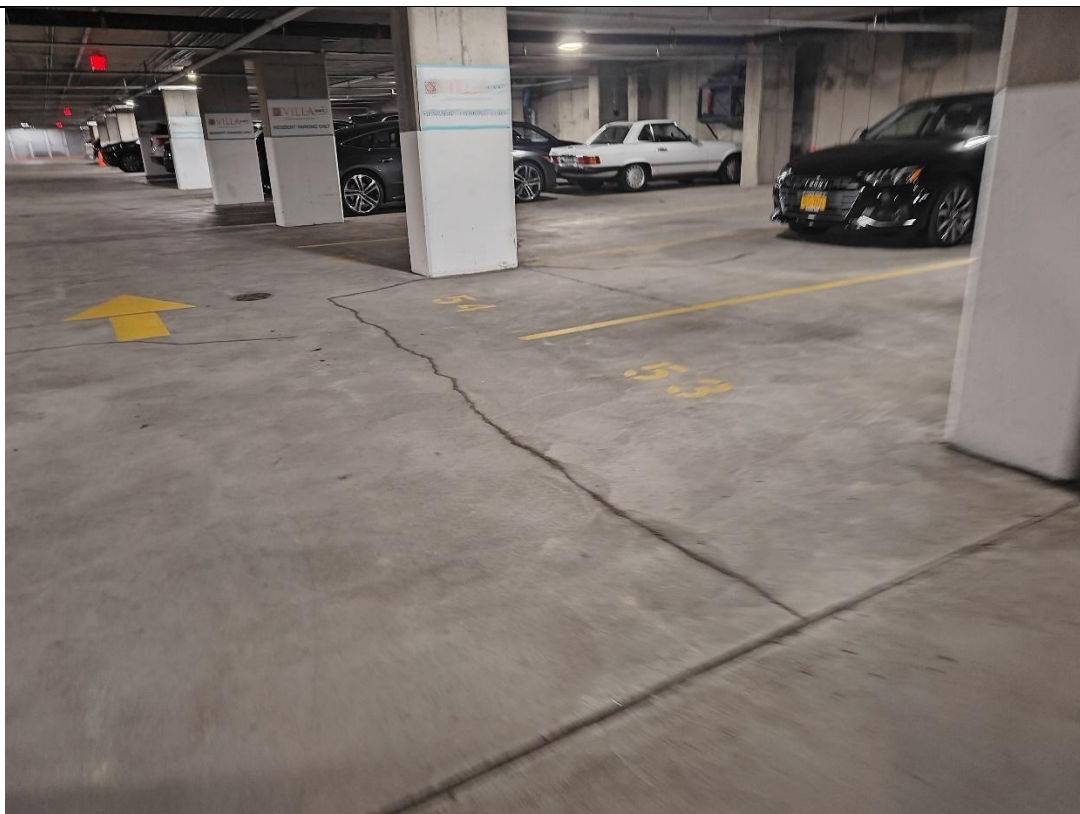
Photo 9 –

Photo showing the overall view of the residential parking area with surficial cracks.

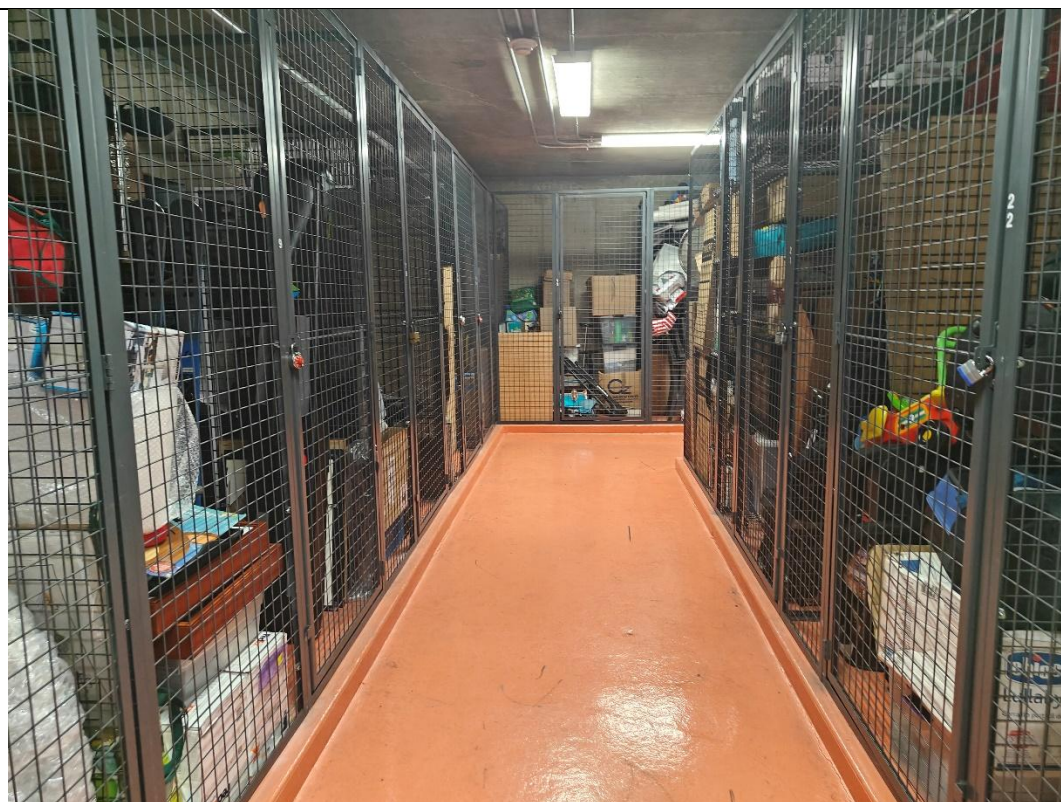
Photo 10 –

Photo showing typical tenant storage area located in the parking garage.

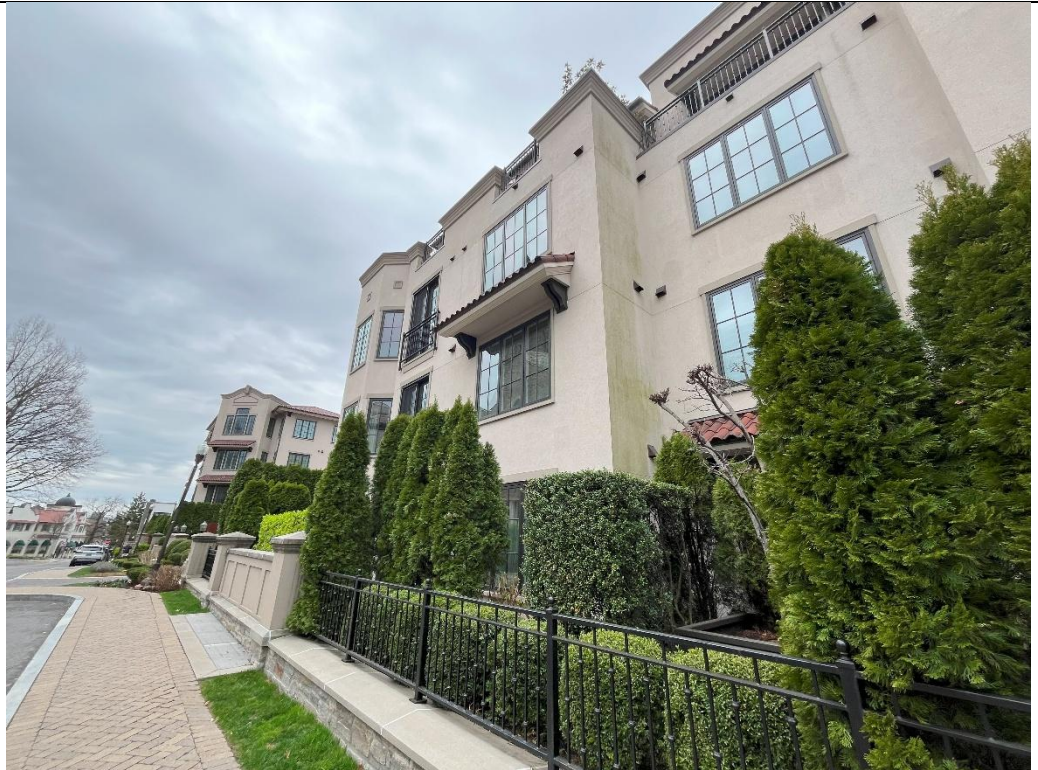
Photo 1 –

Photo showing the landscaped area along Kensington Road near the main building entrance.

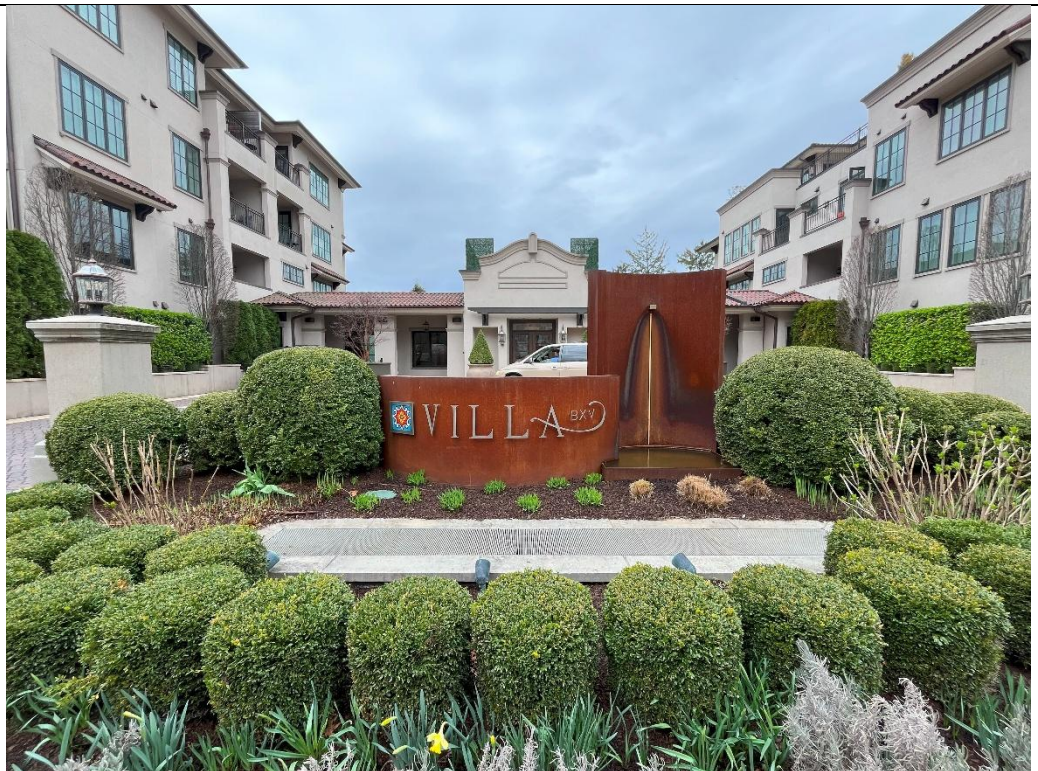
Photo 2 –

View facing north along Kensington Road of the landscaped areas along the front of the building.

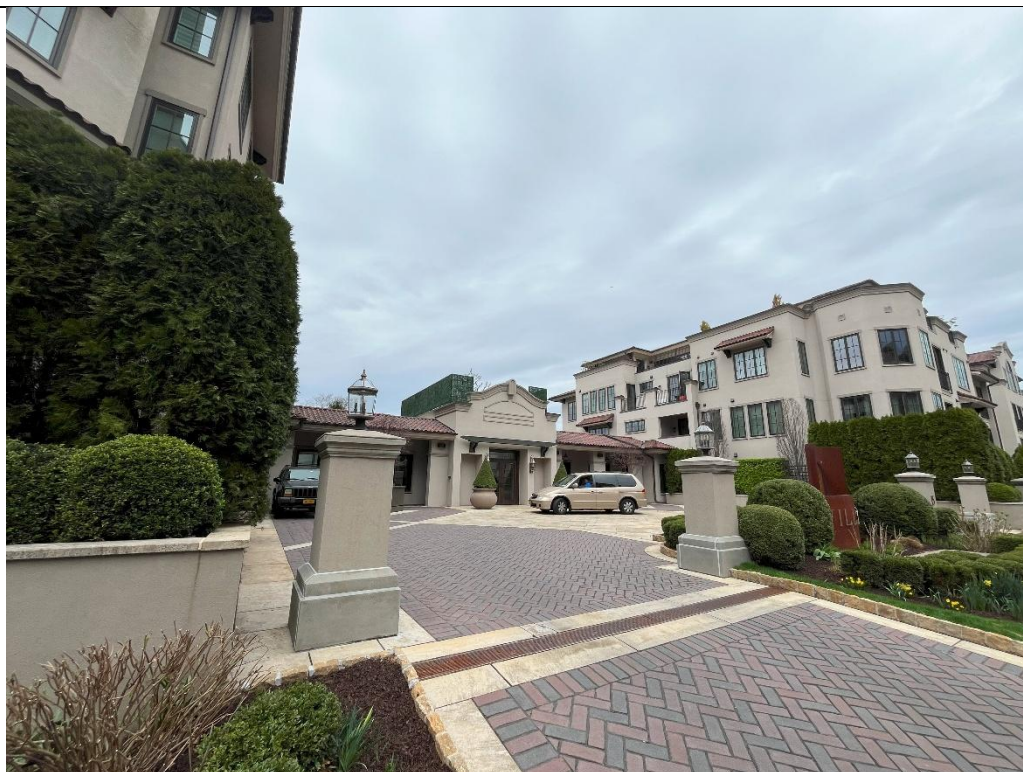
Photo 3 –

View of main building entrance

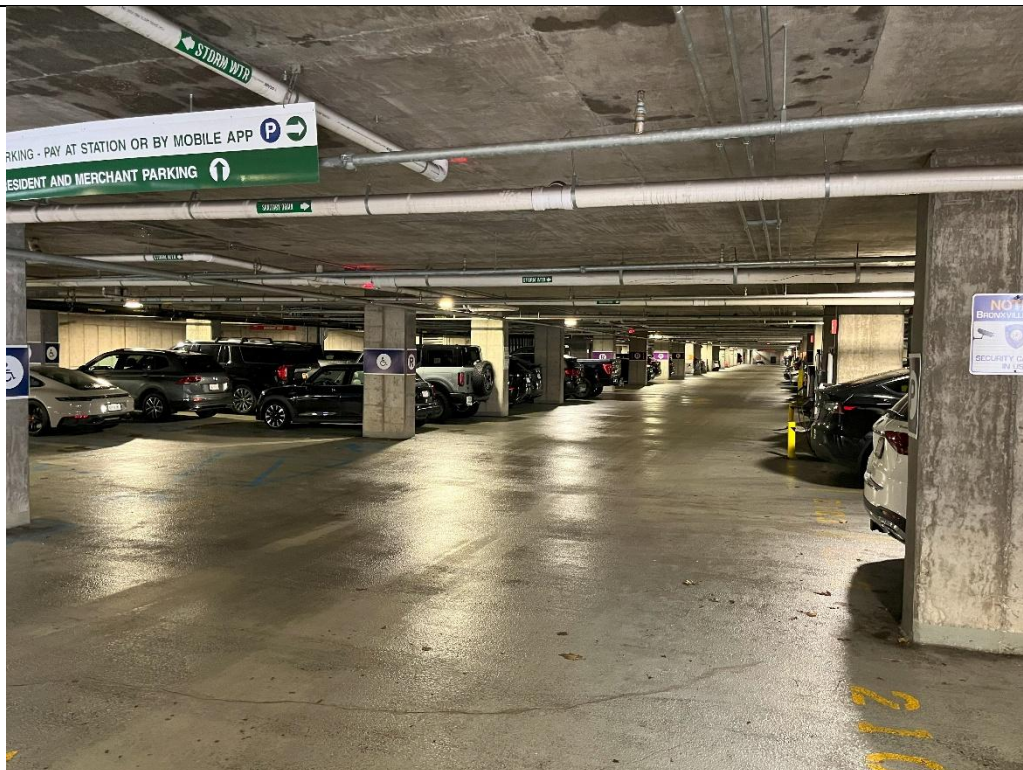
Photo 4 –

Photo of the main basement parking lot area showing no signs of alteration or damage

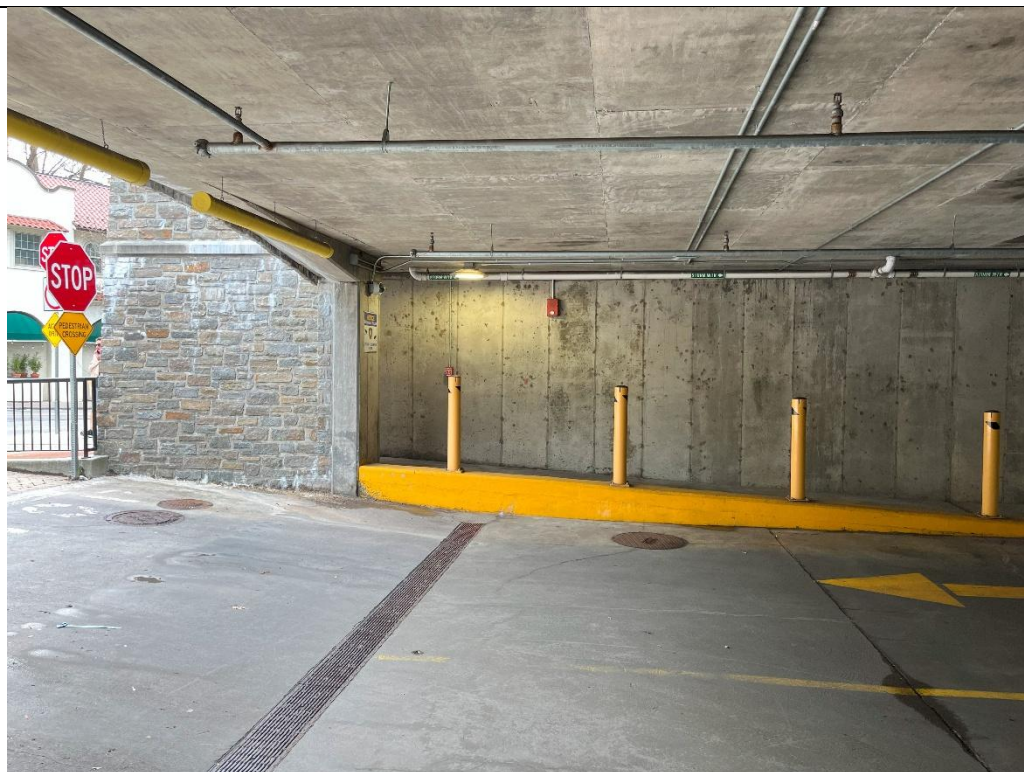
Photo 5 –

Photo of the basement walls in the parking lot showing no signs of damage

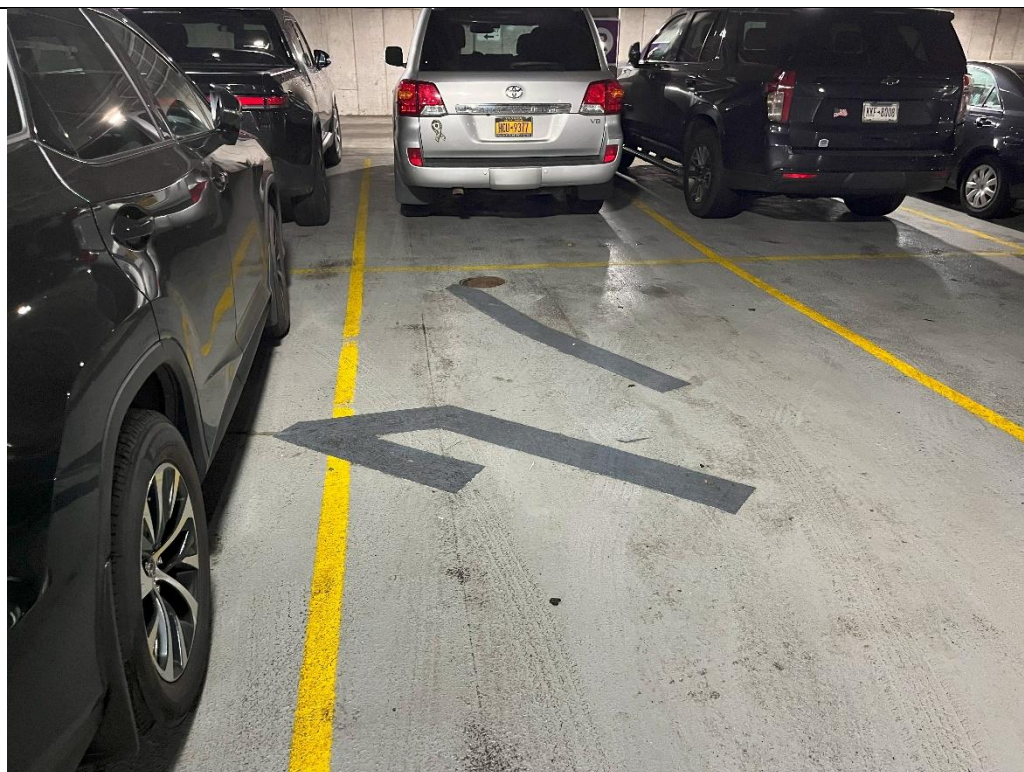
Photo 6 –

Photo showing the additional view of the parking lot floors repaired cracks.

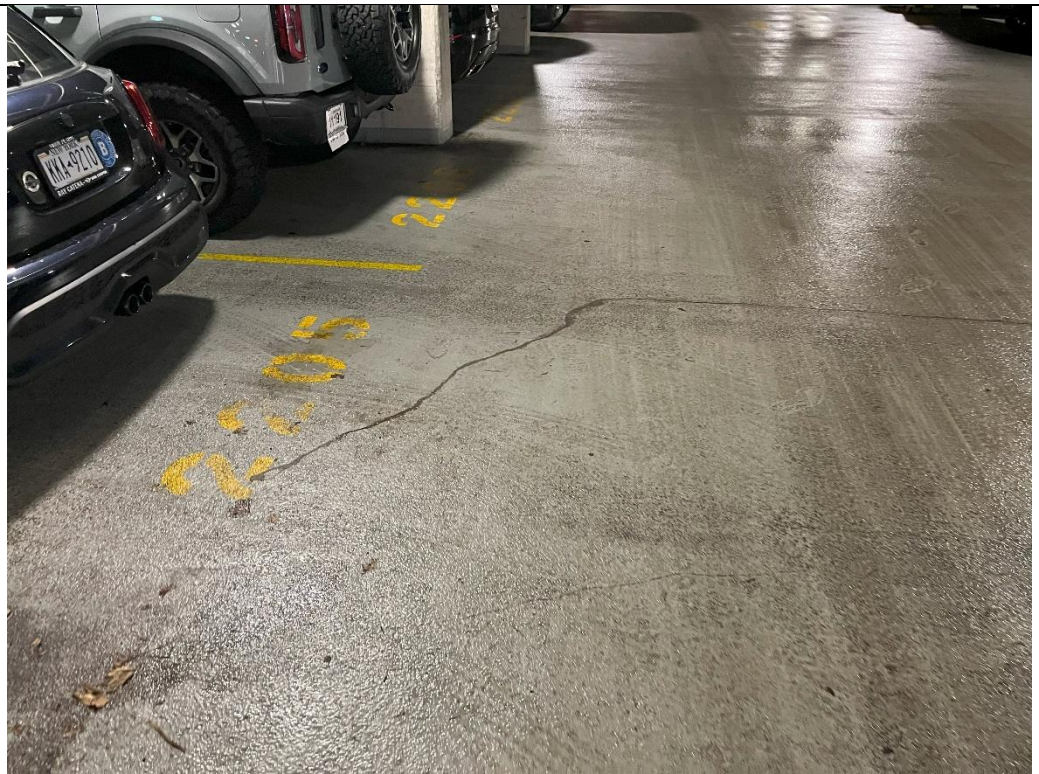
Photo 7 –

- The foundation slab presented with minor surficial hairline cracks likely caused by vehicle traffic, and proximity to the Bronxville Train Station, but not found to be affecting the integrity of the slab.

Photo within residential parking area showing cracks in the concrete slab. Cracks are all surficial with no evidence of undermining the structural integrity of the slab.

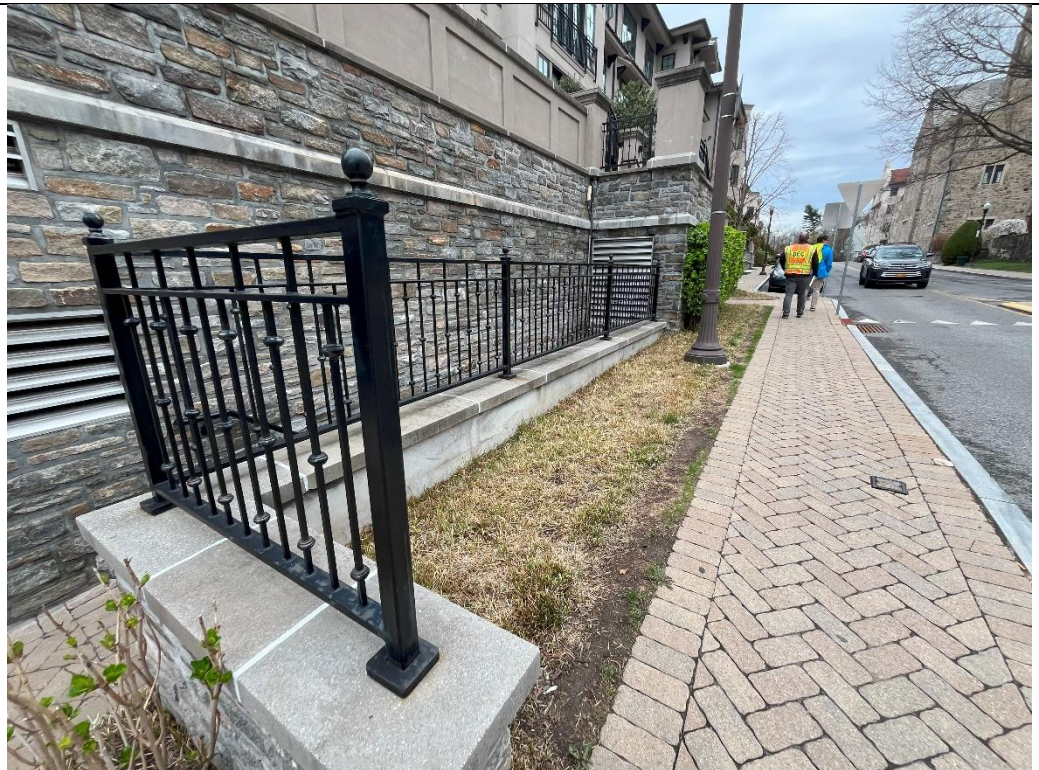
Photo 8 –

Photo showing southern pedestrian entrance to the parking lot.

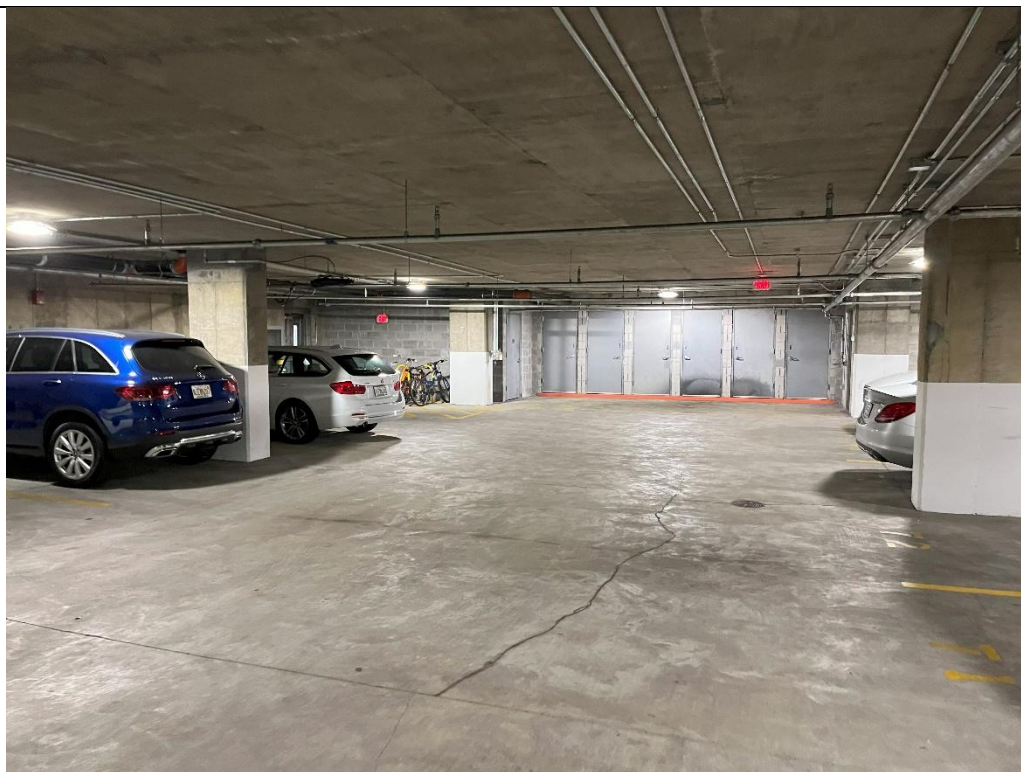
Photo 9 –

Photo showing the overall view of the residential parking area with surficial cracks.

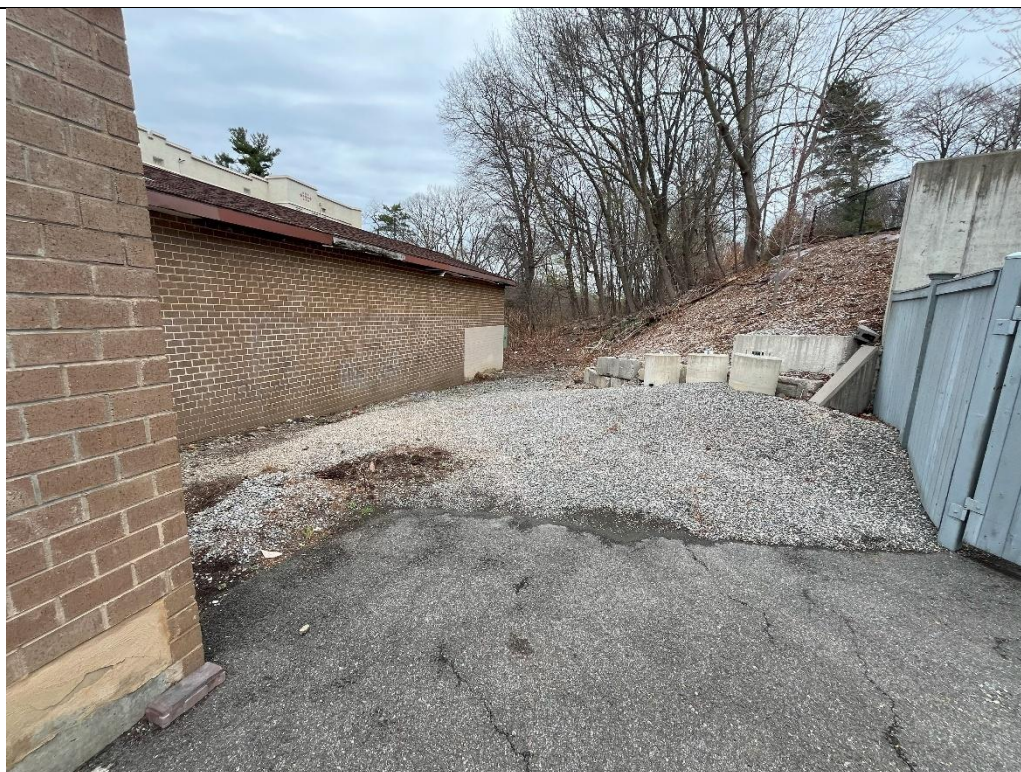
Photo 10 –

Photo showing backfilled capped area to the north of the buildings.
