# PHASE I ENVIRONMENTAL SITE ASSESSMENT

33 John Street Yonkers, New York 10701

April 10, 2006

ACT File #: 5435-YONY

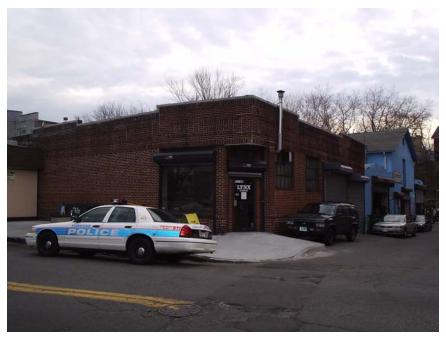
Photograph 1: 33 John Street, Yonkers, New York

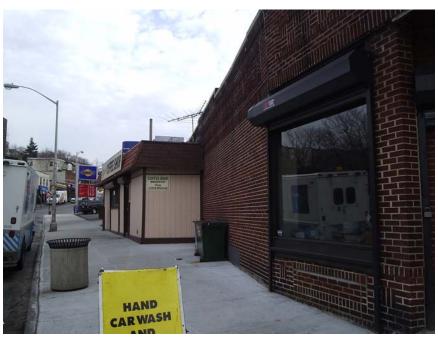
Photograph 2: Subject Property, Coffee Shop

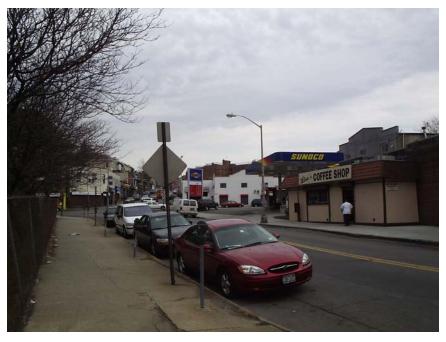
Photograph 3: View of Gasoline Station located to the north of the Subject Property

A gasoline station has been located adjacent to the north of the subject property since prior to 1951. This gasoline station is associated with numerous closed spills, mentioned in Section 5.0 of this report, and may be impacting the environmental quality of the subject property.

The NYSDEC Spills and Leaking Underground Storage Tank (LUST) lists were searched for all reported spills within ½ mile of the subject property. The subject property is not listed in the databases as containing a Spill or LUST. A total of 160 Spills or LUSTs have occurred within ½ mile of the property. The closest active site is located approximately 586 feet south of the subject property. This site and the remaining active sites should not impact upon the environmental quality of the subject property. A total of five closed spills are identified at the gasoline station located adjacent to the north of the subject property. This gasoline station may be impacting the environmental quality of the subject property.

The soil and groundwater quality beneath the subject property should be evaluated to determine if the adjacent gasoline station has impacted the environmental quality of the subject property. This can be accomplished by the installation, sampling and analysis of soil borings and temporary groundwater monitoring wells throughout the subject property. The results of the above evaluation should be presented in a formal Phase II Environmental Site Assessment Report. The Phase II Environmental Site Assessment can be accomplished for approximately \$6,000.00.

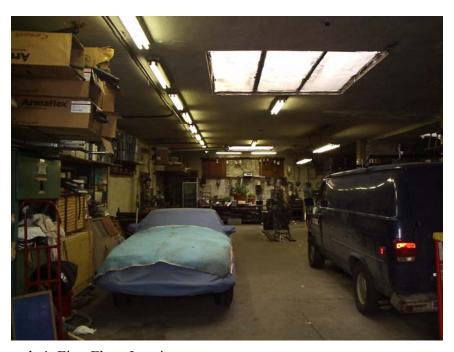
Photograph 4: First Floor Interior

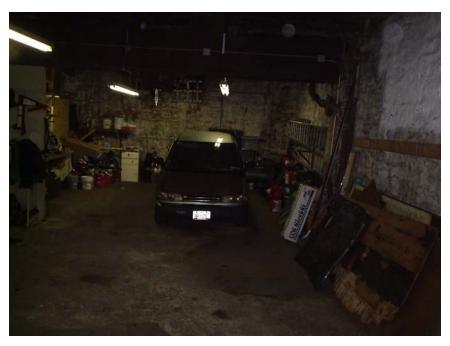
Photograph 5: Basement Interior

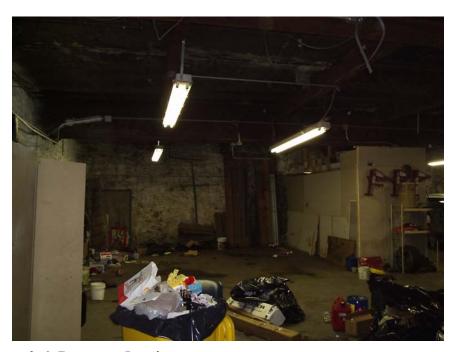
Photograph 6: Basement Interior

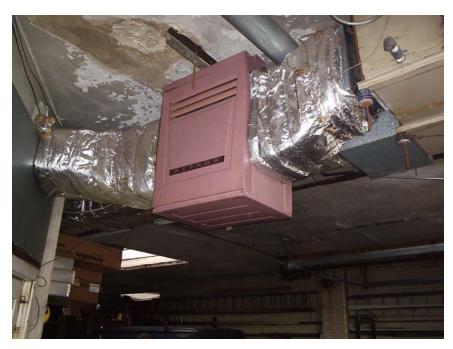
Photograph 7: Overhead Natural Gas Fired Heating Equipment
