MONITORING AND MAINTENANCE PLAN REPORT

MR. CLEANERS – SHRUB OAK SHOPPING CENTER
1360 EAST MAIN STREET
SHRUB OAK
WESTCHESTER COUNTRY, NEW YORK

TECHNICAL REPORT

MARCH 2017

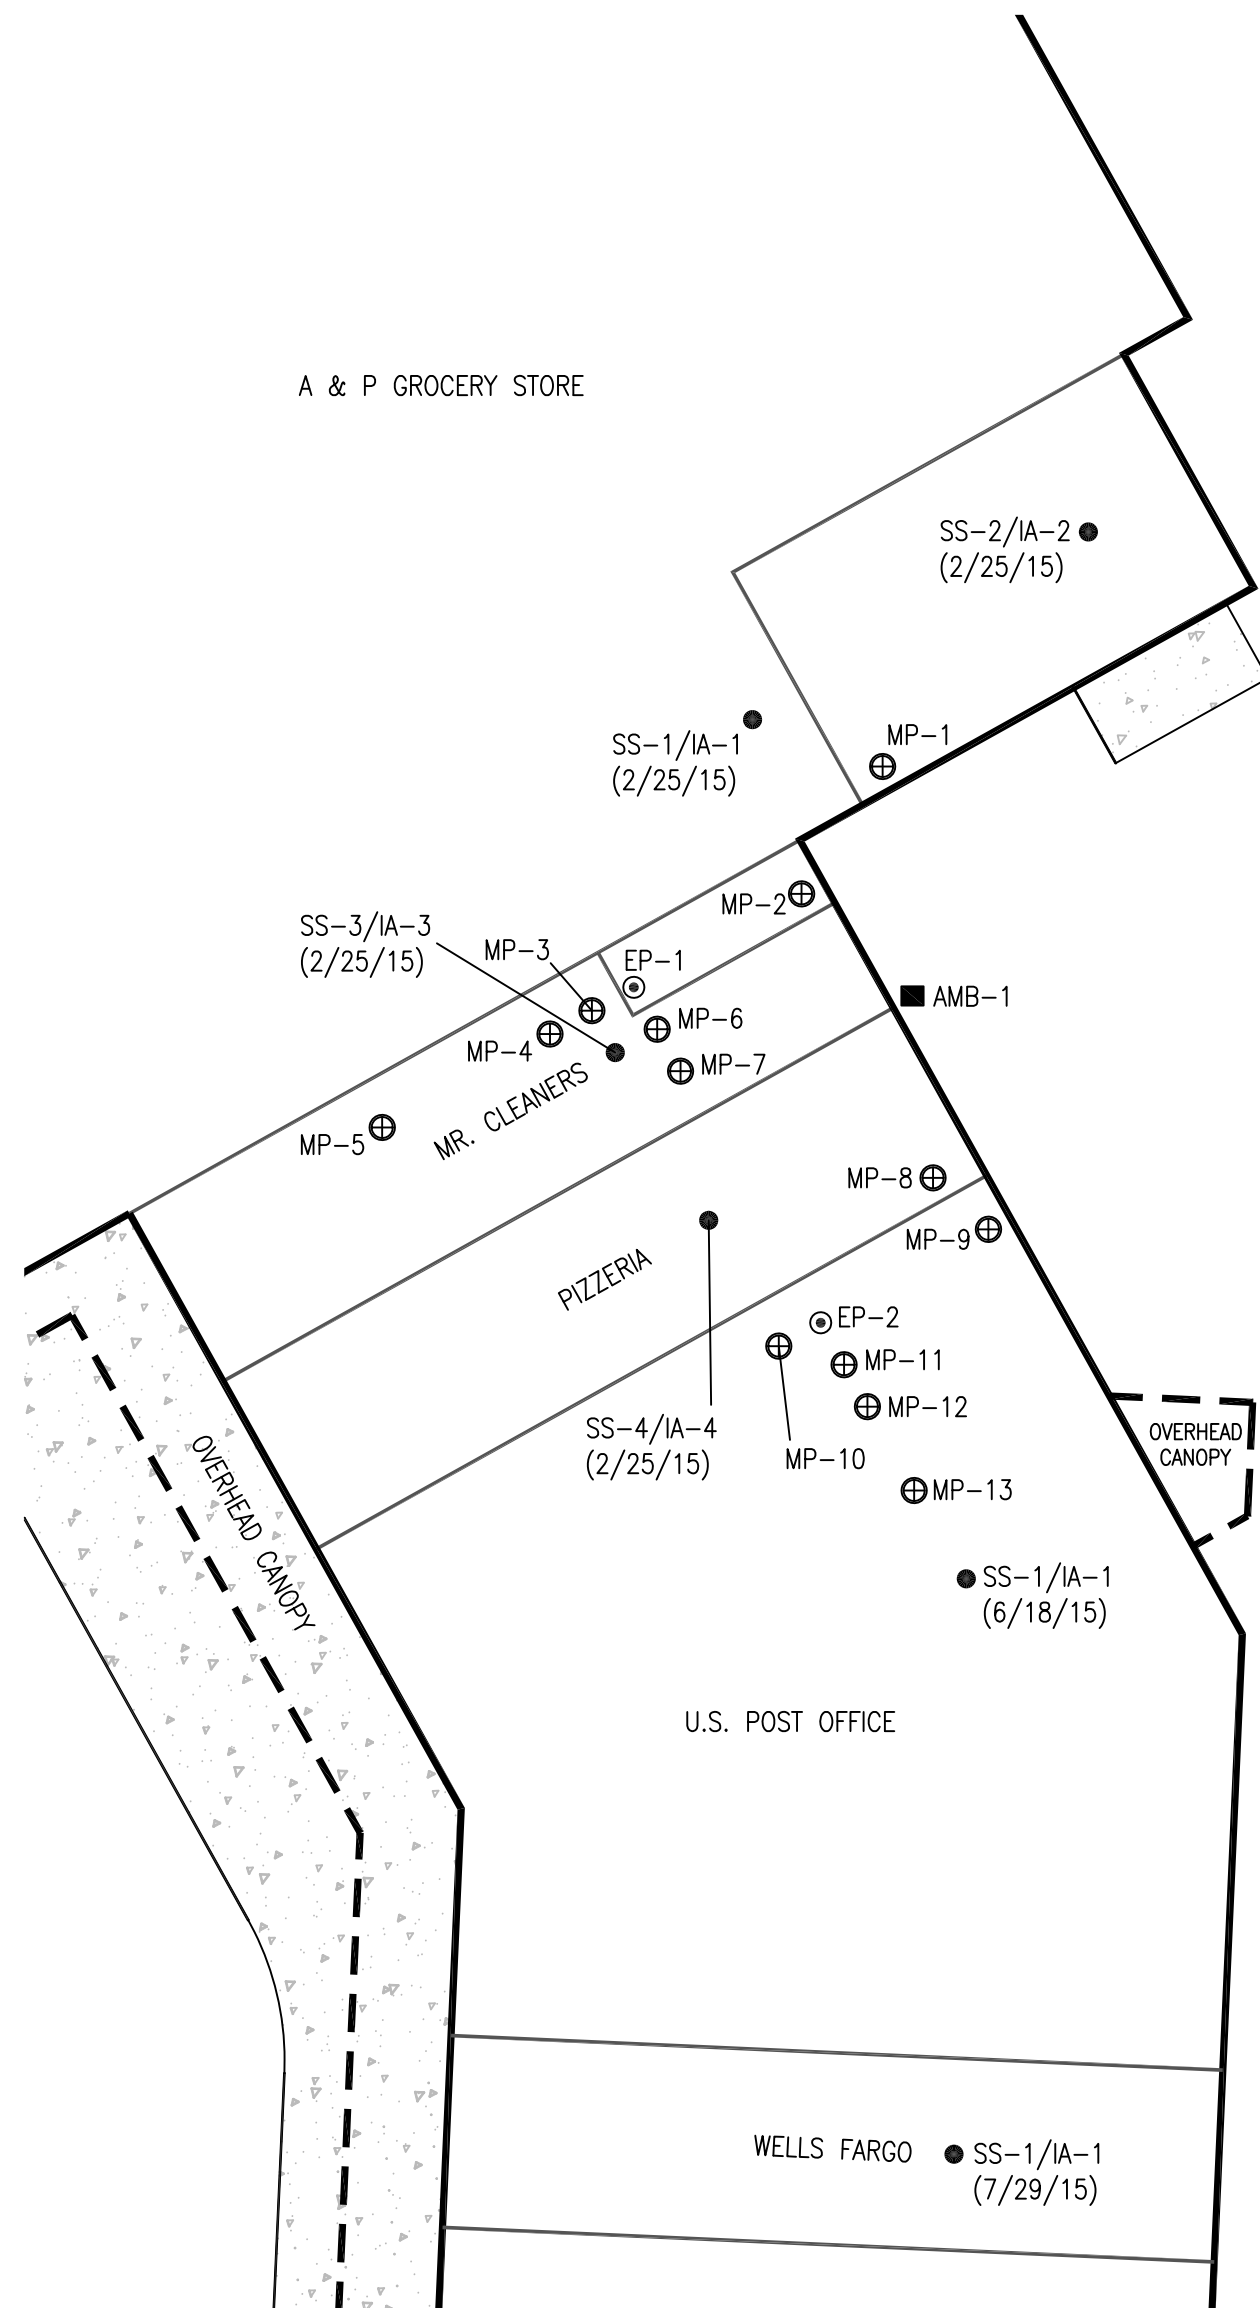
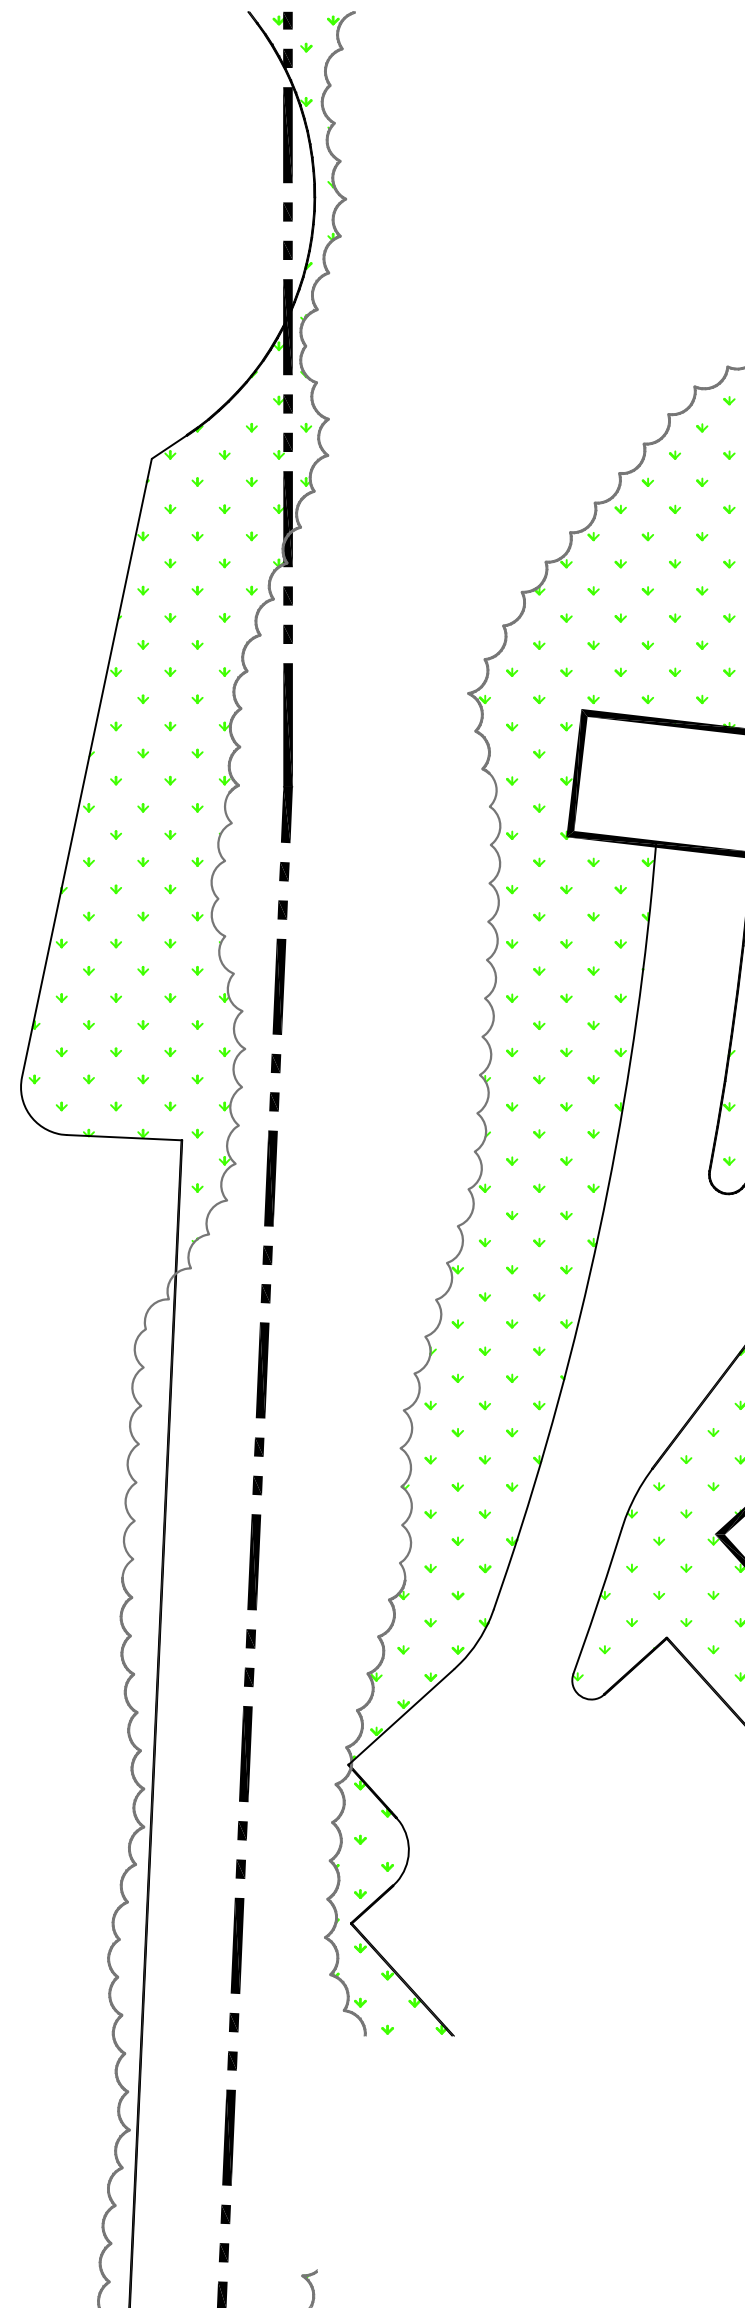
DESCRIPTION : FIGURE 3
GENERALIZED SITE PLAN SHOWING VAPOR
INTRUSION MITIGATION SYSTEM

Following discussion with the NYSDEC, a SSDS was installed during March and April of 2016 at the subject property by AWT Environmental Services Inc. of Sayreville, New Jersey. As is shown on Figure 3, the SSDS consists of depressurization points located in both the post office space and in the dry cleaners space. The depressurization points are constructed of 3-inch PVC piping which is installed through a bore hole in the slab of the building into clean stone below the slab and finished with concrete to insure no leakage around the piping. Each depressurization point is vented individually to an exhaust stack which terminates no less than 12 inches above the roof line and no less than 10 feet from any window or other building opening. The system is powered through the electrical circuit breaker box located in the dry cleaners utility room.

As shown on Figure 3, vacuum monitoring points were installed flush with the floor in the tenant spaces at fixed intervals extending from the depressurization points. At each depressurization point location, an audible vacuum monitoring alarm was installed. Each length of piping associated with the SSDS was labeled accordingly so as to avoid confusion with other PVC pipe runs.

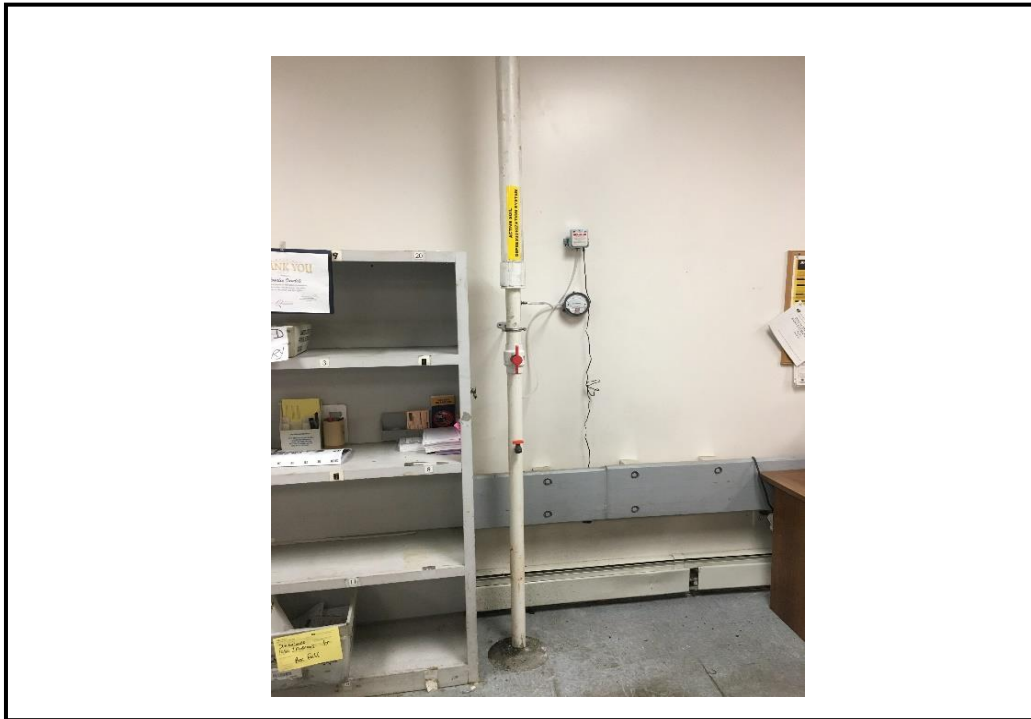
Photo No.: 1

Description: View of the sub-slab depressurization system point operating in the Post Office tenant space.

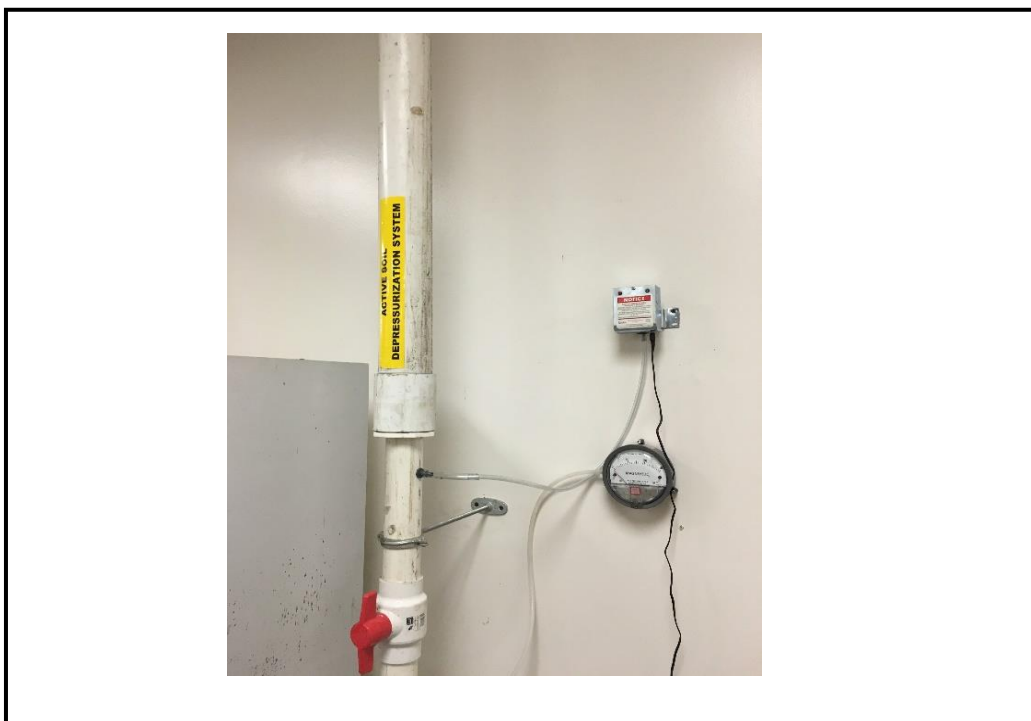
Photo No.: 2

Description: View of the audible alarm attached to the point located in the tenant space.

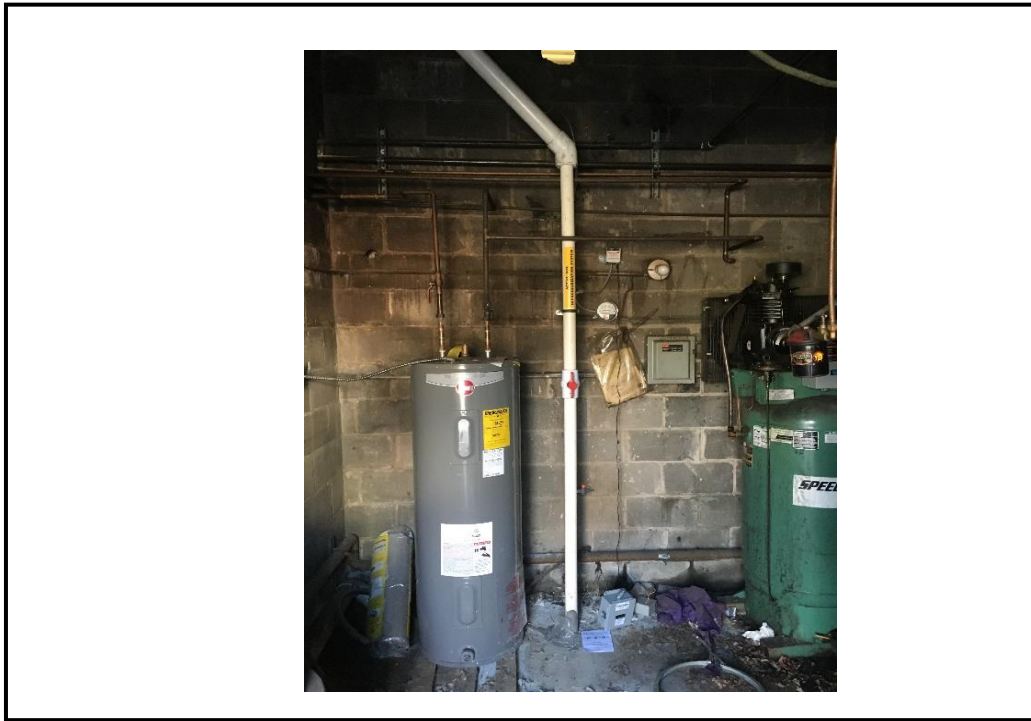
Photo No.: 3

Description: View of the sub-slab depressurization system point operating in the dry cleaner tenant space.

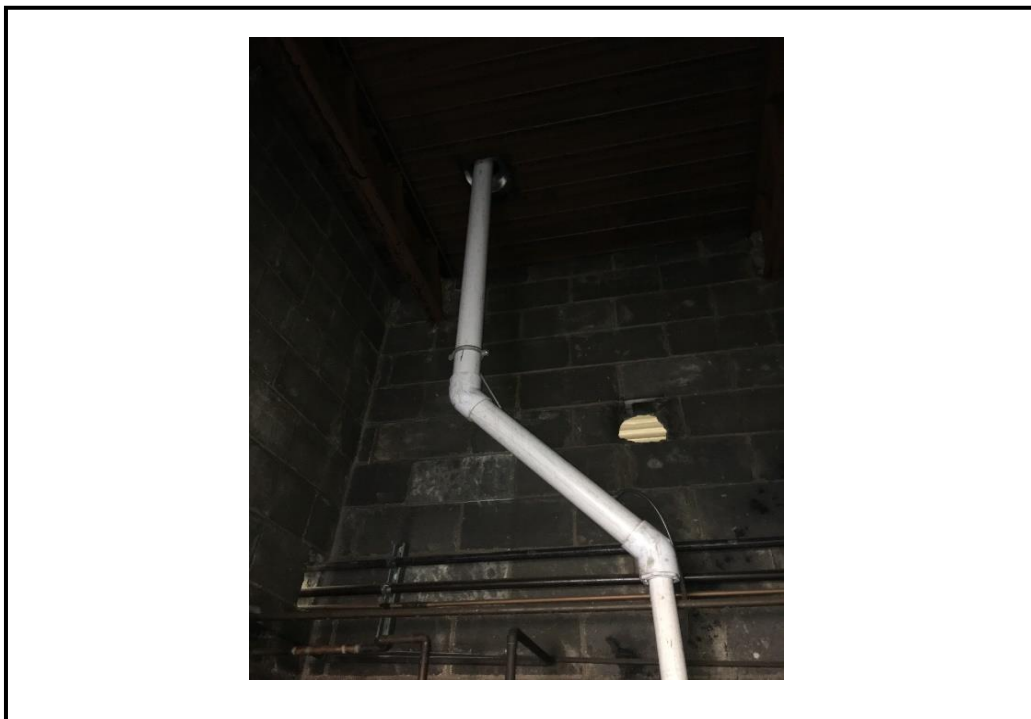
Photo No.: 4

Description: View of the extraction pipe exiting the building in the dry cleaner tenant space.

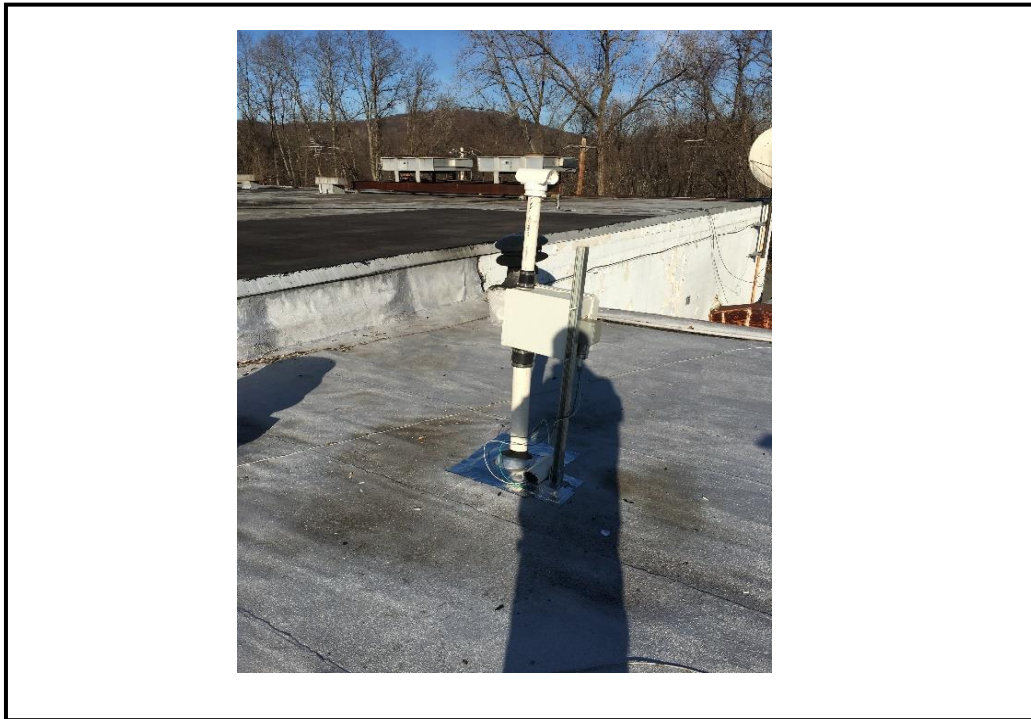
Photo No.: 5

Description: View of the blower and exhaust pipe on the roof of the building.

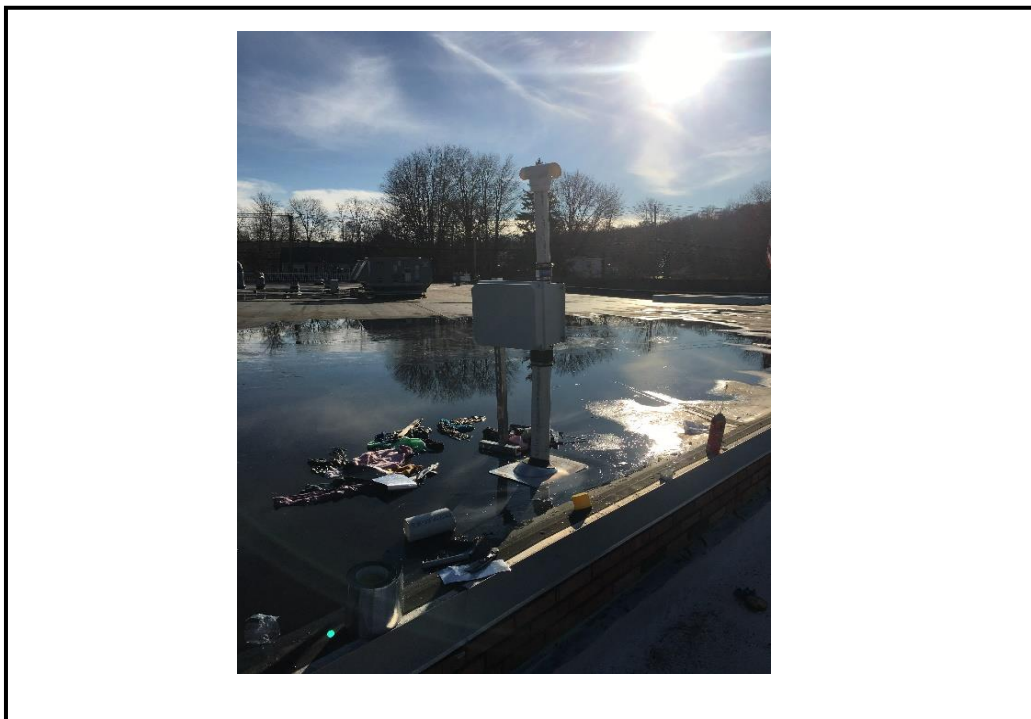
Photo No.: 6

Description: View of the blower and exhaust pipe on the roof of the building.
