Phase II Environmental Site Assessment REPORT

35-95 West Post Road &
80 Brady Place
White Plains, New York

213580.00
Brickman Associates
January 24, 2008

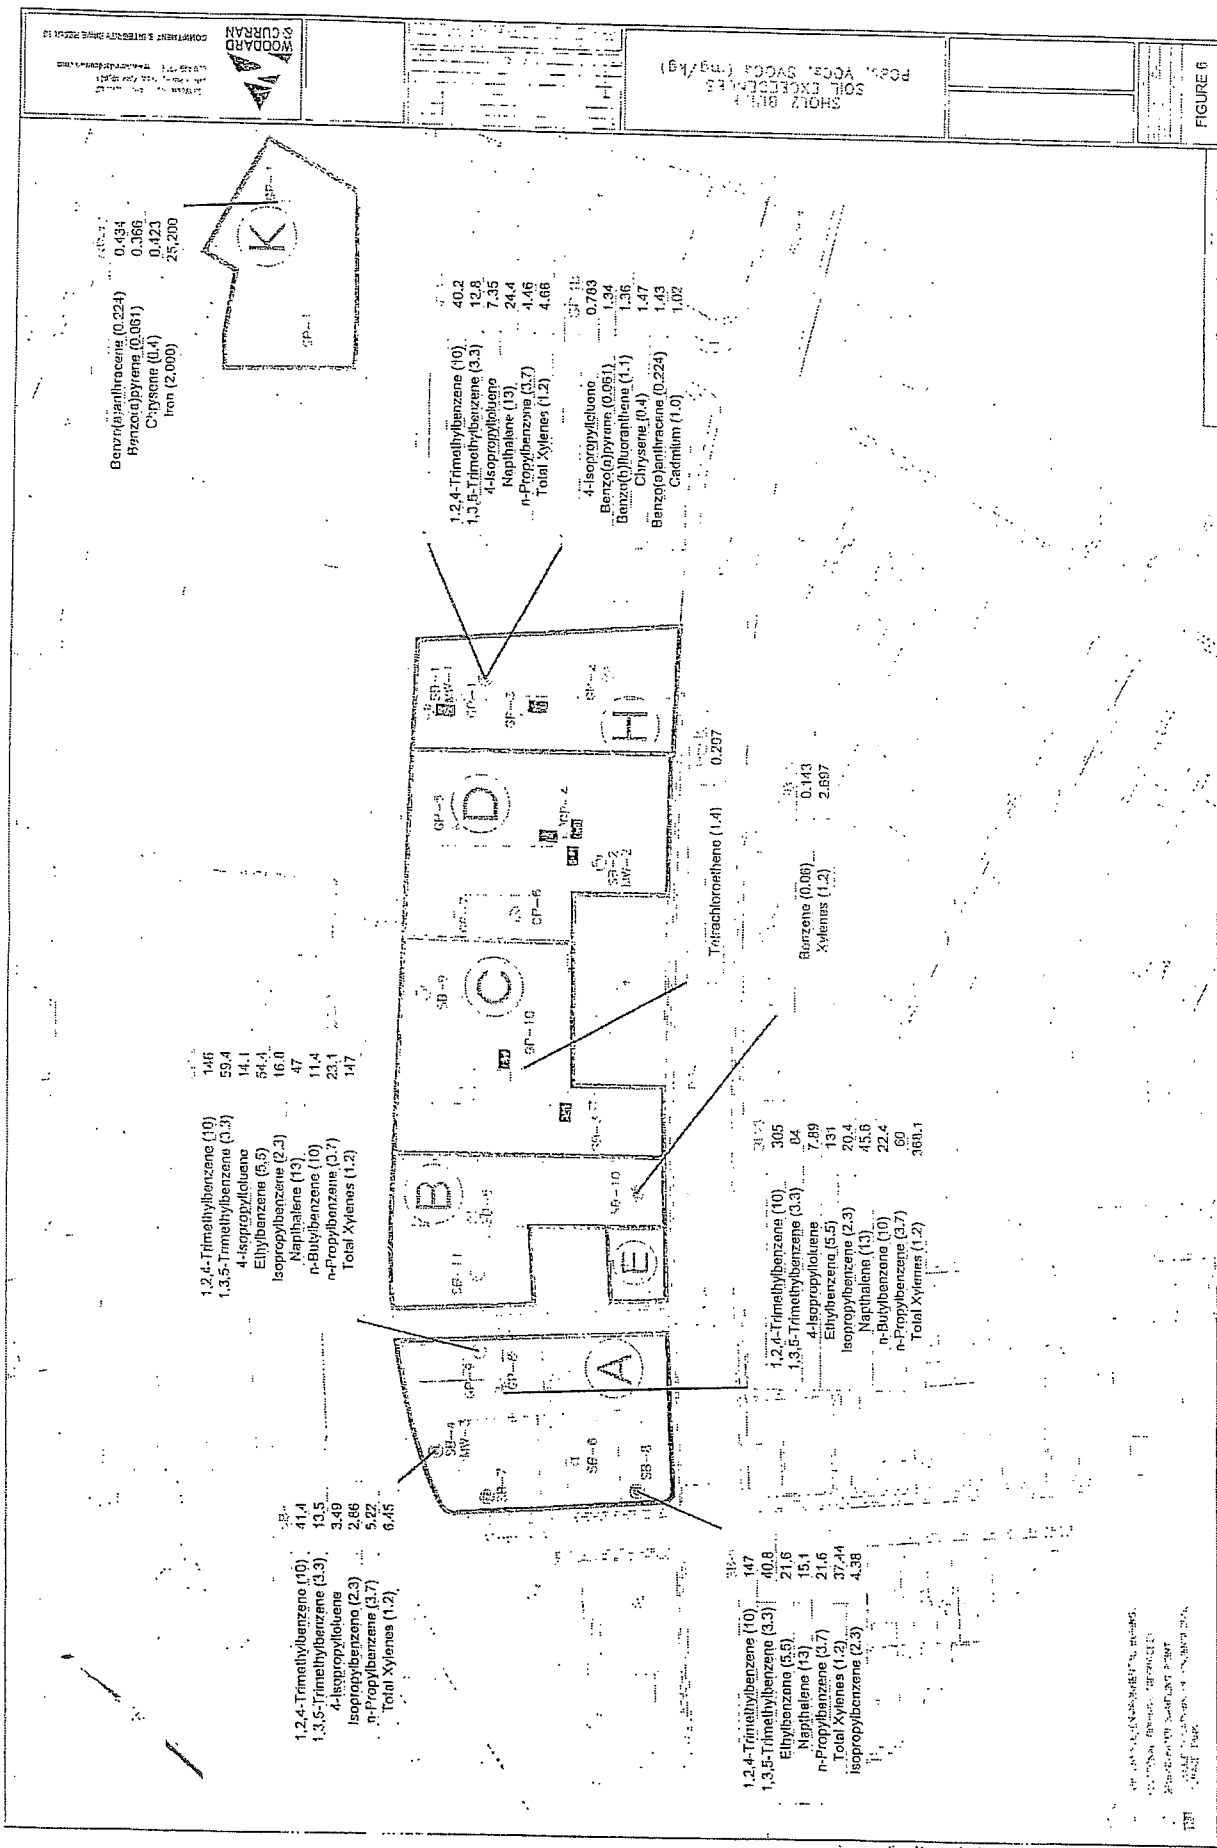
FIGURE 6

SOIL EXTRACTABLES
POLY. ACO. SVCS. (mg/kg)
