FORMER CHATSWORTH COAL AND SUPPLY SITE

**2101 AND 2103 PALMER AVENUE
VILLAGE OF LARCHMONT
WESTCHESTER COUNTY, NEW YORK
NYSDEC SITE #: C360132**

PERIODIC REVIEW REPORT

PERIOD OF 2017 - 2021

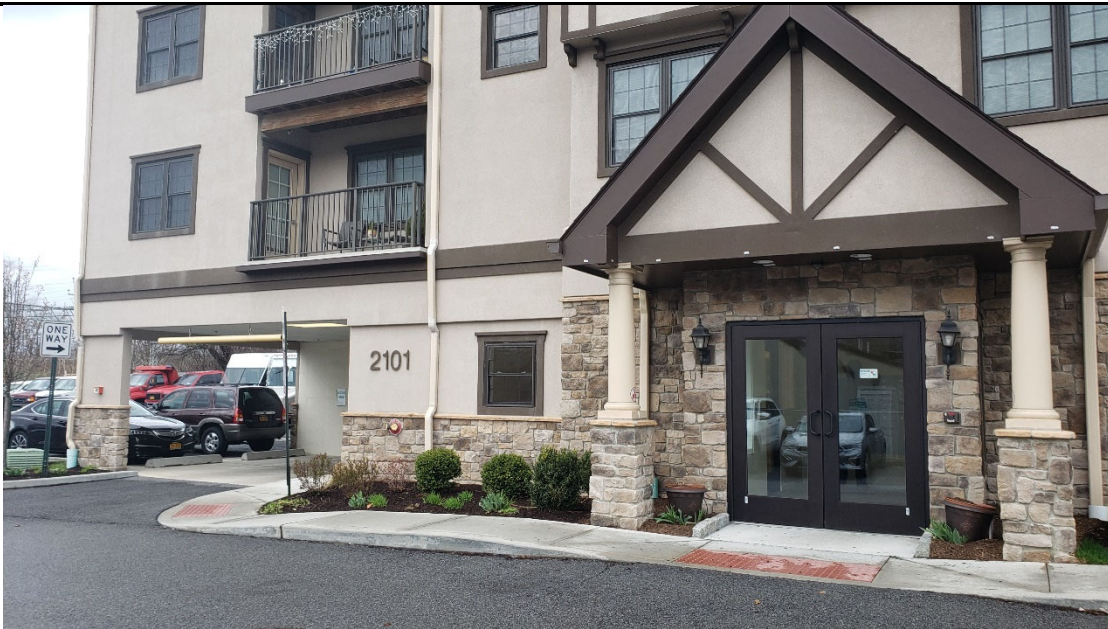
Photograph #1: Facing north, view of the main entrance to 2101 Palmer Avenue.

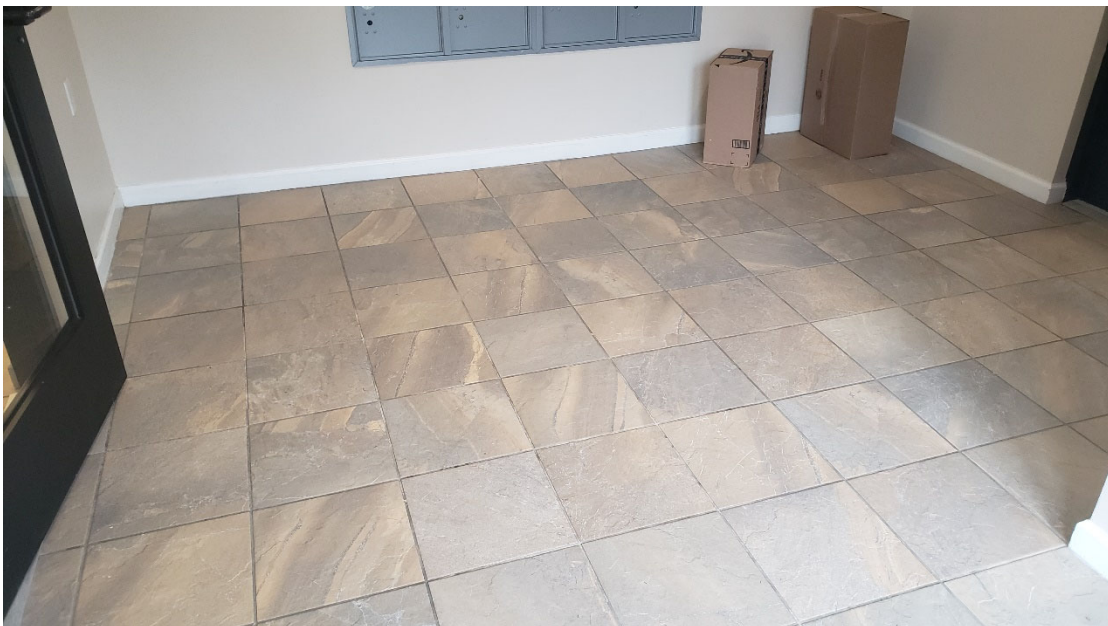
Photograph #2: View of the main entrance/interior at-grade of 2101 Palmer Avenue.

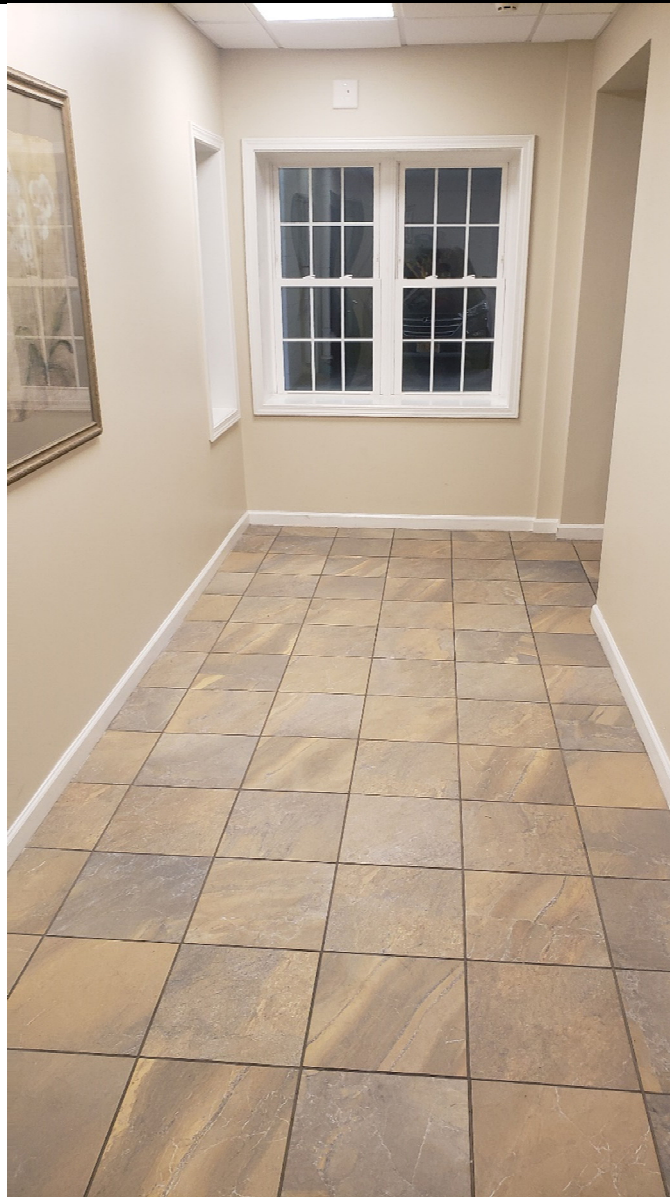
Photograph #3: View of the interior at-grade of 2101 Palmer Avenue.

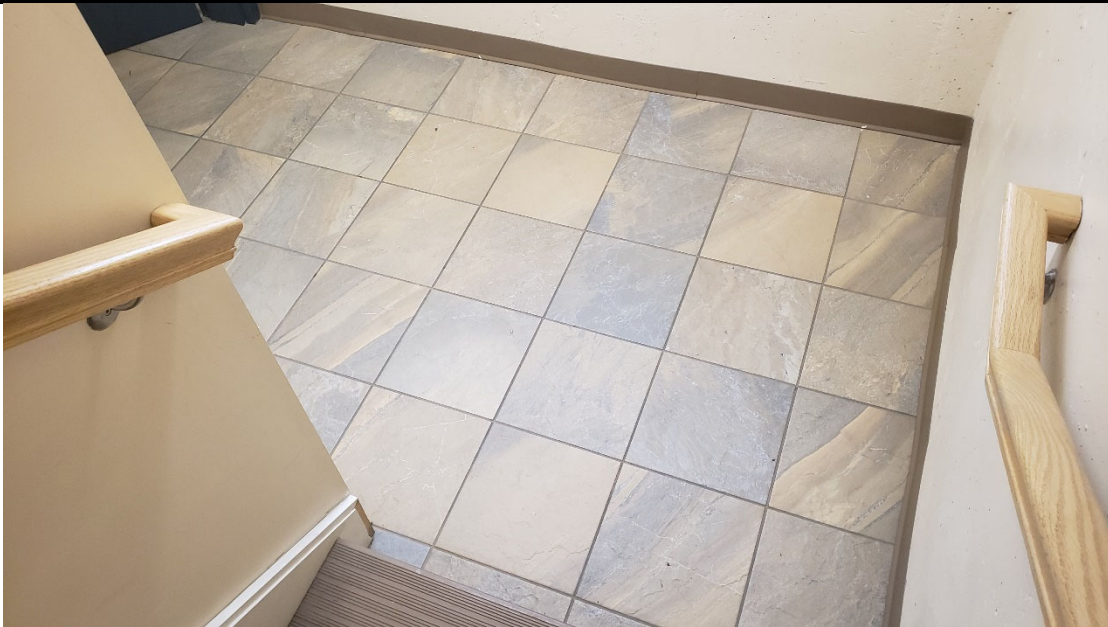
Photograph #4: View of the stairwell interior at-grade of 2101 Palmer Avenue.

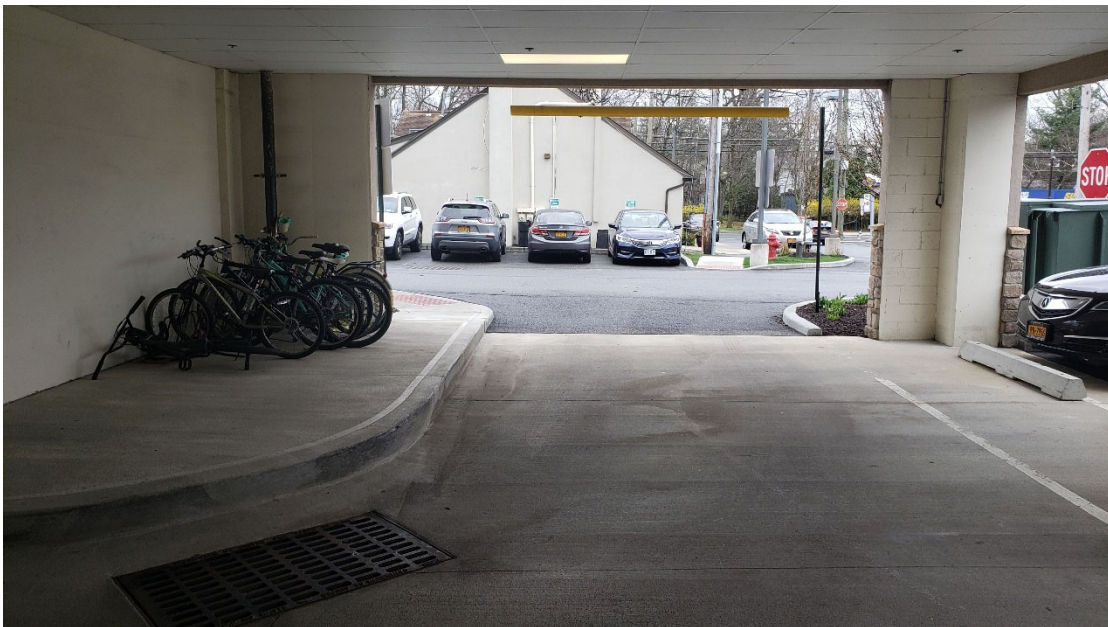
Photograph #5: View of the entrance to the parking garage area of 2101 Palmer Avenue.

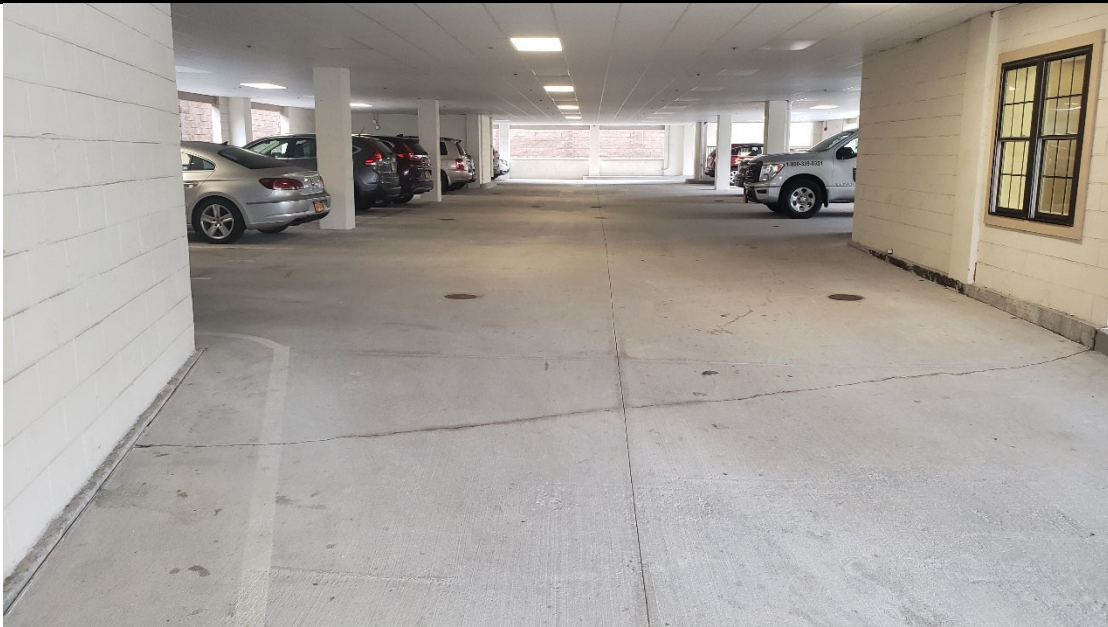
Photograph #6: Facing east, view of the parking garage area of 2101 Palmer Avenue.

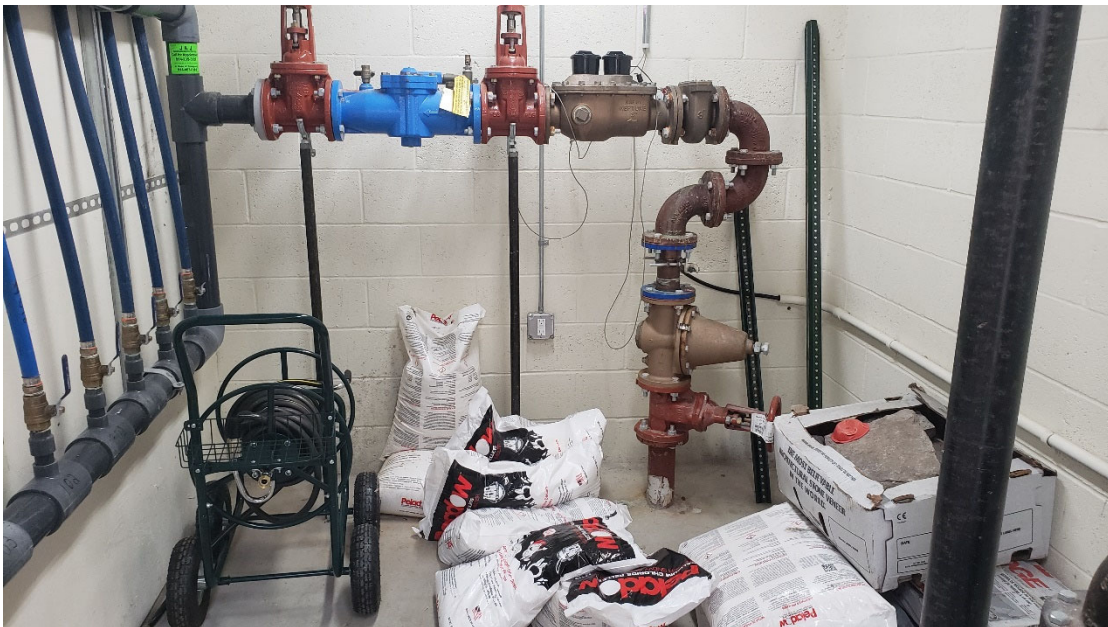
Photograph #7: View of the interior area of the Sprinkler Room of 2101 Palmer Avenue.

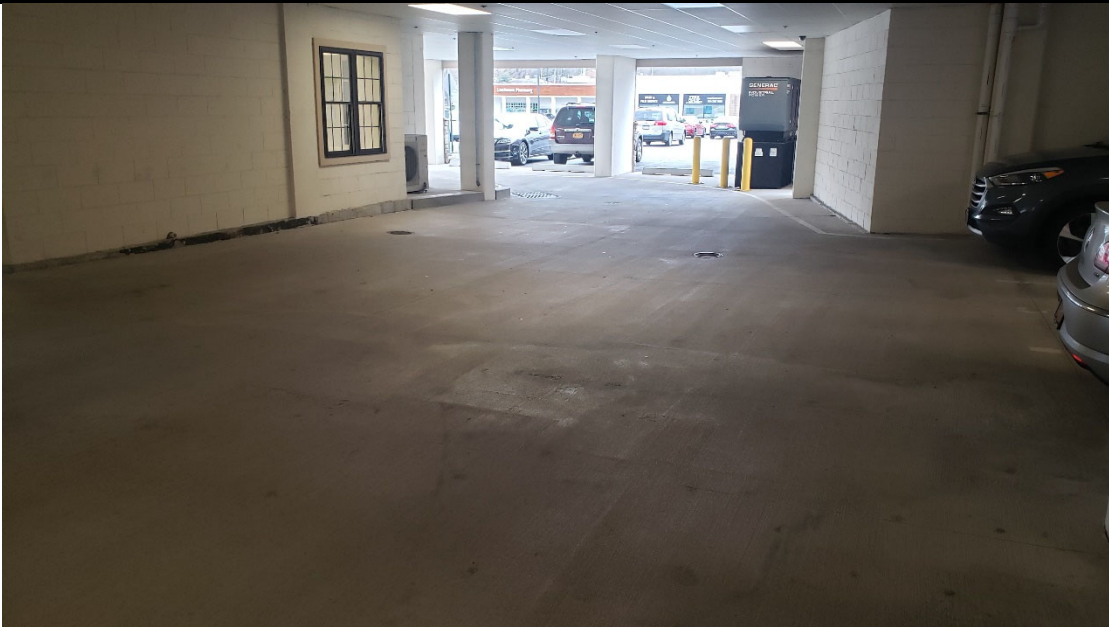
Photograph #8: Facing west/southwest, view of the parking garage area of 2101 Palmer Avenue.

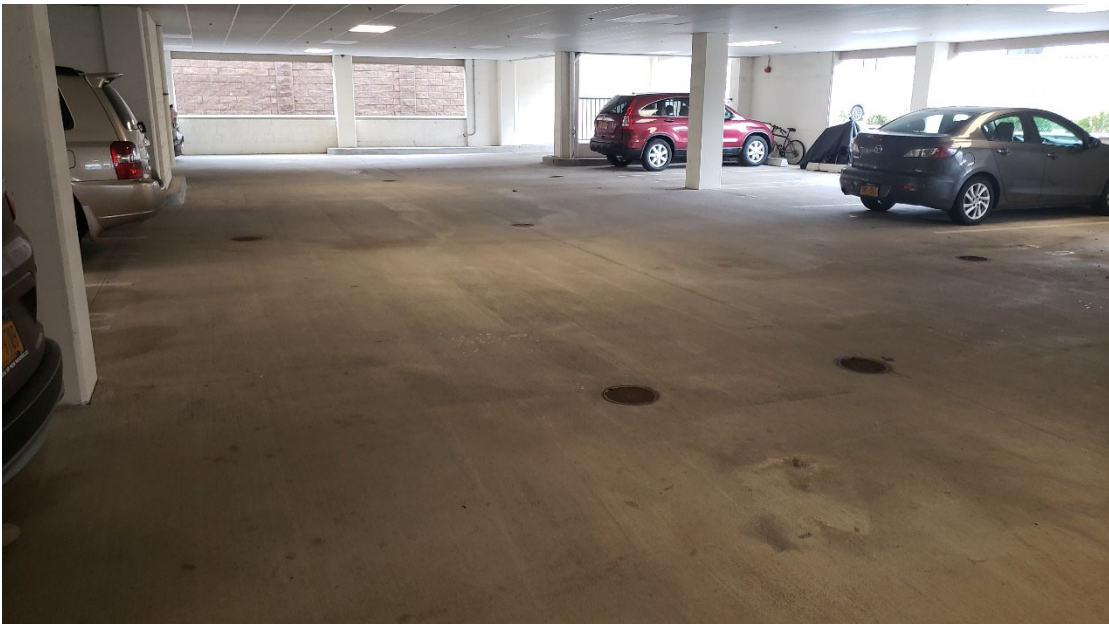
Photograph #9: Facing east/northeast, view of the parking garage area of 2101 Palmer Avenue.

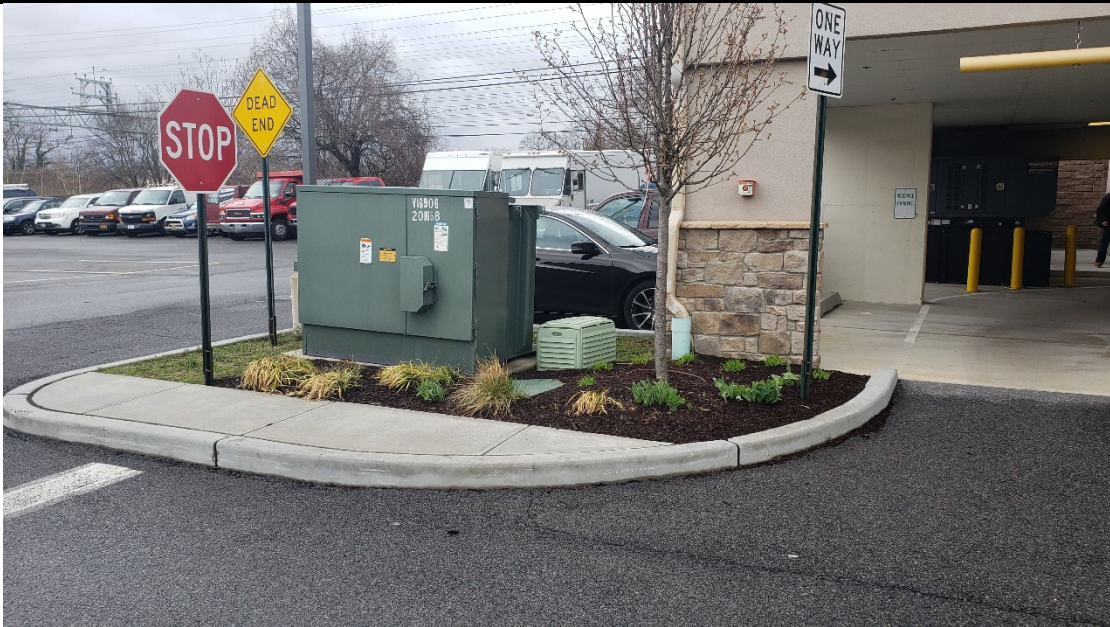
Photograph #10: View of a landscape area on 2101 Palmer Avenue.

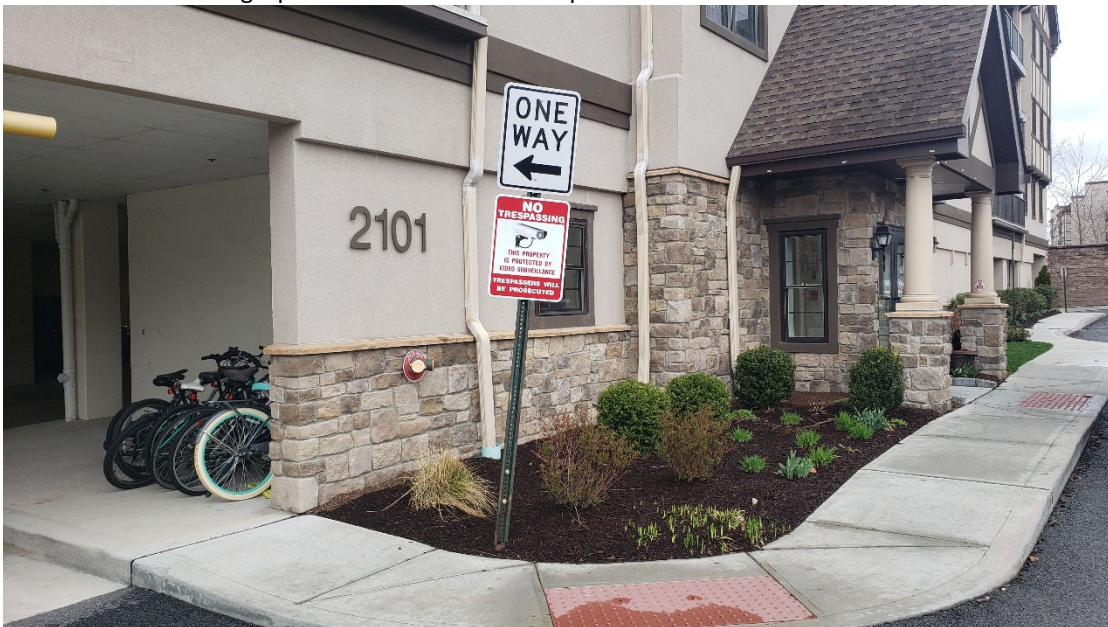
Photograph #11: View of a landscape area on 2101 Palmer Avenue.

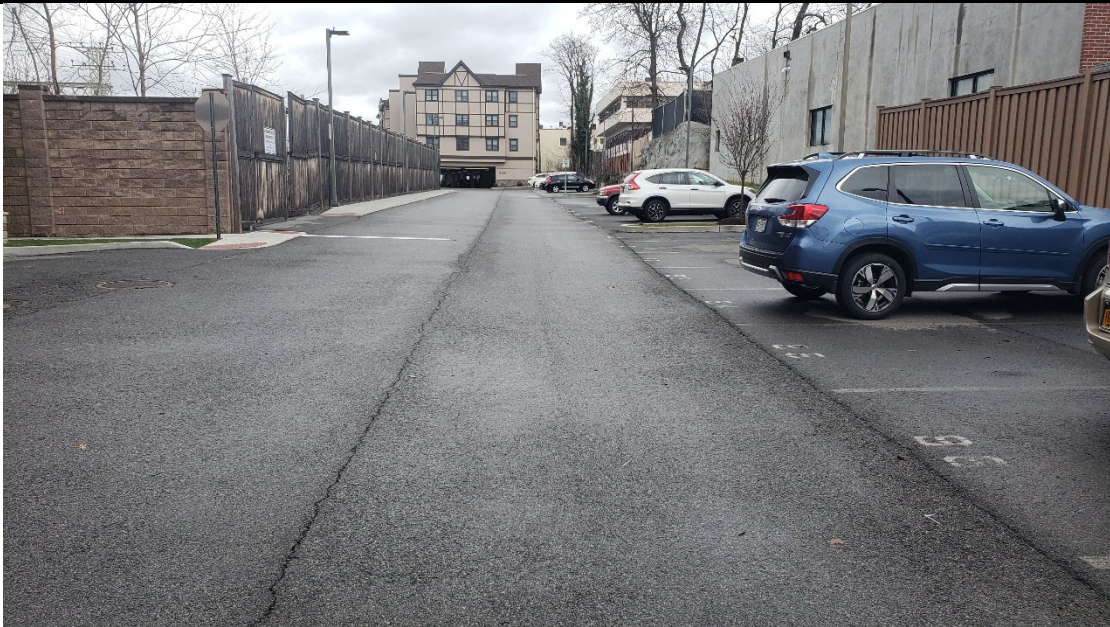
- Length? 2' → 5'
 - Width? 1/4" → 1/2"
 - Depth? < 1"
 - Where are the cracks/depressions/openings located?
MINOR CRACKING IN ASPHALT PARKING LOT THROUGHOUT THE SITE

Photograph #12: Facing east/northeast, view of the asphalt parking lot area of 2101 Palmer Avenue.

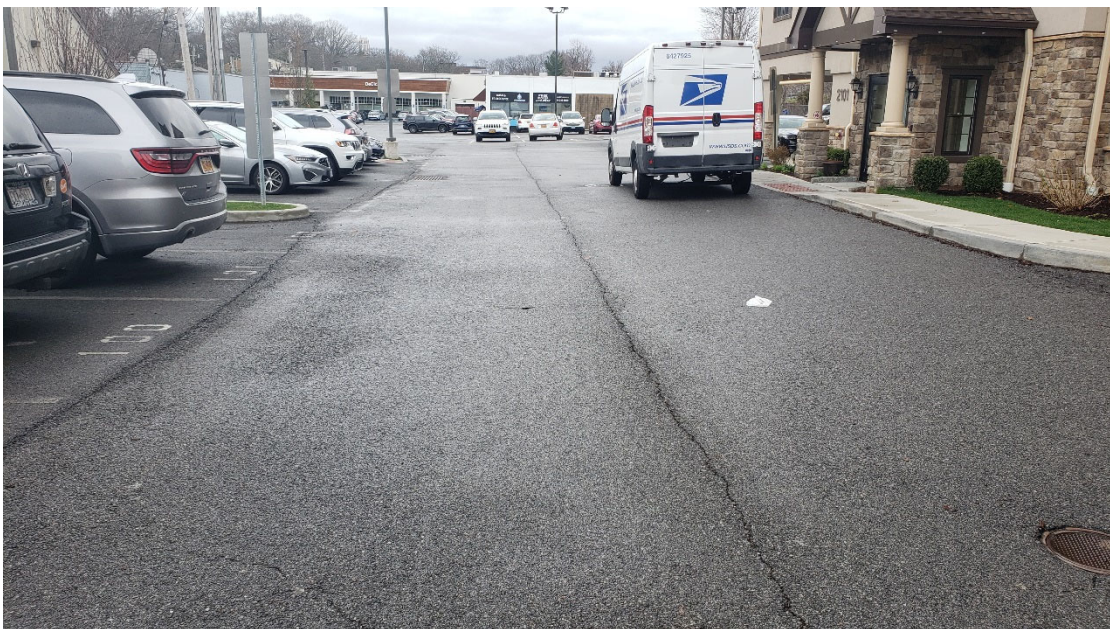
Photograph #13: Facing west/southwest, view of the asphalt parking lot area of 2101 Palmer Avenue.

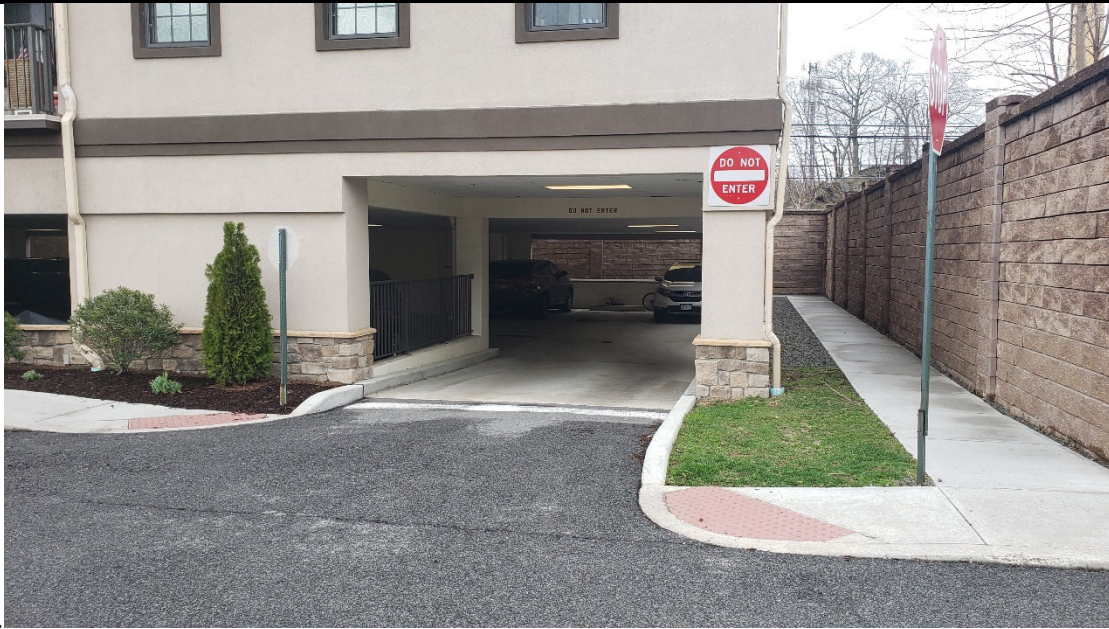
Photograph #14: View of the exit of the parking garage area of 2101 Palmer Avenue.

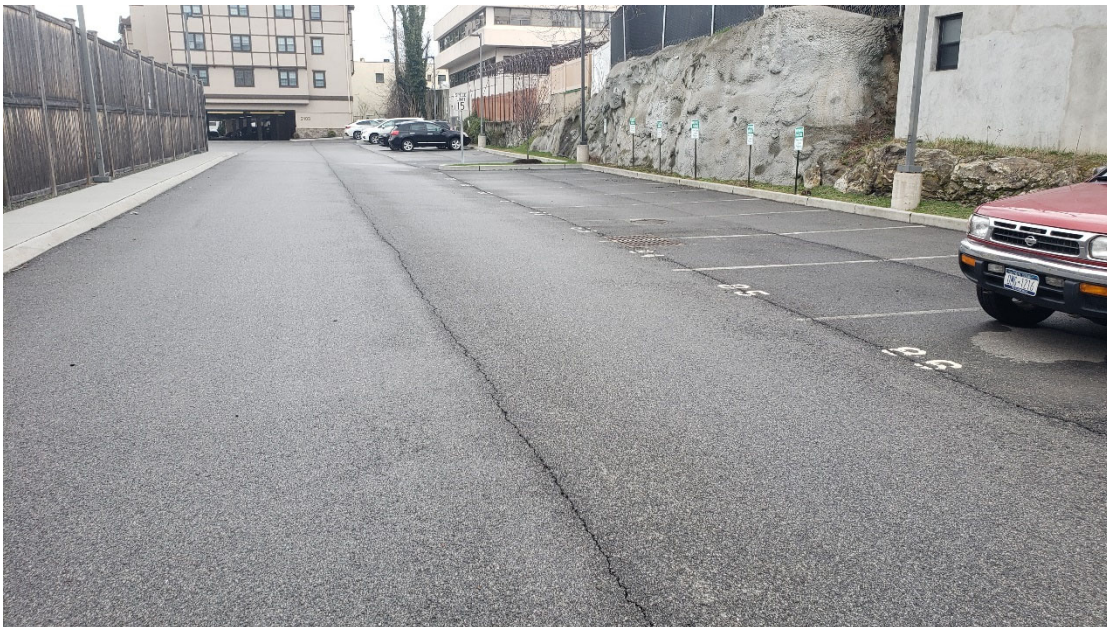
Photograph #15: Facing east/northeast, view of the asphalt parking lot area of 2103 Palmer Avenue.

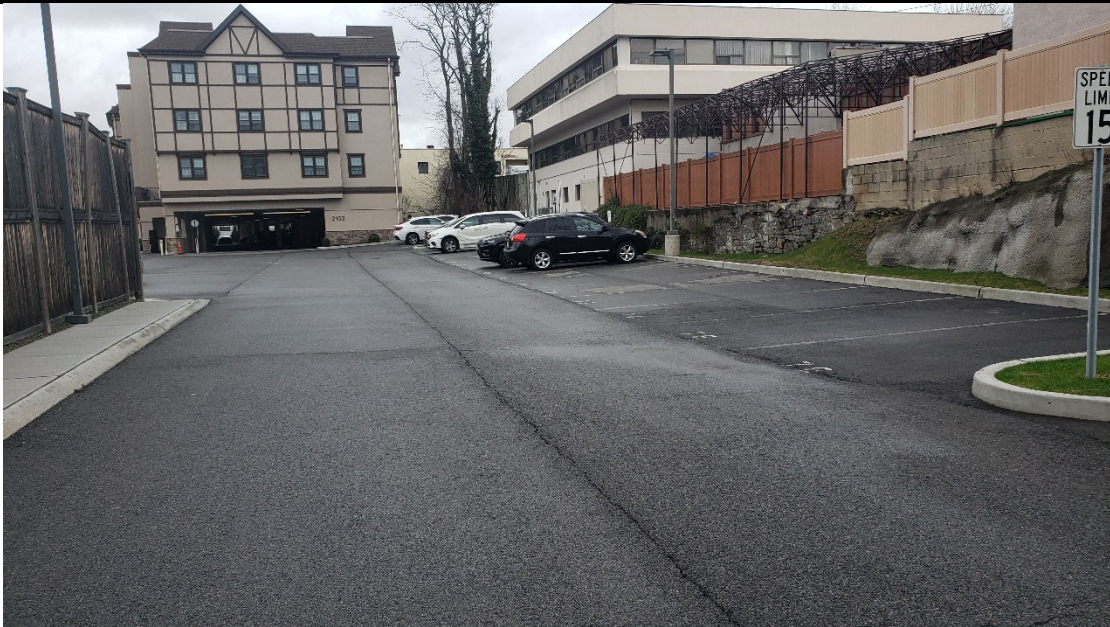
Photograph #16: Facing east/northeast, view of the asphalt parking lot area of 2103 Palmer Avenue.

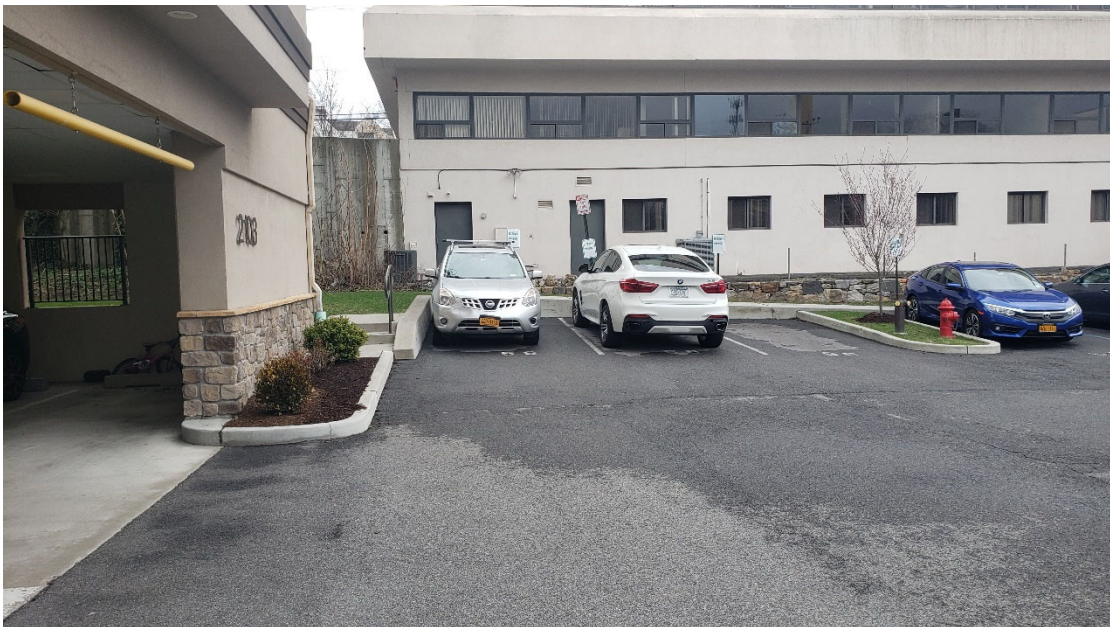
Photograph #17: View of a landscape area and entrance to the parking garage area of 2103 Palmer Avenue.

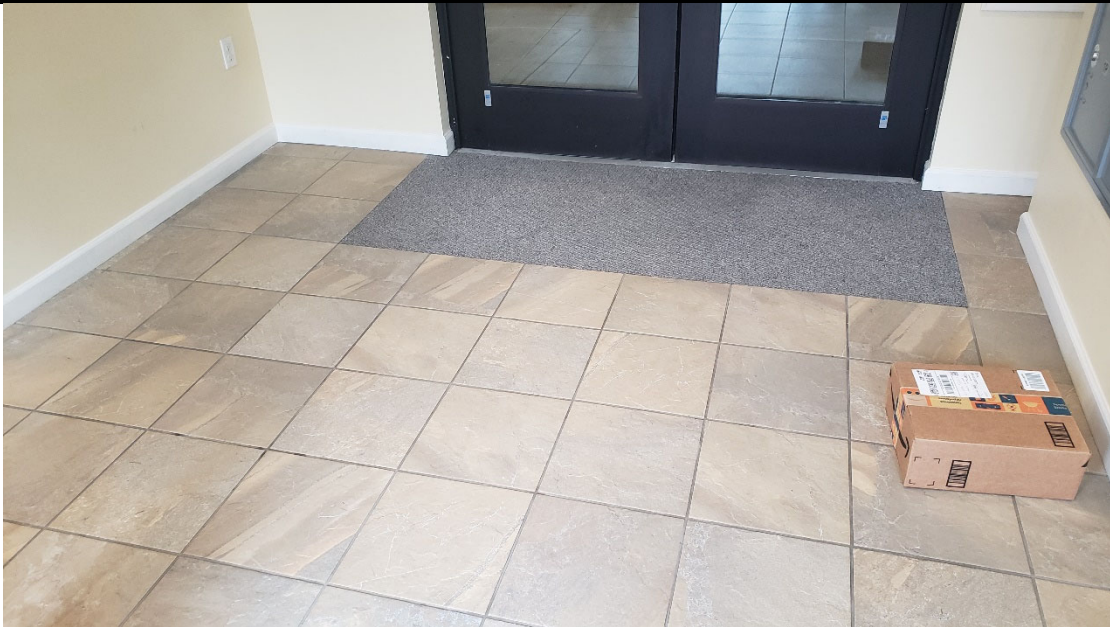
Photograph #18: View of the main entrance/interior at-grade of 2103 Palmer Avenue.

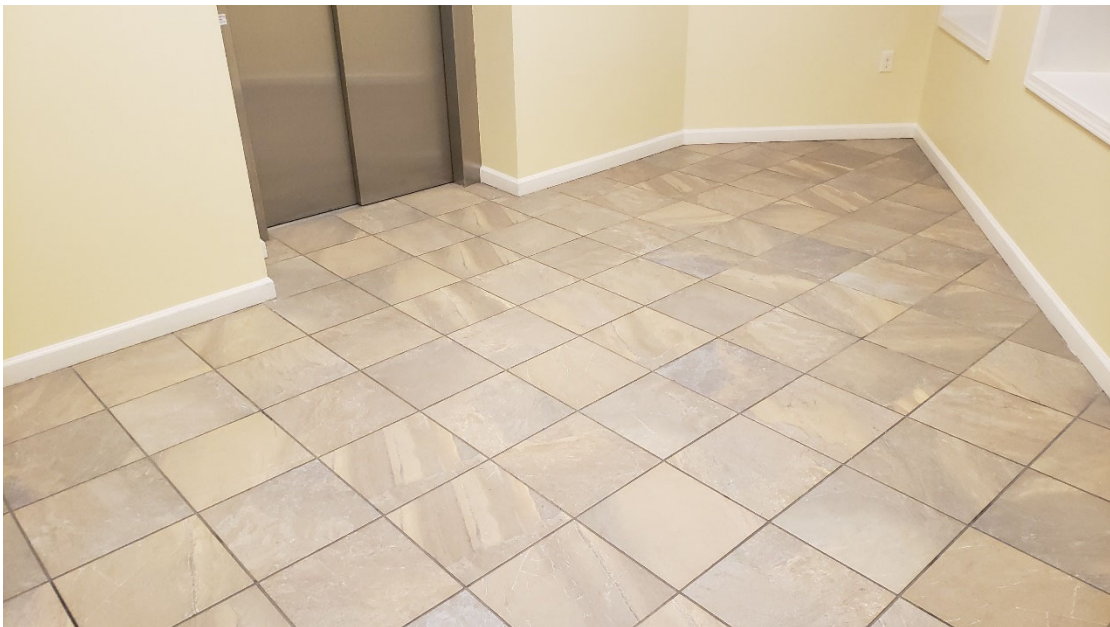
Photograph #19: View of the interior at-grade of 2103 Palmer Avenue.

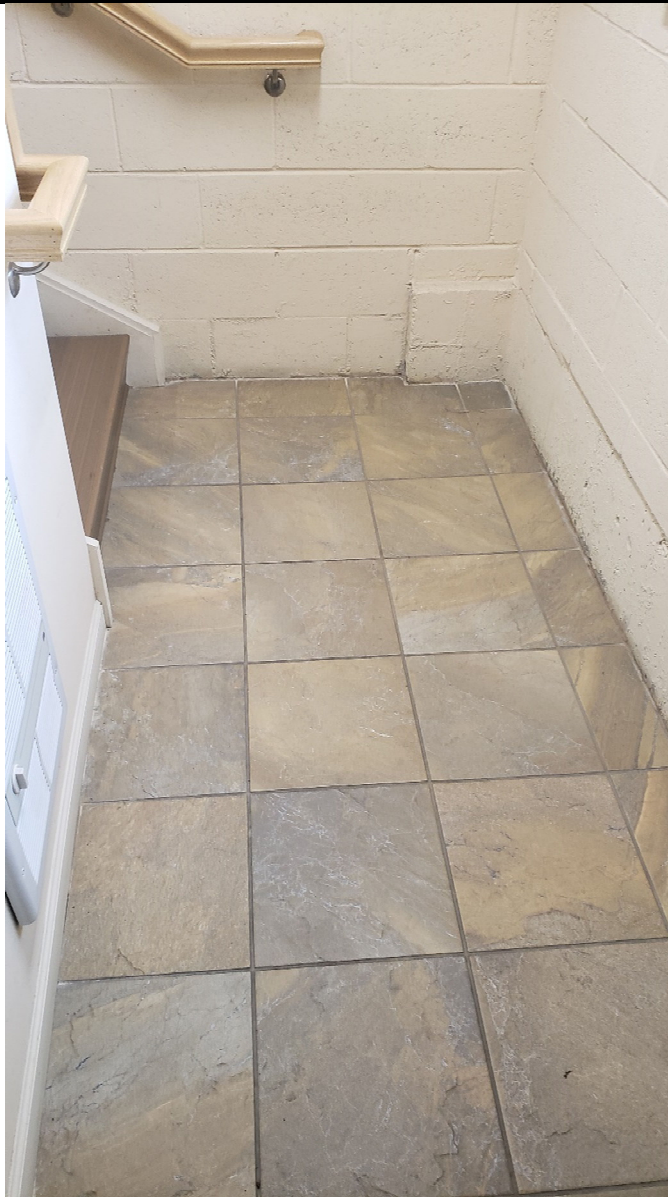
Photograph #20: View of the stairwell interior at-grade of 2103 Palmer Avenue.

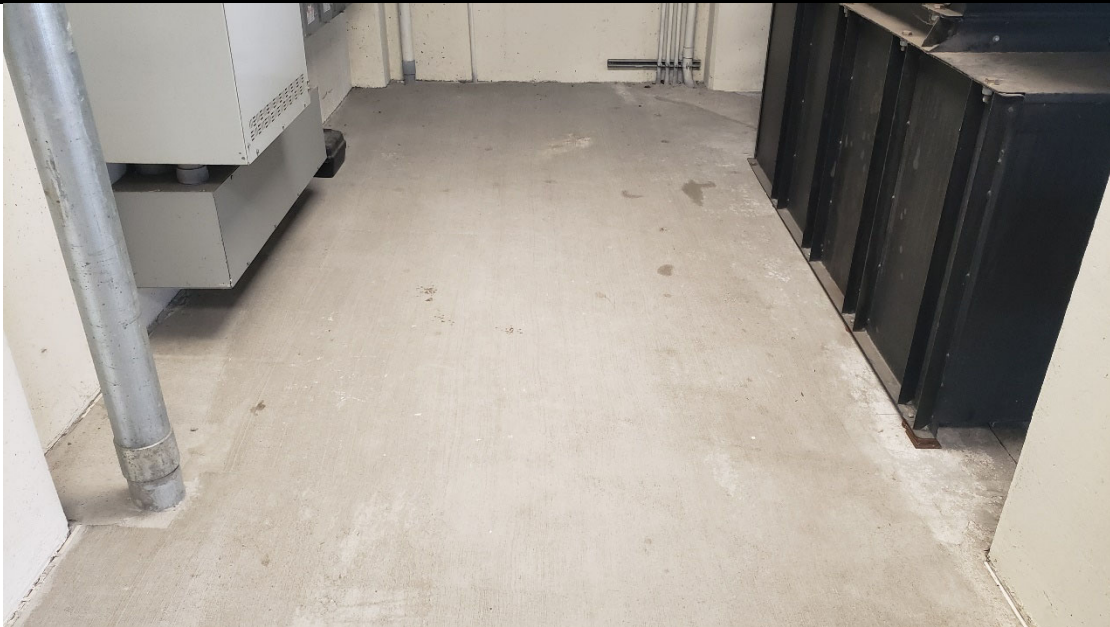
Photograph #21: View of the HVAC Equipment room interior at-grade of 2103 Palmer Avenue.

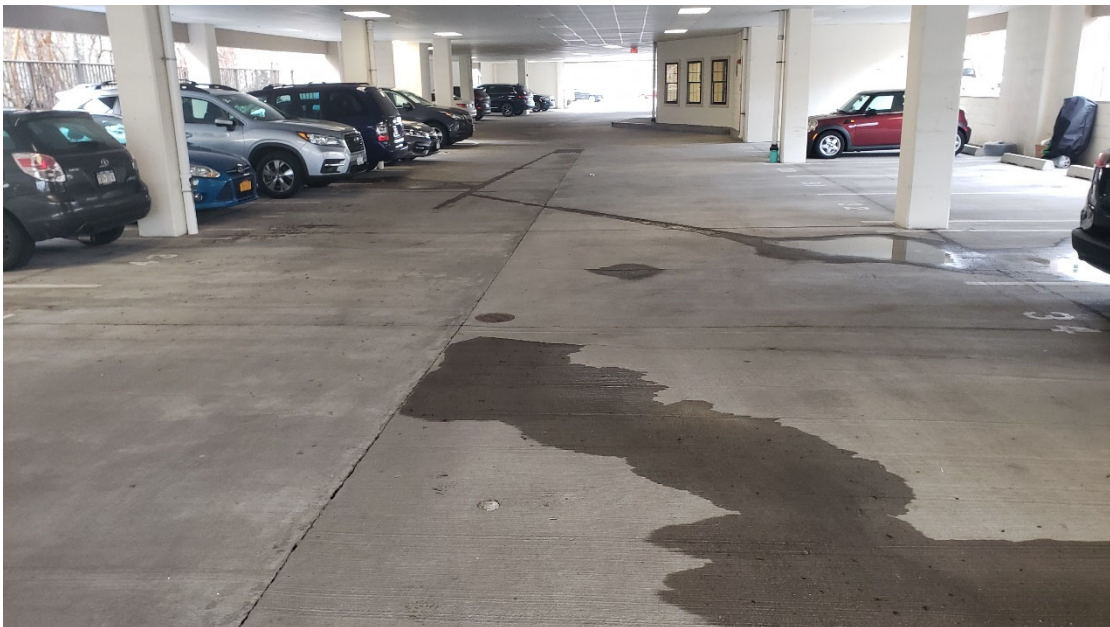
Photograph #22: Facing west/southwest, view of the parking garage area of 2103 Palmer Avenue.

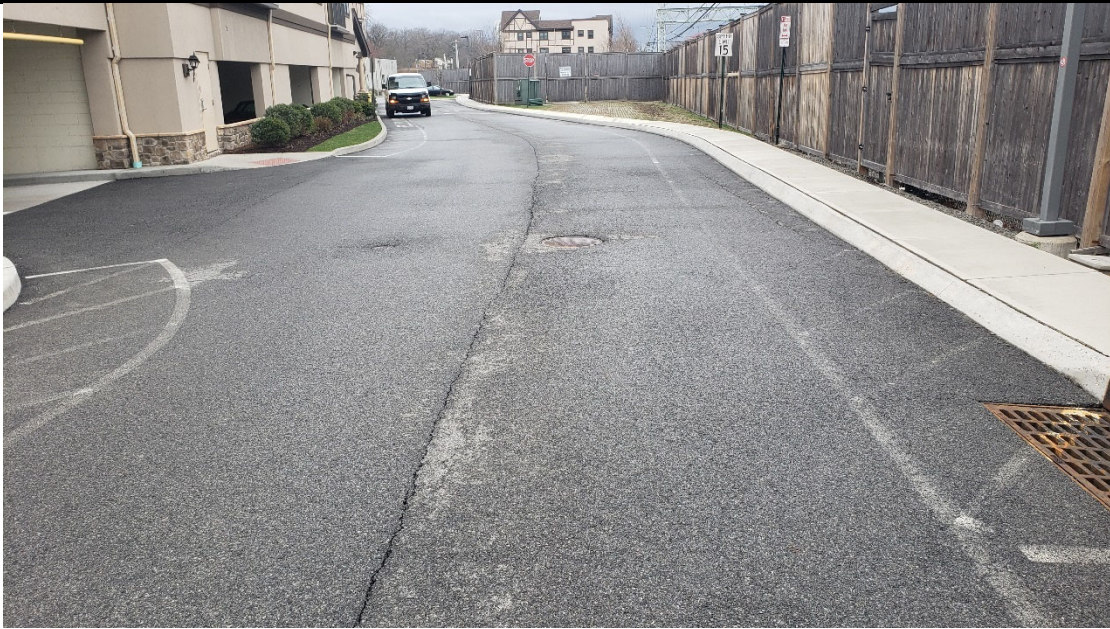
Photograph #23: Facing west/southwest, view of the northernmost asphalt area of 2103 Palmer Avenue.

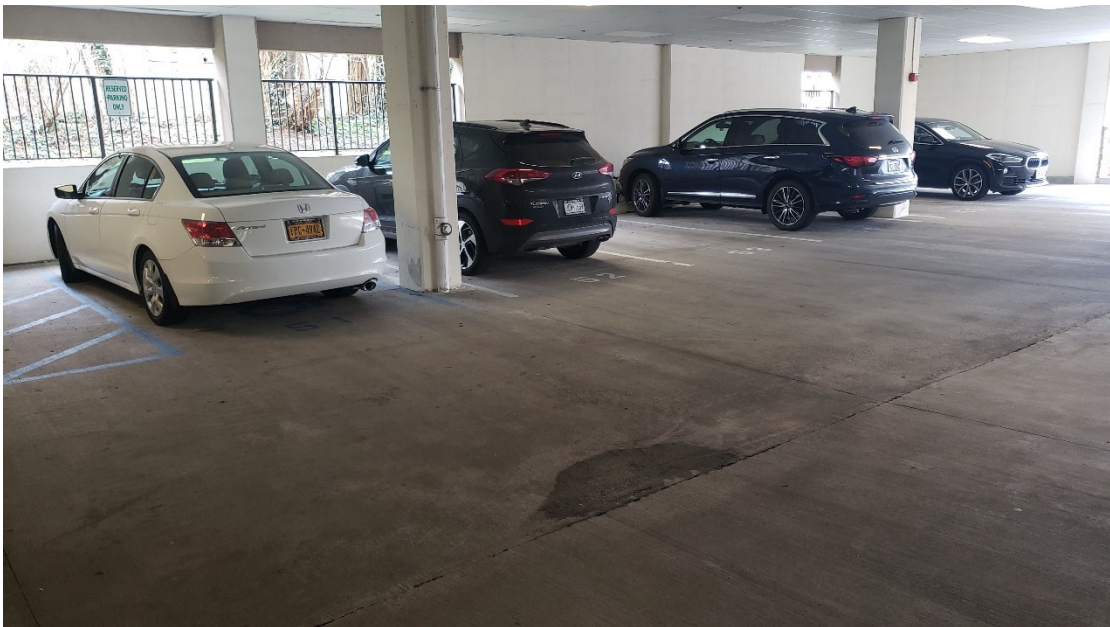
Photograph #24: View of the parking garage area of 2103 Palmer Avenue.
