Re: Brownfield Cleanup Program Periodic Review Report  
November 23, 2021 to November 23, 2022  
300-308 Columbus Avenue, Tuckahoe, NY 10707  
NYSDEC Site Number: C360136

**300 & 308 COLUMBUS AVE**  
TUCKAHOE, NEW YORK

**SITE COVER SYSTEM PLAN**

**300-308 COLUMBUS AVE**  
**TUCKAHOE, NEW YORK**  
**SSDS LOCATION PLAN**

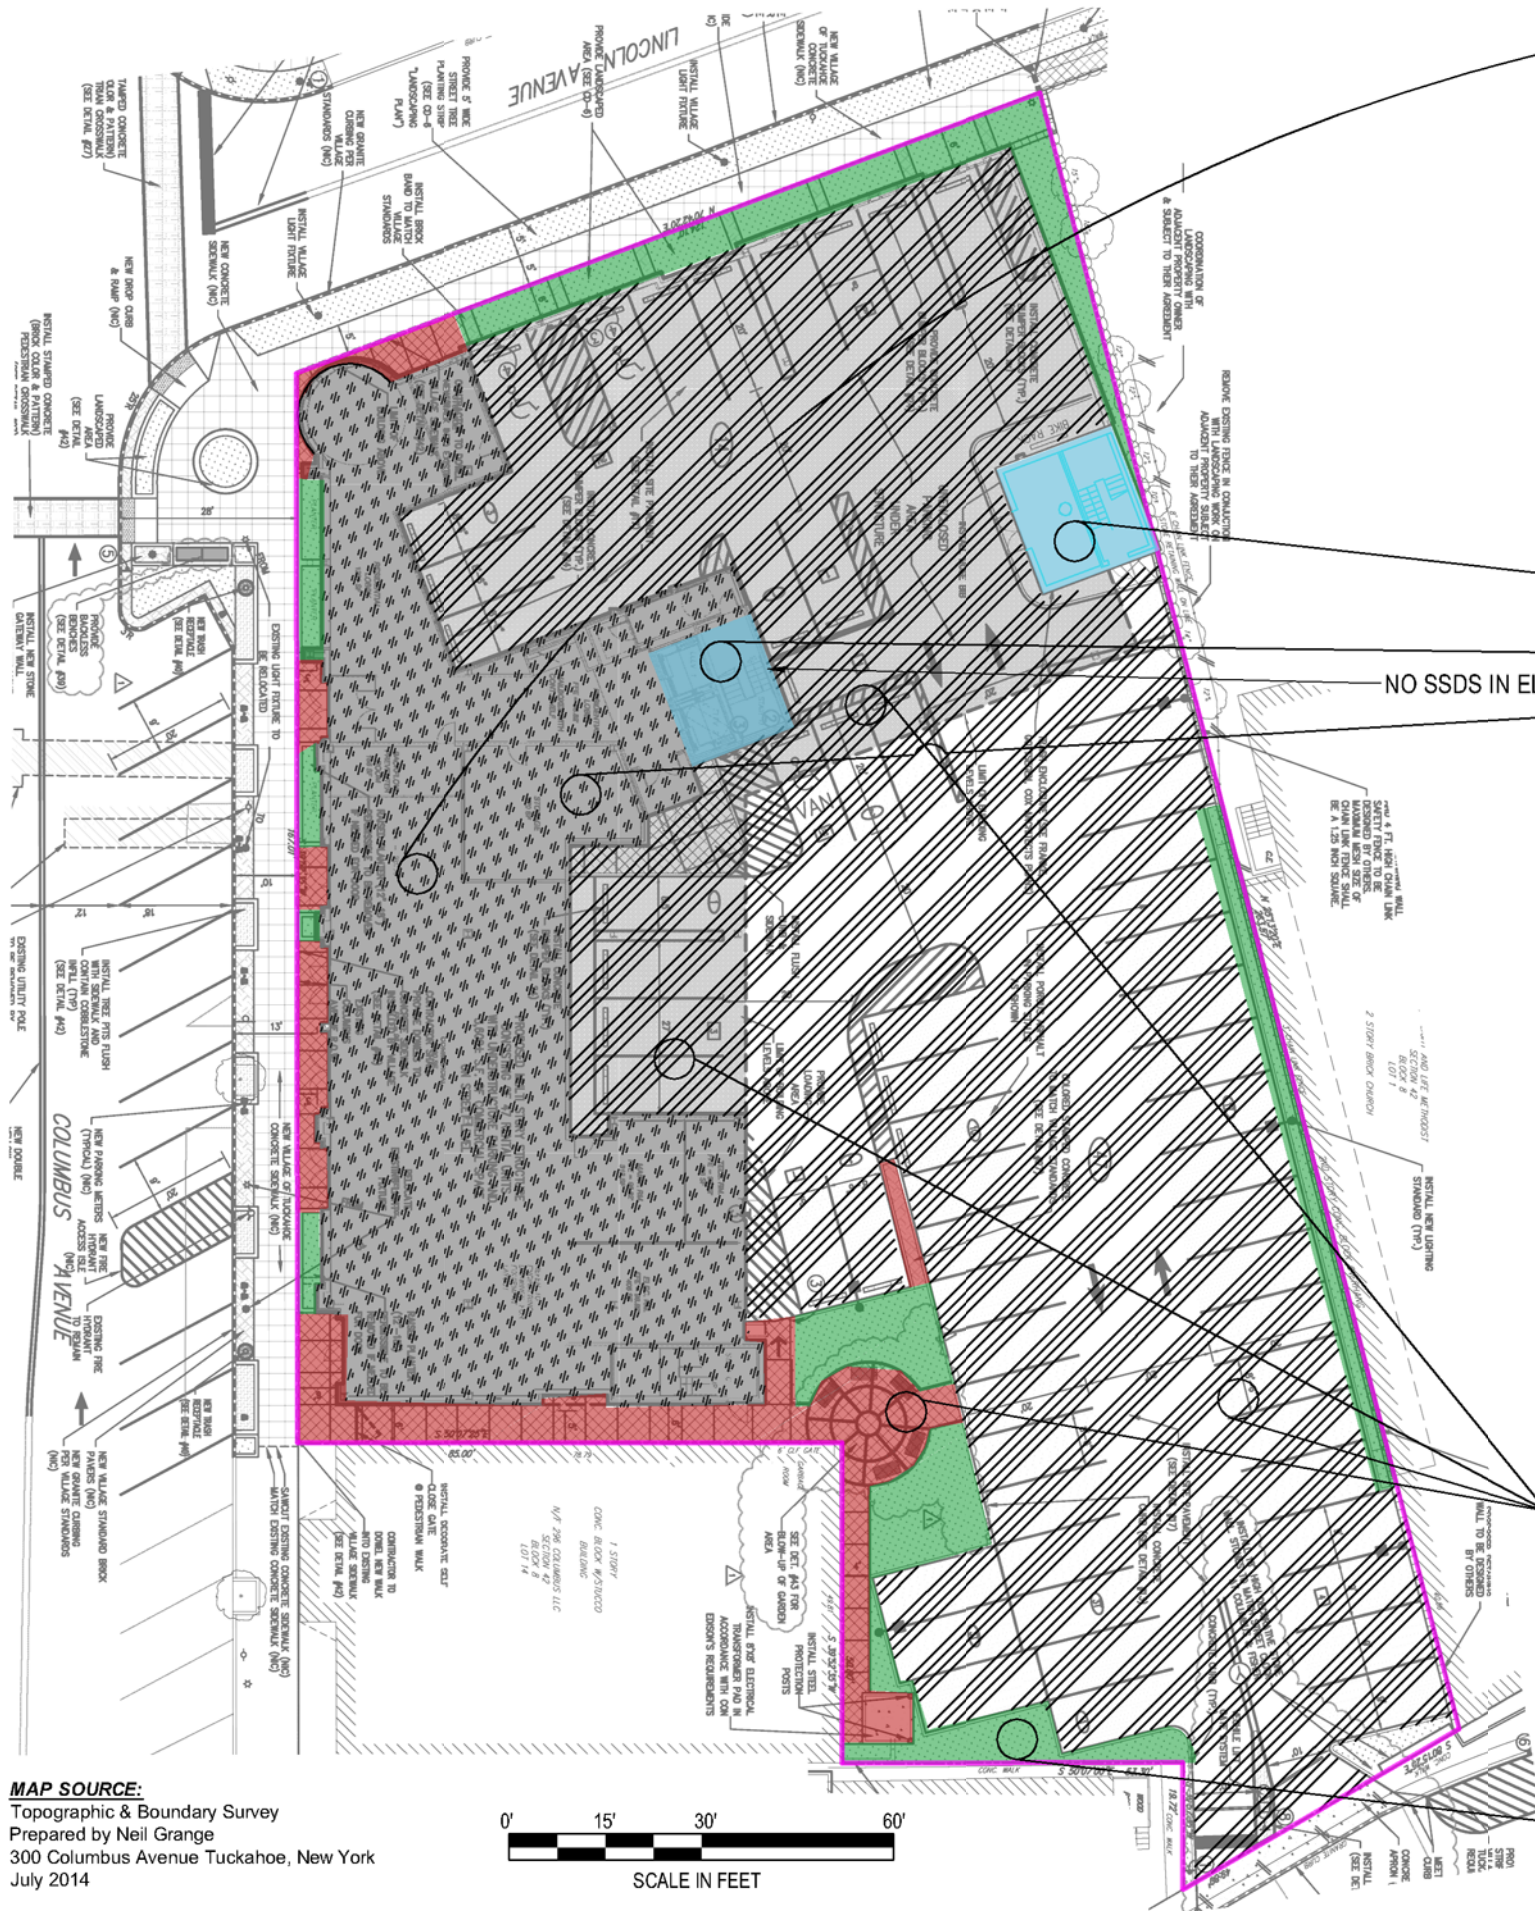
FIGURE  
2

On November 11, 2022, AKRF completed a Site inspection in accordance with the SMP to confirm building conditions, composite cover system integrity, and operation of the passive SSDS. The composite cover system was found to be intact, with no signs of significant cracking, damage, or erosion that would affect the integrity of the cover system. The SSDS system was observed to be intact with no visible signs of damage or broken seals, and the wind-driven turbine for the passive SSDS stack on the roof was properly operating as described in the SMP. While no visual evidence of damage to the cover system or SSDS was noted, a PID was used to field-screen background conditions in indoor areas, around pipe penetrations, and around accessible SSDS components (piping, valves, and the exhaust stack) to confirm the visual observations. The PID was calibrated with 100 parts per million (ppm) isobutylene calibration gas and fresh air in accordance with manufacturer's specifications. No PID readings above background levels were noted during the inspection.

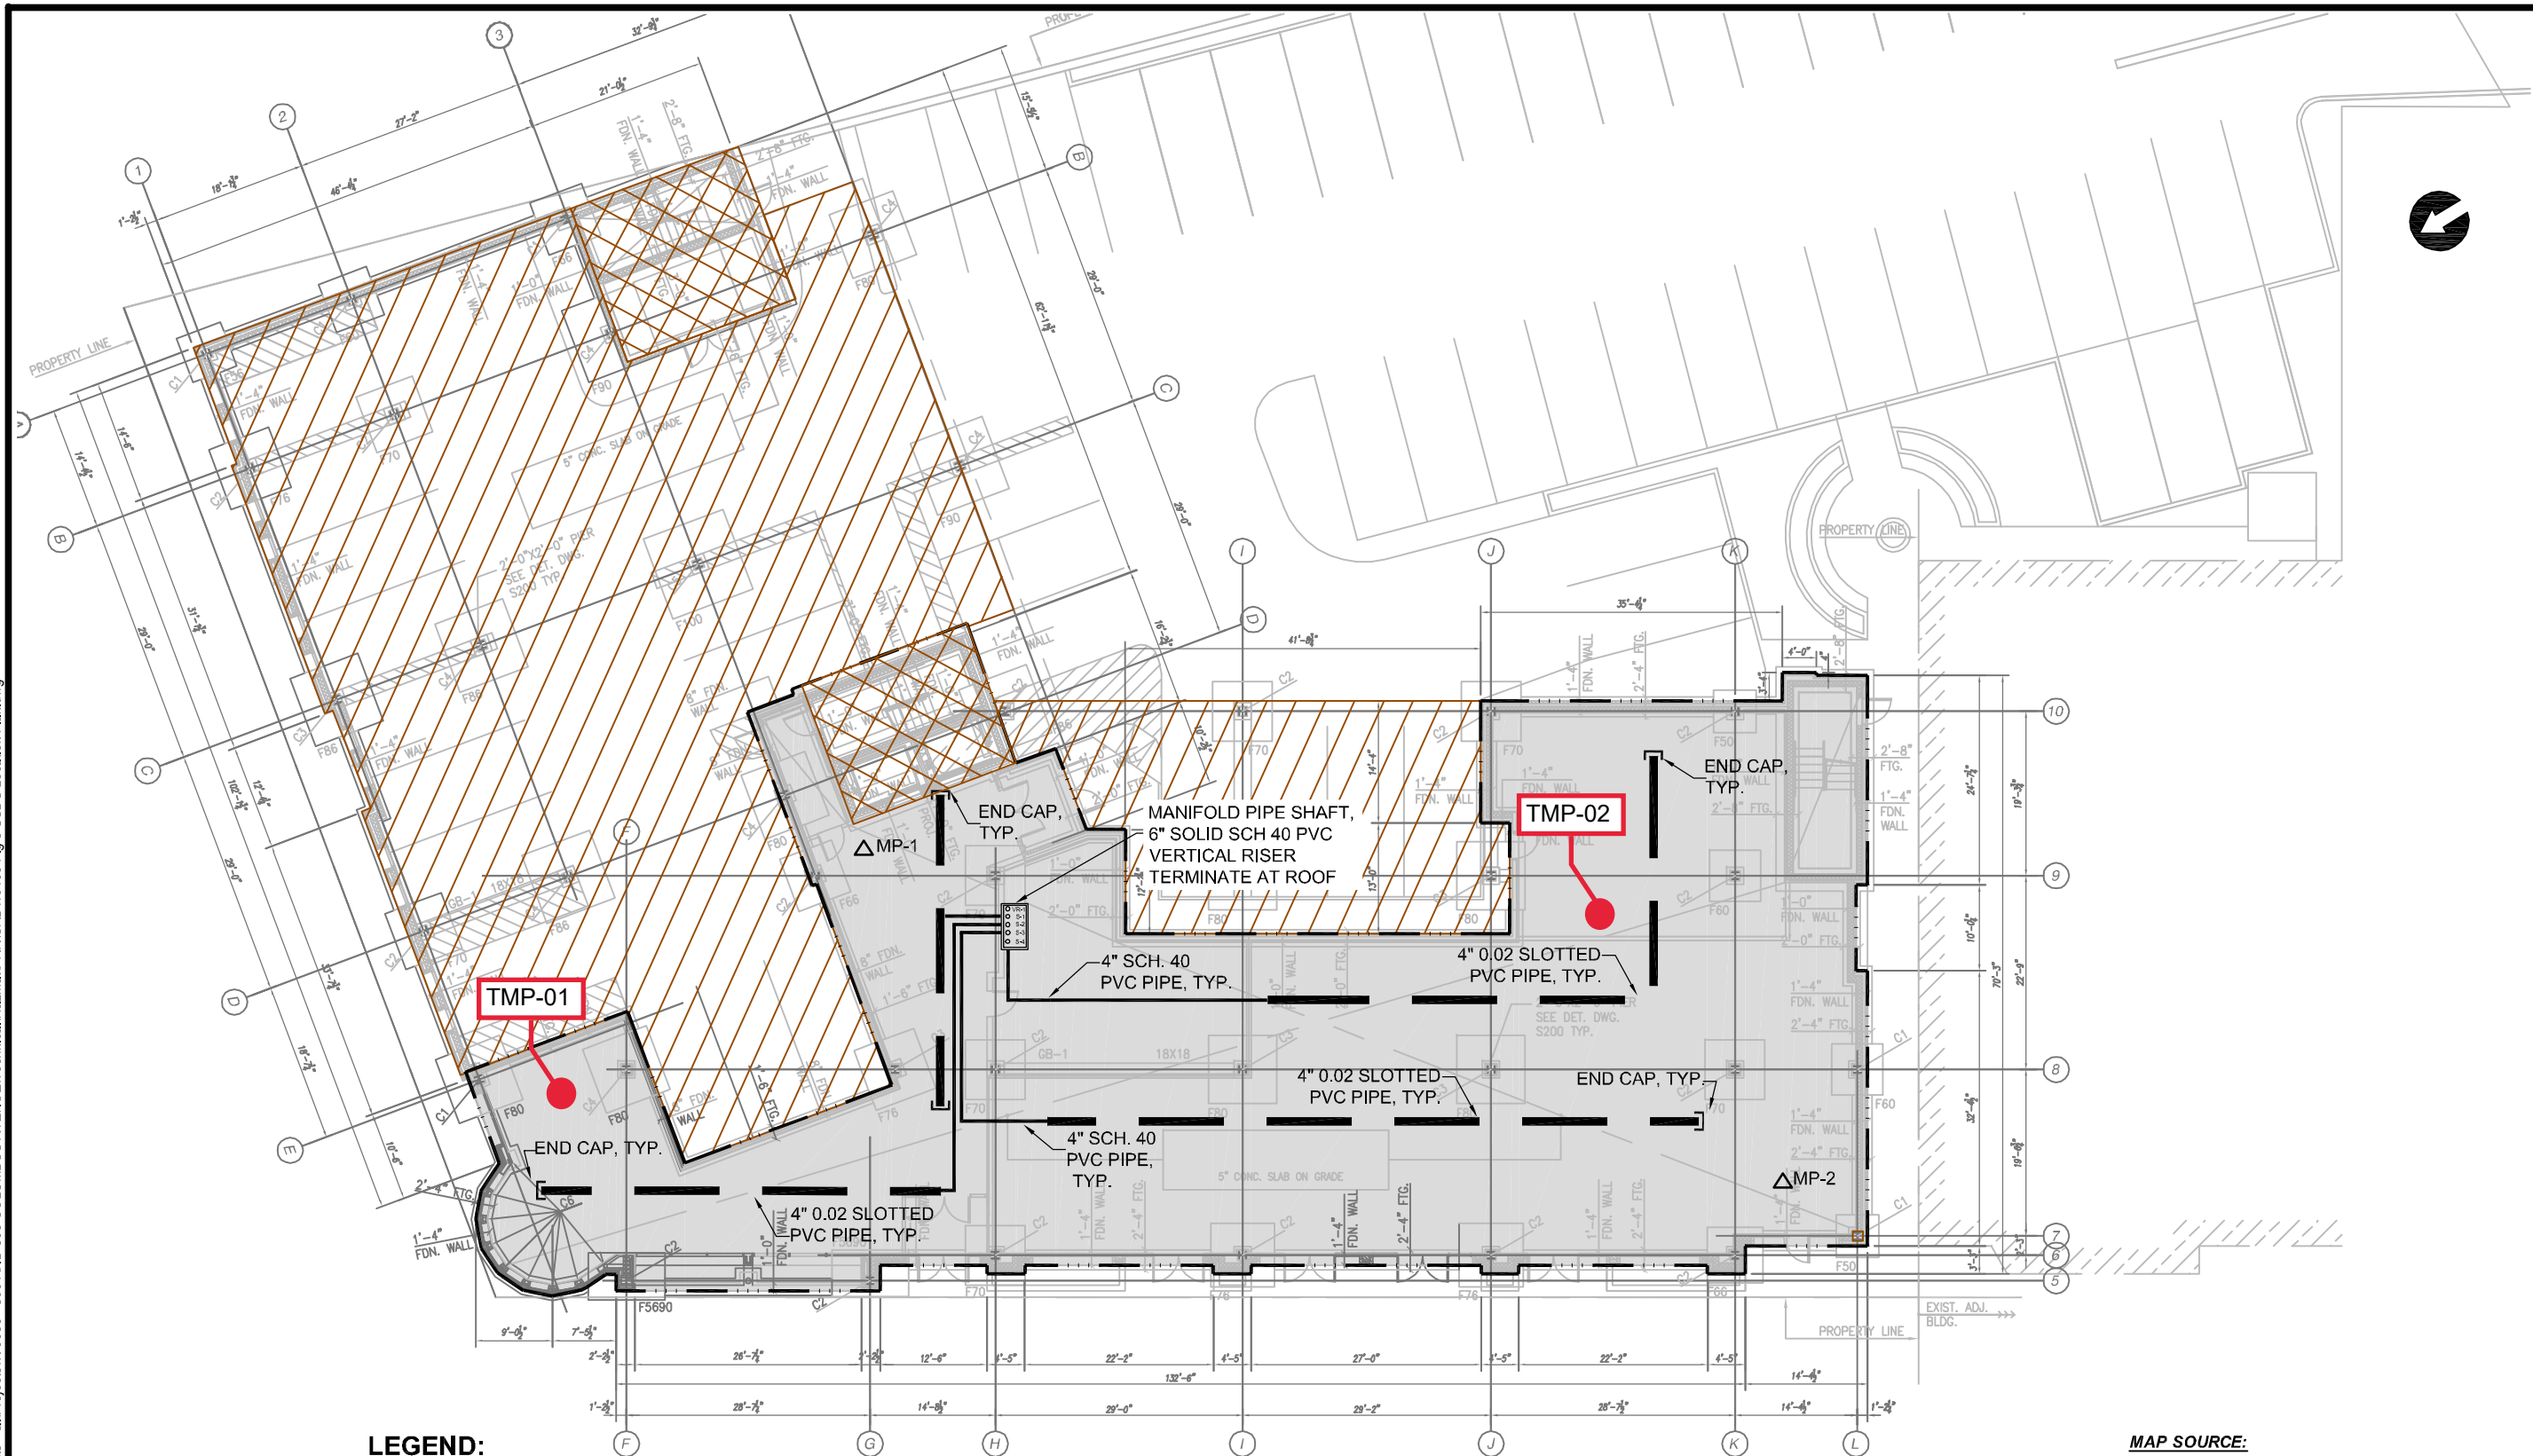
FIGURE  
**3**

On December 15, 2022, AKRF mobilized to the Site to install two temporary sub-slab monitoring points (TMP-1 and TMP-2) at the approximate locations shown on Figure 3. The temporary sub-slab monitoring points were installed by advancing a 1-inch diameter drill bit through the concrete floor slab, installing ¼-inch tubing into the gas permeable aggregate layer below the slab, and filling the void around the tubing with hydrated bentonite. A digital manometer was connected to the tubing and the differential pressure measurements were recorded, after which the tubing was removed and the 1-inch diameter boreholes were backfill/patched with concrete. The differential pressure measurements collected from the temporary sub-slab monitoring points are summarized below in Table T2.

<b>Monitoring Point ID</b>	<b>Location</b>	<b>Differential Pressure (inH<sub>2</sub>O)</b>
TMP-1	Storage Room in northern portion of the Site Building	-0.010
TMP-2	Maintenance Room in the southern portion of the Site building	-0.016

The findings from the evaluation of differential pressure measurements collected indicate that there was lower pressure below the concrete floor slab than the ambient pressure within the building at the time the measurements were collected, suggesting that vacuum-like conditions existed below the slab.
