**COTTAGE PLACE GARDENS PHASE 5  
PARCEL SITE**

**WESTCHESTER COUNTY, NEW YORK**

**Final Engineering Report**

**NYSDEC Site Number: C360161**

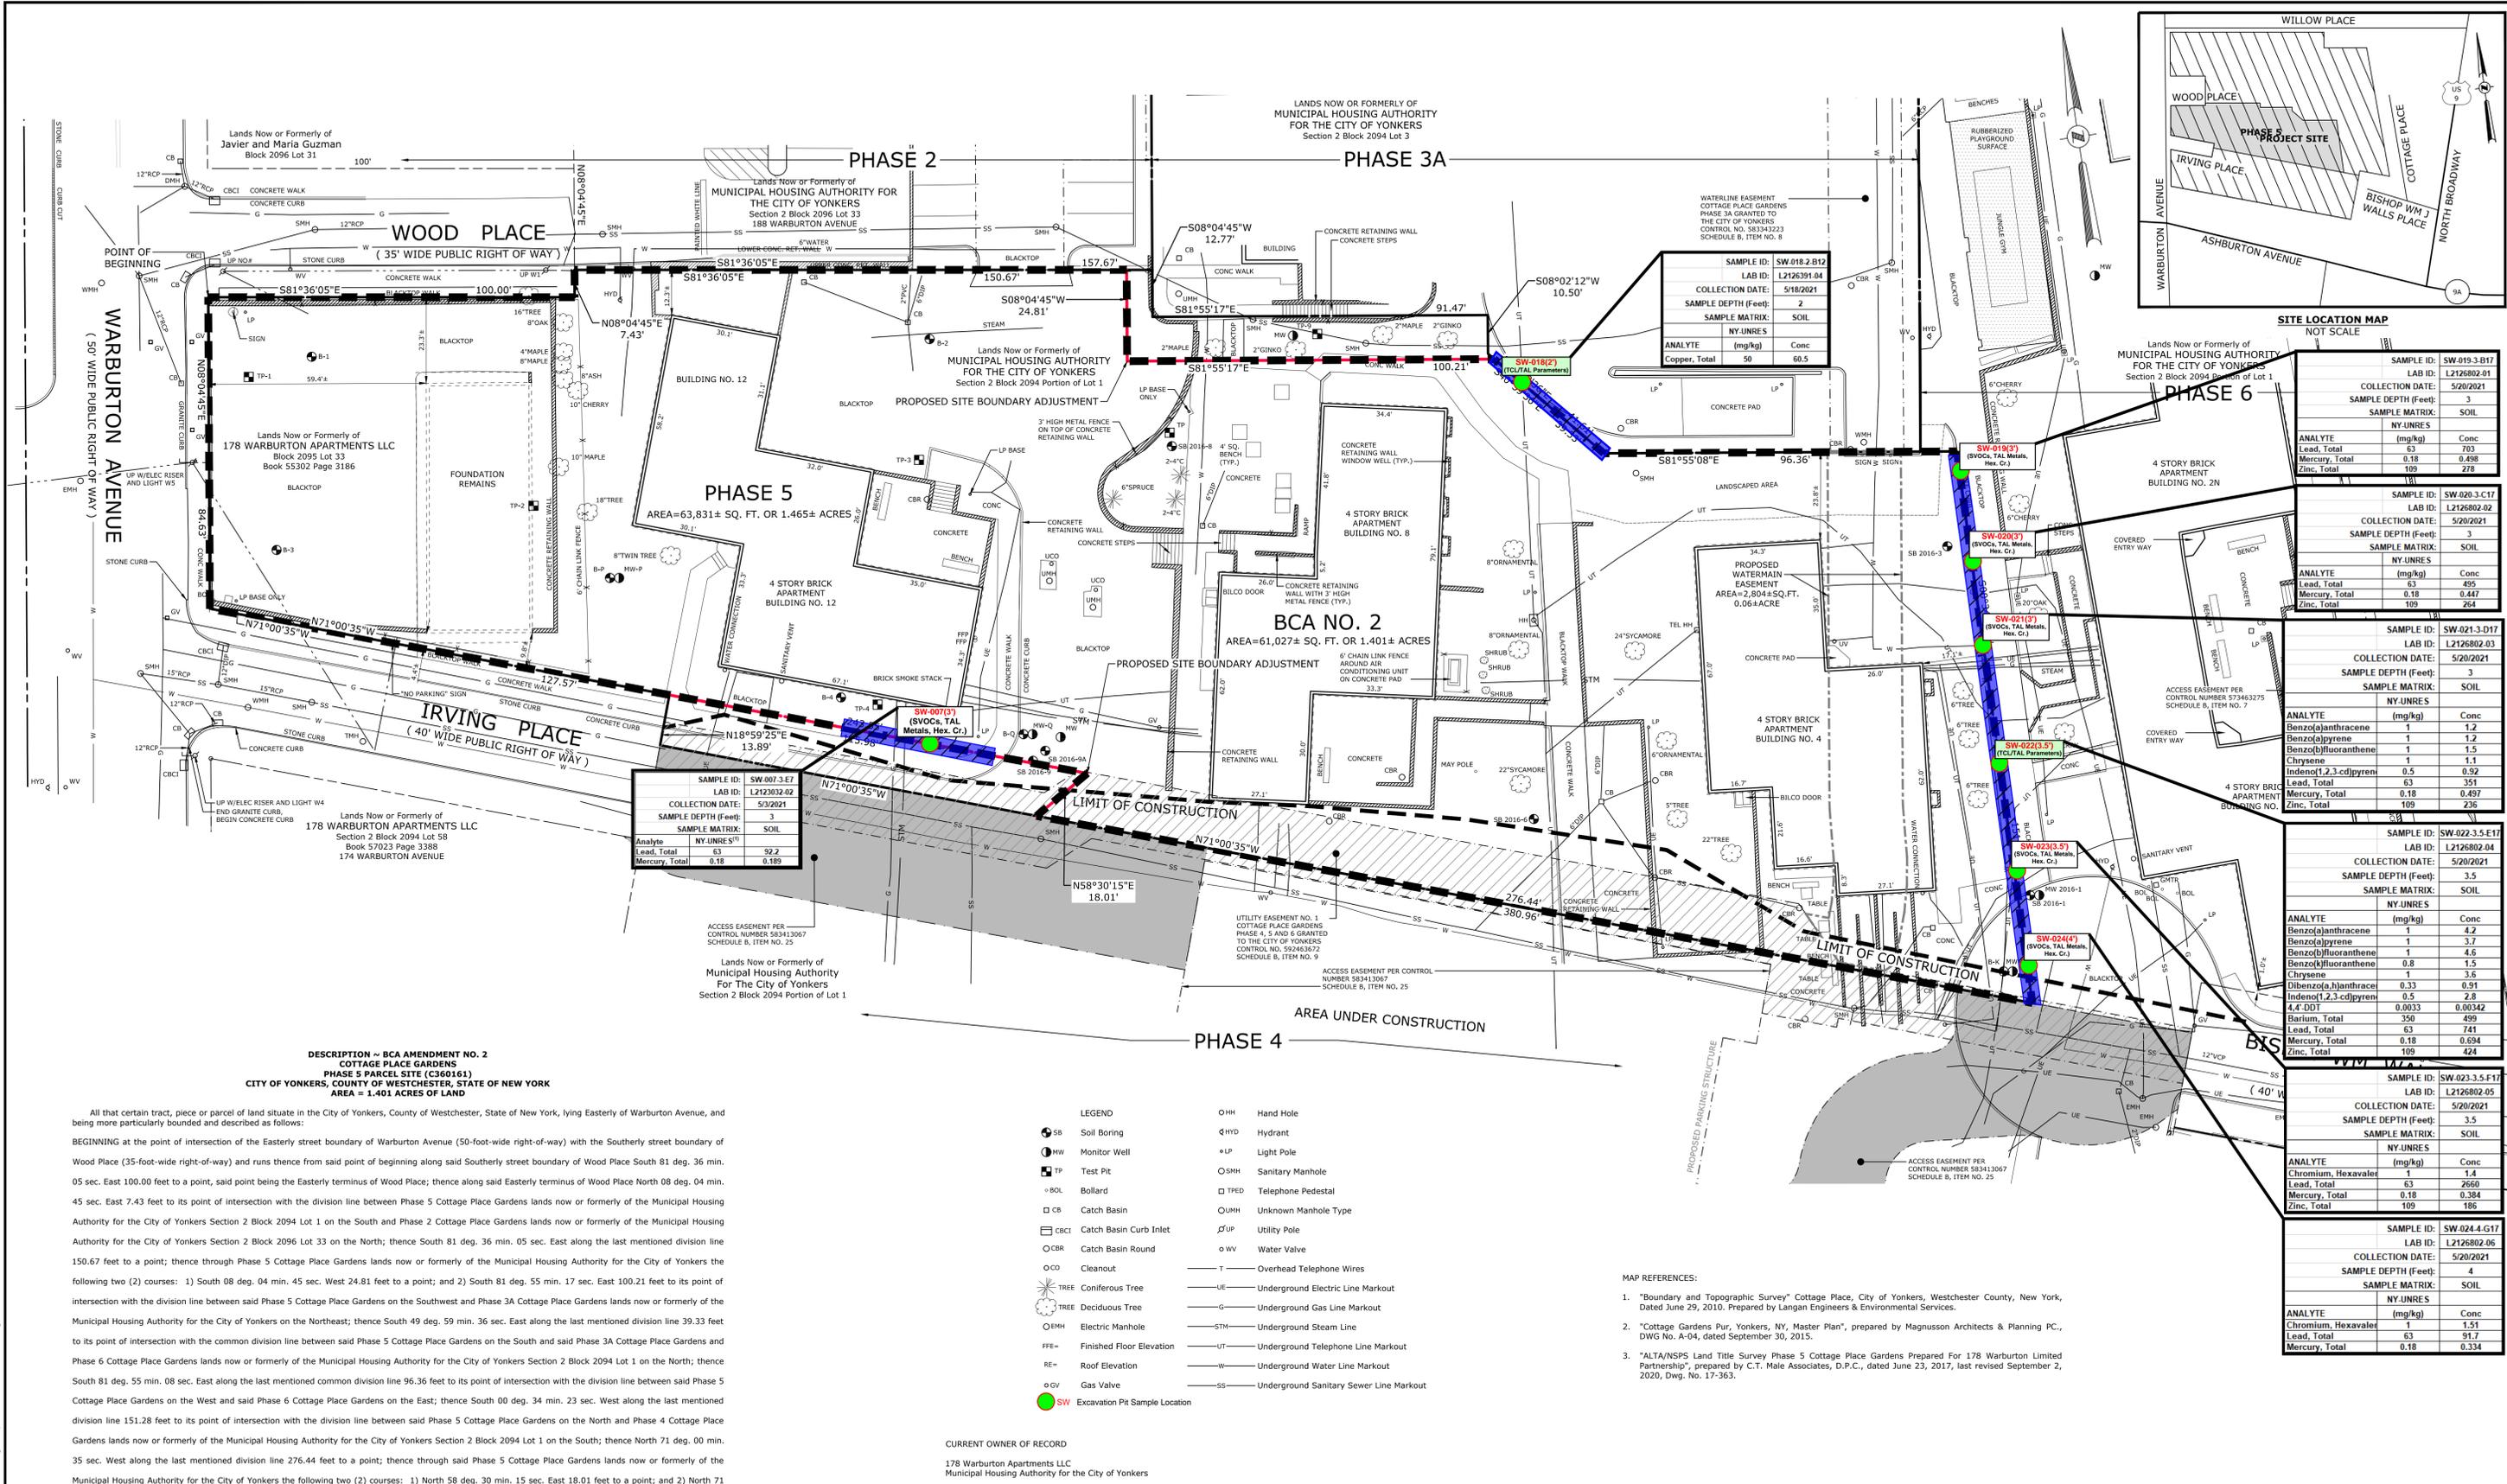
**FIGURE 4: PE SIDE WALL END-POINTS SAMPLES EXCEEDING UU SCOs**

SAMPLE ID: SW-018-2-B12  
LAB ID: L2125391-04  
COLLECTION DATE: 5/18/2021  
SAMPLE DEPTH (Feet): 2  
SAMPLE MATRIX: SOIL  
NY-UNRES: 2  
ANALYTE (mg/kg) Conc  
Copper, Total 50 60.5

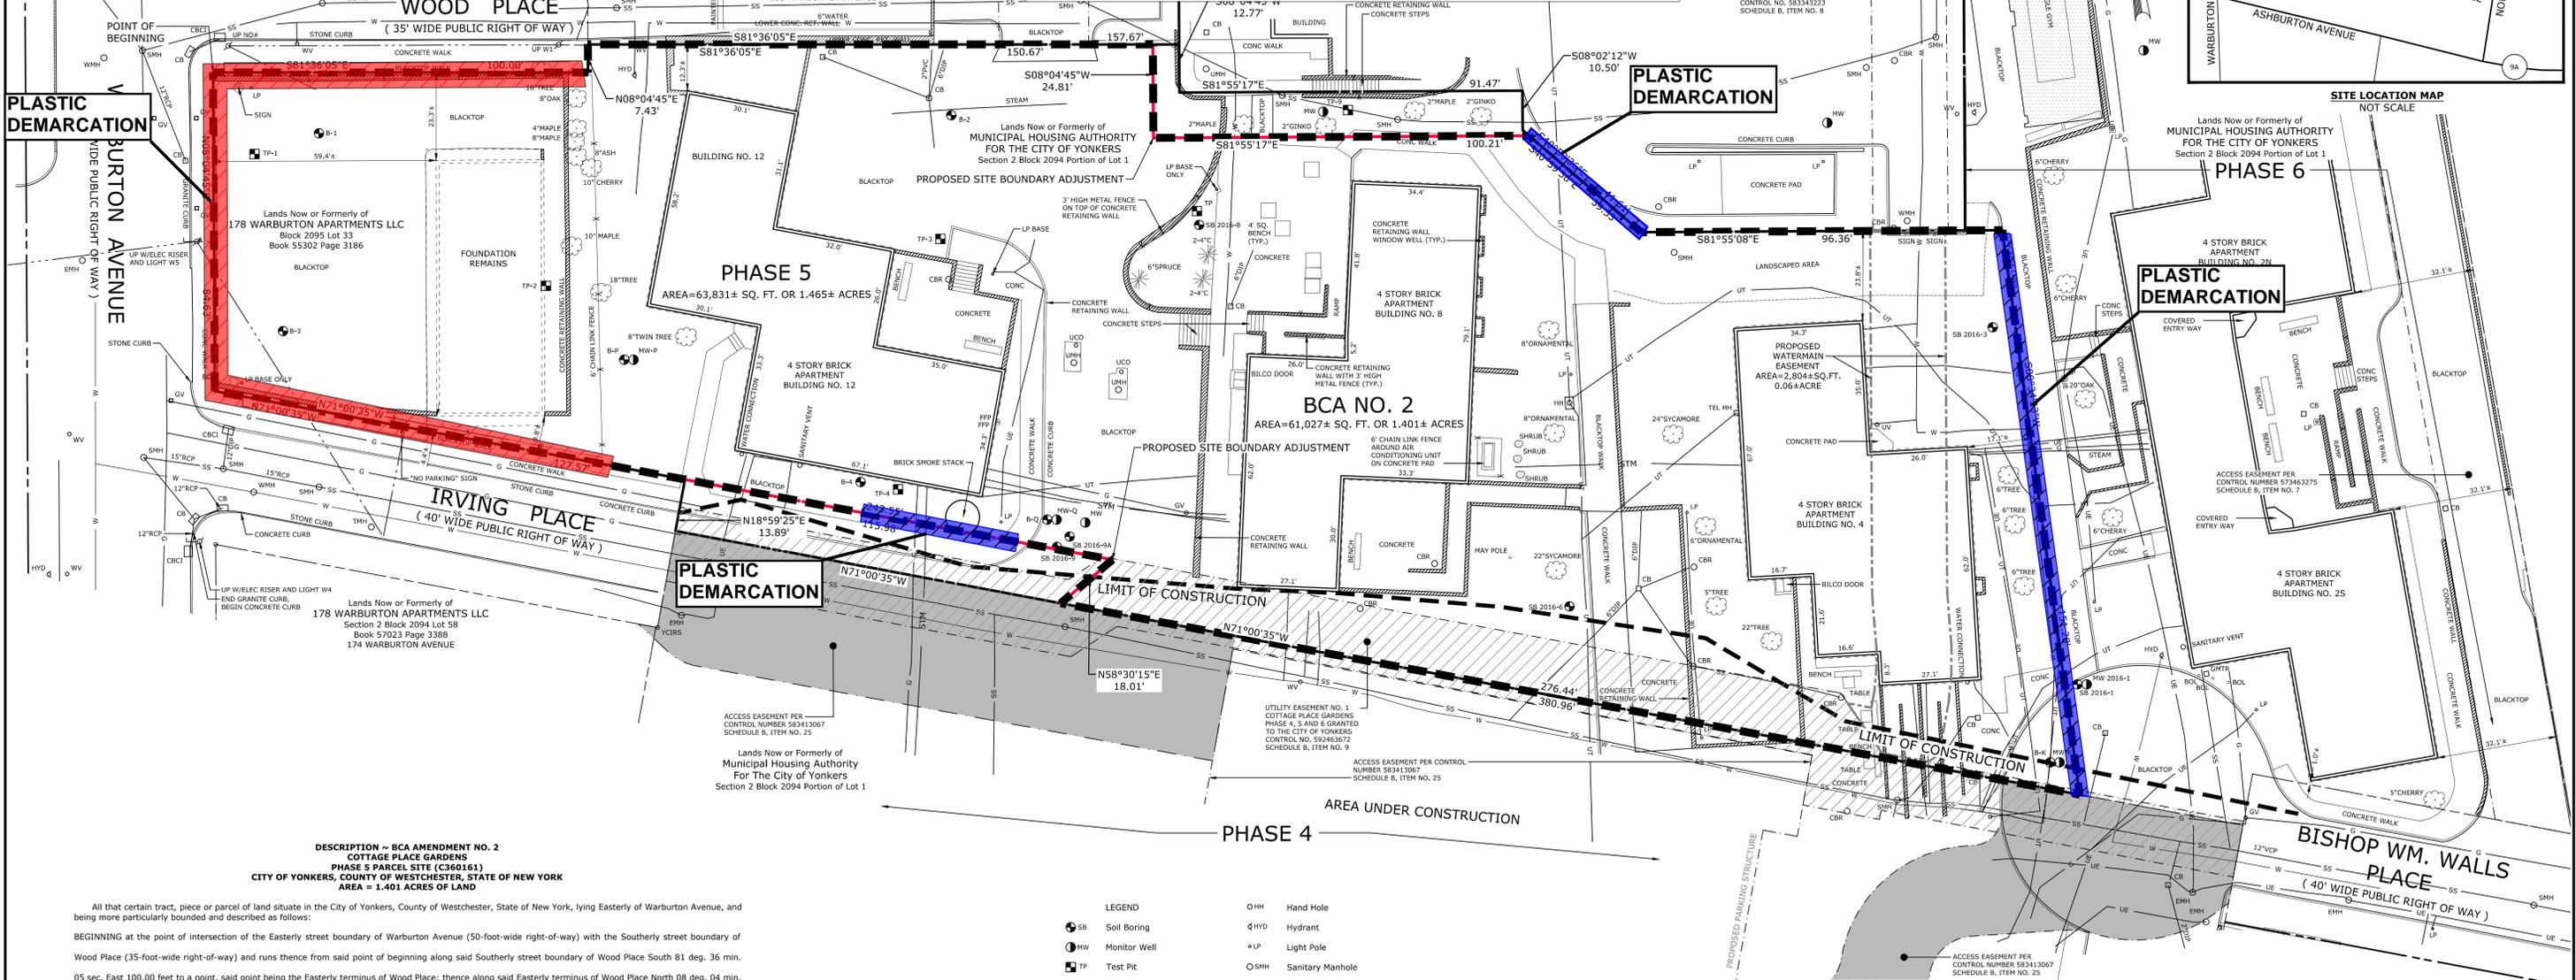
**Denotes the approximate location of demarcation plastic that was placed in the excavation sidewall. The analytical results of sidewall samples collected along the RED highlighted demarcation plastic depicts all analyzed parameters to be at concentrations BELOW Soil Cleanup Objectives for Unrestricted Use Site promulgated at 6 NYCRR Part 375. The demarcation plastic was placed in this area because the analytical results for the sidewall samples were not available prior to backfill being placed within these portions of the Site.**

**Denotes the approximate location of demarcation plastic that was placed in the excavation sidewall. The analytical results of sidewall samples collected along the BLUE highlighted demarcation plastic depicts all analyzed parameters to be at concentrations ABOVE Soil Cleanup Objectives for Unrestricted Use Site promulgated at 6 NYCRR Part 375. The demarcation plastic was placed in this area to indicate that soils extending off-Site at these locations are environmentally impacted and that these soils should not be disturbed without first consulting with the C.T. Male Remediation Engineer.**
