**SURVEY OF THE FORMER CANADIAN RADIUM SITE  
MOUNT KISCO, WESTCHESTER COUNTY, NEW YORK**

**NEW YORK STATE DEPARTMENT OF HEALTH  
BUREAU OF ENVIRONMENTAL RADIATION PROTECTION  
OCTOBER, 1993**

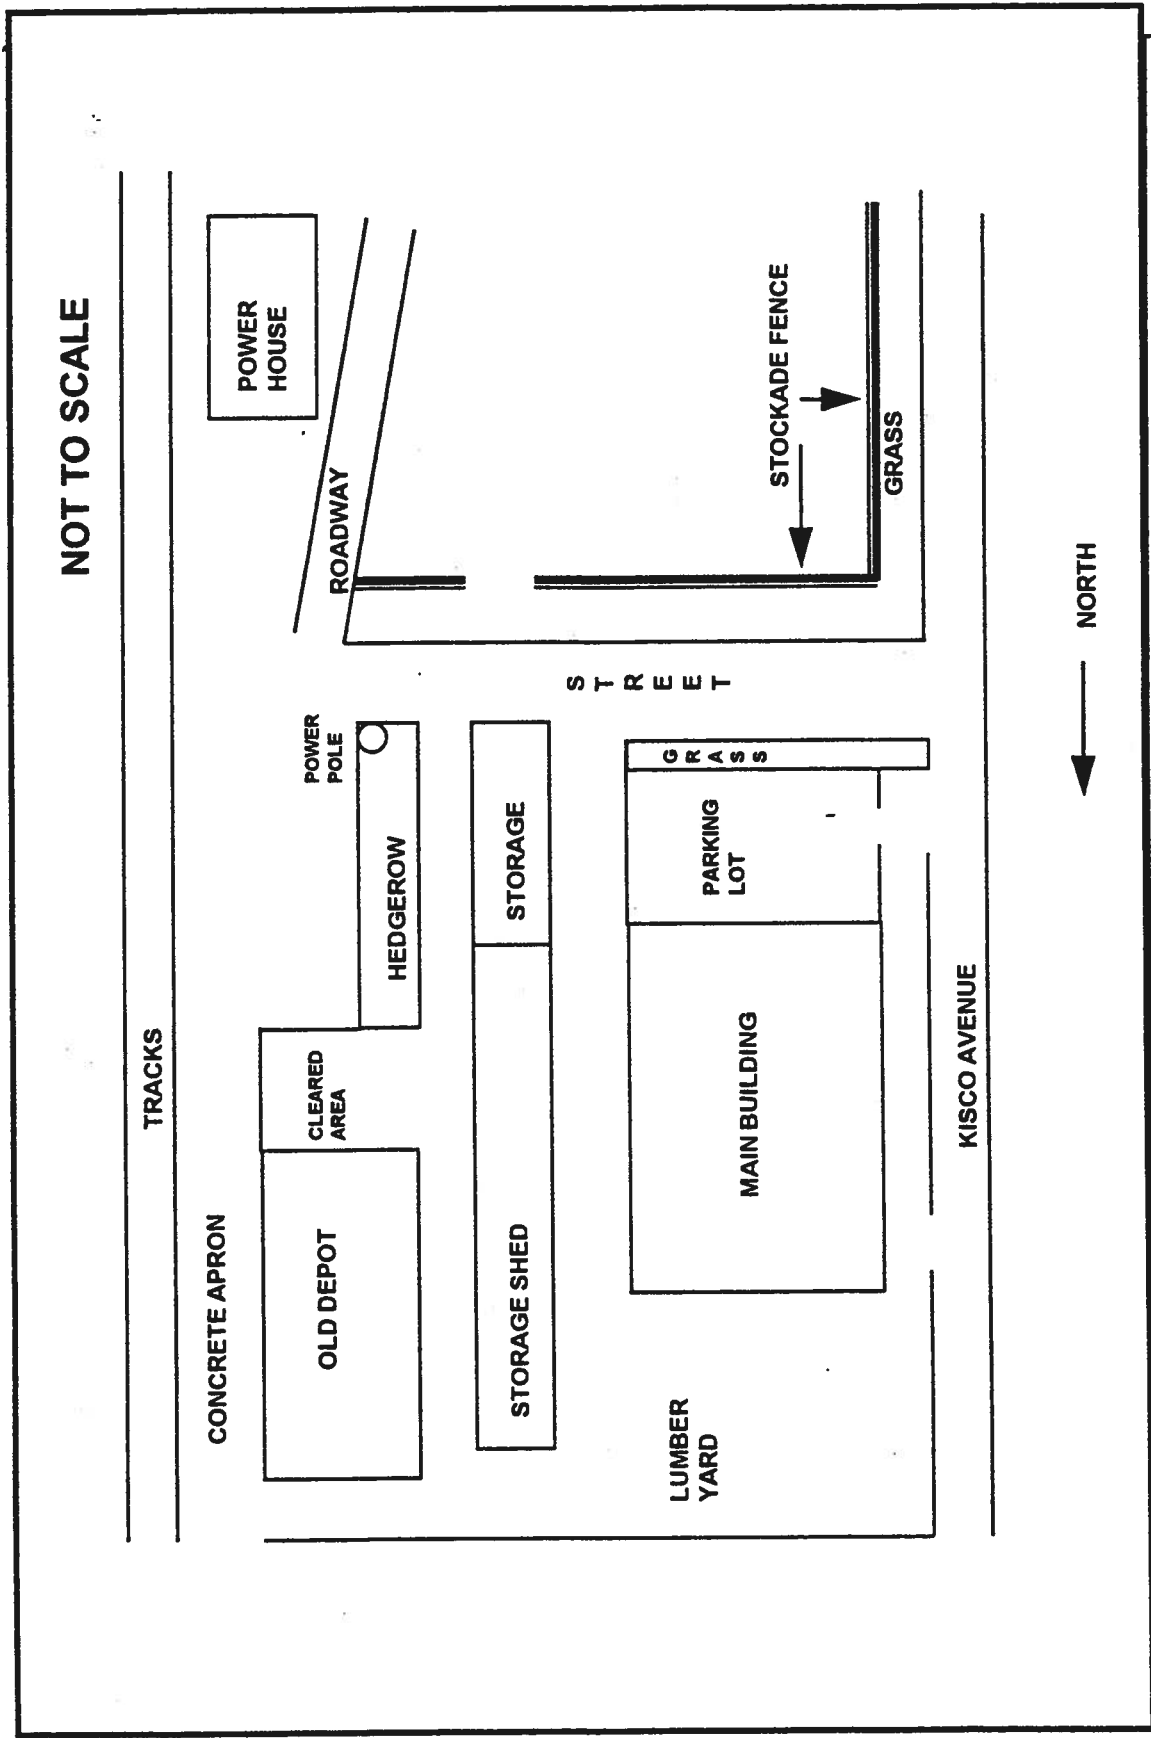
**FIGURE 3**  
**STOCKADE-FENCED AREA USED TO STORE BUILDING MATERIAL**

Figure 3 and Photos 15 to 17 depict the stockade-fenced area used to store building

materials. Roughly a 30,000 sq.ft. area was surveyed. Elevated exposure rate measurements, more than 20  $\mu\text{R/hr}$  above background, were found at several locations in the northern half of the area from the location of the plastic pipes to the entrance gate. Several "hot spots" were also found and are indicated by the readings enclosed in a box in the survey diagram. Typical readings in the yard range from 10-14  $\mu\text{R/hr}$  in the southern half with spots giving elevated exposure rates. The highest measured exposure rate was 140  $\mu\text{R/hr}$ . The highest areas found coincide with the location of the former Canadian Radium building, which was located in the northwest corner of the area and extended to the new roadway.

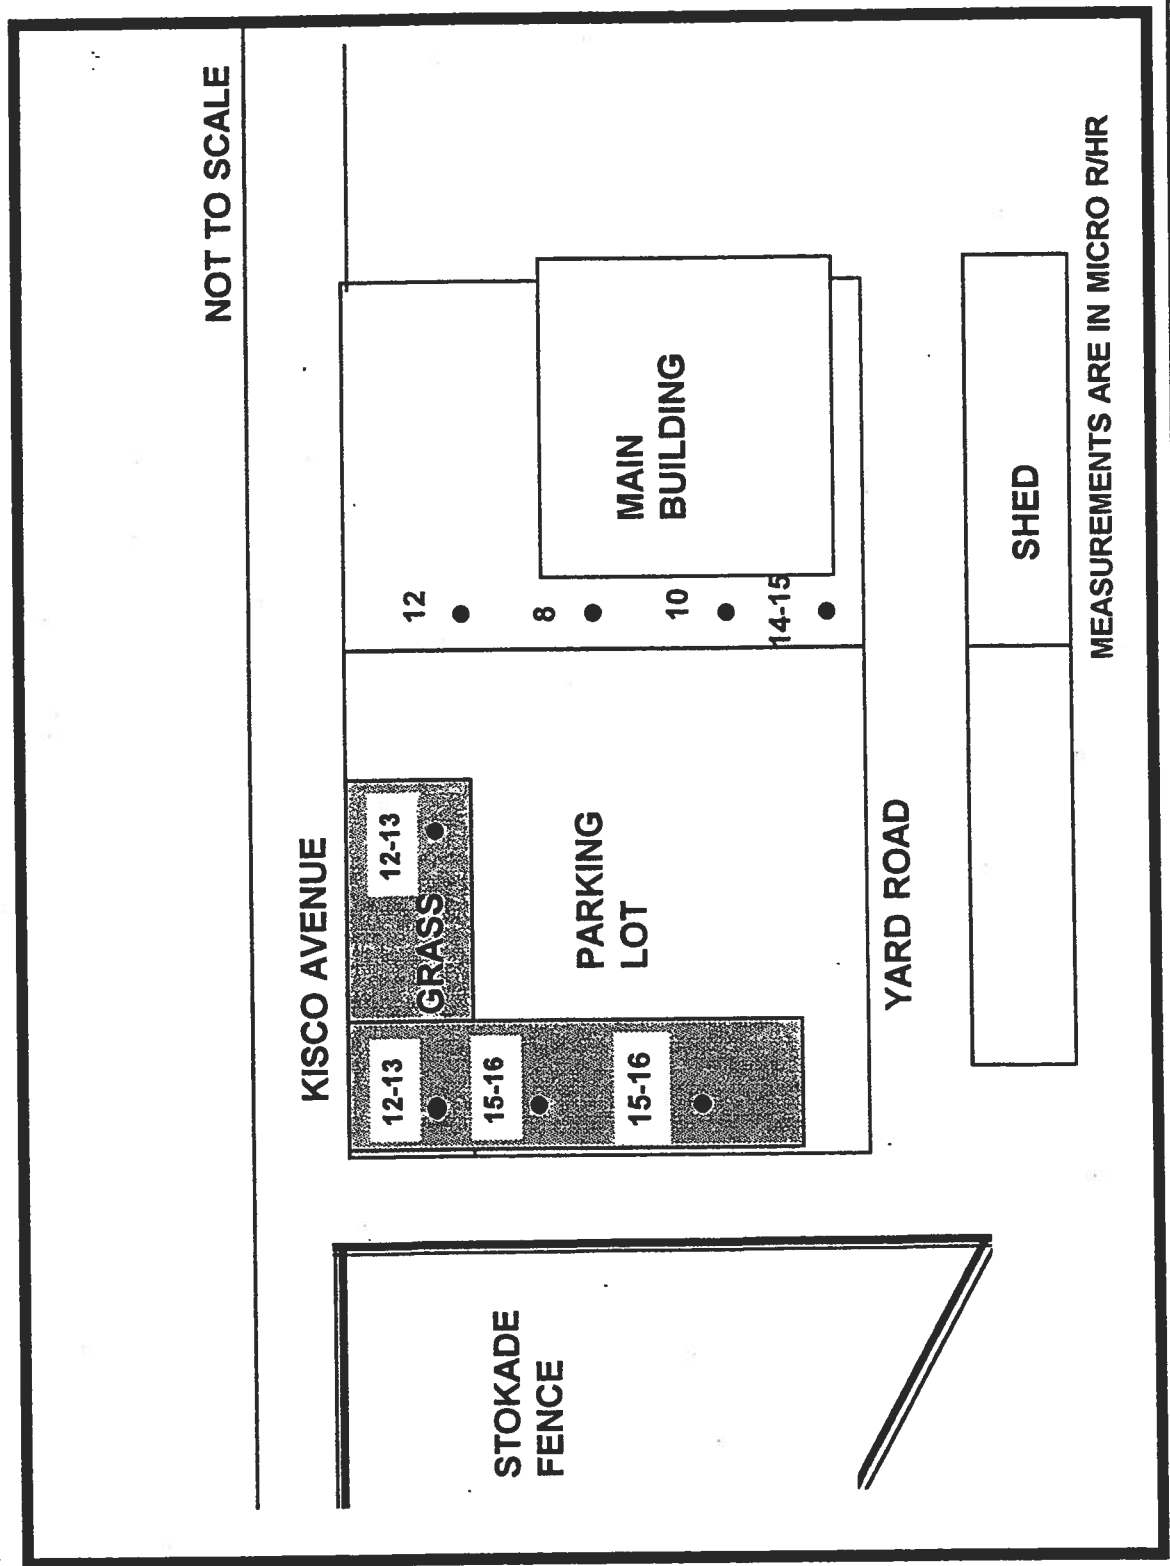
**FIGURE 4  
EMPLOYEE PARKING LOT**

Figure 4 and Photo 6 show the employee parking lot, which is located at the southern side of the main Richard's building. Readings taken in this area show only a slight increase over typical background levels of 7-12  $\mu\text{R/hr}$ , with the highest readings being 15-16  $\mu\text{R/hr}$  along the south grassy area next to the roadway.

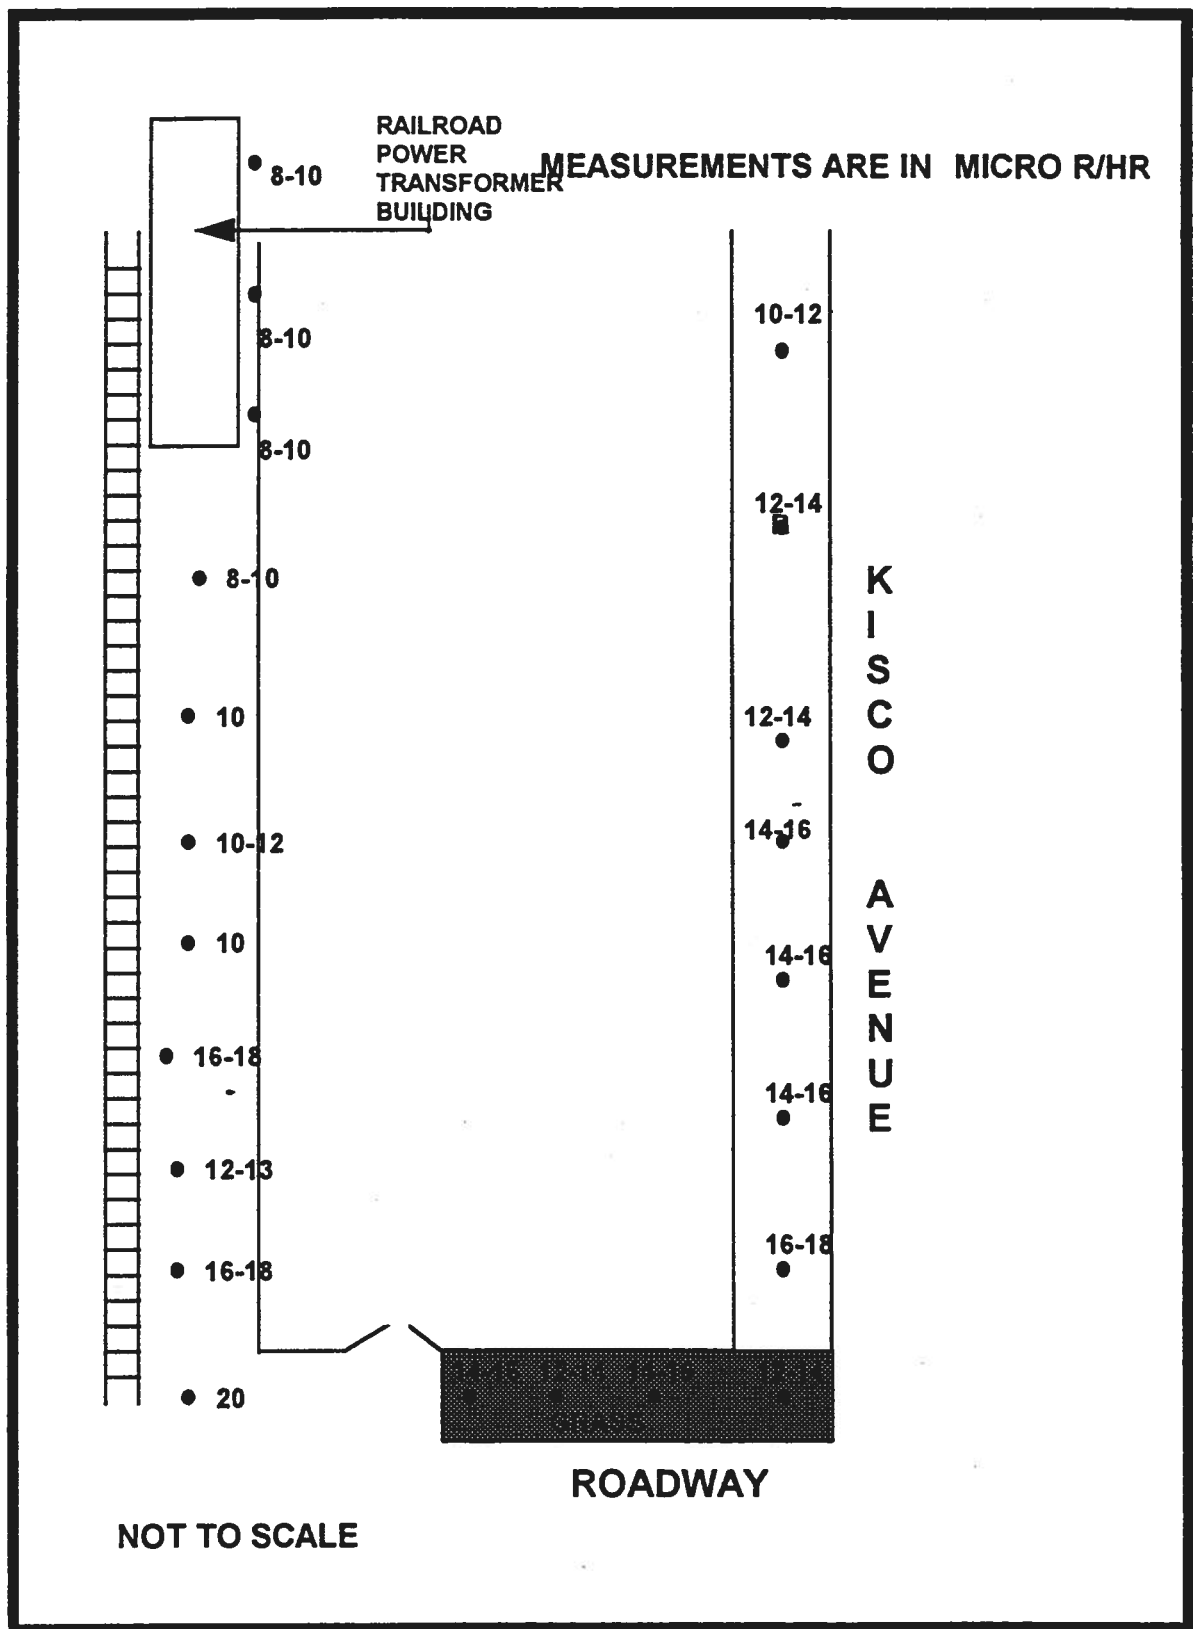
**FIGURE 5  
ROADWAY AND GRASSY AREAS**

Figure 5 and Photos 7 and 8 show the roadway and grassy areas on three sides of the stockade-fenced area. No readings greater than 20  $\mu\text{R/hr}$  above background were found, although levels measured in the northern end are up to 2 times higher than those in the southern portion.

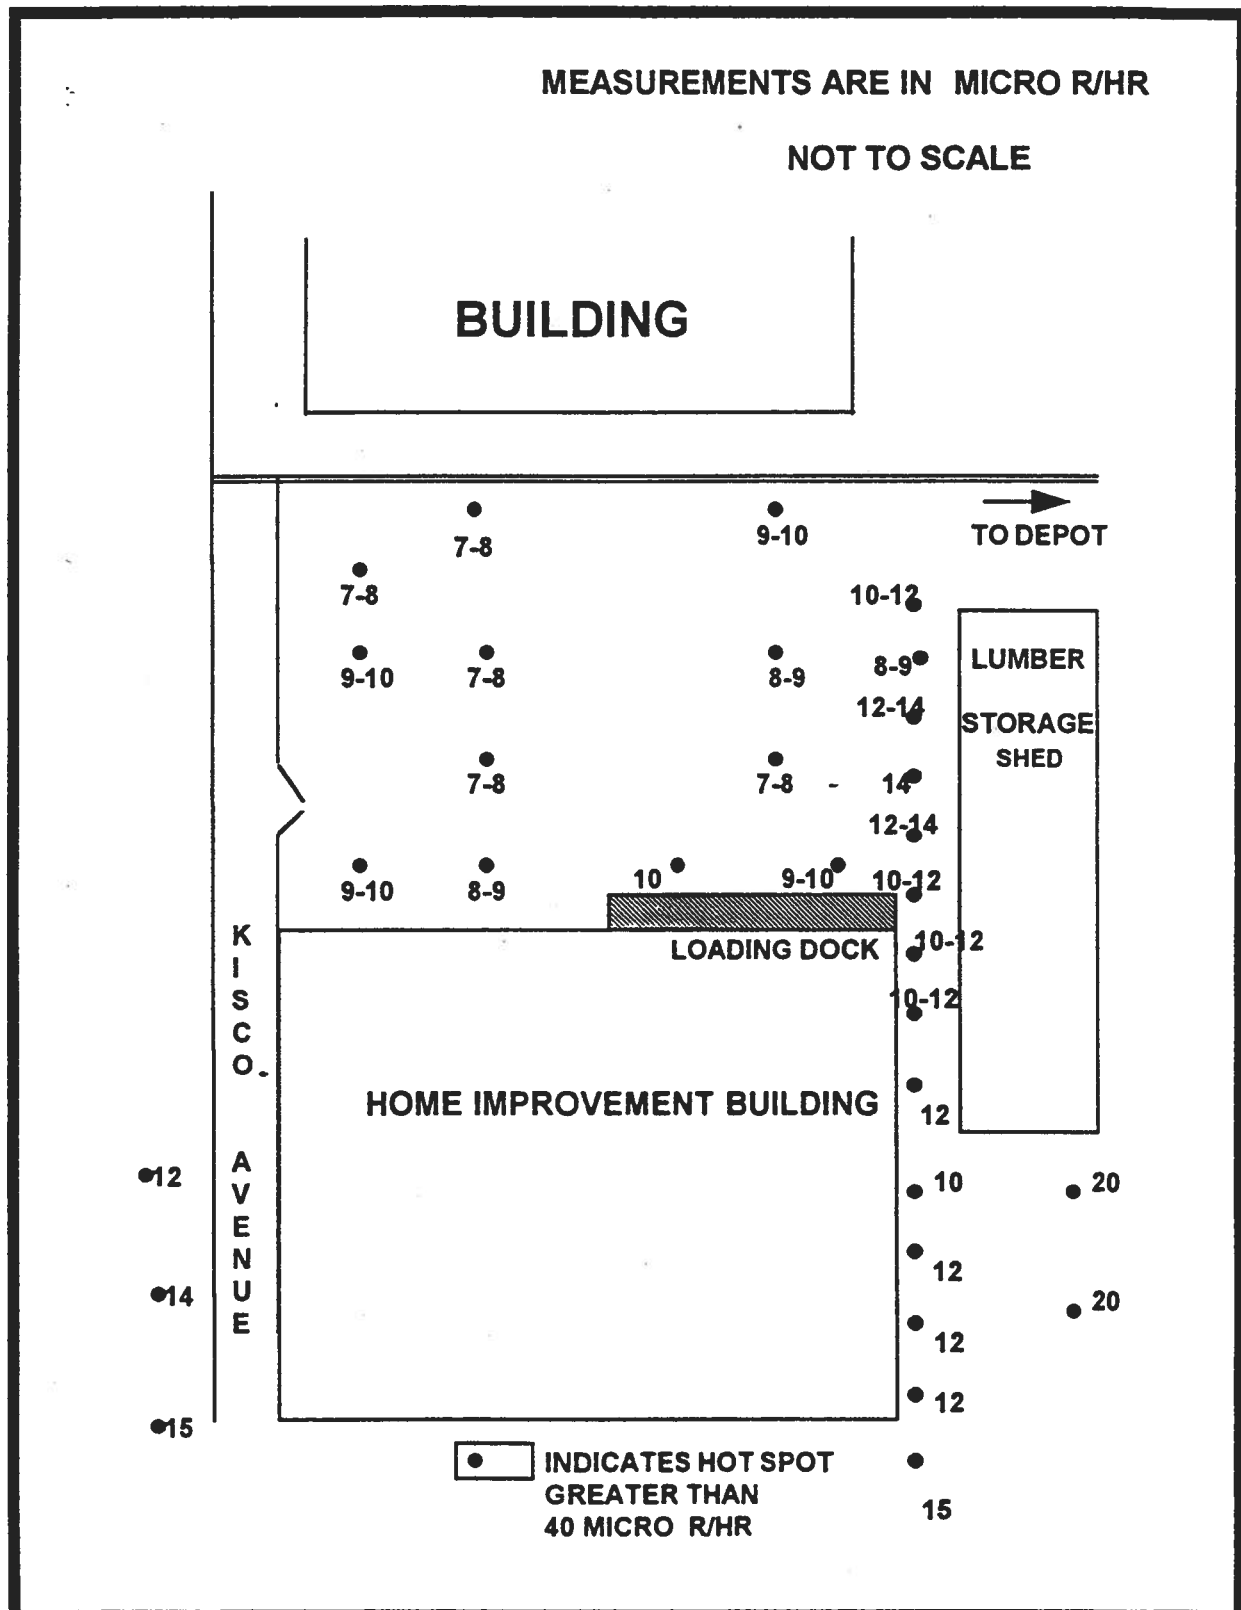
**FIGURE 6**  
**MAIN LUMBERYARD, STORAGE AREA AND ROADWAY NEXT TO**  
**HOME IMPROVEMENT BUILDING**

Figure 6 and Photos 18 and 19 depict the main lumber yard, storage area and roadway which lies on the east and south sides of the main home improvement building. Three readings were also taken across Kisco Avenue opposite to the building near a rock wall (Photos 20 and 21). These readings ranged from 7-20  $\mu\text{R/hr}$ . The lowest readings (7-8  $\mu\text{R/hr}$ ) were found at the northwest portion of the property. Most of the readings were in the range of 10-14  $\mu\text{R/hr}$ . The two highest readings of 20  $\mu\text{R/hr}$  were found next to a fenced hedgerow which runs from the roadway to the lumber storage shed (not shown, see Figure 8).

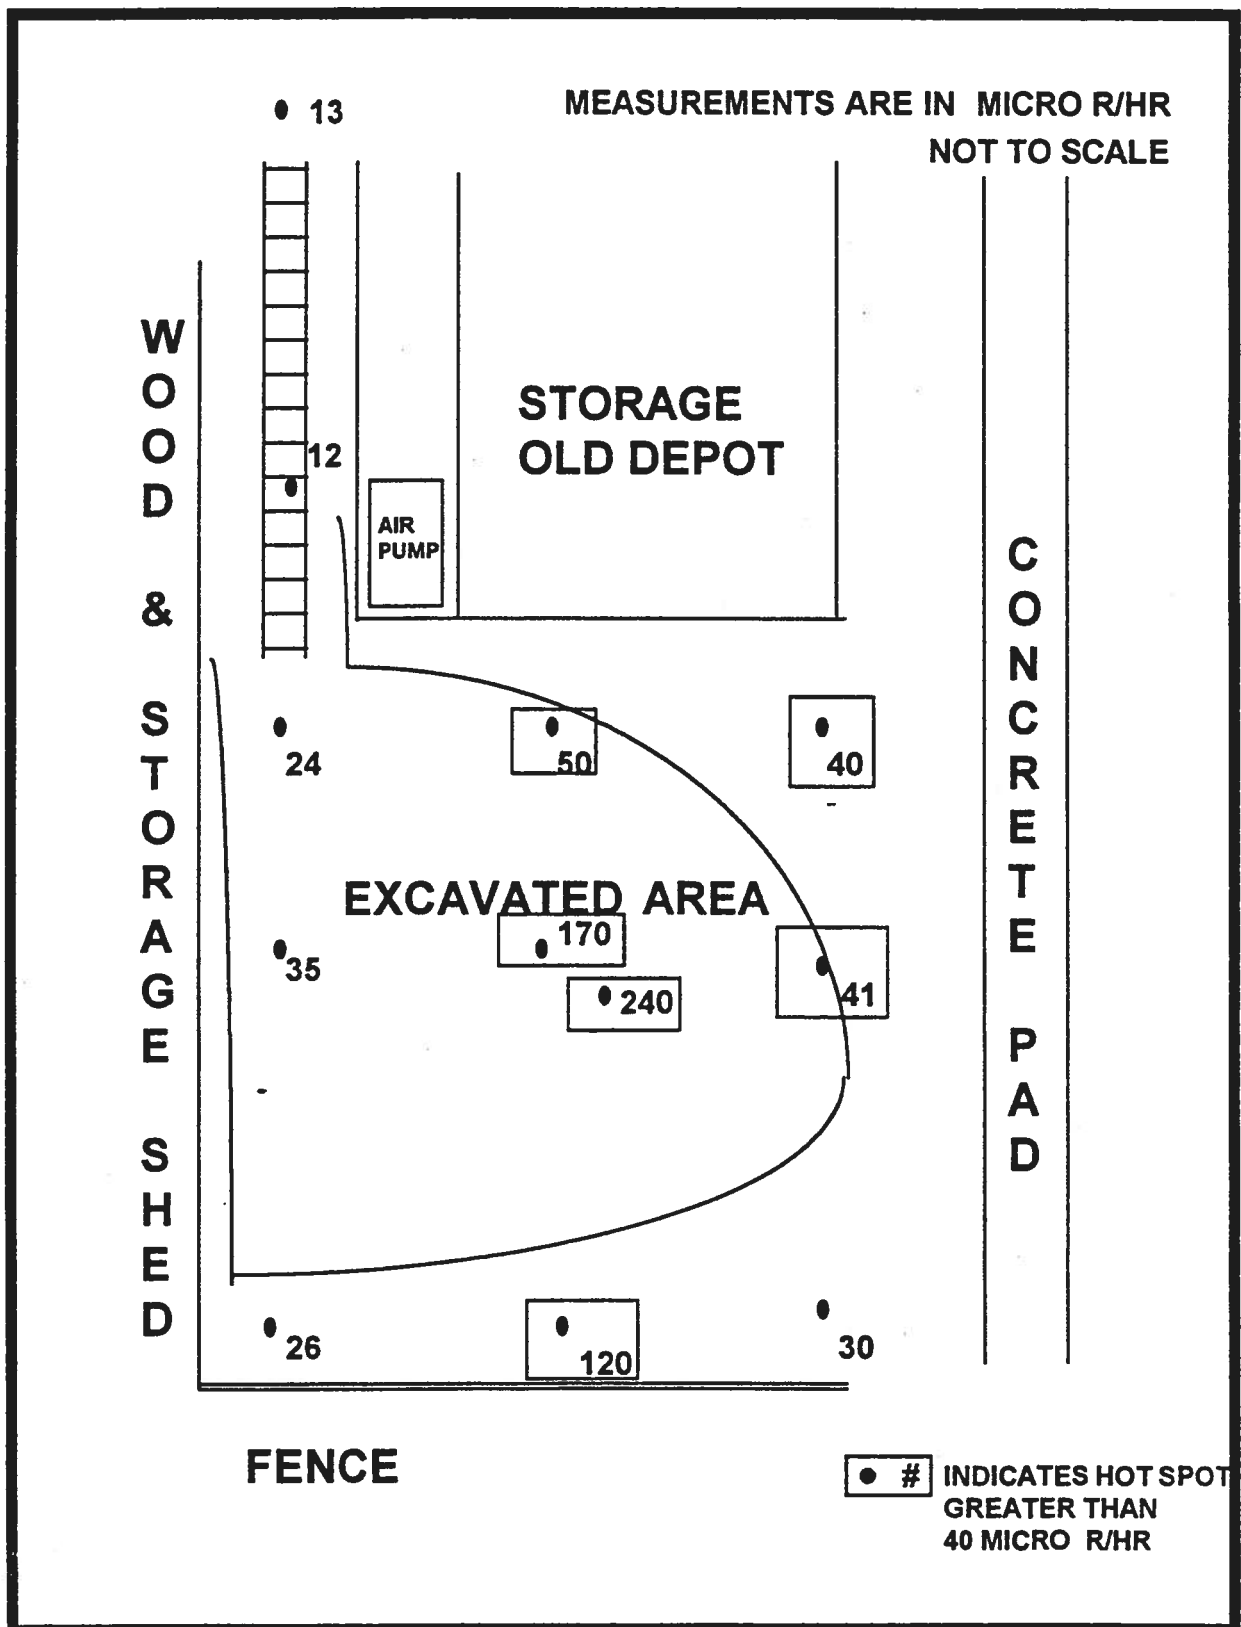
**FIGURE 7**  
**FORMERLY FENCED OLD DEPOT AREA**

Figure 7 and Photos 4, 5 and 11 depict the formerly fenced old depot area which had been known to contain "hot spots". Ongoing excavation, tree removal and railroad tie/rails removal may have brought additional radium contamination to the surface as well as spread the

contamination over a larger area (Photos 22, 23 and 24). The entire area from the southern fence to the old depot building shows elevated readings, indicated by a box in the survey diagram (Figure 7), ranging from 24-170  $\mu\text{R/hr}$  on the systematic survey. Additional "hot" areas may be found in the excavated area. The highest area found during this survey gave an exposure rate of 240  $\mu\text{R/hr}$ . Photos 25 to 28 show changes at the site since the survey of 9/9/93.

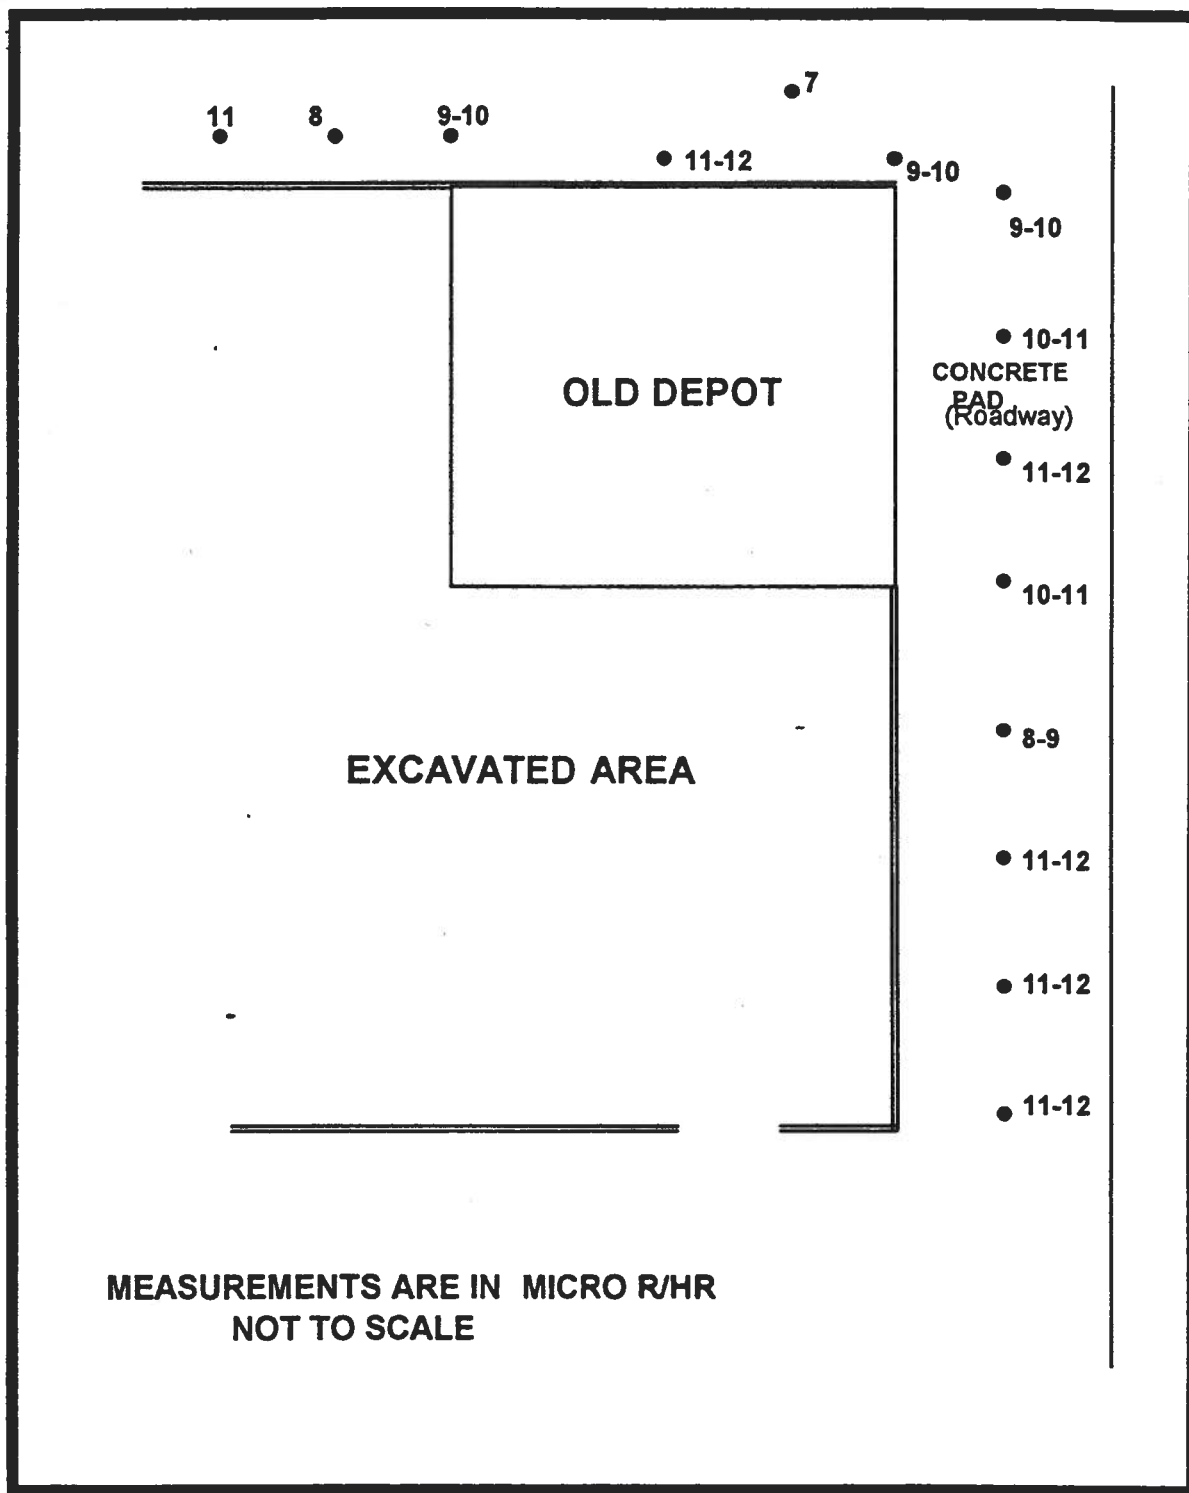
**FIGURE 8**  
**CONCRETE PAD/ROAD FROM NEW ROADWAY TO OLD DEPOT**

Figure 8 and Photo 29 show the concrete pad/road which extends from the new roadway along the railroad tracks to the area located beyond the old depot. All the measurements appear to be within the normal background range of 7-12  $\mu\text{R/hr}$ . The area on the north side of the depot is unpaved and leads to a fence and building at the extreme northern boundary of the Richard's property. No elevated readings were found in this area.

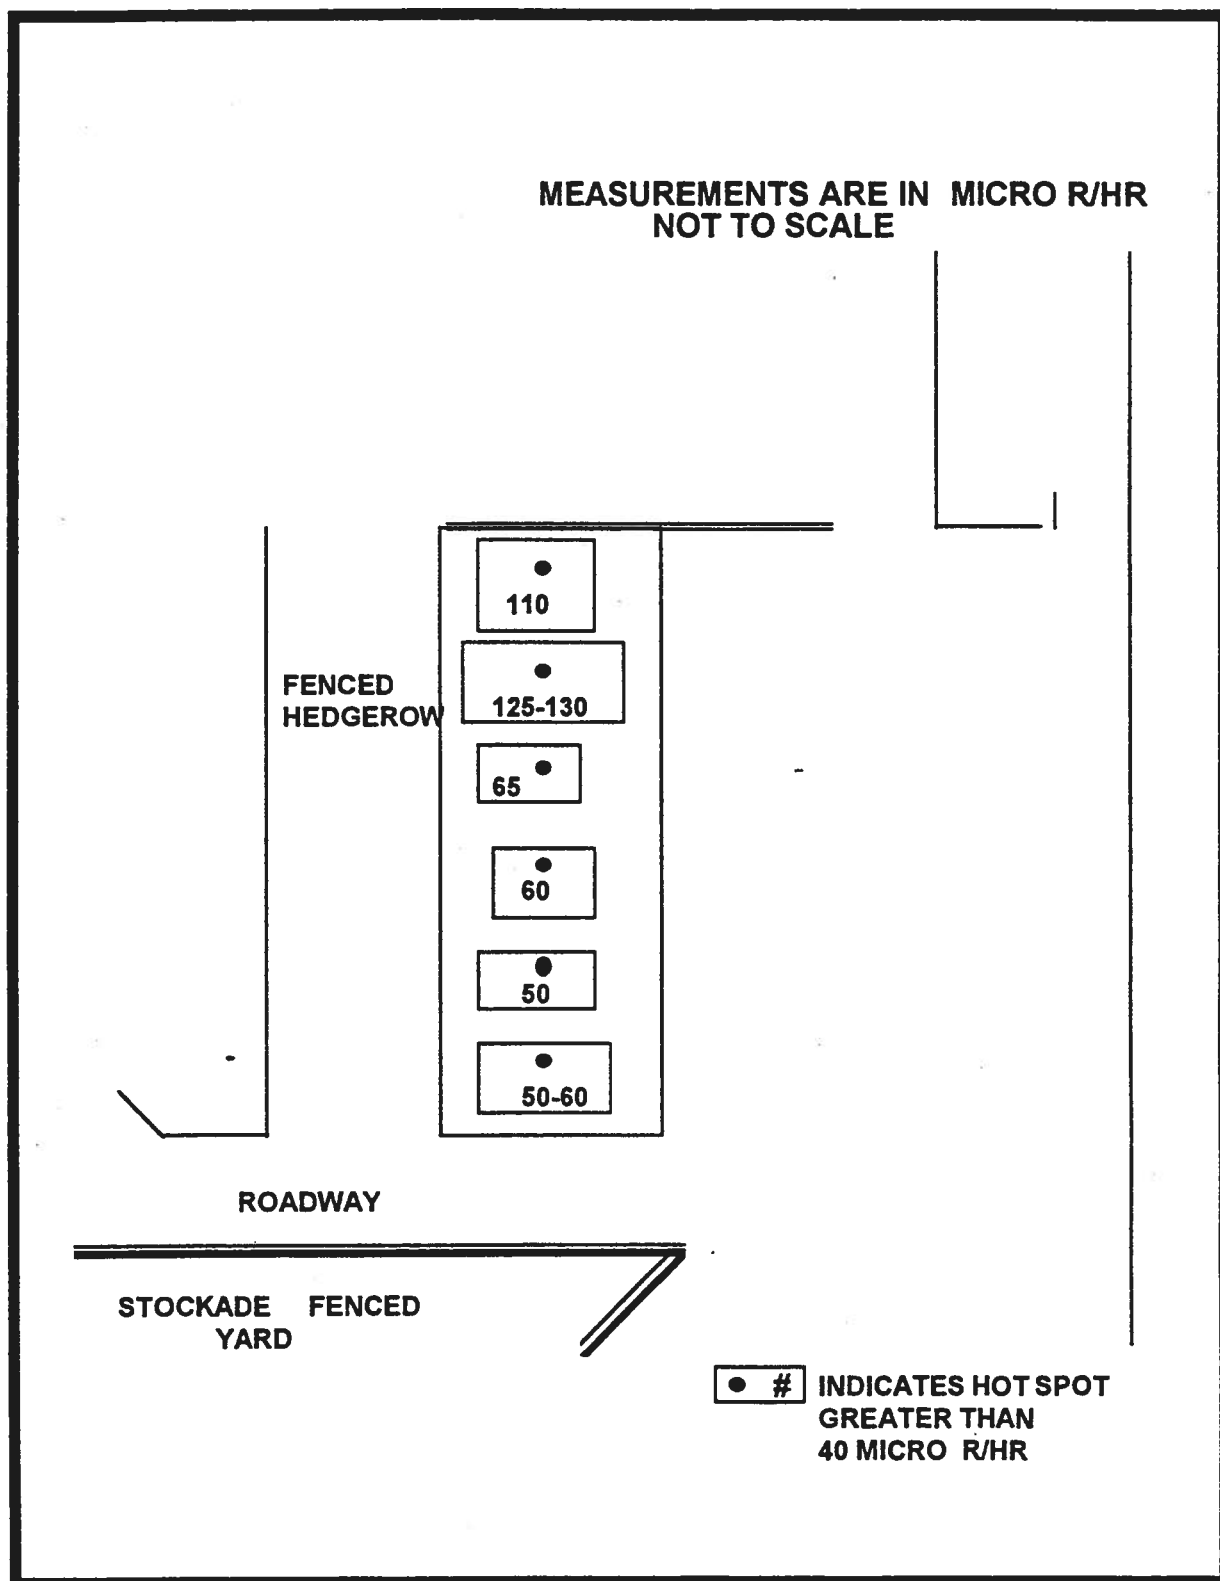
**FIGURE 9**  
**SOIL STRIP PARALLEL TO FENCED HEDGEROW AND CONCRETE**  
**APRON**

Figure 9 and Photo 30 show the narrow, approximately 10 ft. strip of soil, brush and debris which runs parallel to the fenced hedgerow and concrete apron from the new roadway to the fenced depot area. As shown, all measurements along this area show exposure rates well above background ranging from 50-130  $\mu\text{R/hr}$ .

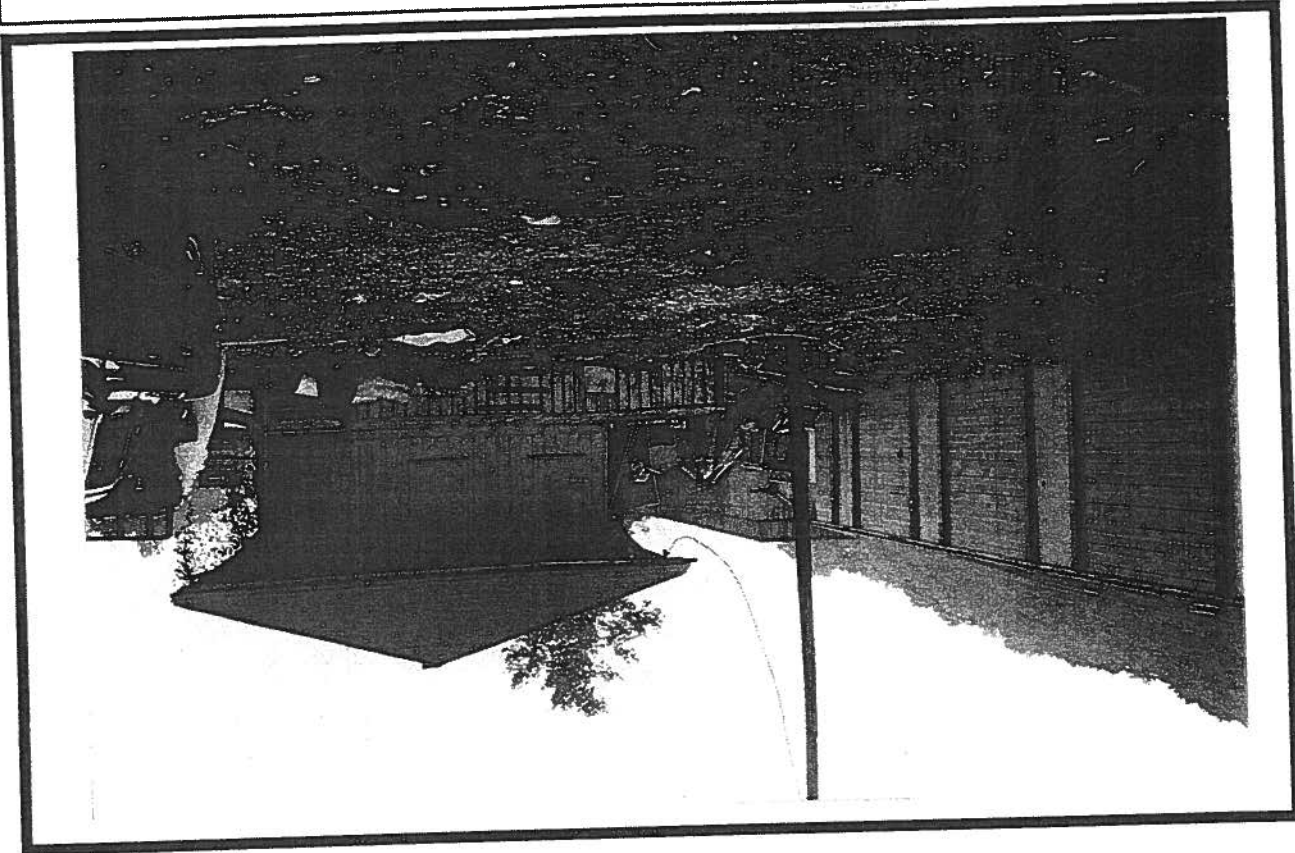
PHOTO 3 Stockade-Fenced Area Used for Building Material Storage

renewal, a new street had been constructed adjacent to the employee parking lot, through what used to be part of the former Canadian Radium site. (Photo#2) The former Canadian Radium site is now enclosed by a stockade fence and is used as a storage area for building materials. The current site layout is depicted in Figure 2. This area, approximately 30,000 sq.ft., is unpaved and is used routinely by employees in the course of their work (Photo#3).

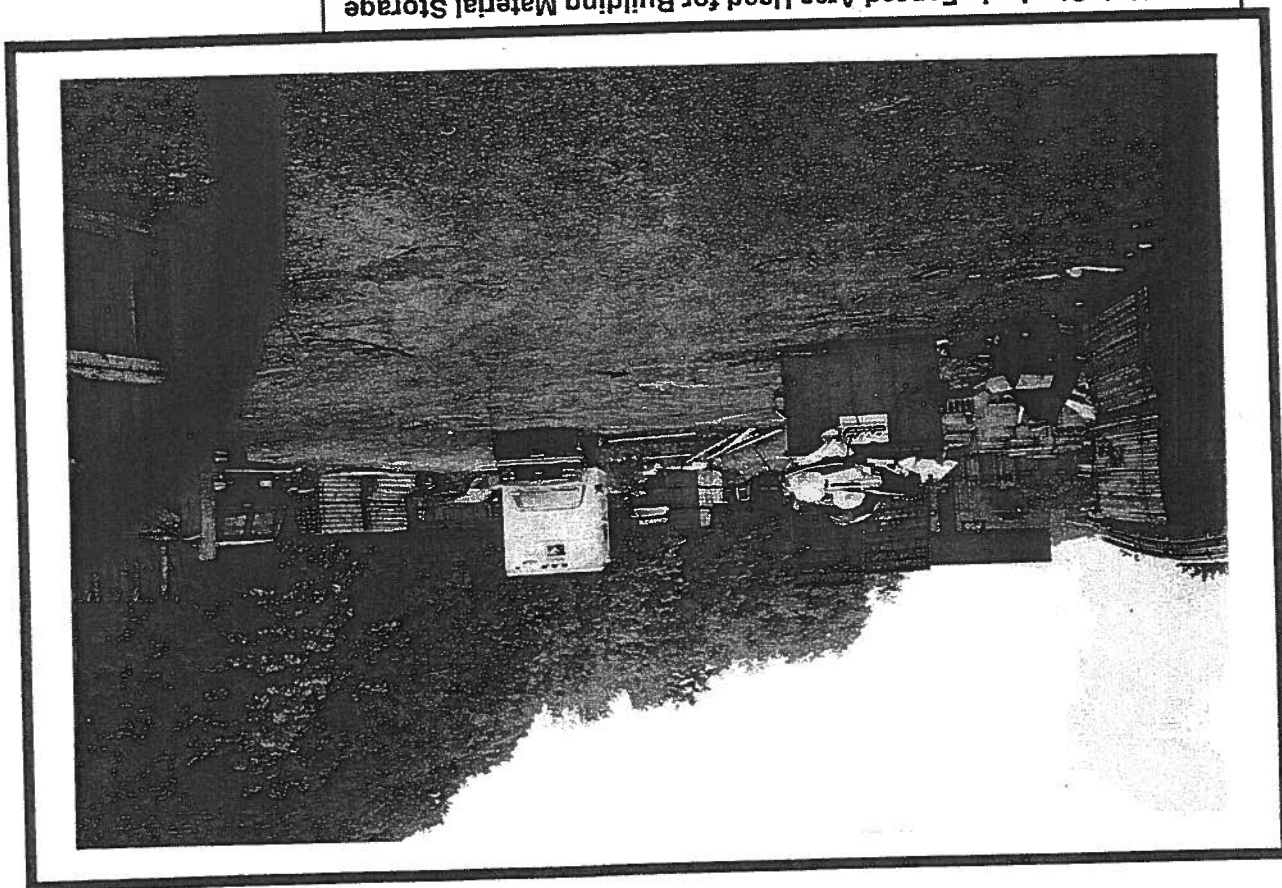
PHOTO 4 Excavated Old Depot Area

An old train station depot which had previously been fenced and considered inaccessible, is now used as a storage facility by Richard's Lumber. At the time of the survey the fenced area, which was known to contain "hot spots", was being cleared, excavated to remove railroad ties, rails and tree stumps and graded for future paving with blacktop (Photo#4).

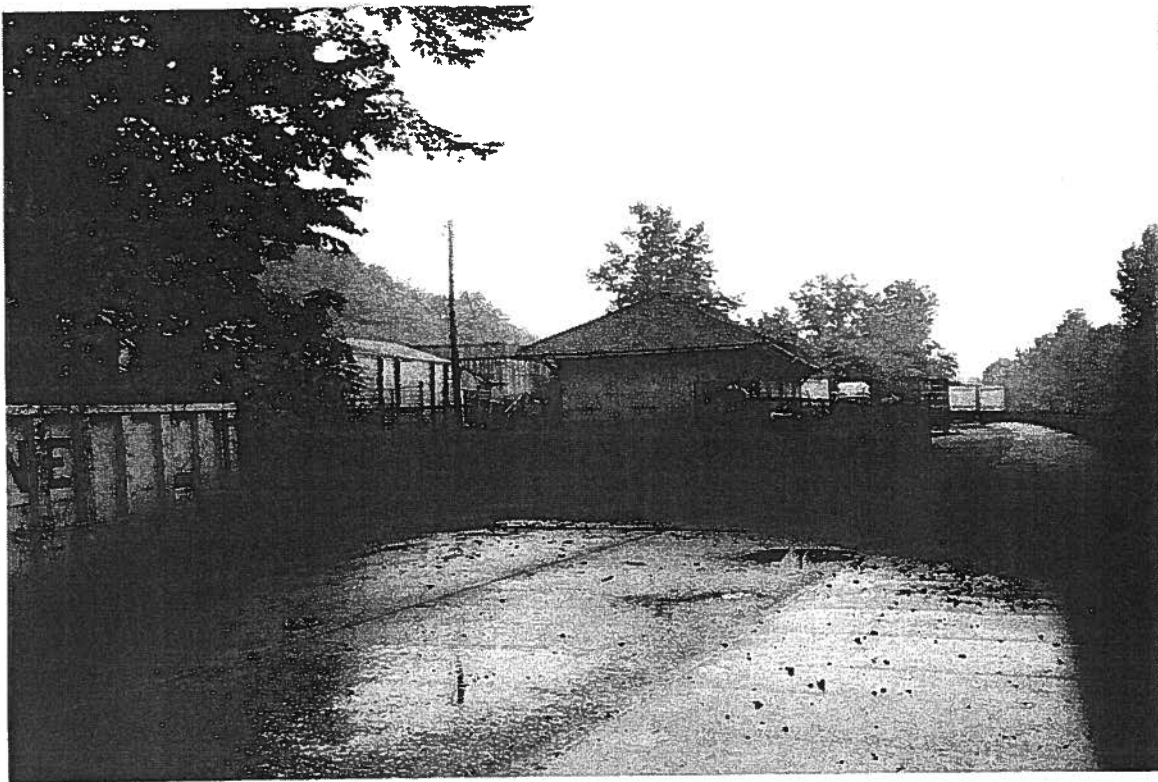
**PHOTO 5** Hedgerow Next to Apron/Roadway

It was indicated at the time of the survey that additional excavation was planned for the hedgerow which begins on the north side of the new road and runs northward toward the old depot. Part of the hedgerow is fenced and runs parallel to the lumber storage shed on the main building property. An approximate 10 ft. unfenced strip abuts a concrete apron leading to the depot (Photo#5).

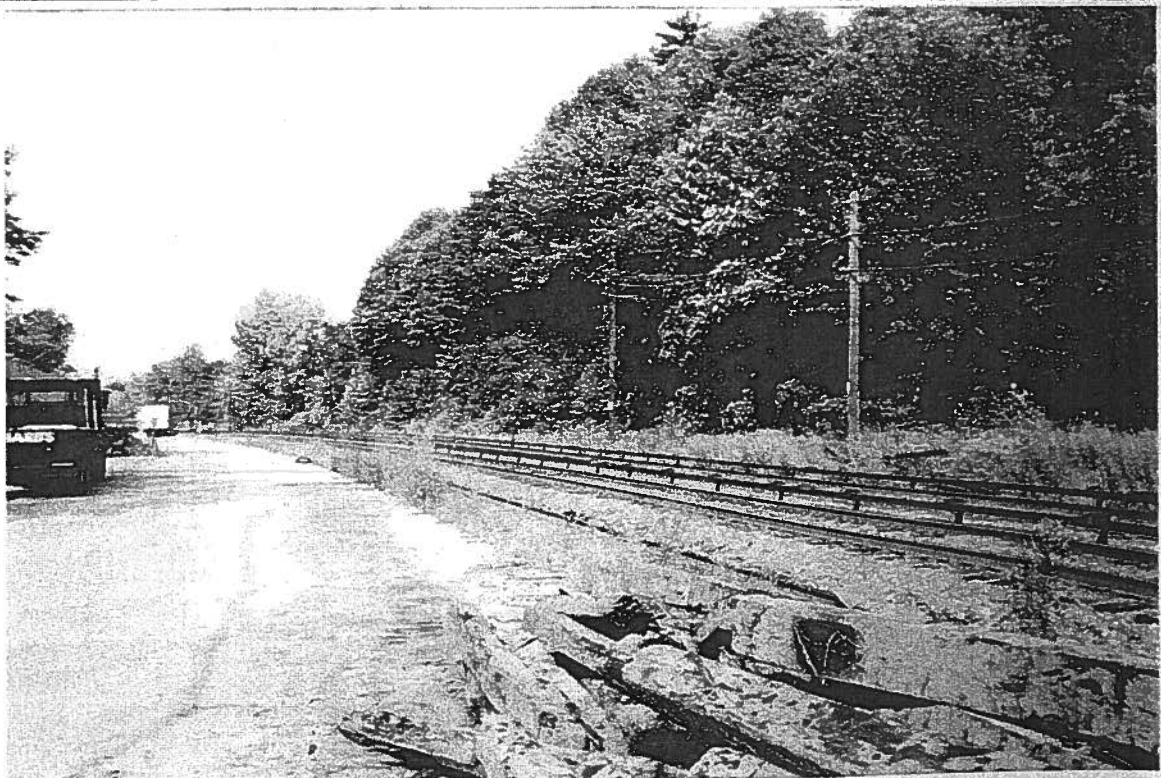
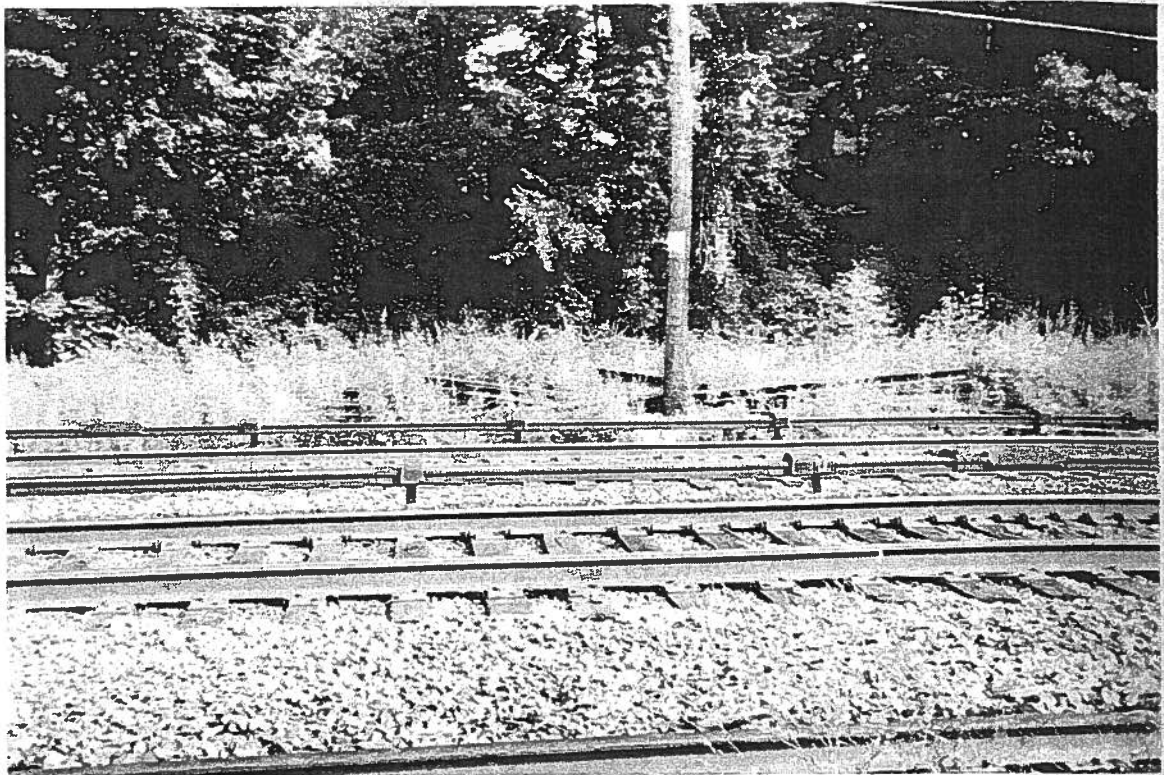
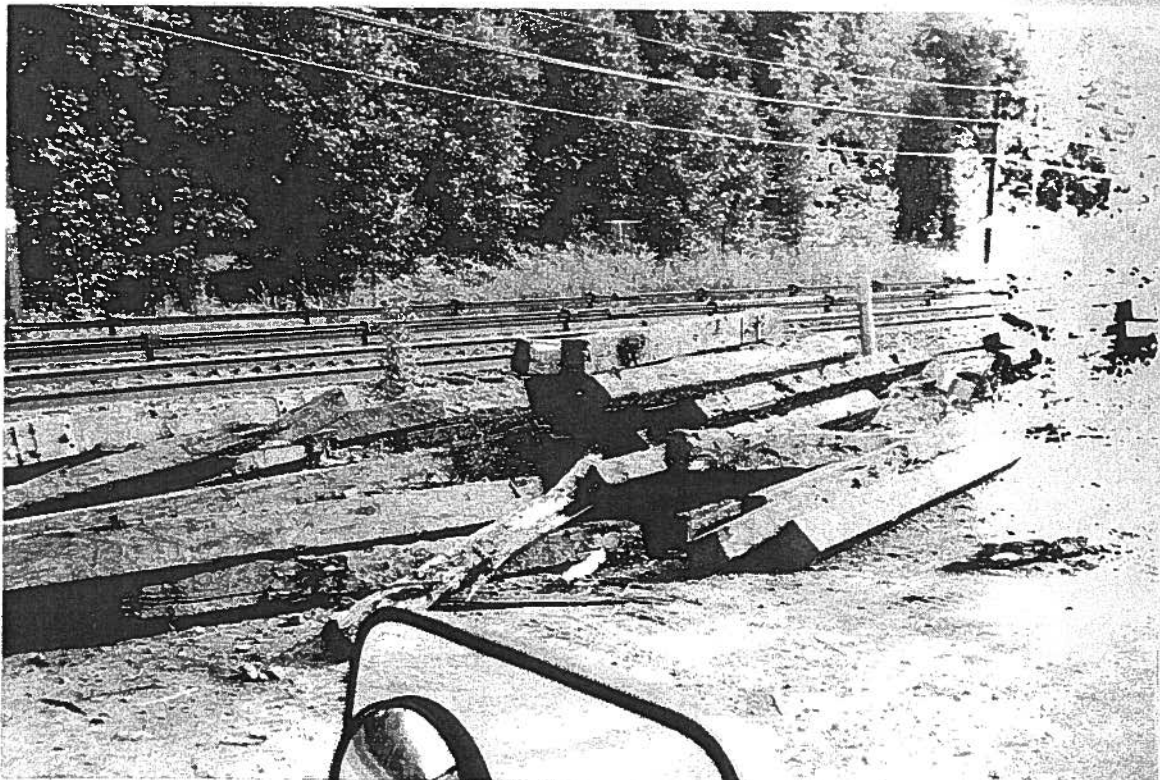
**PHOTO 22 Railroad Tracks Bordering East Side of Property, Possibly Contaminated (Photo 1 of 3)**

**PHOTO 23 Railroad Tracks B ordering East Side of Property, Possibly Contaminated (Photo 2 of 3)**

**PHOTO 24 Railroad Tracks B ordering East Side of Property, Possibly Contaminated (Photo 3 of 3)**
