**SURVEY OF THE FORMER CANADIAN RADIUM SITE  
MOUNT KISCO, WESTCHESTER COUNTY, NEW YORK**

**NEW YORK STATE DEPARTMENT OF HEALTH  
BUREAU OF ENVIRONMENTAL RADIATION PROTECTION  
OCTOBER, 1993**

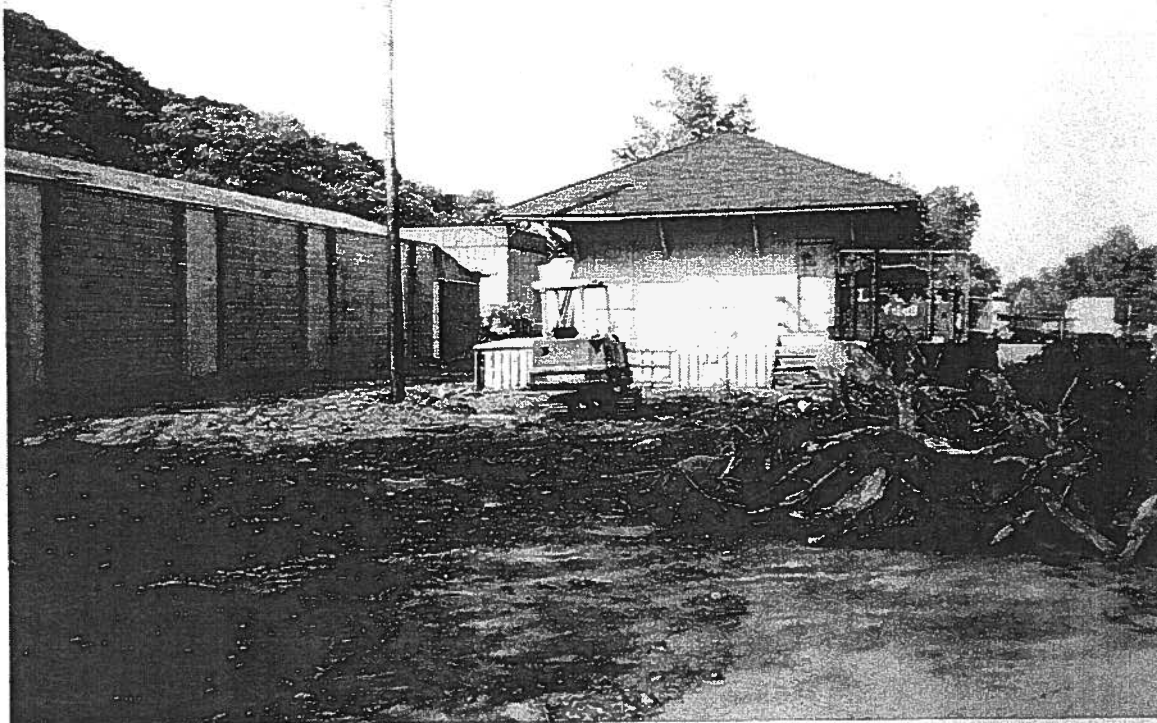
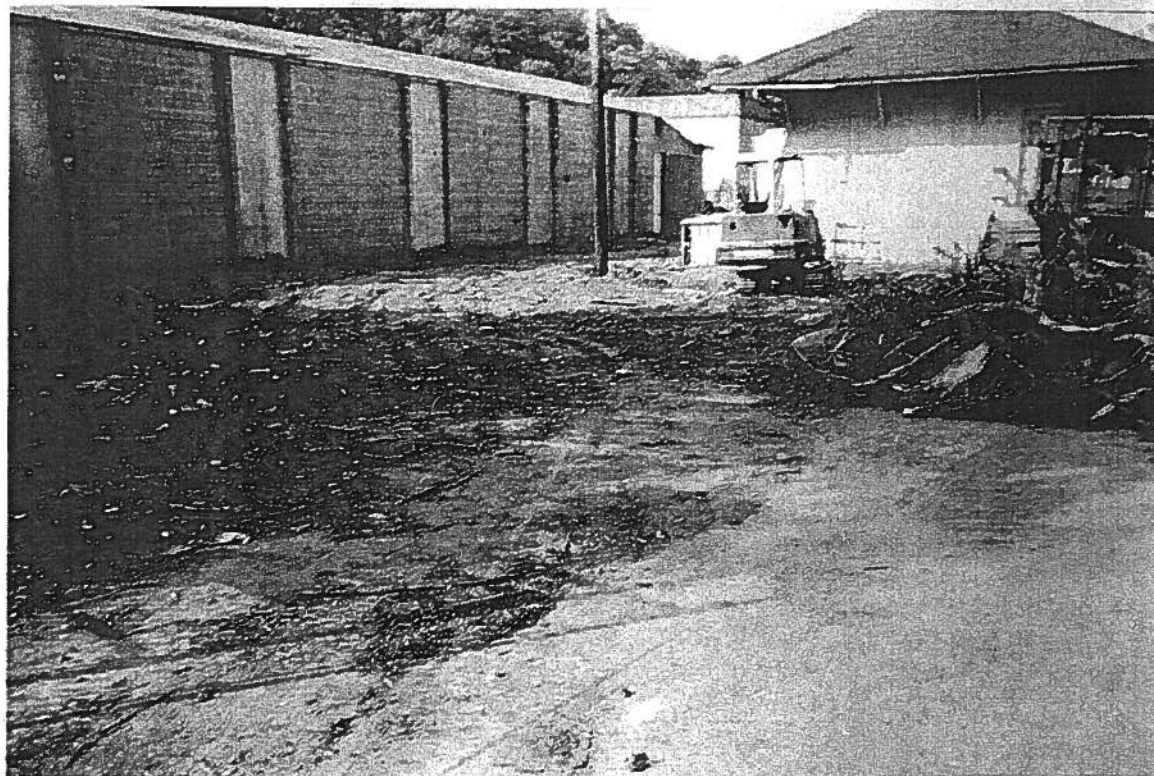
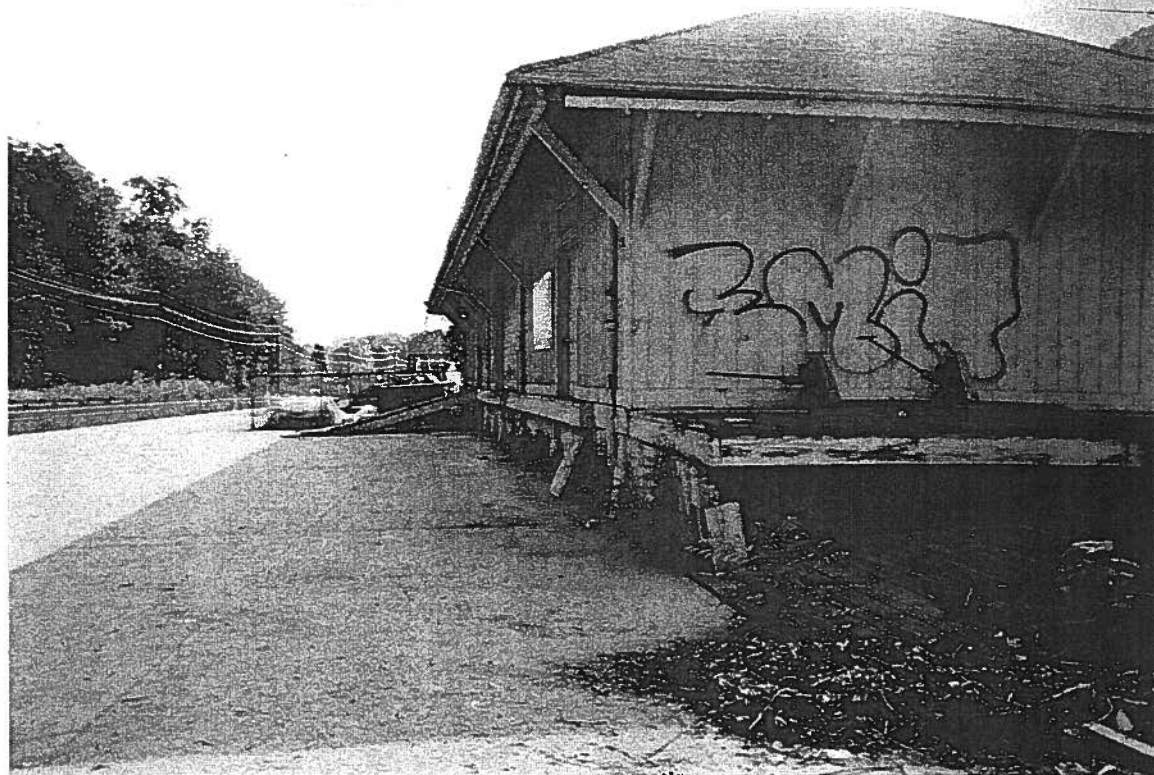
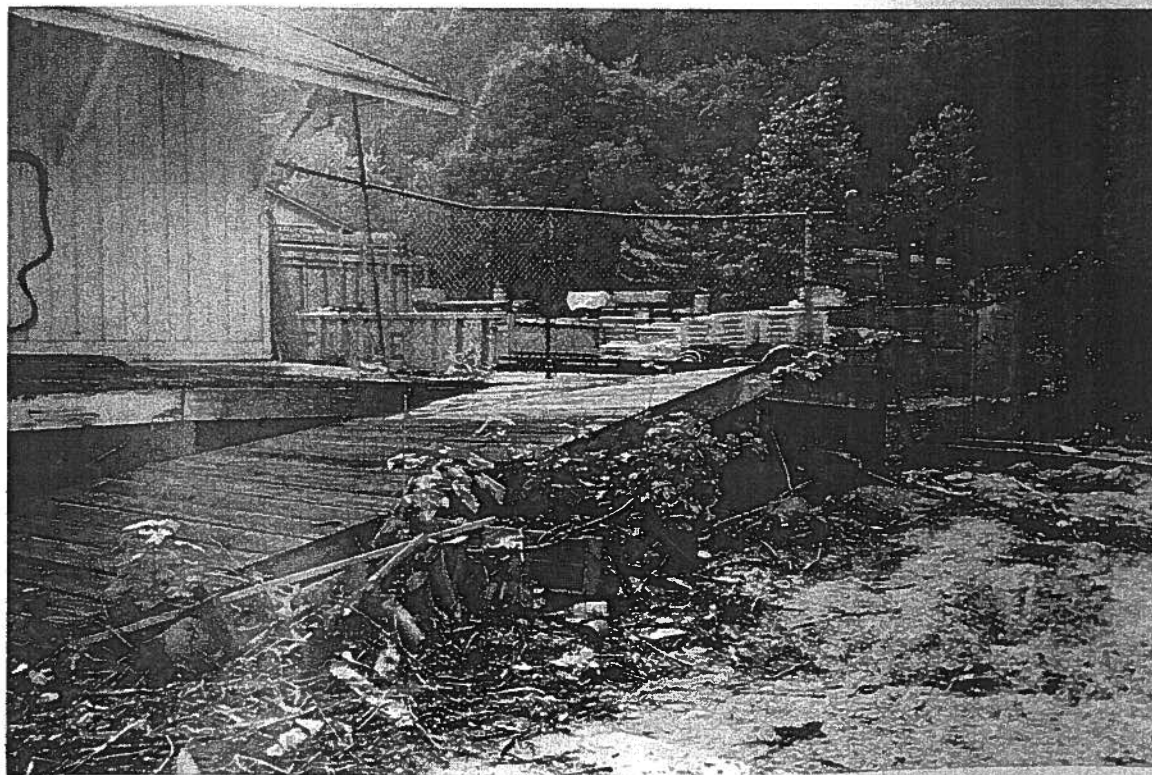
**PHOTO 25 Old Depot Excavated Area. Changes Shown Since 9/9/93 Photos (Photo 1 of 4)**

**PHOTO 26 Old Depot Excavated Area. Changes Shown Since 9/9/93 Photos (Photo 2 of 4)**

PHOTO 27 Old Depot Excavated Area. Changes Shown Since 9/9/93 Photos (Photo 3 of 4)

PHOTO 28 Old Depot Excavated Area. Changes Shown Since 9/9/93 Photos (Photo 4 of 4)

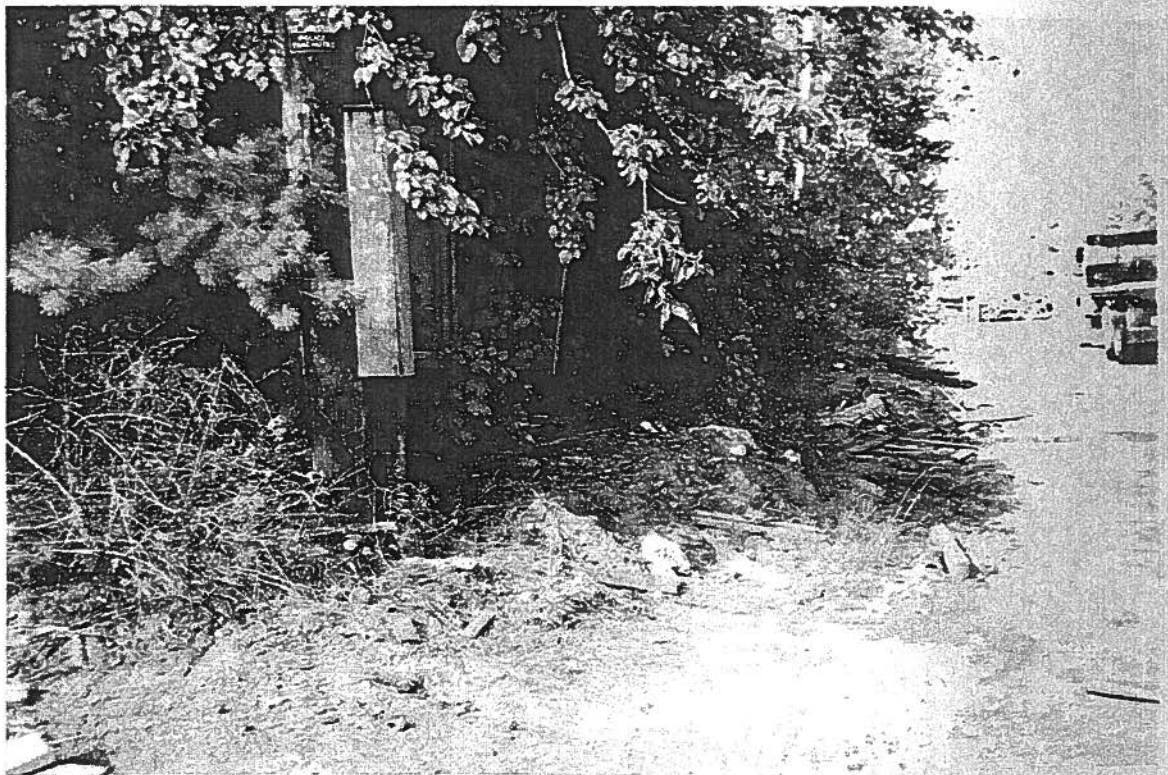
**PHOTO 30 Soil Strip Parallel to Fenced Hedge and Concrete Apron**

Figure 9 and Photo 30 show the narrow, approximately 10 ft. strip of soil, brush and debris which runs parallel to the fenced hedgerow and concrete apron from the new roadway to the fenced depot area. As shown, all measurements along this area show exposure rates well above background ranging from 50-130  $\mu\text{R/hr}$ .

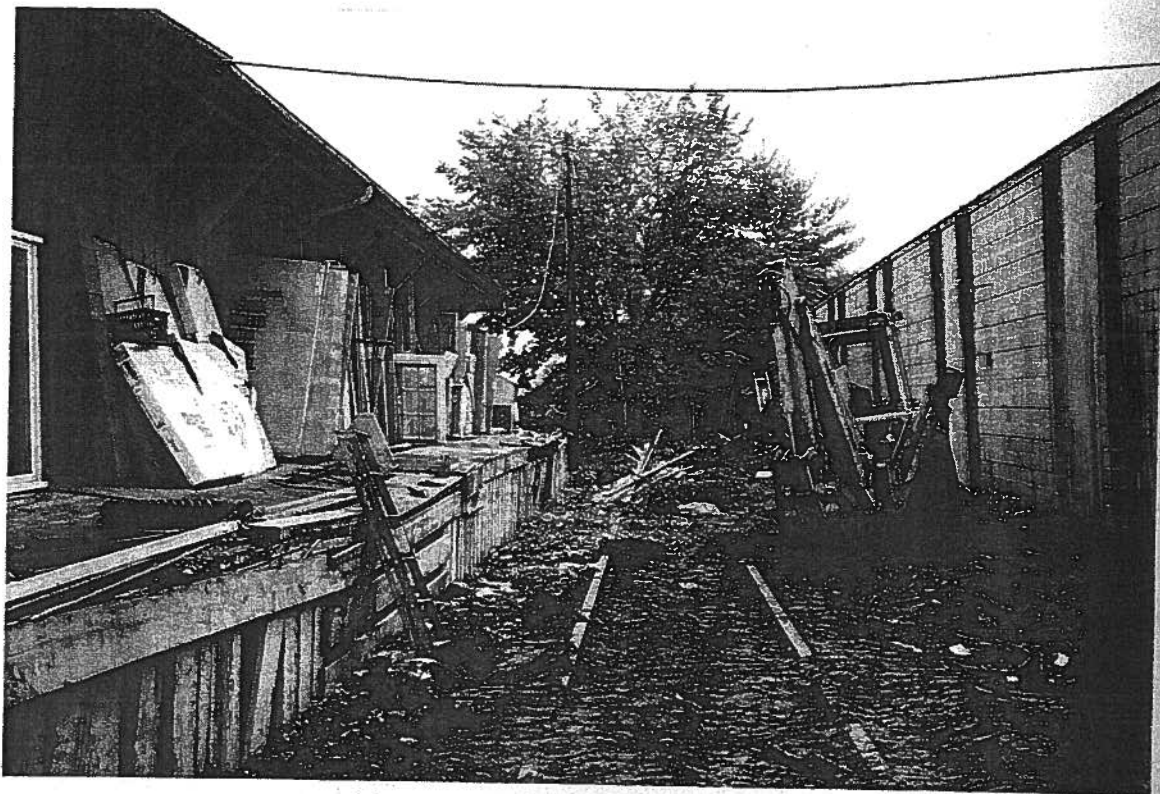
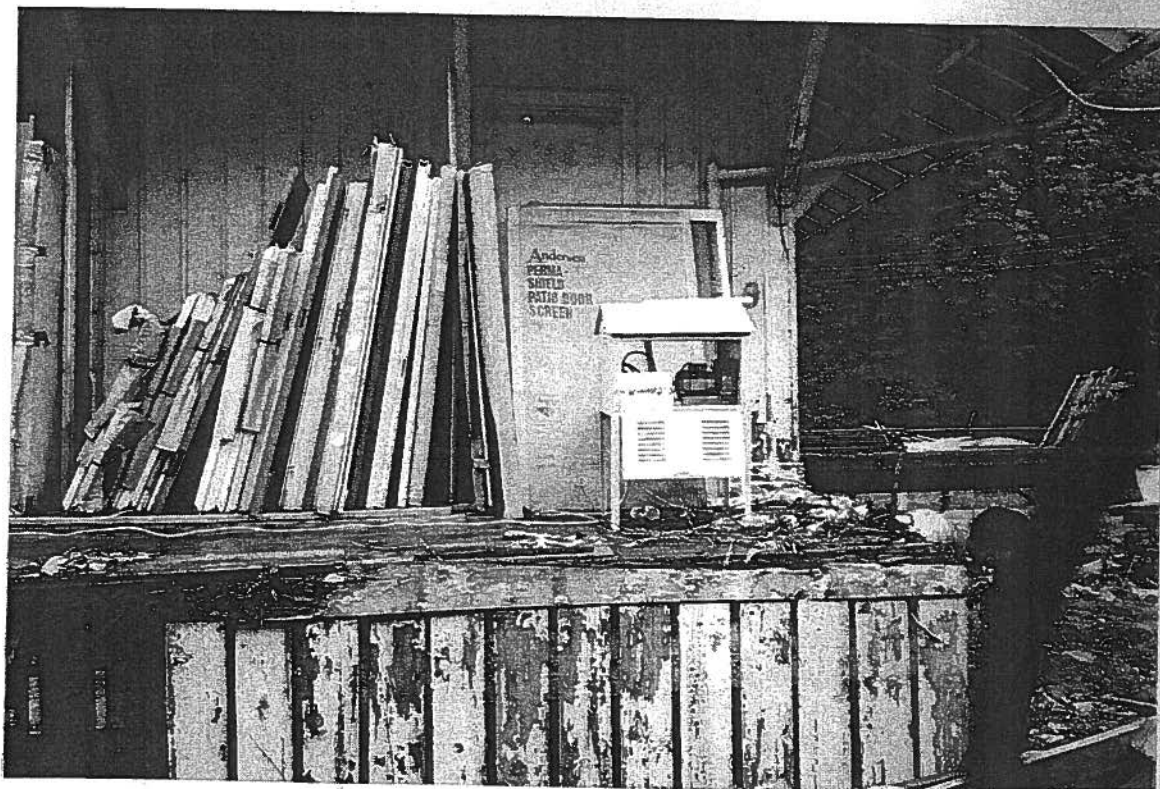
The air samples were analyzed to determine if any radium was present. The location of the air pumps is shown in Photos 31 and 32. The results indicate a radium concentration of less than 0.0001 pCi/m<sup>3</sup> in the air samples (the detection limit). The air sample filter from the hallway pump could not be analyzed due to the fact that it had what appeared to be a pencil hole.
