EROSION CONTROL INSPECTION CHECKLIST

**GARDEN STREET RESIDENCES
NEW ROCHELLE, NY 10901
SESI CONSULTING ENGINEERS PROJECT # 10491**

Date: 01/06/2020

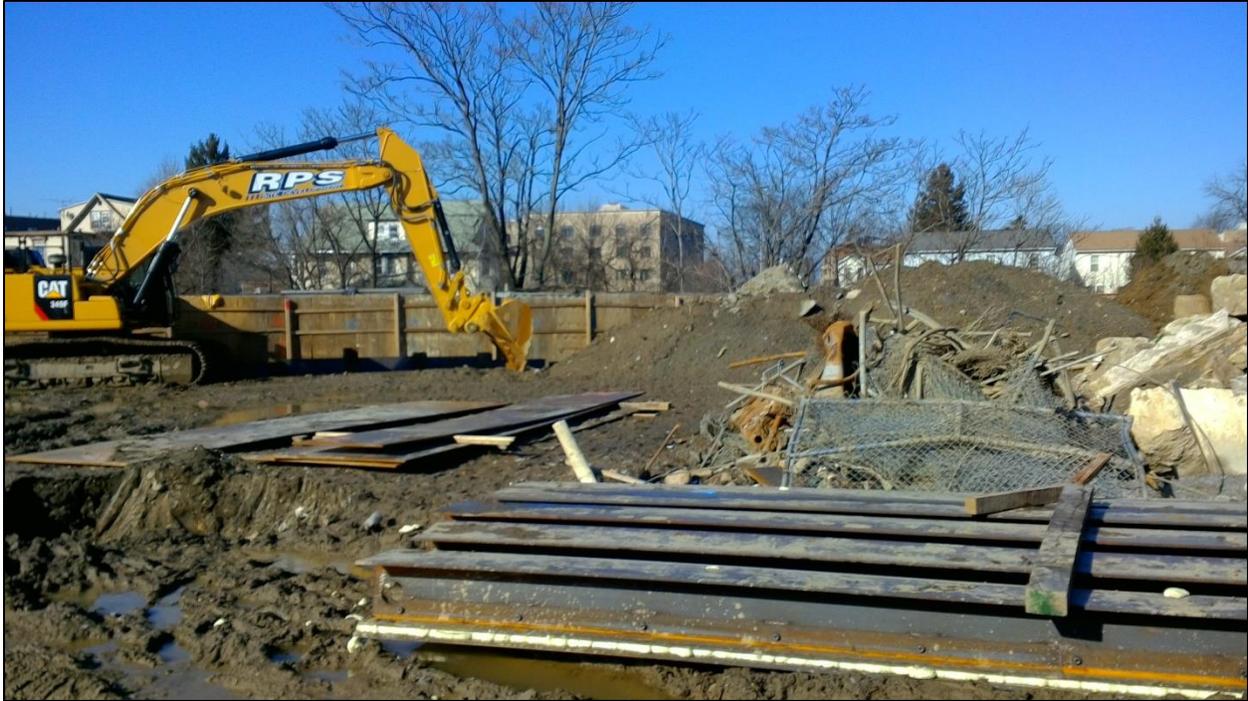
Photo 1: Soil Movement in progress

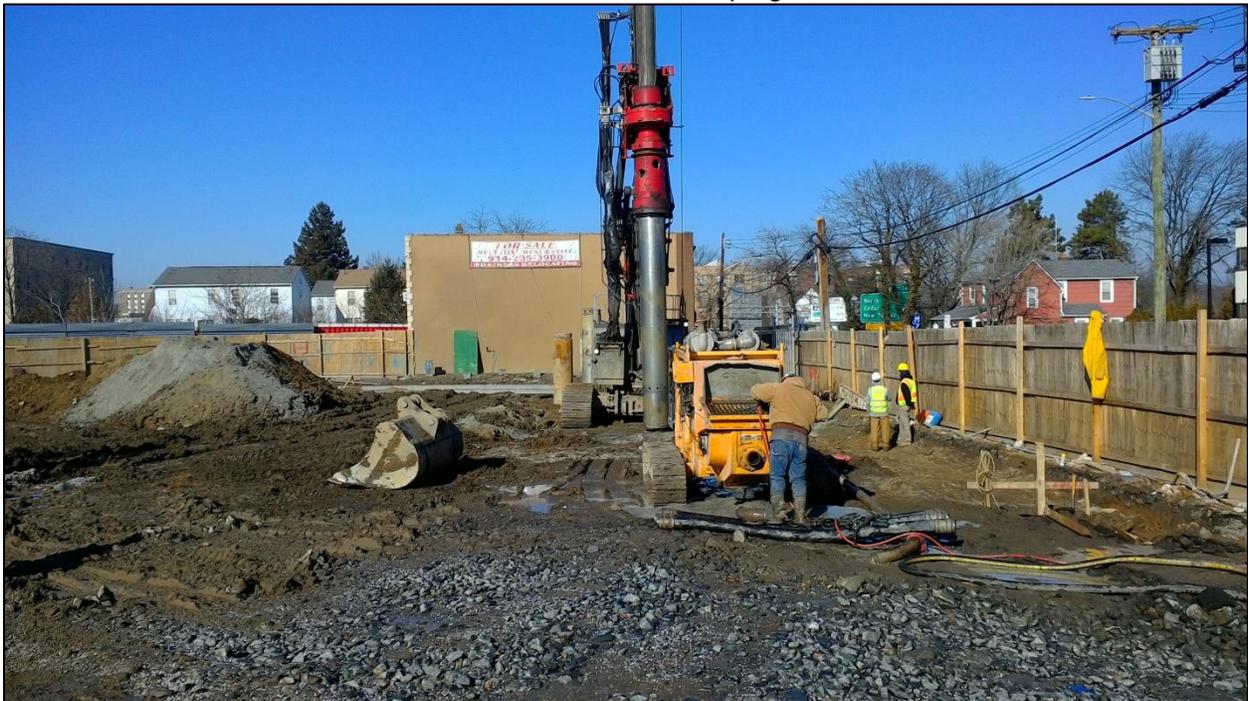
Photo 2: Work in progress

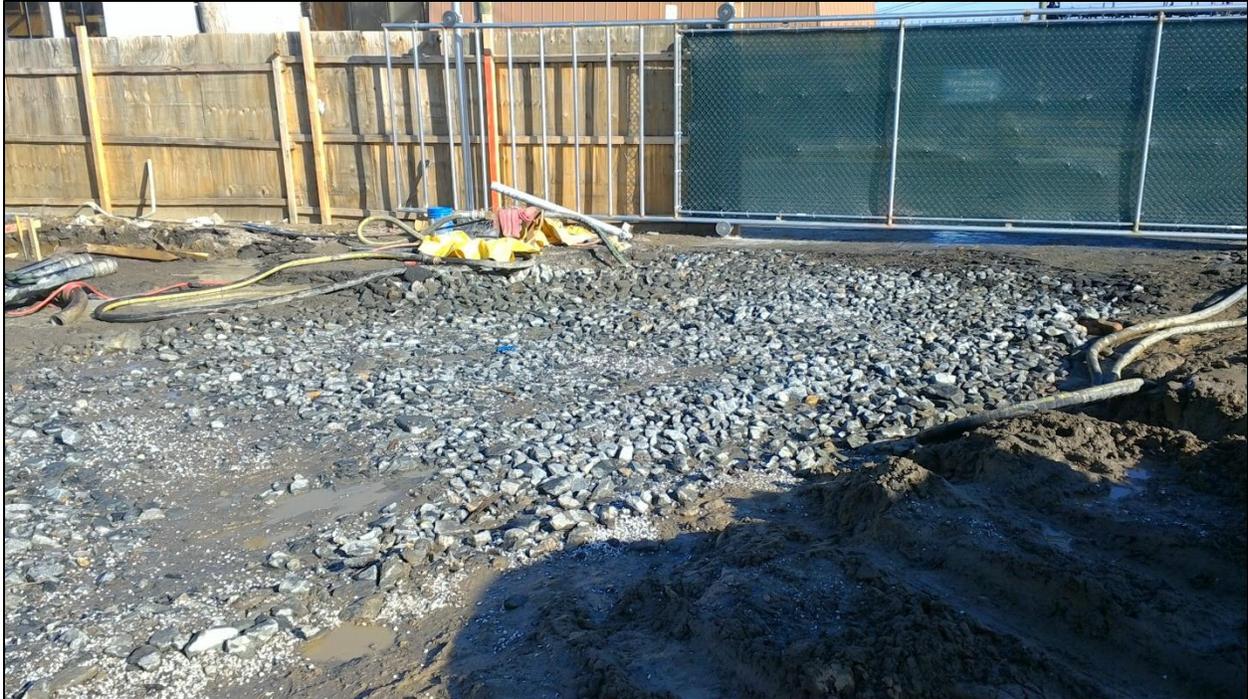
Photo 3: Construction Entrance/Tracking Pad; This entrance will be decommissioned and a new location for the entrance and tracking pad will be utilized.

- SOE / Foundation work observed.
- It is understood that the construction entrance and tracking pad is to be relocated to a different section of the site and will be brought up to the required specifications. The associated work was done after the inspection. A concrete washout is recommended in order to contain the waste of the concrete. It is also understood that the relocation of the construction entrance was worked on after the time of the SWPPP inspection.

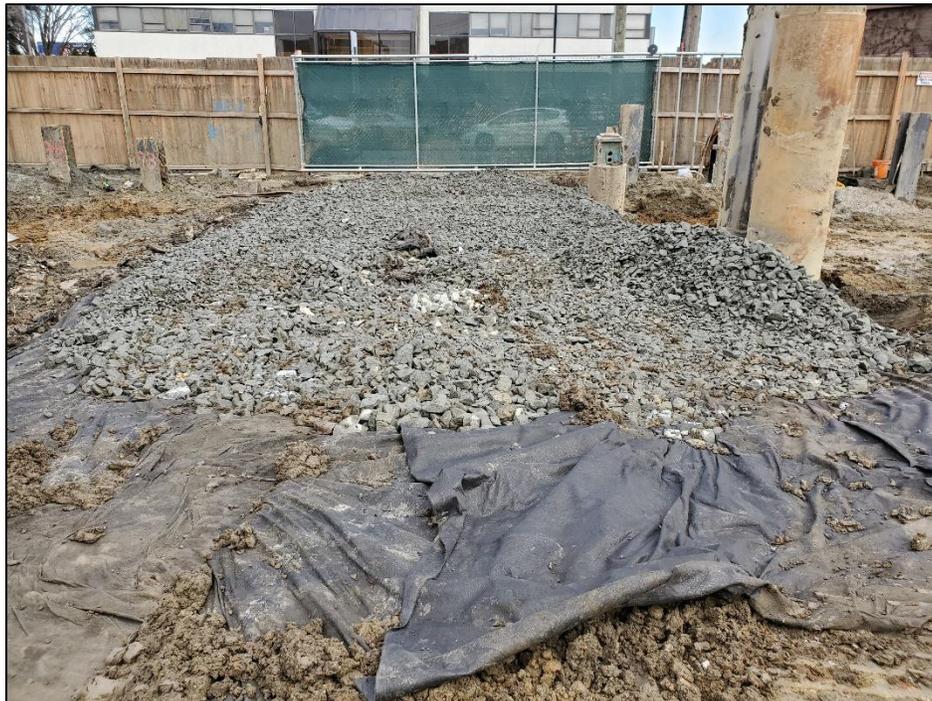
Photo 4: Relocated Construction Entrance/Tracking Pad; Currently in progress and was not utilized during the time of inspection.

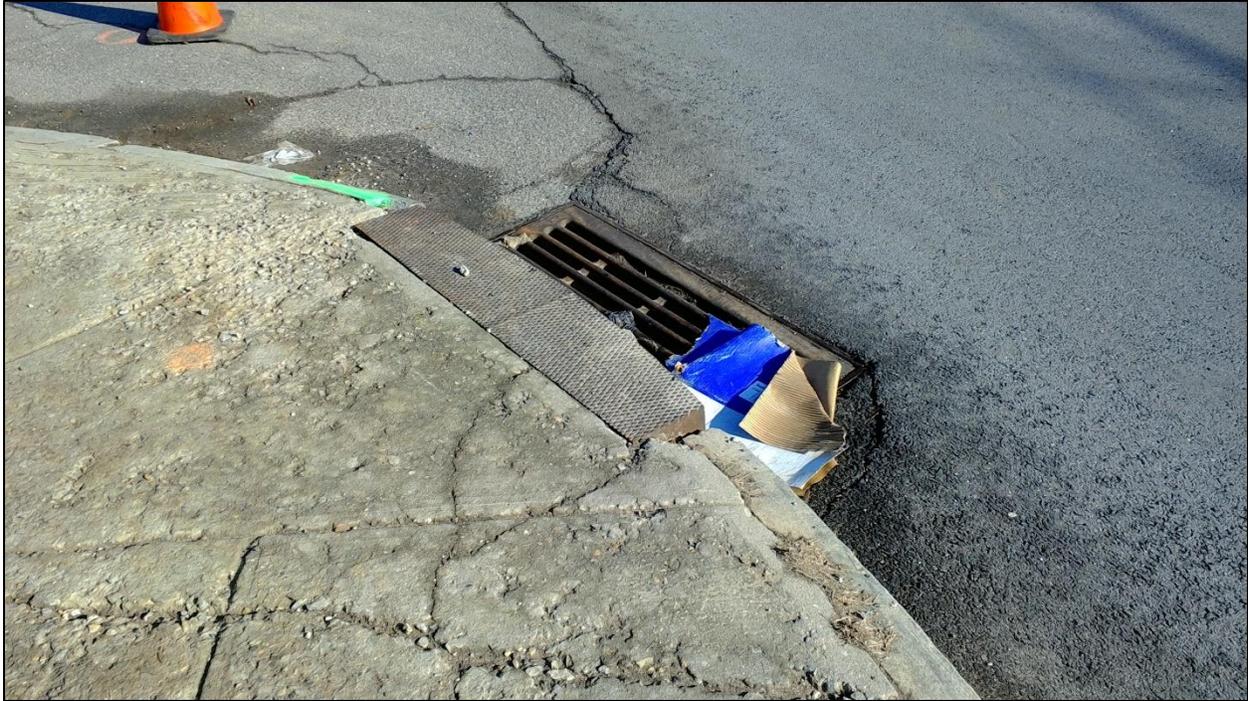
Photo 5: Corner Curb Inlet on intersection of Garden Street and Cottage Place

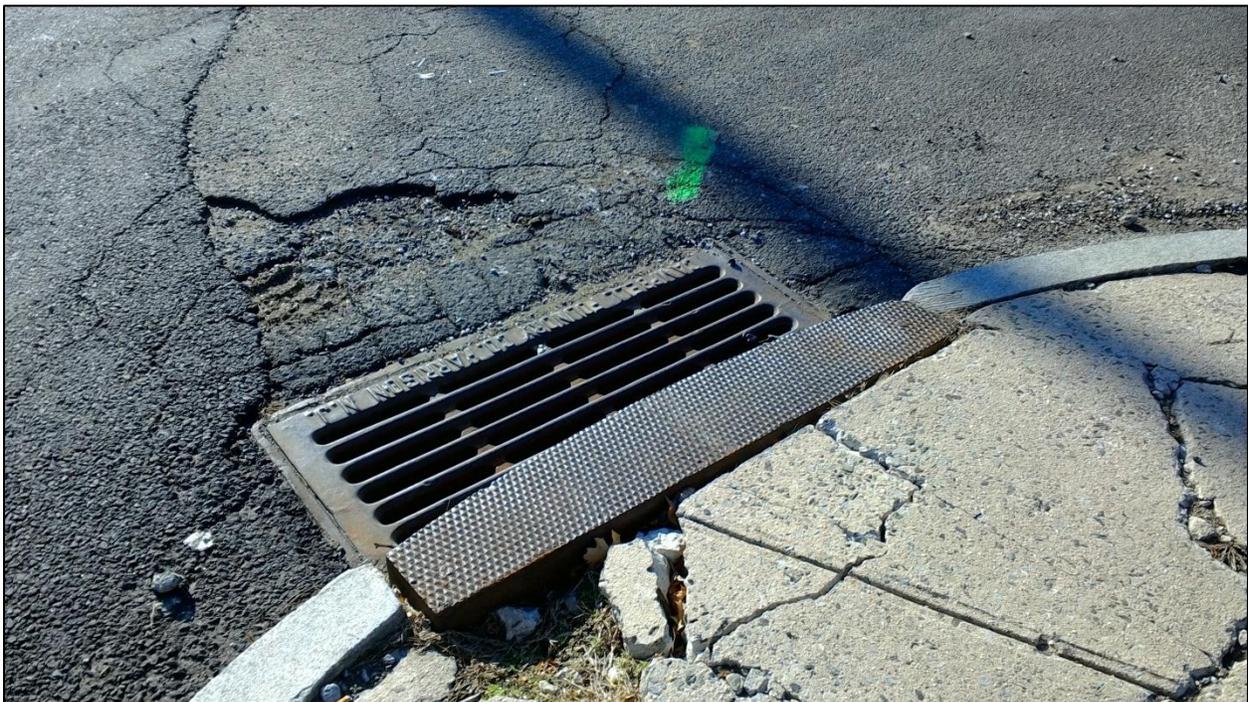
Photo 6: Corner Curb Inlet on opposite side of street, along Garden Street and Cottage Place

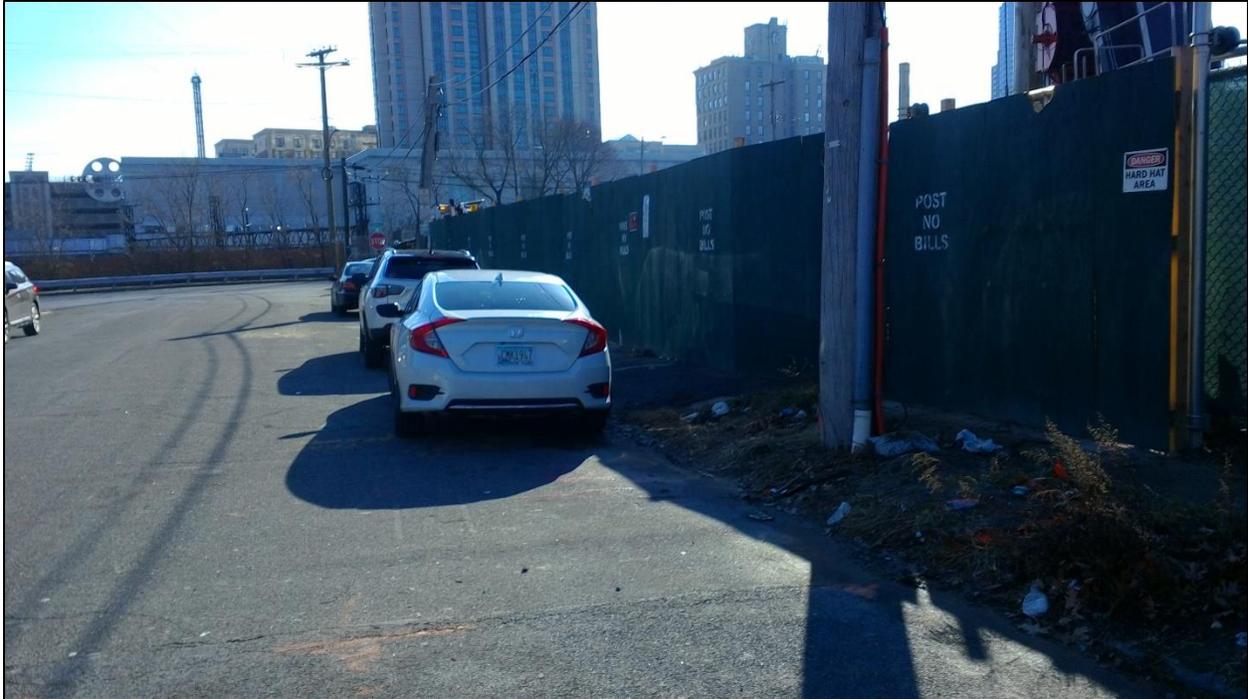
Photo 7: View of Construction Plywood Fence along Cottage Street; The entire site is bounded by these green plywood fences.

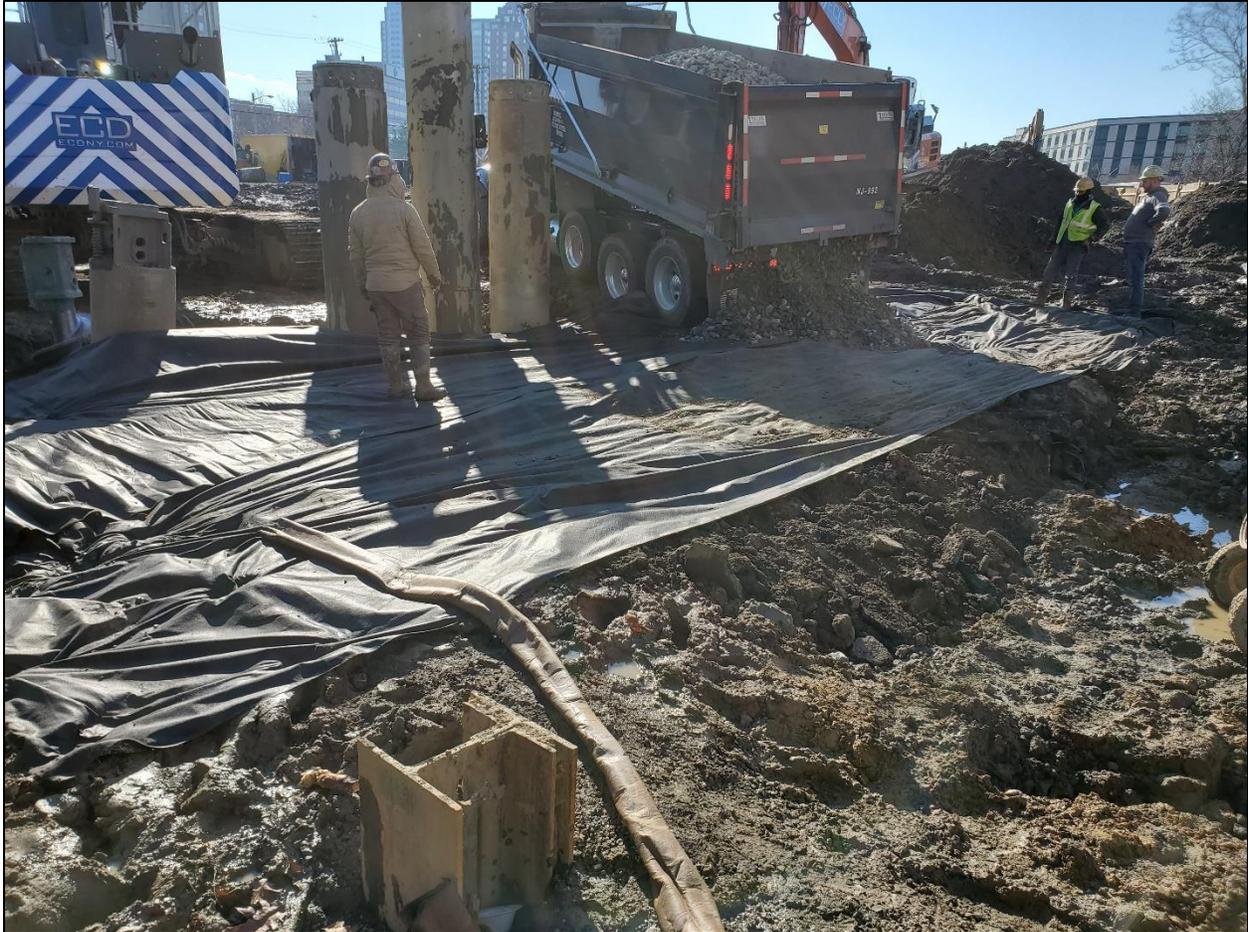
Photo 9: Construction Entrance Relocation in progress
(Taken after inspection was completed)

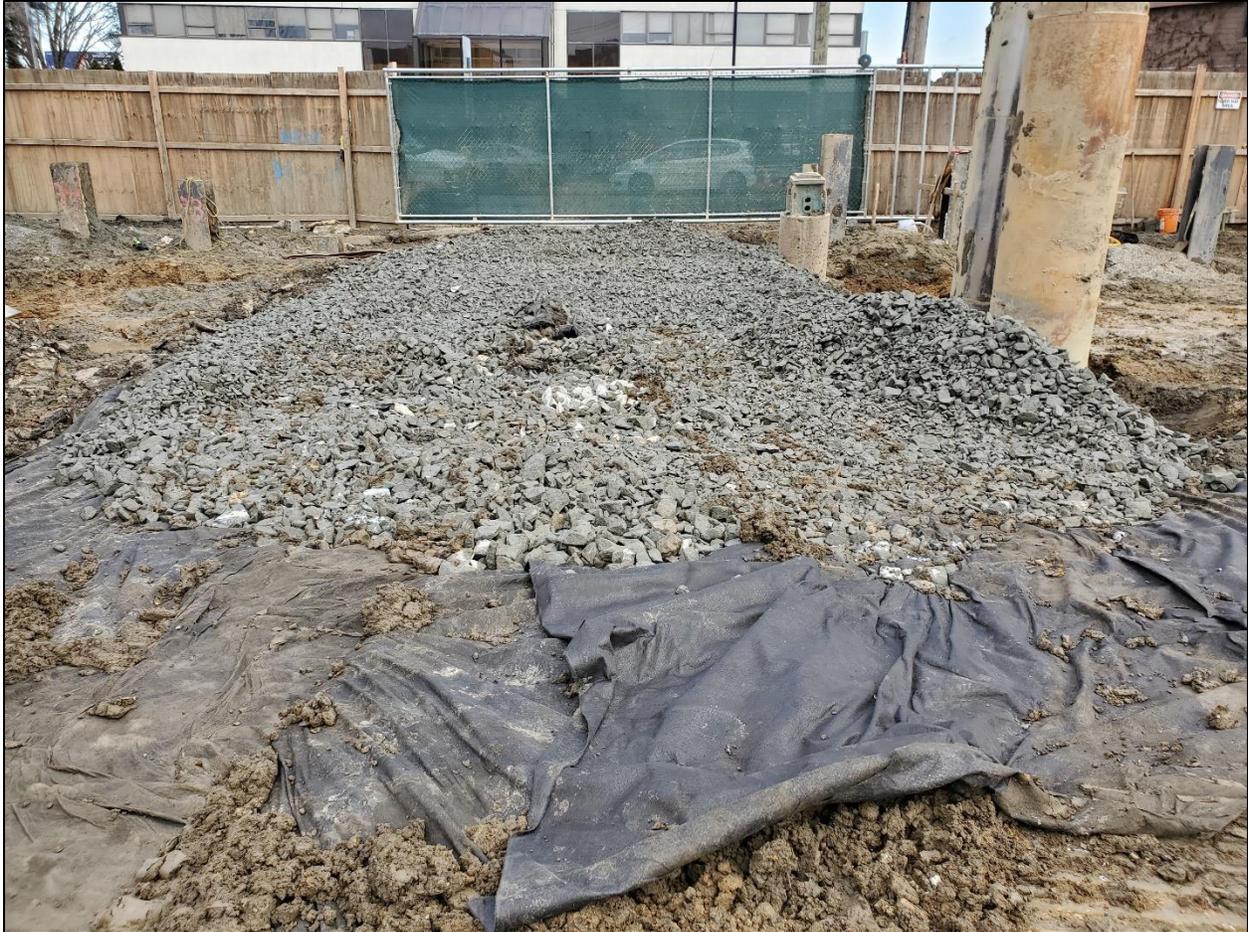
Photo 10: Construction Entrance
(Taken after inspection was completed)

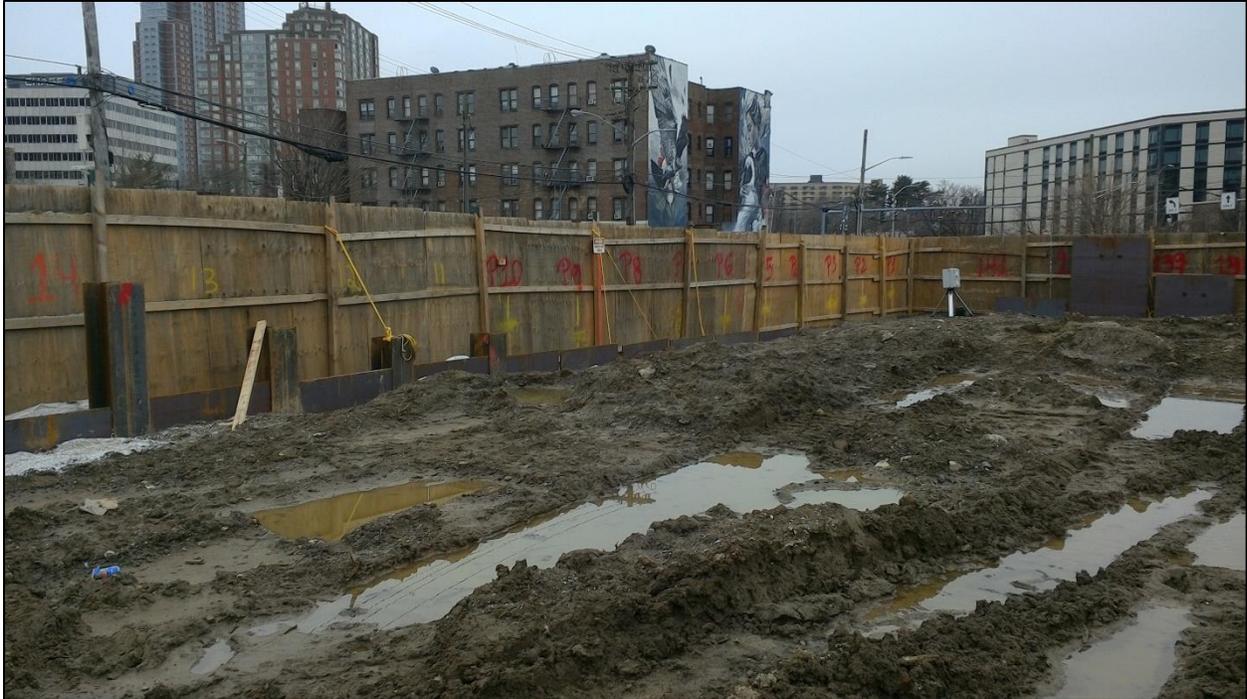
Photo 1: Construction Plywood Fence and Sheet Piles along Garden Street.

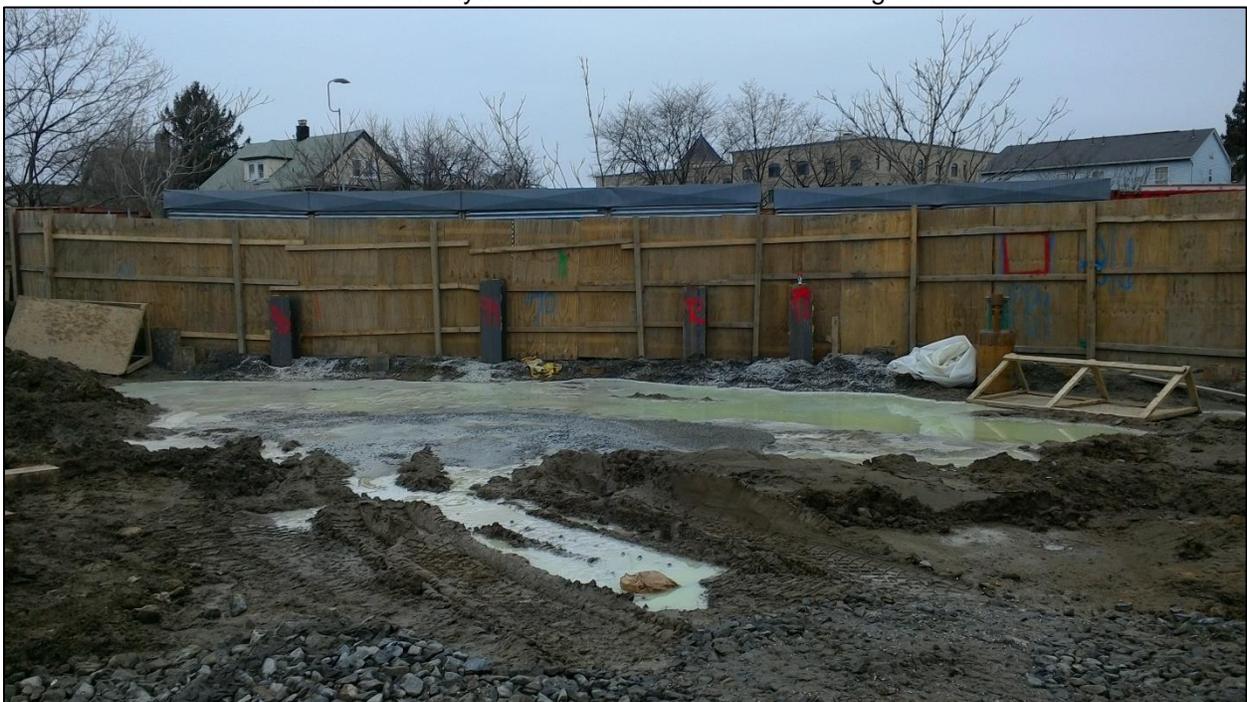
Photo 2: Observed Concrete Washout Area; There should be a designated and properly constructed concrete washout area.

- During this inspection, the entrance was relocated and appears to be in compliance with the approved plans.
- As noted in the previous inspection report, we recommend that concrete washout should be placed on-site moving forward with future concrete work. This is understood to be in progress.
- There are two stockpiles observed on-site. If left inactive for 14 days, we recommend placing silt fences around them to prevent sediment erosion.
- Sediment discharge was not observed during the time of inspection.
- Filter Fabric was added to the corner curb inlet of Garden and Cottage.
- Perimeter sediment controls are recommended to be put in place for the site, in accordance with the approved plans.

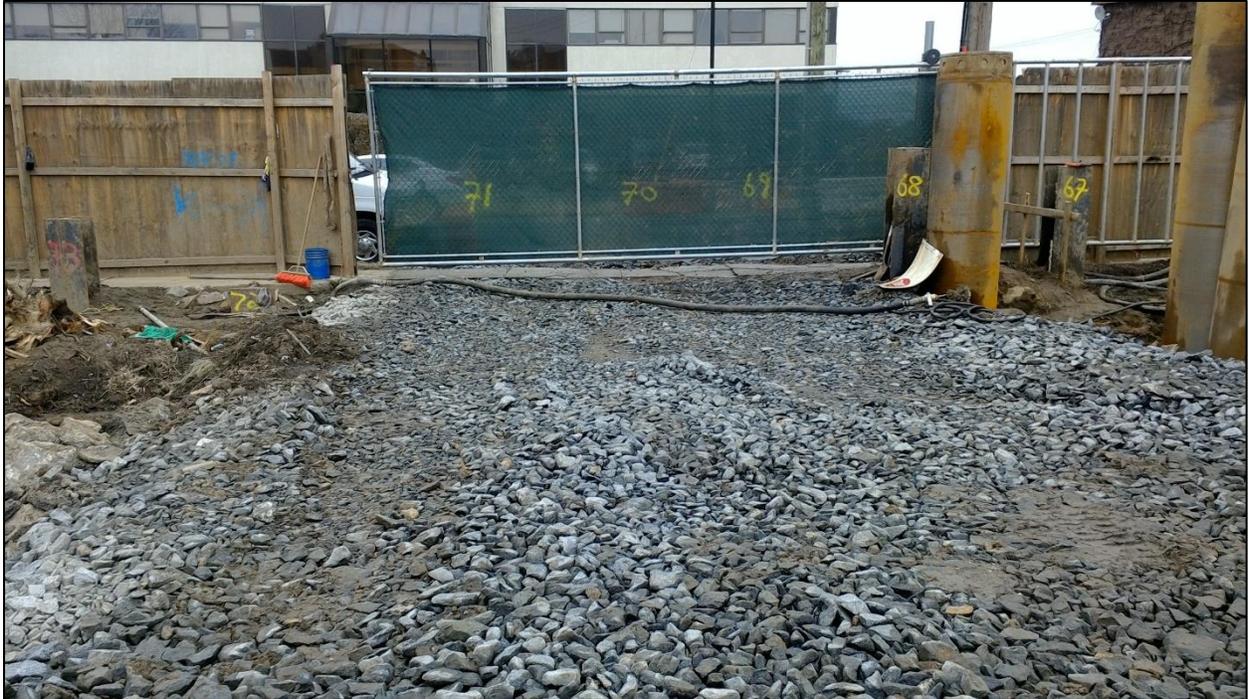
Photo 3: Relocated Construction Entrance.

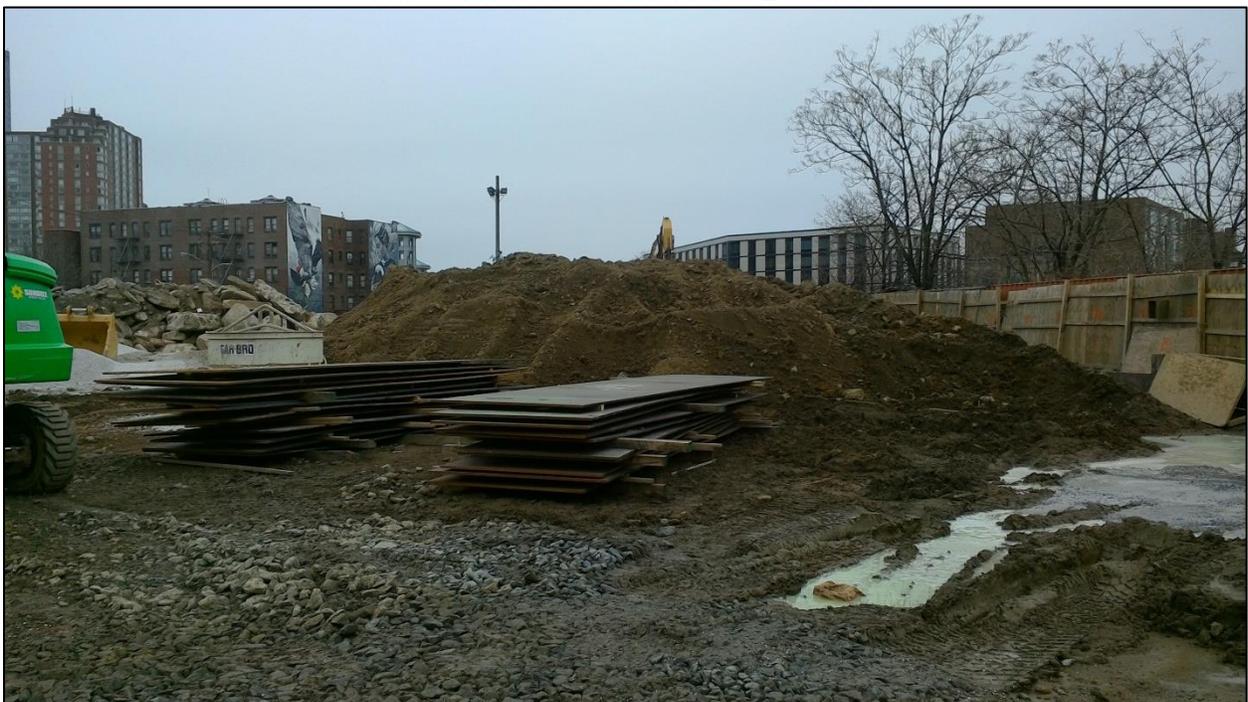
Photo 4: Observed Stockpile on-site; If left inactive for 14 days, a silt fence is recommended to be placed around its edges to prevent sediment erosion.

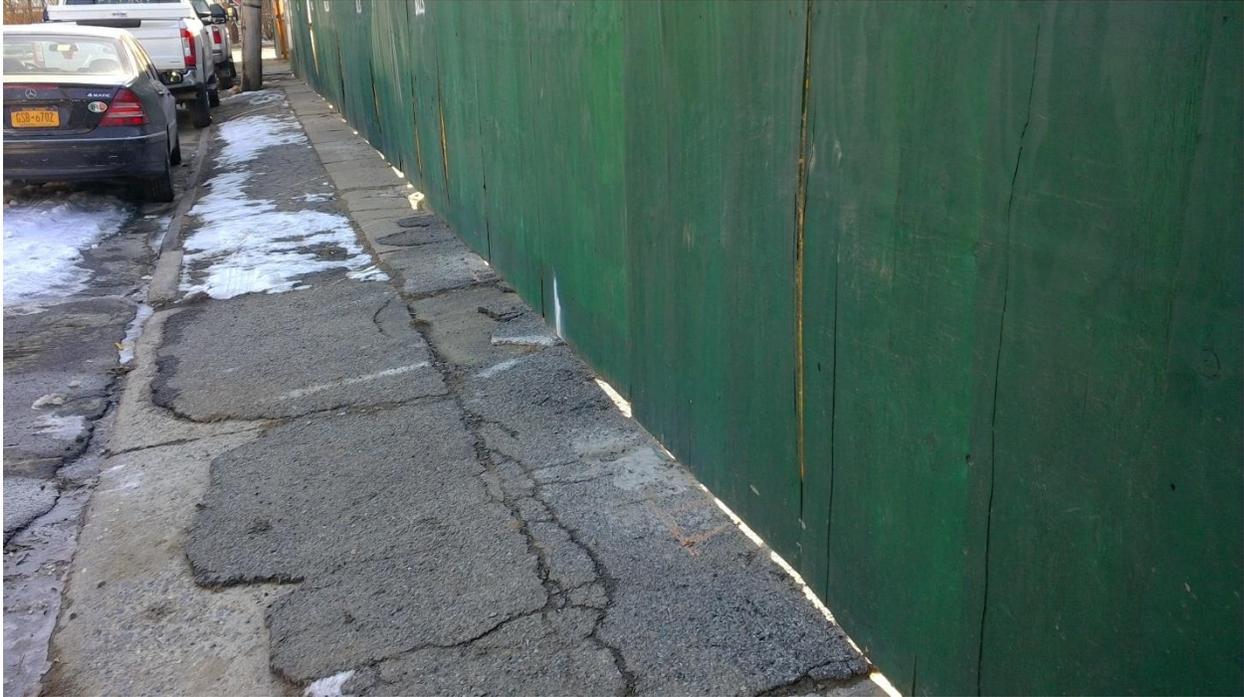
Photo 1: Plywood Fence bounding the entire site.

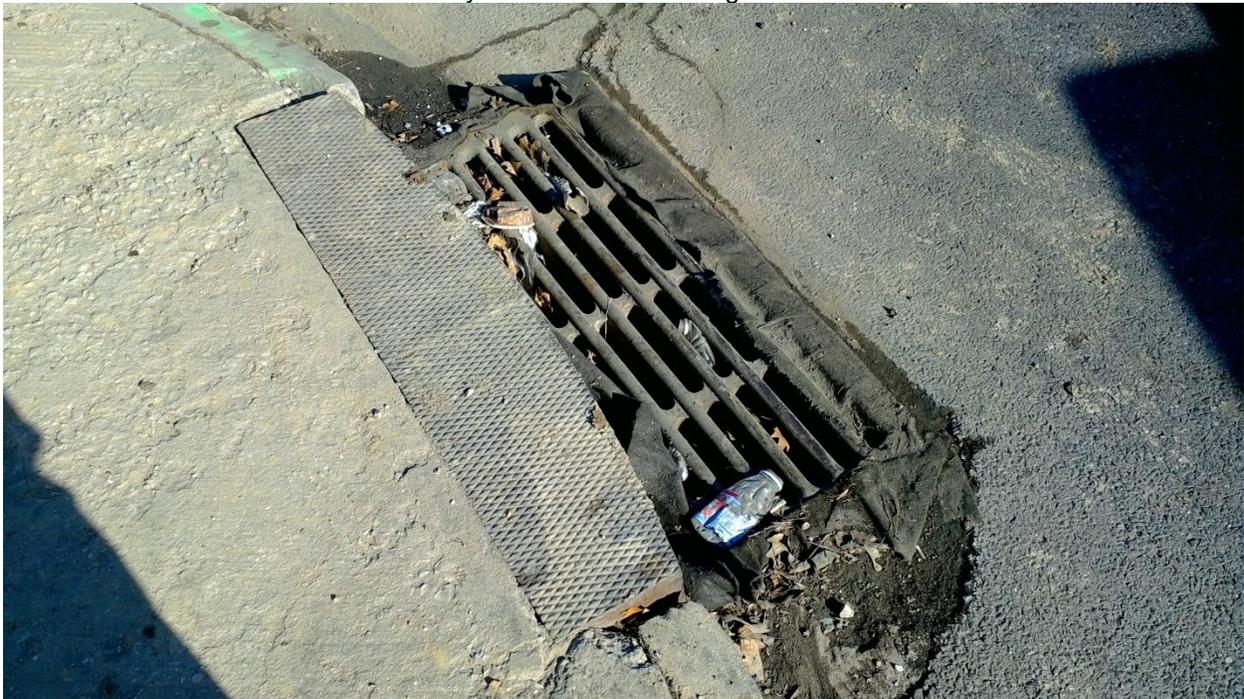
Photo 2: Filter Fabric added to corner curb inlet

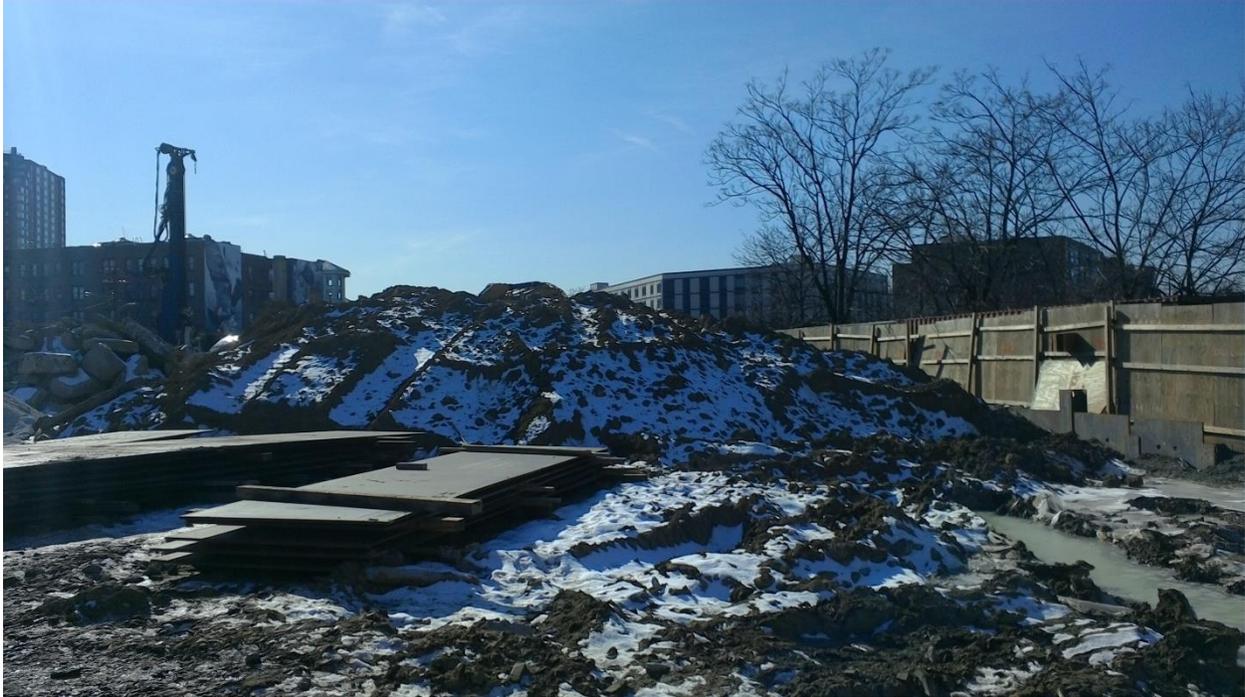
Photo 3: Stockpile on-site; Materials were segregated.

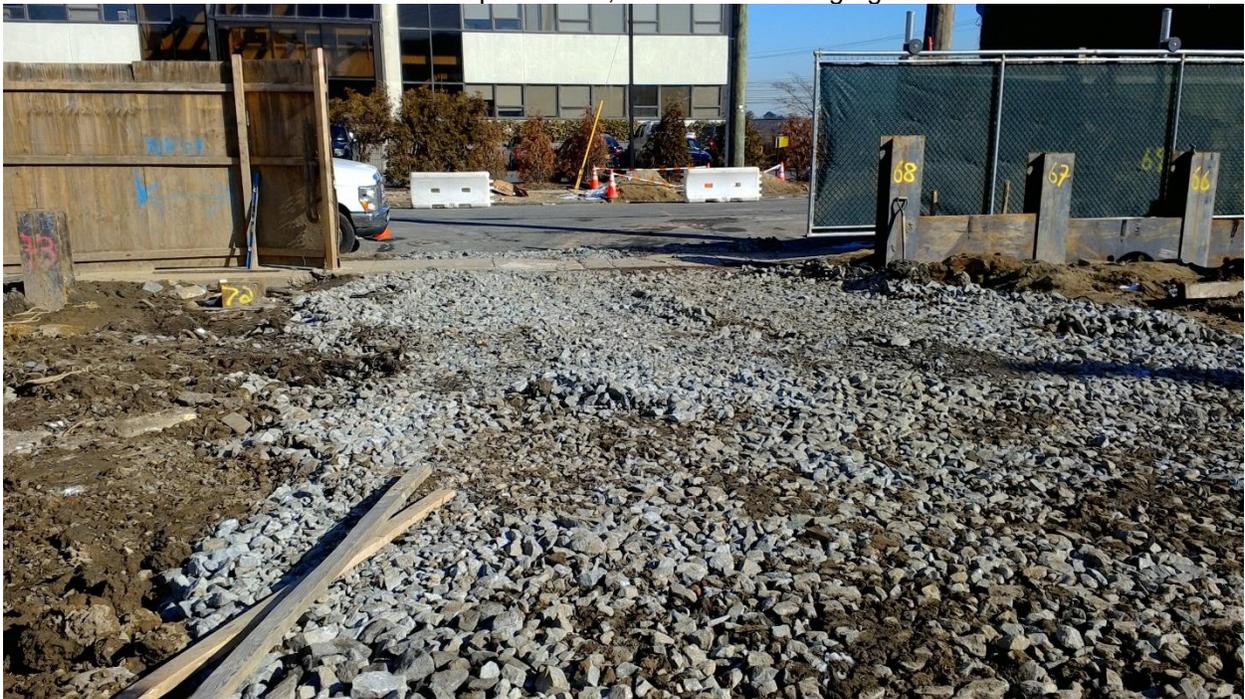
Photo 4: Construction Entrance

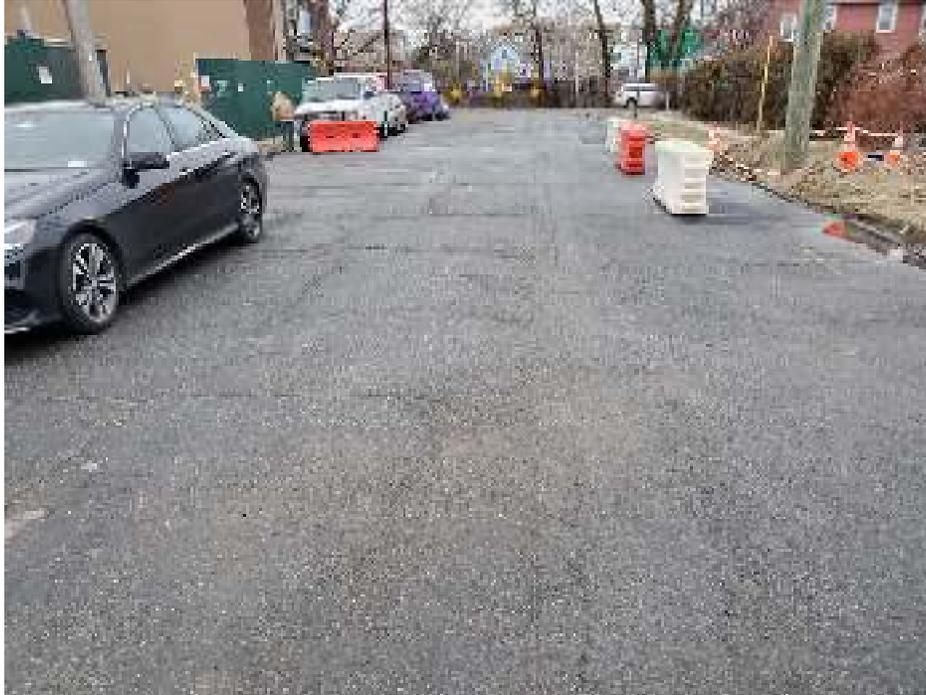
Photo 1: Contractor cleaning sediment along Cottage Place.

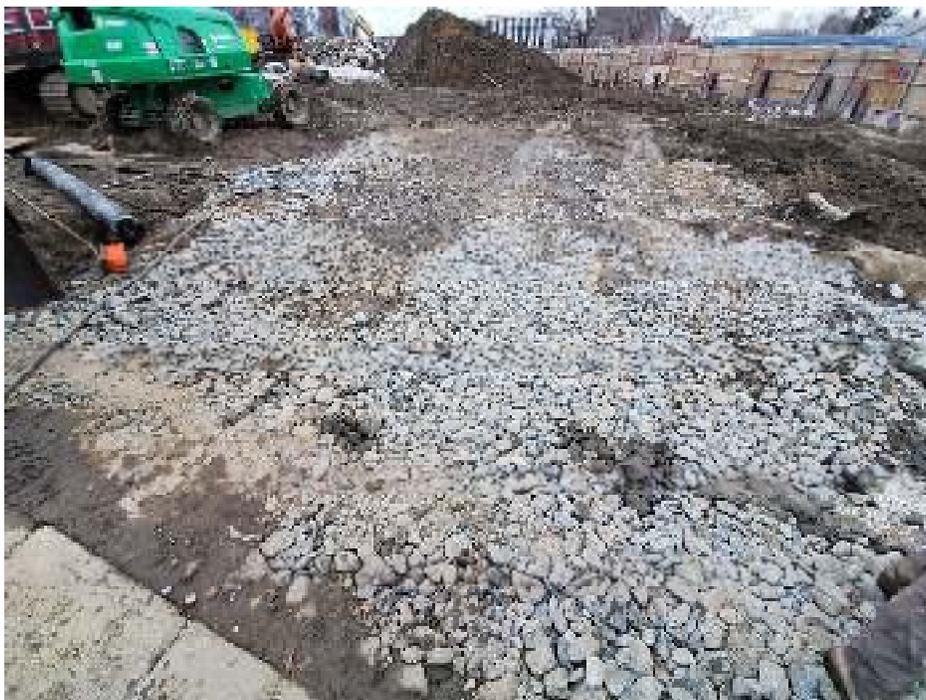
- The construction entrance/tracking pad has significant sediment deposit and is recommended to be refreshed so as to adequately remove tracked sediment from vehicle tires. The client states the construction entrance will be refreshed in the next week.

Photo 2: Construction Entrance heavily laden with sediment, recommend refreshing

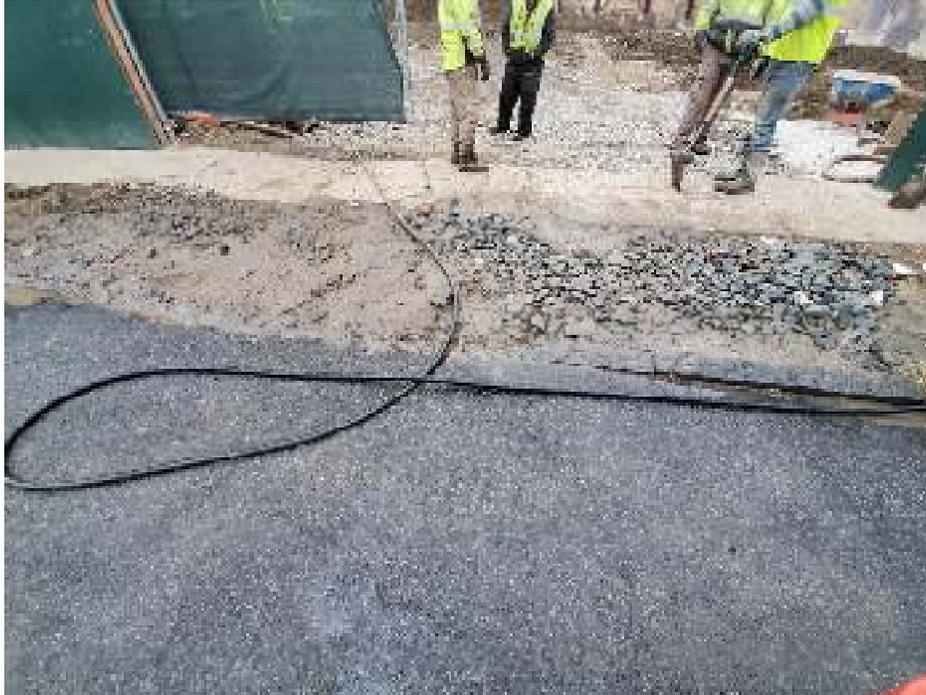
Photo 3: Construction entrance adjacent to Cottage Place, recommend refreshing.

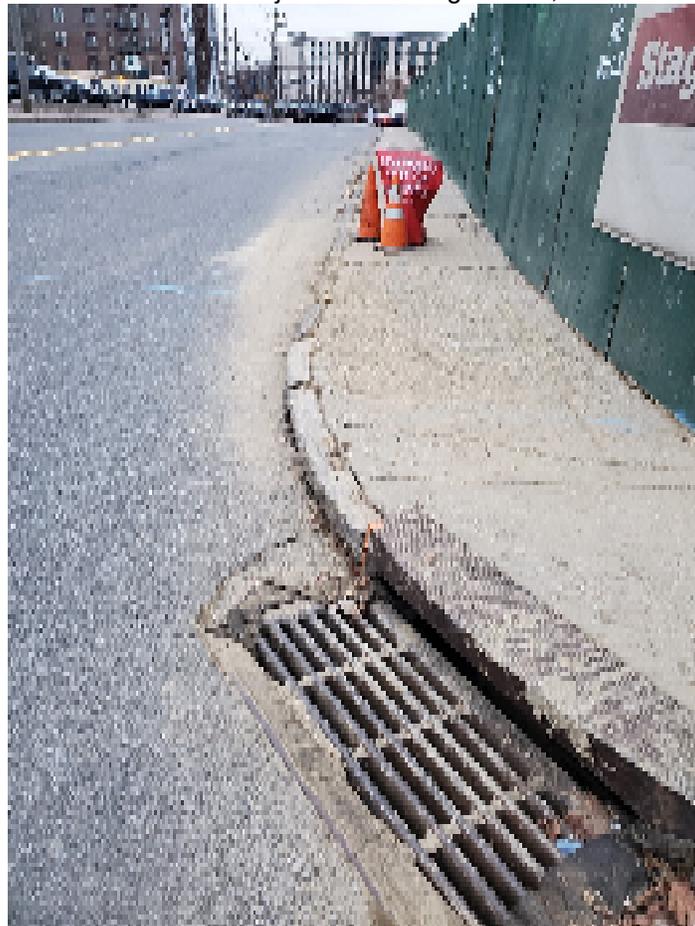
Photo 4: Sediment deposited on southwest corner of Garden Street and Cottage Place from water line discharge earlier in the week. Recommend replacing catch basin controls due to punctured fabric.

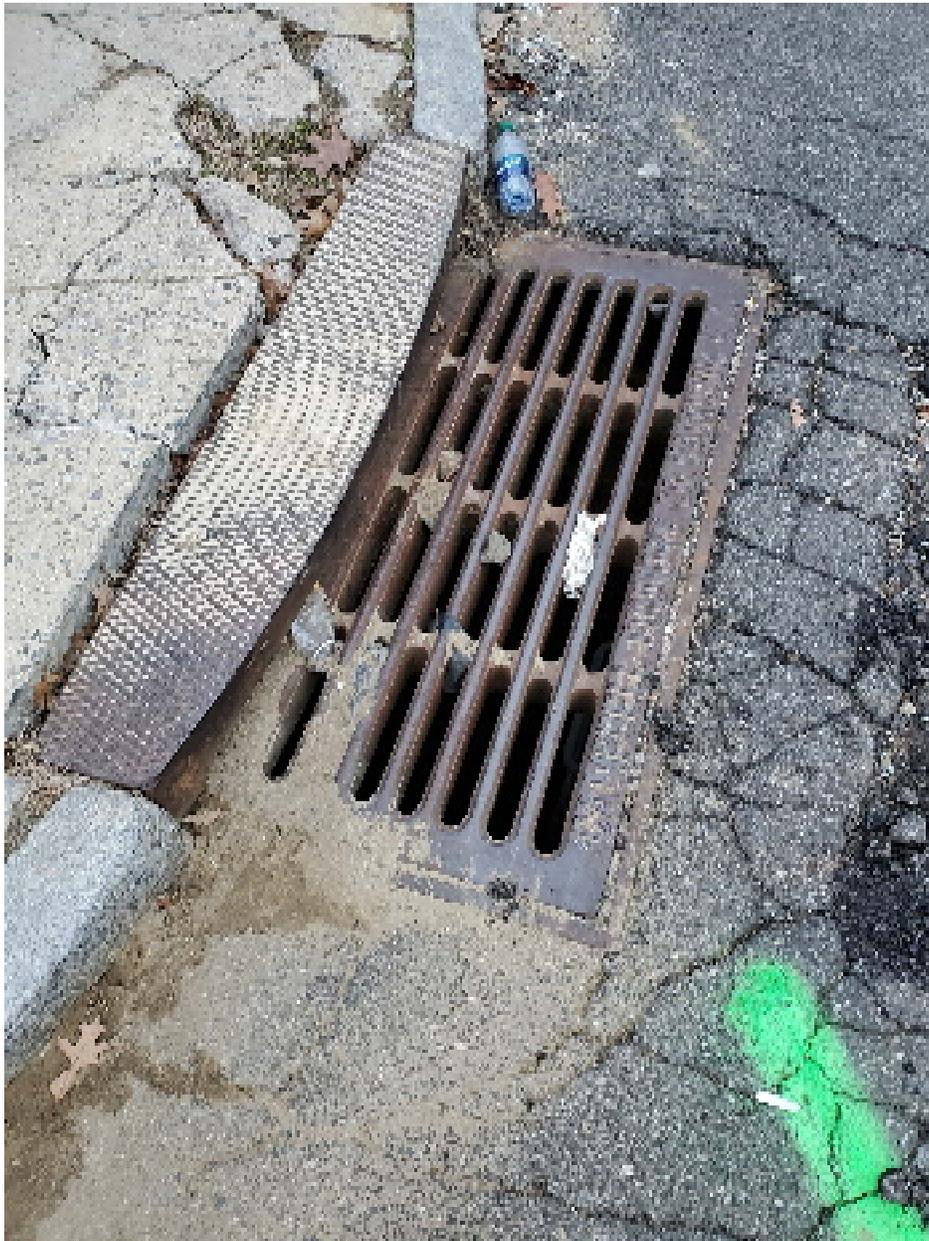
Photo 5: Catch basin on northwest corner of Garden Street and Cottage place. Recommend installing inlet protection controls.

- Catch basin inlet protections are recommended put in place, in accordance with the approved plans. The client states controls will be installed in the next week.

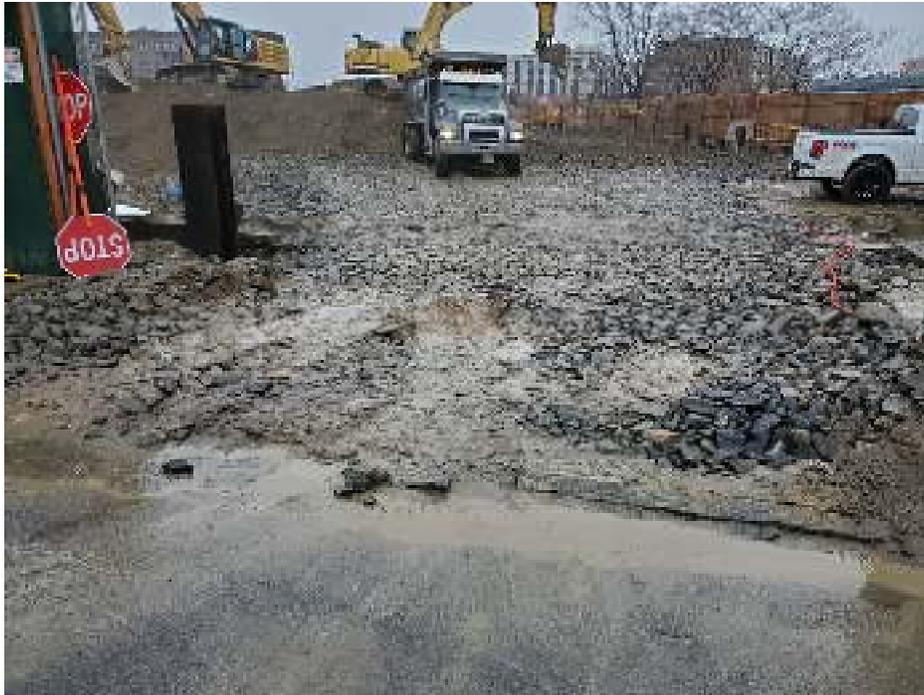
- The construction entrance/tracking pad has significant sediment deposit and is recommended to be refreshed with filter fabric and stone so as to adequately remove tracked sediment from vehicle tires. The client states the construction entrance will be refreshed in the next week.

Photo 1: Western-most construction entrance on Cottage Place. Recommend placing filter fabric and refreshing stone on the tracking pad to prevent soil pumping and off-Site tracking.

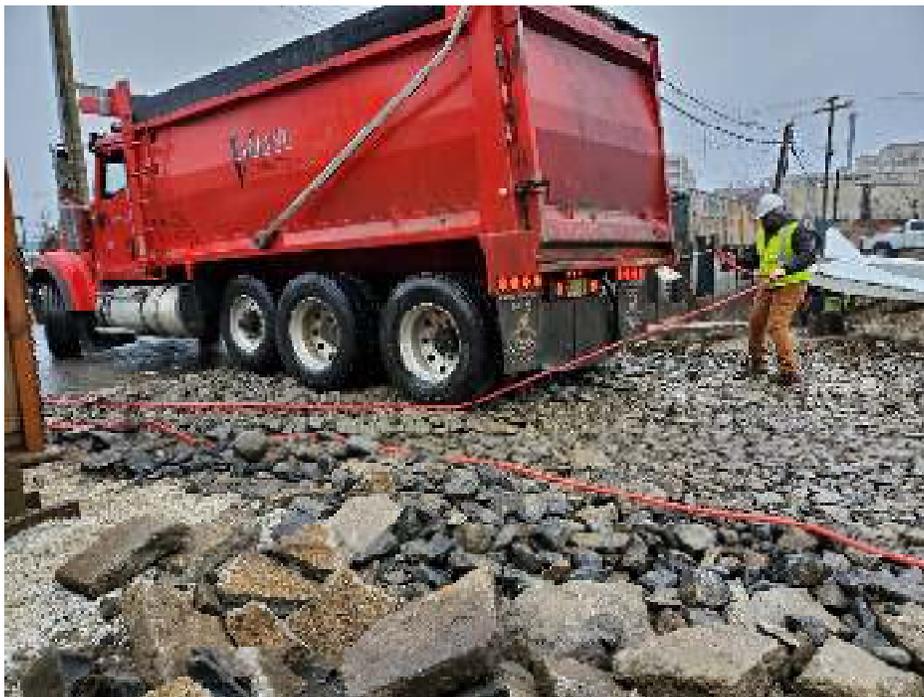
Photo 2: Contractor using water sprayer to clean tracked sediment off truck tires before leaving Site.

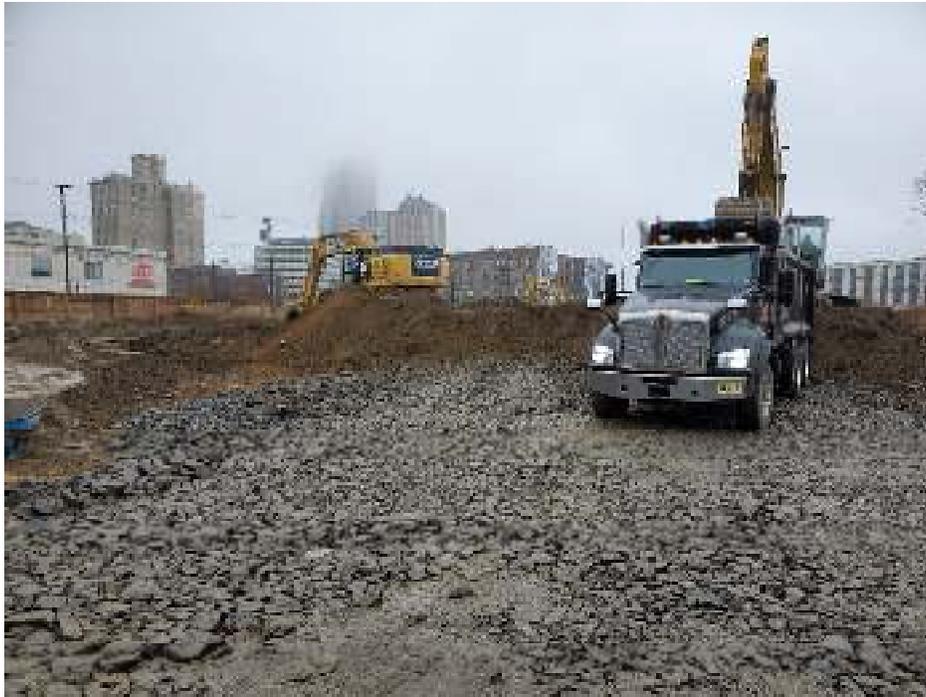
Photo 3: View of active soil stockpiles and truck-loading operations on northwest end of Site, facing south.

- The concrete washout has been removed from the site due to completion of concrete deliveries.
- There are several active stockpiles observed on-site. If left inactive for 14 days, we recommend placing silt fences around them to prevent sediment erosion.

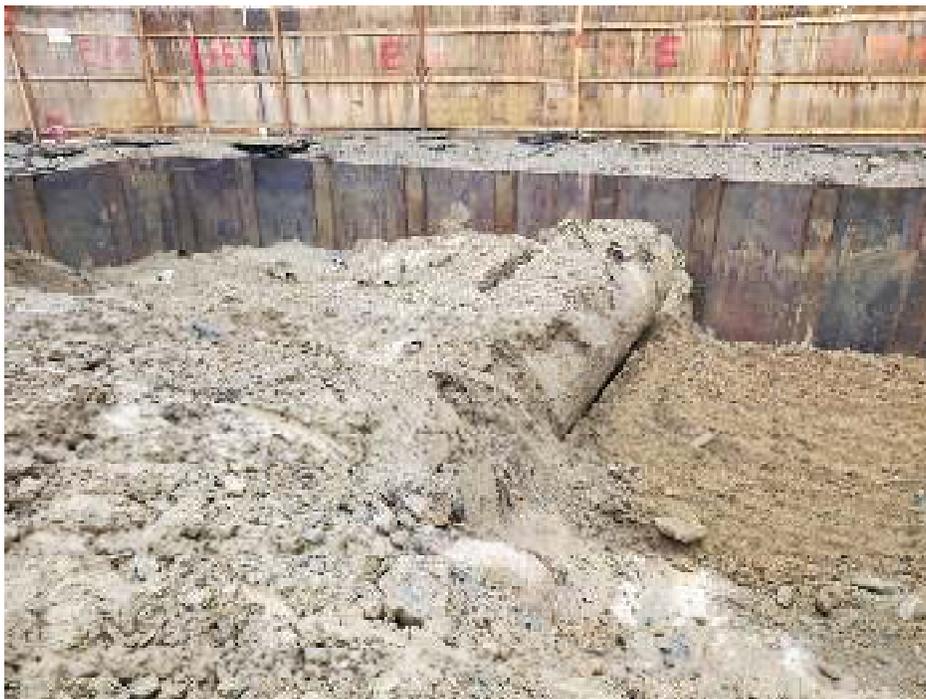
Photo 4: Sheets and piles acting as sediment barrier along vast majority of the perimeter of the Site.
