EROSION CONTROL INSPECTION CHECKLIST

**GARDEN STREET RESIDENCES
NEW ROCHELLE, NY 10901
SESI CONSULTING ENGINEERS PROJECT # 10491**

Date: 01/06/2020

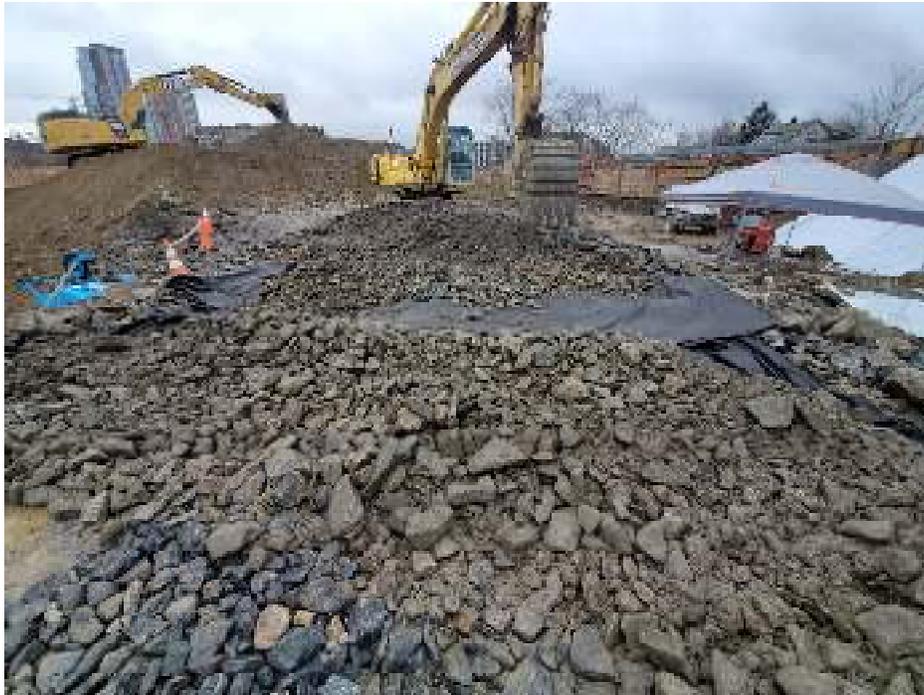
Photo 1: Construction entrance on Cottage Place. Contractor installing stone over filter fabric per SWPPP

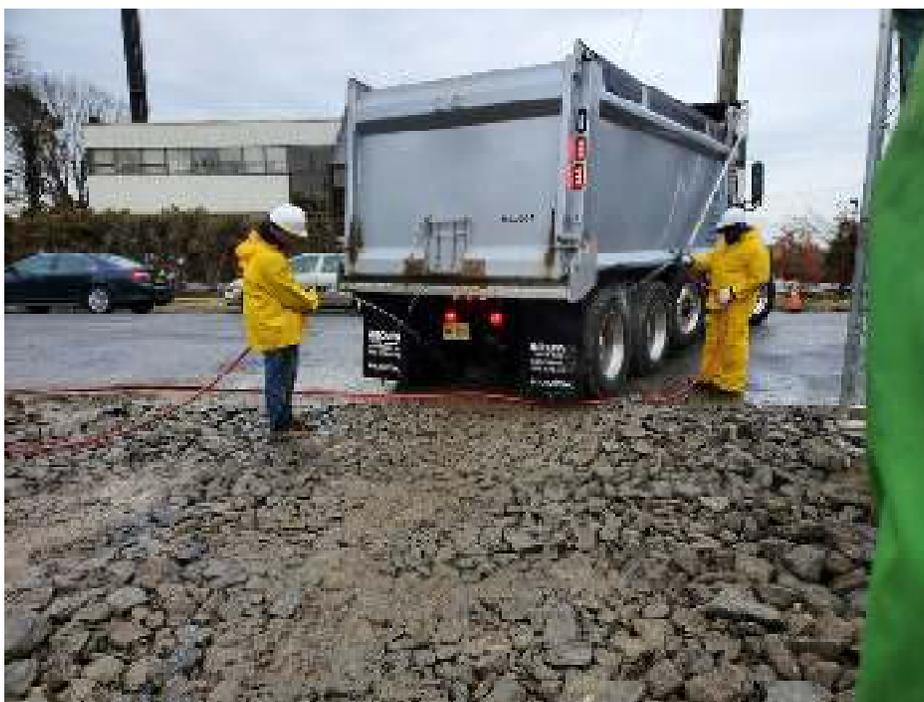
Photo 2: Contractor using water sprayer to clean tracked sediment off truck tires before leaving Site.

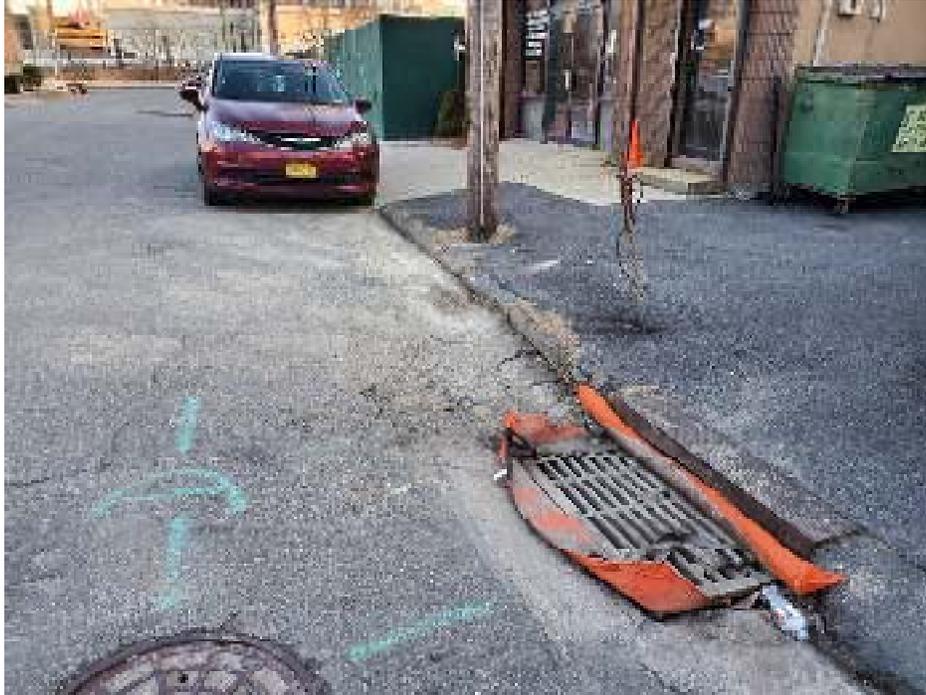
Catch basin inlet protections are installed on 3 of 4 catch basins, with modification recommended to properly filter all sediment-laden water that leaves the Site.

Photo 3: View of inlet protection practice installed over catch basin on northwest side of Cottage Place. Further modification of installation and removal of accumulated sediment is recommended to properly filter all drained sediment in inlet protection practices

- Catch basin inlet protections have been placed in 3 of the 4 catch basins, in accordance with the approved plans. Additional modification is recommended to properly catch all sediment-laden water flows. The client states updated controls will be installed in the next week.

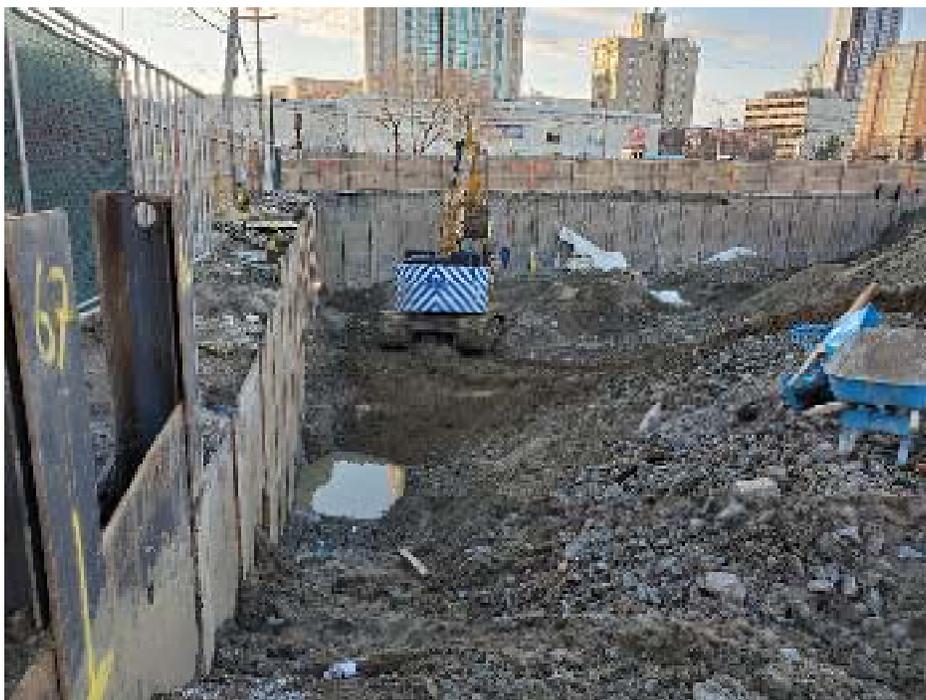
Photo 4: Sheets and piles acting as sediment barrier along vast majority of the perimeter of the Site.

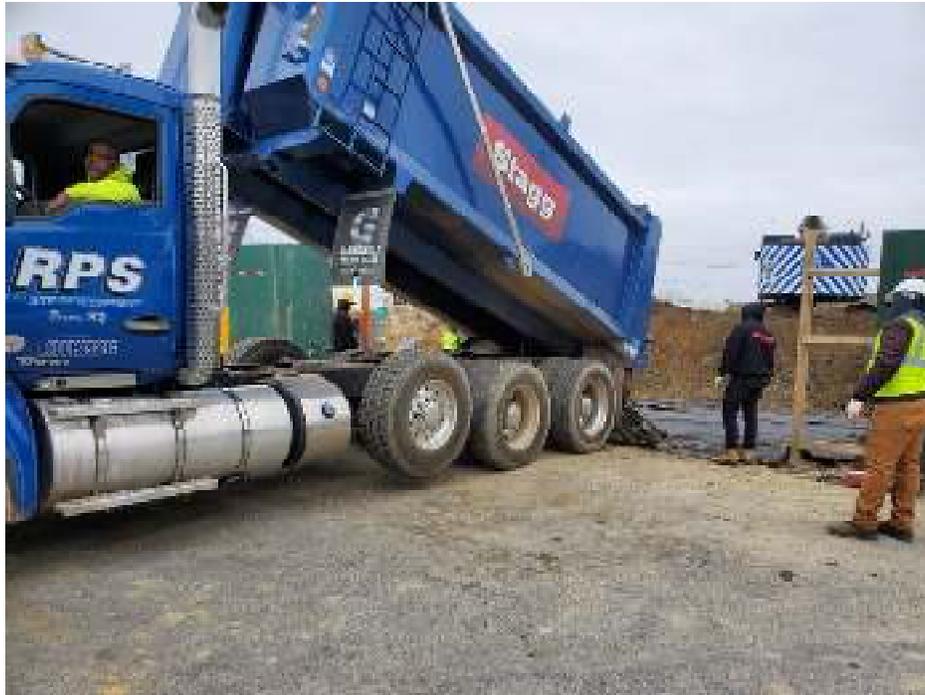
Photo 1: Construction of tracking pad on southern border of site, adjacent to existing parking lot

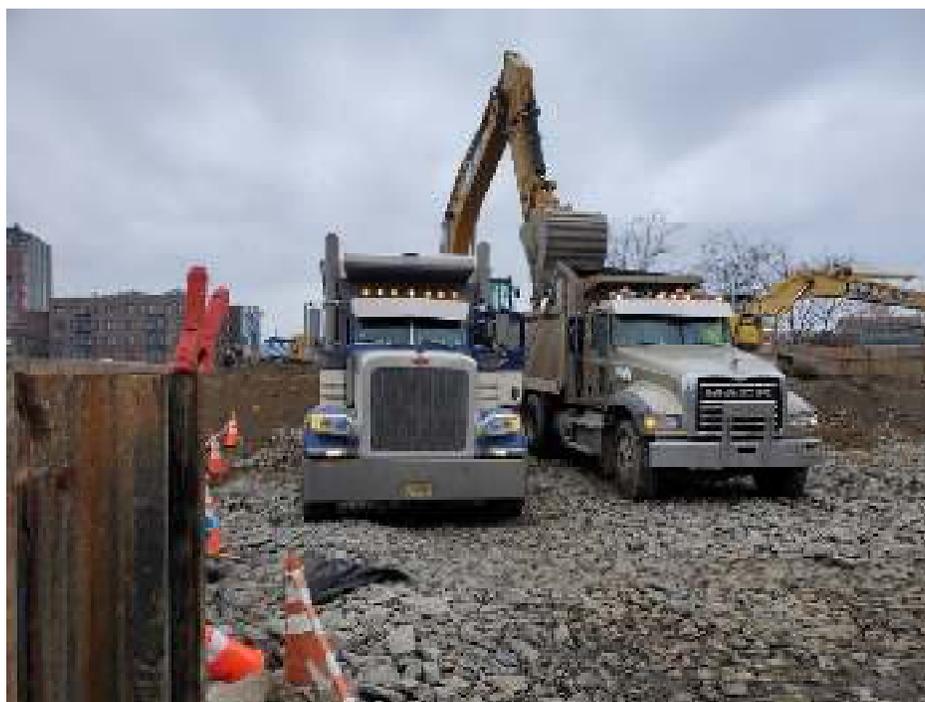
Photo 2: Contractor loading out trucks on Cottage Place construction entrance

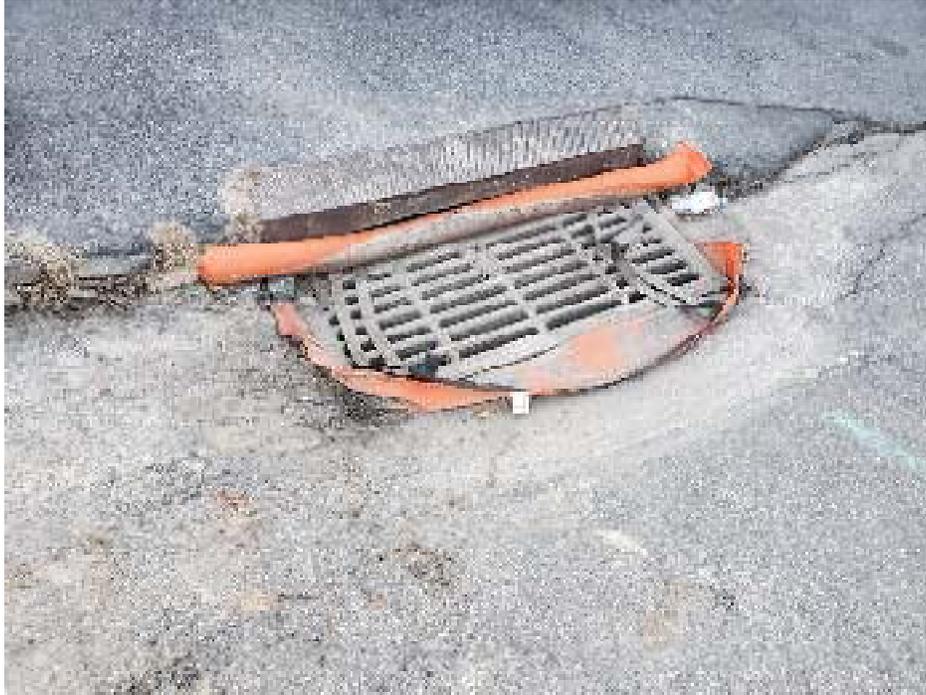
Catch basin inlet protections are installed on 3 of 4 catch basins. The catch basin inlet protection on the northwest end of Cottage Place is over 50% filled with sediment and is recommended to be cleaned out.

Photo 3: View of inlet protection practice installed over catch basin on northwest side of Cottage Place. Further modification of installation and removal of accumulated sediment is recommended to properly filter all drained sediment in inlet protection practices

- Catch basin inlet protections have been placed in 3 of the 4 catch basins, in accordance with the approved plans. Additional modification is recommended to properly catch all sediment-laden water flows, and the inlet protection on the western end of Cottage Place is recommended for replacement due to overfilled and oily condition. The client states updated controls will be installed in the next week.

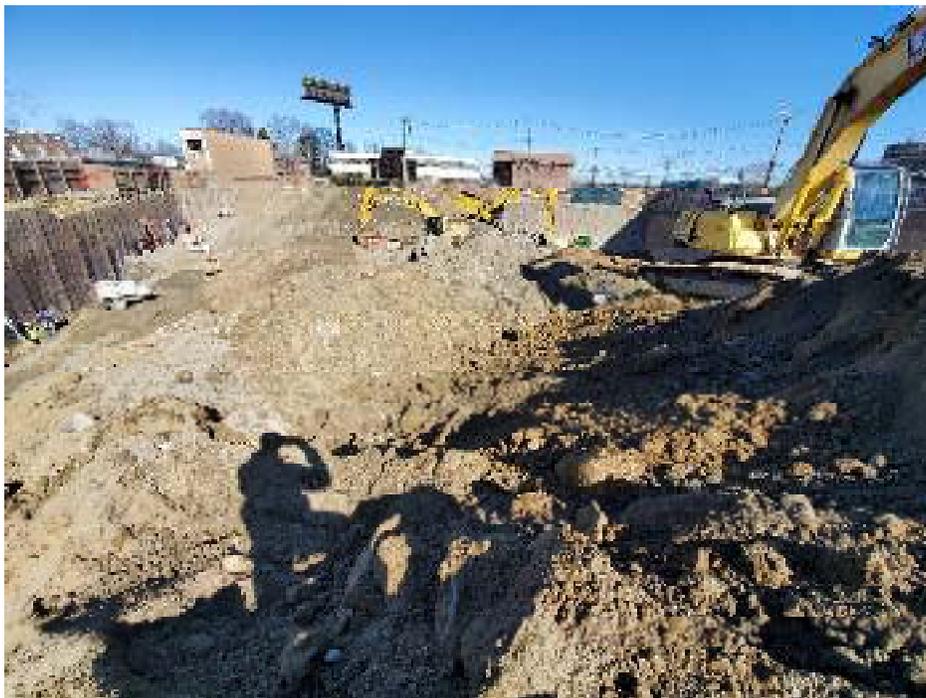
Photo 4: Sheets and piles acting as sediment barrier along vast majority of the perimeter of the Site.

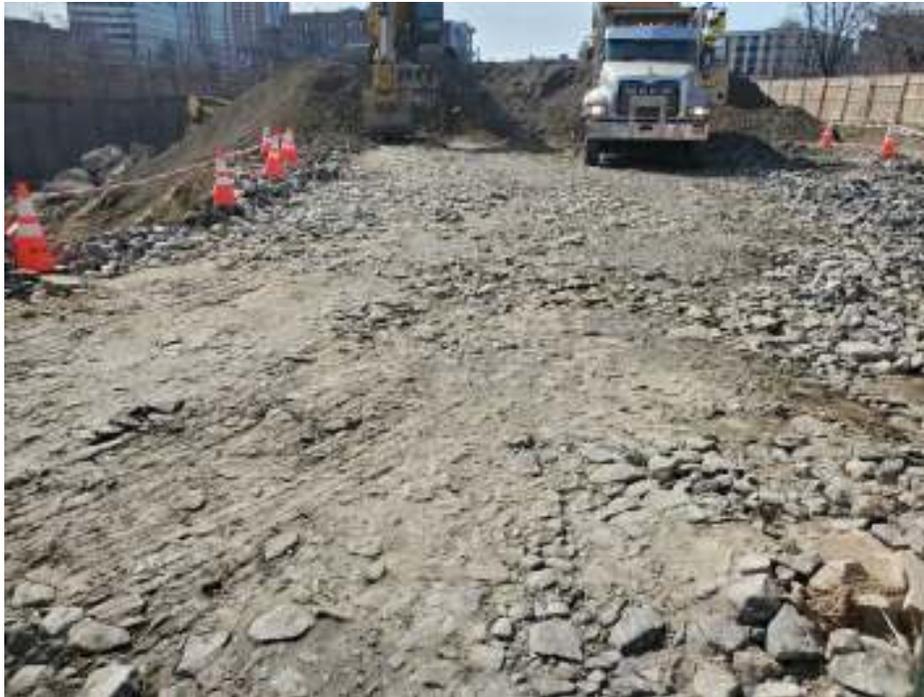
Photo 1: Tracking pad/construction entrance to Cottage Place. Deposited sediment is insufficiently cleaning tracked soils from vehicle tires. Recommend refreshing stone at entrance.

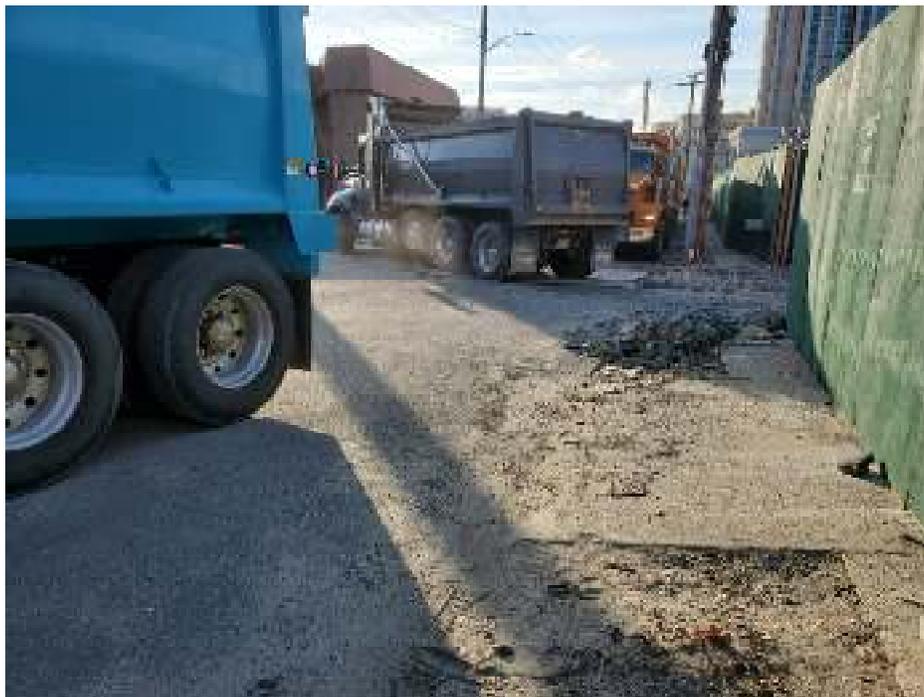
Photo 2: Photograph of visibly dusty conditions due to sediment being tracked off-site along Cottage Place.

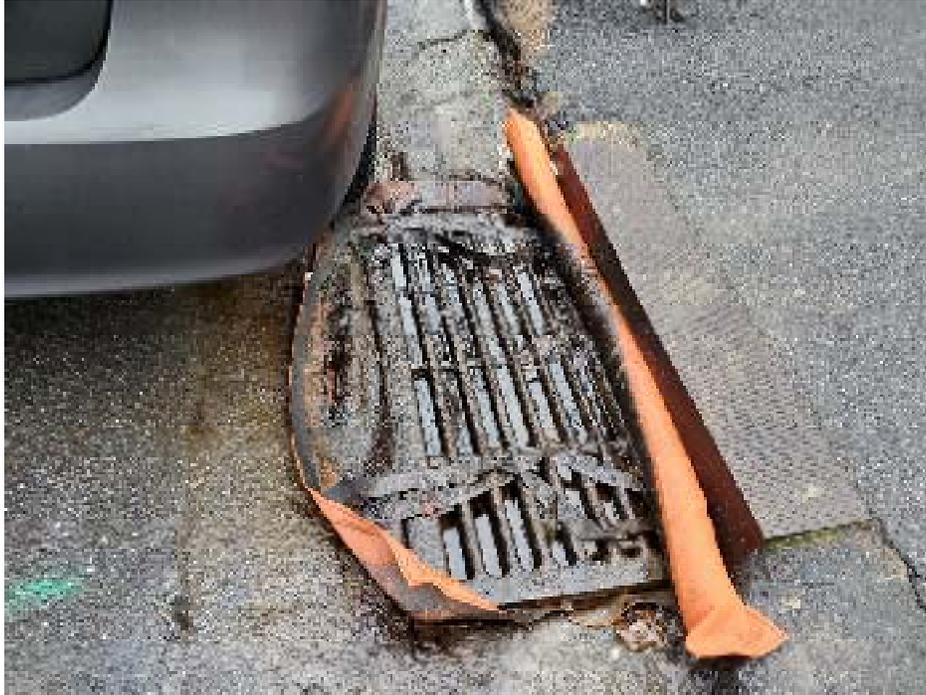
Catch basin inlet protections are installed on 3 of 4 catch basins. The catch basin inlet protection on the northwest end of Cottage Place is over 75% filled with sediment, visibly oily and no longer functioning as intended. Recommend replacement

Photo 3: View of inlet protection practice installed over catch basin on northwest end of Cottage Place. Replacement of the inlet protection is recommended due to oily condition and accumulated sediment to properly filter all drained sediment in inlet protection practices

- Catch basin inlet protections have been placed in 3 of the 4 catch basins, in accordance with the approved plans. Additional modification is recommended to properly catch all sediment-laden water flows, and the inlet protection on the western end of Cottage Place is recommended for replacement due to overfilled and oily condition. The client states updated controls will be installed in the next week.

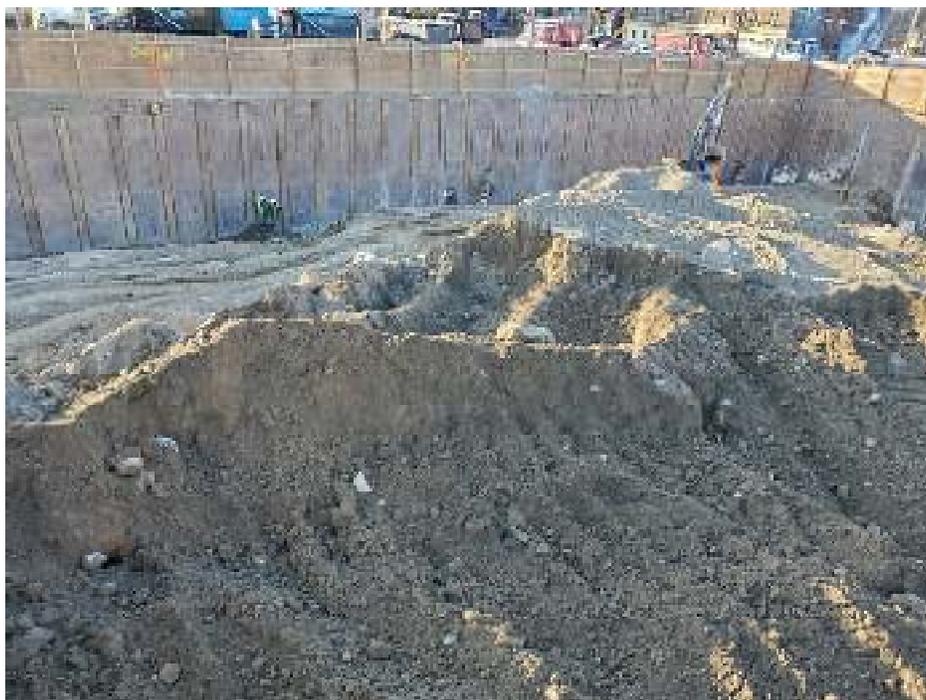
Photo 4: Sheets and piles acting as sediment barrier along vast majority of the perimeter of the Site.

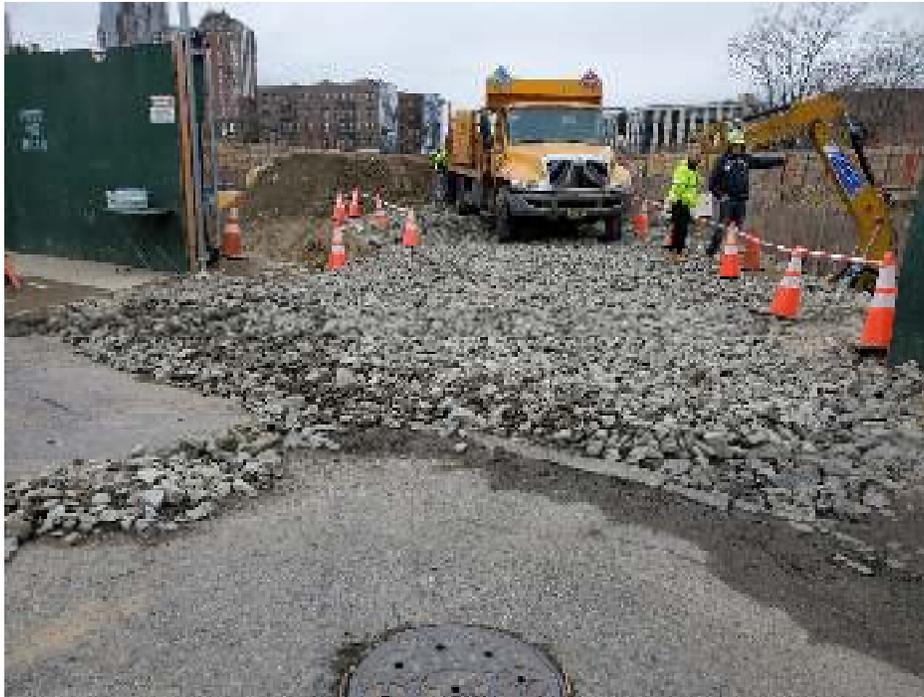
Photo 1: Tracking pad/construction entrance to Cottage Place. Recently placed stone is sufficiently cleaning tracked soils from vehicle tires. No modifications recommended.

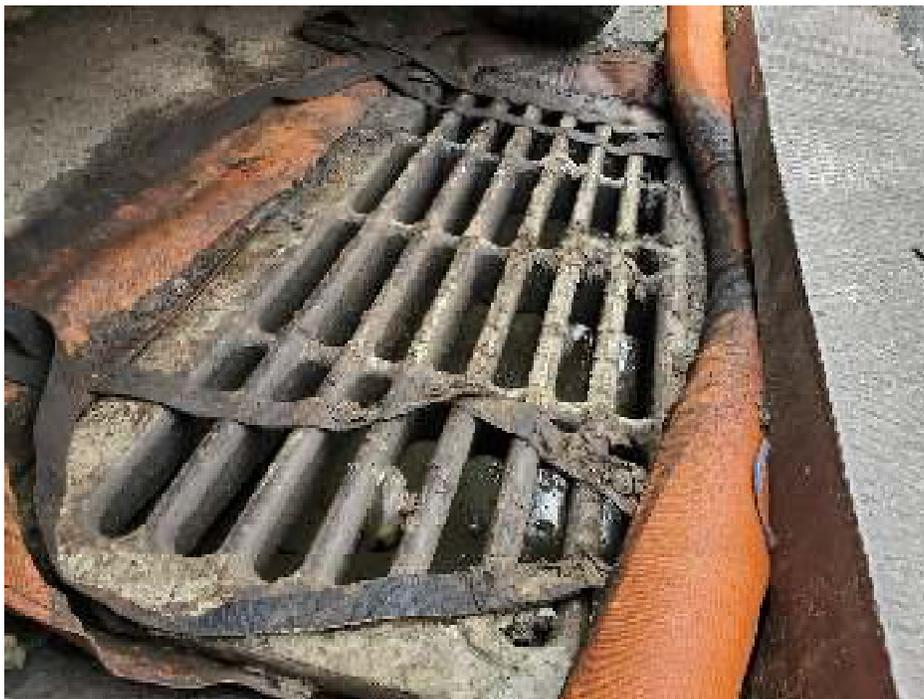
Catch basin inlet protections are installed on 3 of 4 catch basins. The catch basin inlet protection on the northwest end of Cottage Place is over 75% filled with sediment, visibly oily and no longer functioning as intended. Recommend replacement

Photo 2: View of inlet protection practice installed over catch basin on northwest end of Cottage Place. Replacement of the inlet protection is recommended due to oily condition and accumulated sediment to properly filter all drained sediment in inlet protection practices

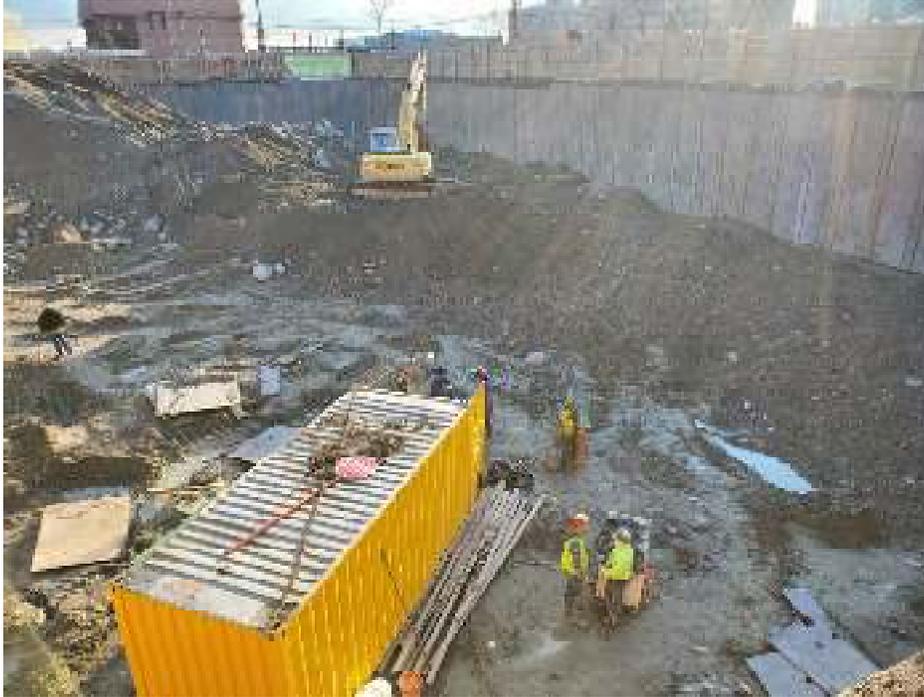
Photo 3: Sheets and piles acting as sediment barrier along vast majority of the perimeter of the Site.

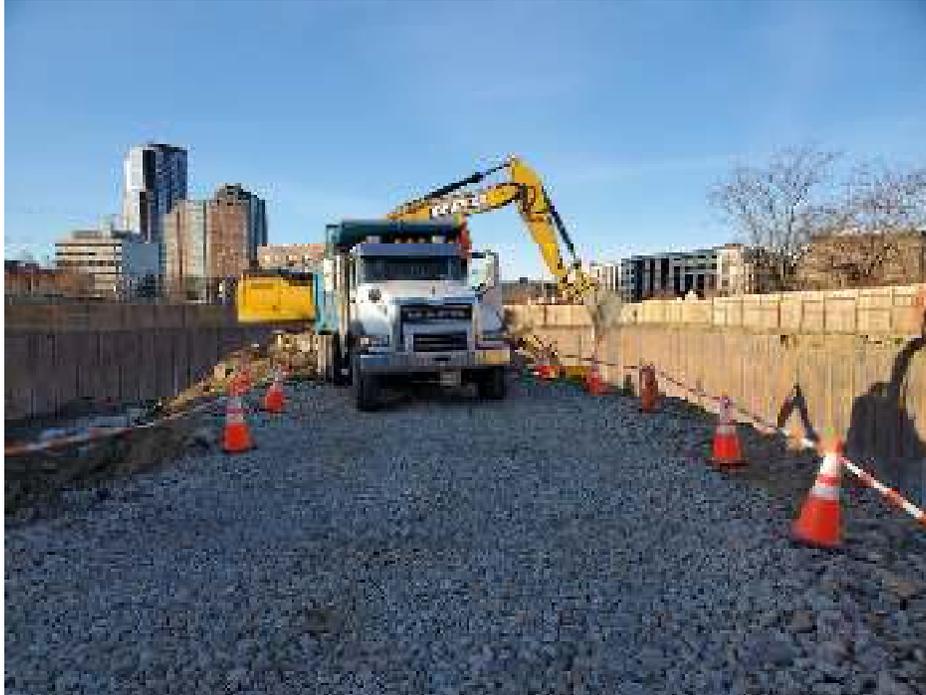
Photo 1: Tracking pad/construction entrance to Cottage Place. Recently placed stone is sufficiently cleaning tracked soils from vehicle tires. No modifications recommended.

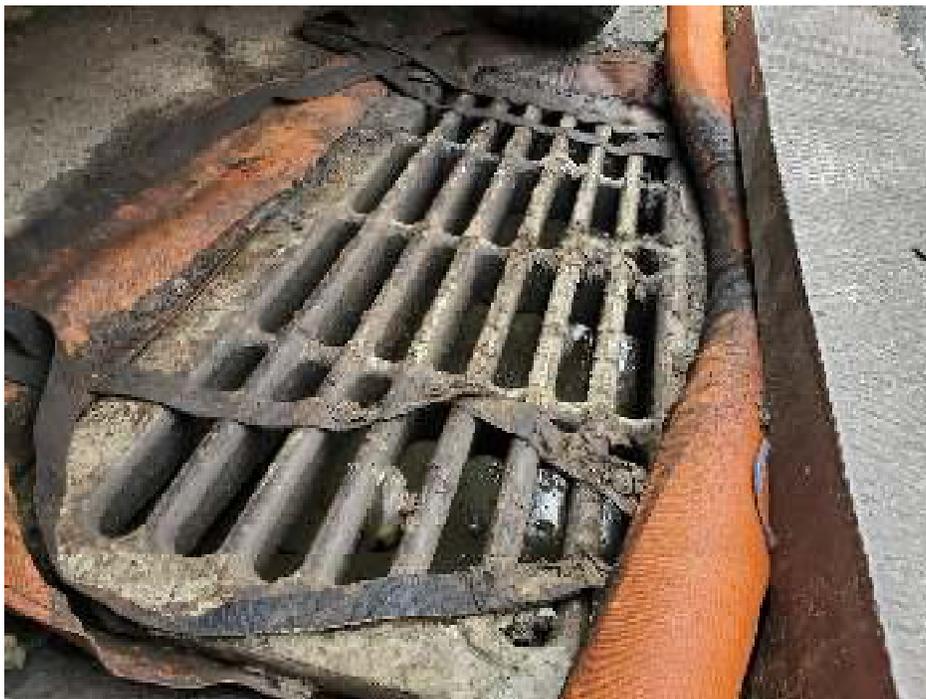
Photo 2: View of inlet protection practice installed over catch basin on northwest end of Cottage Place. Replacement of the inlet protection is recommended due to oily condition and accumulated sediment to properly filter all drained sediment in inlet protection practices

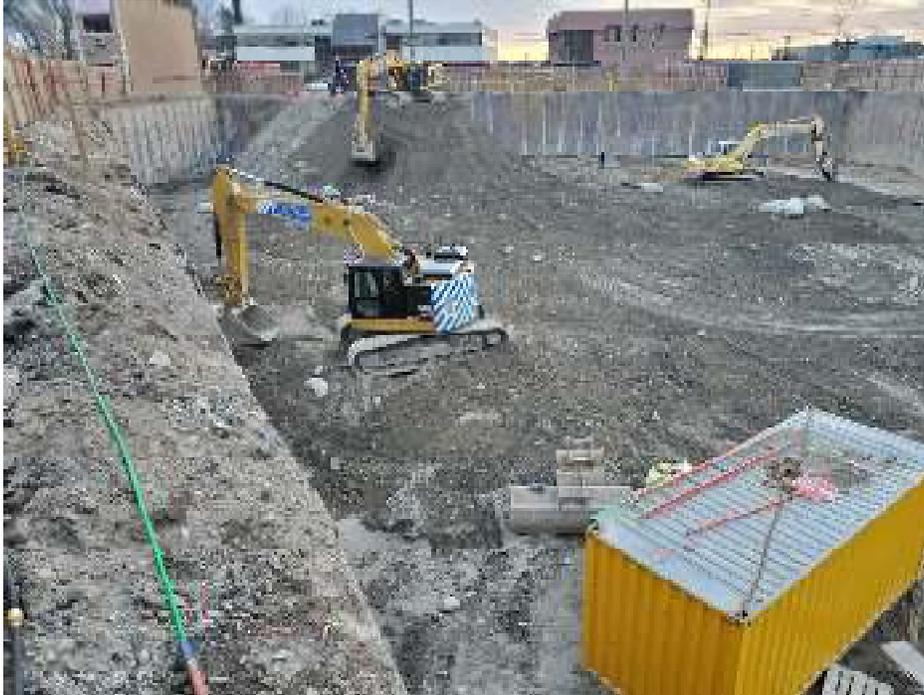
Photo 3: Sheets and piles acting as sediment barrier along vast majority of the perimeter of the Site.

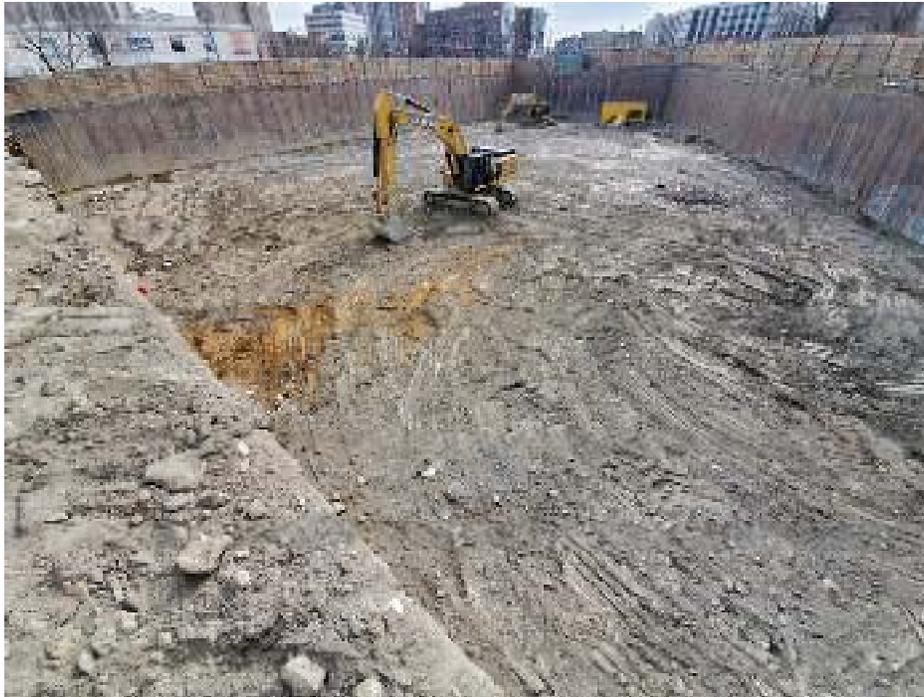
Photo 1: Excavation area currently inactive, view from Cottage Place. Photograph taken on 3/18/20. Sheets and piles acting as sediment barrier along vast majority of the Site perimeter.

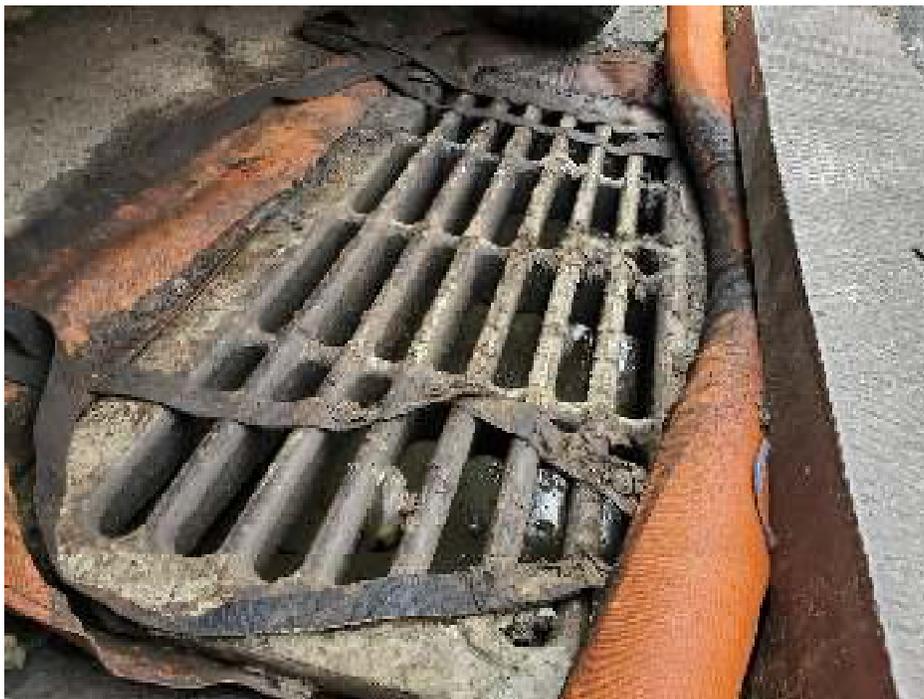
Photo 2: View of inlet protection practice installed over catch basin on northwest end of Cottage Place. Replacement of the inlet protection is recommended due to oily condition and accumulated sediment to properly filter all drained sediment in inlet protection practices.
