## PHASE II ENVIRONMENTAL SITE ASSESSMENT

130 Midland Avenue | Port Chester, New York  
PM Project Number 19-3641-0-0002

**RE: Phase II Environmental Site Assessment  
For the Commercial Property  
Located at 130 Midland Avenue in Port Chester, New York  
PM Environmental, Inc. Project No. 19-3641-0-0002**

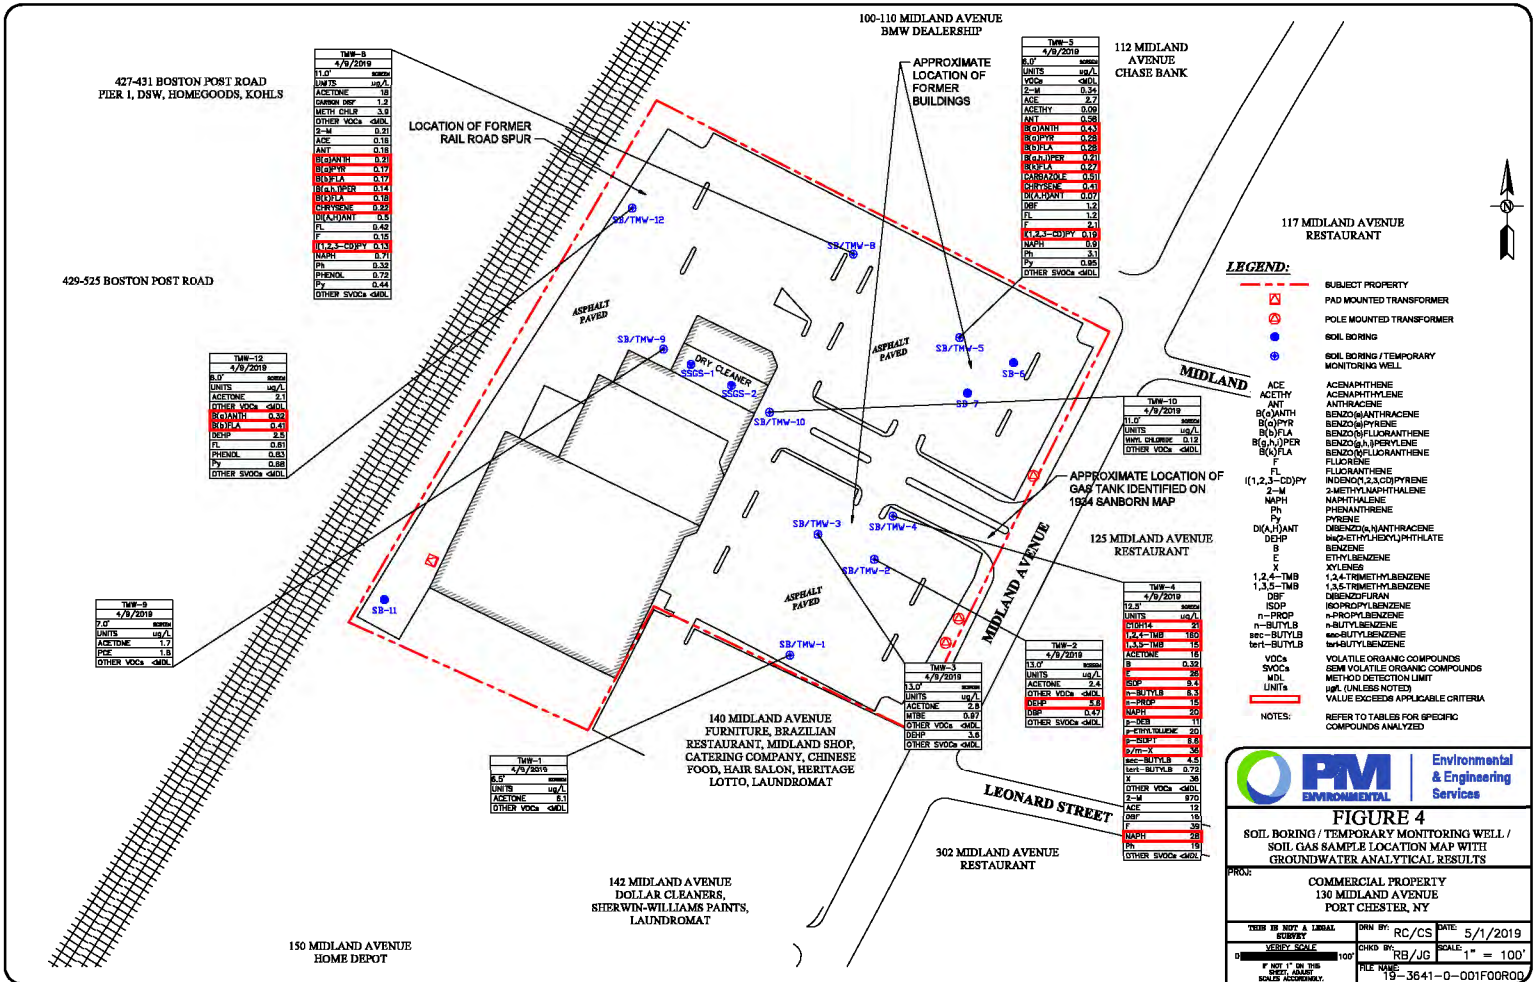
The groundwater analytical results are summarized on Figure 4 and in Table 2. The laboratory analytical reports are included as Appendix B.

Select VOCs were detected above their respective laboratory MDLs in groundwater samples TMW-1 through TMW-4, TMW-8 through TMW-10, and TMW-12. Groundwater sample TMW-4 reported 1,2,4,5-tetramethylbenzene, 1,2,4-trimethylbenzene, 1,3,5-trimethylbenzene, ethylbenzene, isopropylbenzene, n-butylbenzene, n-propylbenzene, and naphthalene at concentrations above the TOGS AWQS GA standards.

Select SVOCs were detected above their respective laboratory MDLs in groundwater samples TMW-2 through TMW-5, TMW-8, and TMW-12. Additionally, concentrations of benzo(a)anthracene (TMW-5, TMW-8, and TMW-12), benzo(a)pyrene (TMW-5 and TMW-8), benzo(b)fluoranthene (TMW-5, TMW-8, and TMW-12), benzo(k)fluoranthene (TMW-5 and TMW-8), bis(2-ethylhexyl)phthalate (TMW-2), chrysene (TMW-5 and TMW-8), and indeno(1,2,3-cd)pyrene (TMW-5 and TMW-8), and naphthalene (TMW-4) were reported in excess of TOGS AWQS GA standards.

Based on the groundwater analytical results, numerous concentrations of select VOCs and SVOCs, many of which considered petroleum-related compounds, were reported in TMW-4 in excess of TOGS AWQS GA. Additionally, concentrations of select SVOCs were reported in excess of TOGS AWQS GA in TMW-2, TMW-5, TMW-8, and TMW-12. Therefore, PM recommends additional investigation to delineate the vertical and horizontal extents of these groundwater impacts at the subject property in order to determine an appropriate remedial strategy.

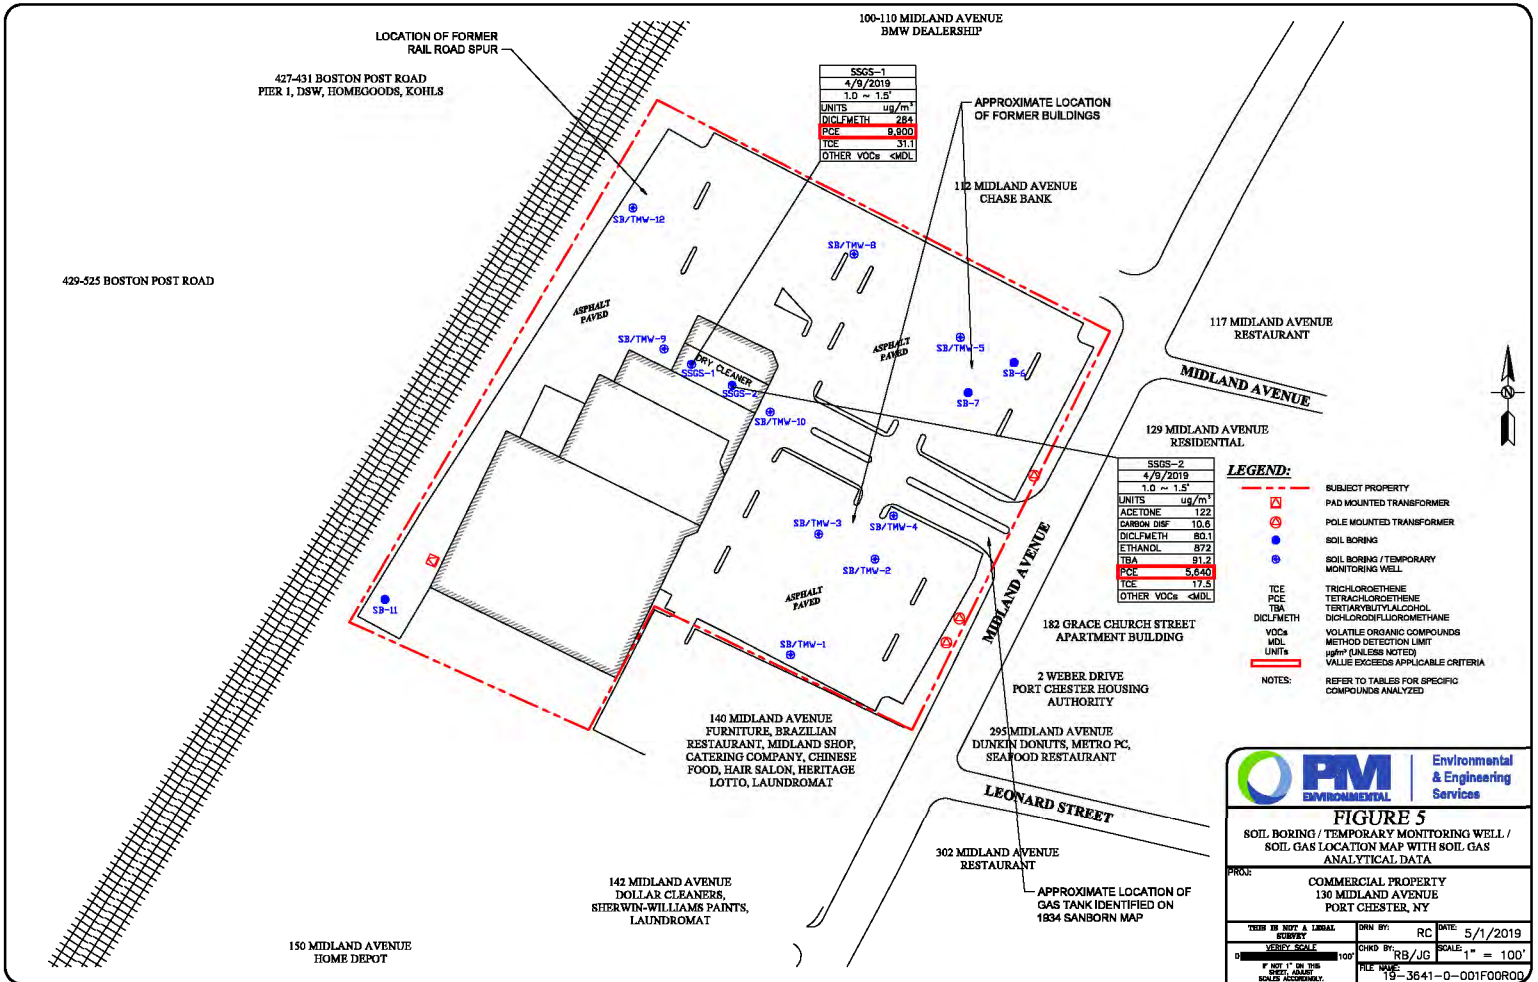
The soil gas analytical results are summarized on Figure 5 and in Table 3. The laboratory analytical reports are included as Appendix B.

Select VOCs were detected in sub-slab soil gas samples SSGS-1 and SSGS-2 at concentrations above the respective laboratory MDLs and below applicable screening levels. SSGS-1 and SSGS-2 each reported tetrachloroethene (PCE) concentrations in excess of the EPA-VISLs for Commercial Sub Slab Soil Gas Screening Concentrations. This indicates that a vapor encroachment condition exists in the former drycleaner tenant space of the subject property building.

Based on the soil gas analytical results, concentrations of PCE exceeding the EPA-VISL have been identified in the sub-slab soil gas beneath the leasehold space at the subject property formerly occupied by a dry-cleaning operation. Therefore, PM recommends further investigation of soil and groundwater directly beneath the leasehold space in order to verify whether a release has occurred as well as a soil gas and indoor air investigation for the adjacent tenant spaces (currently occupied by a pizzeria restaurant and a liquor store) to determine if a vapor exposure pathway exists for either space, and/or whether vapor controls may be necessary.
