Re: Monthly Progress Report – April 2023  
Former United Hospital – 406 Boston Post Road, Port Chester, New York  
NYSDEC BCP Site No. C360202

**Attachment A**  
**Daily Activity Reports**

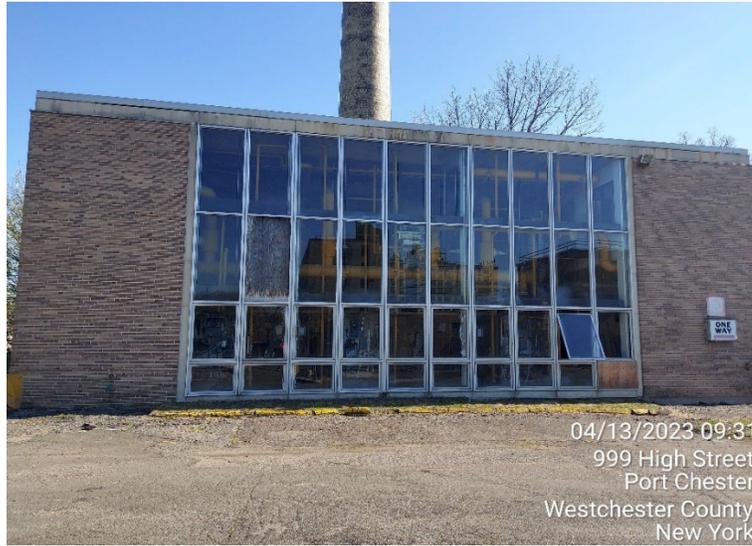
**Photograph 1 - A**  
view of the work area  
prior to mobilization,  
view facing north.

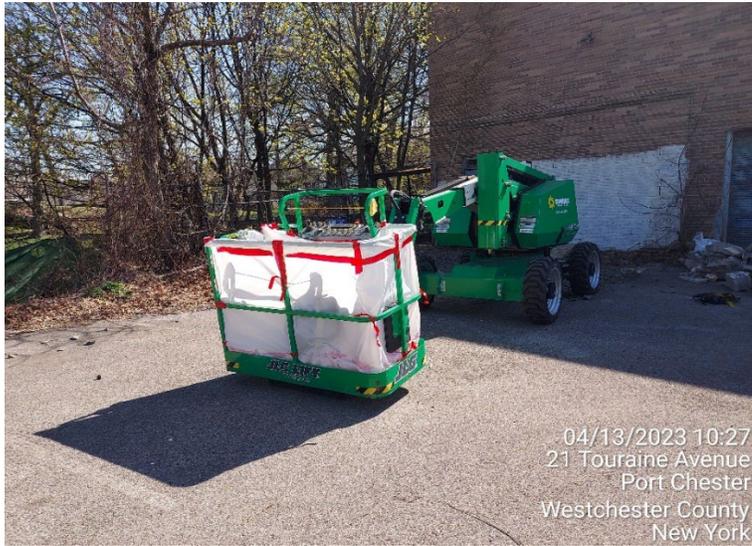
**Photograph 2 -**  
Preparation of the  
work area and boom  
lift with poly, view  
facing northeast.

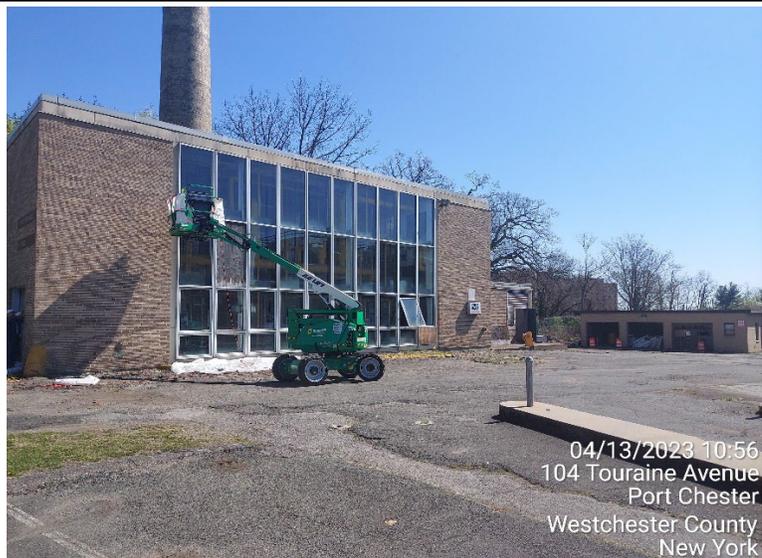
**Photograph 3 -**  
Abatement of  
asbestos- and PCB-  
containing caulking  
at the former power  
plant using hand  
tools, view facing  
east.

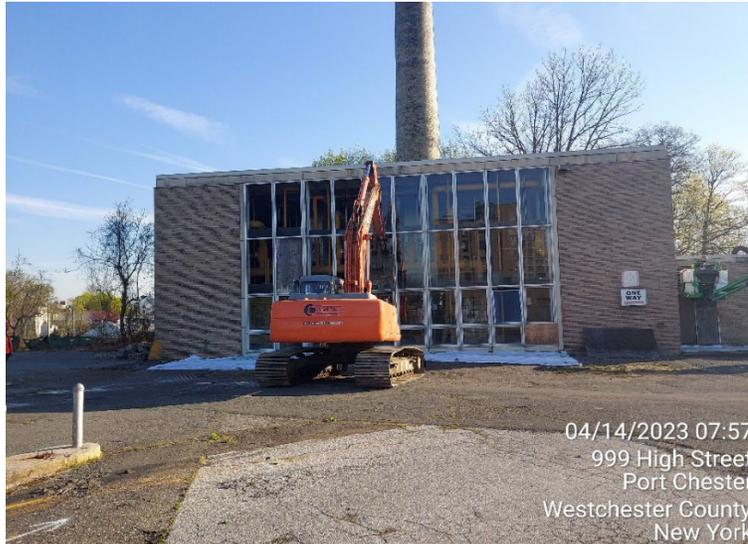
**Photograph 1 -**  
Breaking windows on the former power plant building to facilitate the abatement of asbestos and PCB-containing caulking, view facing north.

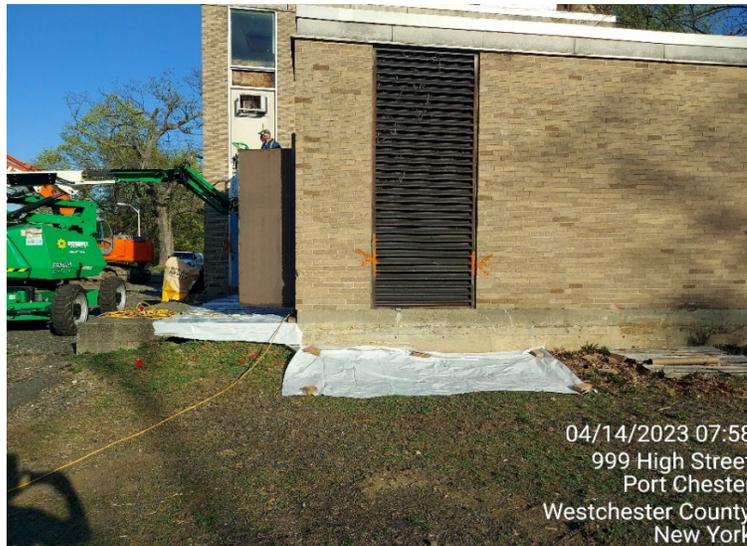
**Photograph 2 -**  
Abatement of asbestos- and PCB-containing caulking at the former power plant using hand tools, view facing west.

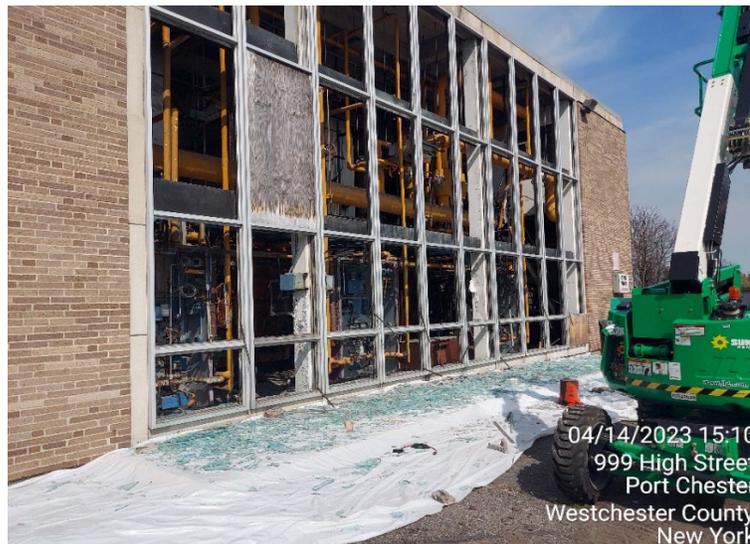
**Photograph 3 -**  
Abatement of asbestos- and PCB-containing caulking at the former power plant using hand tools, view facing northeast.
